**CONSOLIDATED SEWER MAINTENANCE DISTRICT
CONDITION-ASSESSMENT PROGRAM REPORT
PROJECT NO. Y0TV1415B**

**CONDITION-ASSESSMENT REPORT
LOS ANGELES COUNTY PUBLIC WORKS
CONSOLIDATED SEWER MAINTENANCE DISTRICT**

PROJECT NAME:	Y0TV1415B	PROJECT MGR:	Eric Liu
PROJECT DATE:	1/5/2016	CONTACT NO:	(626) 300-3369
SUP. DISTRICT(s):	1	MAP PAGE(S):	1065, 1066, 1090, 1091, 1118
Report By:	Jonathan Gonzalez	Report Date:	11/26/18

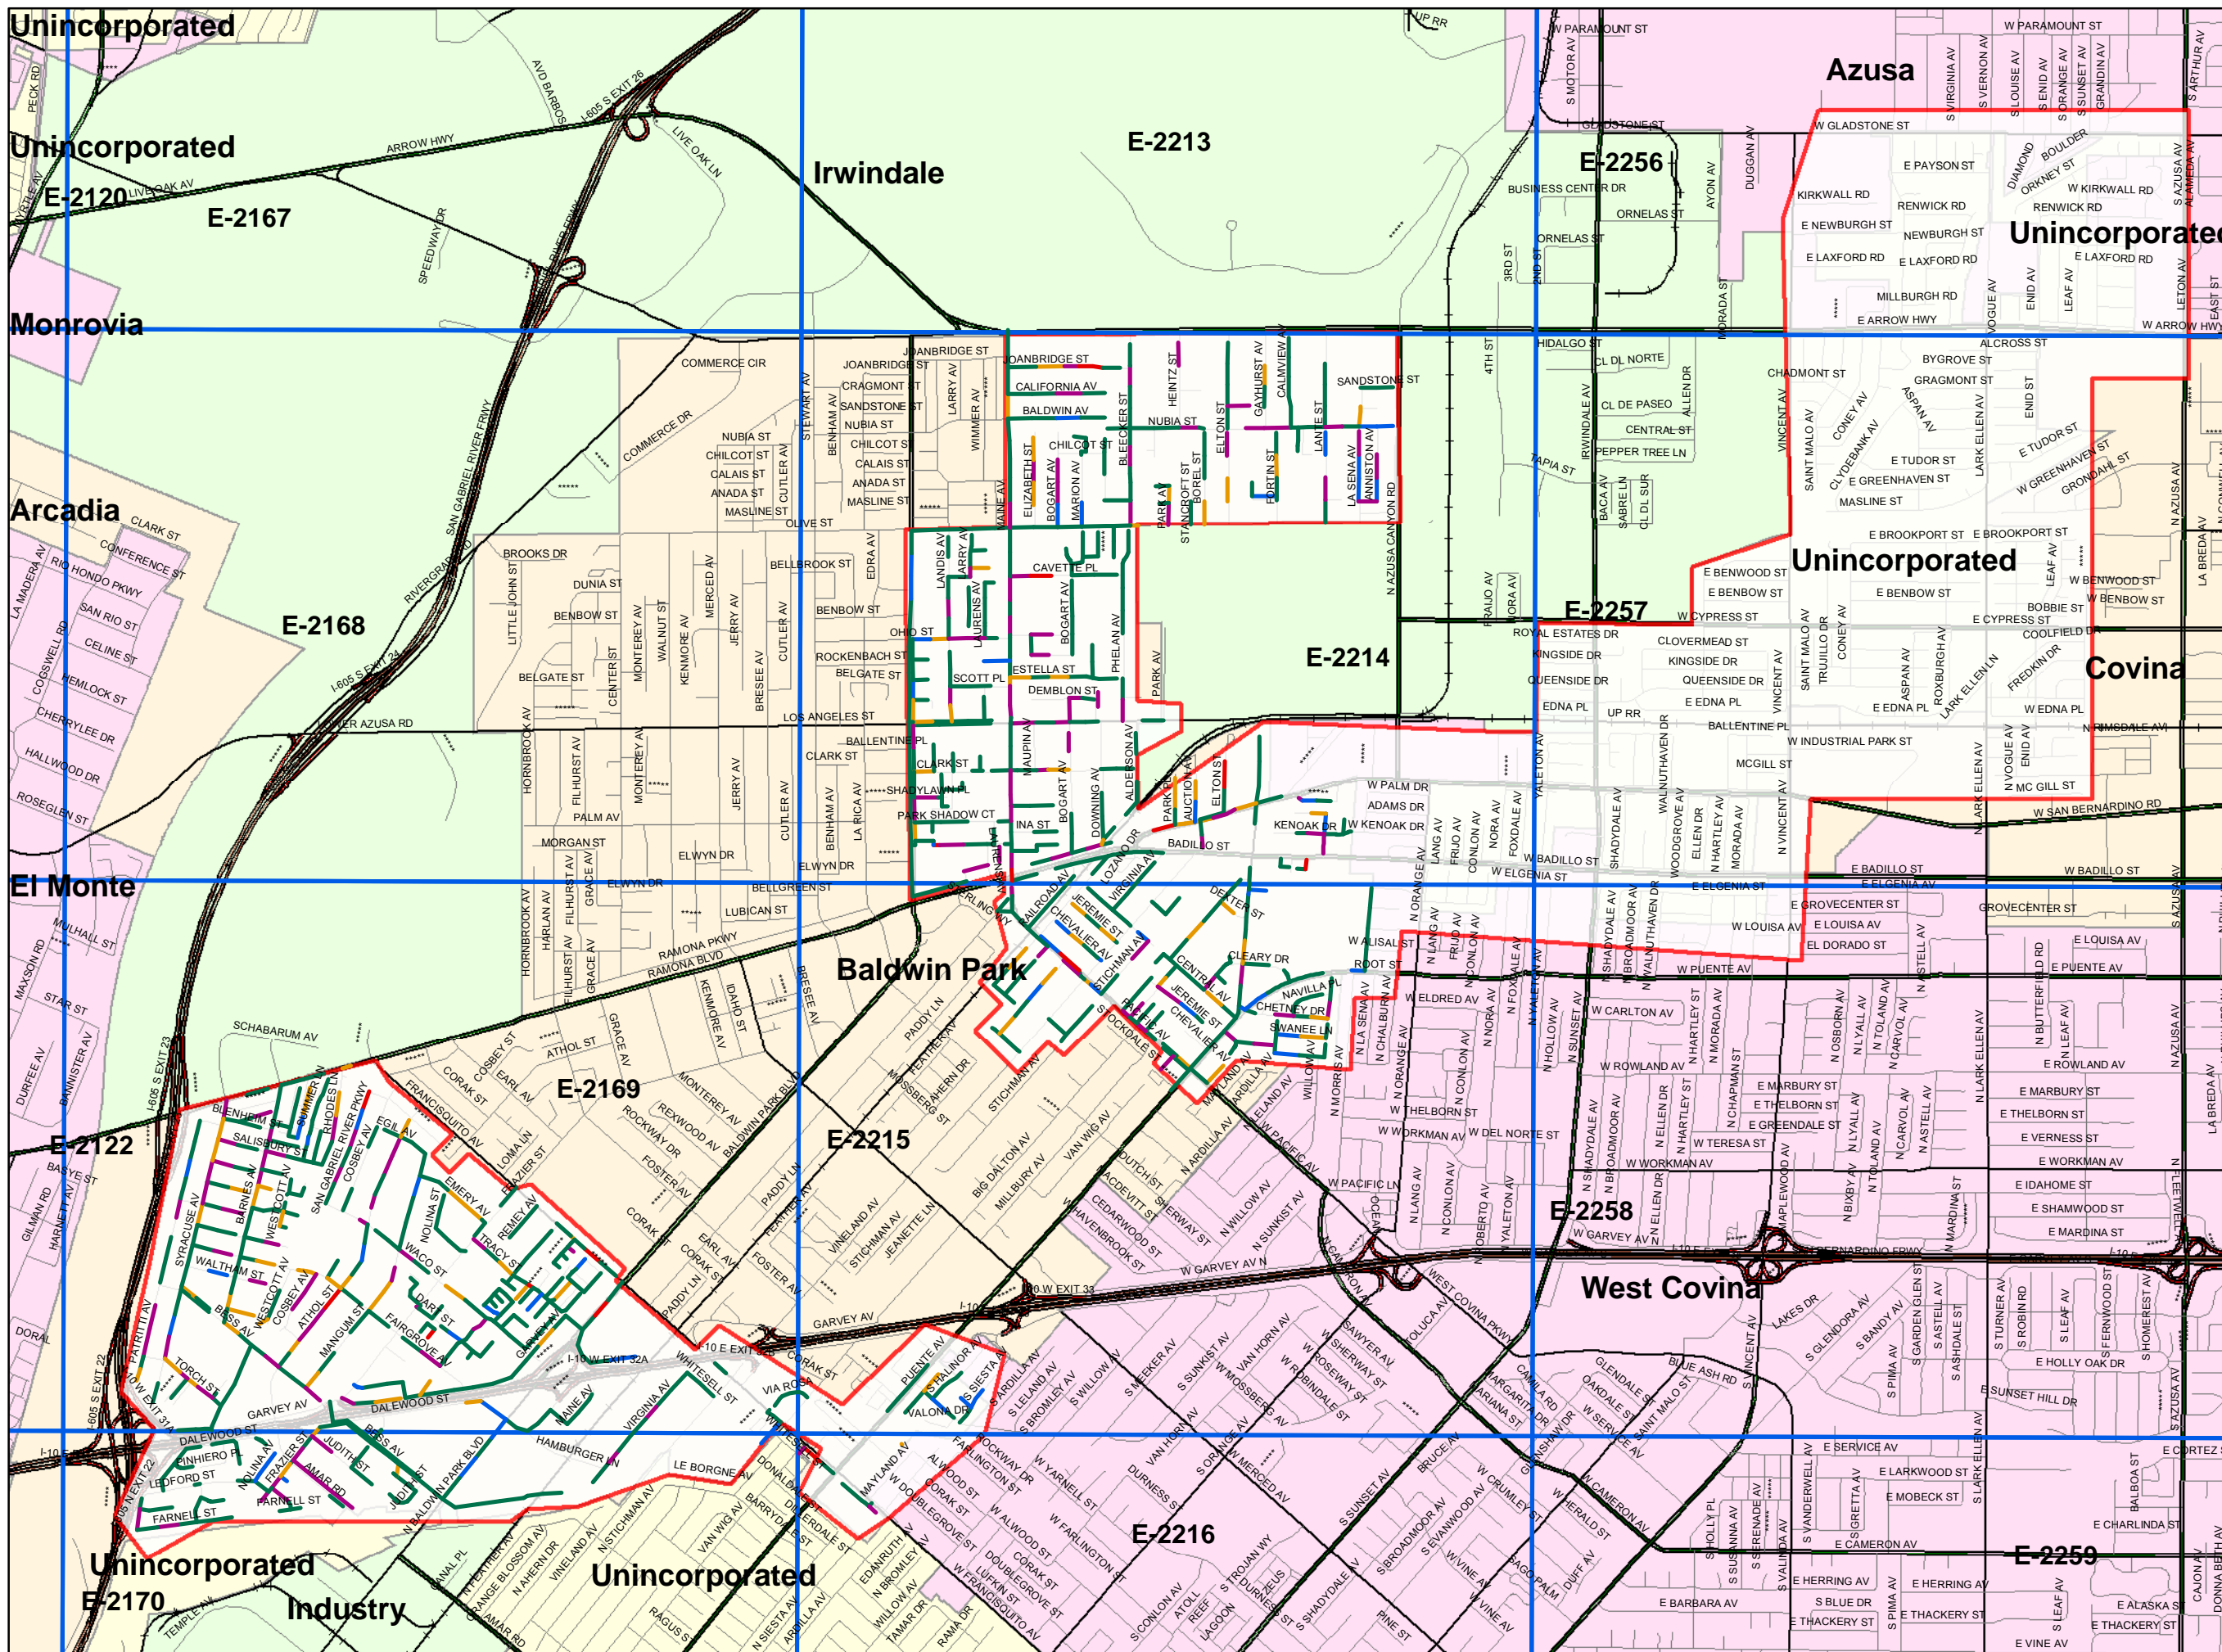
QUICK
MAINTENANCE
RATING
(QMR)

Our inspection revealed that approximately 70.5 percent of the system televised in your City as part of Project No. Y0TV1415B was free of significant blockages or restrictions that would impede sewer flows. The remaining 29.5 percent of the pipe segments had a PACP maintenance grade of 3, 4, or 5 as indicated in the Quick Maintenance Rating Table shown below. These segments have been incorporated into our periodic cleaning schedule for enhanced maintenance.

A color-coded map showing the quick maintenance rating for each pipe segment is provided in Enclosure 2.

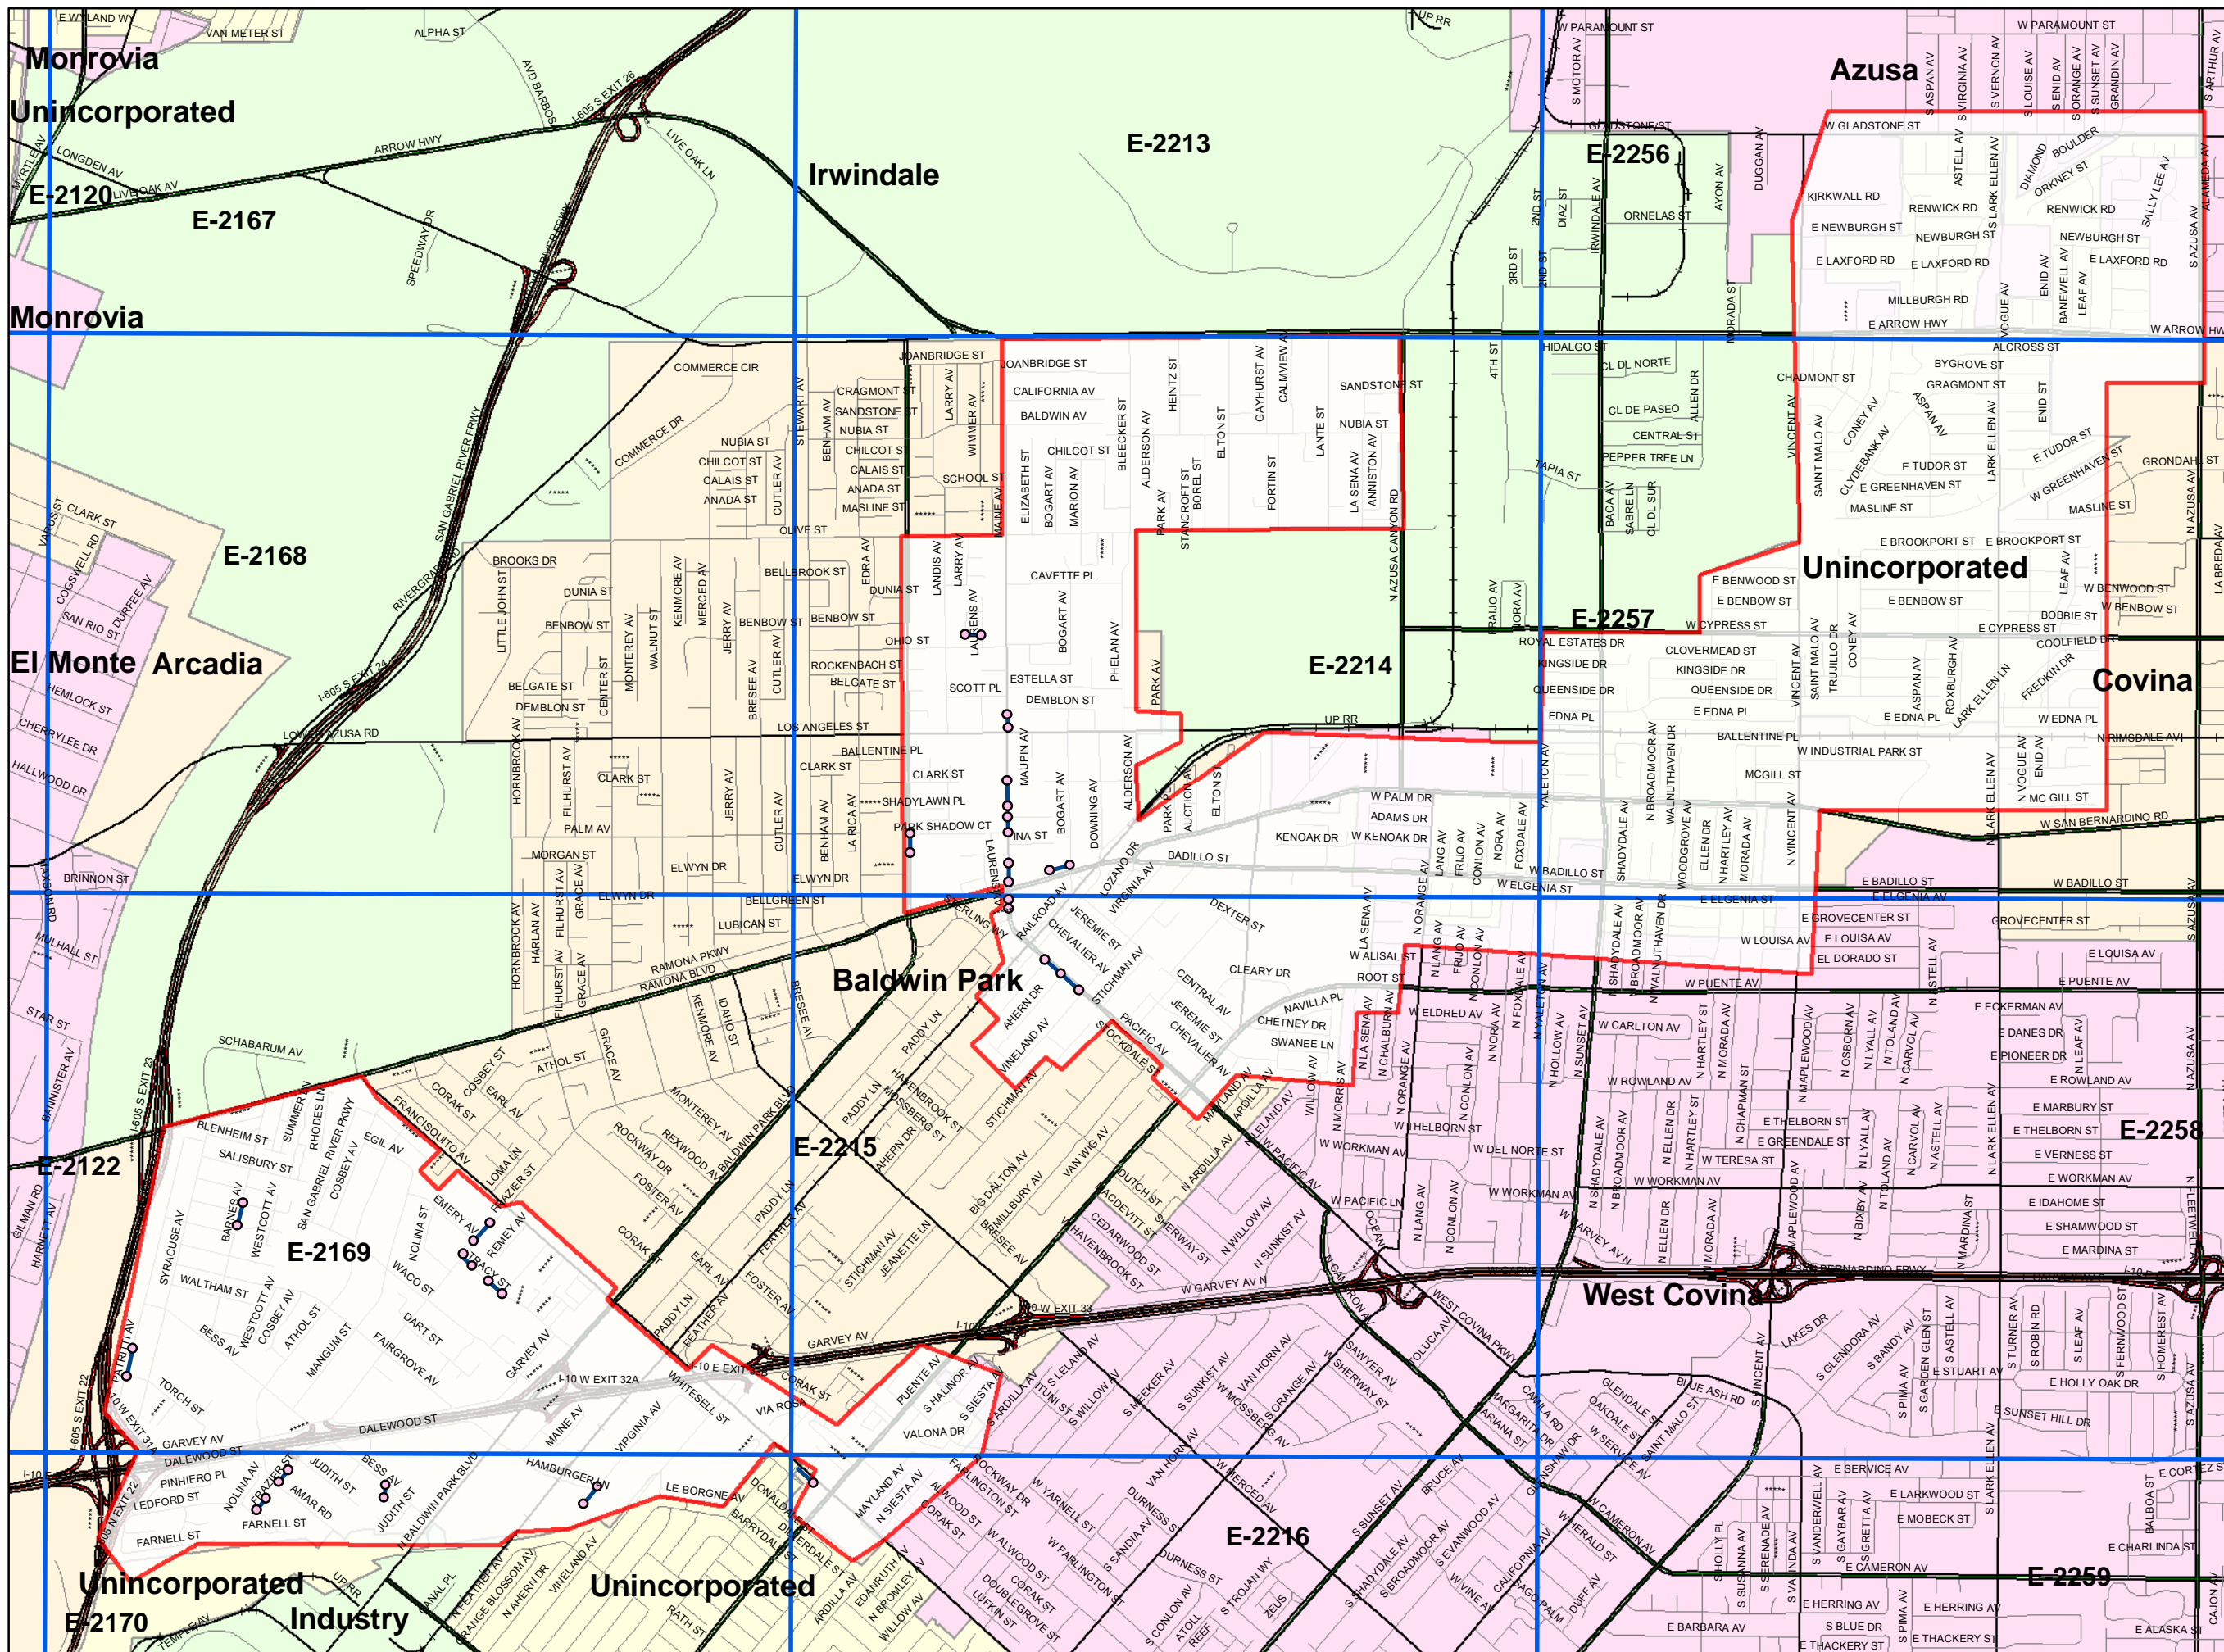
HIGH WATER LEVEL

All sewer pipes where the Water Level, Water Mark, and miscellaneous remarks of camera underwater or sags in the line are at or above 50 percent capacity have been listed and analyzed on the High-Water Level Table in Enclosure 2. The nature of these high-water level conditions is also summarized on this table. When the items have been identified to have high water levels due to sewer line capacity, a Yes is indicated in the capacity column. These areas should be reviewed by the City for existing and future capacity needs.

A map showing the sewer lines with high-water levels is provided in Enclosure 2.

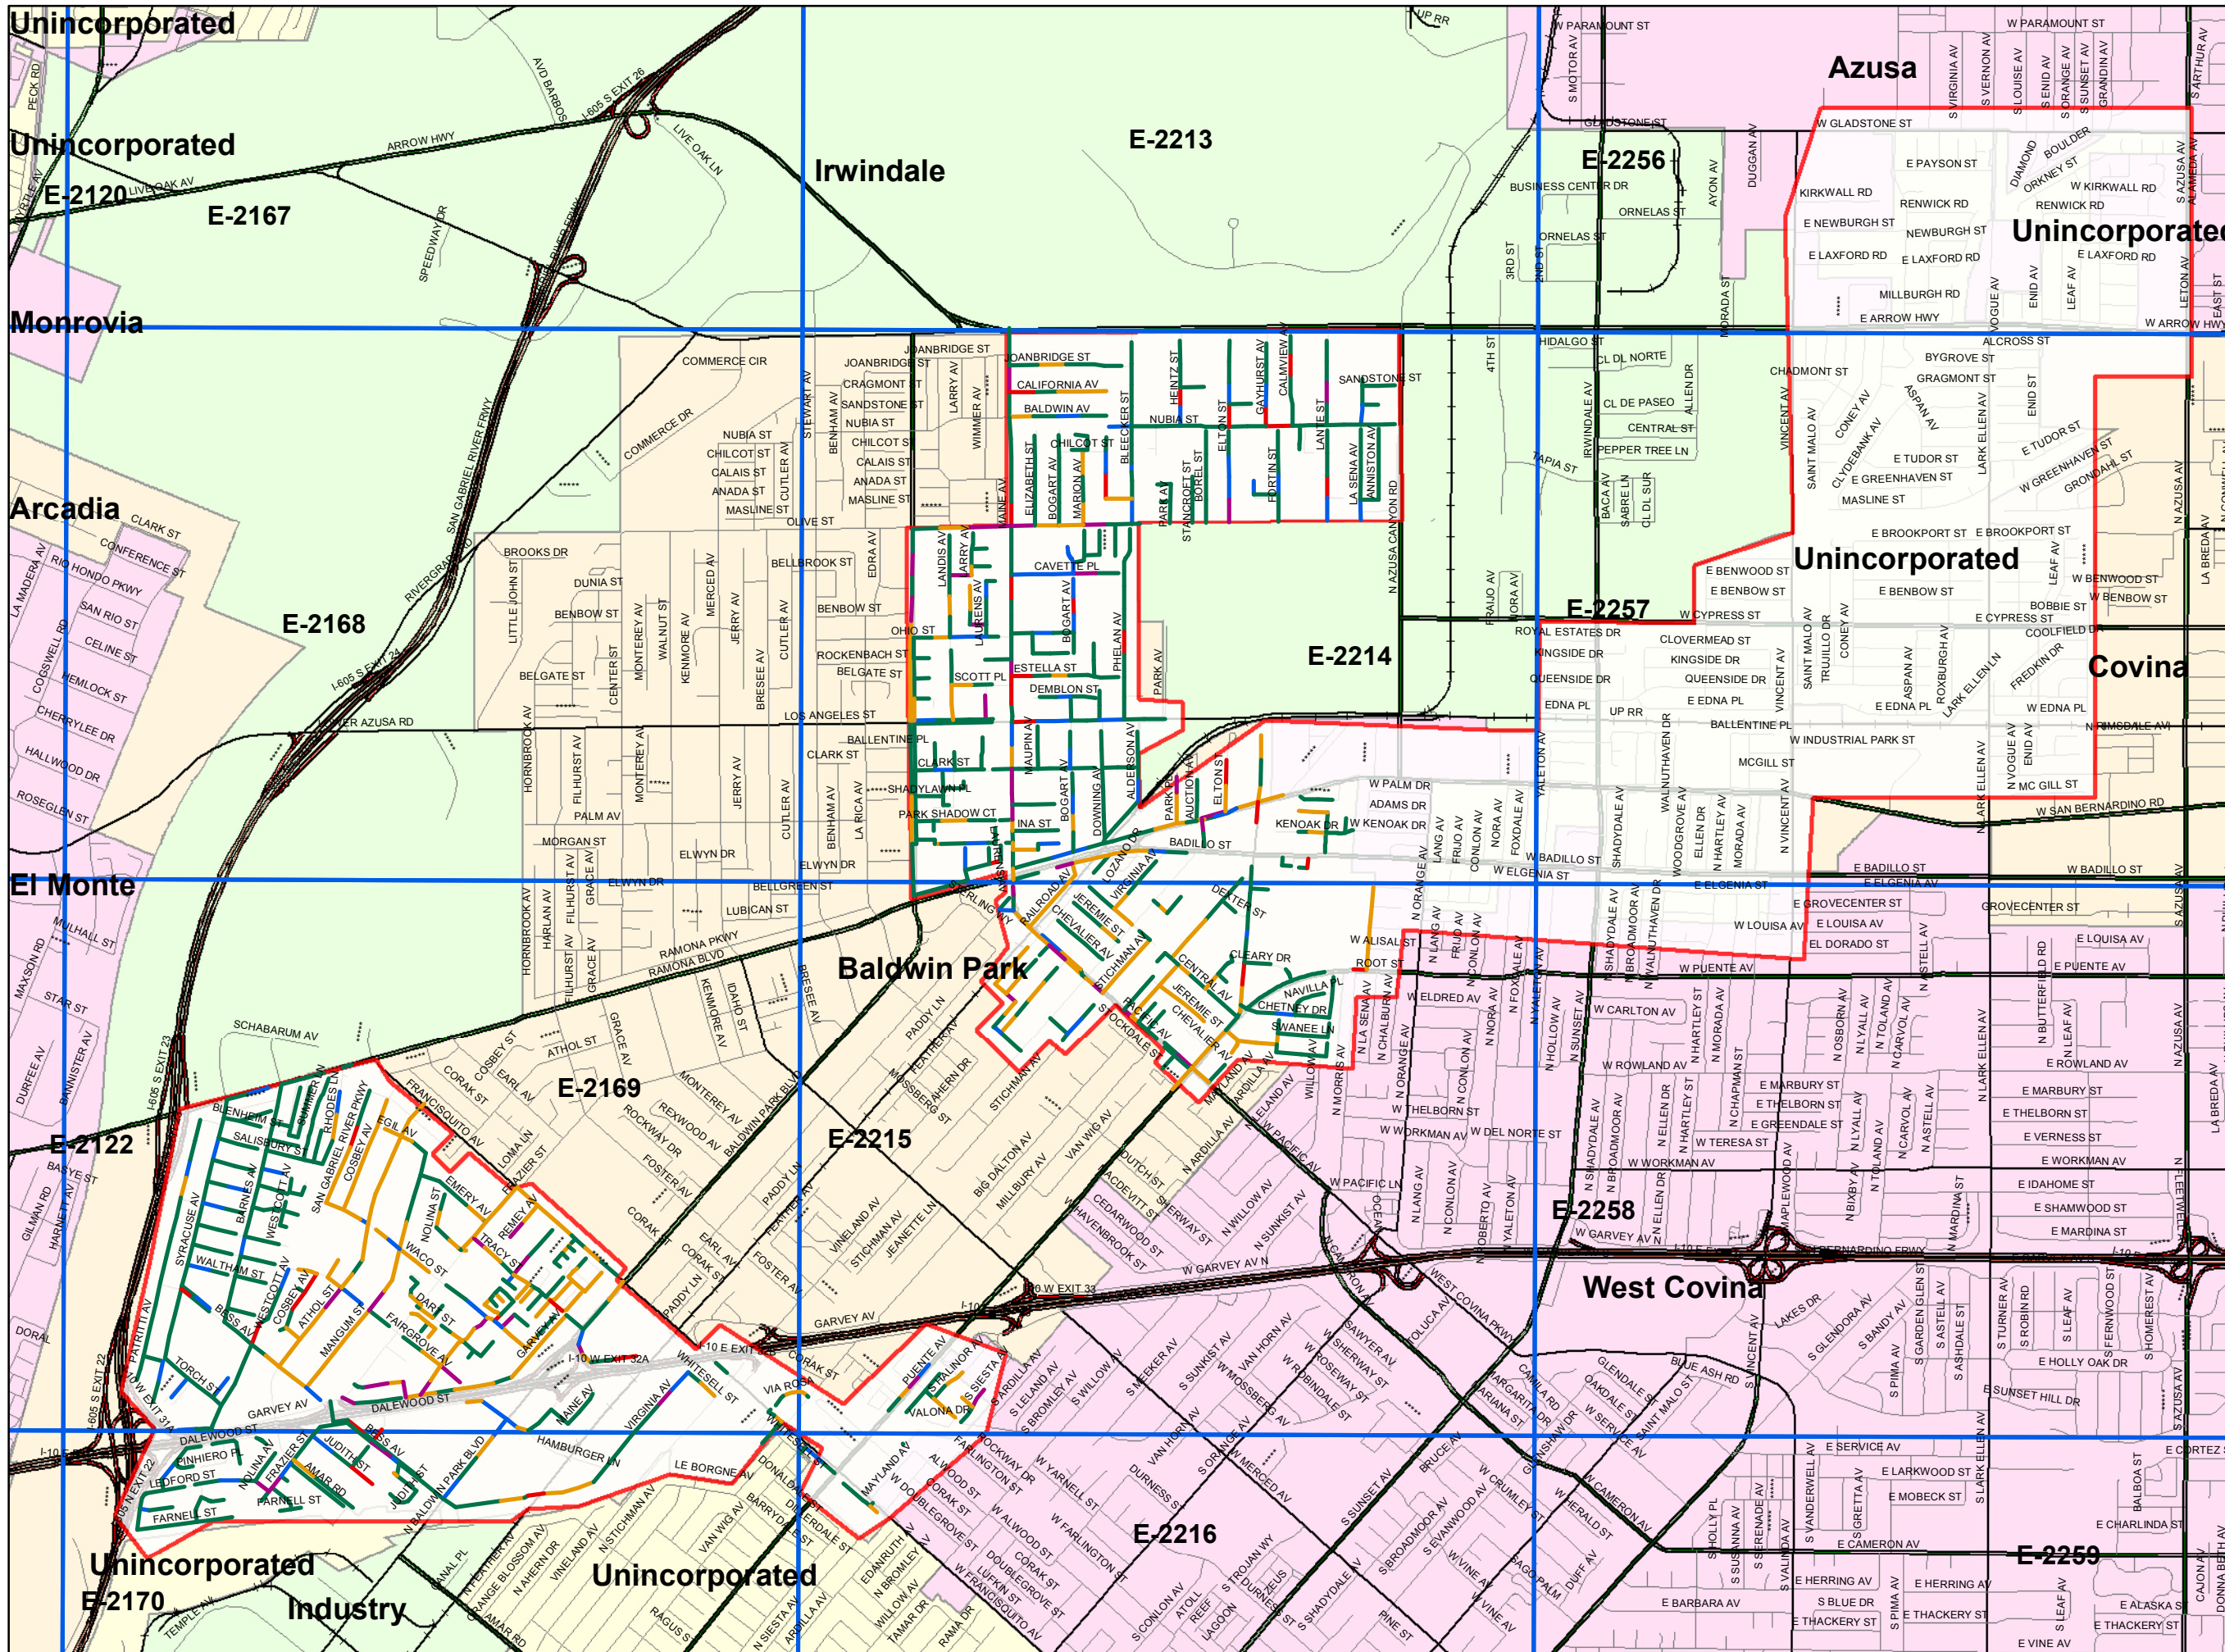
QUICK
STRUCTURAL
RATING
(QSR)

Our inspection revealed that approximately 91.8 percent of the inspected pipe segments within the City were free of severe structural defects. The remaining 8.2 percent of the inspected pipe segments had a PACP structural grade of 4 or 5 as indicated in the Quick Structural Rating Table shown below. These segments have been placed on a priority list for rehabilitations based on the severity and the need for action. For items

A color-coded map showing the Quick Structural Rating for each pipe segment is located in Enclosure 3.

1 through 81 in the Quick Structural Rating Report Priority List (Enclosure 3), which warrant a corrective action, the repair will be programmed in the next 24 months as part of the ongoing Accumulative Capital Outlay Program.
