CONSOLIDATED SEWER MAINTENANCE DISTRICT CONDITION ASSESSMENT PROGRAM REPORT PROJECT Y0TV0506F

**CONDITION ASSESSMENT REPORT
COUNTY OF LOS ANGELES DEPARTMENT OF PUBLIC WORKS
CONSOLIDATED SEWER MAINTENANCE DISTRICT**

| PROJECT NAME: | Y0TV0506F | PROJECT MGR: | Fernando Villaluna |

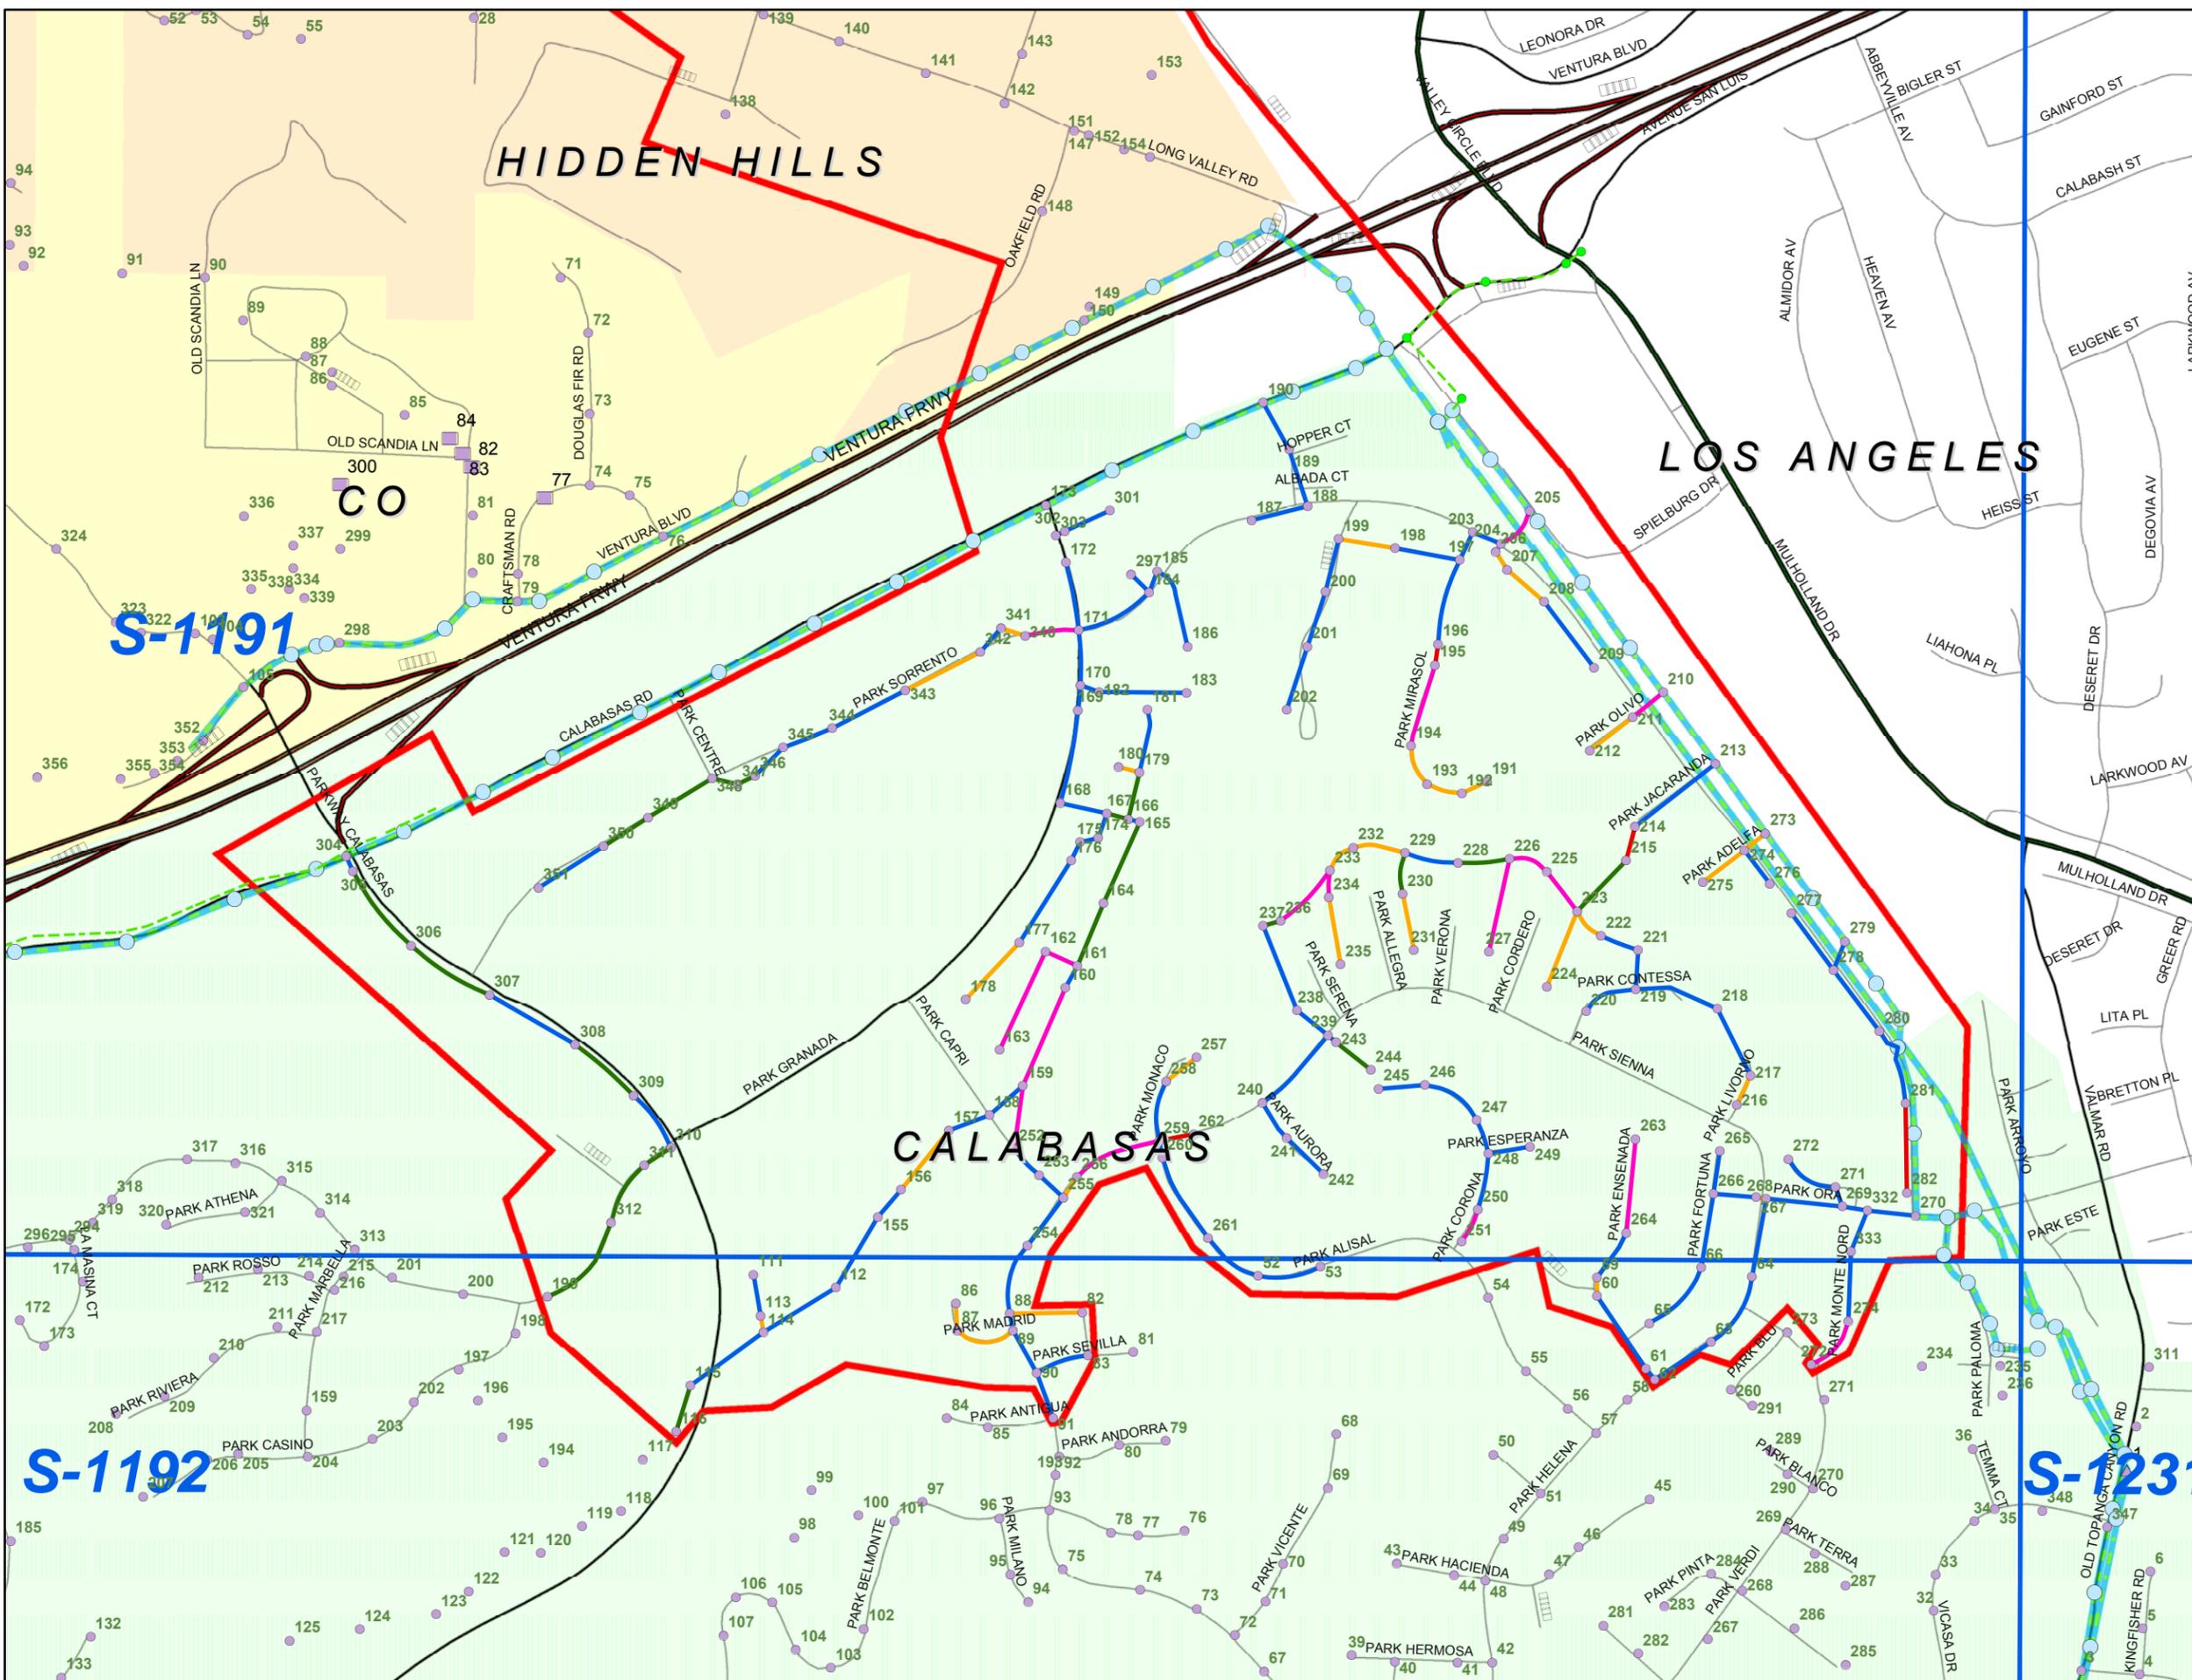
QUICK MAINTENANCE RATING (QMR)

Our inspection revealed that approximately 87.6 percent of the system televised was free of blockages or restrictions that would impede sewer flows. However, the remaining 12.4 percent of the inspected pipe segments within the City of Calabasas had a PACP maintenance grade of 4 or 5 as indicated in the Quick Maintenance Rating Table shown below. These segments have been incorporated into our routine cleaning schedule with corrective action taken as noted on the Quick Maintenance Rating Report Priority List (Enclosure 2). Also included is a color-coded map showing the quick maintenance rating for each pipe segment.

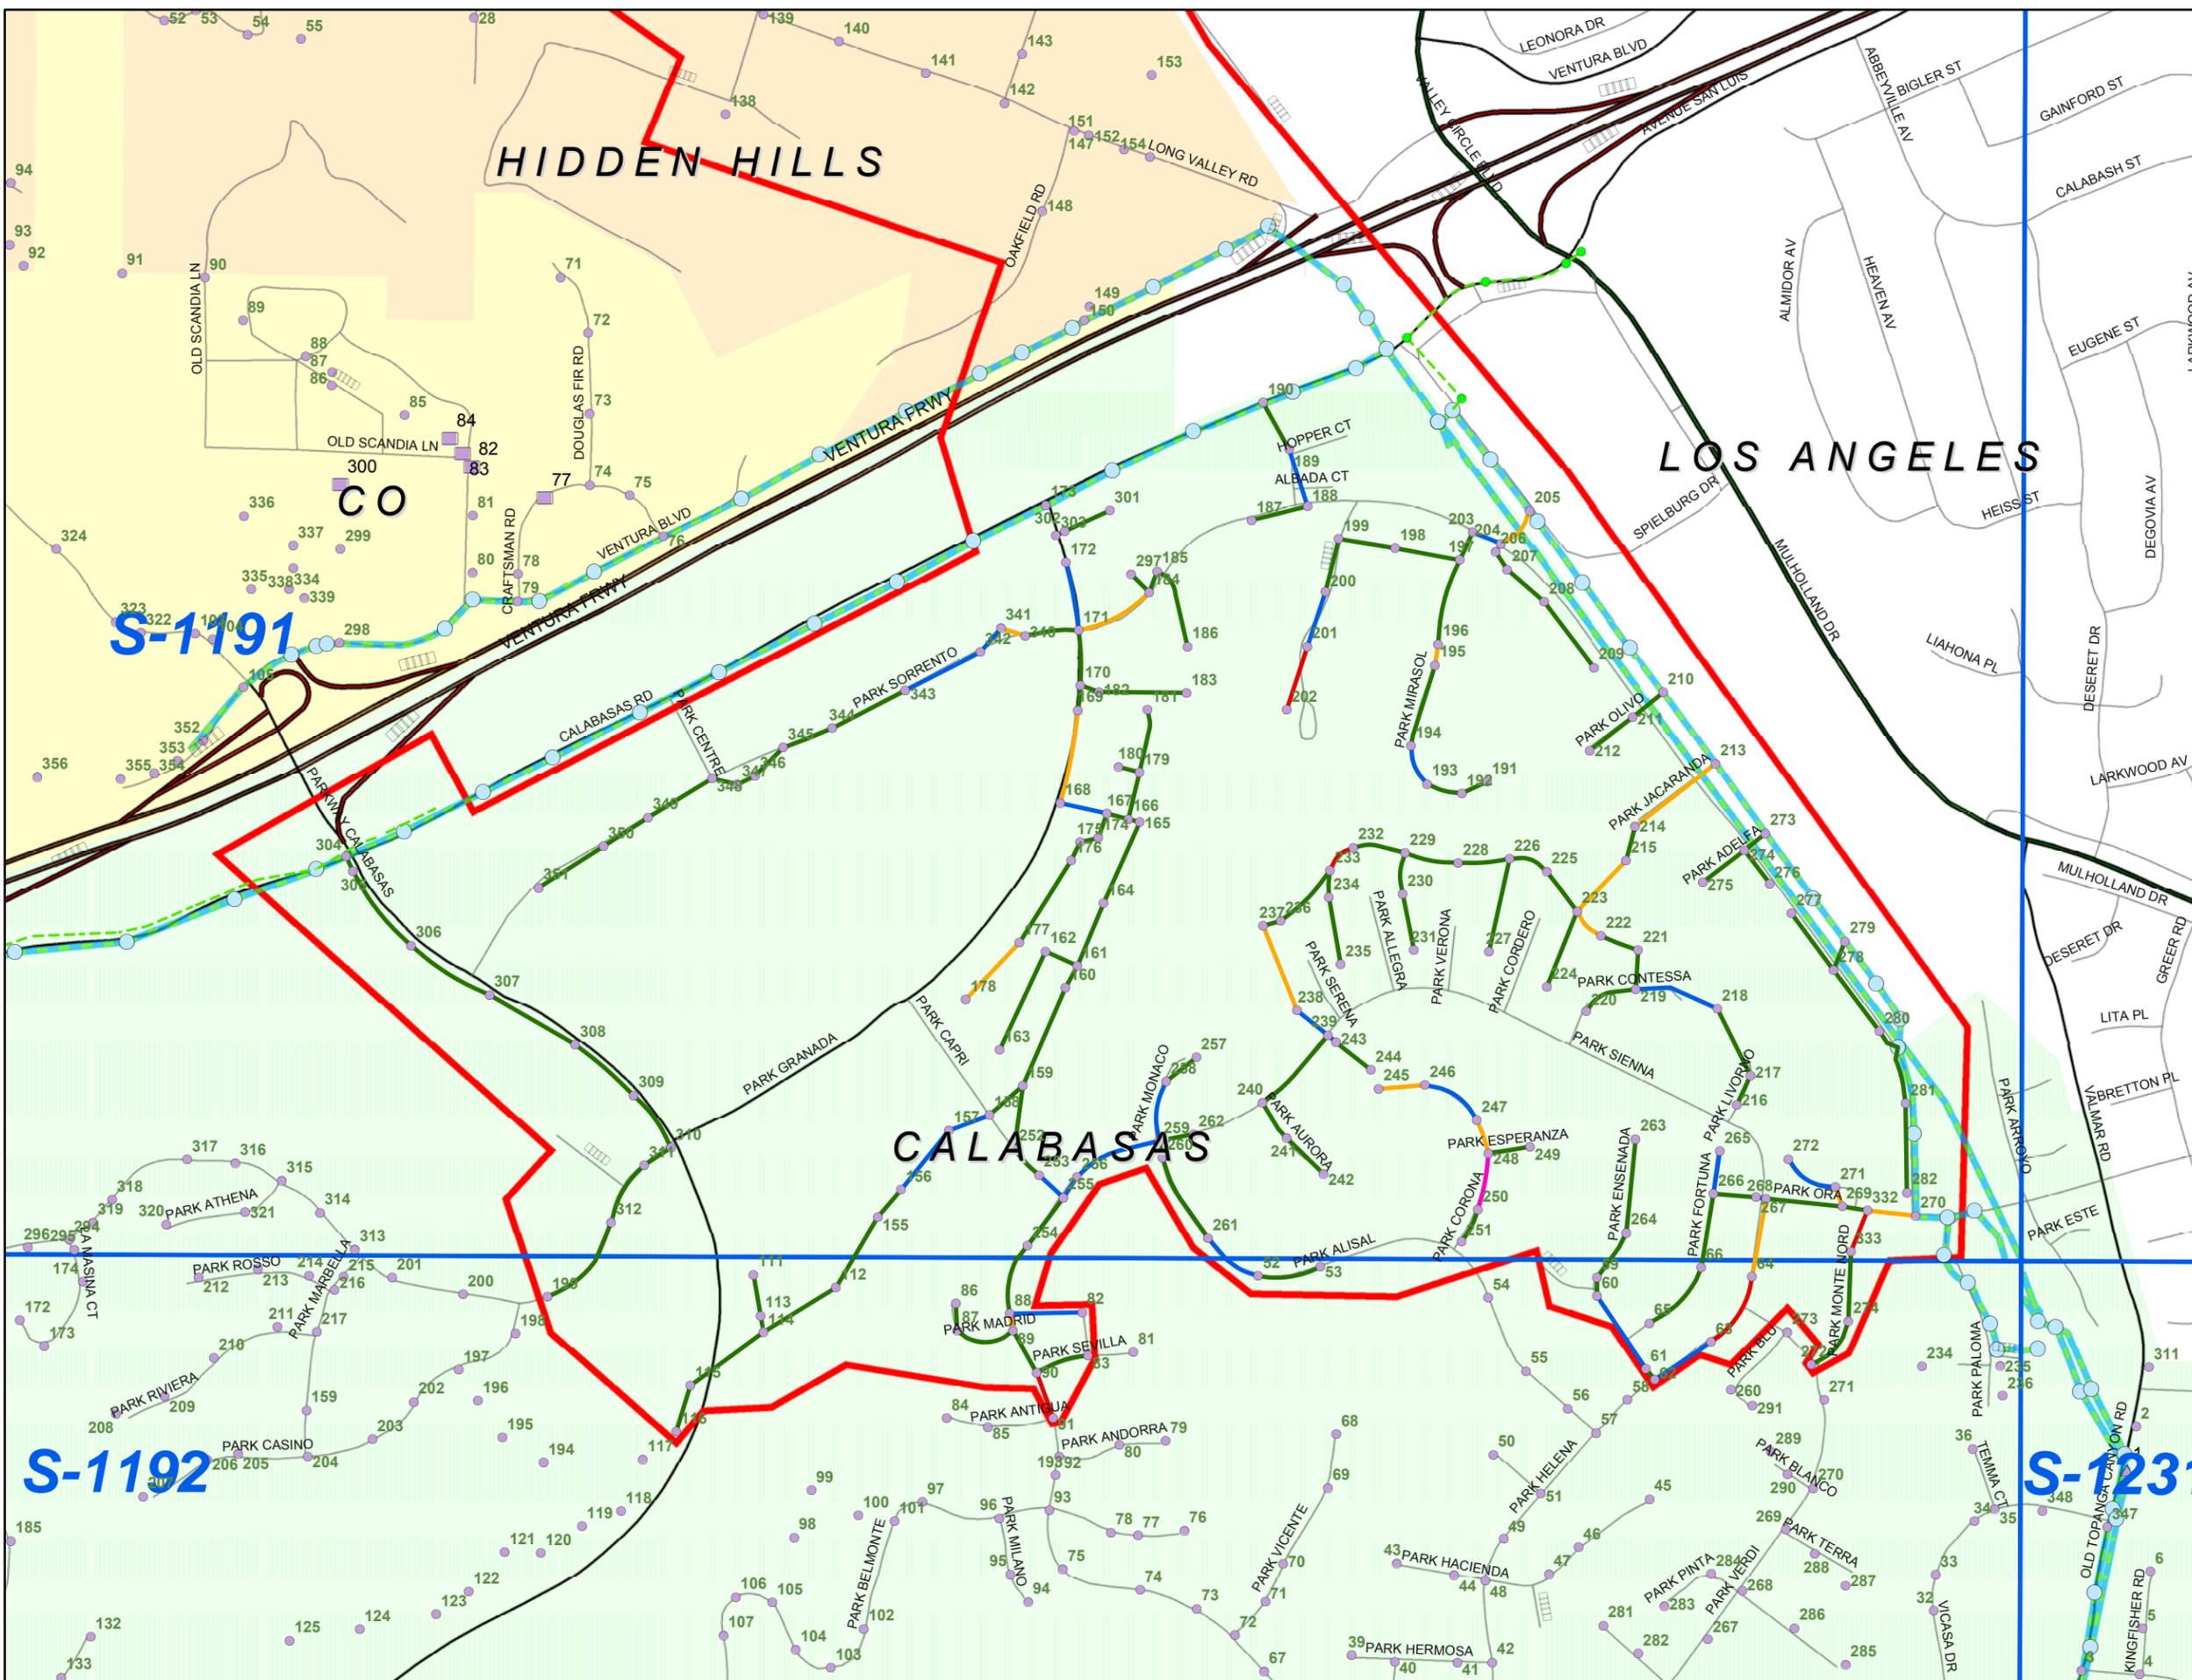
QUICK STRUCTURAL RATING (QSR)

Our inspection revealed that approximately 96.8 percent of the inspected pipe segments within the City of Calabasas were free of severe structural defects. However, the remaining 3.2 percent of the inspected pipe segments had a PACP structural grade of 4 or 5 as indicated in the Quick Structural Rating Table shown below. These segments have been placed on a priority list based on the severity and the need for action. For Items 1 through 6 in the Quick Structural Rating Report Priority List (Enclosure 3), which require a corrective action, the proposed corrective method will be scheduled in the next 24 months as part of the ongoing Accumulative Capital Outlay Project. A color-coded map showing the Quick Structural Rating for each pipe segment is located in Enclosure 3. Copies of the actual inspection reports for these 6 segments are included in Enclosure 4.
