**CONSOLIDATED SEWER MAINTENANCE DISTRICT  
CONDITION ASSESSMENT PROGRAM REPORT  
CITY OF LA CAÑADA FLINTRIDGE**

**CONDITION ASSESSMENT REPORT  
COUNTY OF LOS ANGELES DEPARTMENT OF PUBLIC WORKS  
CONSOLIDATED SEWER MAINTENANCE DISTRICT**

PROJECT NAME:	Y0TV1112B	PROJECT MGR:	Hanna Kebede
PROJECT DATE:	02/13/12	CONTACT NO:	(626) 300-4686
SUP. DISTRICT(s):	5	MAP PAGE(S):	1796,1797,1851,1852
Report By:	Clement Khong	Report Date:	01/07/16

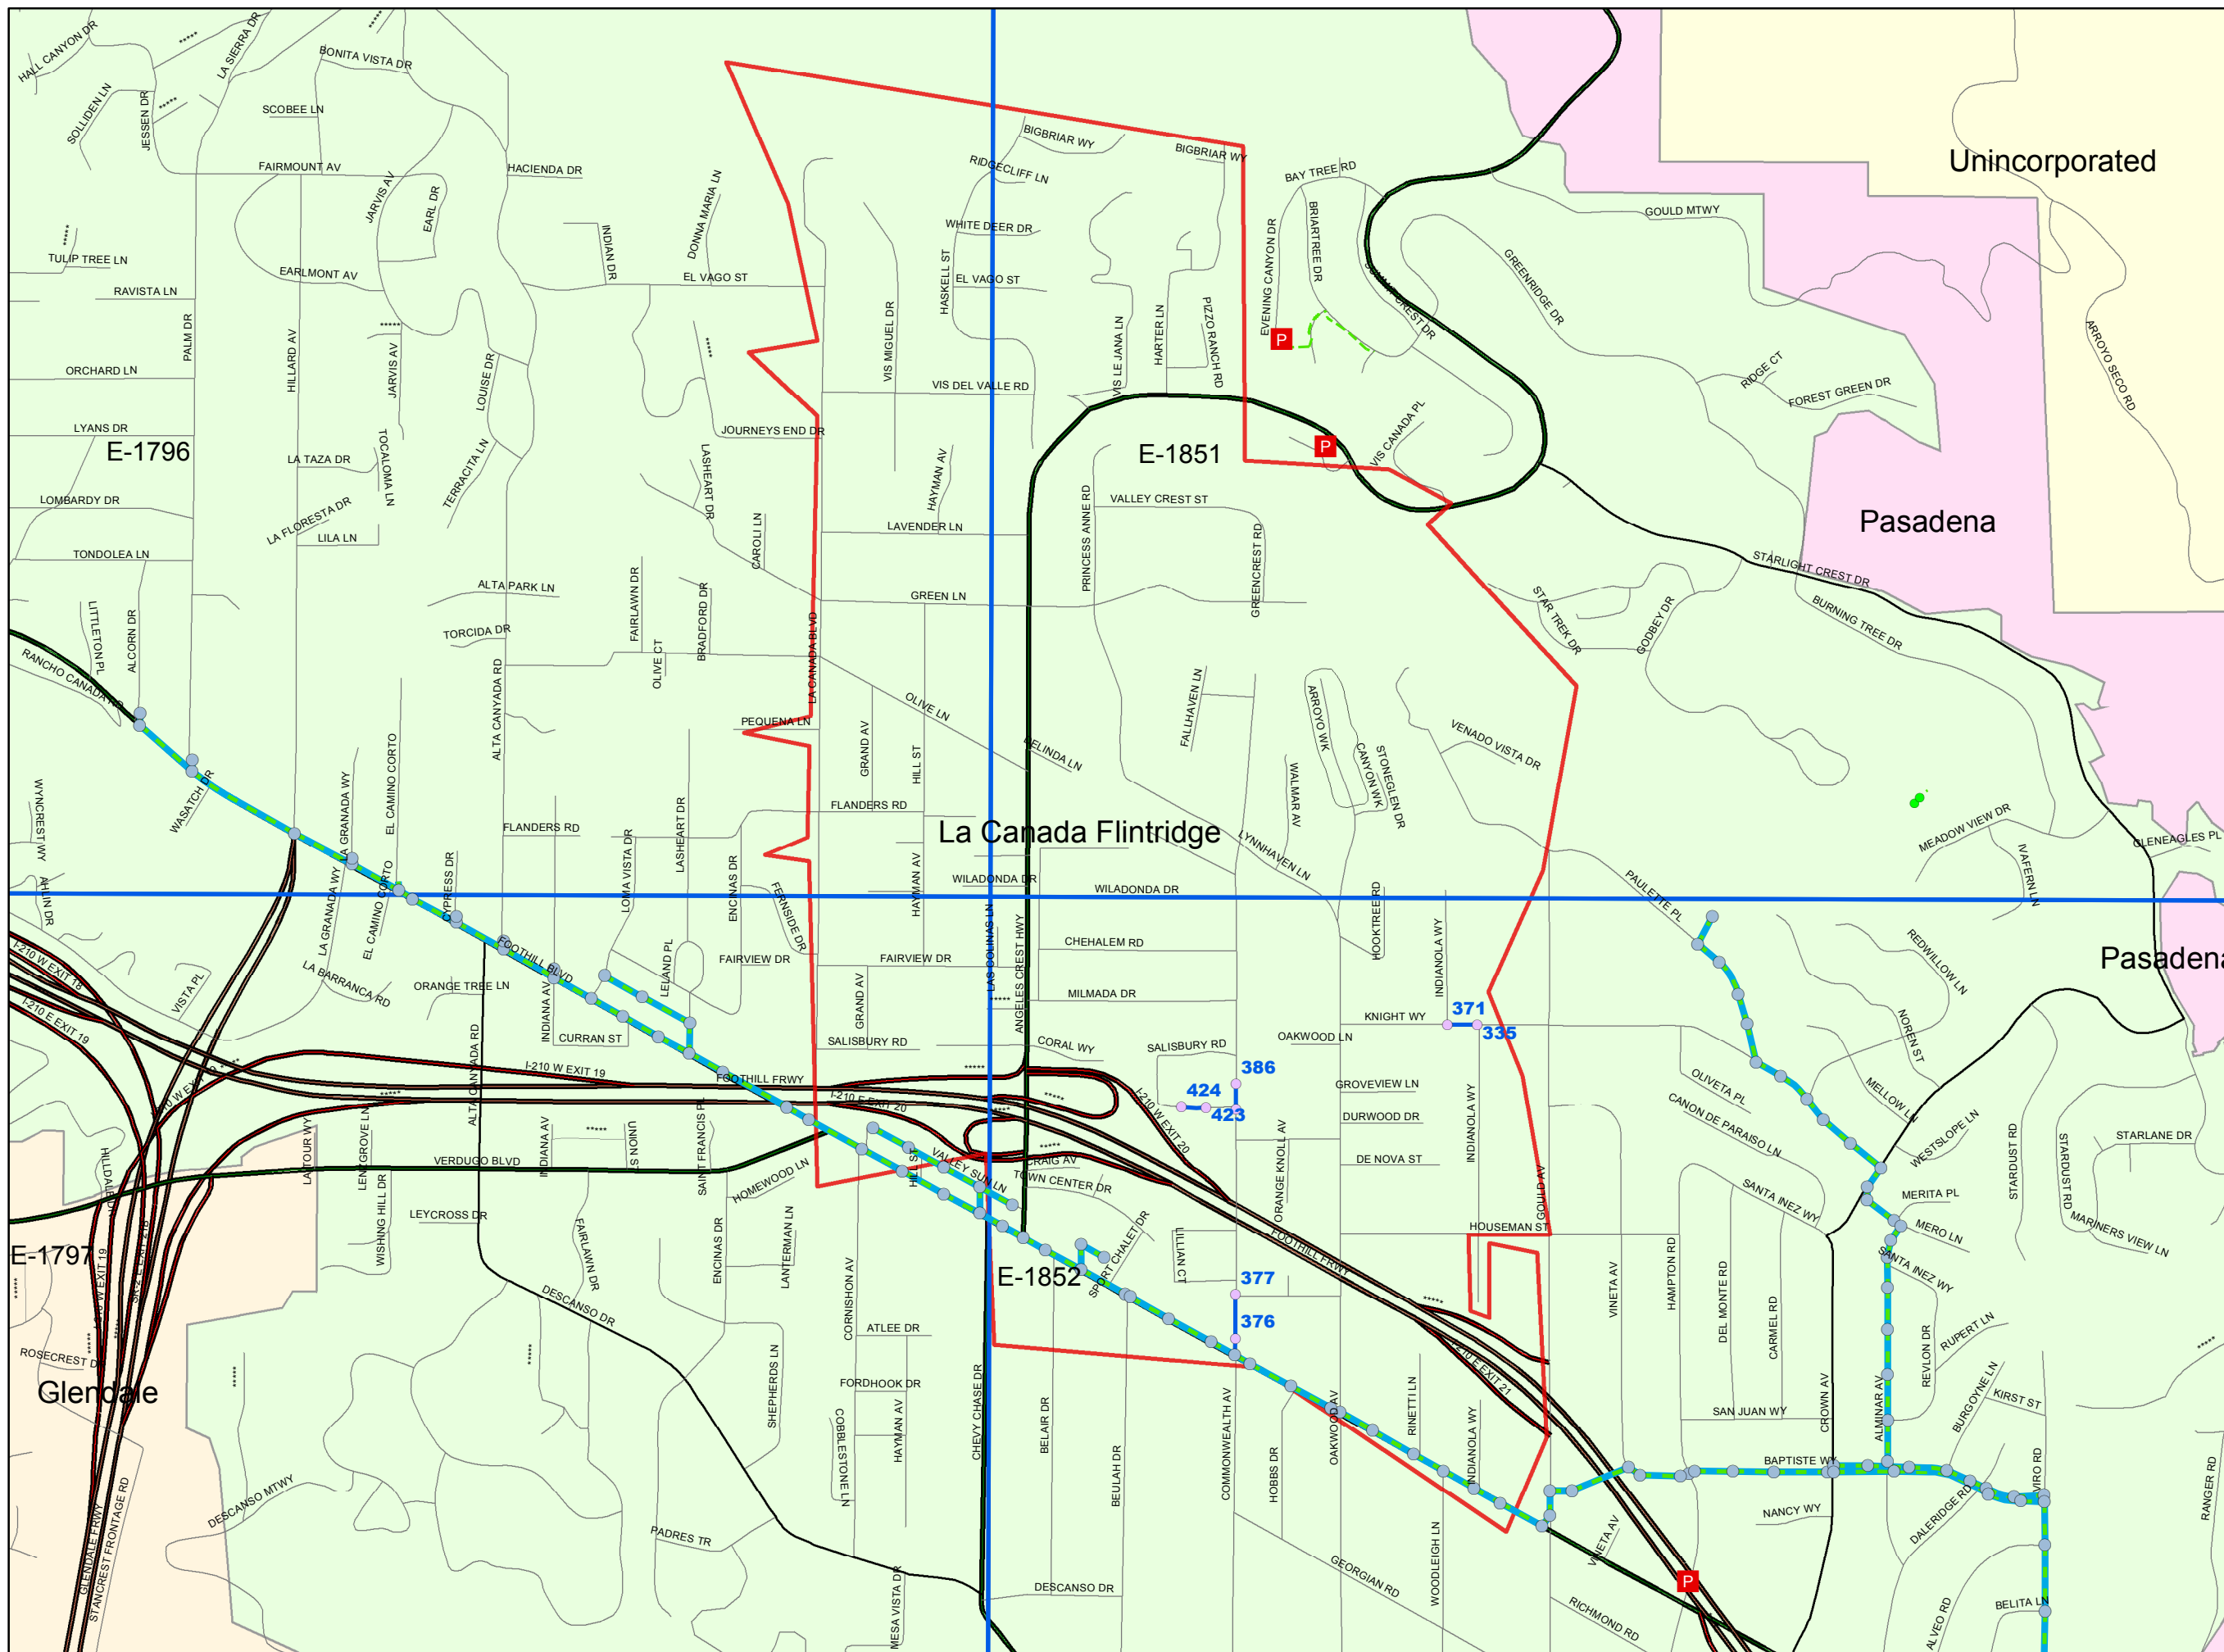
**HIGH WATER LEVEL**

ITEM NO.	QMR	START MH	END MH	STREET	OBSERVATION	CORRECTIVE ACTION
1	5141	1852-0424	1852-0423	PARKMAN DR	Water level: 10%; Water mark: 80%	No action needed.
2	4400	1852-0376	1852-TRNK	COMMONWEALTH AV	Camera underwater; high water level due to trunk line downstream	Hydrojet (10/09/13)
3	4100	1852-0386	1852-0385	COMMONWEALTH AV	High water level; Water mark: 50%	Hydrojet (10/09/13)
4	4100	1852-0371	1852-0335	KNIGHT WAY	Water level: 5%; Water mark: 40%-50%	No action needed.
5	4100	1852-0377	1852-0376	COMMONWEALTH AV	High water level due to change in alignment	Hydrojet (10/09/13)

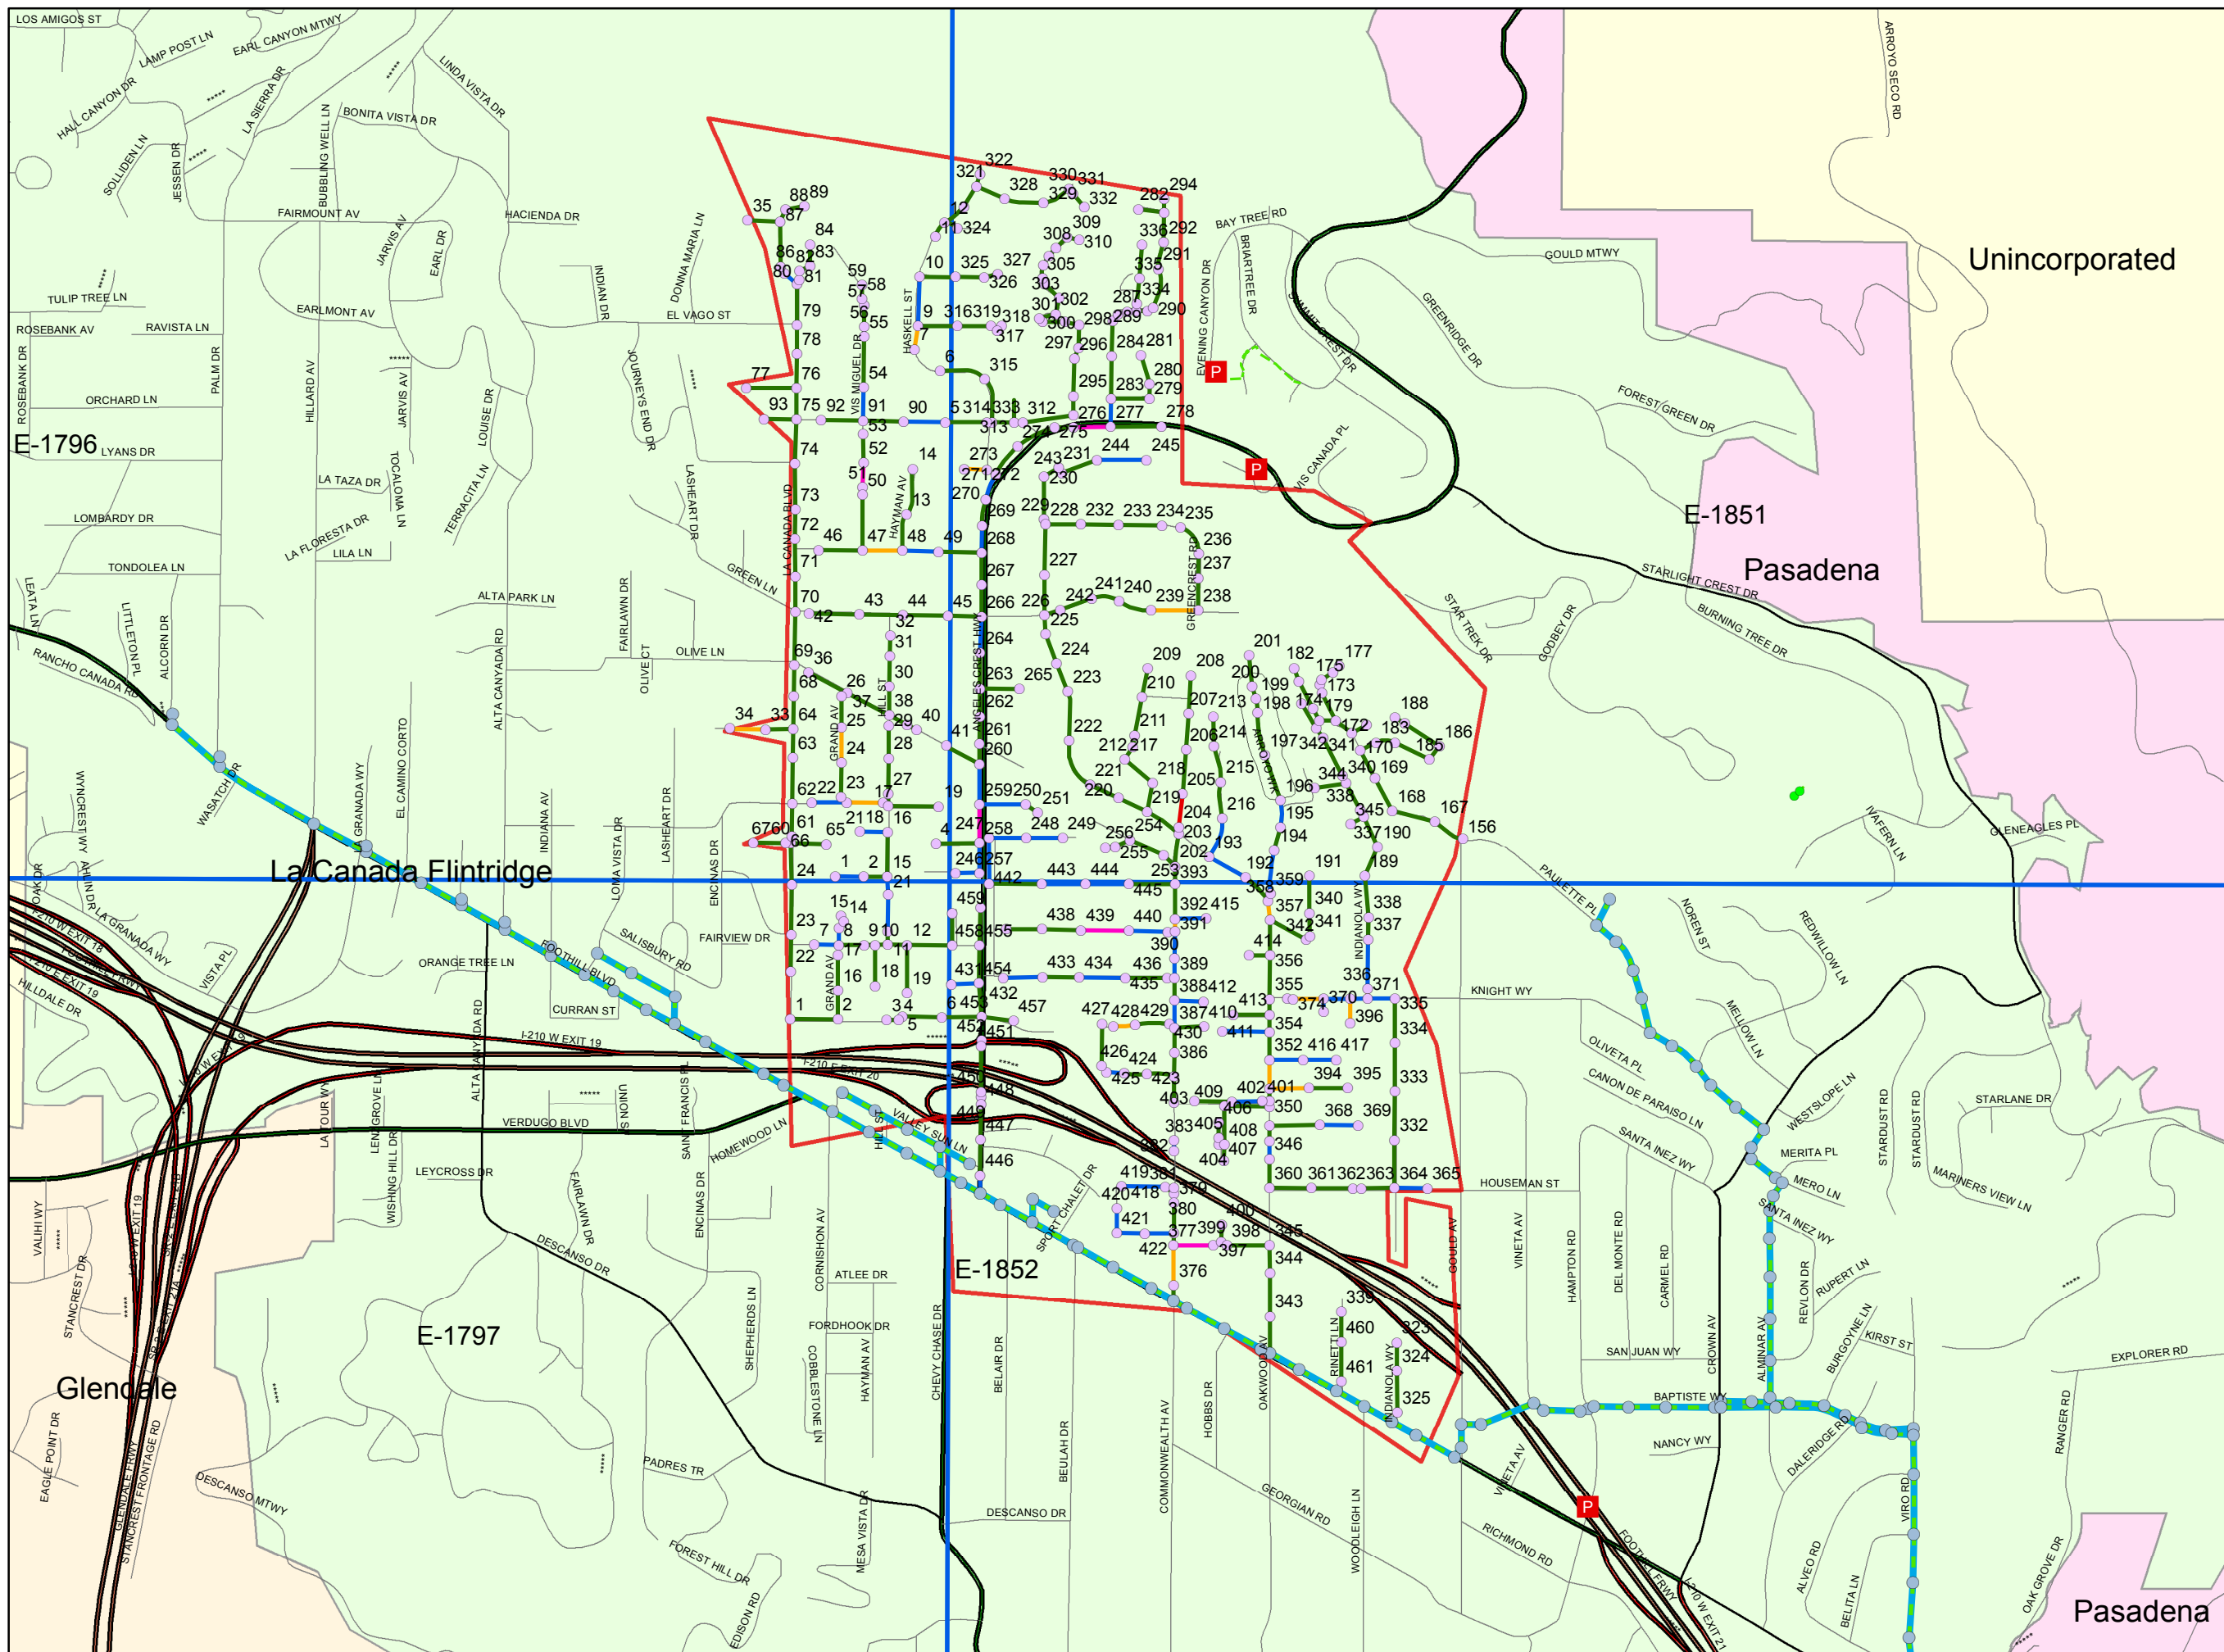
**QUICK  
STRUCTURAL  
RATING  
(QSR)**

ITEM NO.	QSR	START MH	END MH	STREET	OBSERVATION: LOCATION	PROPOSED CORRECTIVE METHOD	LENGTH OF REPAIR (FT)
1	4100	1851-0272	1851-0271	HASKELL ST	Deformation (reinforced plastic pipe): 51'	Structural integrity in tact. No action needed.	
2	4124	1852-0437	1852-0438	CHEHALEM RD.	Repair patch (detached): 160'	Structural integrity in tact. No action needed.	
3	4127	1851-0250	1851-0259	ANGELES CREST HWY.	Deformed (5%): 211'	Structural integrity in tact. No action needed.	
4	4137	1796-0046	1796-0047	LAVENDER LN	Joint offset: 1'; Hole: 25'	Structural integrity in tact. No action needed.	
5	4300	1852-0376	1852-TRNK	COMMONWEALTH AV	Fracture longitudinal: 100',218',283'; Fracture multiple: 173'; Hole: 280'	Structural integrity in tact. No action needed.	
6	4731	1796-0005	1851-0333	VISTA DEL VALLE RD	Joint offsets: 17',84'; Hole: 162',180'; Fractures: 177', 195'-199', 235', 249'	Lining: MH to MH	289
7	5100	1851-0201	1851-0200	OAKWOOD AVE	Broken at MH 1851-0201 (part of MH base)	Structural integrity in tact. No action needed.
