COUNTY OF LOS ANGELES

DEPARTMENT OF PUBLIC WORKS

CONSOLIDATED SEWER MAINTENANCE DISTRICT CONDITION ASSESSMENT PROGRAM REPORTS PROJECT NOS. Y0TV0809C AND Y0TV0809D

**CONDITION ASSESSMENT REPORT
COUNTY OF LOS ANGELES DEPARTMENT OF PUBLIC WORKS
CONSOLIDATED SEWER MAINTENANCE DISTRICT**

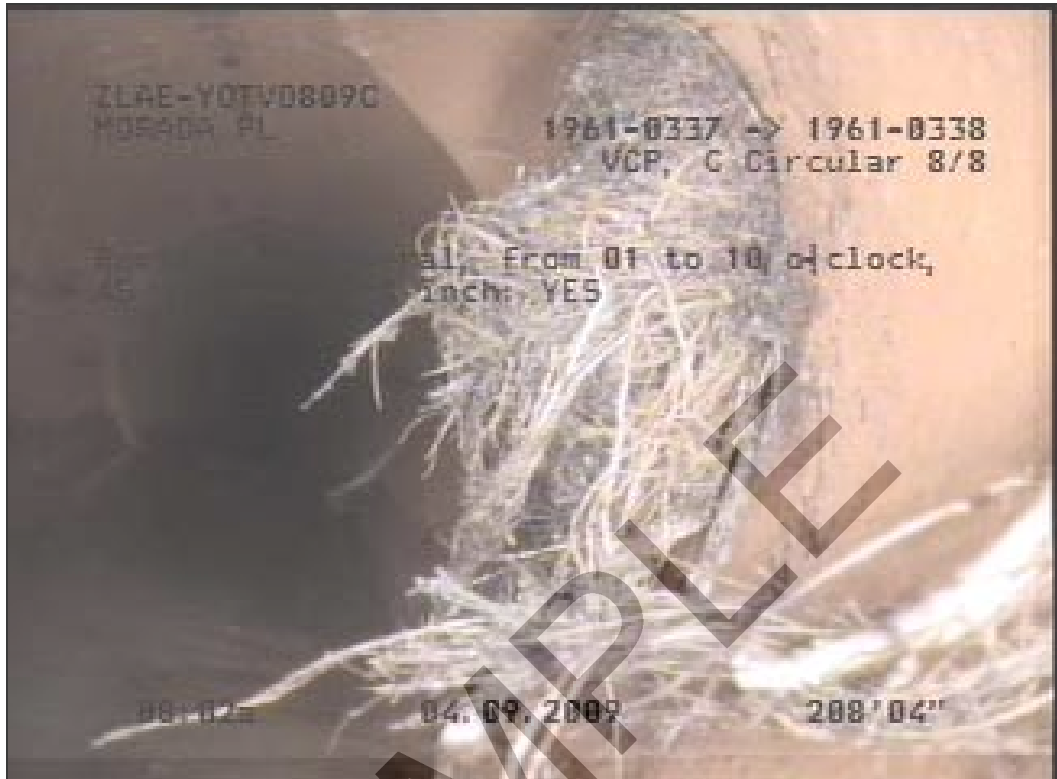
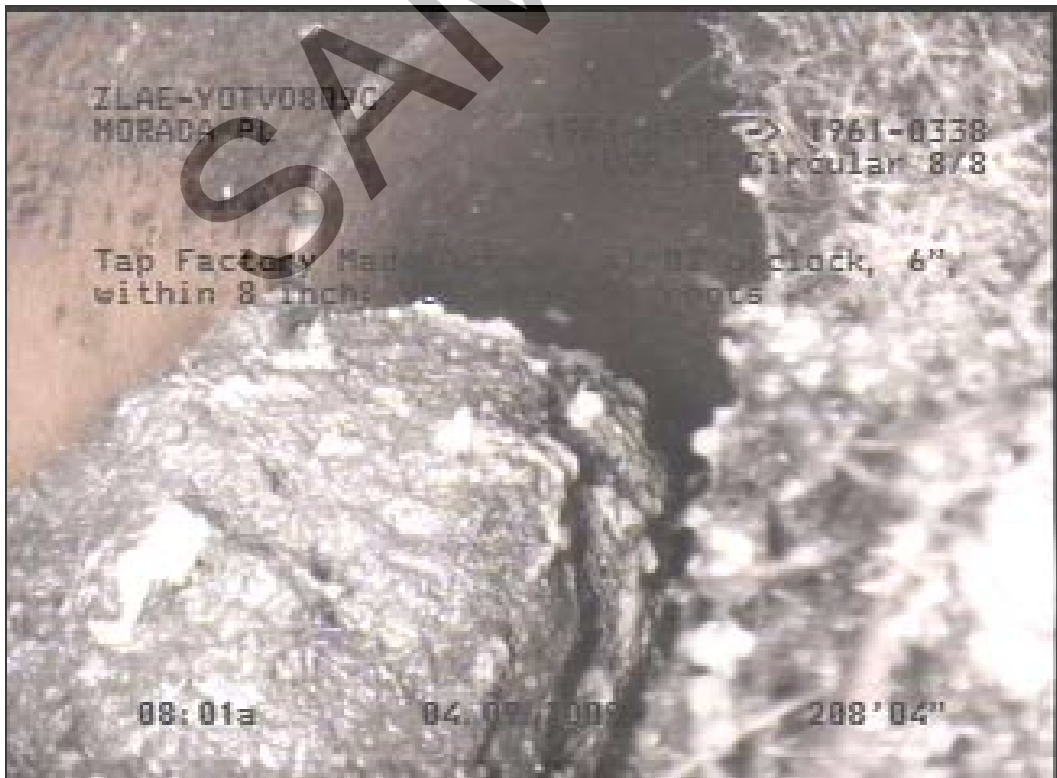
**1570 MORADA PLACE
ALTADENA**
Roots at Lateral Connection

For your reference, we have enclosed photos of your lateral connection showing the presence of the root blockage. Also enclosed are some literature on ways of minimizing sewer overflows and damage to your home.

your sewer lateral within 90 days to remove roots and any other obstructions that may cause a sewage backup.

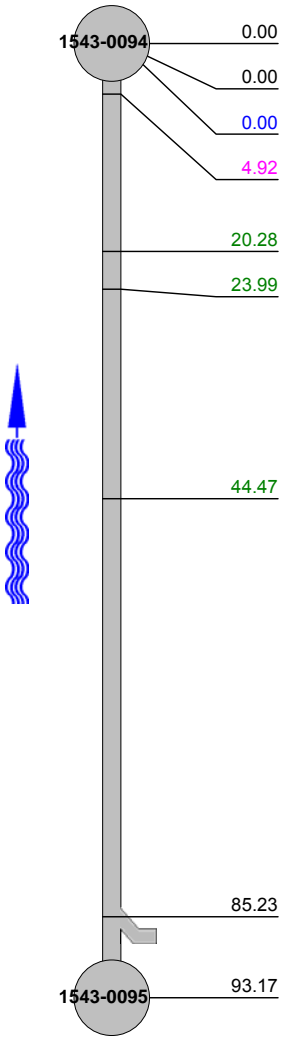
1:225	position	observation	MPEG	photo	grade
	0.00	Downstream Manhole, Survey Begins 1543-0095		63	
	0.00	Water Level, 5 ☐ of cross sectional area			
	0.00	Water Mark, 5 ☐ of cross sectional area			M 2
	4.92	Fracture Multiple, from 12 to 12 o'clock, within 8 inch: YES	00:00:46	64, b	S 4
	20.28	Roots Fine Joint, from 02 to 05 o'clock, within 8 inch: YES	00:01:42	66, b	M 1
	23.99	Roots Fine Joint, from 12 to 12 o'clock, within 8 inch: YES	00:01:58	68, b	M 1
	44.47	Roots Fine Joint, from 02 to 05 o'clock, within 8 inch: YES	00:02:52	70, b	M 1
	85.23	Tap Factory Made Active, at 09 o'clock, 6", within 8 inch: YES	00:04:27	72	
	93.17	Upstream Manhole, Survey Ends 1543-0094	00:04:56	73

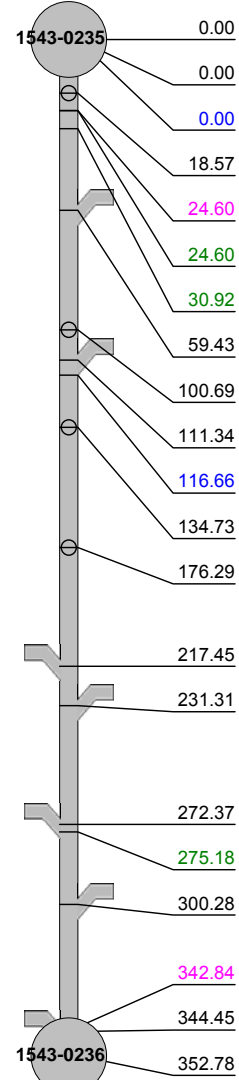
0.00	Upstream Manhole, Survey Begins 1543-0235		34	
	0.00	Water Level, 5 ☐ of cross sectional area			
	0.00	Water Mark, 5 ☐ of cross sectional area			M 2

18.57	Tap Factory Made Active, at 12 o'clock, 6", within 8 inch: YES, Remark: Roots	00:01:20	35	
	24.60	Fracture Multiple, from 03 to 09 o'clock, within 8 inch: YES	00:01:38	36, b	S 4
