CONSOLIDATED SEWER MAINTENANCE DISTRICT CONDITION ASSESSMENT PROGRAM REPORT CITY OF RANCHO PALOS VERDES

**CONDITION ASSESSMENT REPORT
COUNTY OF LOS ANGELES DEPARTMENT OF PUBLIC WORKS
CONSOLIDATED SEWER MAINTENANCE DISTRICT**

PROJECT NAME:	Y0TV1112C	PROJECT MGR:	Eric Liu
PROJECT DATE:	03/11/2015	CONTACT NO:	(626) 300-3369
SUP. DISTRICT(s):	4	MAP PAGE(S):	1491,1492,1545,1546,1599, 1653,1654
Report By:	Eric Liu	Report Date:	11/14/16

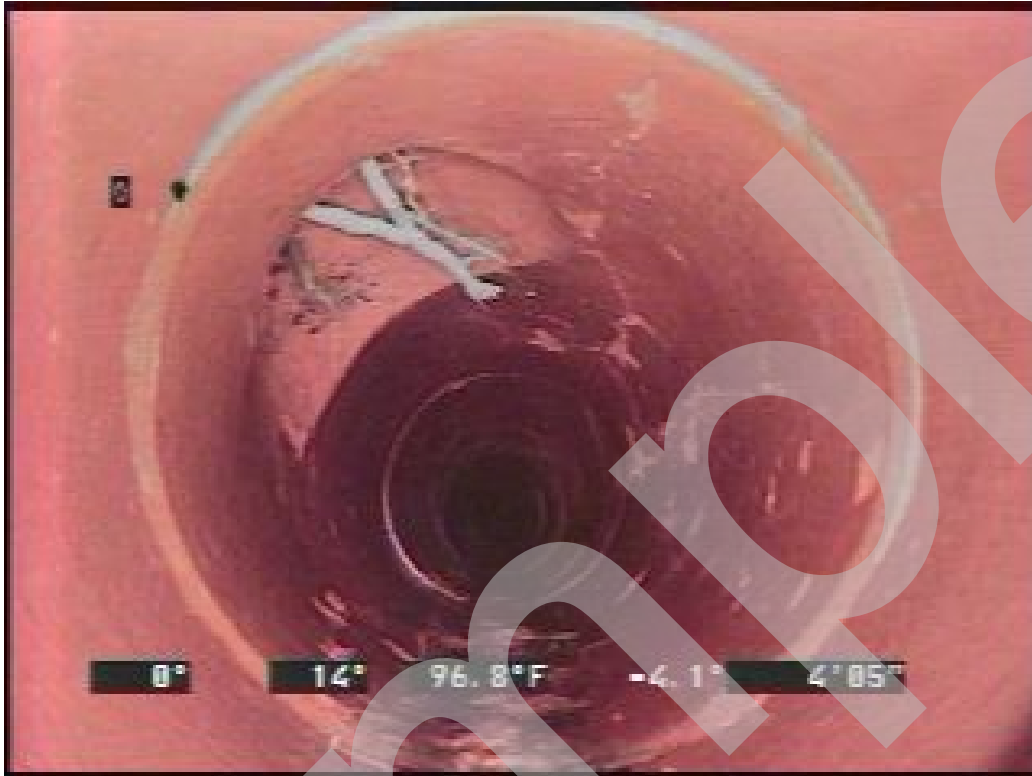
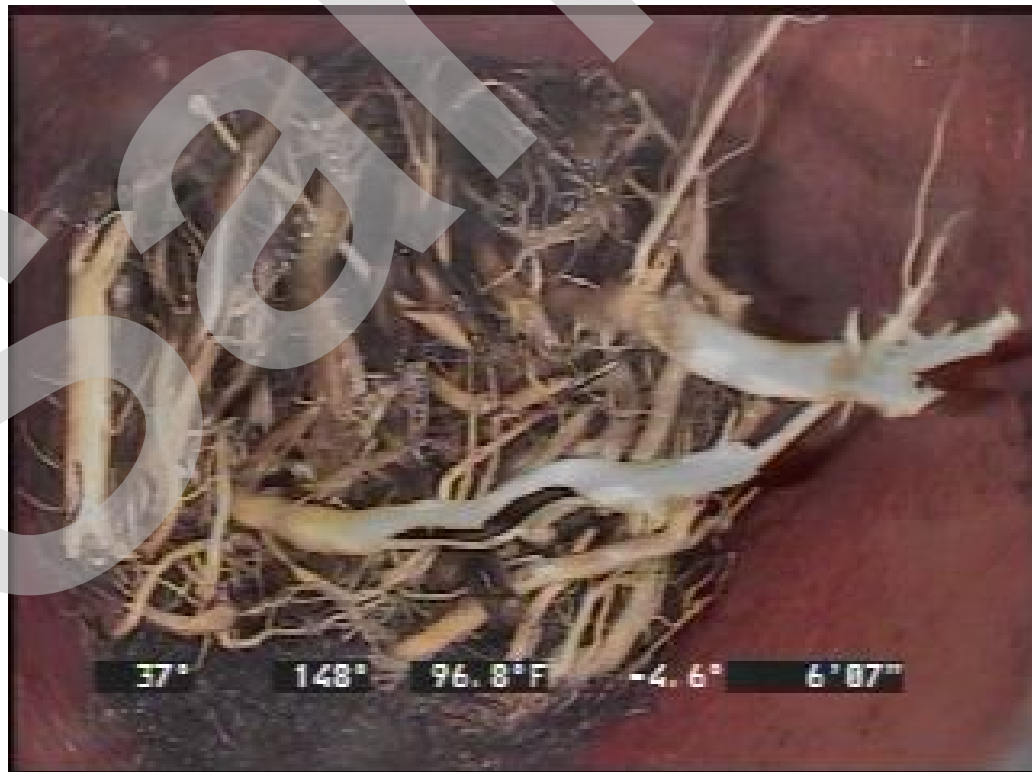
We have enclosed photos of your lateral connection showing the root blockage. In addition, we have included literature on ways to minimize sewer overflows and damage to your home. Please consider establishing a routine cleaning schedule for your sewer lateral to minimize potential plumbing problems caused by root intrusion that are likely to reoccur.

Roots at Lateral Connection

As the property owner, you are responsible for the entire length of the sewer lateral, which includes the portion that extends beyond the property line into the public right of way. We request that you contact a licensed plumber to service your sewer lateral within 90 days to remove roots and any other obstructions that may cause a sewage backup.
