### **CONSOLIDATED SEWER MAINTENANCE DISTRICT CONDITION ASSESSMENT PROGRAM REPORT – CITY OF TEMPLE CITY**

**CONDITION ASSESSMENT REPORT  
COUNTY OF LOS ANGELES DEPARTMENT OF PUBLIC WORKS  
CONSOLIDATED SEWER MAINTENANCE DISTRICT**

| PROJECT NAME: | Y0TV1112B | PROJECT MGR: | Hanna Kebede |

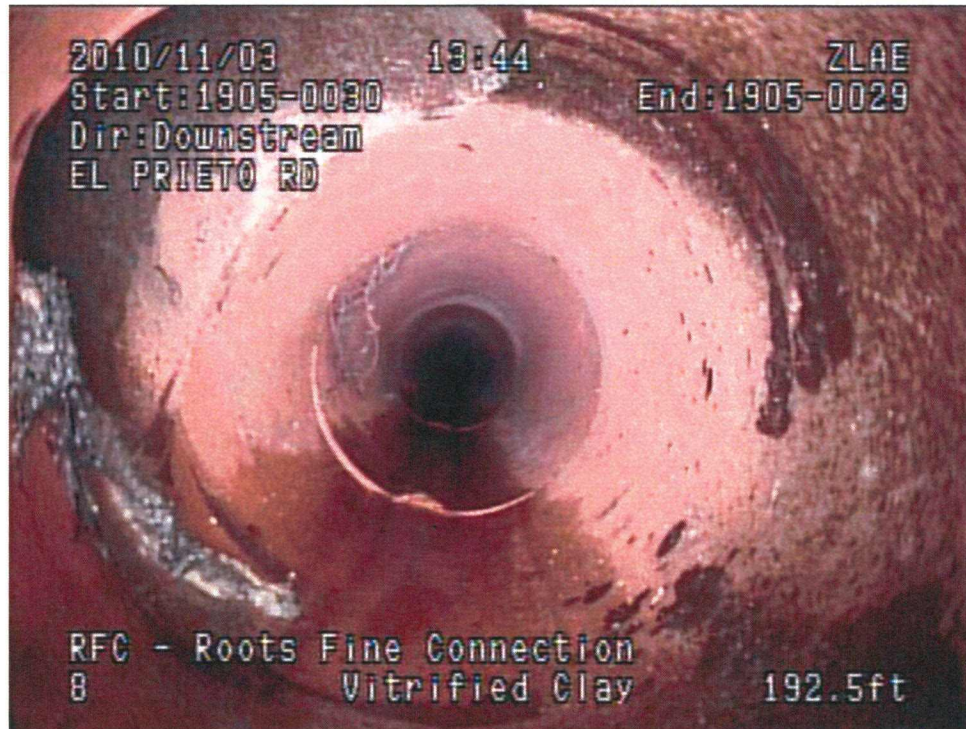
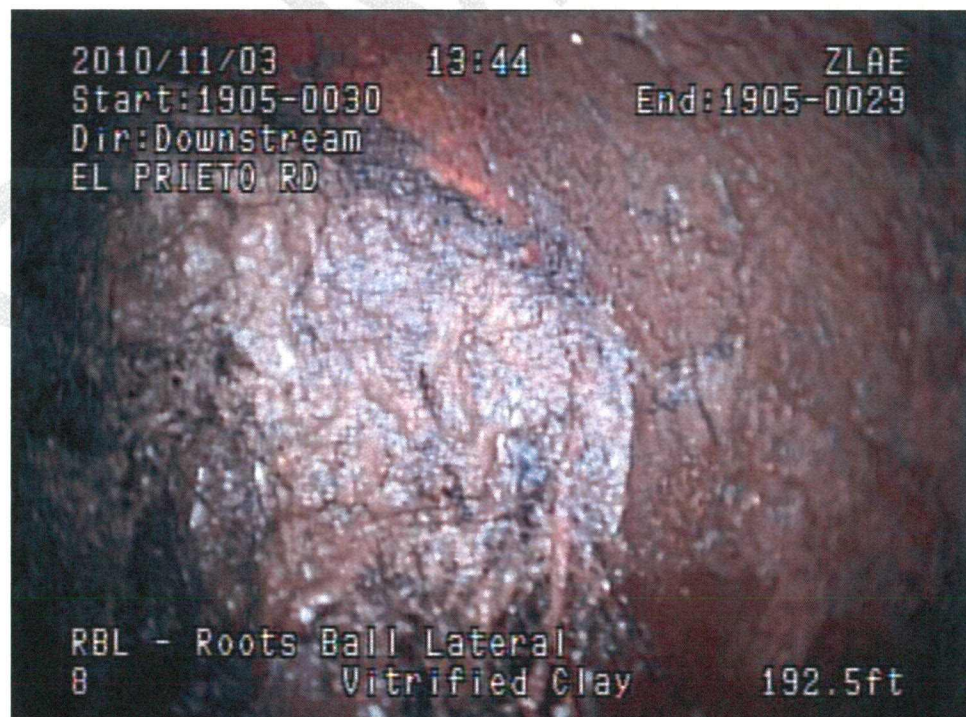
We have enclosed photos of your lateral connection showing the root blockage. In addition, we have included literature on ways to minimize sewer overflows and damage to your home. Please consider establishing a routine cleaning schedule for your sewer lateral to minimize potential plumbing problems caused by root intrusion that are likely to reoccur.

Roots at Lateral Connection

As the property owner, you are responsible for the entire length of the sewer lateral, which includes the portion that extends beyond the property line into the public right of way. We request that you contact a licensed plumber to service your sewer lateral within 90 days to remove roots and any other obstructions that may cause a sewage backup.
