CONSOLIDATED SEWER MAINTENANCE DISTRICT CONDITION ASSESSMENT PROGRAM REPORT PROJECT Y0TV0506F

**CONDITION ASSESSMENT REPORT
COUNTY OF LOS ANGELES DEPARTMENT OF PUBLIC WORKS
CONSOLIDATED SEWER MAINTENANCE DISTRICT**

PROJECT NAME:	Y0TV0506F	PROJECT MGR:	Fernando Villaluna
PROJECT DATE:	06/27/06 – 08/04/06	CONTACT NO:	(626) 300-3380
SUP. DISTRICT(s):	3	MAP PAGE(S):	1065
Report By:	Phyo Kyaw	Report Date:	11/17/08

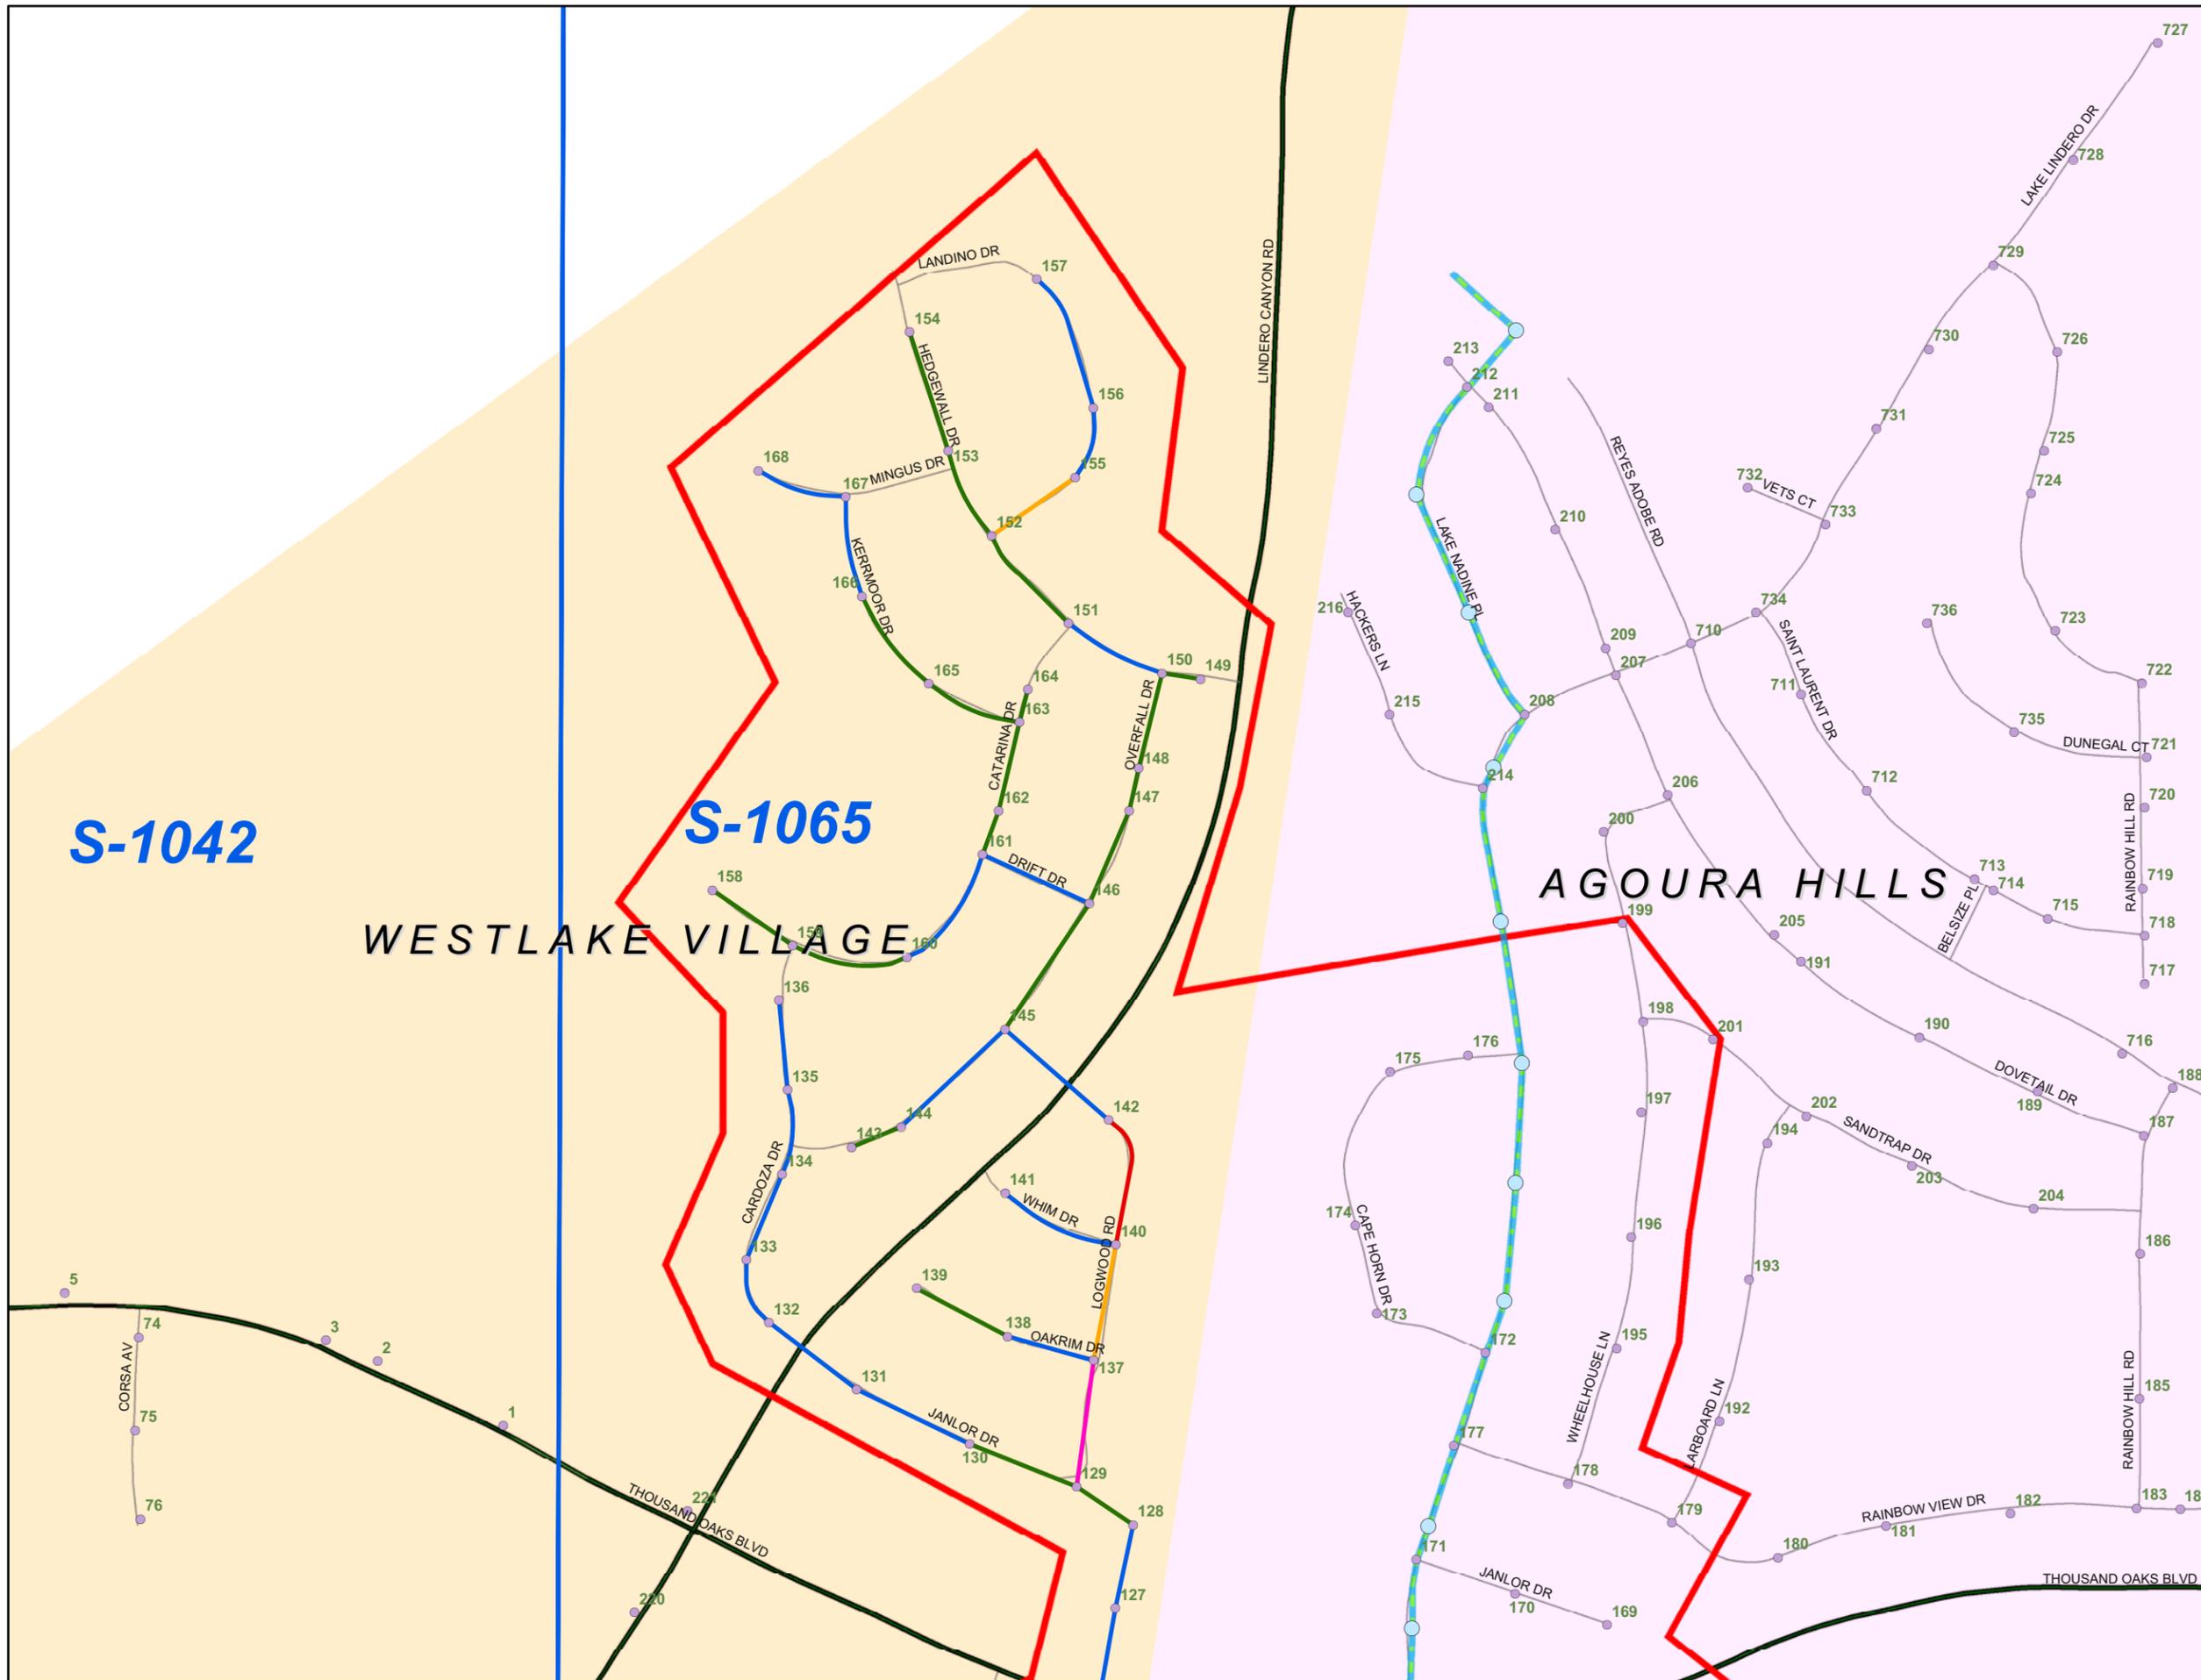
QUICK MAINTENANCE RATING (QMR)

Item No.	QMR	Start MH	End MH	Street	Observation	Corrective Action Taken
1	5132	1065-0142	1065-0140	LOGWOOD RD	Infiltration gusher; Deposits; Sag	Hydrojet (Completed 10/22/08)
2	4100	1065-0137	1065-0129	LOGWOOD RD	Infiltration runner	No action needed.
3	4100	1065-0674	1065-0667	SEINE CT	Infiltration runner	No action needed.
4	4100	1065-0667	1065-0666	MARSEILLE WAY	Infiltration runner	No action needed.

Item No.	QMR	Start MH	End MH	Street	Observation
1	5100	1065-0705	1065-0666	CLERMONT CT	Deposit settlement in lateral
