**REPORT ON 2016-17 INSPECTION OF
LACDPW SCRDS FACILITIES**

**CONTRACT:STORMWATER CAPTURE RUBBER DAM
MAINTENANCE SERVICES (2014-IT001)**

AUGUST 20, 2018

RUBBER DAM INSPECTION REPORT

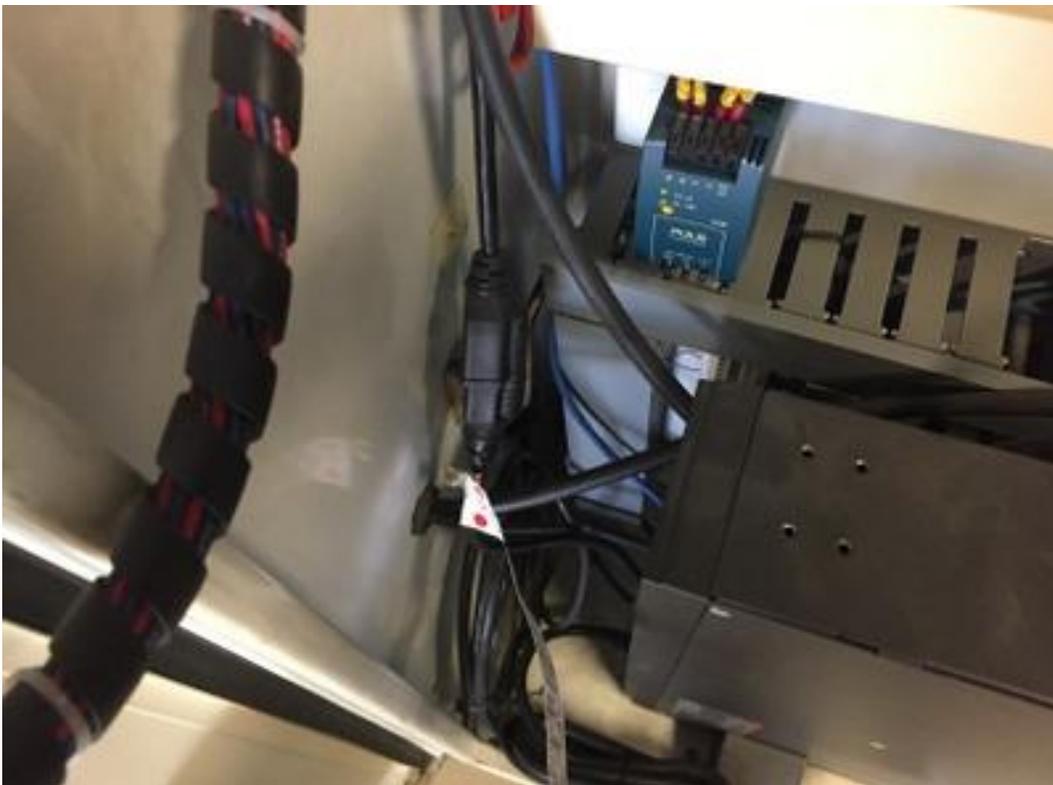
- 1) Rubber Dam body is severley deteriorated and requires replacement.
- 2) UPS needs replacement.

PHOTO 16 DAMAGED UPS

- 1) Rubber Dam body is severley deteriorated and requires replacement.
- 2) Replace UPS and tie in to PLC Programming & Alarms.

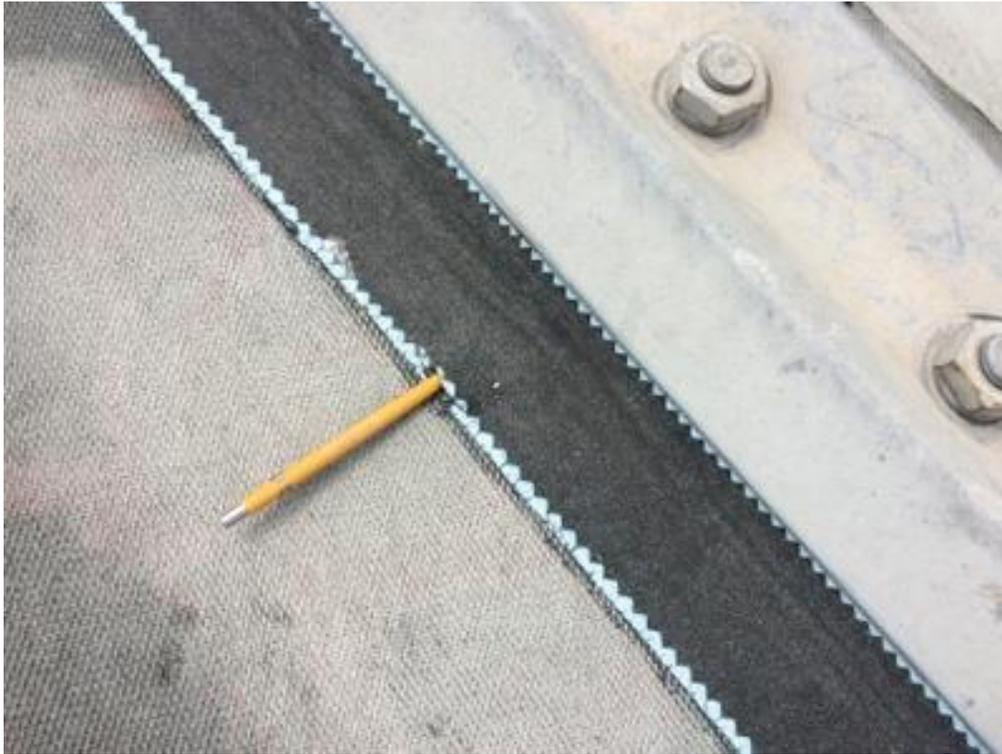
PHOTO 13

1) Overall condition of Rubber Dam, Mechanical and Electrical equipment at site:
 Rubber Body - Class D Repair at right abutment needs removal and replacement.
 Mechanical Equipment - Motor Valve lacks proportional feedback as included at Valley 2 & 3.
 Electrical Equipment - UPS needs replacement, Building alarm not working.
 Radio, Antenna & Antenna Mast - No significant damage observed

DETERIORATED CLASS D REPAIR

- 1) Remove and replace Class D repair at right abutment.
- 2) Replace UPS and tie in to PLC Programming & Alarms.
- 3) Repair and test building alarm.
- 4) Re-wire and test slide gate panels.

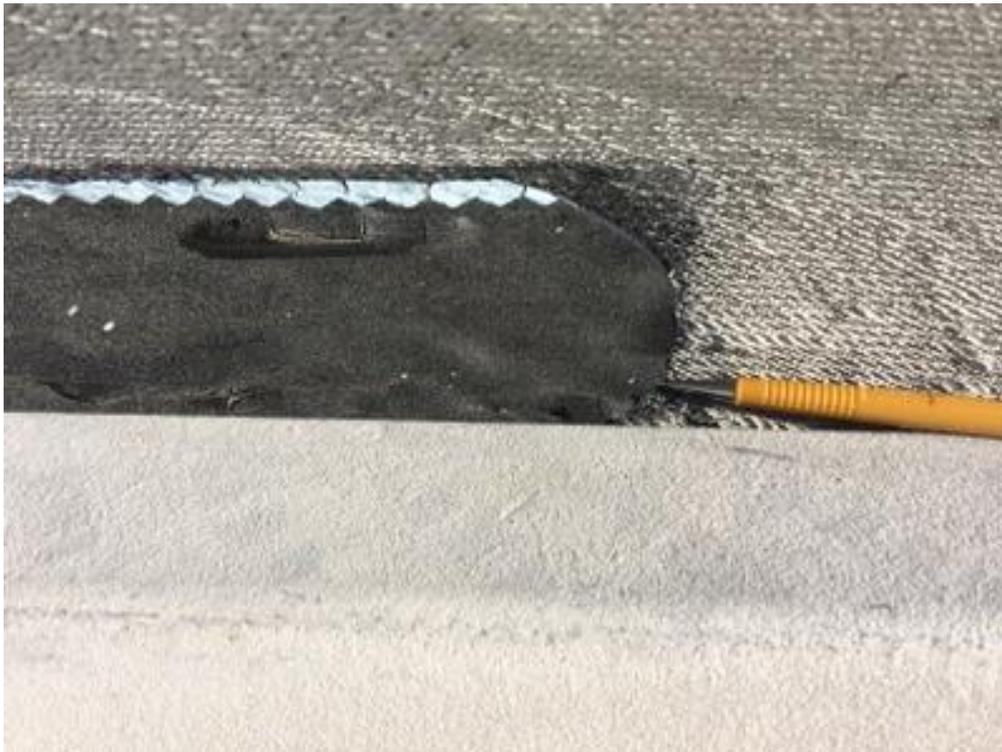
PHOTO 14

DETERIORATED CLASS D REPAIR

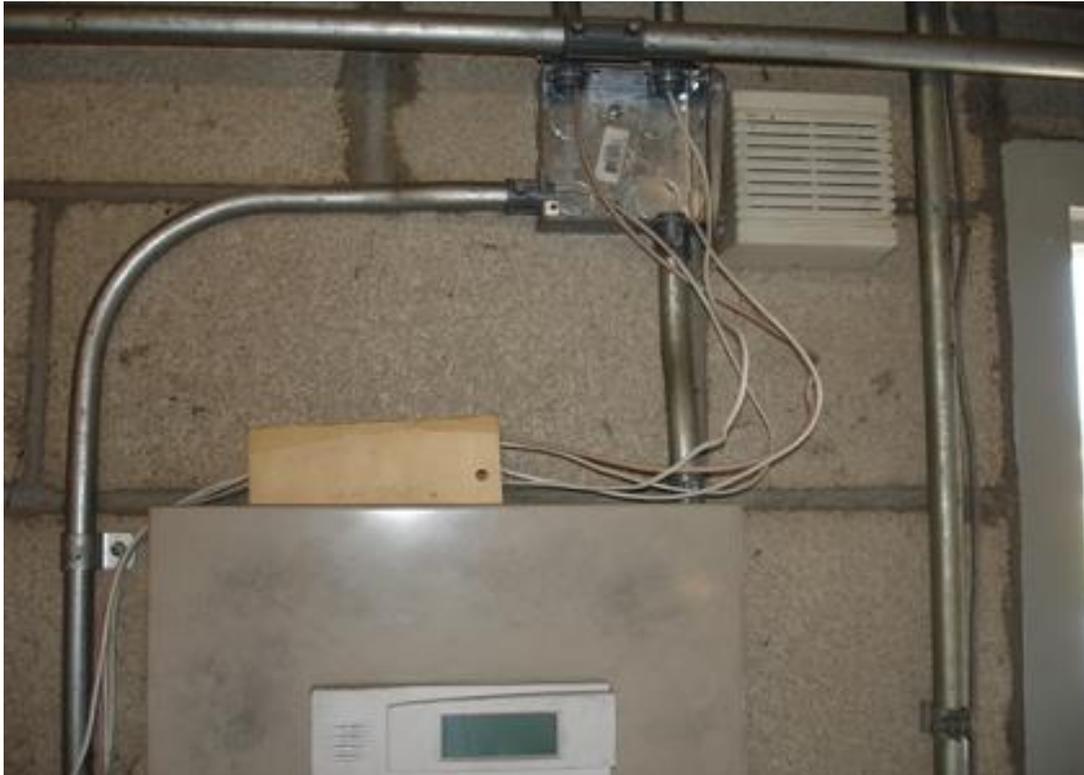
- 1) Motor Valve lacks proportional feedback as included at Valley 2 & 3.
- 2) Motor Valve exhausts the Rubber Dam significantly faster than the Blower can reinflate the Rubber Dam
- 3) UPS needs replacement.
- 4) Building alarm not working.
- 5) Slide gate panels wiring missing.

PHOTO 15 ALARM PANEL

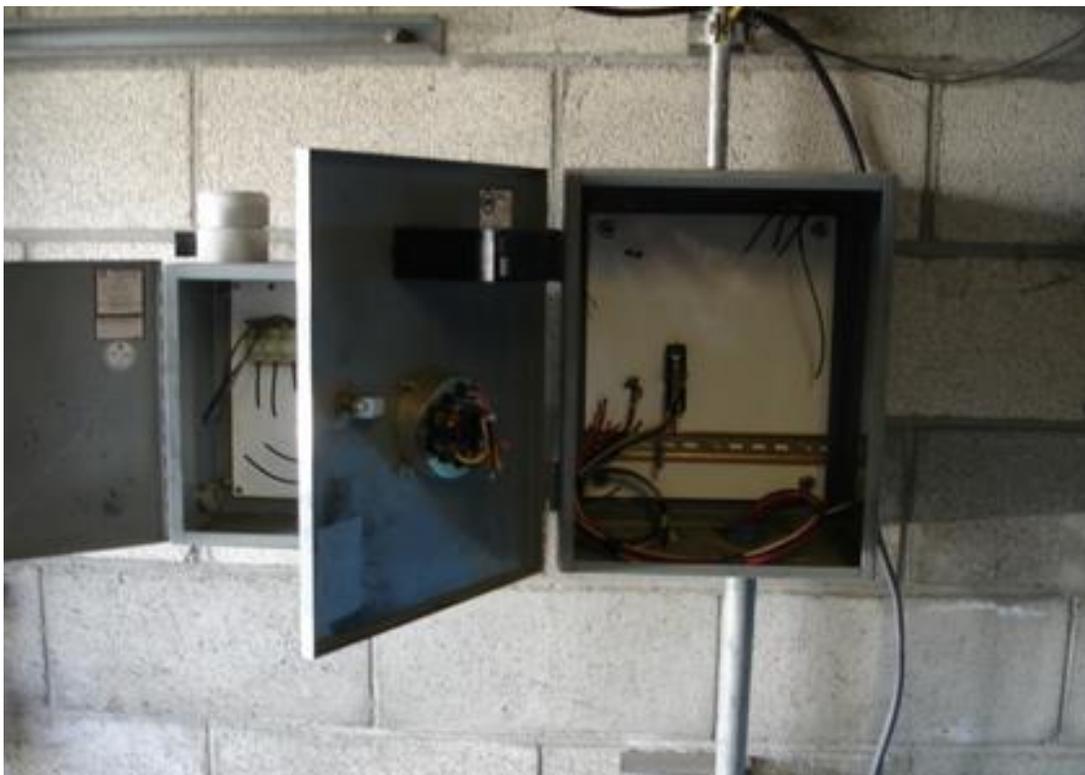
PHOTO 16 SLIDE GATE PANELS

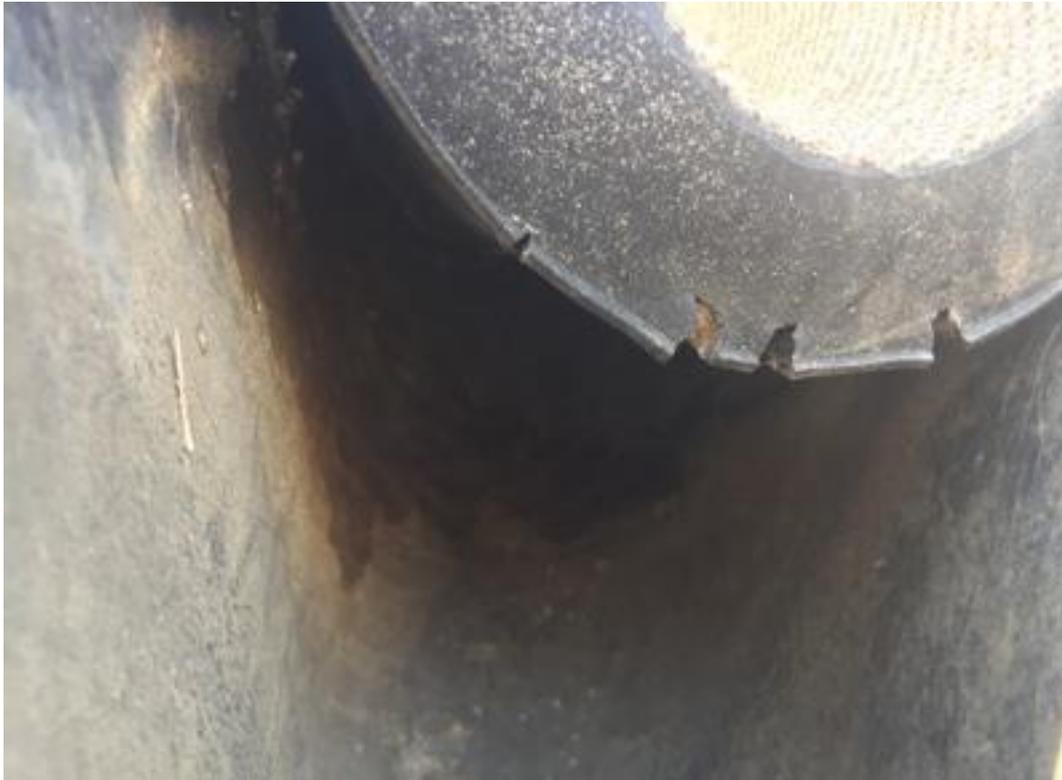
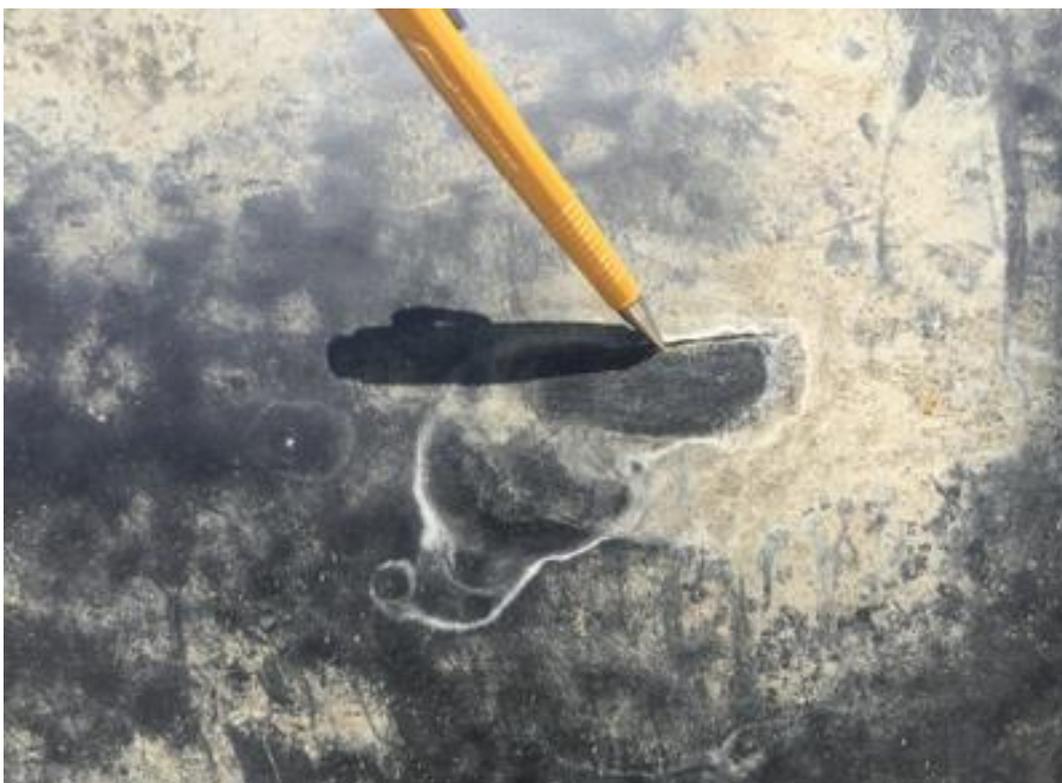
PHOTO 15

1) Overall condition of Rubber Dam, Mechanical and Electrical equipment at site:
 Rubber Body - Found damaged areas requiring 6 Class A repairs.
 Mechanical Equipment - No significant damage observed
 Electrical Equipment - No significant damage observed, UPS needs replacement.
 Radio, Antenna & Antenna Mast - No significant damage observed

CLASS A REPAIR TYPICAL

- 1) Make 6 Class A repairs.
- 2) Replace UPS and tie in to PLC Programming & Alarms.
- 3) Move radio antenna up 10-15 ft to top of pole.

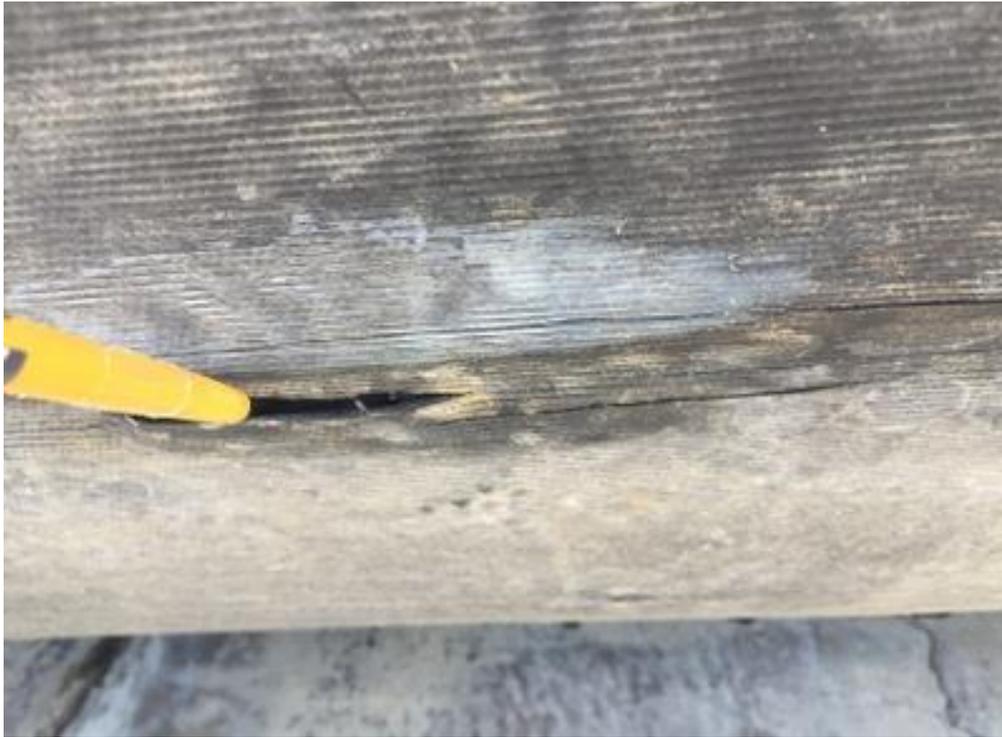
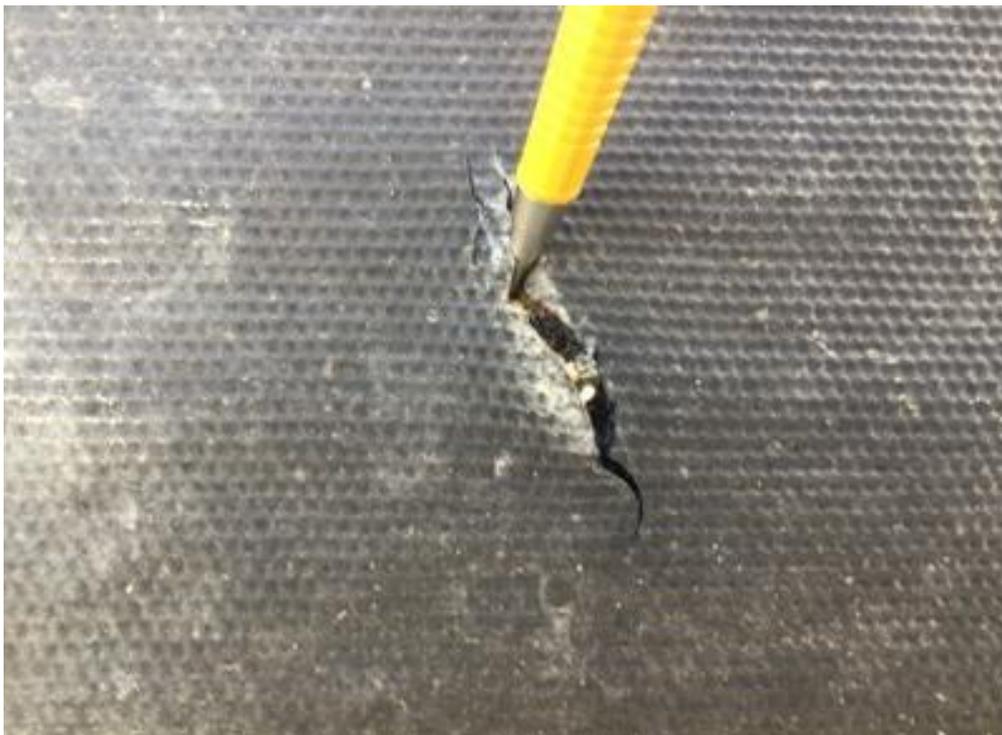
- 1) Surface cracking downstream needs repair.

PHOTO 15 DOWNSTREAM CRACKING

PHOTO 16 DOWNSTREAM CRACKING

- 1) Repair surface cracking.

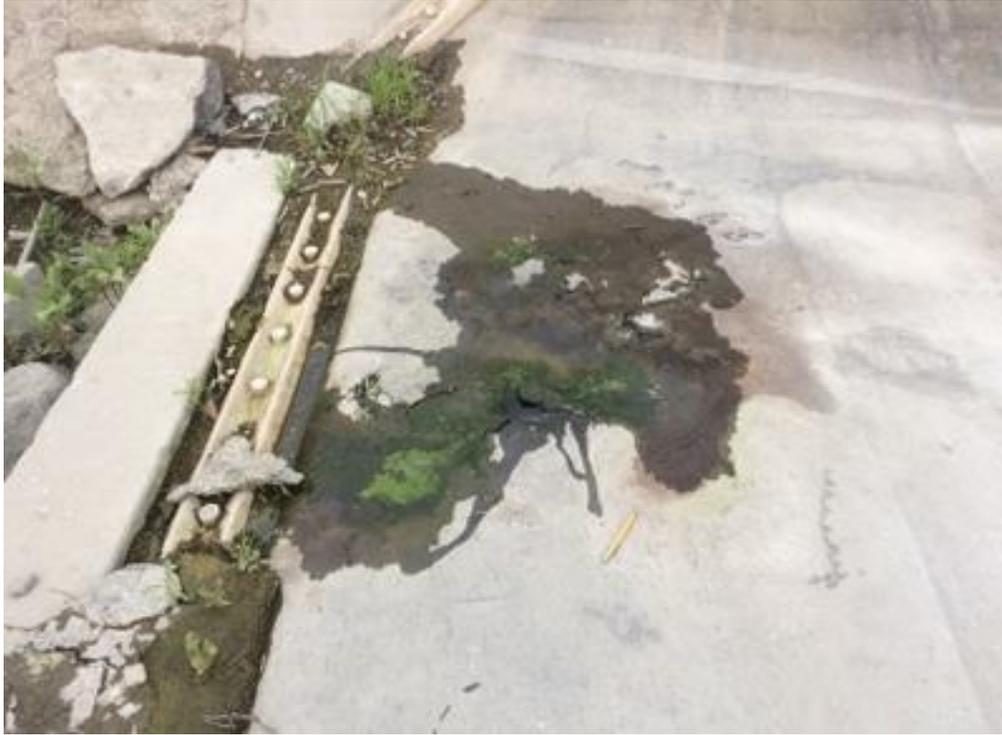
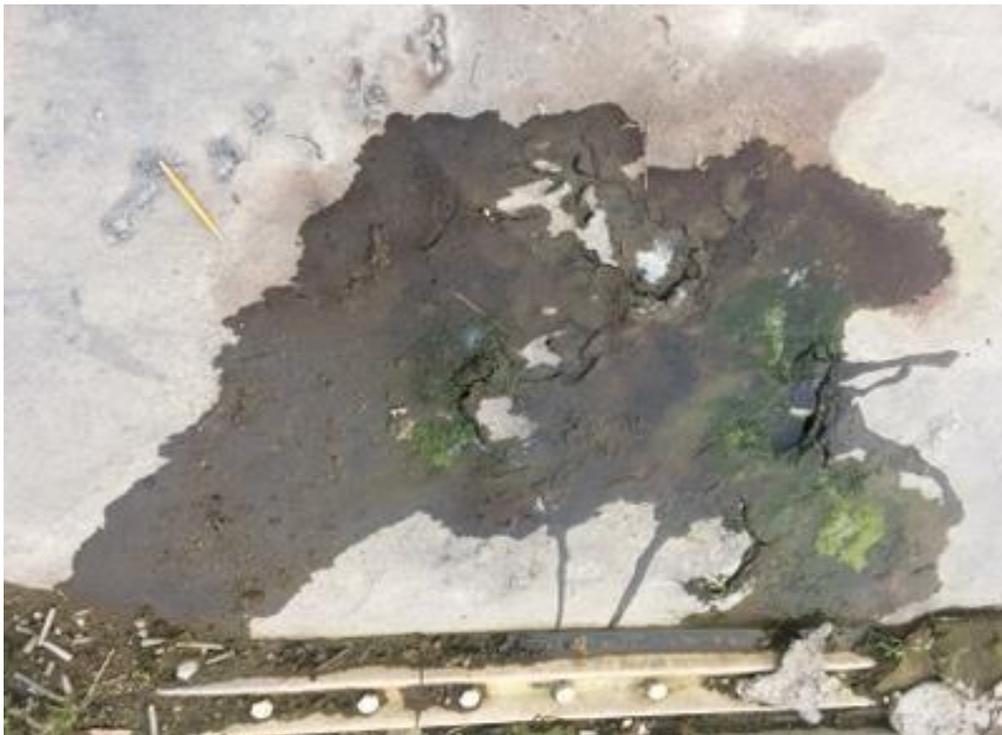
PHOTO 9

1) Overall condition of Rubber Dam, Mechanical and Electrical equipment at site:
 Rubber Body - 3 ft x 3 ft fire damage at left abutment. Bolt missing at right abutment.
 Mechanical Equipment - No significant damage observed
 Electrical Equipment - UPS needs replacement.
 Radio, Antenna & Antenna Mast - No significant damage observed

LEFT ABUTMENT BURNED AREA

- 1) Replace Rubber Dam.
- 2) Replace UPS.
- 3) Replace bolt at right abutment.

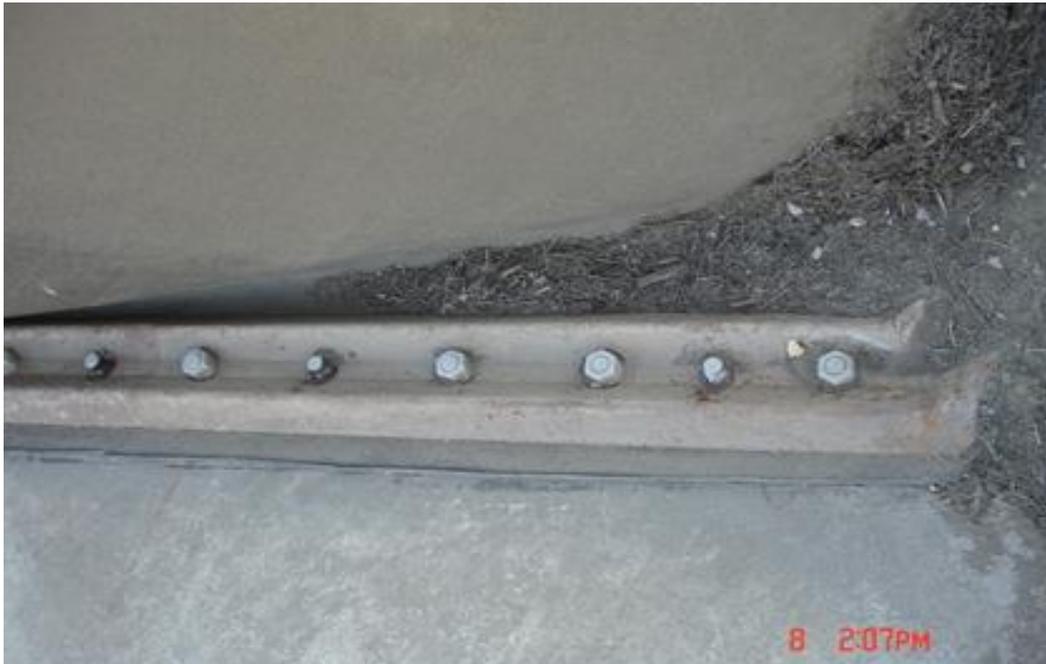
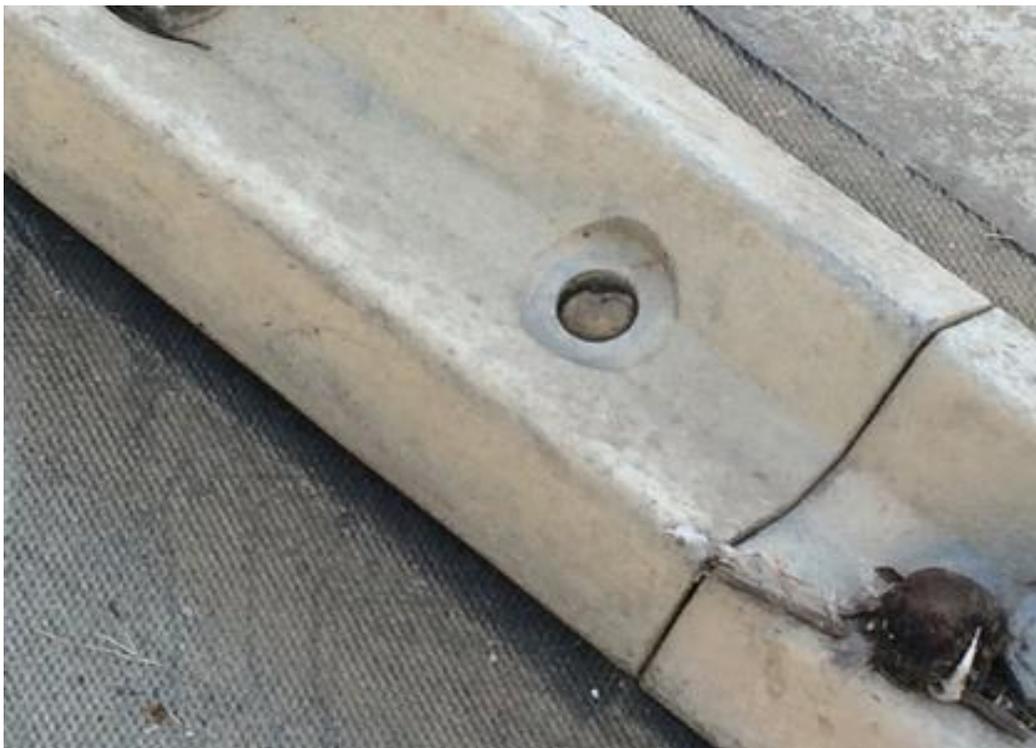
PHOTO 11 MISSING BOLT RIGHT AUTMENT

PHOTO 12 MISSING BOLT RIGHT AUTMENT DETAIL

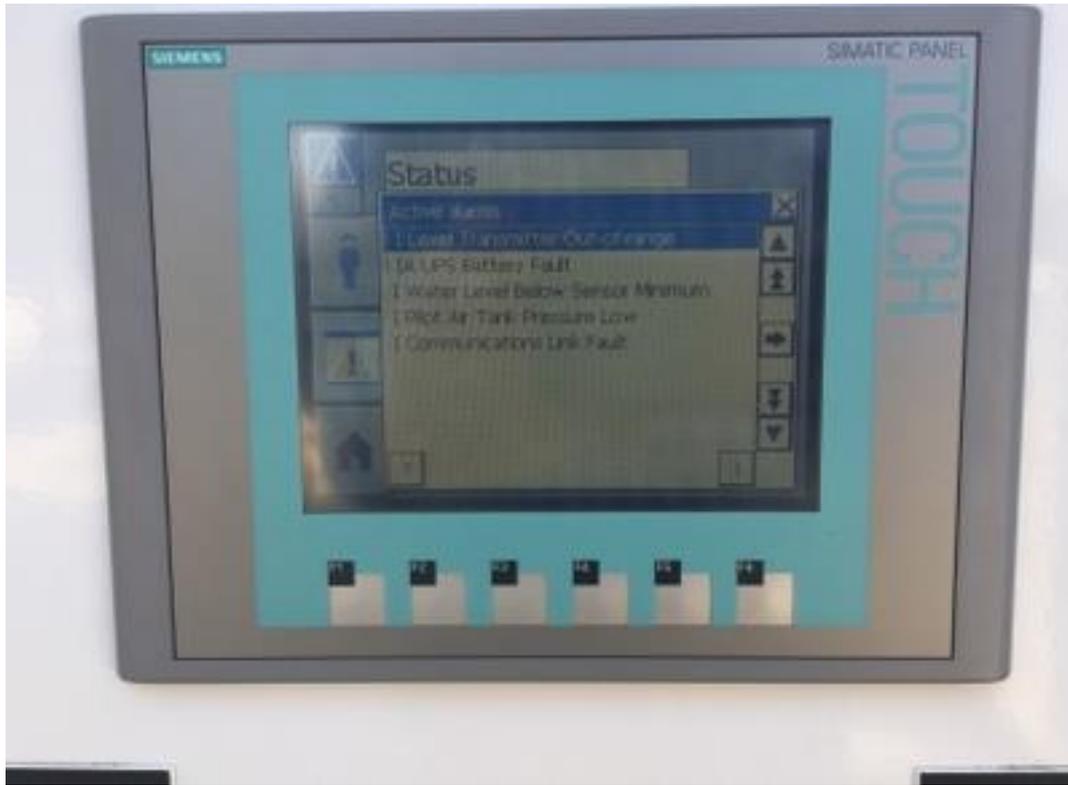
PHOTO 7

HMI ALARMS

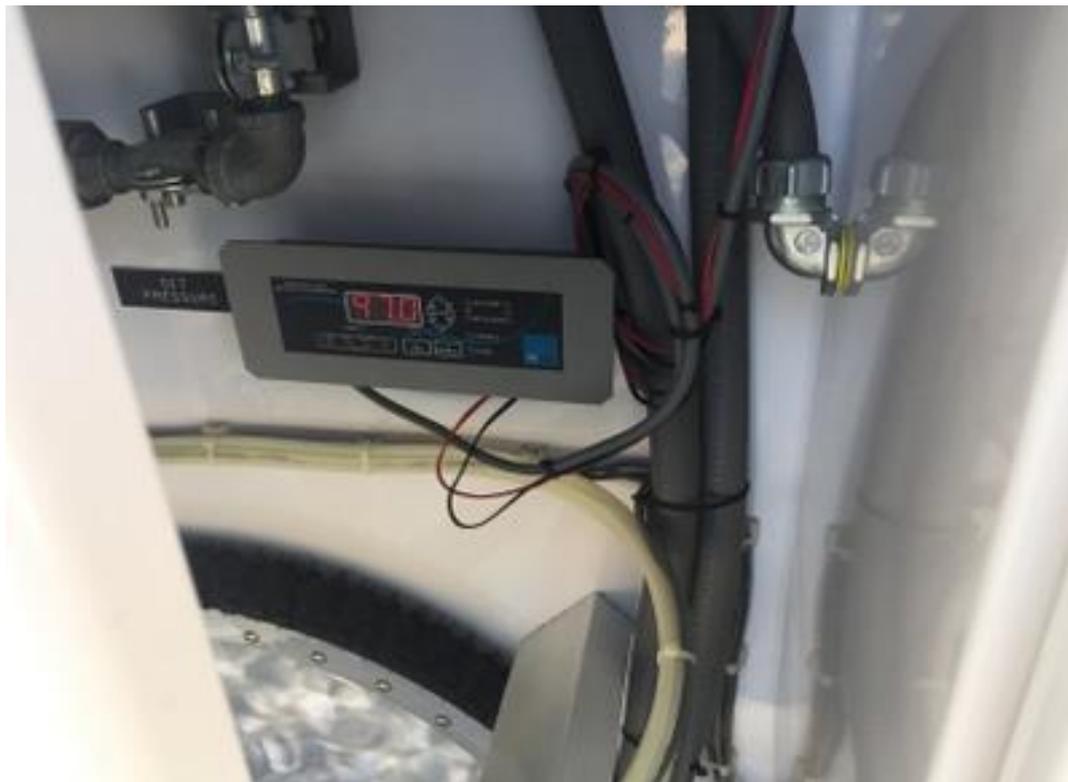
PHOTO 8

HIGH TEMP ALARM
