CONSOLIDATED SEWER MAINTENANCE DISTRICT CONDITION ASSESSMENT PROGRAM REPORT – CITY OF BRADBURY

CONDITION ASSESSMENT REPORT COUNTY OF LOS ANGELES DEPARTMENT OF PUBLIC WORKS CONSOLIDATED SEWER MAINTENANCE DISTRICT

PROJECT NAME: Y0TV1112B PROJECT MGR: Hanna Kebede PROJECT DATE: 10/03/13 CONTACT NO: (626) 300-4686 SUP. DISTRICT(s): 5 MAP PAGE(S): 2122, 2166

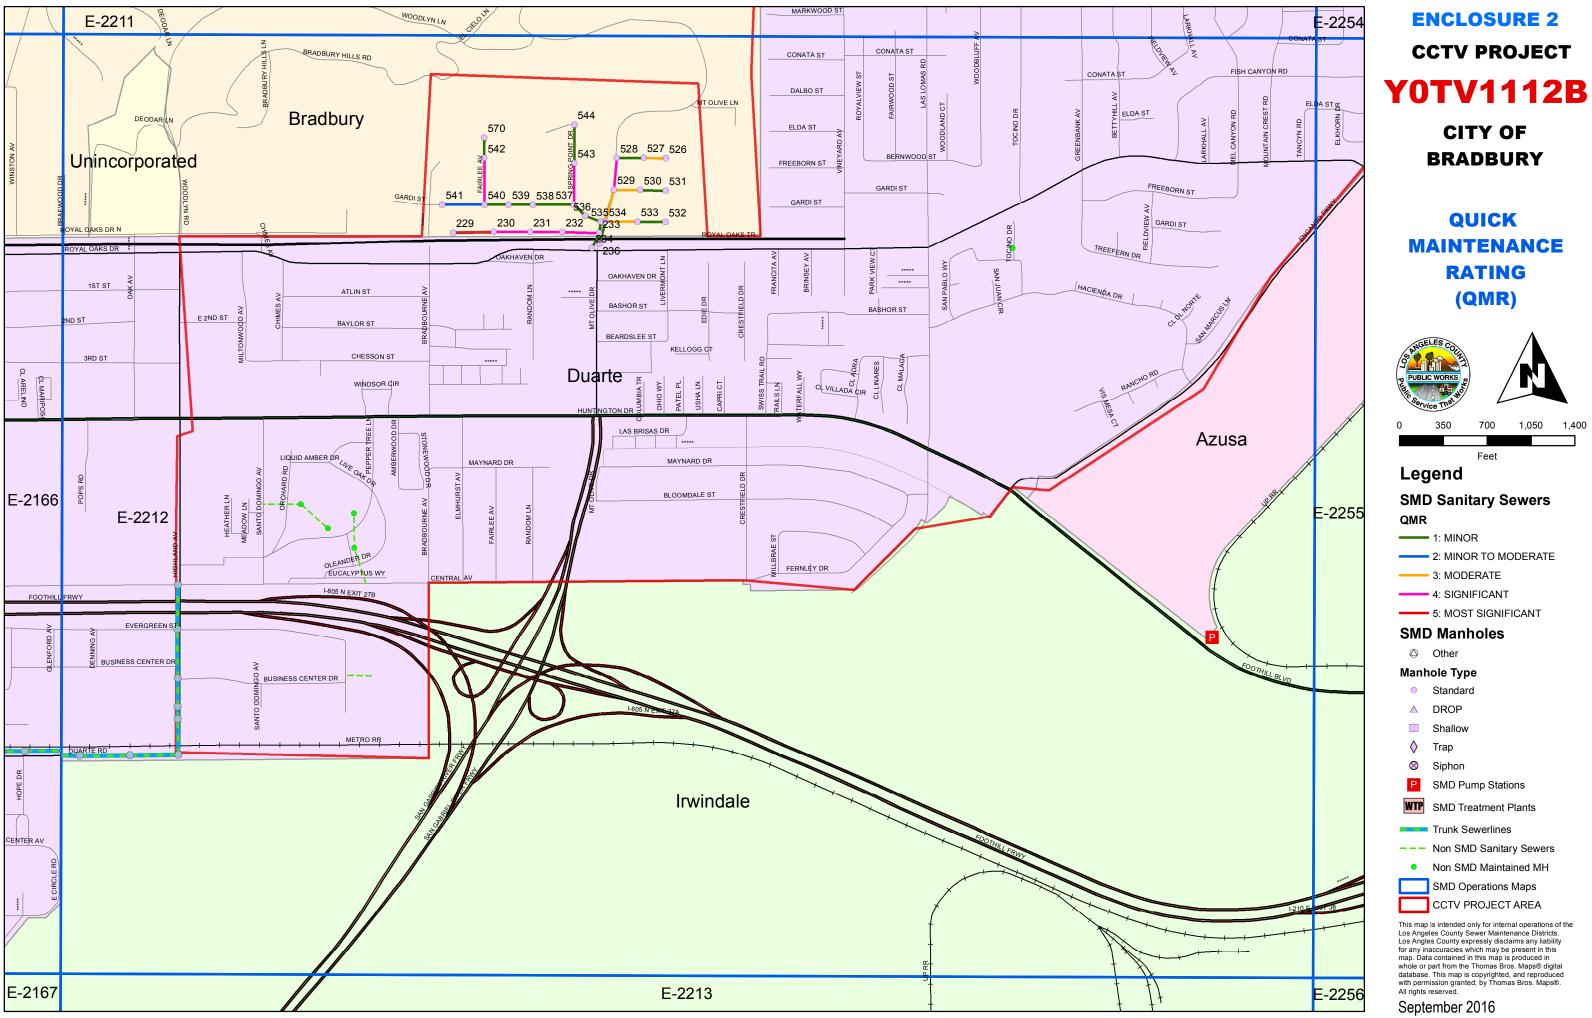
MAINTENANCE

Our inspection revealed that approximately 56 percent of the system televised was free of blockages or restrictions that would impede sewer flows. However, the remaining 44 percent of the pipe segments within the City had a PACP maintenance grade of 3, 4, or 5 as indicated in the Quick Maintenance Rating Table shown below. These segments have been incorporated into our enhanced cleaning schedule with corrective action taken.

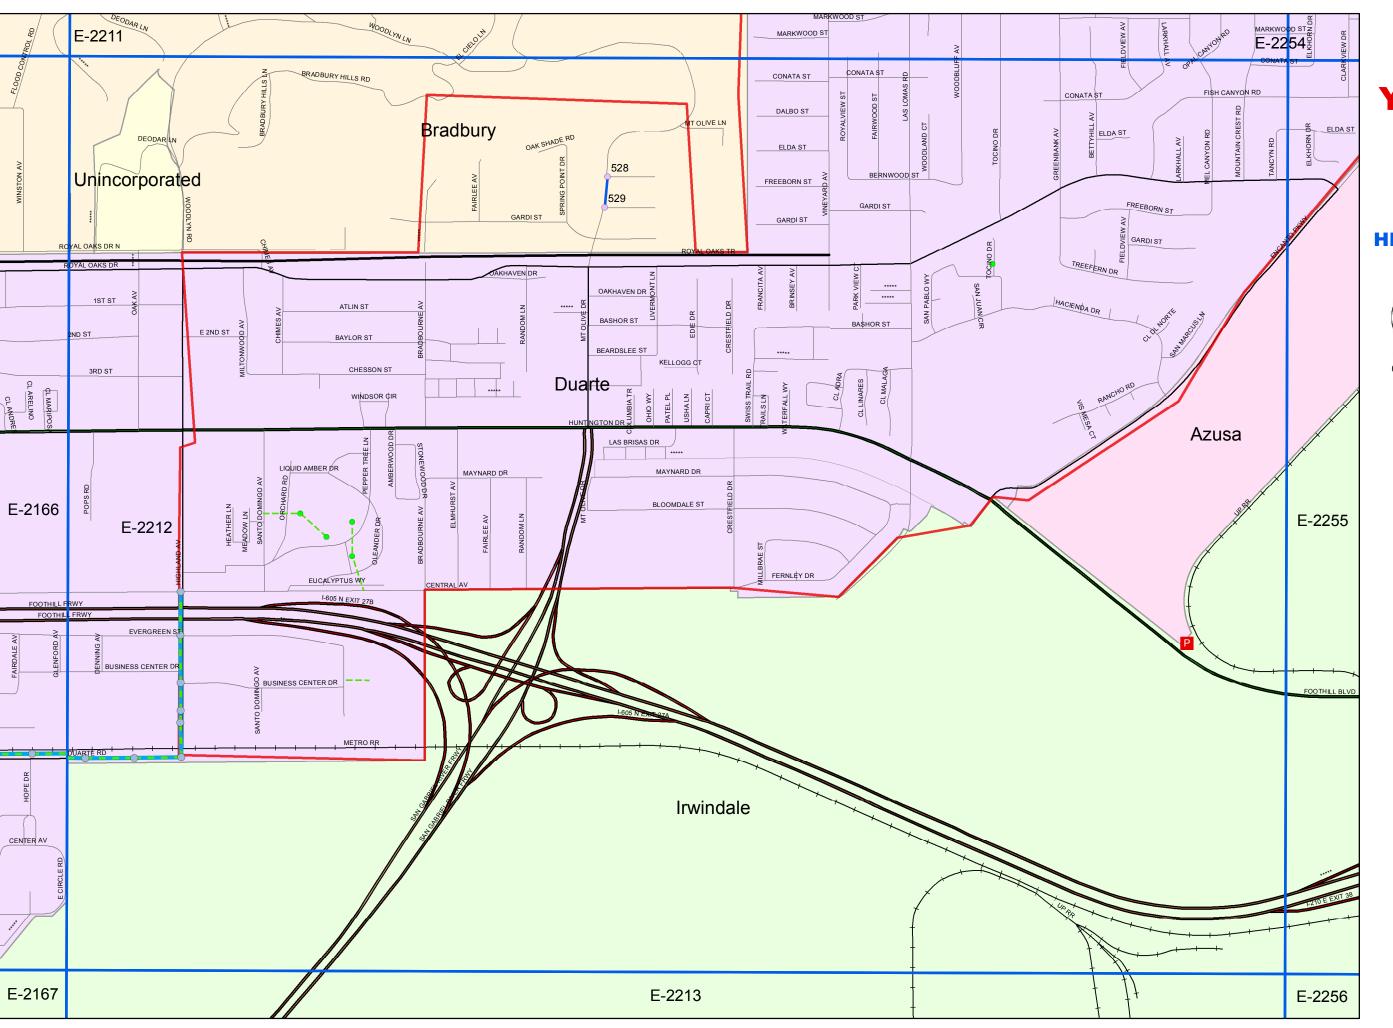
HIGH WATER LEVEL

Our inspection revealed that one segment exhibited visual signs associated with high water levels due to a sag in the line. The capacity of the sewer pipe can be determined by analyzing several PACP codes, including Water Level, Water Mark, and miscellaneous remarks, which indicate the camera was underwater or there were sags in the line. A sewer pipe is considered at capacity when 50 percent of the diameter of the sewer pipe is full of water. However, there are conditions in which the Water Level or Water Mark reaches 50 percent or greater due to heavy flows in adjoining pipes, a temporary stoppage caused by debris in the sewer line, or a sag in the line. Therefore, additional review of this pipe segment was conducted to determine if any capacity issues exist.

ITEM NO.	QMR	START MH	END MH	STREET	OBSERVATION	SAG (ft)
1	4200	2212-0528	2212-0529	MOUNT VIEW DR	High water level (sag)	6

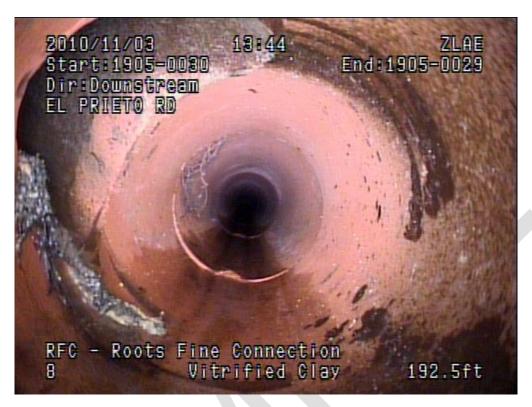
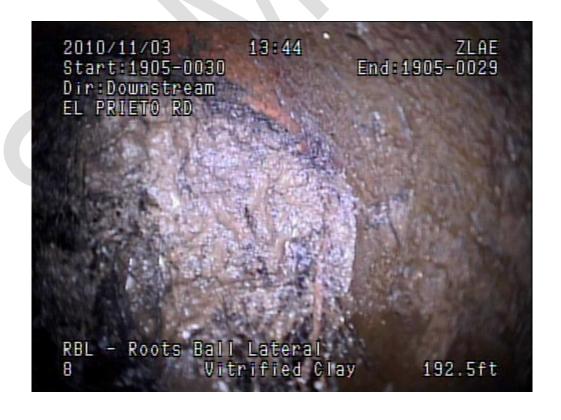
Roots at Lateral Connection

The County of Los Angeles Consolidated Sewer Maintenance District is responsible for the maintenance of the sanitary sewer system in your area. We recently televised the sewer mainline and discovered roots in your sewer lateral connection. The intrusion of the roots from your lateral may block the flow of sewage in the mainline sewer causing an overflow upstream of your property. You are hereby requested to perform maintenance on the private sewer lateral serving the property located at 4474 El Prieto Road, Altadena, California 91001.

We have enclosed photos of your lateral connection showing the root blockage. In addition, we have included literature on ways to minimize sewer overflows and damage to your home. Please consider establishing a routine cleaning schedule for your sewer lateral to minimize potential plumbing problems caused by root intrusion that are likely to reoccur.

As the property owner, you are responsible for the entire length of the sewer lateral, which includes the portion that extends beyond the property line into the public right of way. We request that you contact a licensed plumber to service your sewer lateral within 90 days to remove roots and any other obstructions that may cause a sewage backup.

Your licensed plumber is required to protect the District's sewer mainlines from dislodged roots and other debris by utilizing catcher baskets at the manhole downstream from your lateral connection. Prior to your plumber cleaning your lateral, please notify the District's sewer maintenance yard in your area at (626) 446-5227 to arrange for authorization to access the downstream manhole.

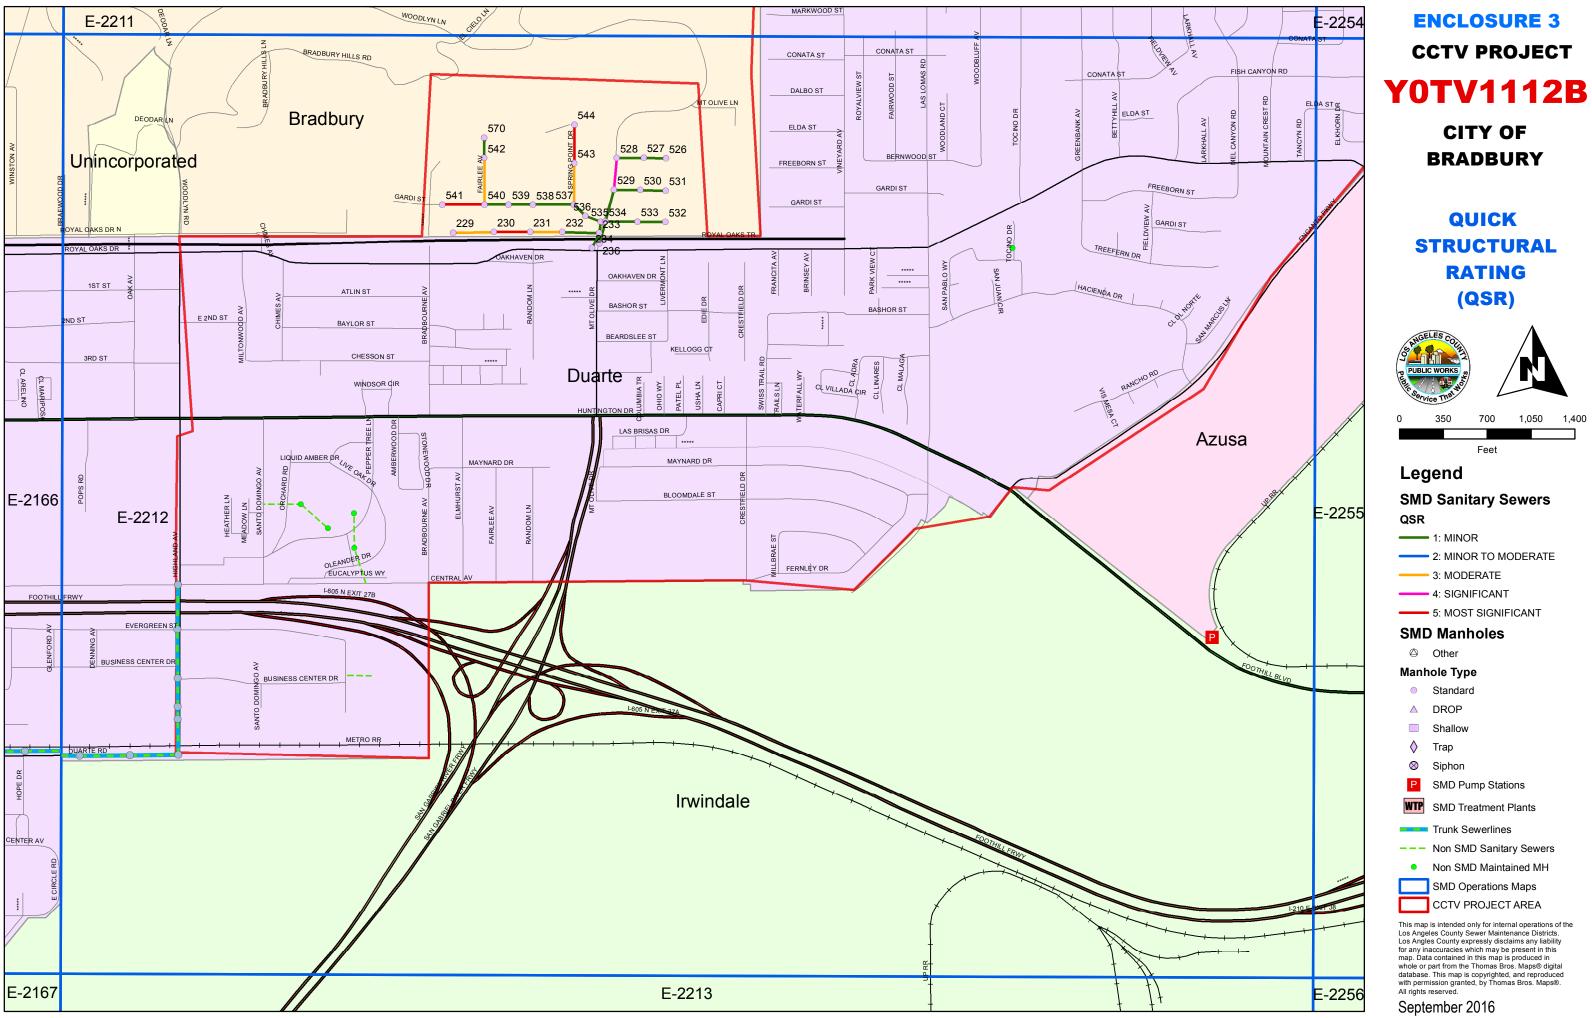
STRUCTURAL

Our inspection revealed that approximately 84 percent of the inspected pipe segments within the City were free of severe structural defects. However, the remaining 16 percent of the inspected pipe segments had a PACP structural grade of 4 and 5 as indicated in the Quick Structural Rating Table shown on page 4. These segments have been placed on a priority list based on the severity and need for action. For items 1 through 4 in the Quick Structural Rating Report Priority List (Enclosure 3), which require a corrective action, the proposed repair or replacement will be scheduled in the next 24 months as part of the ongoing Accumulative Capital Outlay Project.

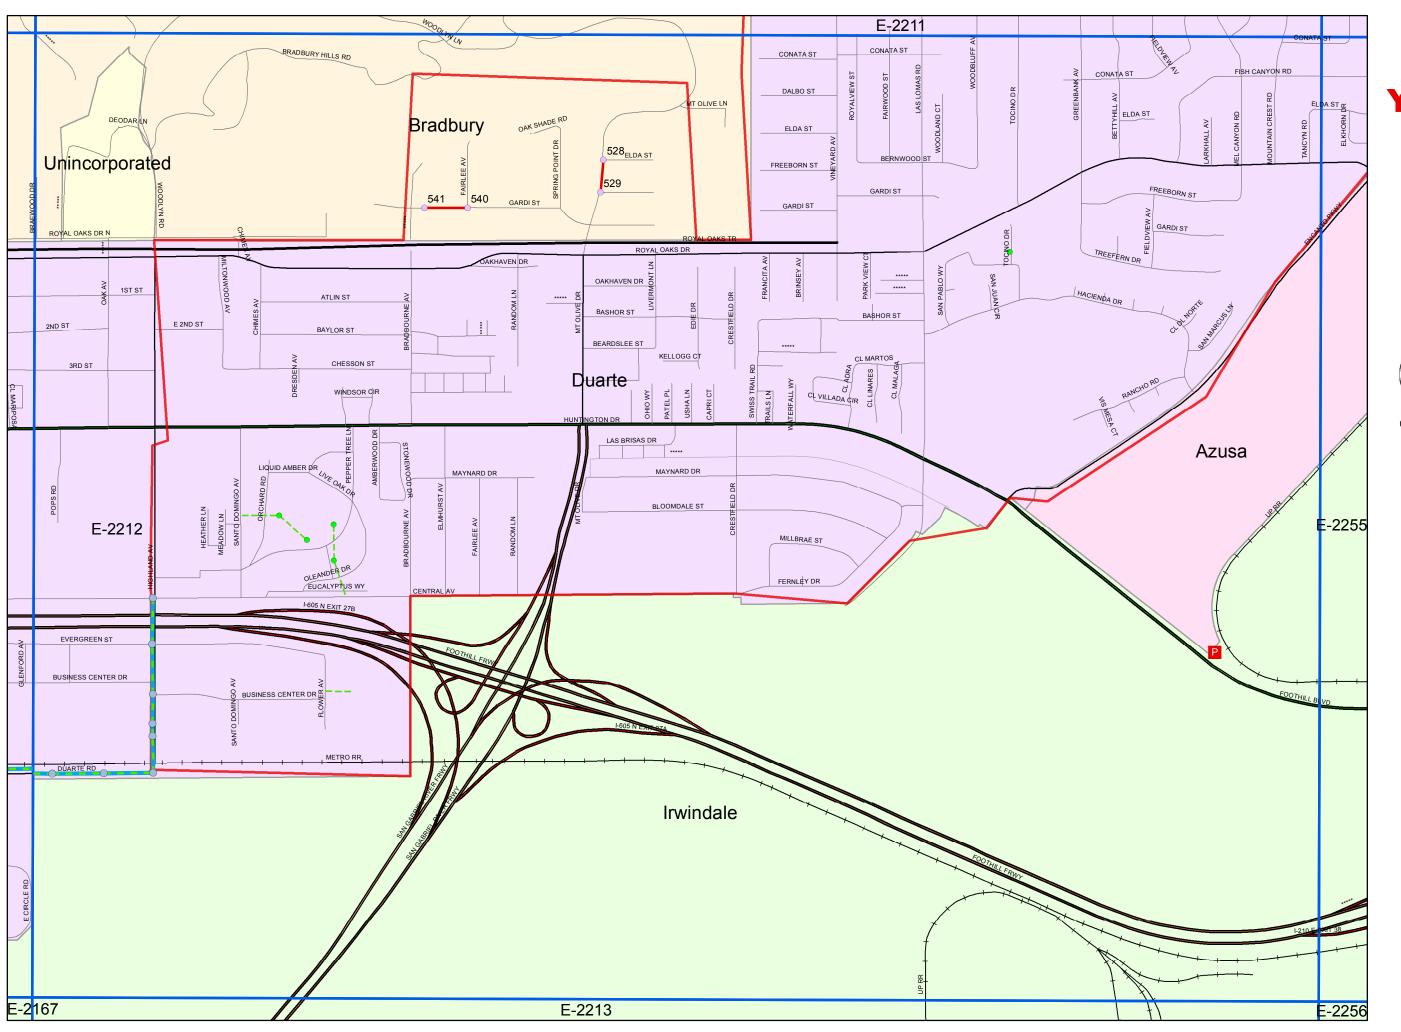
LINING & POINT REPAIR PROJECTS

ITEM NO.	QSR	START MH	END MH	STREET	OBSERVATION: LOCATION	PROPOSED CORRECTIVE METHOD	LENGTH OF REPAIR (FT)
1	5143	2212-0541	2212-0540	GARDI ST	Fractures: 25'; 269', 333'	Lining: MH to MH	340
2	5134	2212-0544	2212-0543	SPRINGPOINT DR	Broken: 26'	Structural integrity in tact. No action needed.	
3	5132	2212-0230	2212-0231	EASEMENT	Cracks: multiple locations	Structural integrity in tact. No action needed.	
4	4100	2212-0528	2212-0529	MOUNT VIEW DR	Fractures: 35'	Lining: MH to MH	253
