**CONSOLIDATED SEWER MAINTENANCE DISTRICT
CONDITION-ASSESSMENT PROGRAM REPORT
PROJECT NO. Y0TV1314B2**

**CONDITION-ASSESSMENT REPORT
LOS ANGELES COUNTY PUBLIC WORKS
CONSOLIDATED SEWER MAINTENANCE DISTRICT**

PROJECT NAME:	Y0TV1314B2	PROJECT MGR:	ERIC LIU
PROJECT DATE:	7/23/2014	CONTACT NO:	(626) 300-3369
SUP. DISTRICT(s):	1	MAP PAGE(S):	1915, 1916, 1969, 1970
Report By:	Jonathan Gonzalez	Report Date:	9/17/2018

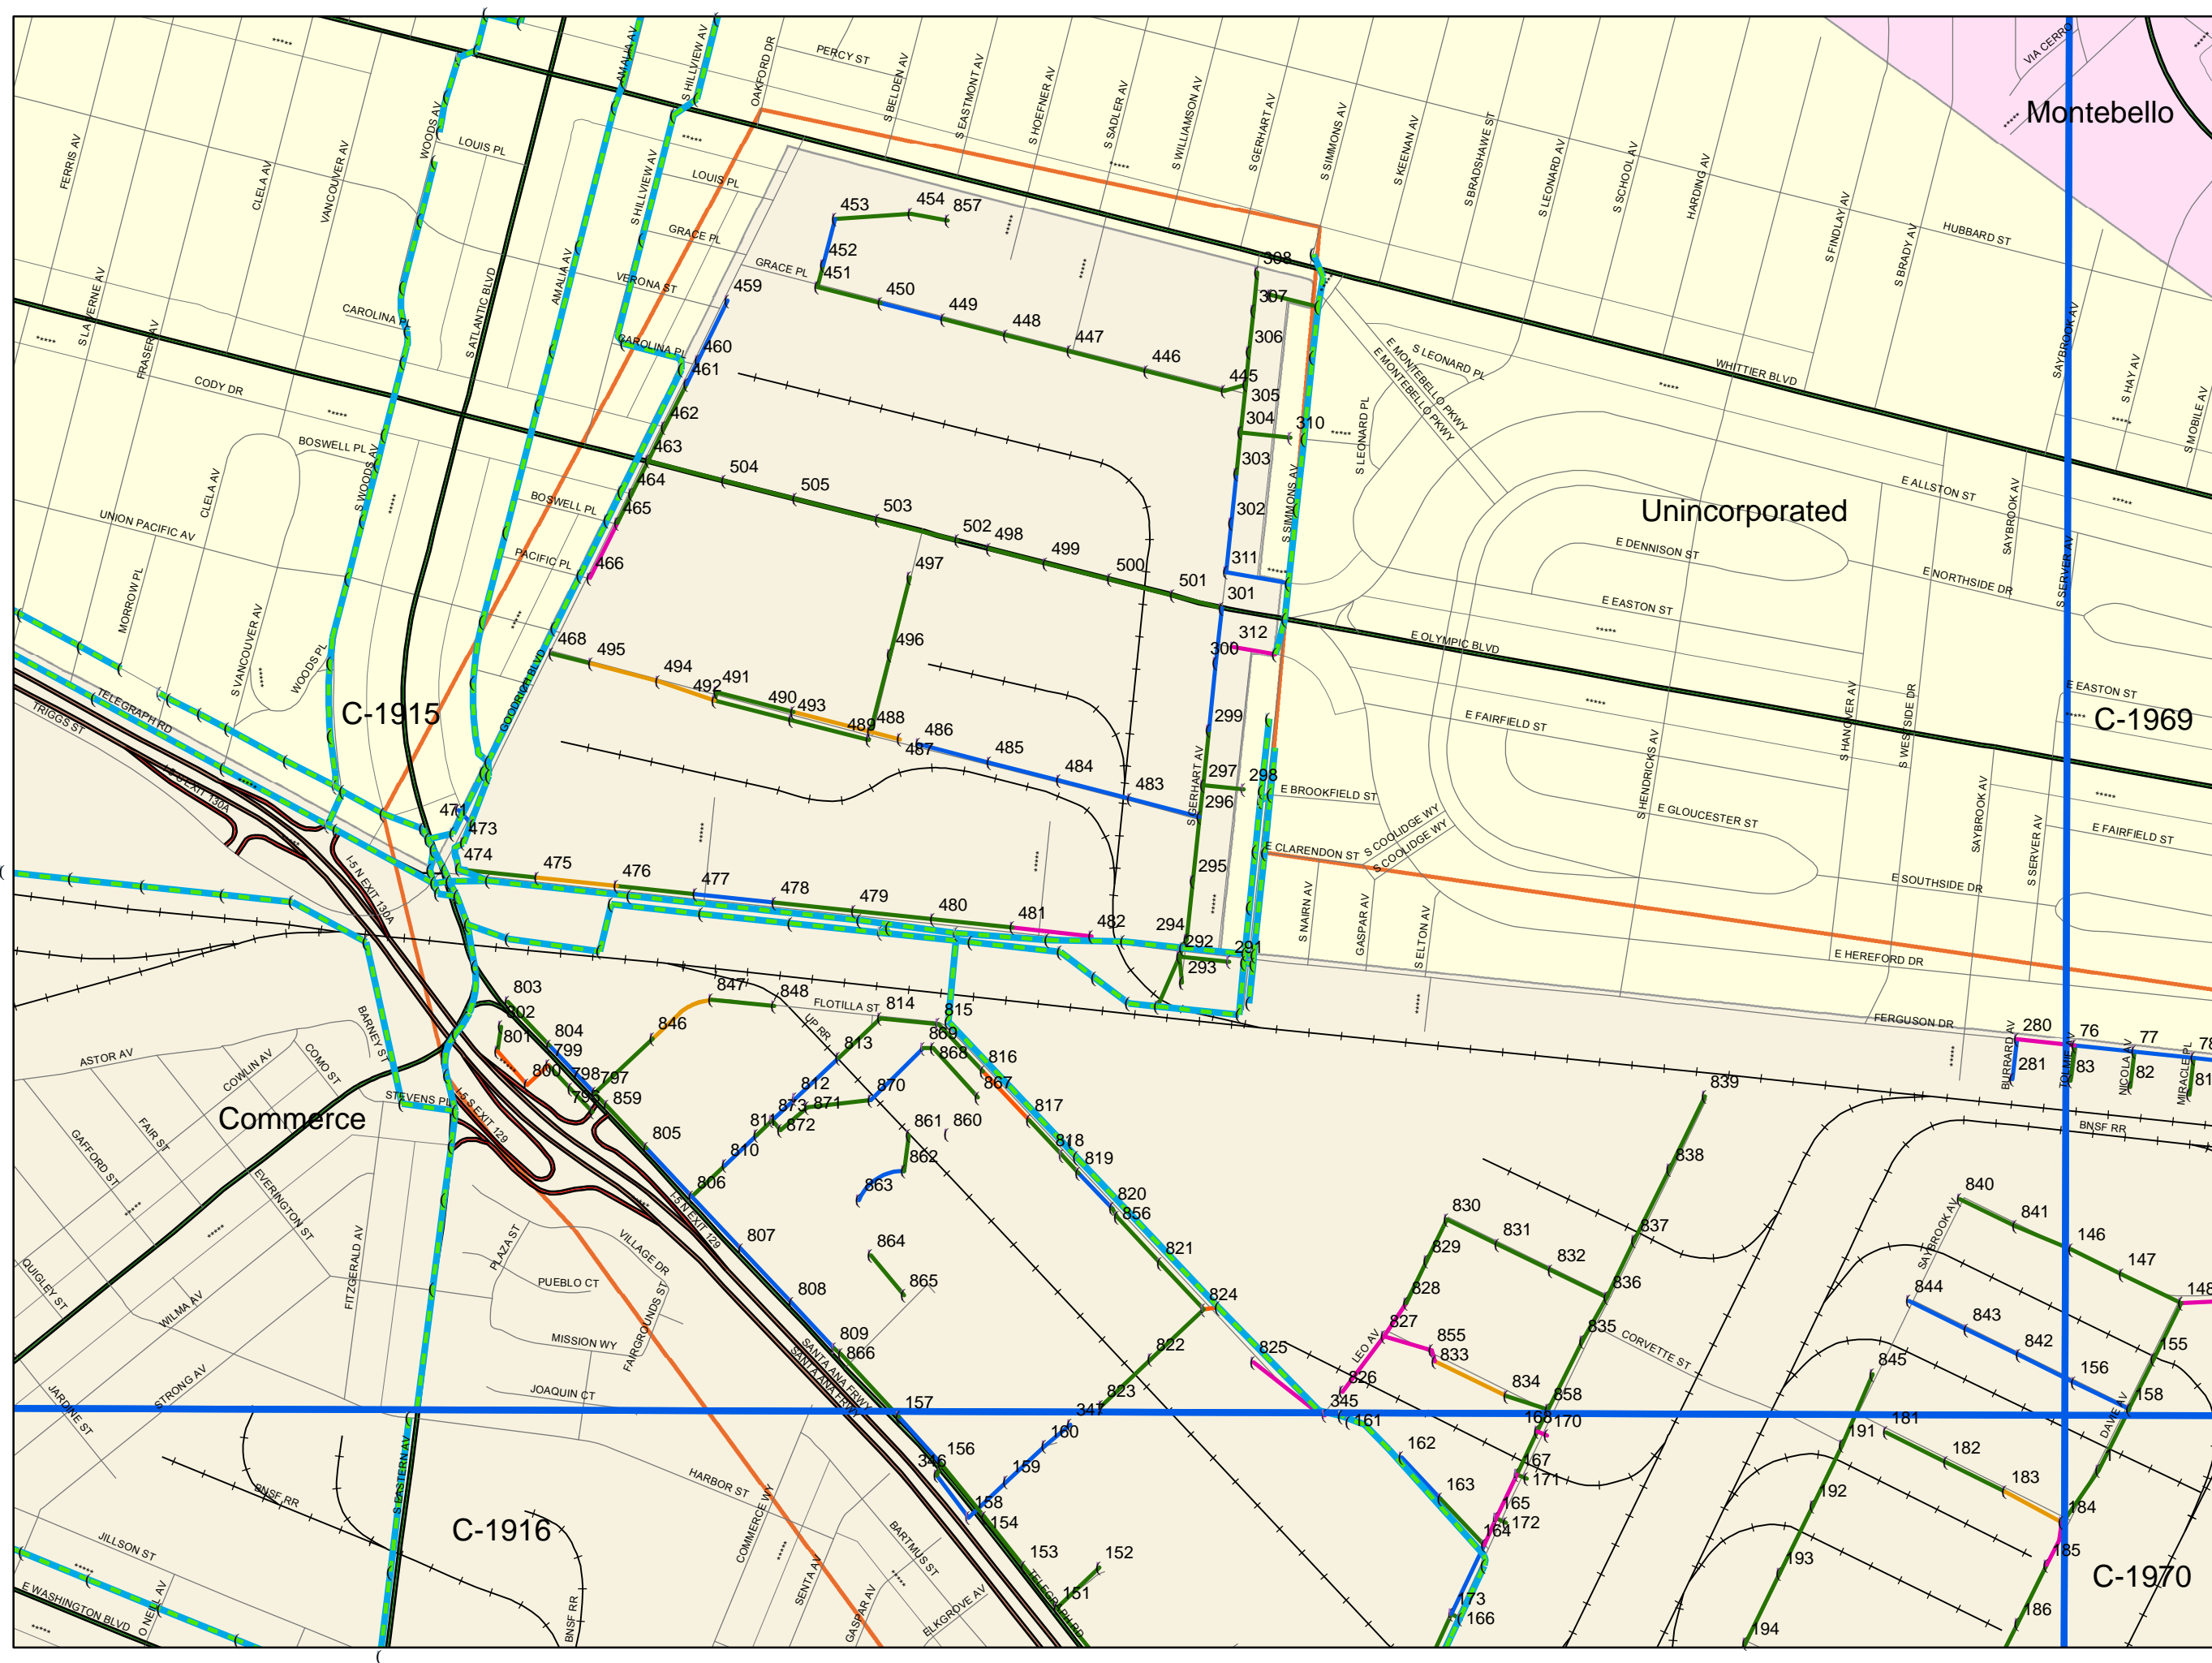
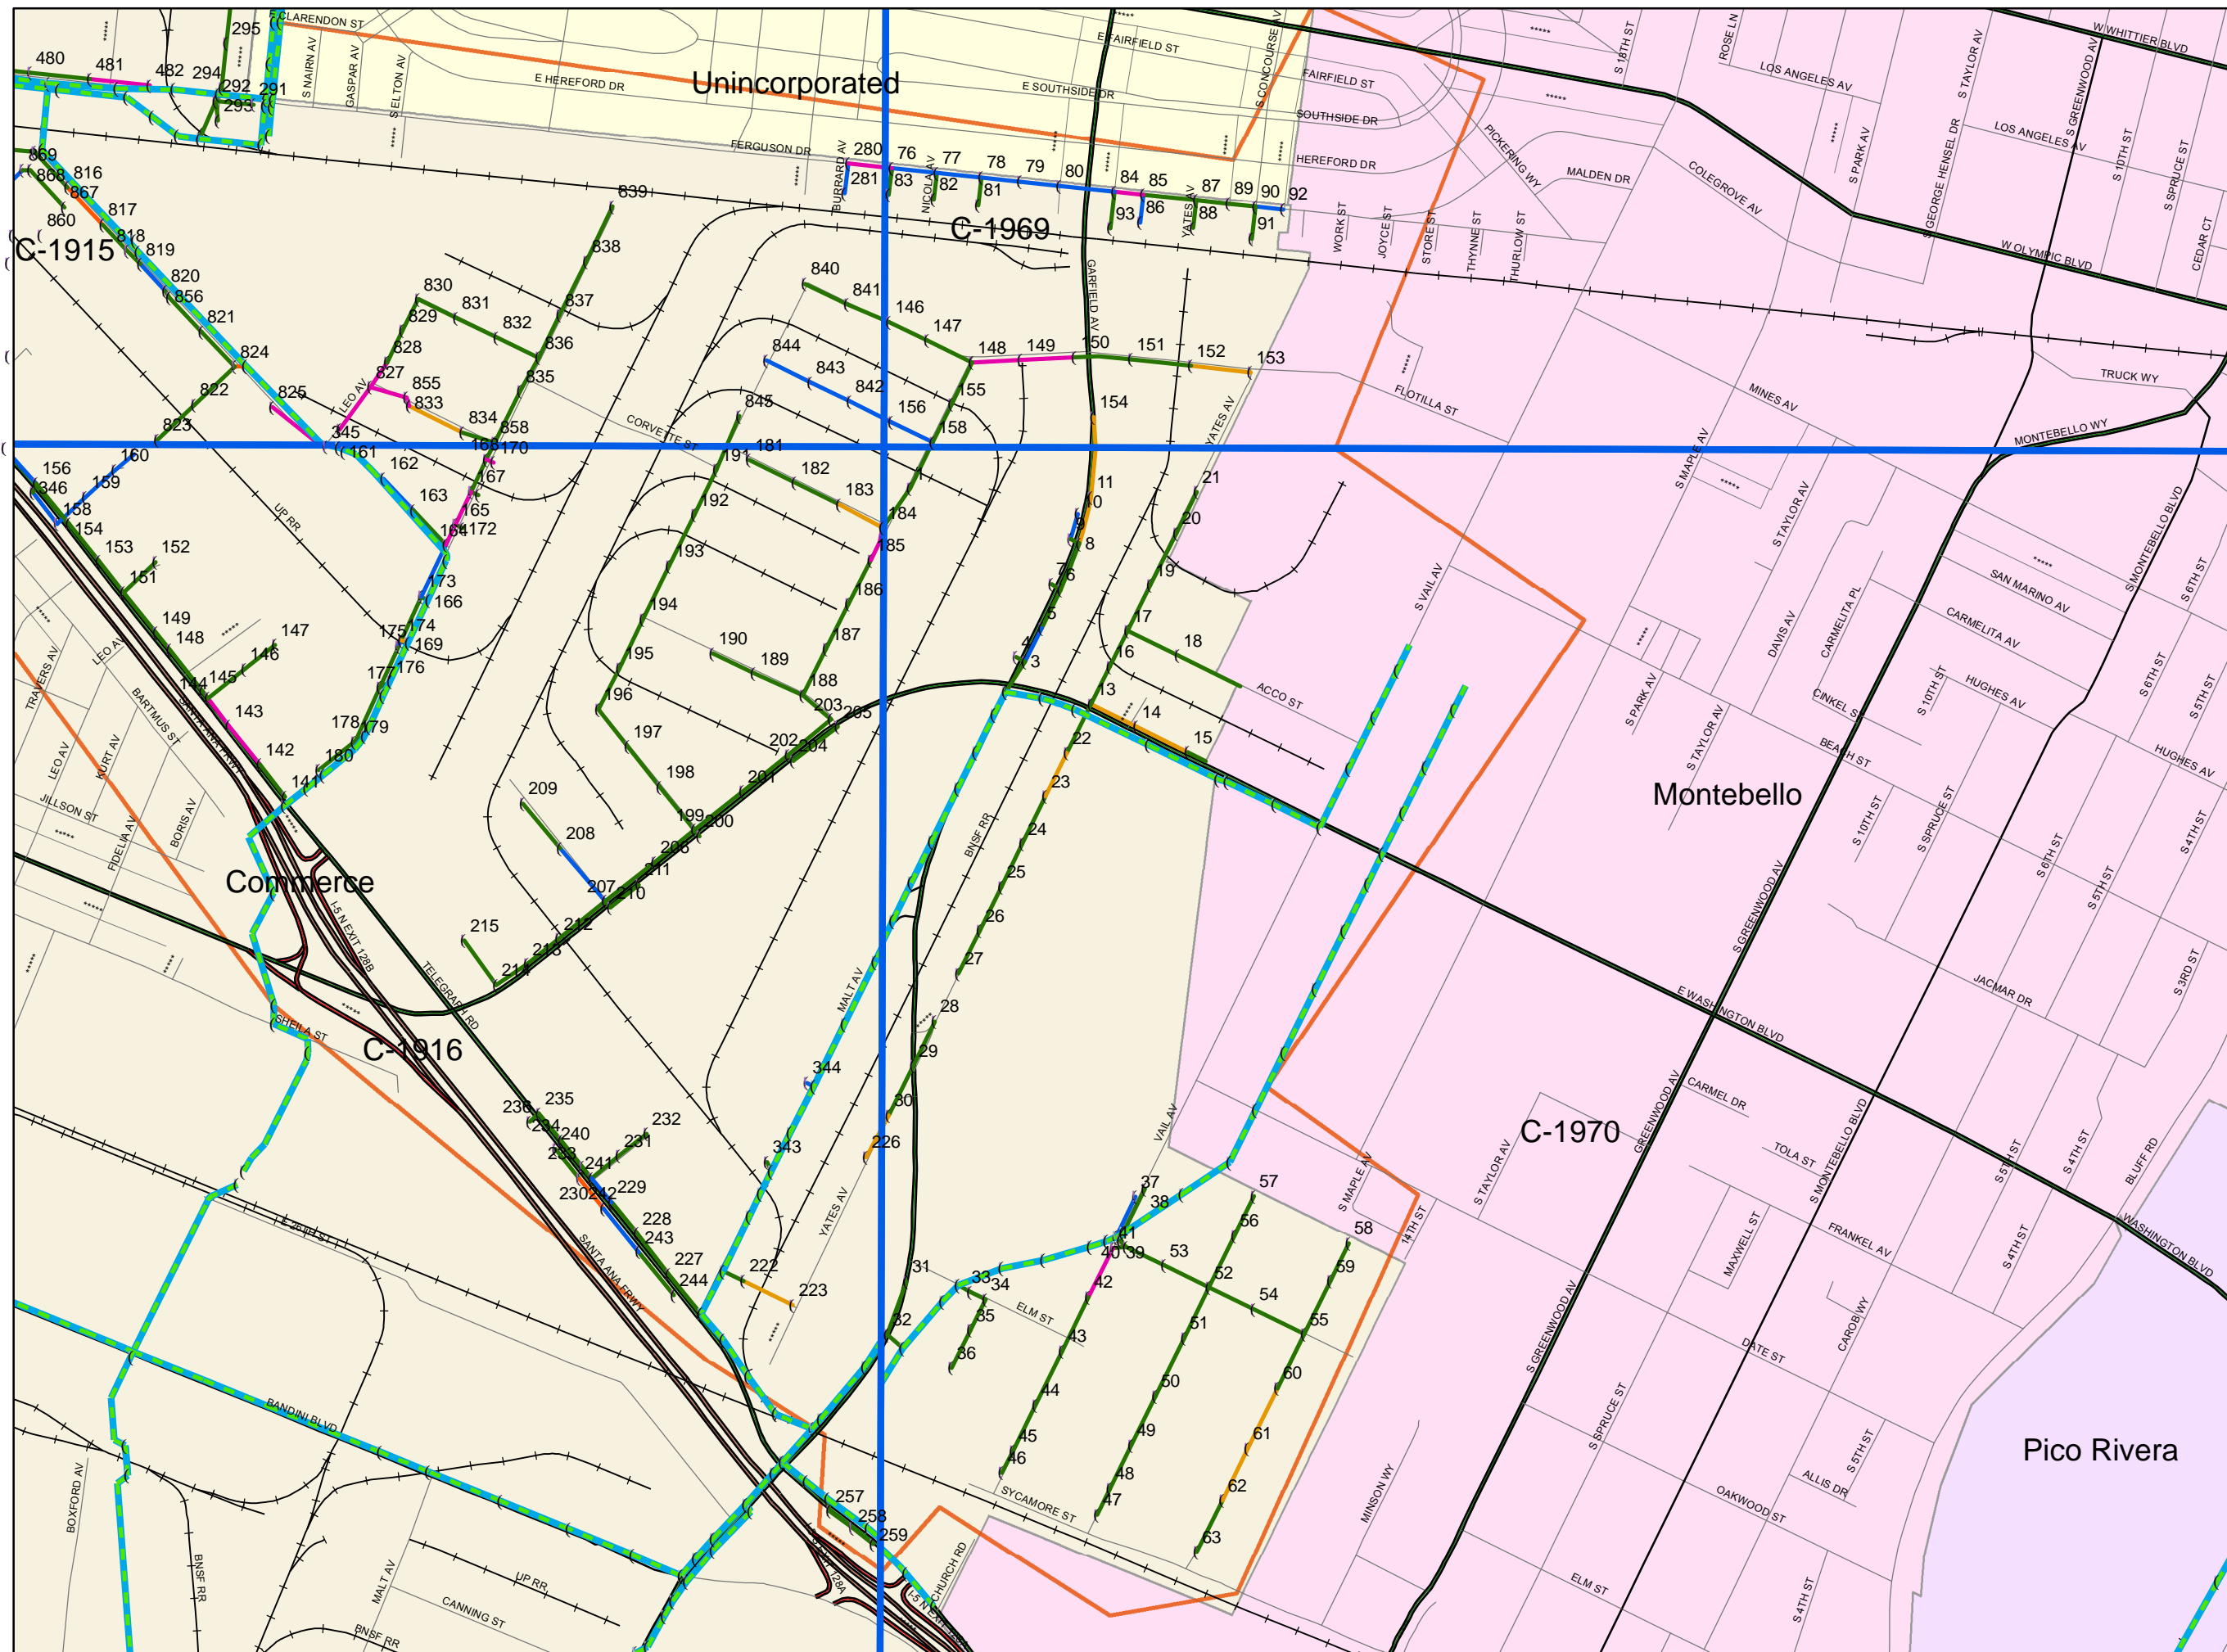
QUICK
MAINTENANCE
RATING

Our inspection revealed that approximately 85.8 percent of the system televised in your City as part of Project No. Y0TV1314B2 was free of significant blockages or restrictions that would impede sewer flows. The remaining 14.2 percent of the pipe segments had a PACP maintenance grade of 3, 4, or 5 as indicated in the Quick Maintenance Rating Table shown below. These segments have been incorporated into our periodic cleaning schedule for enhanced maintenance.

A color-coded map showing the quick maintenance rating for each pipe segment is provided in Enclosure 2.

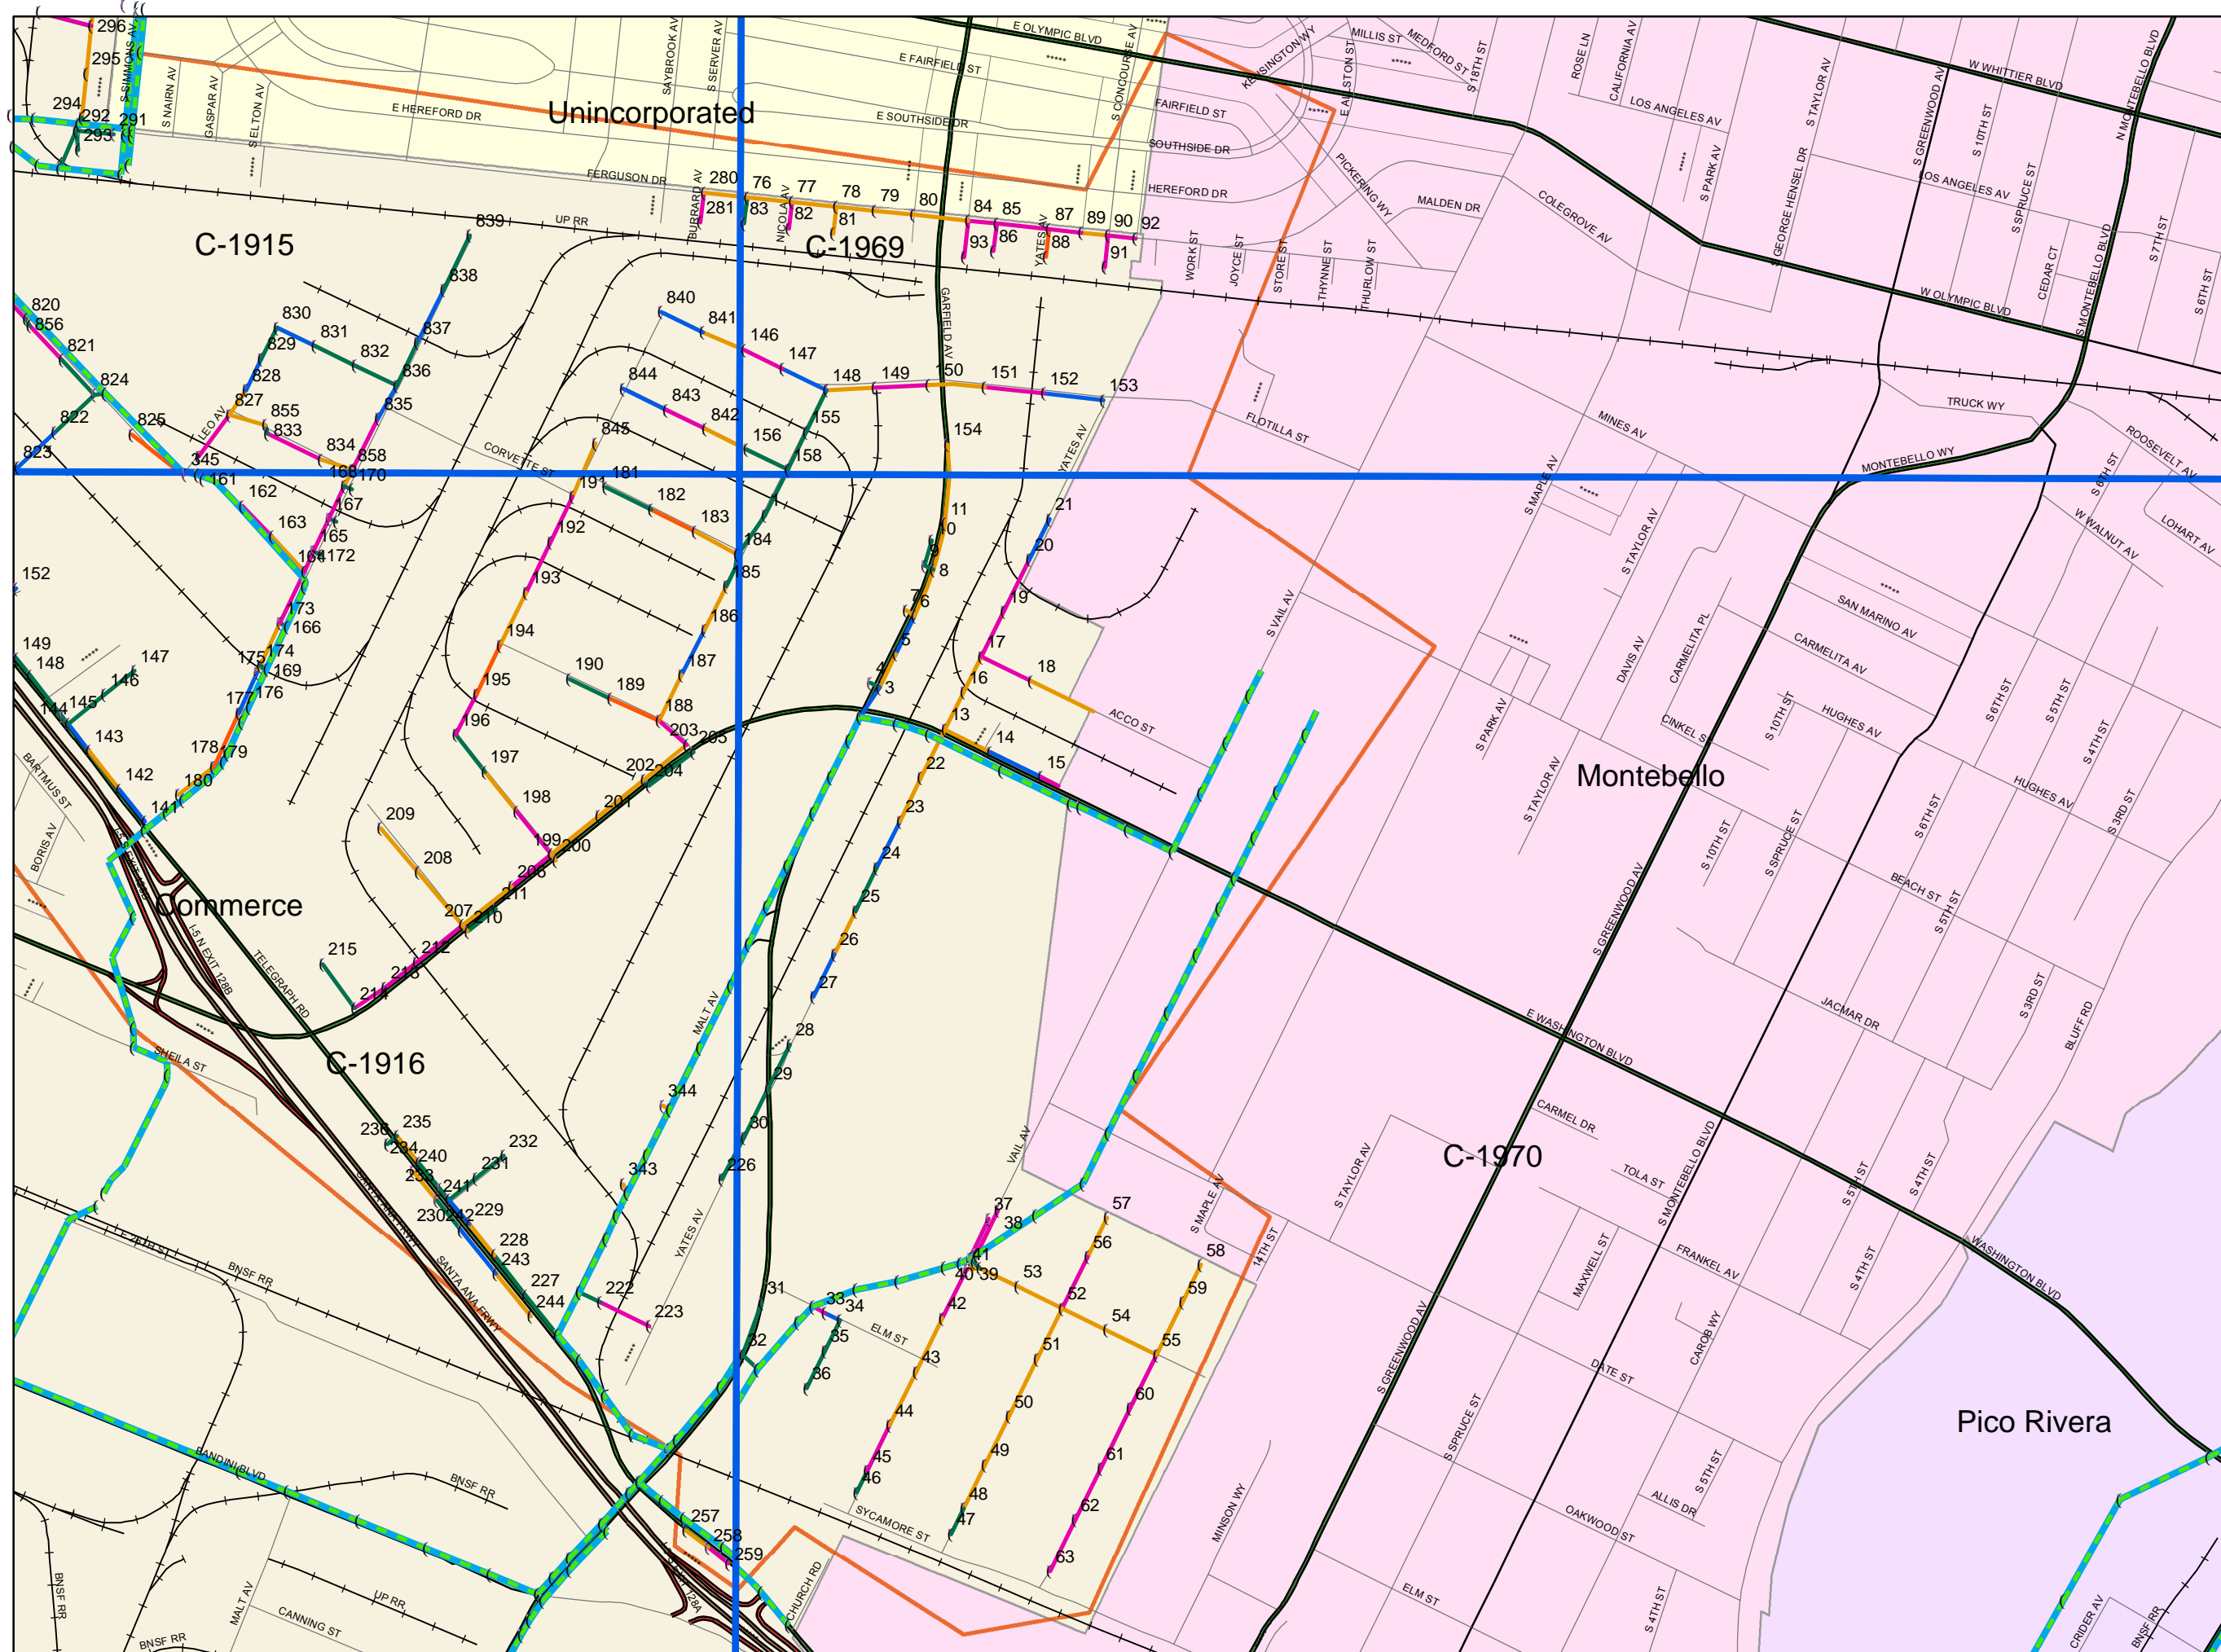
QUICK STRUCTURAL RATING

Our inspection revealed that approximately 73.2 percent of the inspected pipe segments within the City were free of severe structural defects. The remaining 26.8 percent of the inspected pipe segments had a PACP structural grade of 4 or 5 as indicated in the Quick Structural Rating Table shown below. These segments have been placed on a priority list based on the severity and the need for action. For items 1 through 88 in the Quick Structural Rating Report Priority List (Enclosure 3), which warrant a corrective action, the proposed corrective action will be programmed in the next 24 months as part of the ongoing Accumulative Capital Outlay Program.

A color-coded map showing the Quick Structural Rating for each pipe segment is located in Enclosure 3.
