CONSOLIDATED SEWER MAINTENANCE DISTRICT CONDITION ASSESSMENT PROGRAM REPORT PROJECT Y0TV0506F

CONDITION ASSESSMENT REPORT COUNTY OF LOS ANGELES DEPARTMENT OF PUBLIC WORKS CONSOLIDATED SEWER MAINTENANCE DISTRICT

PROJECT NAME: Y0TV0506F PROJECT MGR: Fernando Villaluna

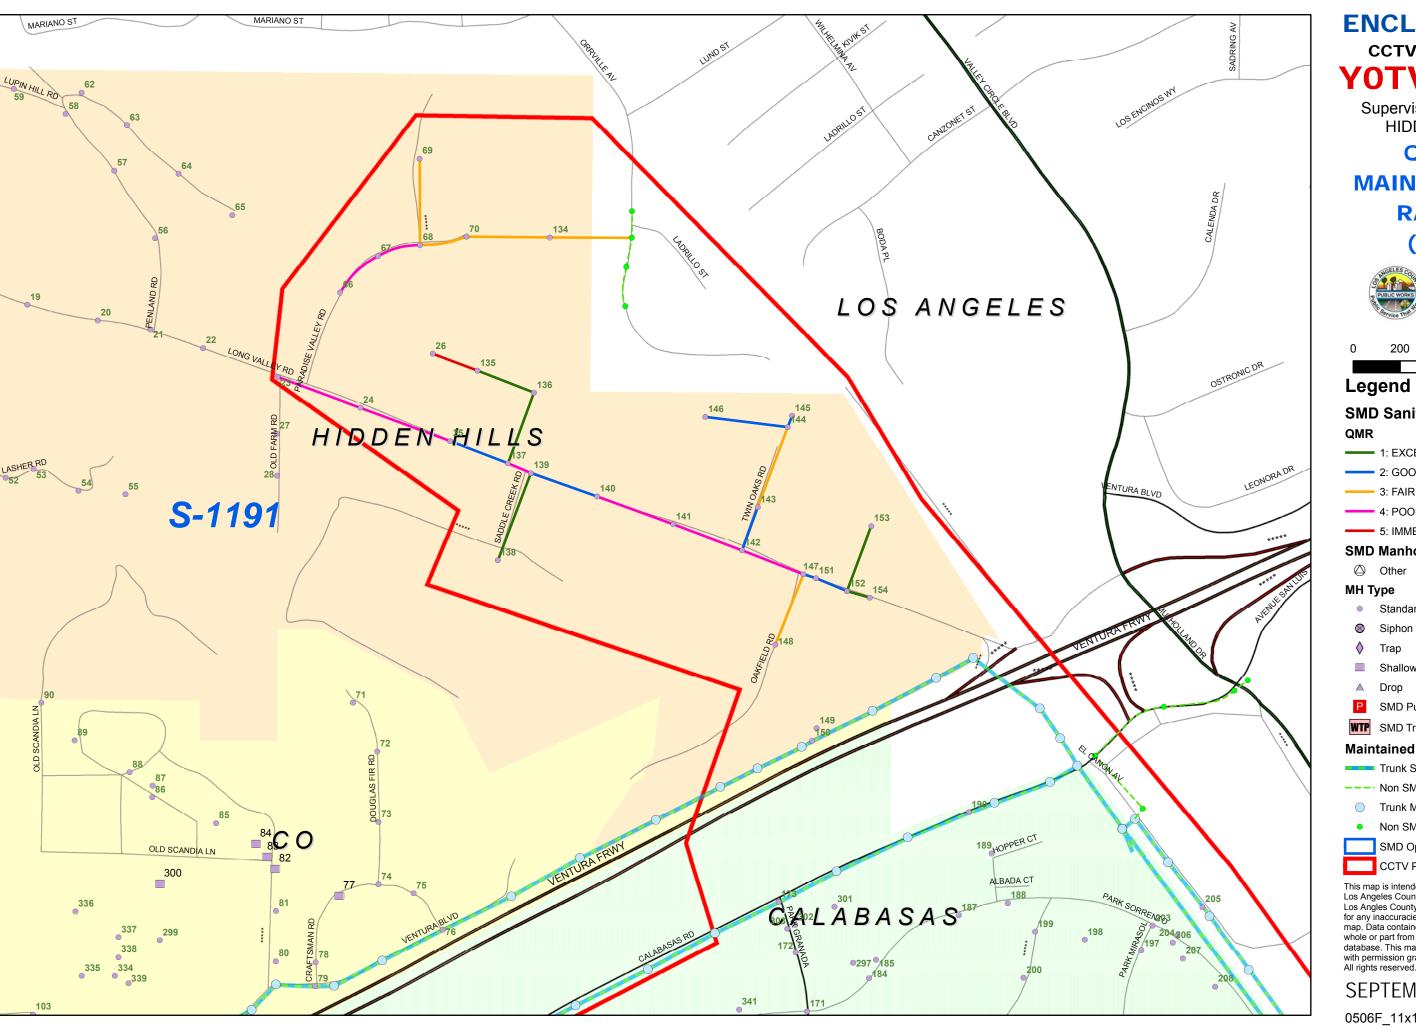
ENCLOSURE 2 CCTV PROJECT Y0TV0506F

Item No.	QMR	Start MH	End MH	Street	Observation	Corrective Action Taken
1	5121	1191-0135	1191-0026	ALLEY by PARADISE	Debris	Hydrojet (Completed 10/30/08)
				VALLEY and LONG VALLEY		
2	4434	1191-0024	1191-0025	LONG VALLEY	Grease; Roots	Hydrojet (Completed 10/29/08)
3	4338	1191-0023	1191-0024	LONG VALLEY	Grease	Hydrojet (Completed 10/29/08)
4	4300	1191-0147	1191-0142	LONG VALLEY	Camera underwater	Hydrojet (Completed 10/30/08)
5	4133	1191-0140	1191-0141	LONG VALLEY	Camera underwater	Hydrojet (Completed 10/30/08)
6	4132	1191-0066	1191-0067	PARADISE VALLEY	Infiltration weeper	No action needed
7	4125	1191-0067	1191-0068	PARADISE VALLEY	Grease	Hydrojet (Completed 10/29/08)

The following line segments received a Quick Maintenance Rating of above 4000 due to the observation of Root Ball or Deposit inside the lateral connection. CSMD does not maintain lateral lines: it is the responsibility of the parcel owner to maintain their respective lateral lines to facilitate the flow of wastewater from their property to the mainline. Therefore, these lines were not included on the Prioirty List above identified with maintenance deficiencies in need of immediate attention by CSMD.

Item No.	QMR	Start MH	End MH	Street	Observation
1	4233	1191-0141	1191-0142	LONG VALLEY	Roots in lateral
2	4111	1191-0137	1191-0139	LONG VALLEY	Roots in lateral

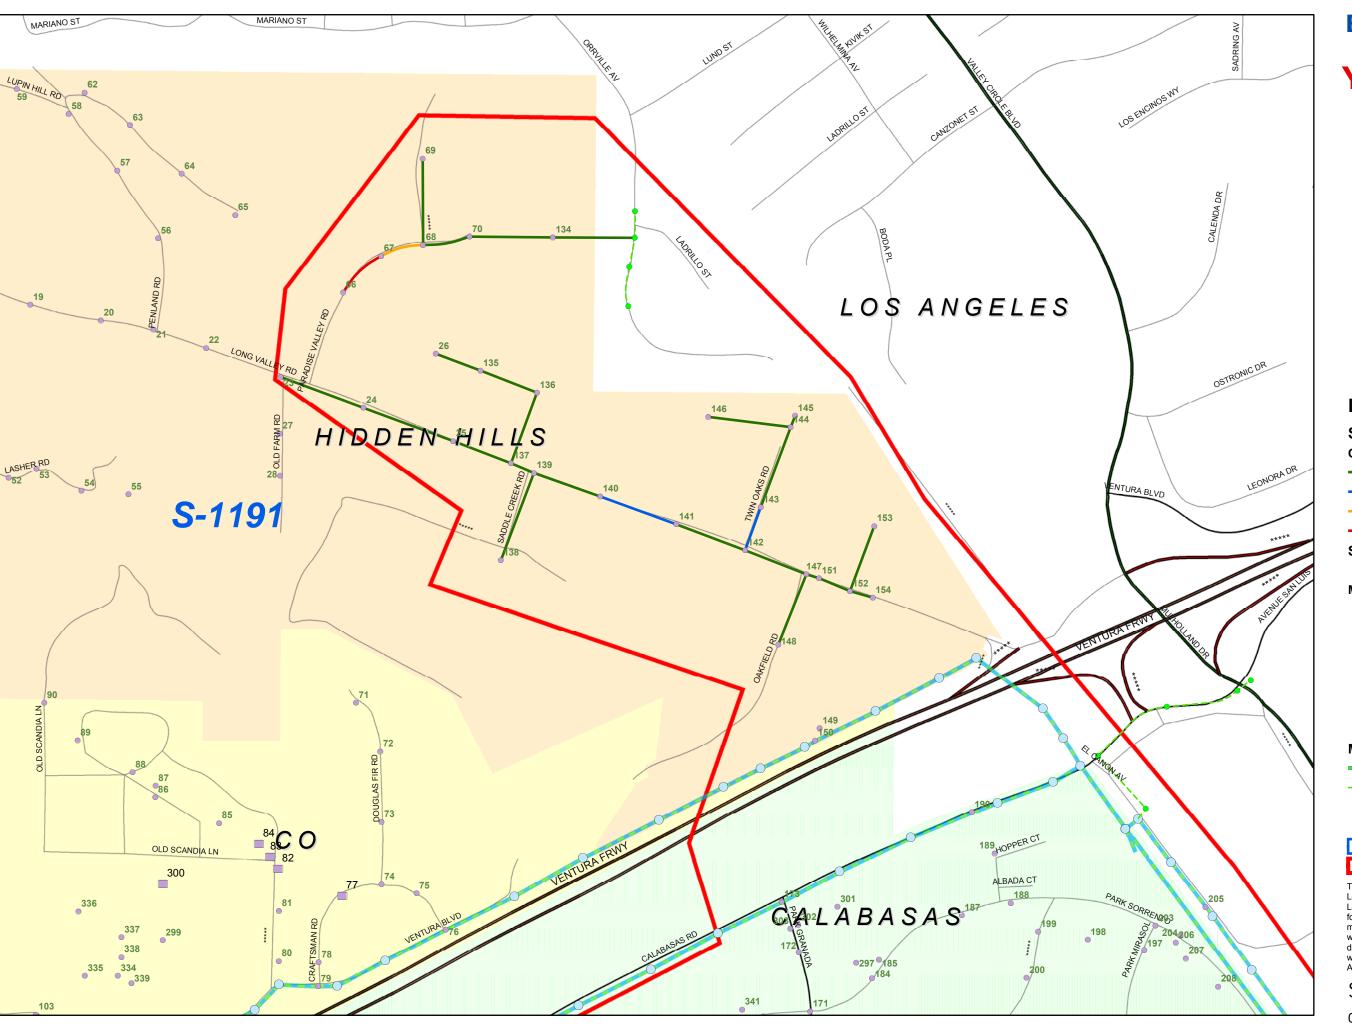
CCTV PROJECT YOTVO506F

Iter No	QSR	Start MH	End MH	Street	Observation: Location	Proposed Corrective Method	Length of Repair (FT)
1	5131	1191-0066	1191-0067	PARADISE VALLEY	Hole: End MH	CSMD will repair MH base	-
