CONSOLIDATED SEWER MAINTENANCE DISTRICT CONDITION ASSESSMENT PROGRAM REPORT PROJECT Y0TV0506E

**CONDITION ASSESSMENT REPORT
COUNTY OF LOS ANGELES DEPARTMENT OF PUBLIC WORKS
CONSOLIDATED SEWER MAINTENANCE DISTRICT**

PROJECT NAME:	Y0TV0506E	PROJECT MGR	Kari Eskridge
PROJECT DATE:	05/10/06-09/15/06	CONTACT NO	(626) 300-3390
SUP DISTRICT(s):	1	MAP PAGE(S)	2260, 2261, 2262
Report By:	Phyo Kyaw	Report Date	09/10/09

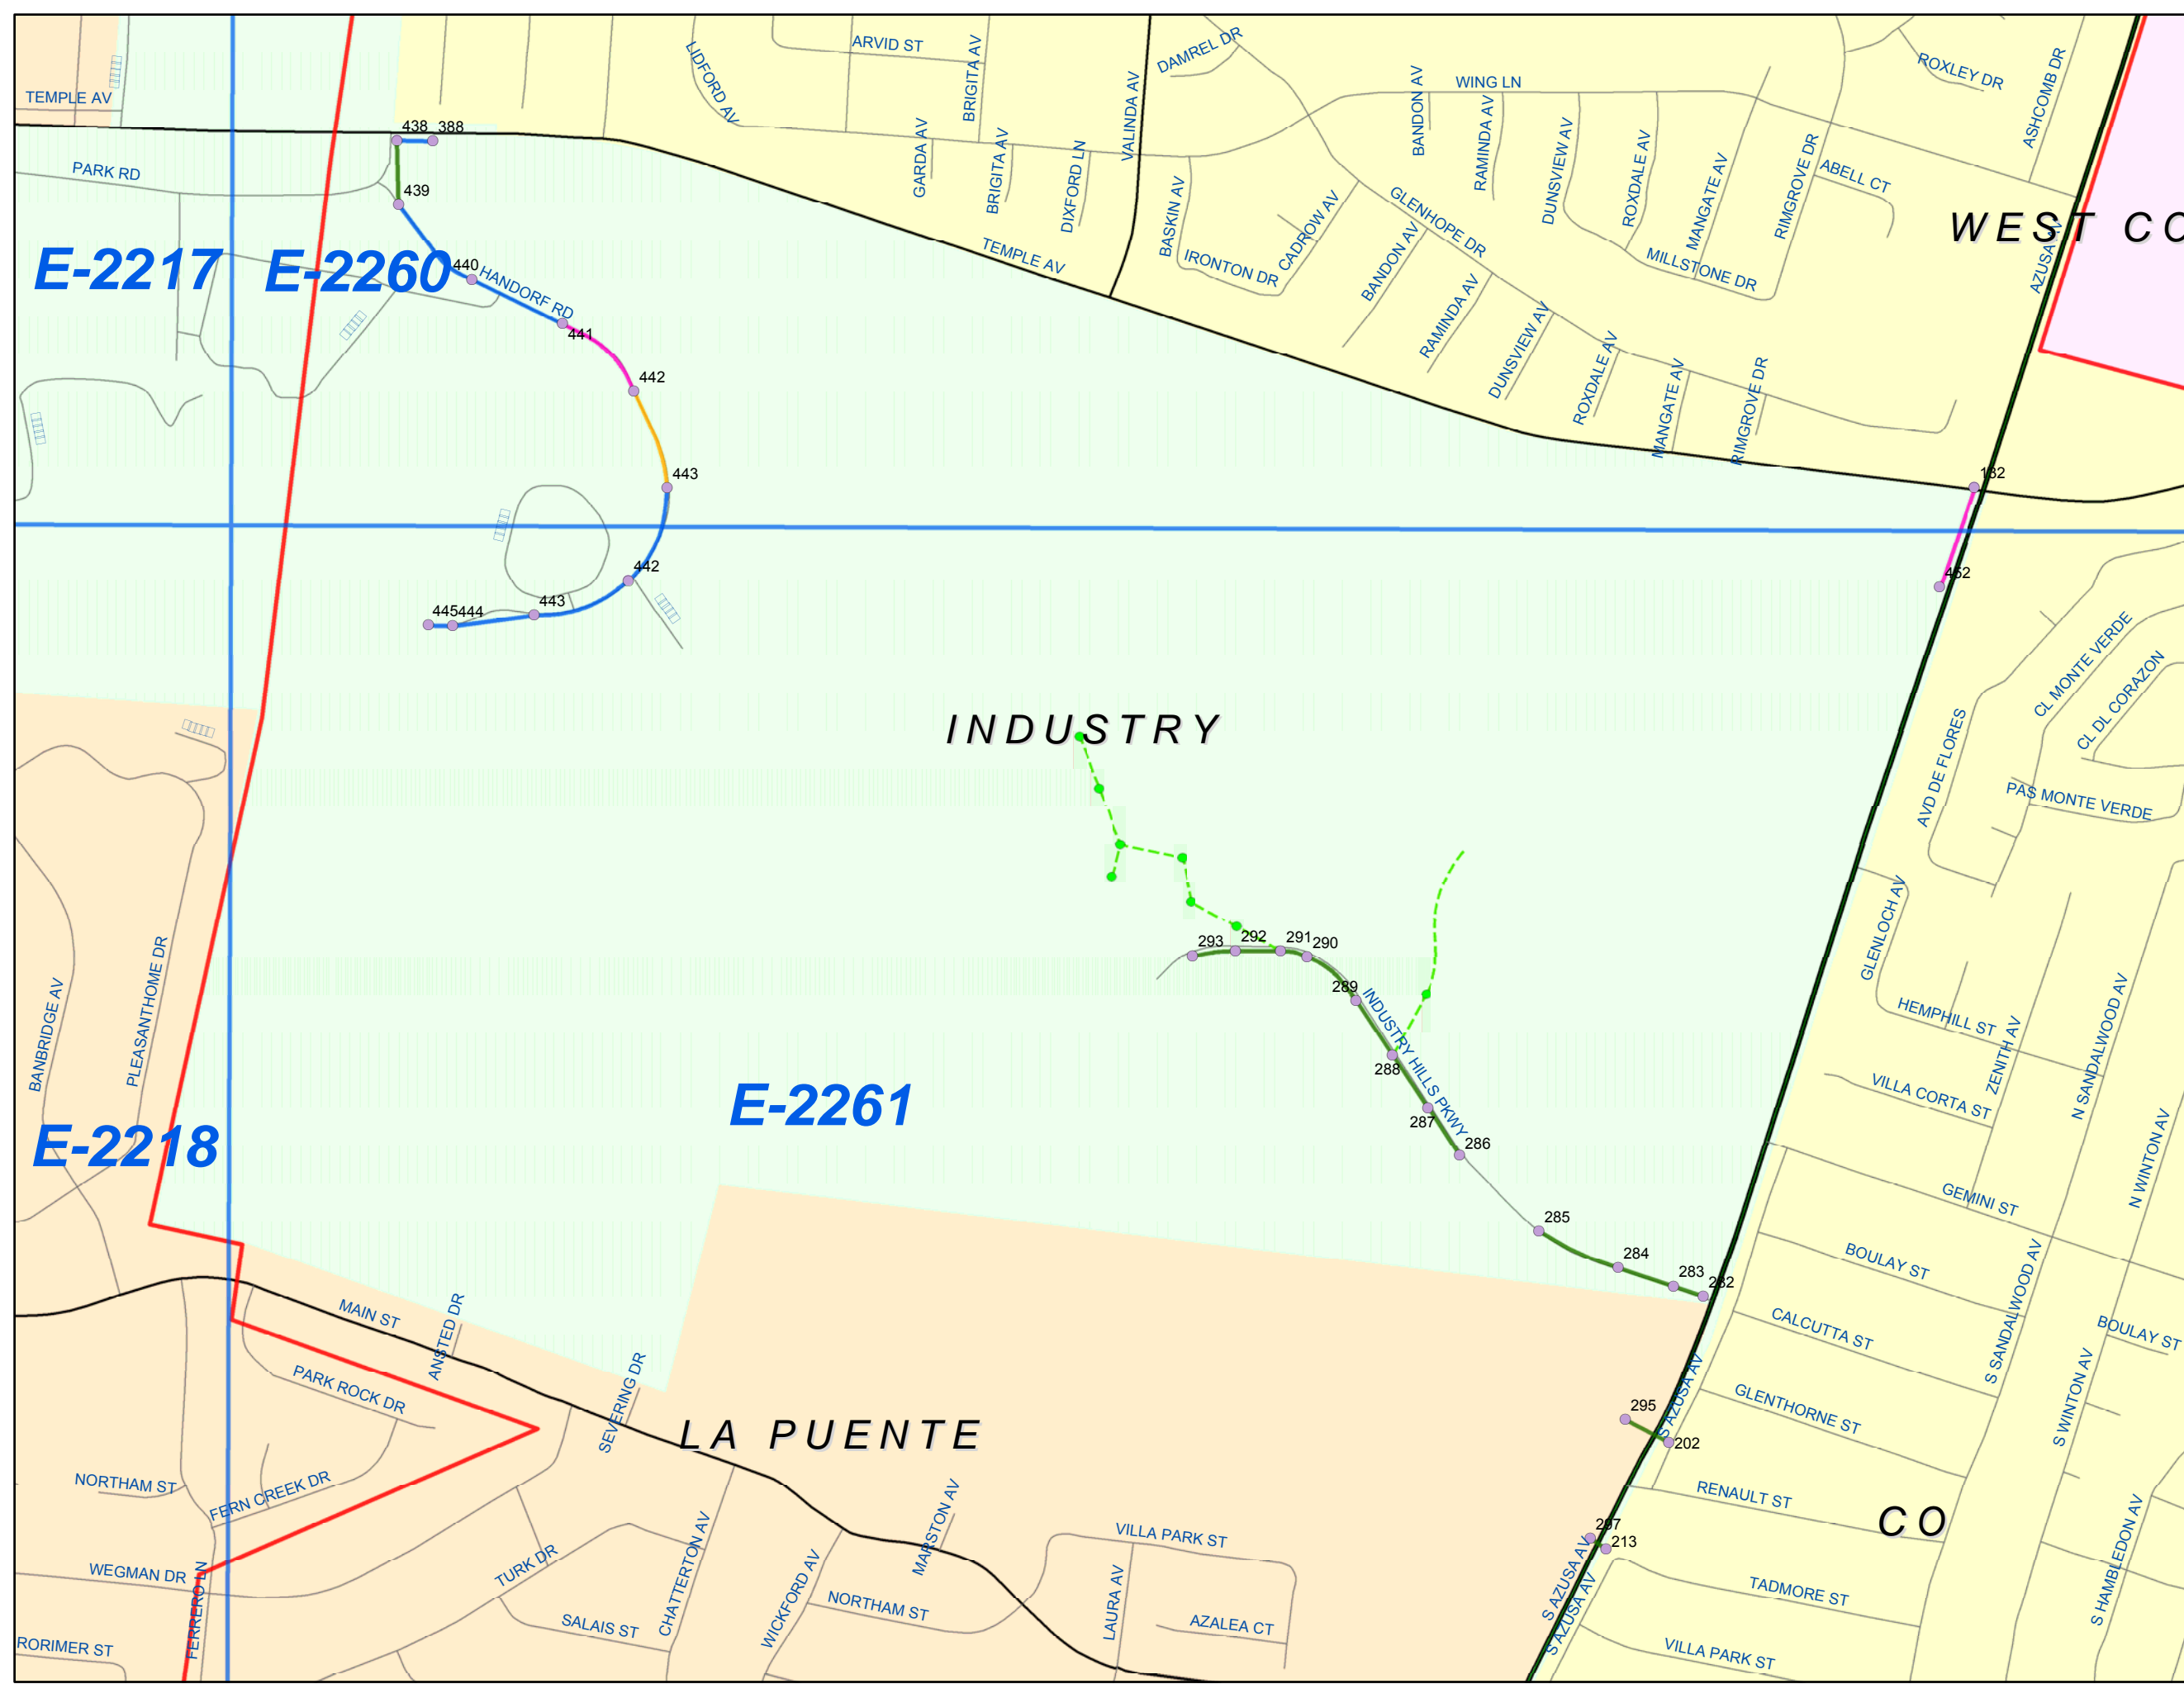
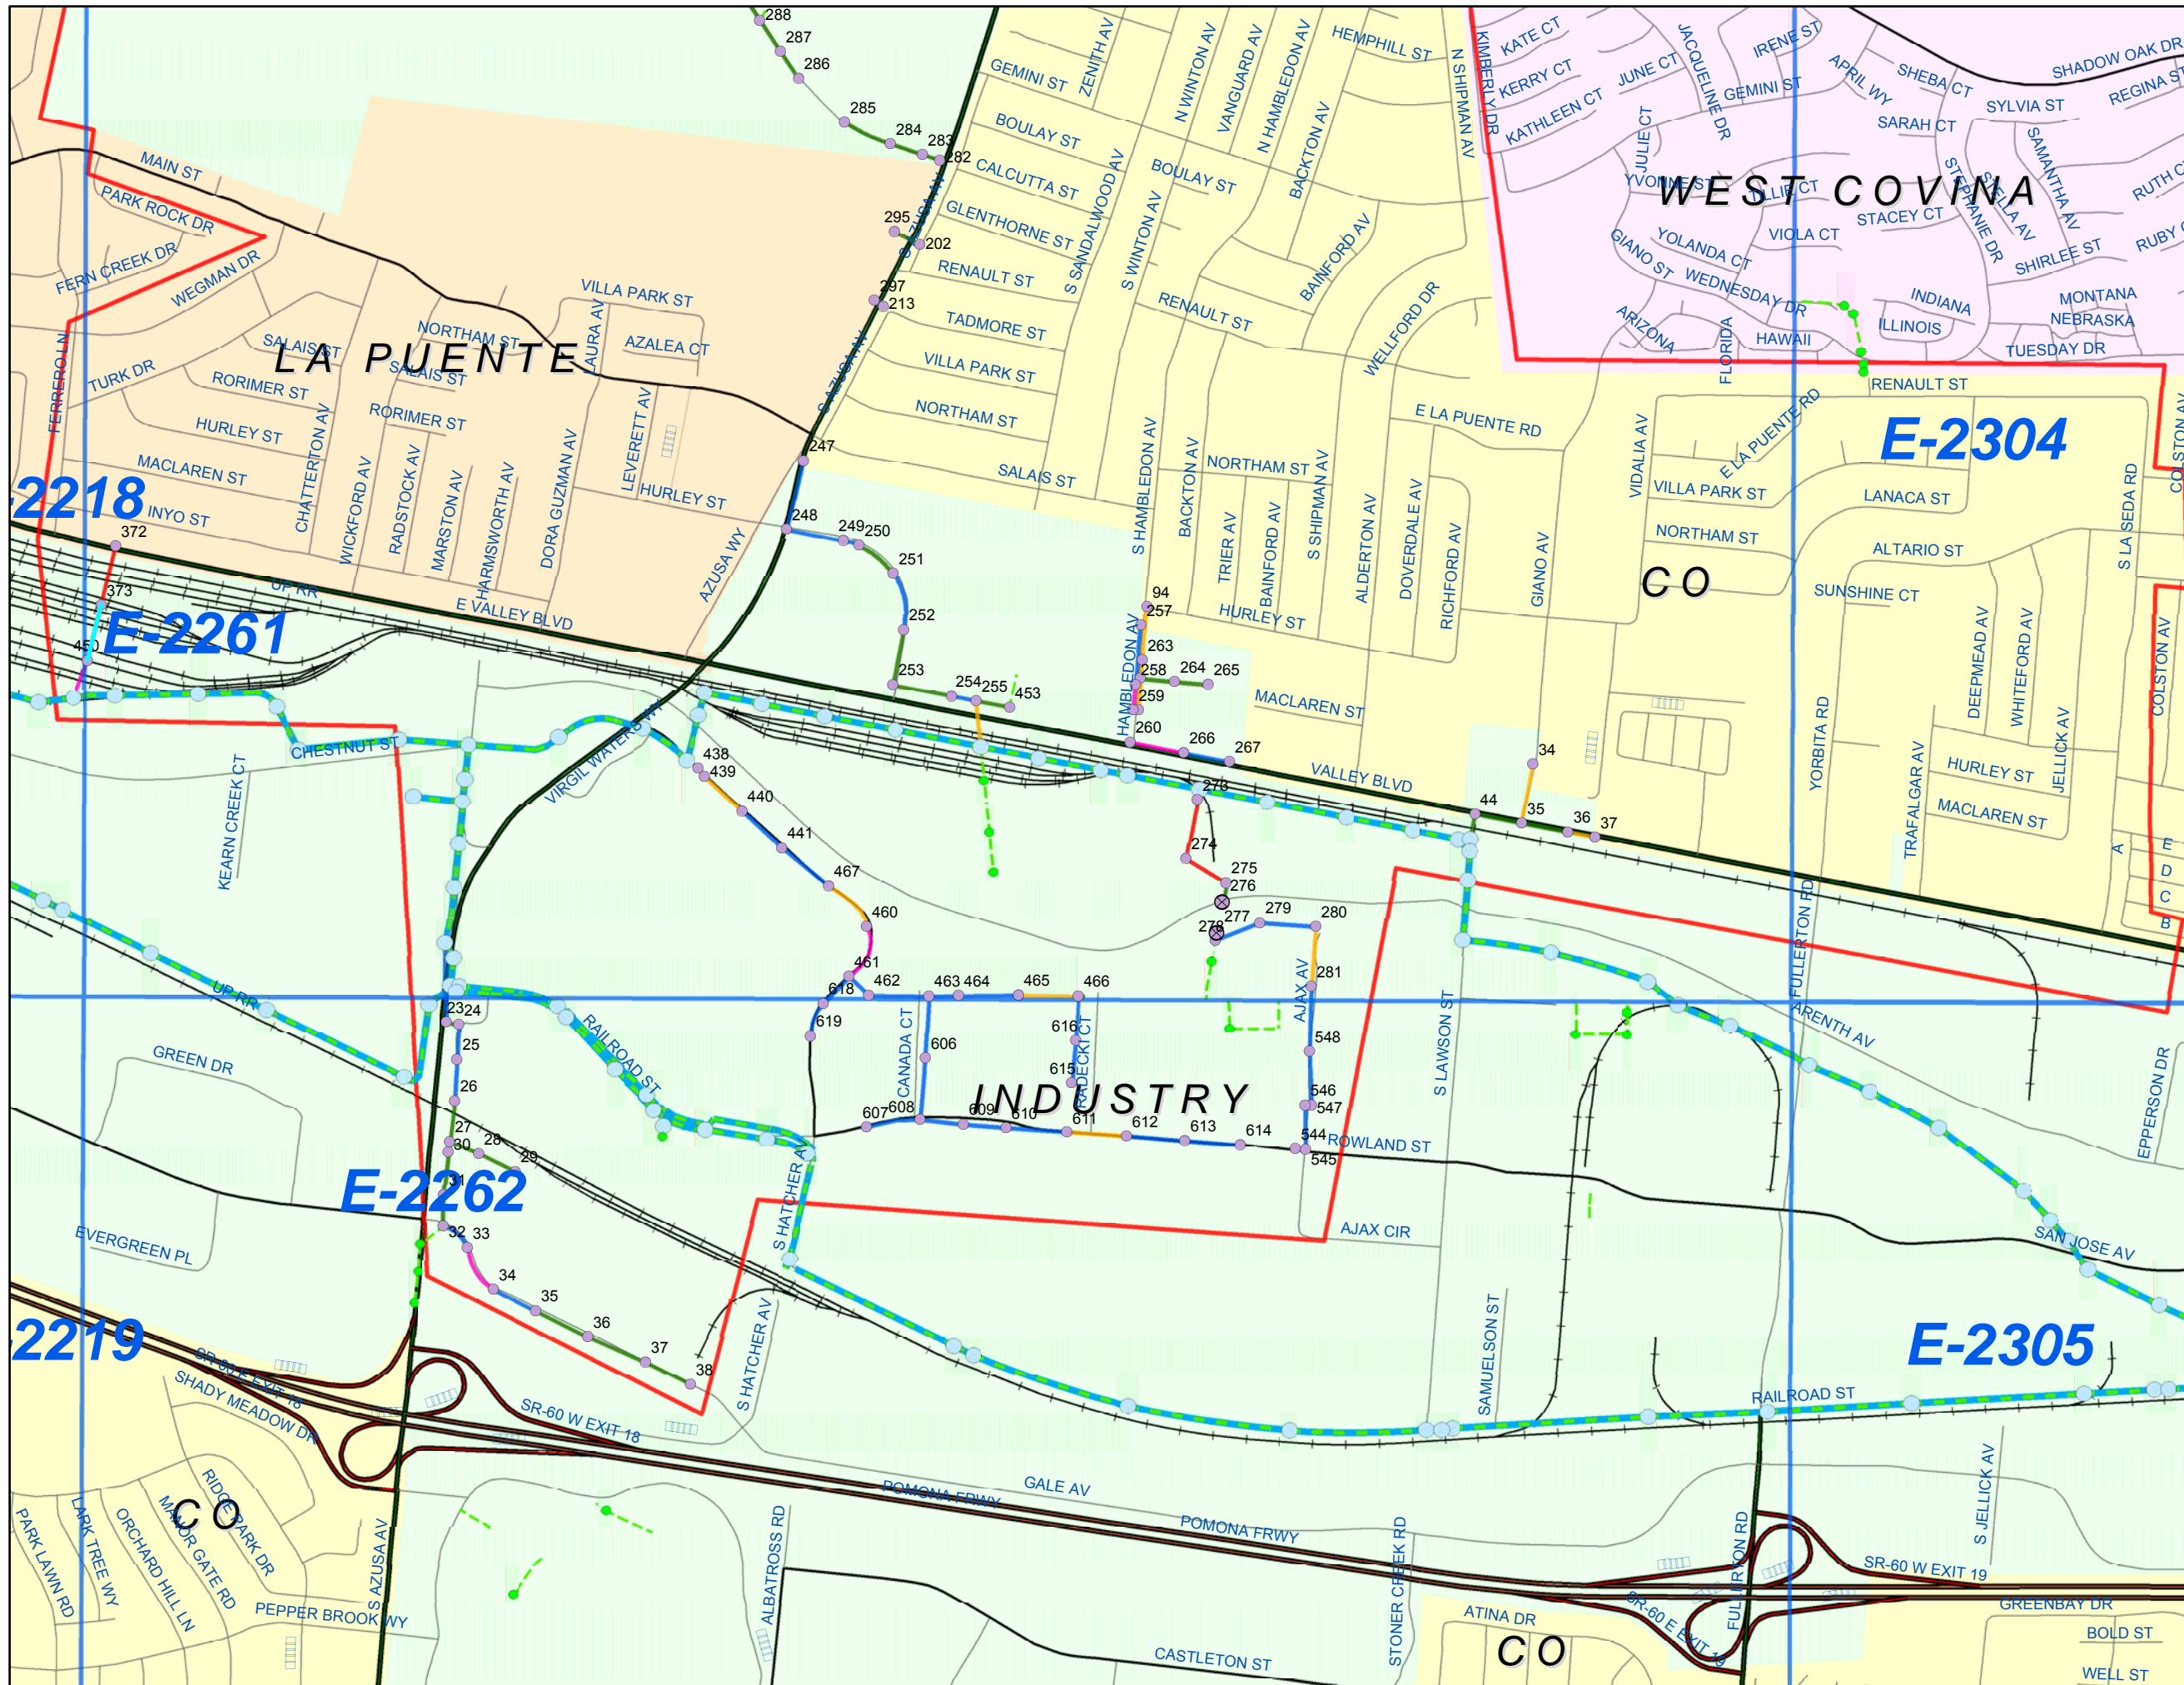
QUICK MAINTENANCE RATING (QMR)

Our inspection revealed that approximately 87.2 percent of the system televised was free of blockages or restrictions that would impede sewer flows. However, the remaining 12.8 percent of the inspected pipe segments within the City of Industry area had a PACP maintenance grade of 4 or 5 as indicated in the Quick Maintenance Rating Table shown below. These segments have been incorporated into our routine cleaning schedule with corrective action taken as noted on the Quick Maintenance Rating Report Priority List (Enclosure 2). Also included is a color-coded map showing the quick maintenance rating for each pipe segment.

ITEM NO.	QMR	START MH	END MH	STREET	OBSERVATION	CORRECTIVE ACTION TAKEN
1	5131	2261-0273	2261-0274	Easement (between Arenth □ UPRR)	Deposits	Hydrojet (completed 05/16/08)
2	5100	2261-0372	2261-0373	Easement (between Valley □ UPRR)	Camera underwater	Hydrojet (completed 05/21/09)
3	5100	2261-0274	2261-0275	Easement (between Arenth □ UPRR)	Deposits	Hydrojet (completed 05/16/08)
4	4300	2261-0373	2261-0450	Easement (UPRR, between Valley □ Chestnut)	High water flow	No action needed.
5	4222	2262-0034	2262-0033	Gale Ave	Sag	Hydrojet (completed 09/17/07)
6	4200	2261-0450	2218-TRNK	Easement (UPRR, between Valley □ Chestnut)	Camera underwater	Hydrojet (completed 05/21/09)
7	412N	2261-0452	2260-0132	Azusa Ave	Deposits	Hydrojet (completed 05/22/09)
8	4127	2261-0461	2261-0460	Chestnut St	Deposits	Hydrojet (completed 05/22/09)
9	4123	2261-0258	2261-0259	Hambledon Ave	Grease	Hydrojet (completed 05/21/09)
10	4121	2260-0442	2260-0441	Maintenance Rd	Rootball	Rodder (completed 04/01/08)

11	4100	2261-0266	2261-0260	Valley Blvd	Camera underwater	Hydrojet (completed 05/22/09)
12	4100	2262-0545	2262-0544	Rowland St	Deposits	Hydrojet (completed 03/13/08)

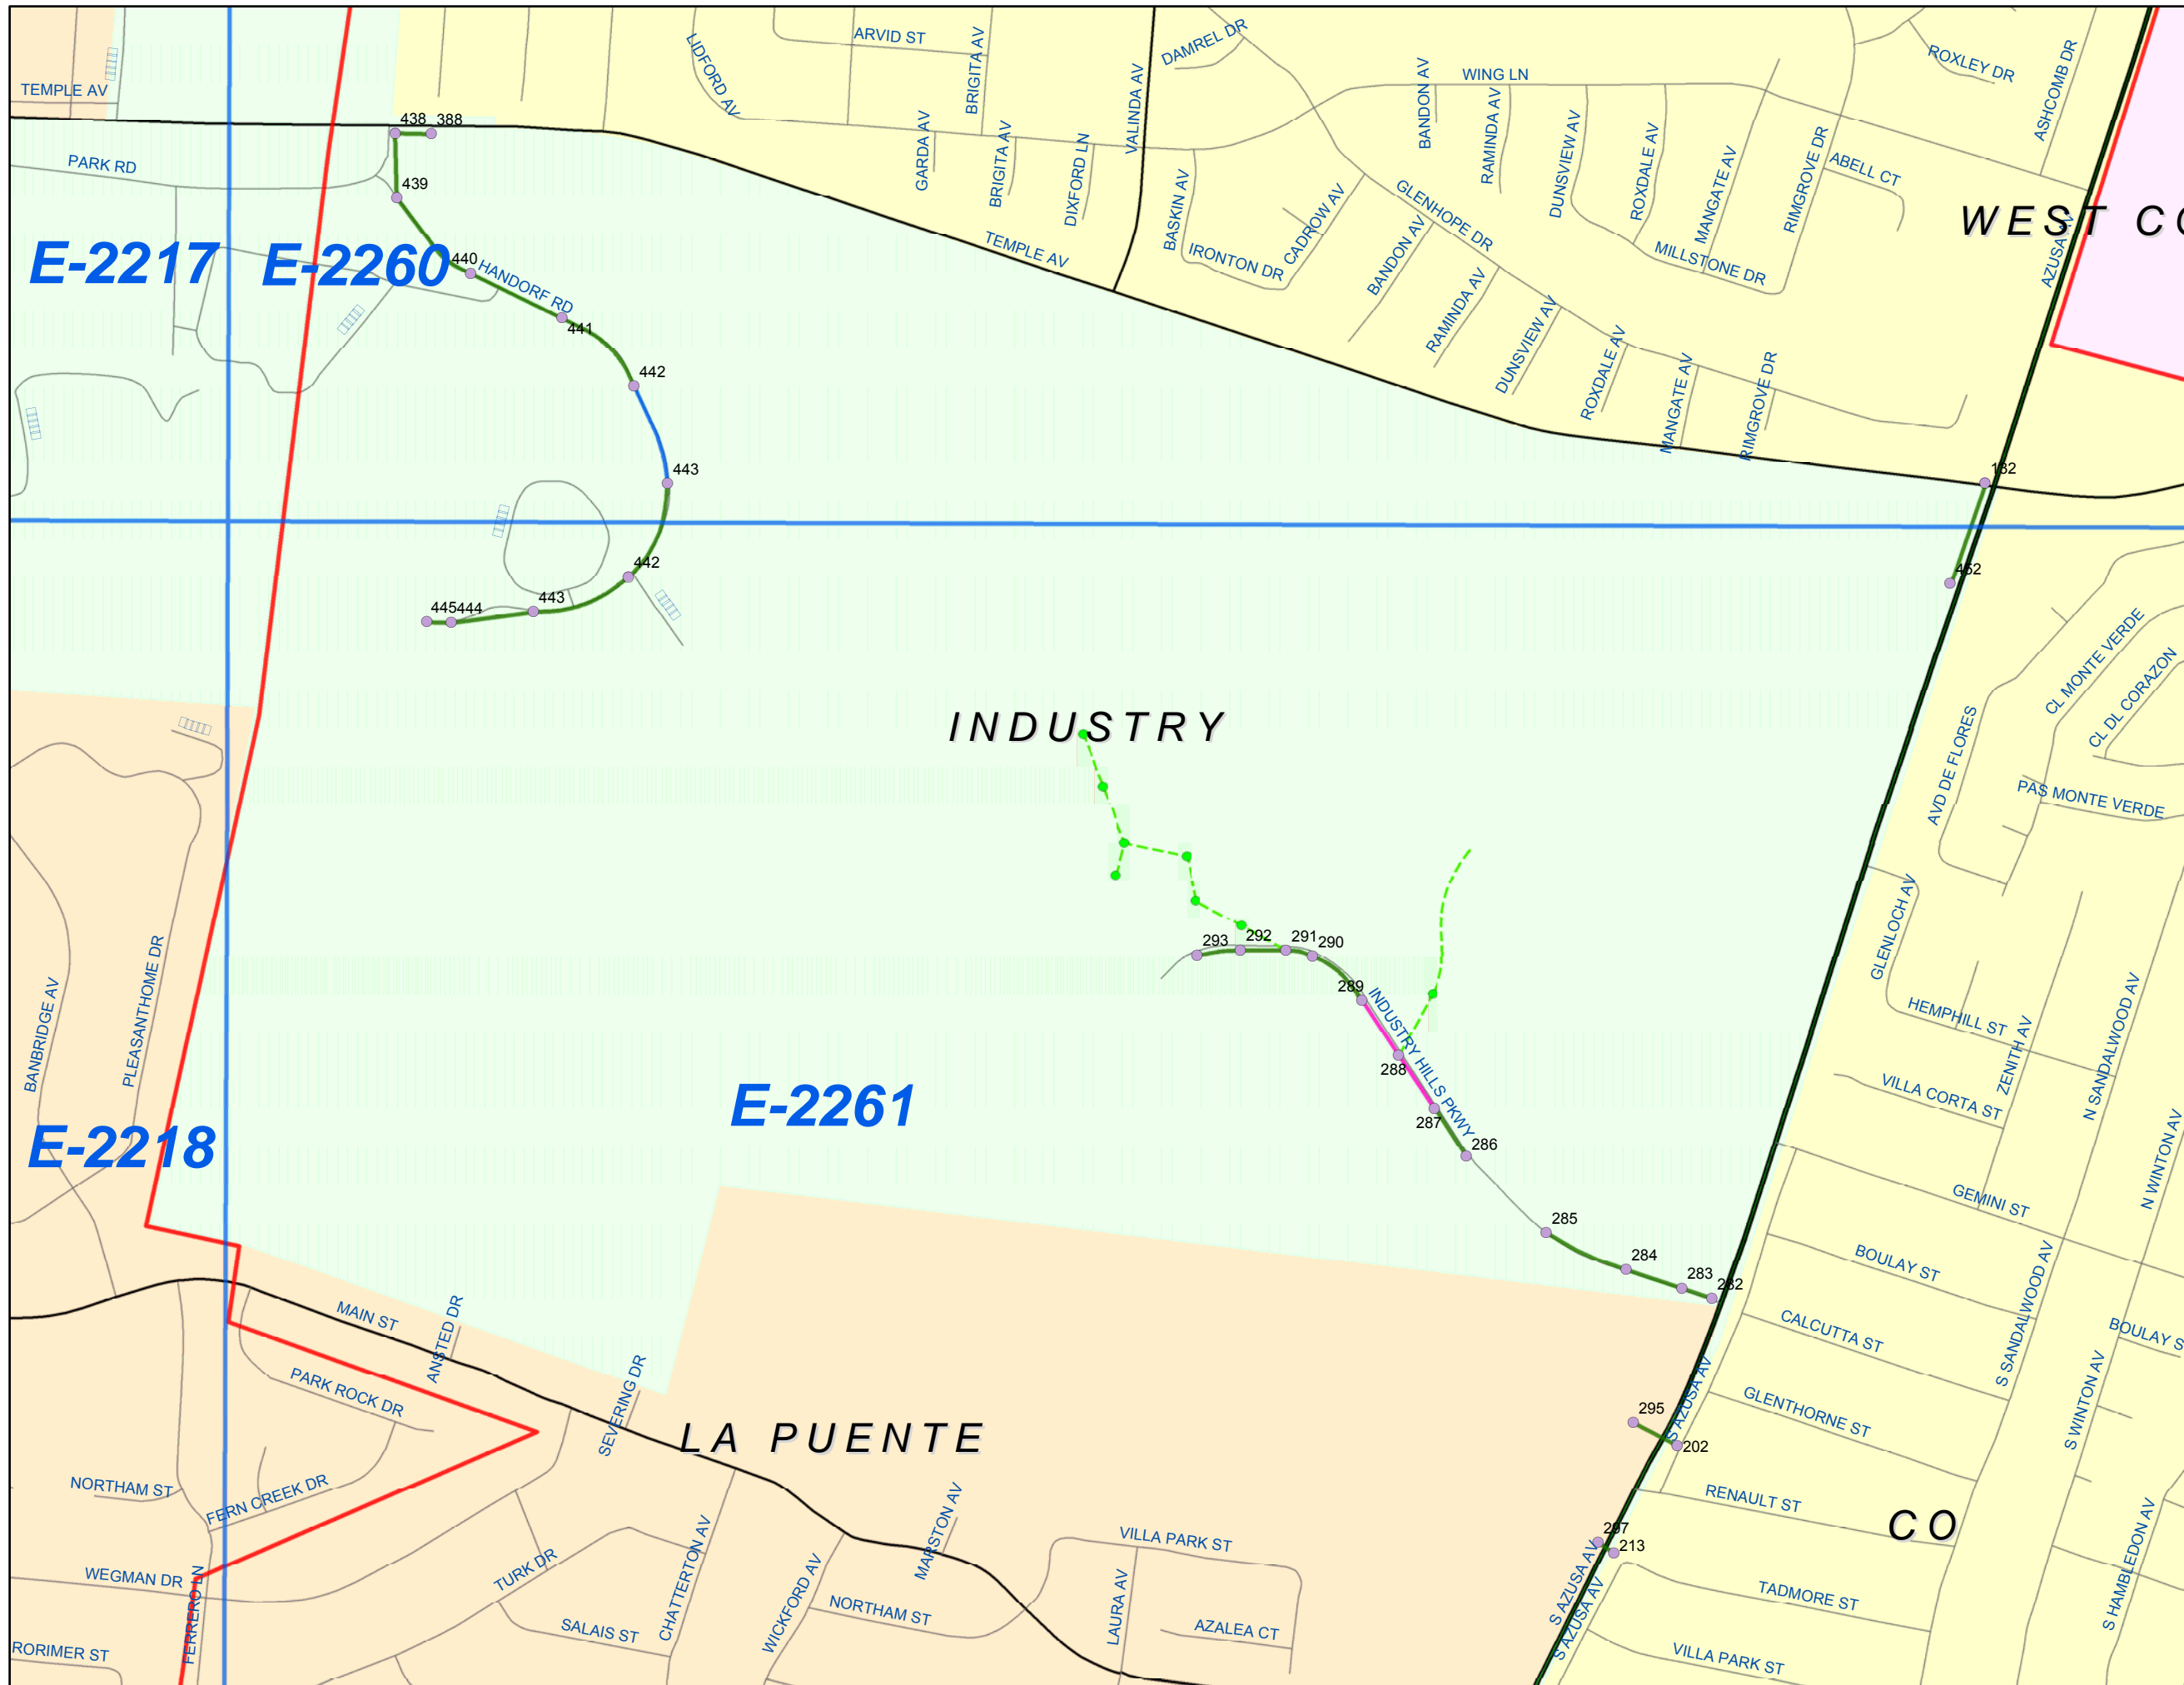
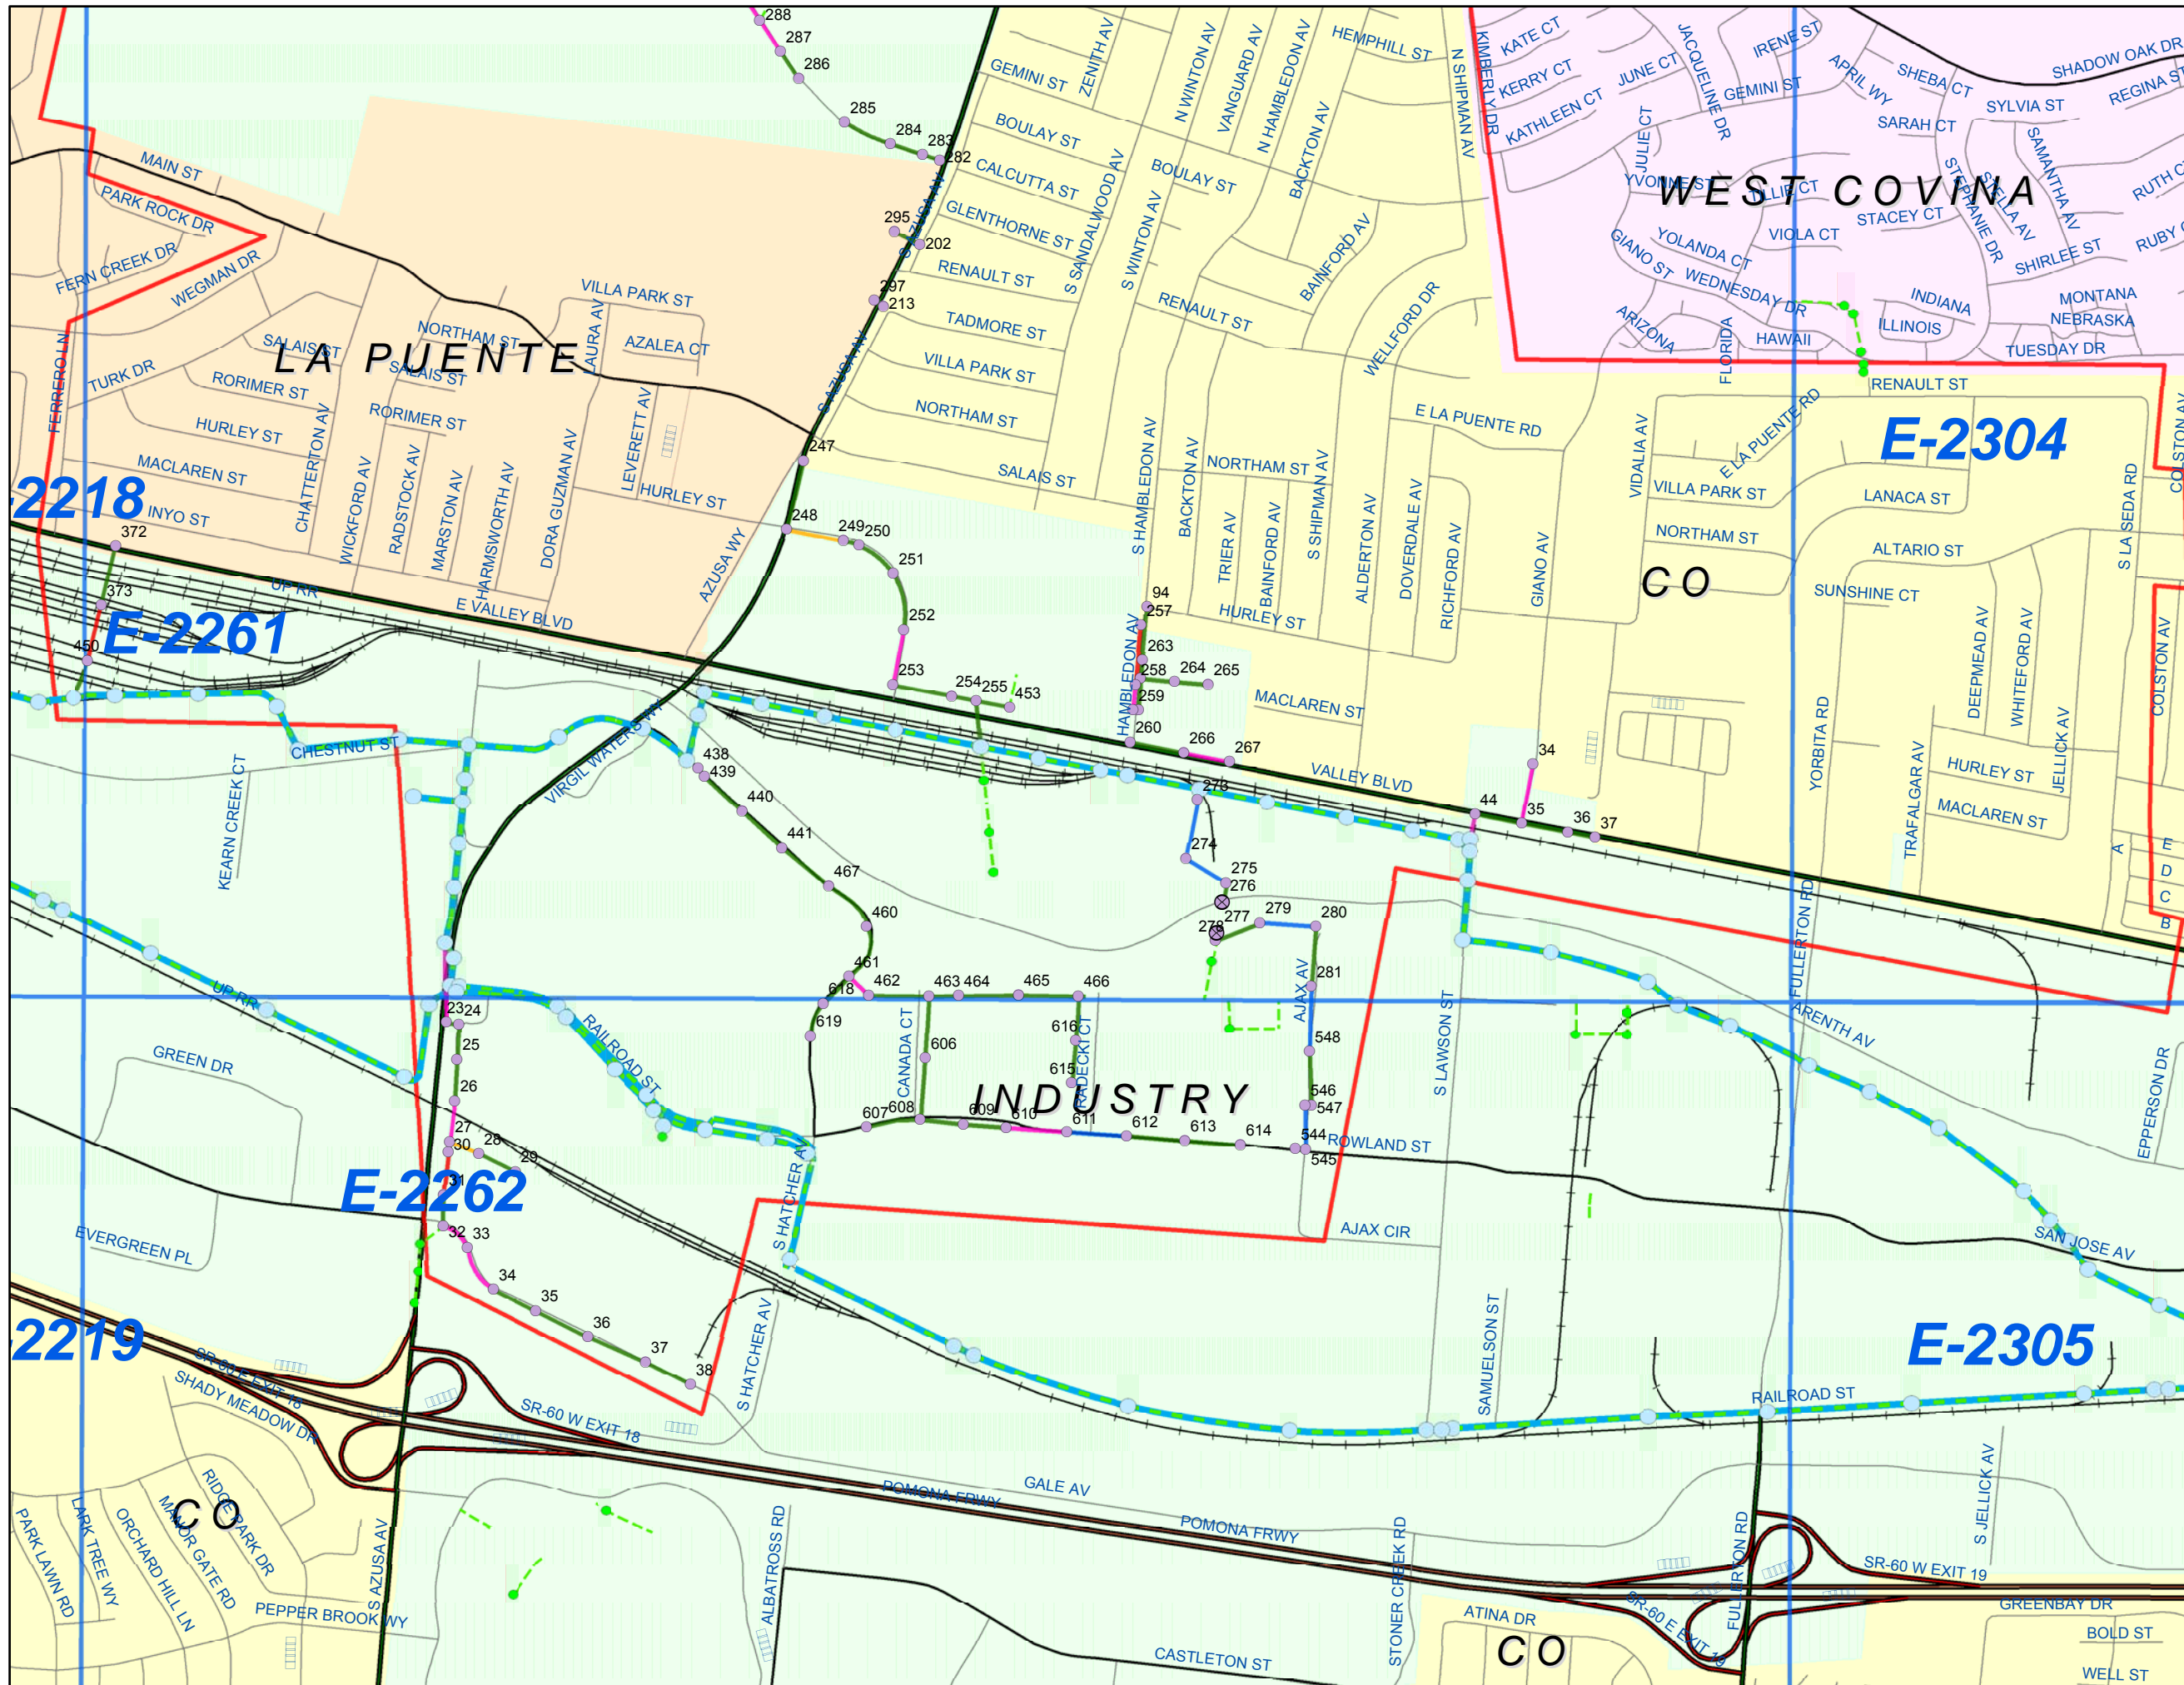
QUICK STRUCTURAL RATING (QSR)

Our inspection revealed that approximately 83.7 percent of the inspected pipe segments within the City of Industry were free of severe structural defects. However, the remaining 16.3 percent of the inspected pipe segments had a PACP structural grade of 4 or 5 as indicated in the Quick Structural Rating Table shown below. These segments have been placed on a priority list based on the severity and the need for action. For Items 1 through 17 in the Quick Structural Rating Report Priority List (Enclosure 3) which require a corrective action, the proposed corrective method will be scheduled in the next 24 months as part of the ongoing Accumulative Capital Outlay Project. A color-coded map showing the Quick Structural Rating for each pipe segment is located in Enclosure 3. Copies of the actual inspection report for these 17 segments are included in Enclosure 4.

ITEM NO.	QSR	START MH	END MH	STREET	OBSERVATION: LOCATION	PROPOSED CORRECTIVE ACTION	LENGTH OF REPAIR (FT)
1	5143	2261-0257	2261-0258	Hambledon Ave	Hole: End MH 2261-0258; multiple fractures	CSMD will repair MH base.	-
2	5131	2261-0373	2261-0450	Easement (UPRR, between Valley □ Chestnut)	Hole at lateral cap: 29' ; fractures: 44'	Structural integrity intact. No action needed.	-
3	5100	2262-0030	2262-0031	Azusa Ave	Broken with void visible / joint offset: 5'	Point Repair	-
4	4300	2261-0289	2261-0288	Industry Hills Pkwy	Multiple fractures: 66', 175'; End MH 2261-0288	CSMD will repair MH base. Lining: MH to MH	183
5	4234	2261-0273	2261-TRNK	Easement (between Arenth □ UPRR)	Multiple fractures and cracks: 36', 46'	Lining: MH to MH	62
6	4200	2261-0258	2261-0259	Hambledon Ave	Fracture: 8'	Structural integrity intact. No action needed.	-
7	4133	2262-0023	2261-TRNK	Azusa Ave	Fractures: 287'	Structural integrity intact. No action needed.	-

8	4132	2261-0034	2261-0035	Giano Ave	Fracture: 296'	Structural integrity intact. No action needed.	-
9	4121	2262-0027	2262-0026	Azusa Ave	Multiple fractures: 22'	Lining: MH to MH	210
10	4111	2262-0611	2262-0610	Rowland St	Fracture: 254'	Structural integrity intact. No action needed.	-
11	4100	2262-0033	2262-0032	Gale Ave	Fracture: 161'	Structural integrity intact. No action needed.	-
12	4100	2262-0034	2262-0033	Gale Ave	Hole with soil visible and fractures: 266'	Structural integrity intact. No action needed.	-
13	4100	2261-0044	2261-TRNK	Valley Blvd	Fracture: 166'	Structural integrity intact. No action needed.	-
14	4100	2261-0252	2261-0253	Hurley St	Fracture: 292'	Structural integrity intact. No action needed.	-
15	4100	2261-0267	2261-0266	Valley Blvd	Fracture: 130'	Structural integrity intact. No action needed.	-
16	4100	2261-0288	2261-0287	Industry Hills Pkwy	Multiple fractures: 75'	Lining: MH to MH	200

17	4100	2261-0461	2261-0462	Chestnut St	Fractures: 45'	Structural integrity intact. No action needed.	-
