**CONSOLIDATED SEWER MAINTENANCE DISTRICT
CONDITION ASSESSMENT PROGRAM REPORT
PROJECT NO. Y0TV0910C**

**CONDITION ASSESSMENT REPORT
COUNTY OF LOS ANGELES DEPARTMENT OF PUBLIC WORKS
CONSOLIDATED SEWER MAINTENANCE DISTRICT**

PROJECT NAME:	Y0TV0910C	PROJECT MGR:	Hanna Kebede
COMPLETION DATE:	01/27/2011	CONTACT NO:	(626) 300-4686
SUP. DISTRICT(S):	5	MAP PAGE(S):	2262, 2305, 2347 & 2348
Report By:	Hanna Kebede	Report Date:	05/05/2014

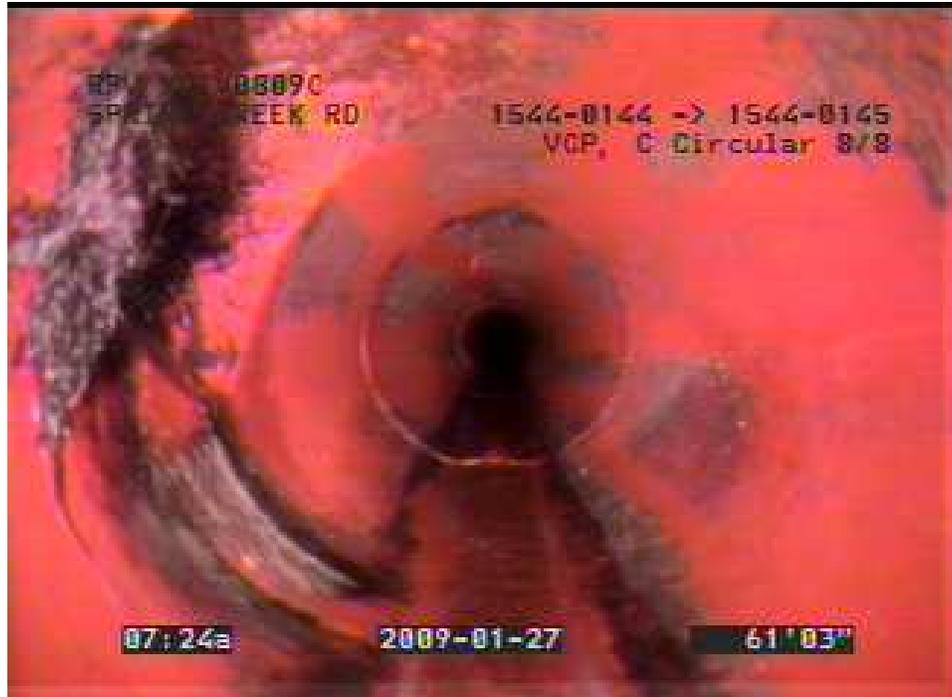
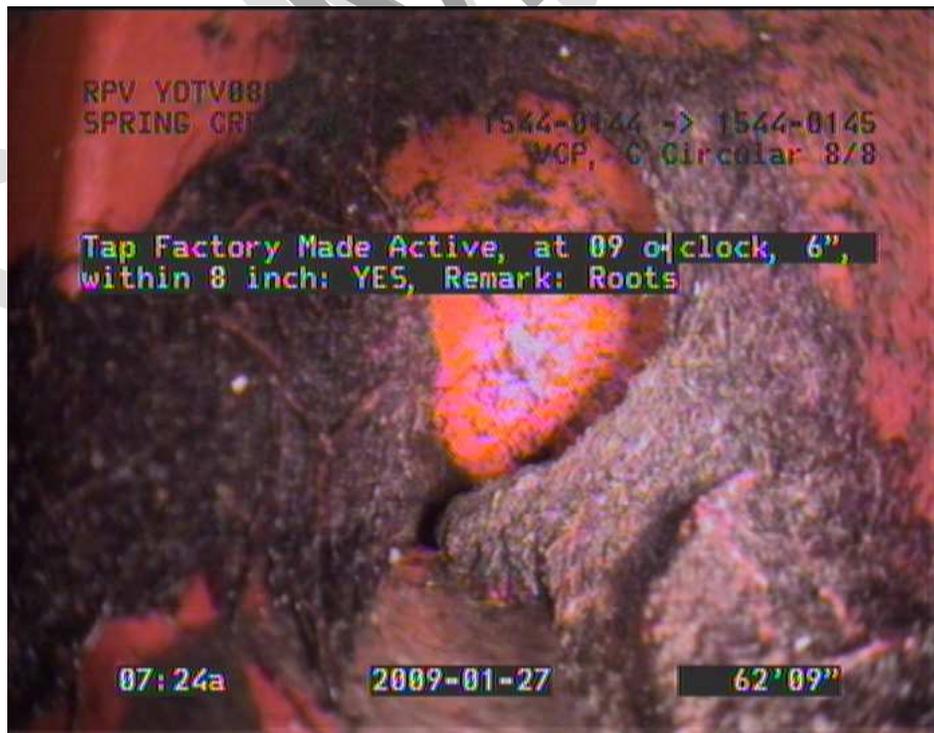
XXXX
Roots at Lateral Connection

Using closed-circuit television (CCTV) camera technology, the District recently televised the sanitary sewer mainline and discovered the presence of roots in your sewer lateral connection. The intrusion of the roots from your lateral may block the flow of sewage in the mainline sewer causing a sanitary sewer overflow upstream of your property.

Since the CCTV inspection, the sewer mainline has been cleaned and blockages from root growth have been removed; however, the root blockage in your sewer lateral is still present. As the property owner, you are responsible for the entire length of the sewer lateral, which includes the portion that extends beyond the property line into the public right of way. We request that you contact a qualified plumbing contractor to service your sewer lateral within 90 days to remove roots and any other obstructions that may cause a sewage backup.

Prior to your plumbing contractor servicing your lateral, please notify the District's sewer maintenance yard in your area at XXXX to arrange for authorization to access the downstream manhole.
