DEPARTMENT OF PUBLIC WORKS

August 14, 2014

CONSOLIDATED SEWER MAINTENANCE DISTRICT CONDITION ASSESSMENT PROGRAM REPORT PROJECT NO. Y0TV1011B

**CONDITION ASSESSMENT REPORT
COUNTY OF LOS ANGELES DEPARTMENT OF PUBLIC WORKS
CONSOLIDATED SEWER MAINTENANCE DISTRICT**

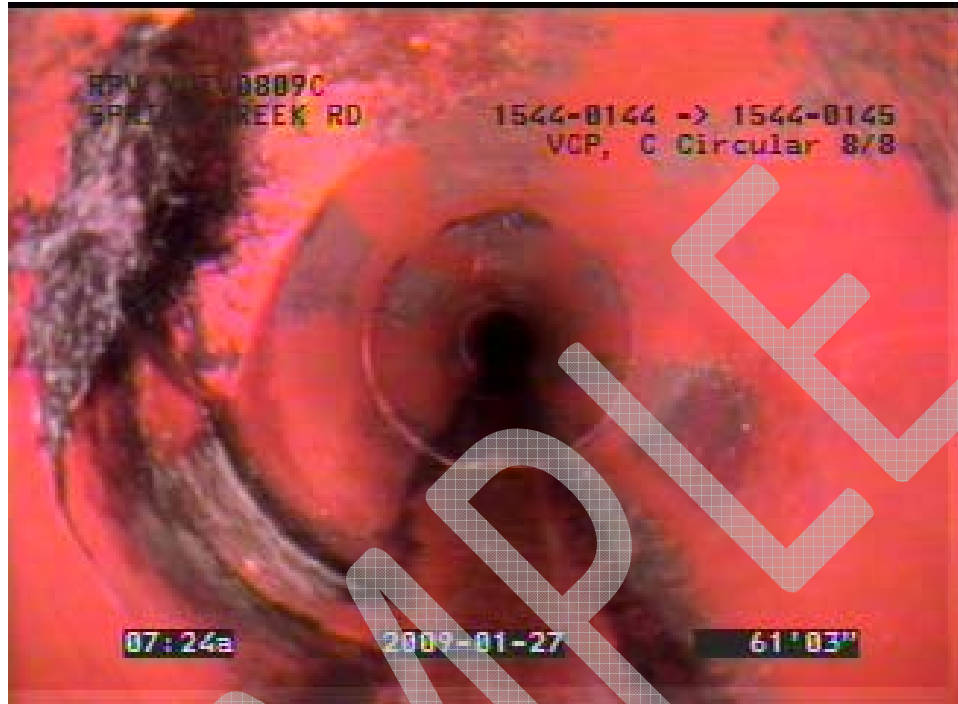
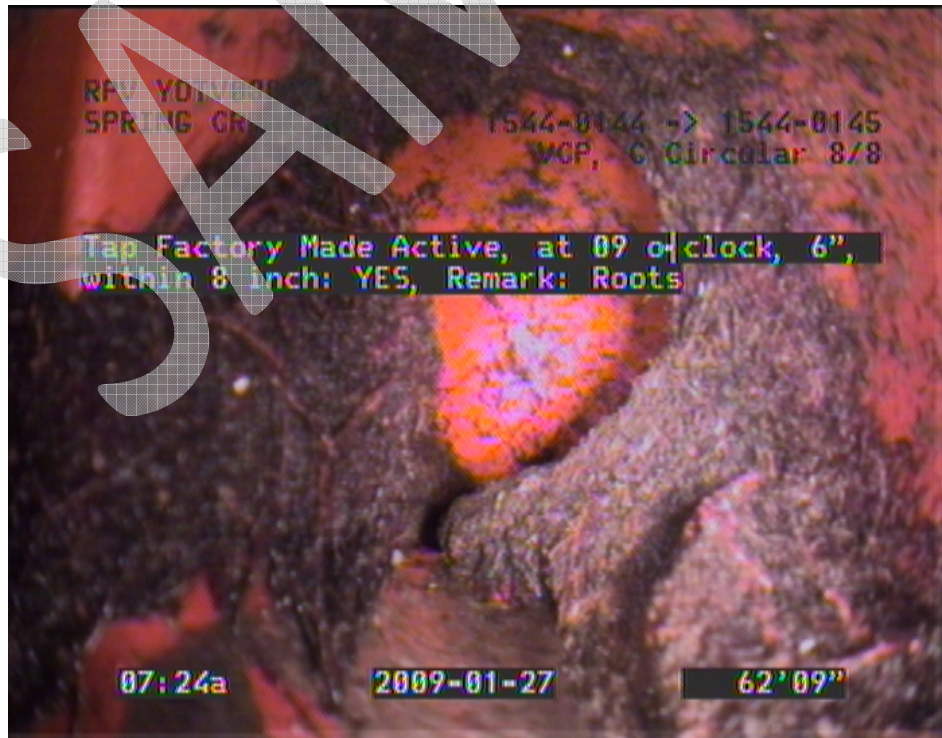
XXXX
Roots at Lateral Connection

Since the CCTV inspection, the sewer mainline has been cleaned and blockages from root growth have been removed; however, the root blockage in your sewer lateral is still present. As the property owner, you are responsible for the entire length of the sewer lateral, which includes the portion that extends beyond the property line into the public right of way. We request that you contact a qualified plumbing contractor to service your sewer lateral within 90 days to remove roots and any other obstructions that may cause a sewage backup.

For your reference, we have enclosed photos of your lateral connection showing the presence of the root blockage. Also enclosed are some literature on ways of minimizing sewer overflows and damage to your home.

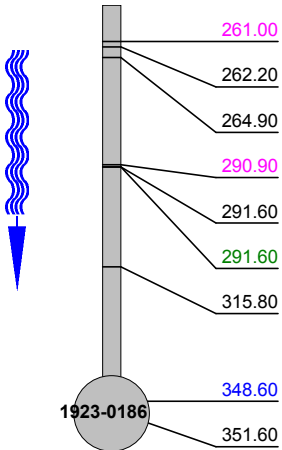
Date: 20110621	P.O.#:	Weather: Dry	Surveyed By: Rigo Alvarez	section number: 2987	PSR: 42914
Total Pipe Length: 342.00	Survey Customer: LACDPW	System Owner: LAK	Clean Date: 06/17/2011	Pre-Cleaned: Jetting	Map Grid #: 1923

1:561	position	observation	grade
	<u>261.00</u>	Fracture Multiple, from 8 to 4 o'clock, within 8 inch: YES	S 4
	<u>262.20</u>	Tap Factory Active, at 10 o'clock, 6", within 8 inch: NO	
	<u>264.90</u>	Tap Factory Active, at 2 o'clock, 6", within 8 inch: NO	
	<u>290.90</u>	Fracture Multiple, from 8 to 5 o'clock, within 8 inch: YES	S 4
	<u>291.60</u>	Tap Factory Active, at 10 o'clock, 6", within 8 inch: NO	
	<u>291.60</u>	Roots Fine Lateral, at 10 o'clock, within 8 inch: NO	M 1
	<u>315.80</u>	Tap Factory Active, at 2 o'clock, 6", within 8 inch: NO	
	<u>348.60</u>	Water Level, 5 %, within 8 inch: NO	M 2
	<u>351.60</u>	Manhole, within 8 inch: NO, Remarks: 1923-0186

QSR	QMR	SPR	MPR	OPR	SPRI	MPRI	OPRI
5143	3222	29	12	41	3.63	2	2.93

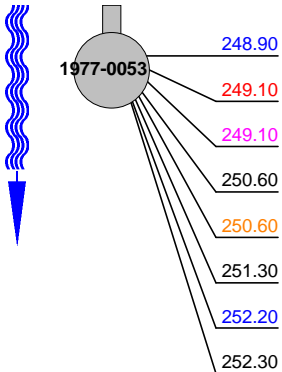
Date: 20110527	P.O.#: Y0TV1011B	Weather: Dry	Surveyed By: Gilbert Contreras	section number: 2393	PSR: 35823
Total Pipe Length: 312.00	Survey Customer: LACDPW	System Owner: LAK	Clean Date: 05/26/2011	Pre-Cleaned: Jetting	Map Grid #:

1:528	position	observation	grade
	<u>248.90</u>	Roots Fine Barrel, from 3 to 9 o'clock, within 8 inch: NO	M 2
	<u>249.10</u>	Broken, from 7 to 6 o'clock, within 8 inch: YES	S 5
	<u>249.10</u>	Fracture Multiple, from 7 to 6 o'clock, within 8 inch: YES	S 4
	<u>250.60</u>	Roots Fine Joint, from 7 to 10 o'clock, within 8 inch: YES	
	<u>250.60</u> F1	Crack Multiple, from 7 to 5 o'clock, within 8 inch: YES, End	S 3
	<u>251.30</u>	Tap Factory Active, at 6 o'clock, 6", within 8 inch: NO	
	<u>252.20</u>	Water Level, 10 %, within 8 inch: NO	M 2
	<u>252.30</u>	Manhole, within 8 inch: NO, Remarks: 1977-0053

QSR	QMR	SPR	MPR	OPR	SPRI	MPRI	OPRI
5141	3224	16	14	30	3.2	2.33	2.73

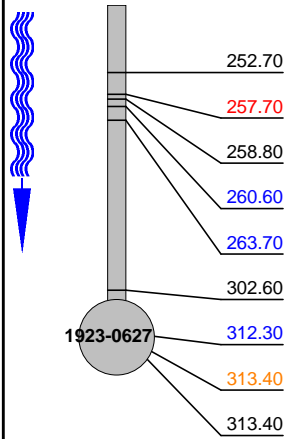
Date: 20110608	P.O.#:	Weather: Dry	Surveyed By: Martin Garcia	section number: 2708	PSR: 42512
Total Pipe Length: 350.00	Survey Customer: LACDPW	System Owner: LAK	Clean Date: 06/07/2011	Pre-Cleaned: Jetting	Map Grid #: 0

1:528	position	observation	grade
	252.70	Tap Factory Capped, at 9 o'clock, 6", within 8 inch: NO	
	257.70	Hole Void Visible, from 11 to 12 o'clock, within 8 inch: YES	S 5
	258.80	Tap Break-in Active, at 12 o'clock, 6", within 8 inch: NO	
	260.60	Fracture Circumferential, from 3 to 9 o'clock, within 8 inch: YES	S 2
	263.70	Fracture Circumferential, from 8 to 4 o'clock, within 8 inch: YES	S 2
	302.60	Tap Factory Capped, at 9 o'clock, 6", within 8 inch: NO	
	312.30	Water Level, 10 %, within 8 inch: NO	M 2
	313.40 F1	Crack Multiple, from 7 to 5 o'clock, within 8 inch: YES, End	S 3
	313.40	Manhole, within 8 inch: NO, Remarks: 1923-0627

QSR	QMR	SPR	MPR	OPR	SPRI	MPRI	OPRI
5141	2611	37	13	50	2.64	1.86	2.38

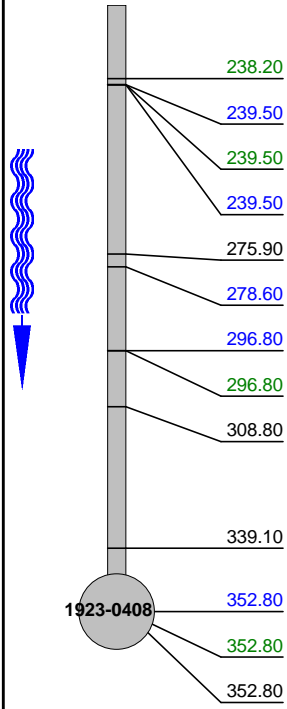
1:495	position	observation	grade
	<u>238.20</u>	Crack Circumferential, from 1 to 7 o'clock, within 8 inch: YES	S 1
	<u>239.50</u>	Tap Factory Defective, at 3 o'clock, 6", within 8 inch: NO	M 2
	<u>239.50</u>	Crack Circumferential, from 6 to 6 o'clock, within 8 inch: NO, Remarks: IN LATERAL	S 1
	<u>239.50</u>	Crack Longitudinal, at 12 o'clock, within 8 inch: NO	S 2
	<u>275.90</u>	Tap Factory Active, at 9 o'clock, 6", within 8 inch: NO	
	<u>278.60</u>	Water Mark, 20 %, within 8 inch: NO	M 2
	<u>296.80</u>	Tap Factory Defective, at 3 o'clock, 6", within 8 inch: NO	M 2
	<u>296.80</u>	Crack Circumferential, from 6 to 6 o'clock, within 8 inch: NO, Remarks: IN LATERAL	S 1
	<u>308.80</u>	Tap Factory Active, at 9 o'clock, 6", within 8 inch: NO	
	<u>339.10</u>	Tap Factory Active, at 3 o'clock, 6", within 8 inch: NO	
	<u>352.80</u>	Water Level, 15 %, within 8 inch: NO	M 2
	<u>352.80</u>	Vermin Cockroach, within 8 inch: NO	M 1

<u>352.80</u>	Manhole, within 8 inch: NO, Remarks: 1923-0408

QSR	QMR	SPR	MPR	OPR	SPRI	MPRI	OPRI
5141	2912	25	20	45	2.27	1.82	2.05

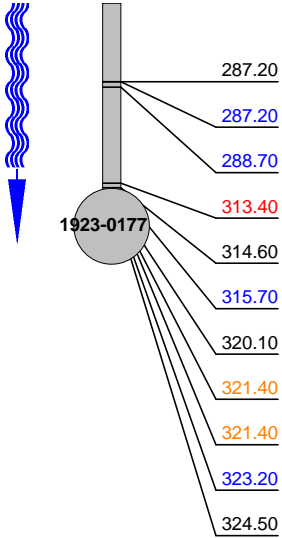
Date: 20110623	P.O.#:	Weather: Dry	Surveyed By: Rigo Alvarez	section number: 3010	PSR: 42908
Total Pipe Length: 345.00	Survey Customer: LACDPW	System Owner: LAK	Clean Date: 06/21/2011	Pre-Cleaned: Jetting	Map Grid #: 1923

1:594	position	observation	grade
	<u>287.20</u>	Tap Factory Active, at 2 o'clock, 6", within 8 inch: NO	
	<u>287.20</u>	Fracture Circumferential, from 9 to 2 o'clock, within 8 inch: NO, Remarks: Barrel	S 2
	<u>288.70</u>	Crack Longitudinal, at 10 o'clock, within 8 inch: YES	S 2
	<u>313.40</u>	Broken, from 7 to 4 o'clock, within 8 inch: YES	S 5
	<u>314.60</u>	Tap Factory Active, at 2 o'clock, 6", within 8 inch: NO	
	<u>315.70</u>	Crack Longitudinal, at 10 o'clock, within 8 inch: YES	S 2
	<u>320.10</u>	Tap Factory Active, at 10 o'clock, 6", within 8 inch: NO	
	<u>321.40</u>	Fracture Longitudinal, at 4 o'clock, within 8 inch: YES	S 3
	<u>321.40</u>	Fracture Longitudinal, at 7 o'clock, within 8 inch: YES	S 3
	<u>323.20</u>	Water Level, 5 %, within 8 inch: NO	M 2
	<u>324.50</u>	Manhole, within 8 inch: NO, Remarks: 1923-0177

QSR	QMR	SPR	MPR	OPR	SPRI	MPRI	OPRI
5141	2300	40	6	46	2.67	2	2.56

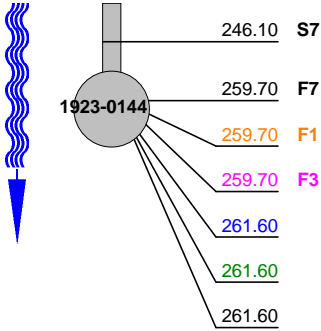
Date: 20110714	P.O.#: Y0TV1011B	Weather: Dry	Surveyed By: Gilbert Contreras	section number: 3572	PSR: 42989
Total Pipe Length: 263.00	Survey Customer: LACDPW	System Owner: LAK	Clean Date: 07/13/2011	Pre-Cleaned: Jetting	Map Grid #:

1:528	position	observation	grade
	246.10	S7	
	259.70	F7	
	259.70	F1	S 3
	259.70	F3	S 4
	261.60	Water Level, 15 %, within 8 inch: NO	M 2
	261.60	Vermin Cockroach, within 8 inch: NO	M 1
	261.60	Manhole, within 8 inch: NO, Remarks: 1923-0144

QSR	QMR	SPR	MPR	OPR	SPRI	MPRI	OPRI
4734	4126	41	17	58	3.42	2.13	2.9

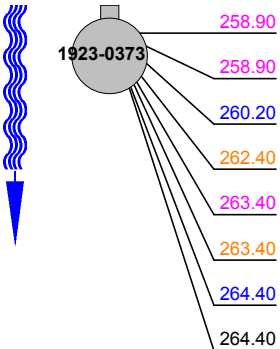
Date: 20110608	P.O.#: Y0TV1011B	Weather: Dry	Surveyed By: Gilbert Contreras	section number: 2848	PSR: 42742
Total Pipe Length: 268.00	Survey Customer: LACDPW	System Owner: LAK	Clean Date: 06/07/2011	Pre-Cleaned: Jetting	Map Grid #:

1:561	position	observation	grade
	<u>258.90</u> S5	Fracture Multiple, from 7 to 5 o'clock, within 8 inch: YES, Start	S 4
	<u>258.90</u>	Broken, from 8 to 9 o'clock, within 8 inch: YES	S 4
	<u>260.20</u>	Tap Factory Defective, at 9 o'clock, 6", within 8 inch: NO	M 2
	<u>262.40</u> F4	Water Level Sag, 35 %, within 8 inch: NO, End	M 3
	<u>263.40</u> F5	Fracture Multiple, from 7 to 5 o'clock, within 8 inch: YES, End	S 4
	<u>263.40</u> F3	Crack Multiple, from 7 to 5 o'clock, within 8 inch: YES, End	S 3
	<u>264.40</u>	Water Level, 15 %, within 8 inch: NO	M 2
	<u>264.40</u>	Manhole, within 8 inch: NO, Remarks: 1923-0373

QSR	QMR	SPR	MPR	OPR	SPRI	MPRI	OPRI
4335	3329	27	27	54	3.38	2.25	2.7

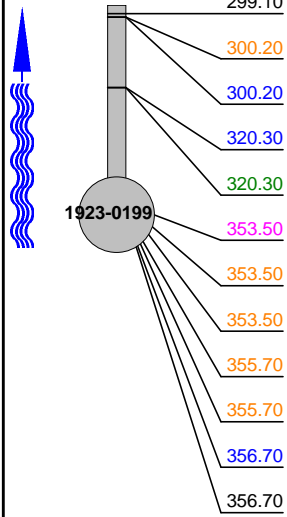
Date: 20110718	P.O.#: Y0TV1011B	Weather: Dry	Surveyed By: Gilbert Contreras	section number: 3592	PSR: 42926
Total Pipe Length: 340.00	Survey Customer: LACDPW	System Owner: LAK	Clean Date: 07/15/2011	Pre-Cleaned: Jetting	Map Grid #:

1:660	position	observation	grade
	299.10	Tap Factory Active, at 9 o'clock, 6", within 8 inch: NO	
	300.20 F1	Water Level Sag, 35 %, within 8 inch: NO, End	M 3
	300.20	Water Level, 10 %, within 8 inch: NO	M 2
	320.30	Tap Factory Defective, at 9 o'clock, 6", 2, within 8 inch: NO	M 2
	320.30	Crack Circumferential, from 8 to 10 o'clock, within 8 inch: NO	S 1
	353.50	Fracture Multiple, from 7 to 5 o'clock, within 8 inch: YES	S 4
	353.50 S3	Fracture Longitudinal, at 8 o'clock, within 8 inch: YES, Start	S 3
	353.50 S2	Fracture Longitudinal, at 5 o'clock, within 8 inch: YES, Start	S 3
	355.70 F3	Fracture Longitudinal, at 8 o'clock, within 8 inch: YES, End	S 3
	355.70 F2	Fracture Longitudinal, at 5 o'clock, within 8 inch: YES, End	S 3
	356.70	Water Level, 10 %, within 8 inch: NO	M 2
	356.70	Manhole, within 8 inch: NO, Remarks: 1923-0199

QSR	QMR	SPR	MPR	OPR	SPRI	MPRI	OPRI
4137	3226	26	19	45	2.89	2.11	2.5

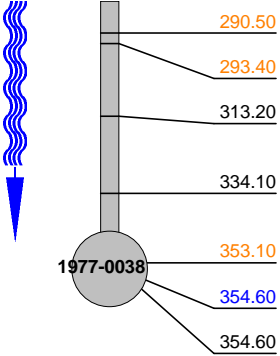
1:627	position	observation	grade
	<u>290.50</u>	Crack Multiple, from 12 to 5 o'clock, within 8 inch: YES	S 3
	<u>293.40</u> S2	Crack Multiple, from 7 to 5 o'clock, within 8 inch: YES, Start	S 3
	<u>313.20</u>	Tap Factory Active, at 9 o'clock, 6", within 8 inch: NO	
	<u>334.10</u>	Tap Factory Active, at 3 o'clock, 6", within 8 inch: NO	
	<u>353.10</u> F2	Crack Multiple, from 7 to 5 o'clock, within 8 inch: YES, End	S 3
	<u>354.60</u>	Water Level, 10 %, within 8 inch: NO	M 2
	<u>354.60</u>	Manhole, within 8 inch: NO, Remarks: 1977-0038

QSR	QMR	SPR	MPR	OPR	SPRI	MPRI	OPRI
4138	2511	30	11	41	2.73	1.83	2.41

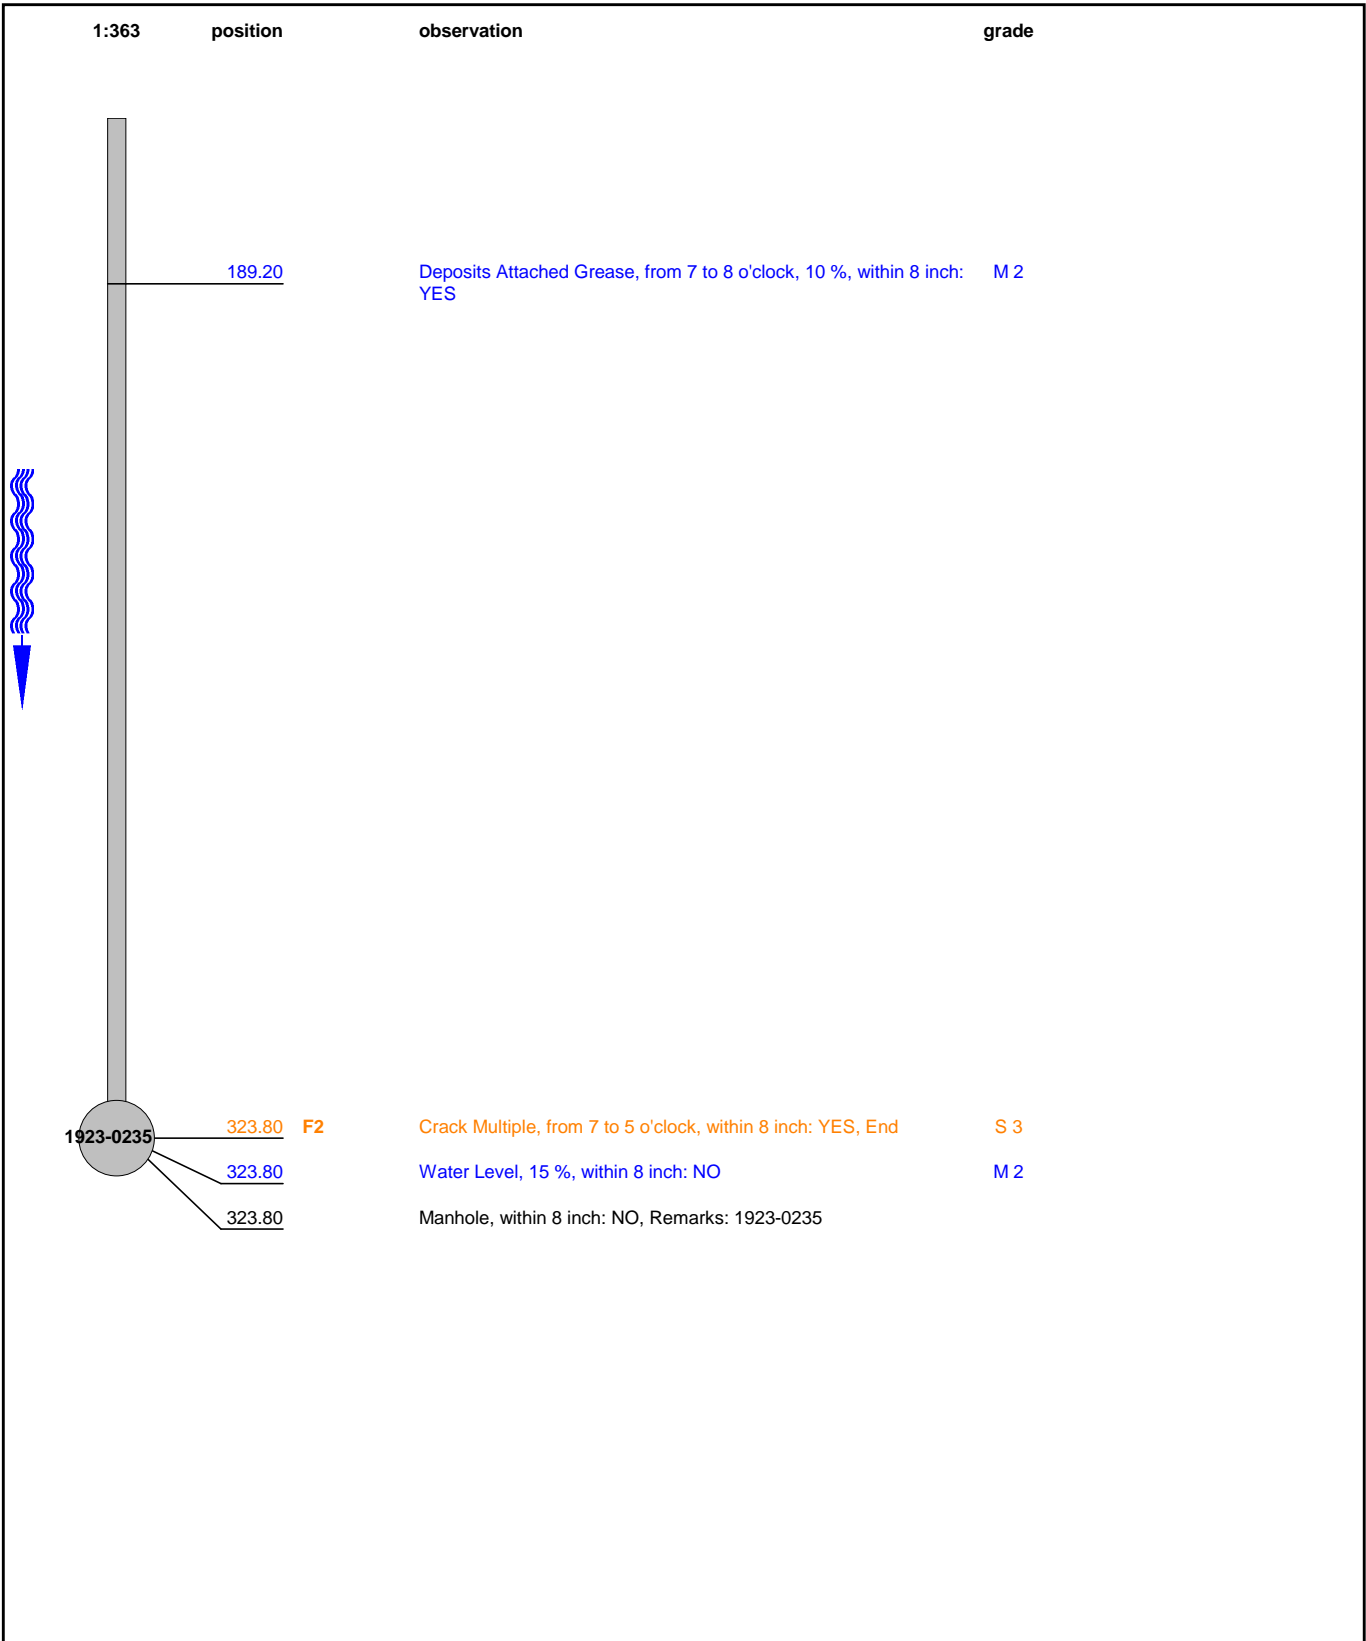
Date: 20110714	P.O.#: Y0TV1011B	Weather: Dry	Surveyed By: Gilbert Contreras	section number: 3566	PSR: 42841
Total Pipe Length: 346.00	Survey Customer: LACDPW	System Owner: LAK	Clean Date: 07/13/2011	Pre-Cleaned: Heavy Cleaning	Map Grid #:

QSR	QMR	SPR	MPR	OPR	SPRI	MPRI	OPRI
4236	3225	26	17	43	3.25	2.13	2.69
