# COUNTY OF LOS ANGELES

## DEPARTMENT OF PUBLIC WORKS

### **CONSOLIDATED SEWER MAINTENANCE DISTRICT CONDITION ASSESSMENT PROGRAM REPORT PROJECT Y0TV0607C**

**CONDITION ASSESSMENT REPORT  
COUNTY OF LOS ANGELES DEPARTMENT OF PUBLIC WORKS  
CONSOLIDATED SEWER MAINTENANCE DISTRICT**

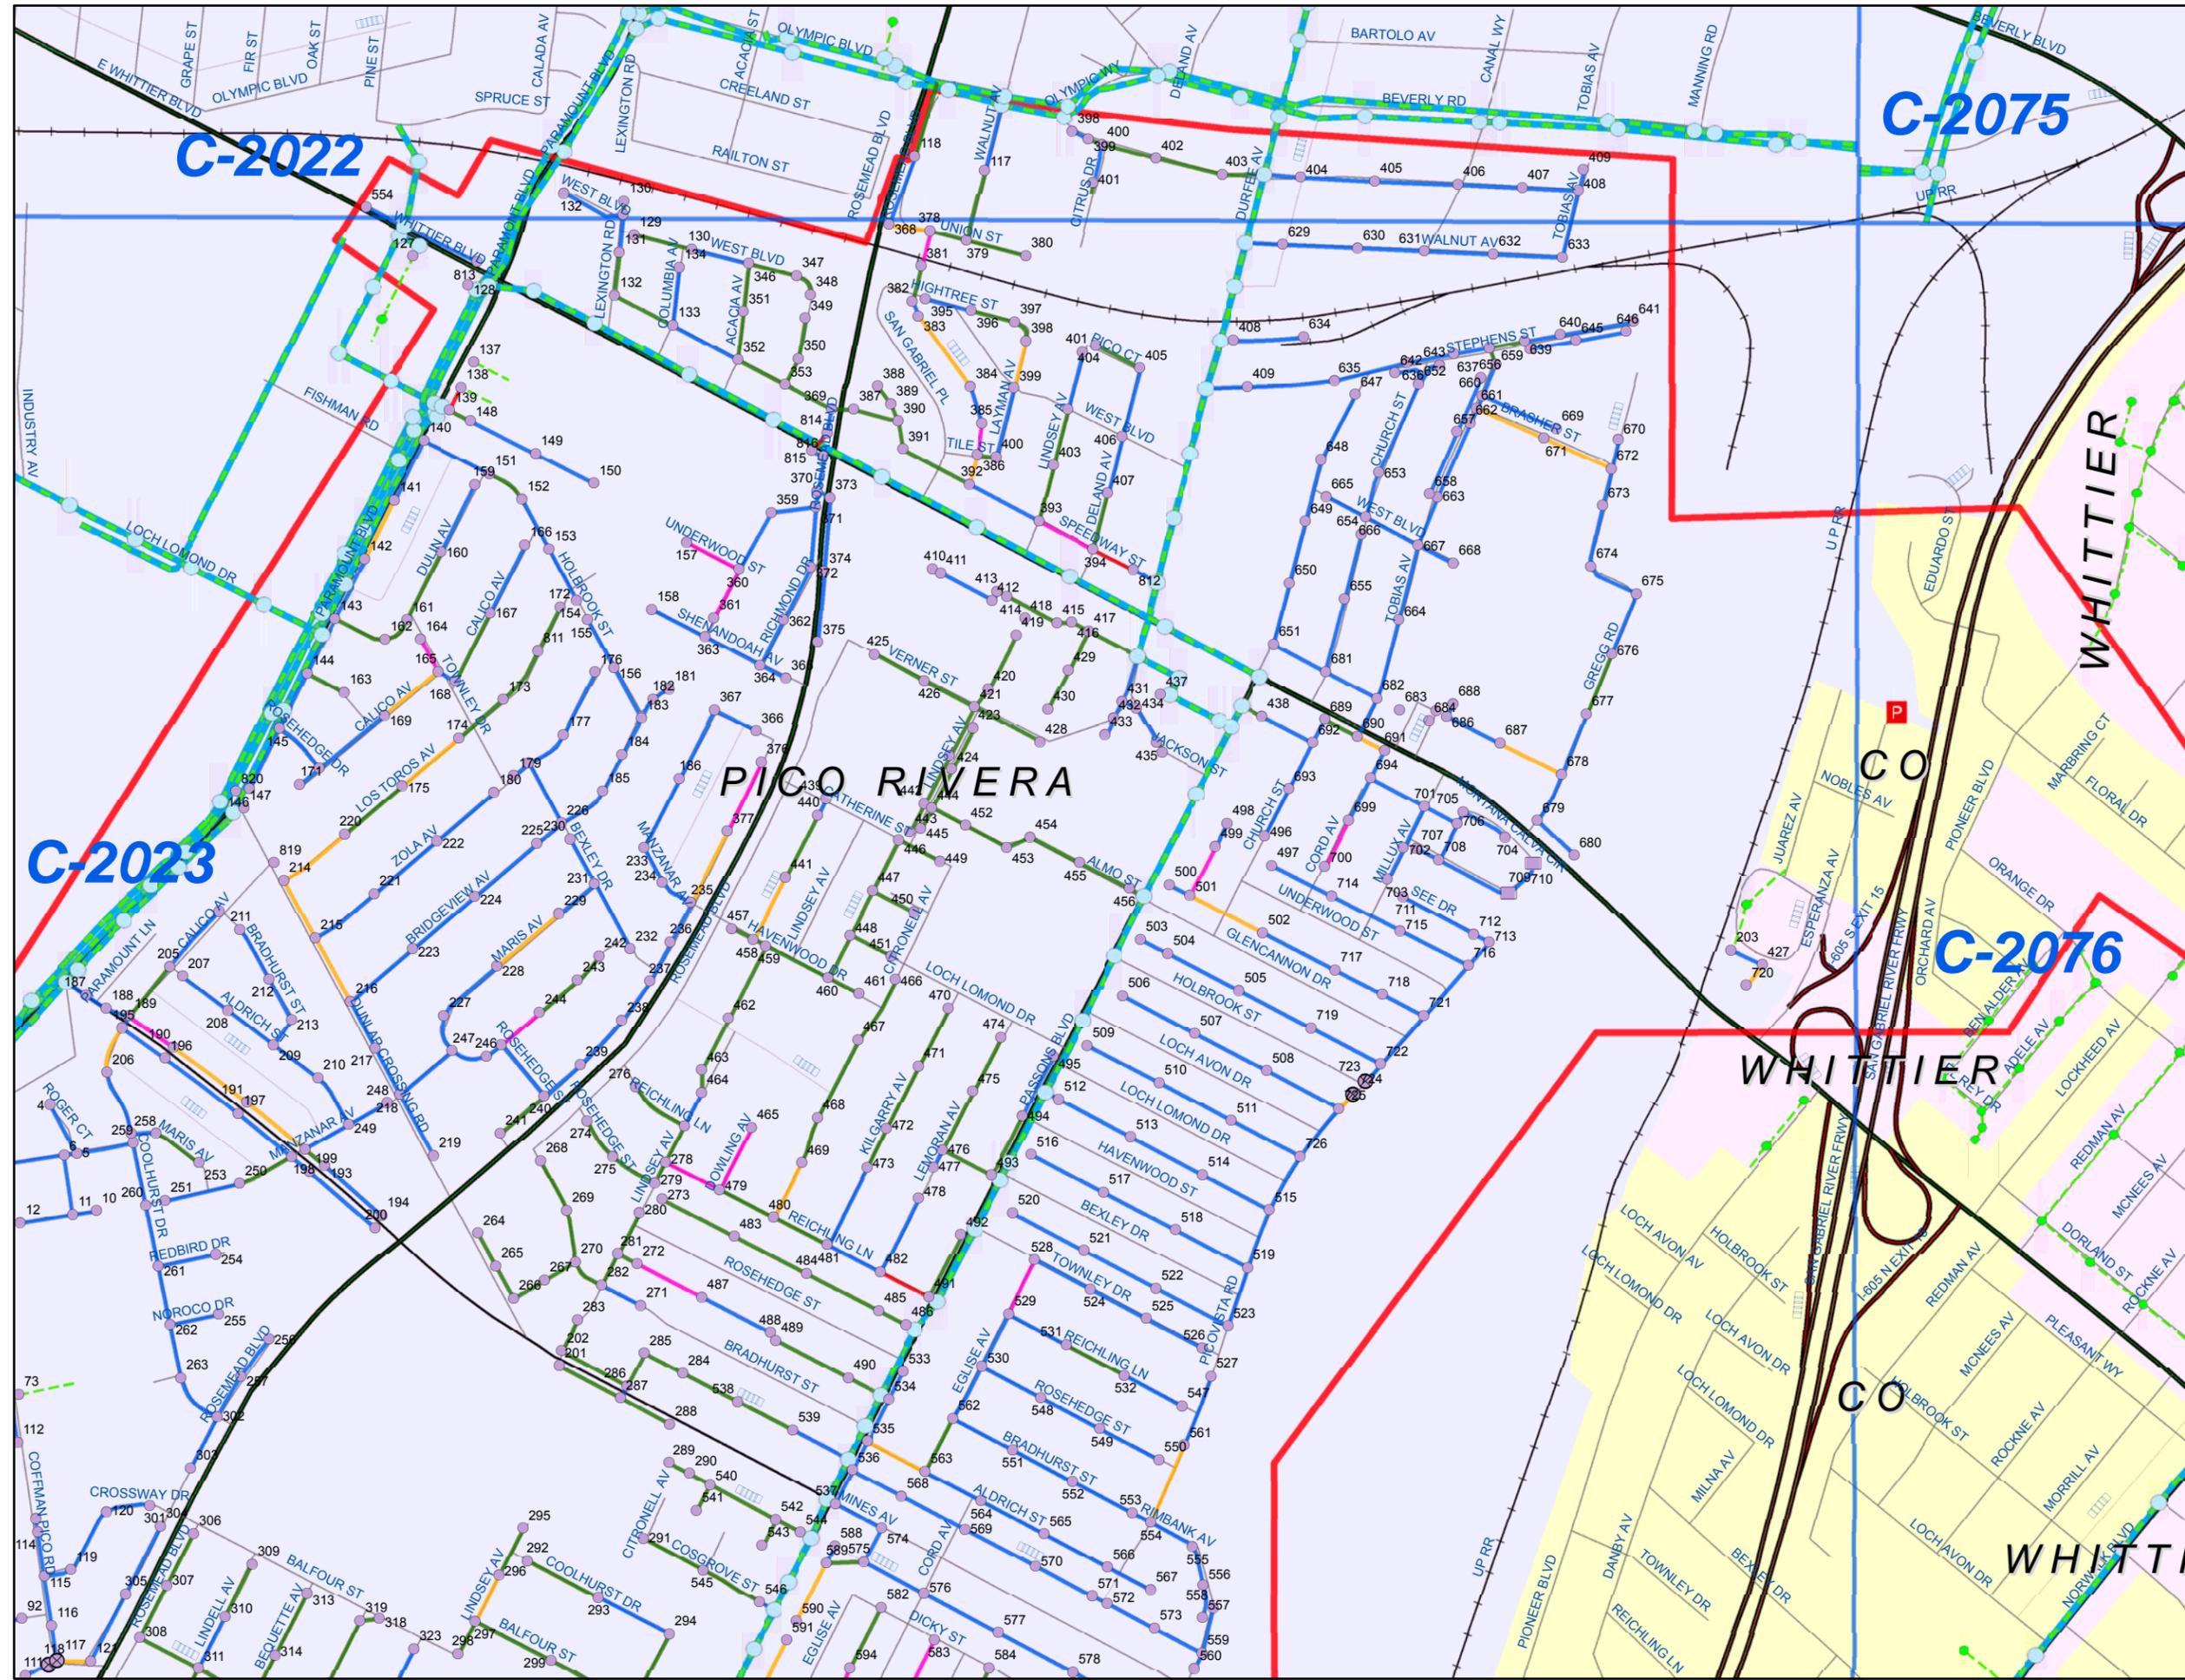
### QUICK MAINTENANCE RATING (QMR)

Our inspection revealed that approximately 94.1 percent of the system televised was free of blockages or restrictions that would impede sewer flows. However, the remaining 5.9 percent of the inspected pipe segments within the City of Pico Rivera had a PACP maintenance grade of 4 or 5 as indicated in the Quick Maintenance Rating Table shown below. These segments have been incorporated into our routine cleaning schedule with corrective action taken as noted on the Quick Maintenance Rating Report Priority List (Enclosure 2). Also included is a color-coded map showing the quick maintenance rating for each pipe segment.

The following line segments received a Quick Maintenance Rating of above 4000 due to the observation of Root Ball or Deposit inside the lateral connection CSMD does not maintain lateral lines: it is the responsibility of the parcel owner to maintain their respective lateral lines to facilitate the flow of wastewater from their property to the mainline. Therefore, these lines were not included on the Priority List above identified with maintenance deficiencies in need of immediate attention by CSMD.

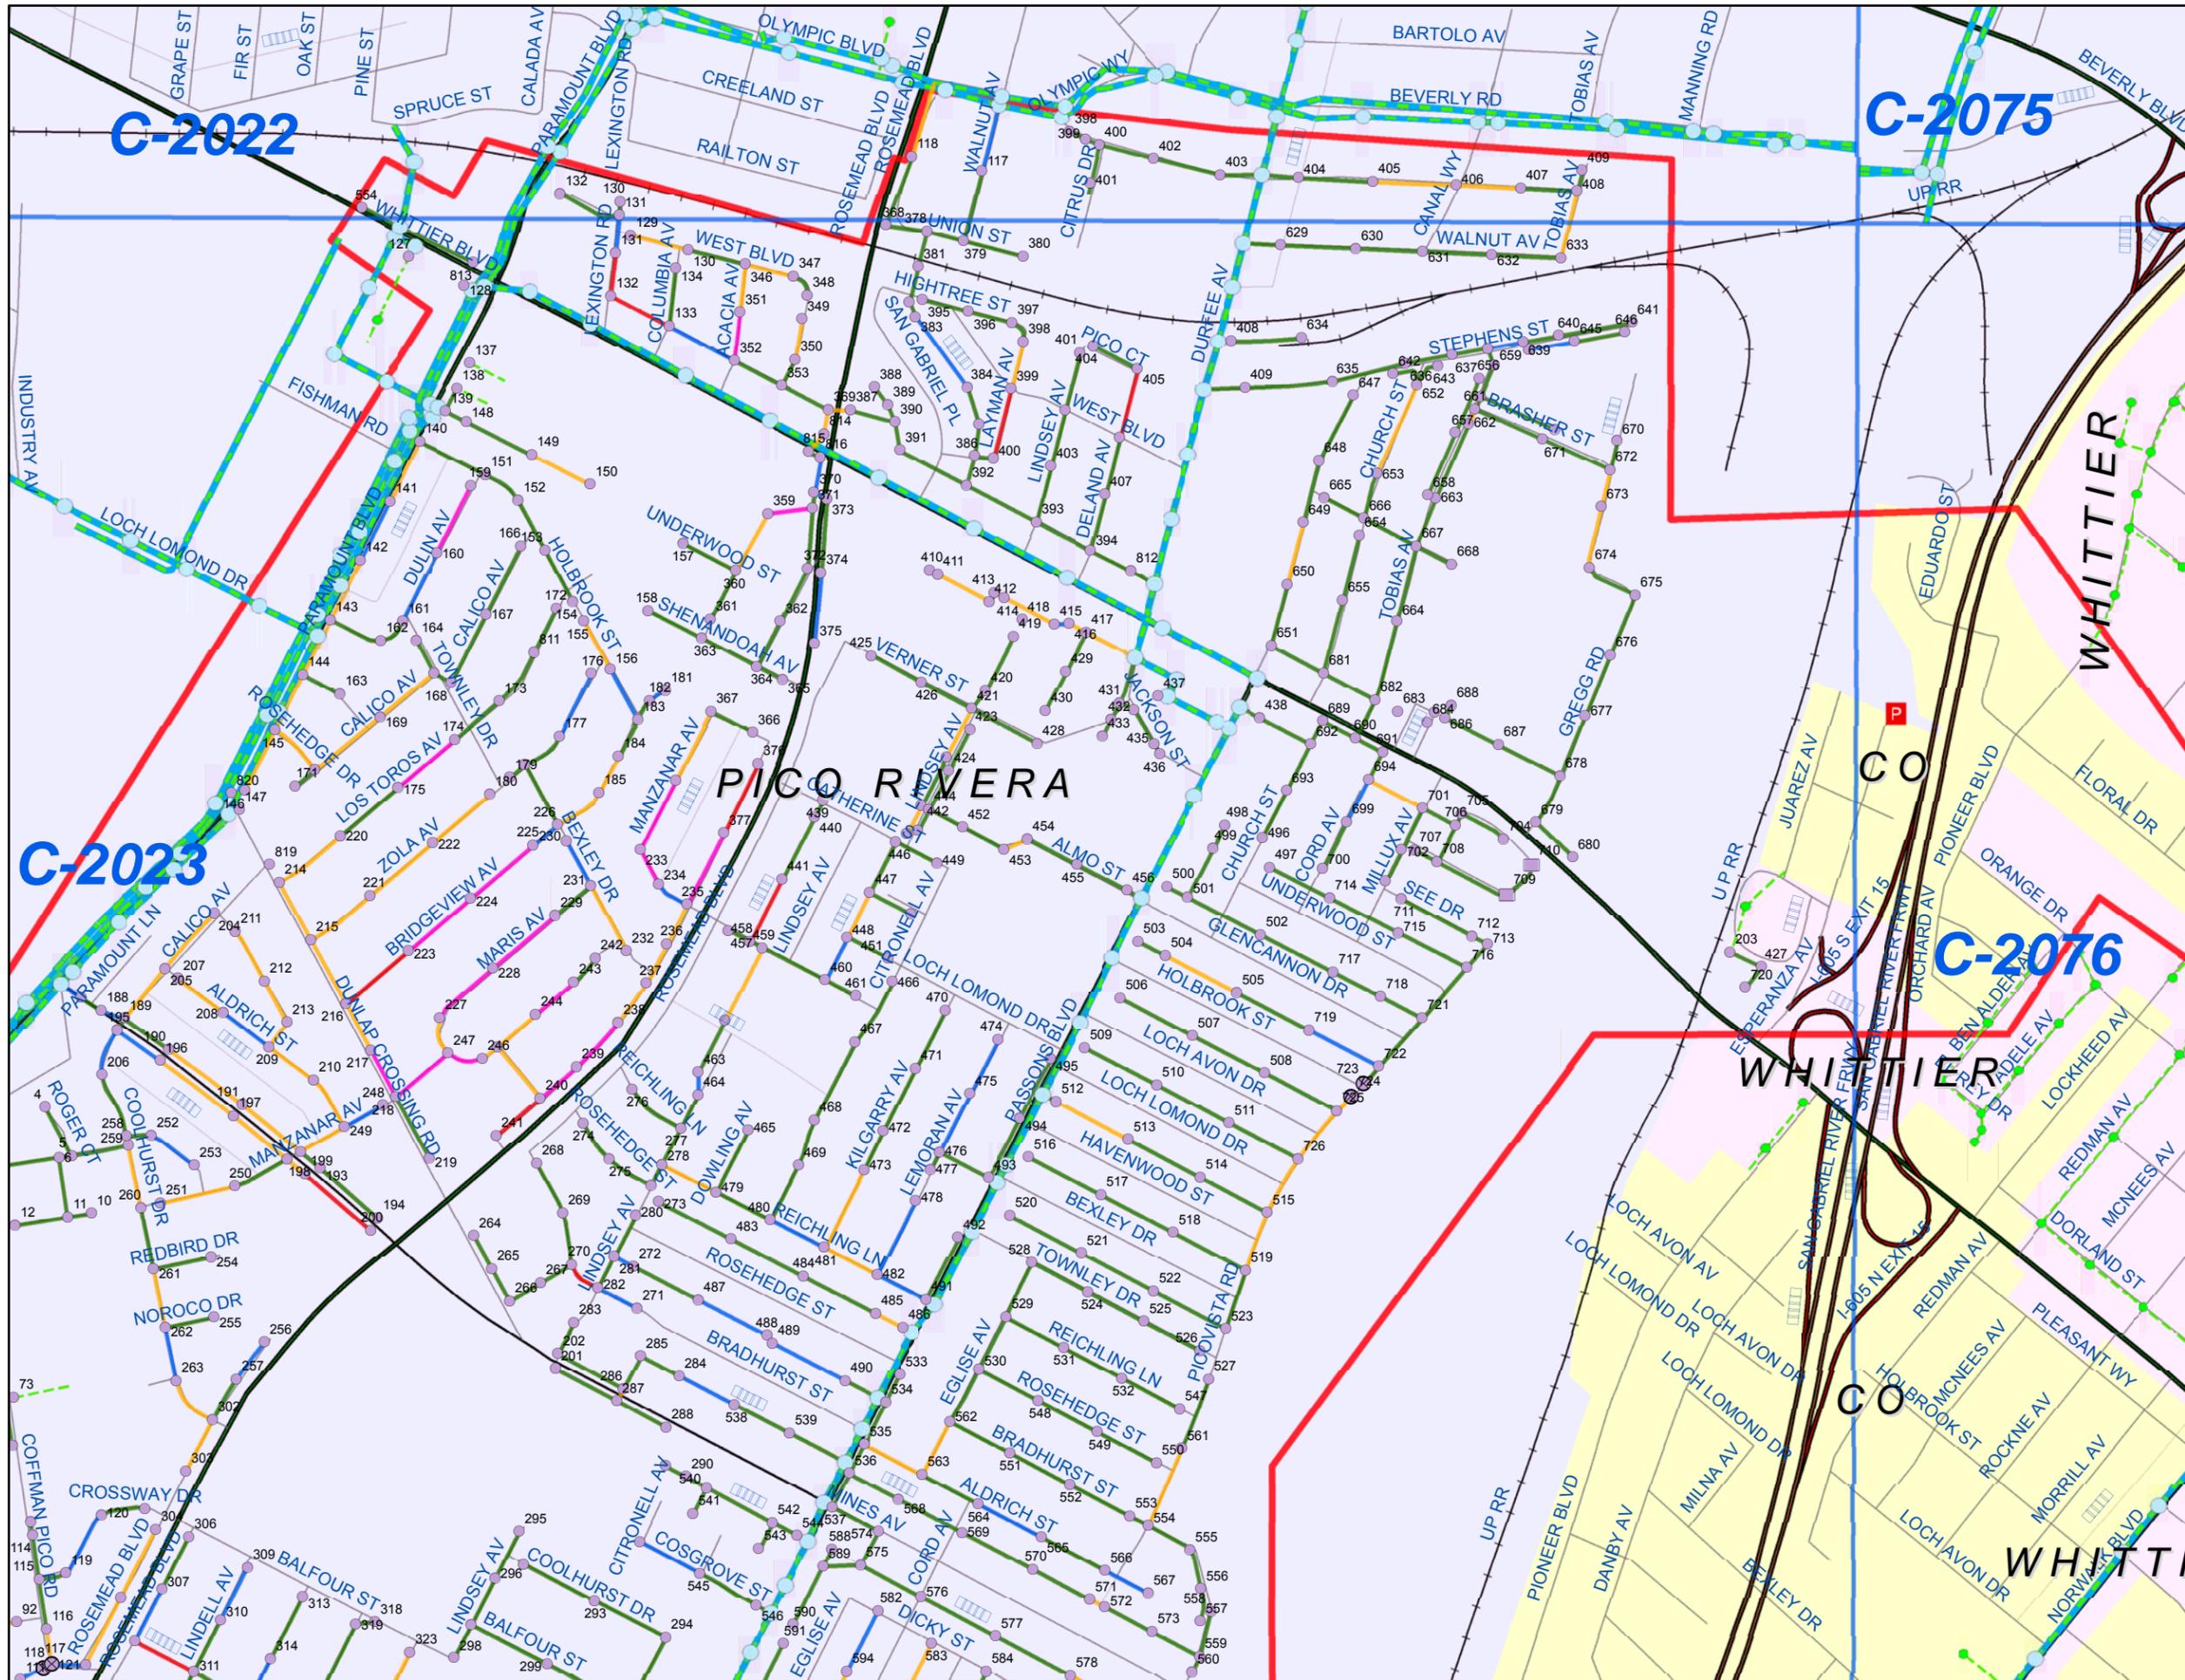
Our inspection revealed that approximately 93.5 percent of the inspected pipe segments within the City of Pico Rivera were free of severe structural defects. However, the remaining 6.5 percent of the inspected pipe segments had a PACP structural grade of 4 or 5 as indicated in the Quick Structural Rating Table shown below. These segments have been placed on a priority list based on the severity and the need for action. For Items 1 through 72 in the Quick Structural Rating Report Priority List (Enclosure 3) which require a corrective action, the proposed corrective method will be scheduled in the next 24 months as part of the ongoing Accumulative Capital Outlay Project. A color-coded map showing the Quick Structural Rating for each pipe segment is located in Enclosure 3. Copies of the actual inspection reports for these 72 segments are included in Enclosure 4.

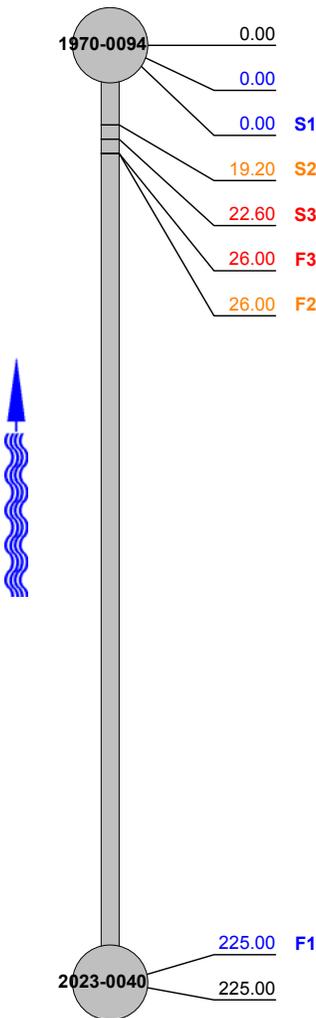
Remark: **TVed upstream, Broken pipe ,Debris**

19.20 <b>S2</b>	Crack Multiple, from 04 to 08 o'clock, within 8 inch: YES, start	00:02:31	7046	S 3
	22.60 <b>S3</b>	Broken, from 03 to 09 o'clock, within 8 inch: YES, start	00:02:56	7047, b	S 5

26.00 <b>F3</b>	Broken, from 03 to 09 o'clock, within 8 inch: YES, end	00:03:55	7049	S 5
	26.00 <b>F2</b>	Crack Multiple, from 04 to 08 o'clock, within 8 inch: YES, end	00:04:00	7050	S 3
