**CONSOLIDATED SEWER MAINTENANCE DISTRICT
CONDITION ASSESSMENT PROGRAM REPORT
PROJECT Y0TV0506A**

**CONDITION ASSESSMENT REPORT
COUNTY OF LOS ANGELES DEPARTMENT OF PUBLIC WORKS
CONSOLIDATED SEWER MAINTENANCE DISTRICT**

PROJECT NAME:	Y0TV0506A	PROJECT MGR:	Fernando Villaluna
PROJECT DATE:	12/31/2005	CONTACT NO:	(626) 300-3380
SUP. DISTRICT(S):	4	MAP PAGE(S):	2129 □ 2130
Report By:	Eric Liu	Report Date:	02/22/2011

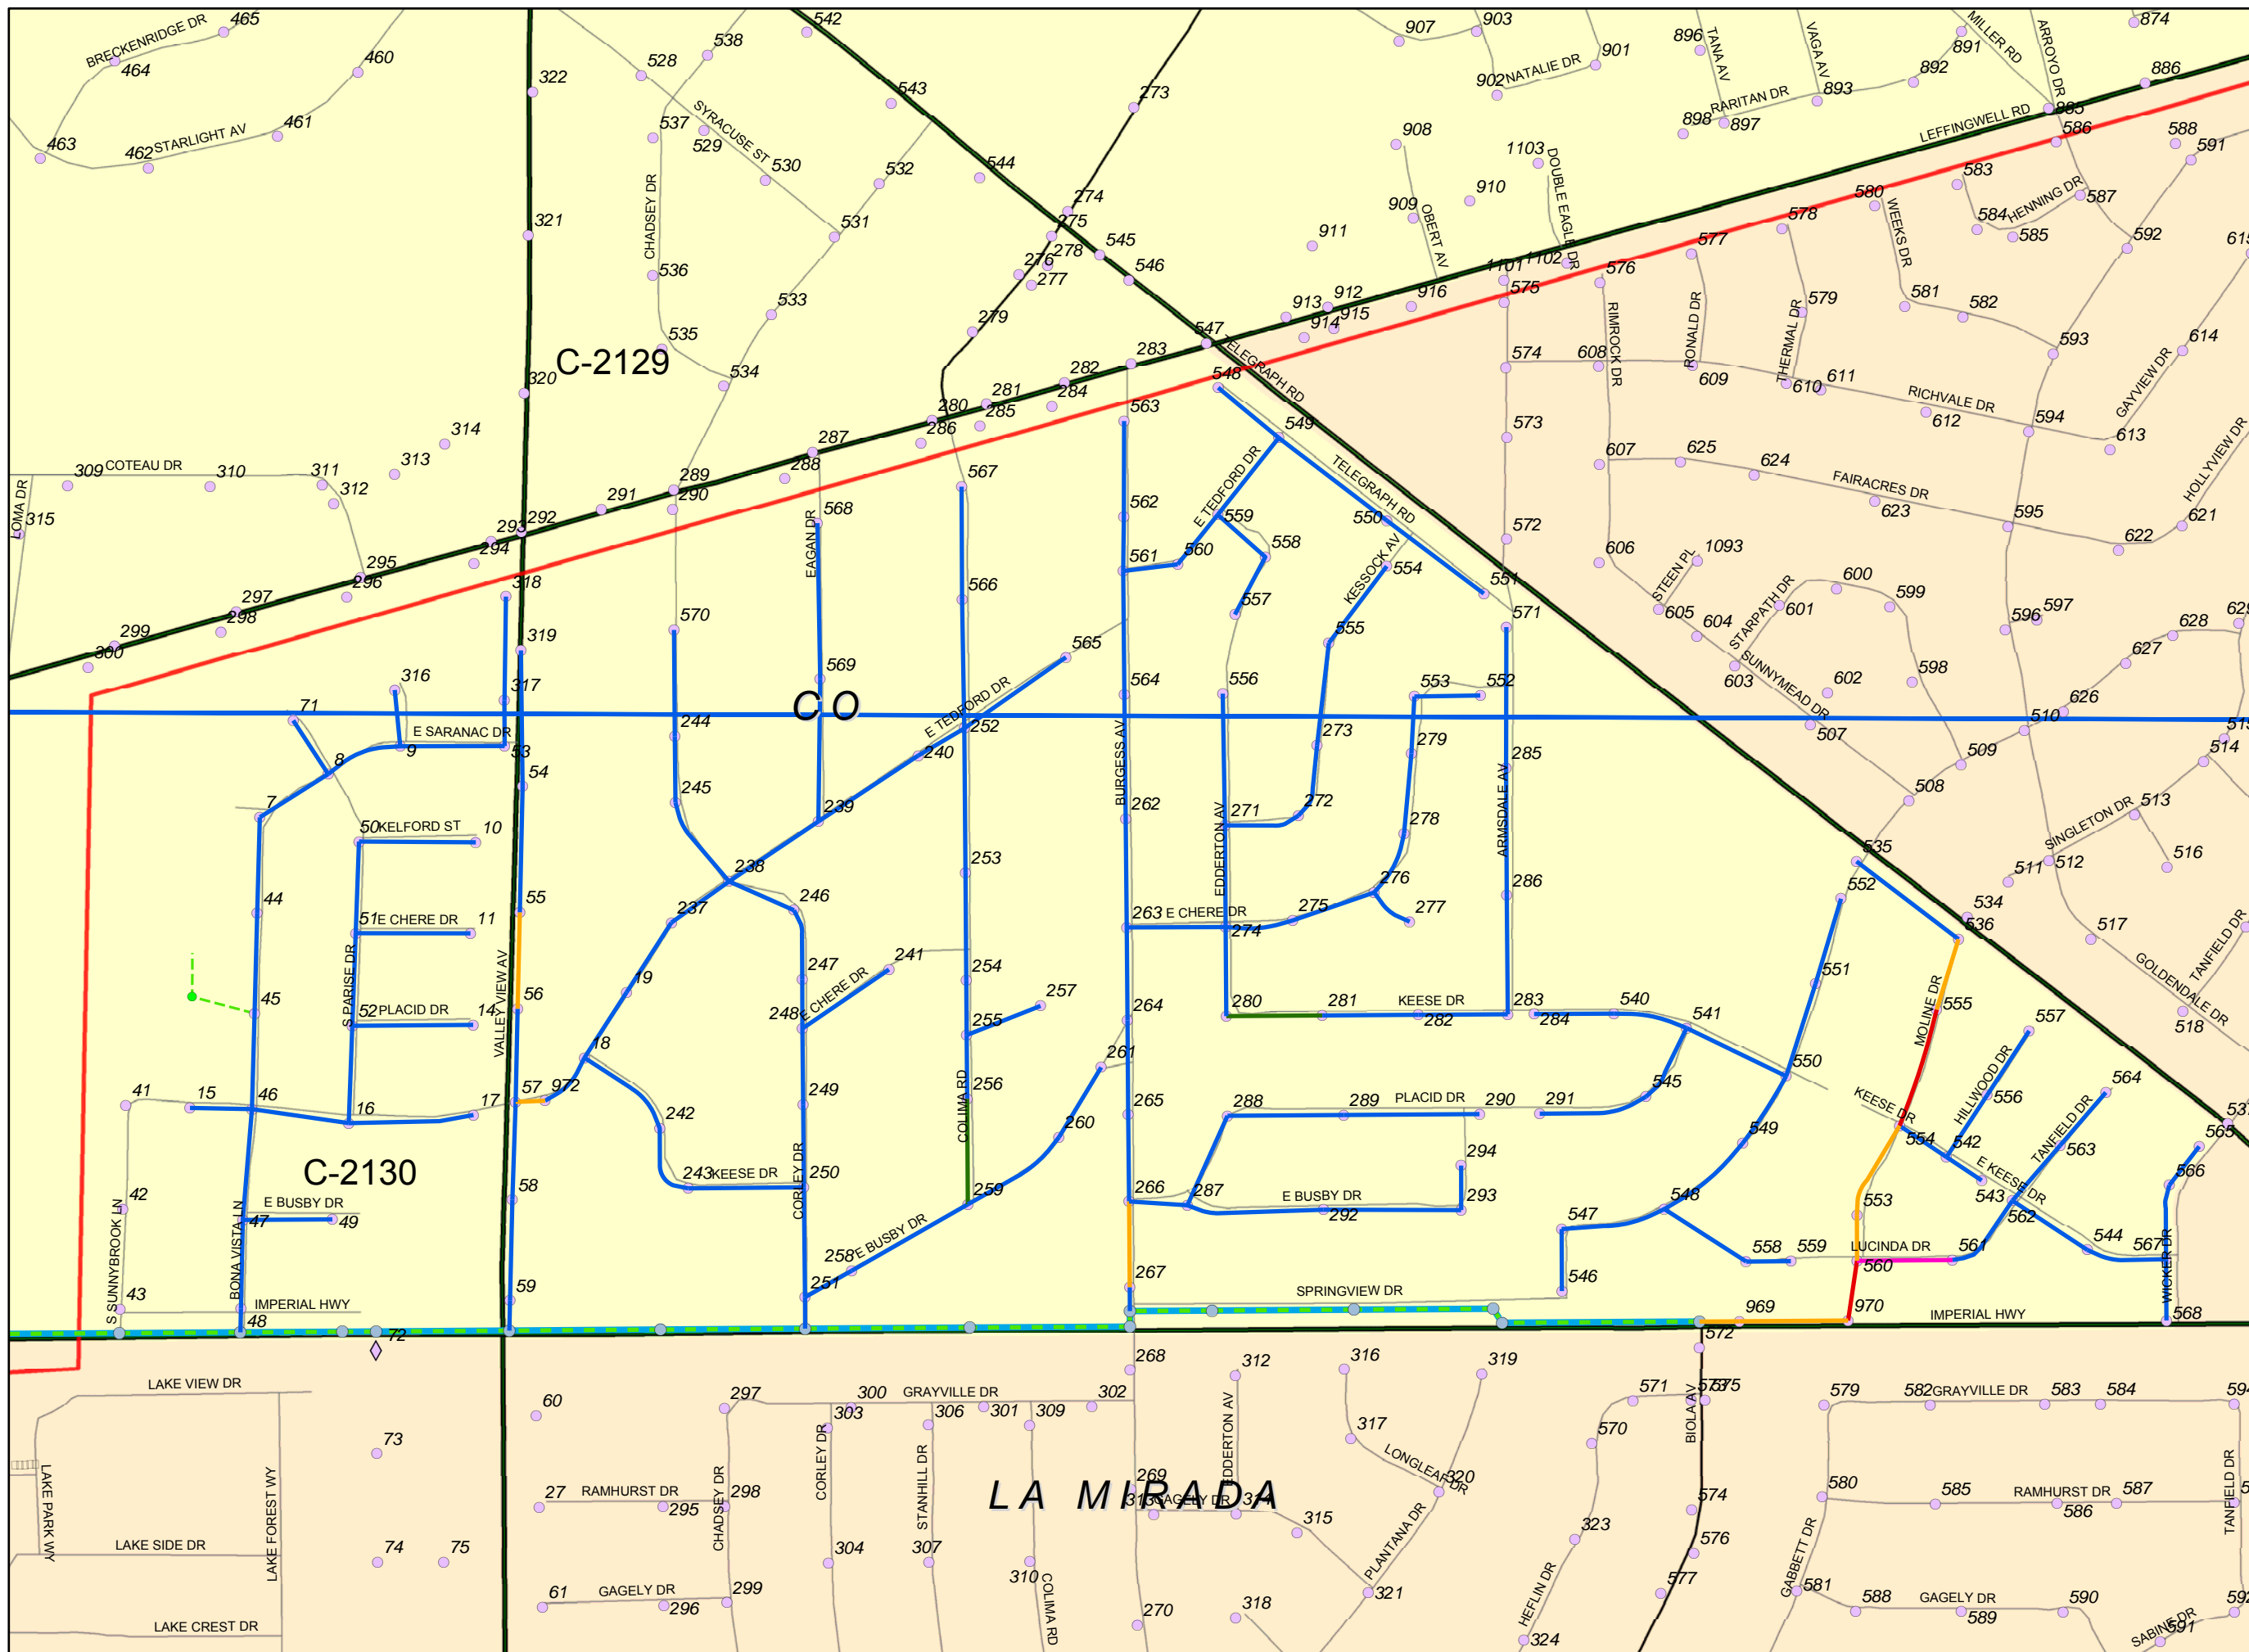
QUICK MAINTENANCE RATING (QMR)

Item No.	QMR	Start MH	End MH	Street	Observation	Corrective Action Taken
1	5231	2130-0560	2130-0970	Easement by MOLINE and LUCINDA	Root; deposit attached grease; root ball lateral; high water mark	Hydrojet (10/08/09) Rodder (05/10/10) Letter to homeowner
2	5121	2130-0555	2130-0554	MOLINE DR	Debris; high water mark; water level	Hydrojet (02/05/10)
3	4122	2130-0561	2130-0560	LUCINDA DR	Deposit attached grease	Hydrojet (01/11/11)

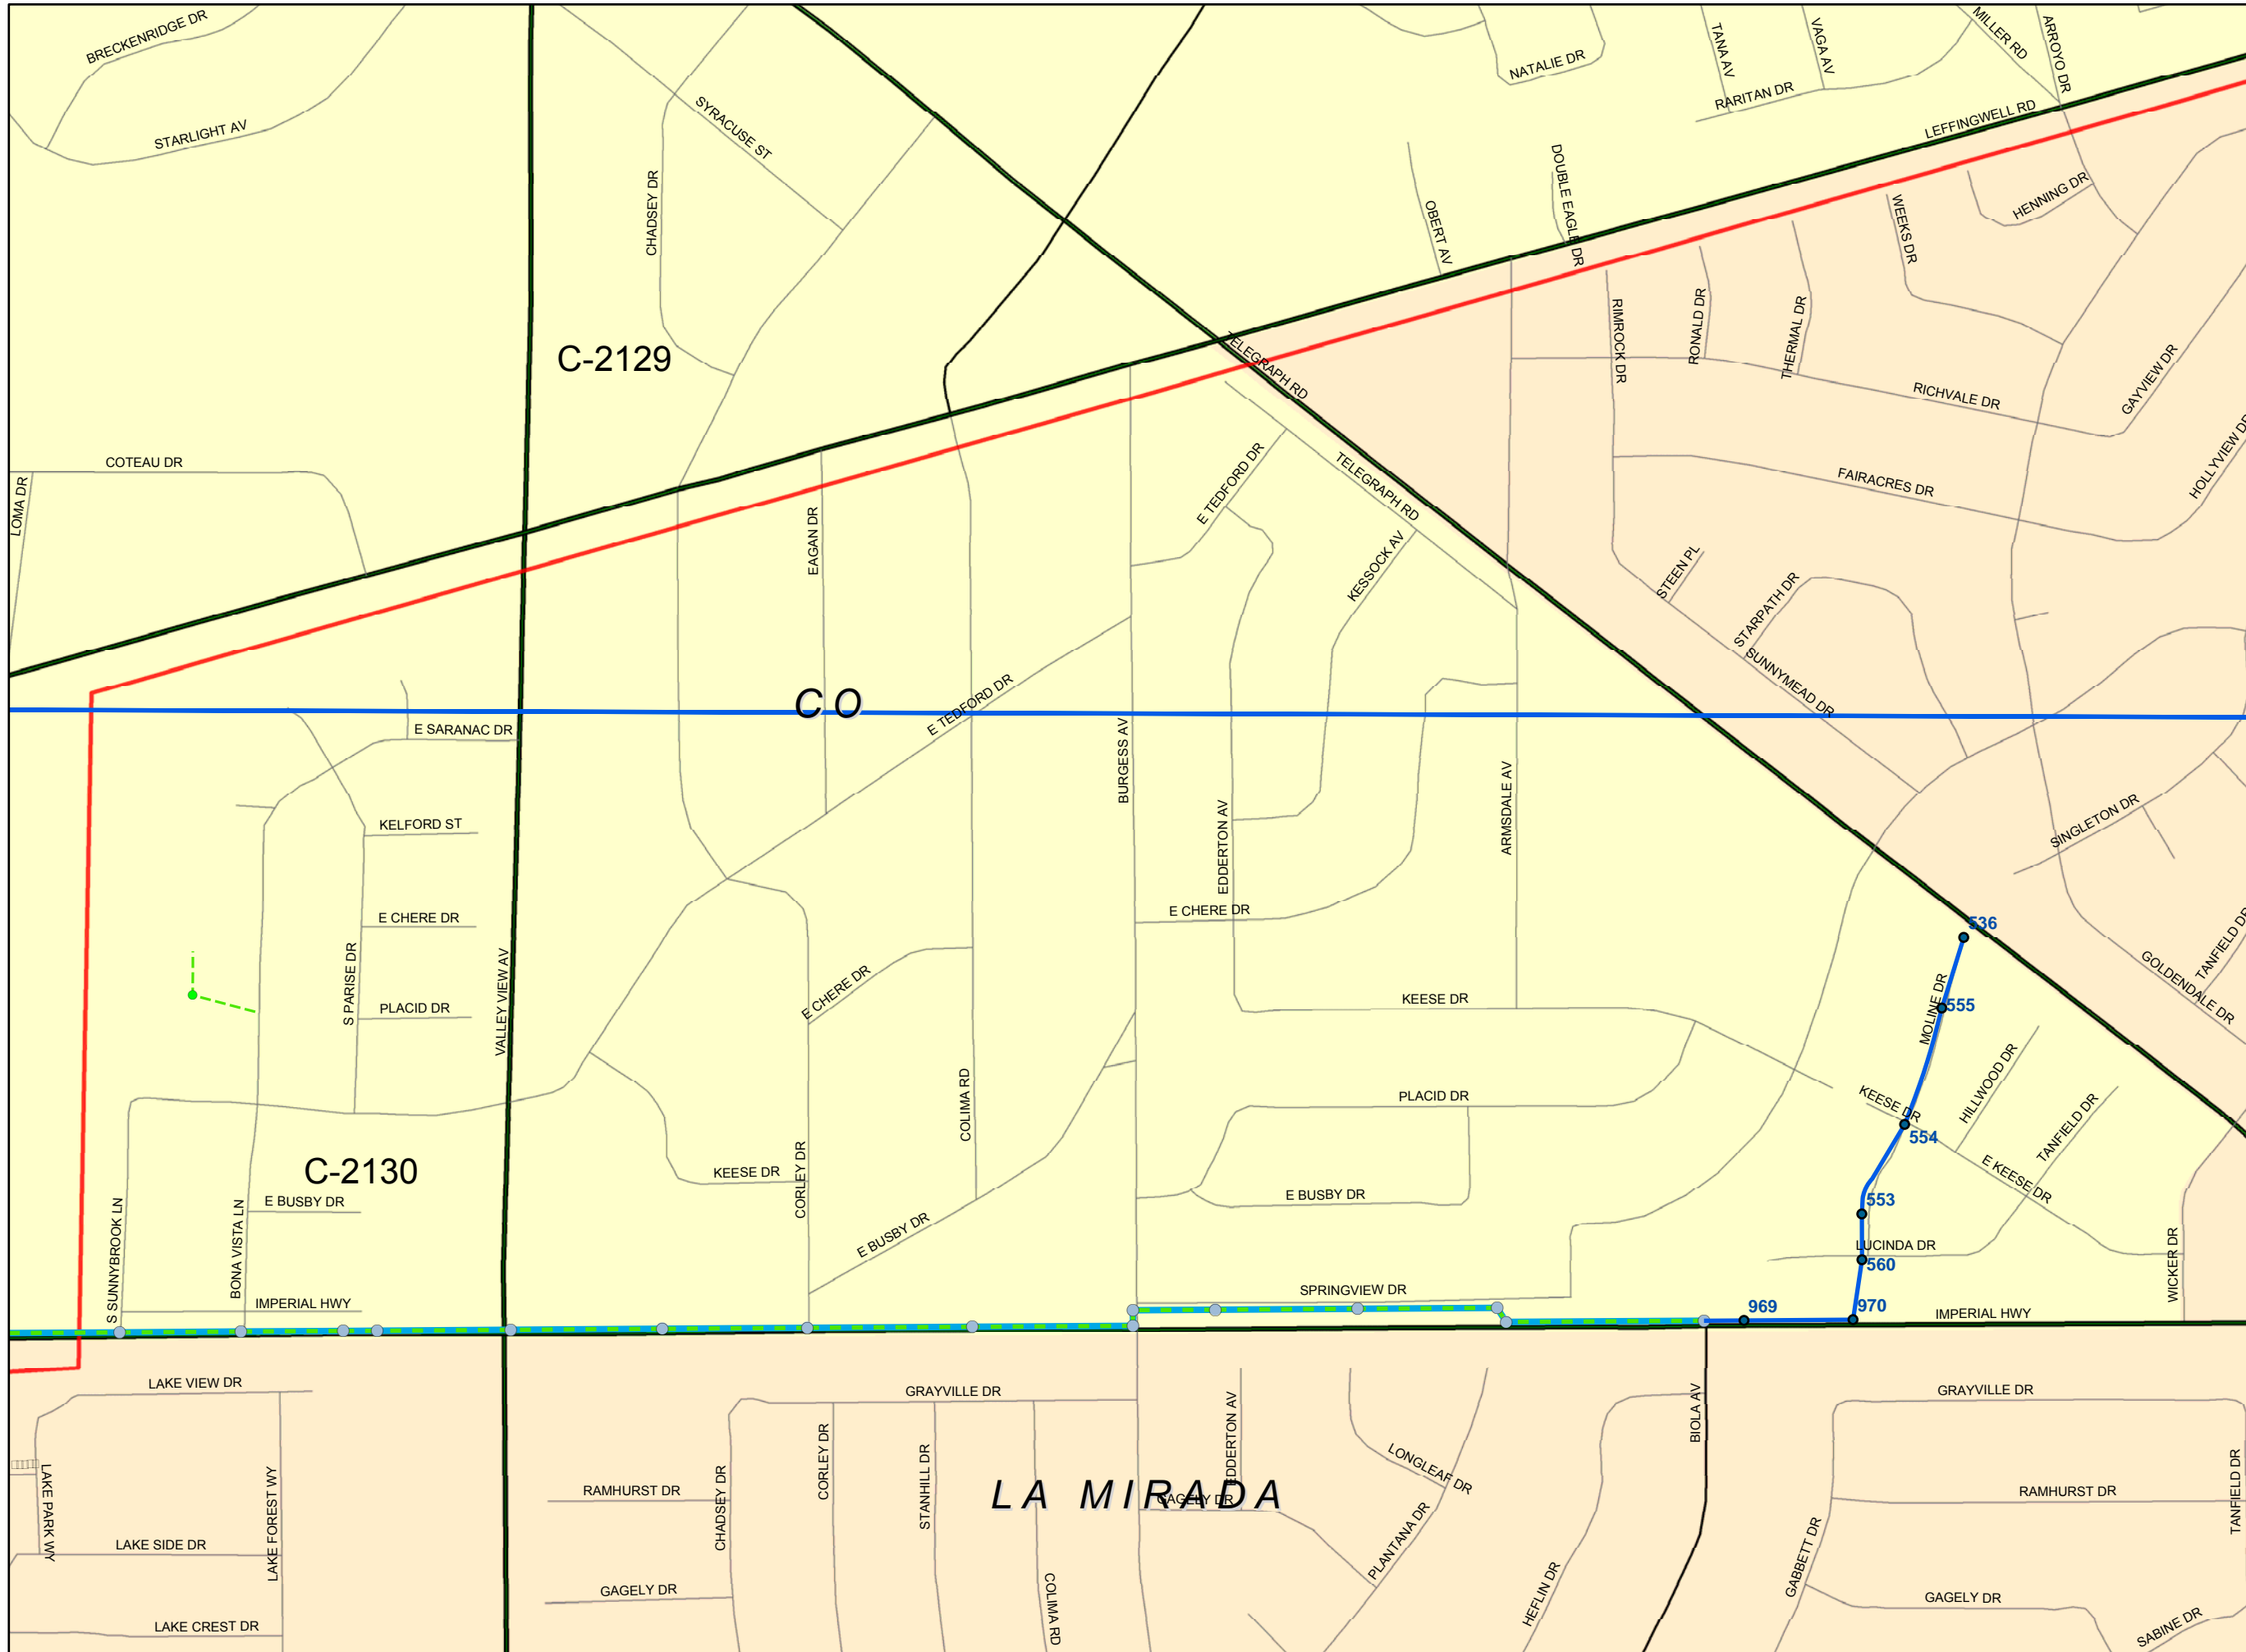
HIGH WATER LEVELS

Item No.	QMR	START MH	END MH	STREET	OBSERVATION		SAG (ft)
1	5231	2130-0560	2130-0970	Easement by MOLINE and LUCINDA	High water mark; high water level	Water mark (50%); water level (40% - 50%): trunk line	
2	5121	2130-0555	2130-0554	MOLINE DR	High water mark; high water level	Water mark (75%); water level (40% - 50%): trunk line	
3	3221	2130-0554	2130-0553	MOLINE DR	High water mark; sag	Water mark (50%); sag (40%): 50' - 180' : trunk line	130
4	3122	2130-0969	2130-TRNK	IMPERIAL HWY	High water mark	Water mark (50%)	
5	3121	2130-0970	2130-0969	IMPERIAL HWY	High water mark	Water mark (50% - 70%)	
6	3121	2130-0553	2130-0560	MOLINE DR	High water level	Manhole full of water: trunk line	
7	3121	2130-0536	2130-0555	MOLINE DR	High water mark; sag	Water mark (50%); sag (40%): 165' - 180' : trunk line	15

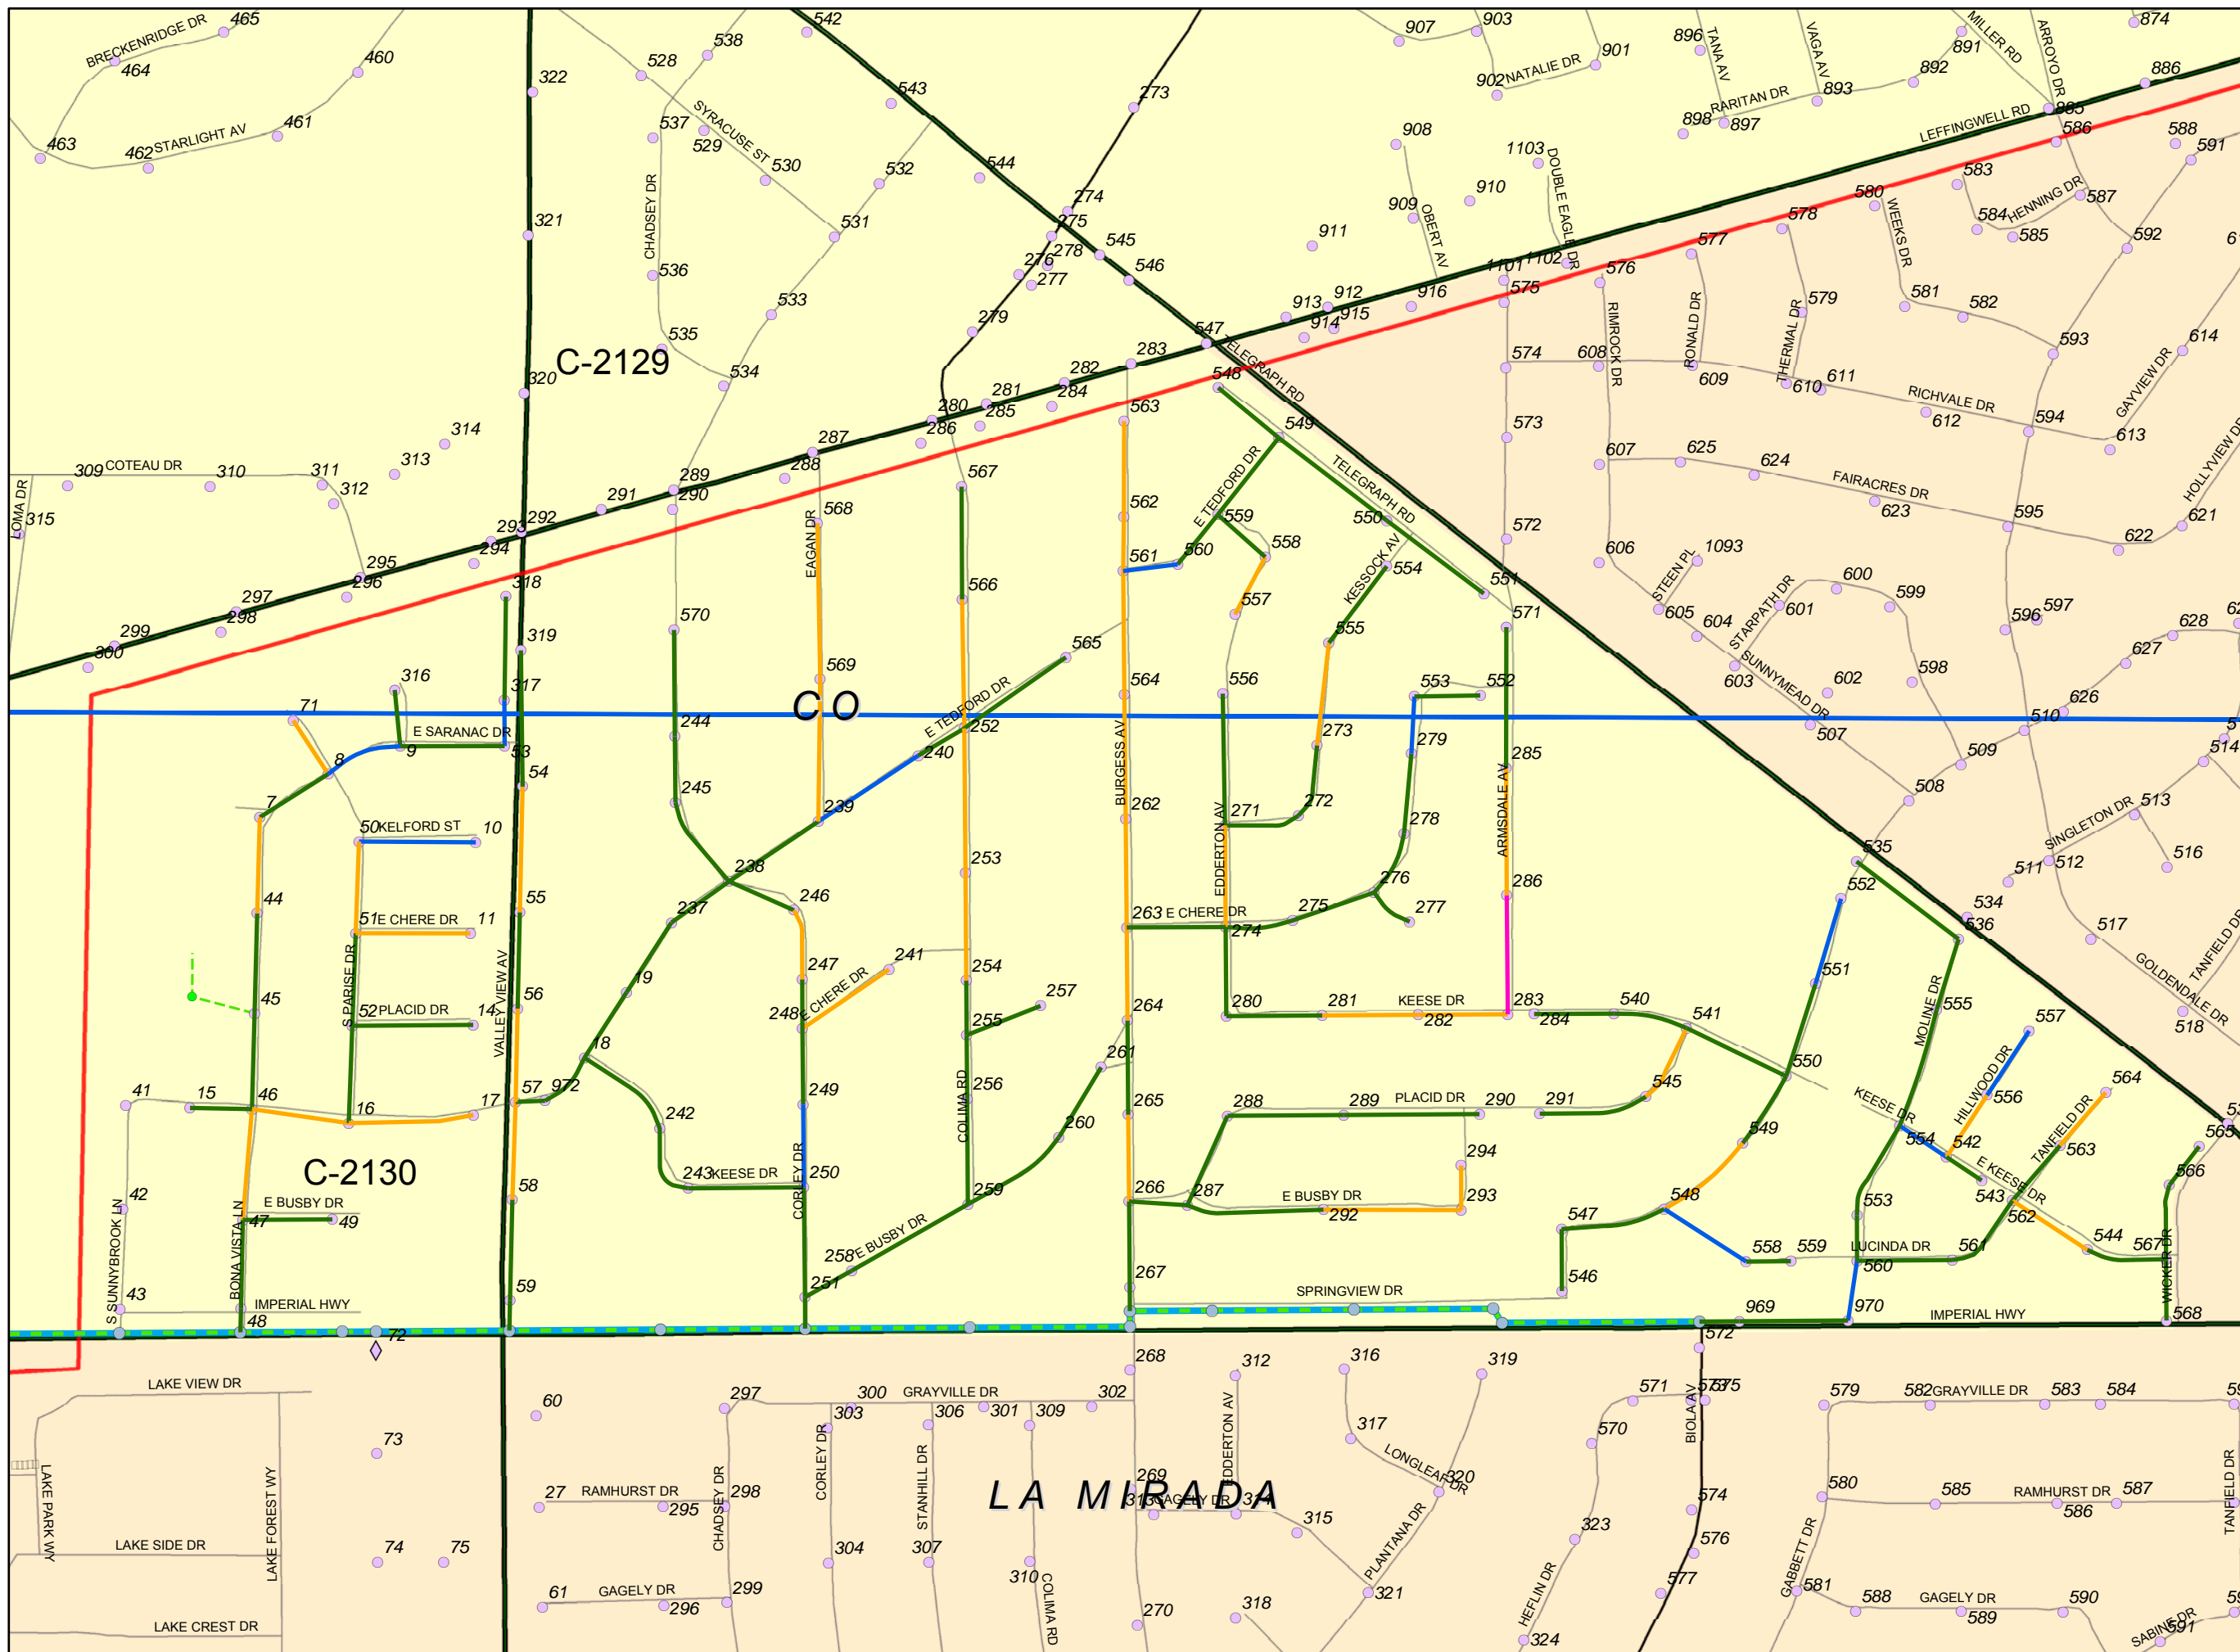
QUICK STRUCTURAL RATING (QSR)

Item No.	QSR	Start MH	End MH	Street	Observation: Location	Proposed Corrective Method	Length of Repair (FT)
1	4136	2130-0286	2130-0283	ARMSDALE AV	Broken (lateral): 79'; broken: 14', 153', 318'; fractures: 242'	Lining: MH to MH	341'
