**CONSOLIDATED SEWER MAINTENANCE DISTRICT
CONDITION ASSESSMENT PROGRAM REPORT
PROJECT Y0TV0506D**

**CONDITION ASSESSMENT REPORT
COUNTY OF LOS ANGELES DEPARTMENT OF PUBLIC WORKS
CONSOLIDATED SEWER MAINTENANCE DISTRICT**

PROJECT NAME:	Y0TV0506D	PROJECT MGR:	Kari Eskridge
PROJECT DATE:	4/17/06-8/14/06	CONTACT NO:	(626) 300-3390
SUP. DISTRICT(S):	5	MAP PAGE(S):	2297, 2298, 2299
Report By:	Phyo Kyaw	Report Date:	03/24/09

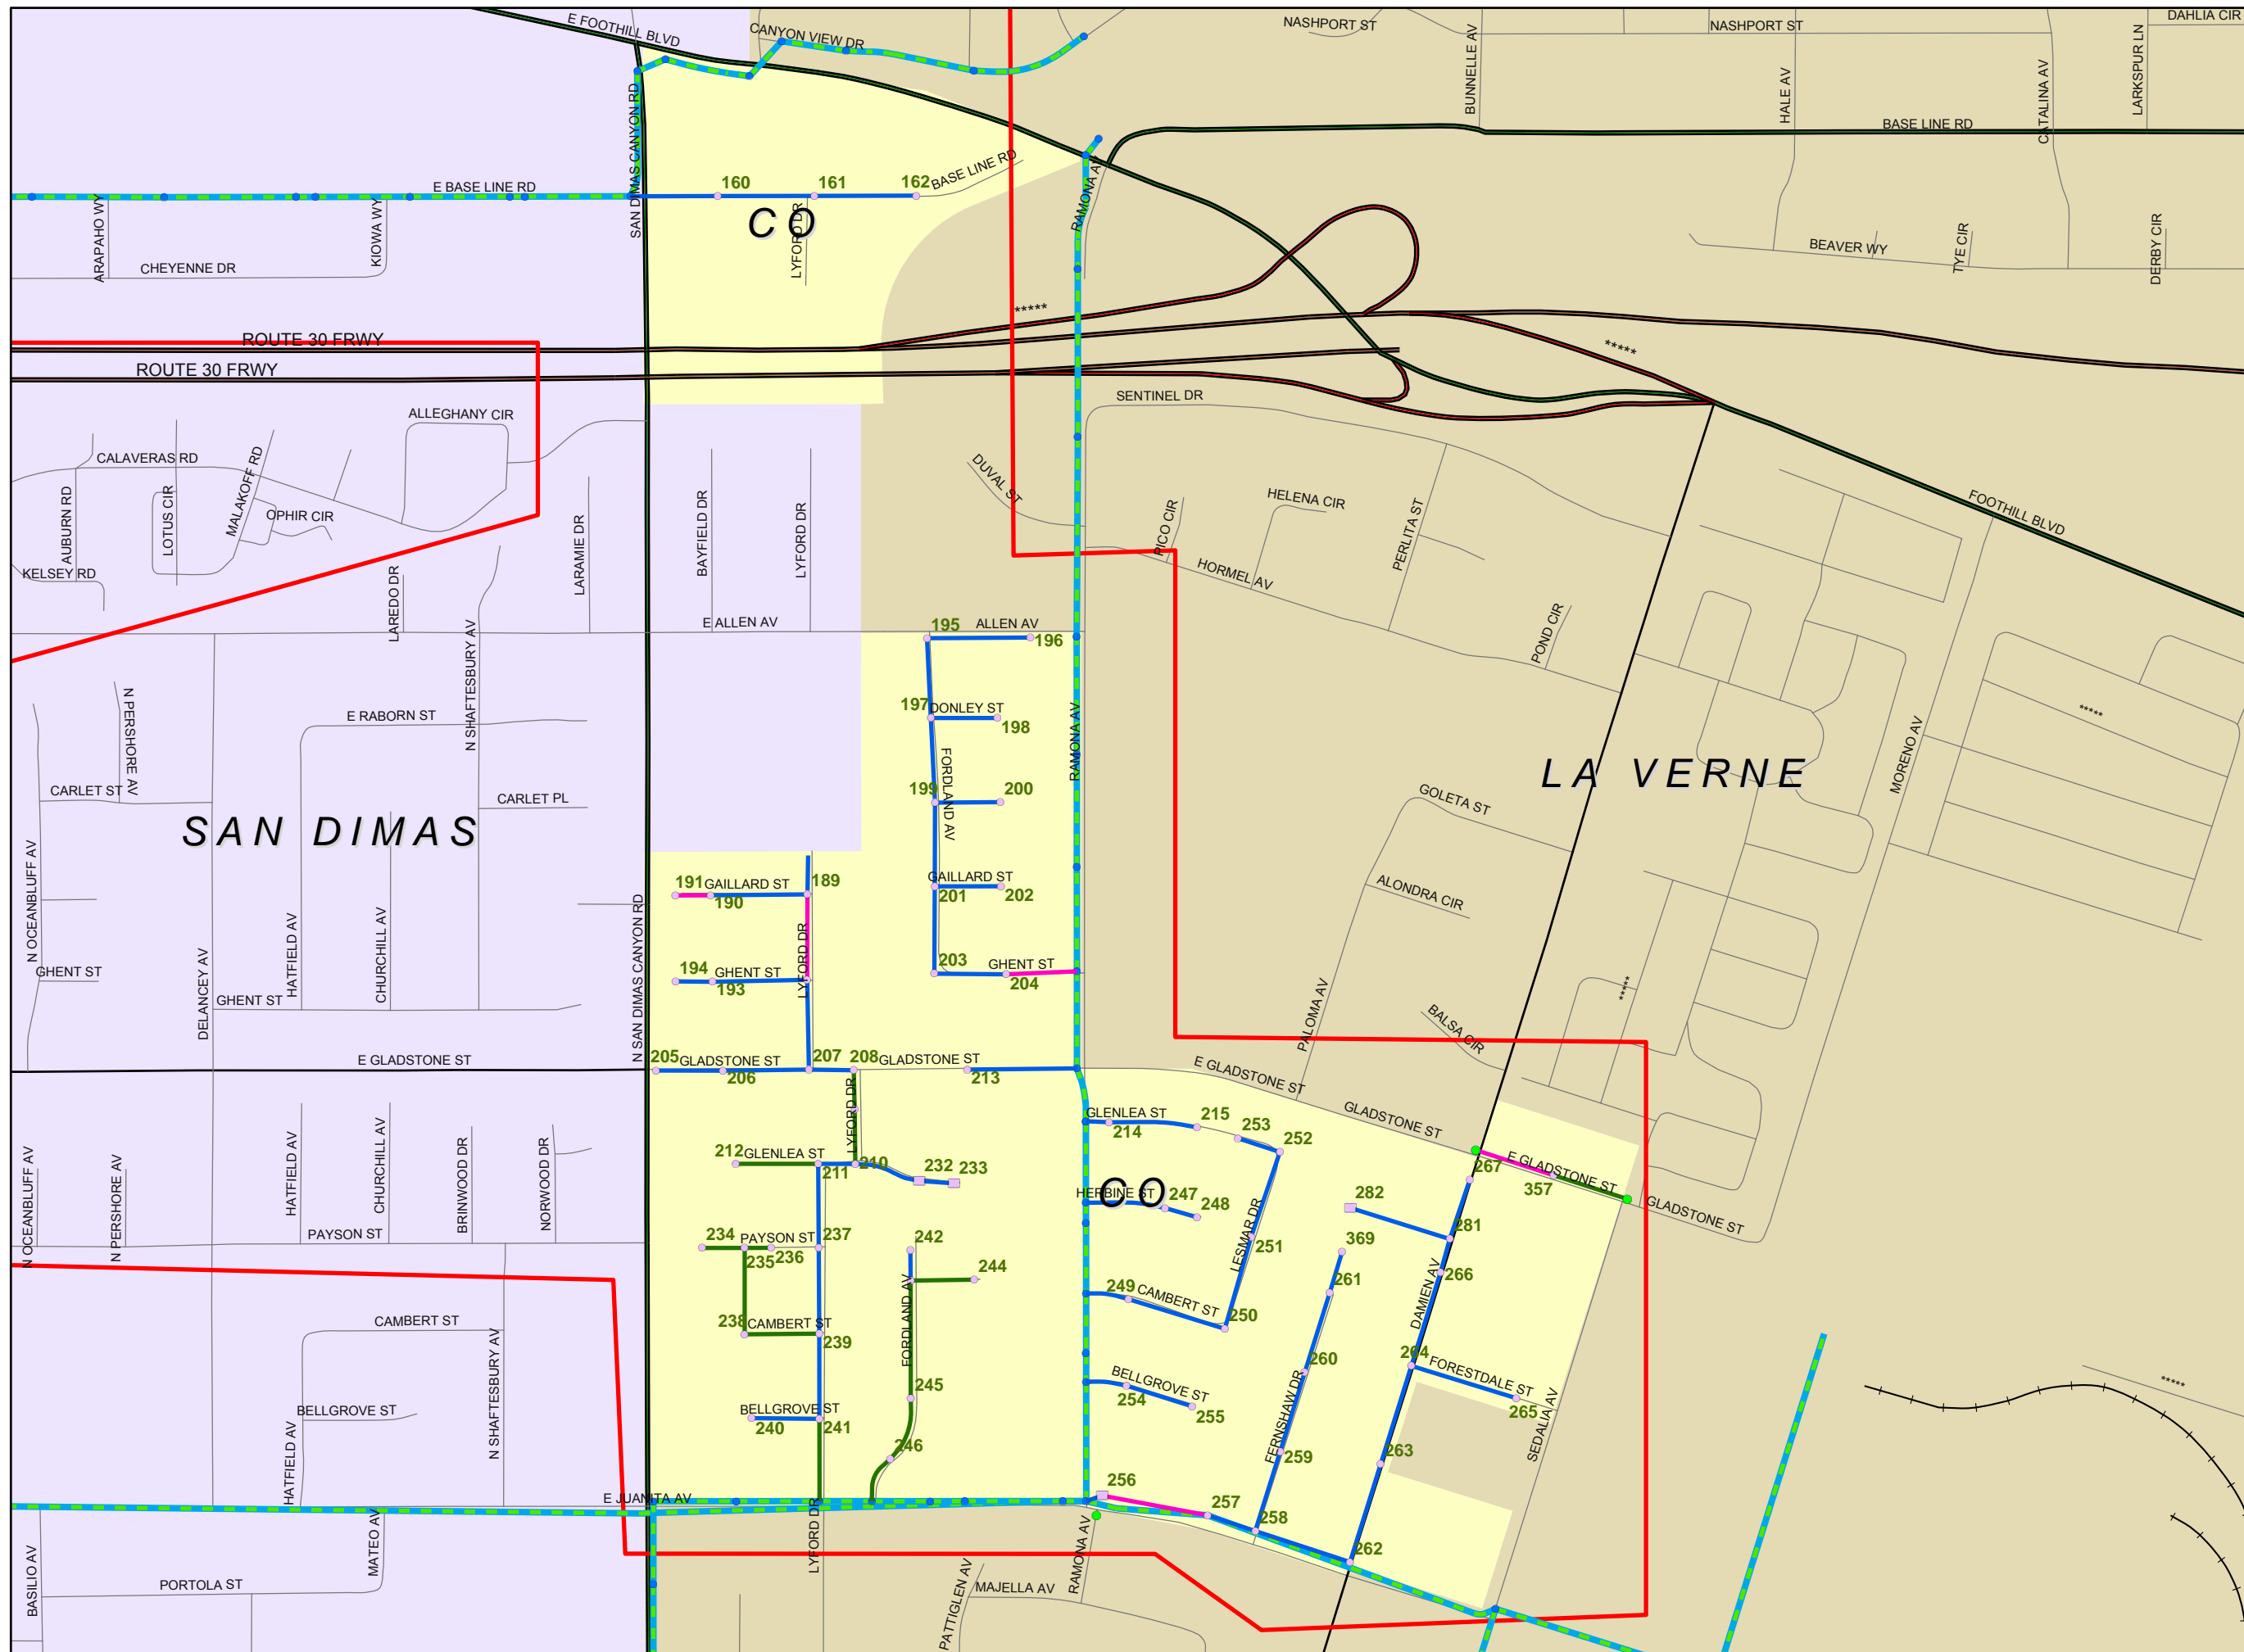
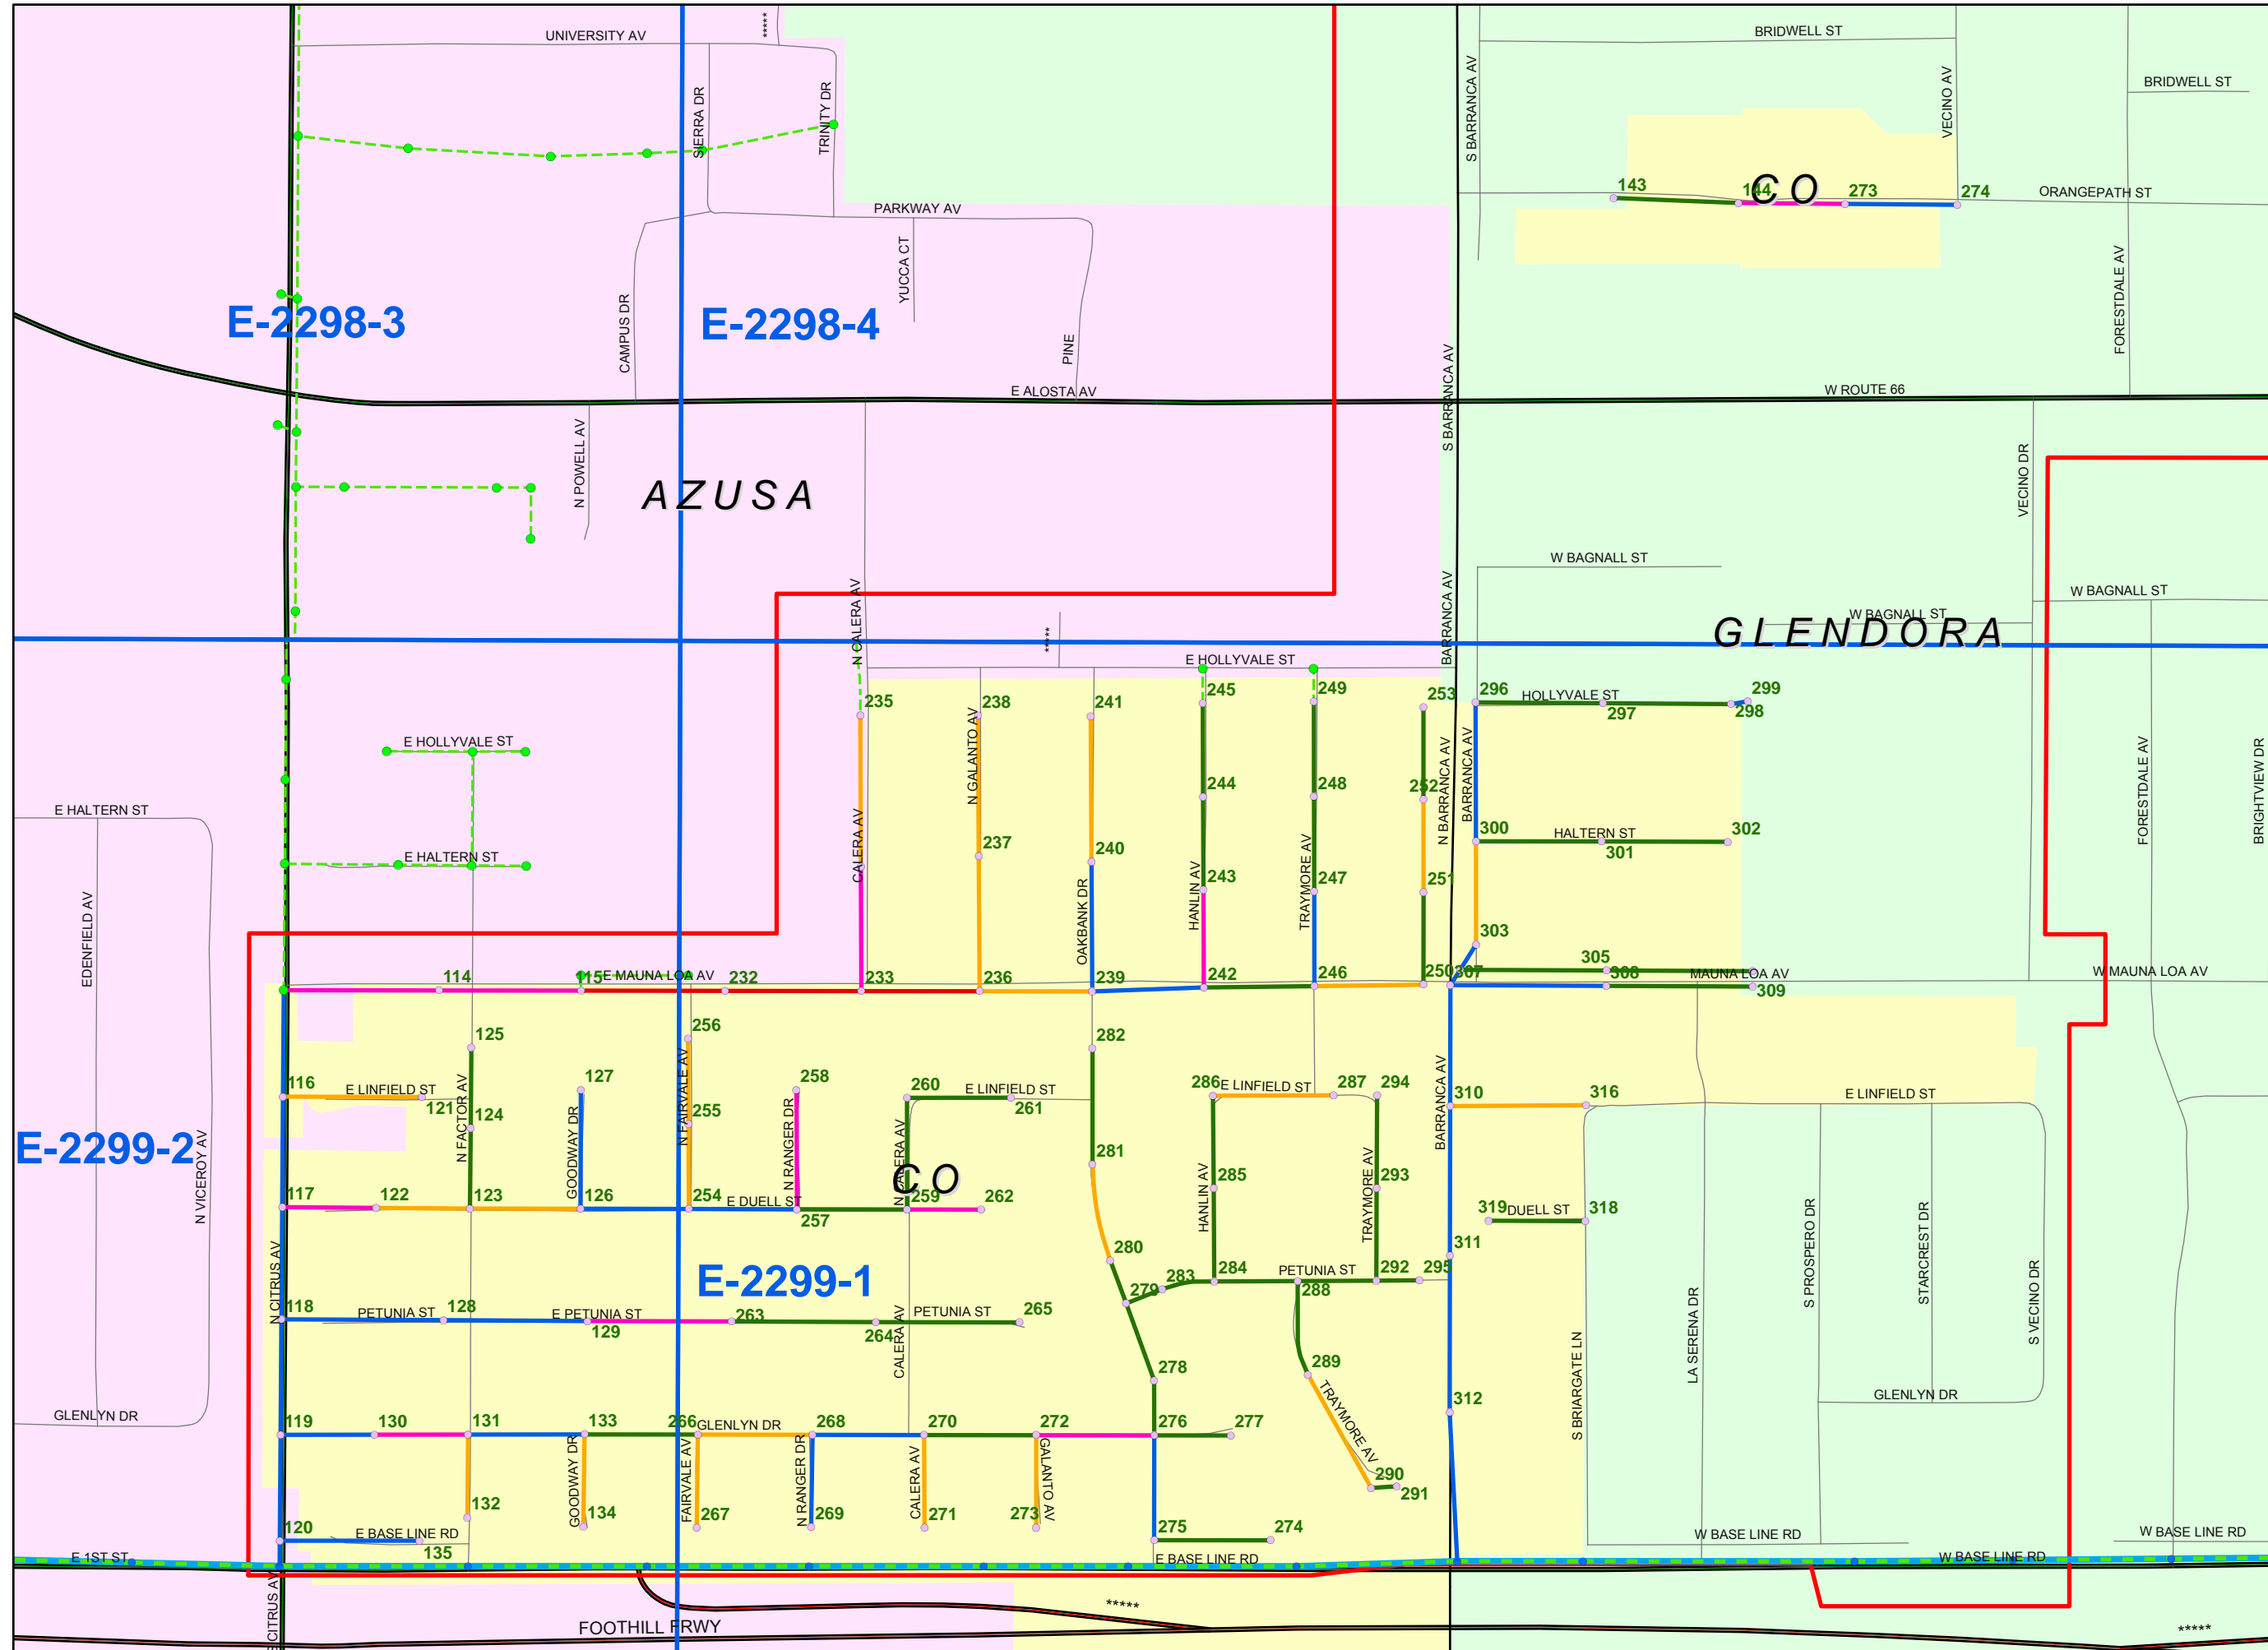
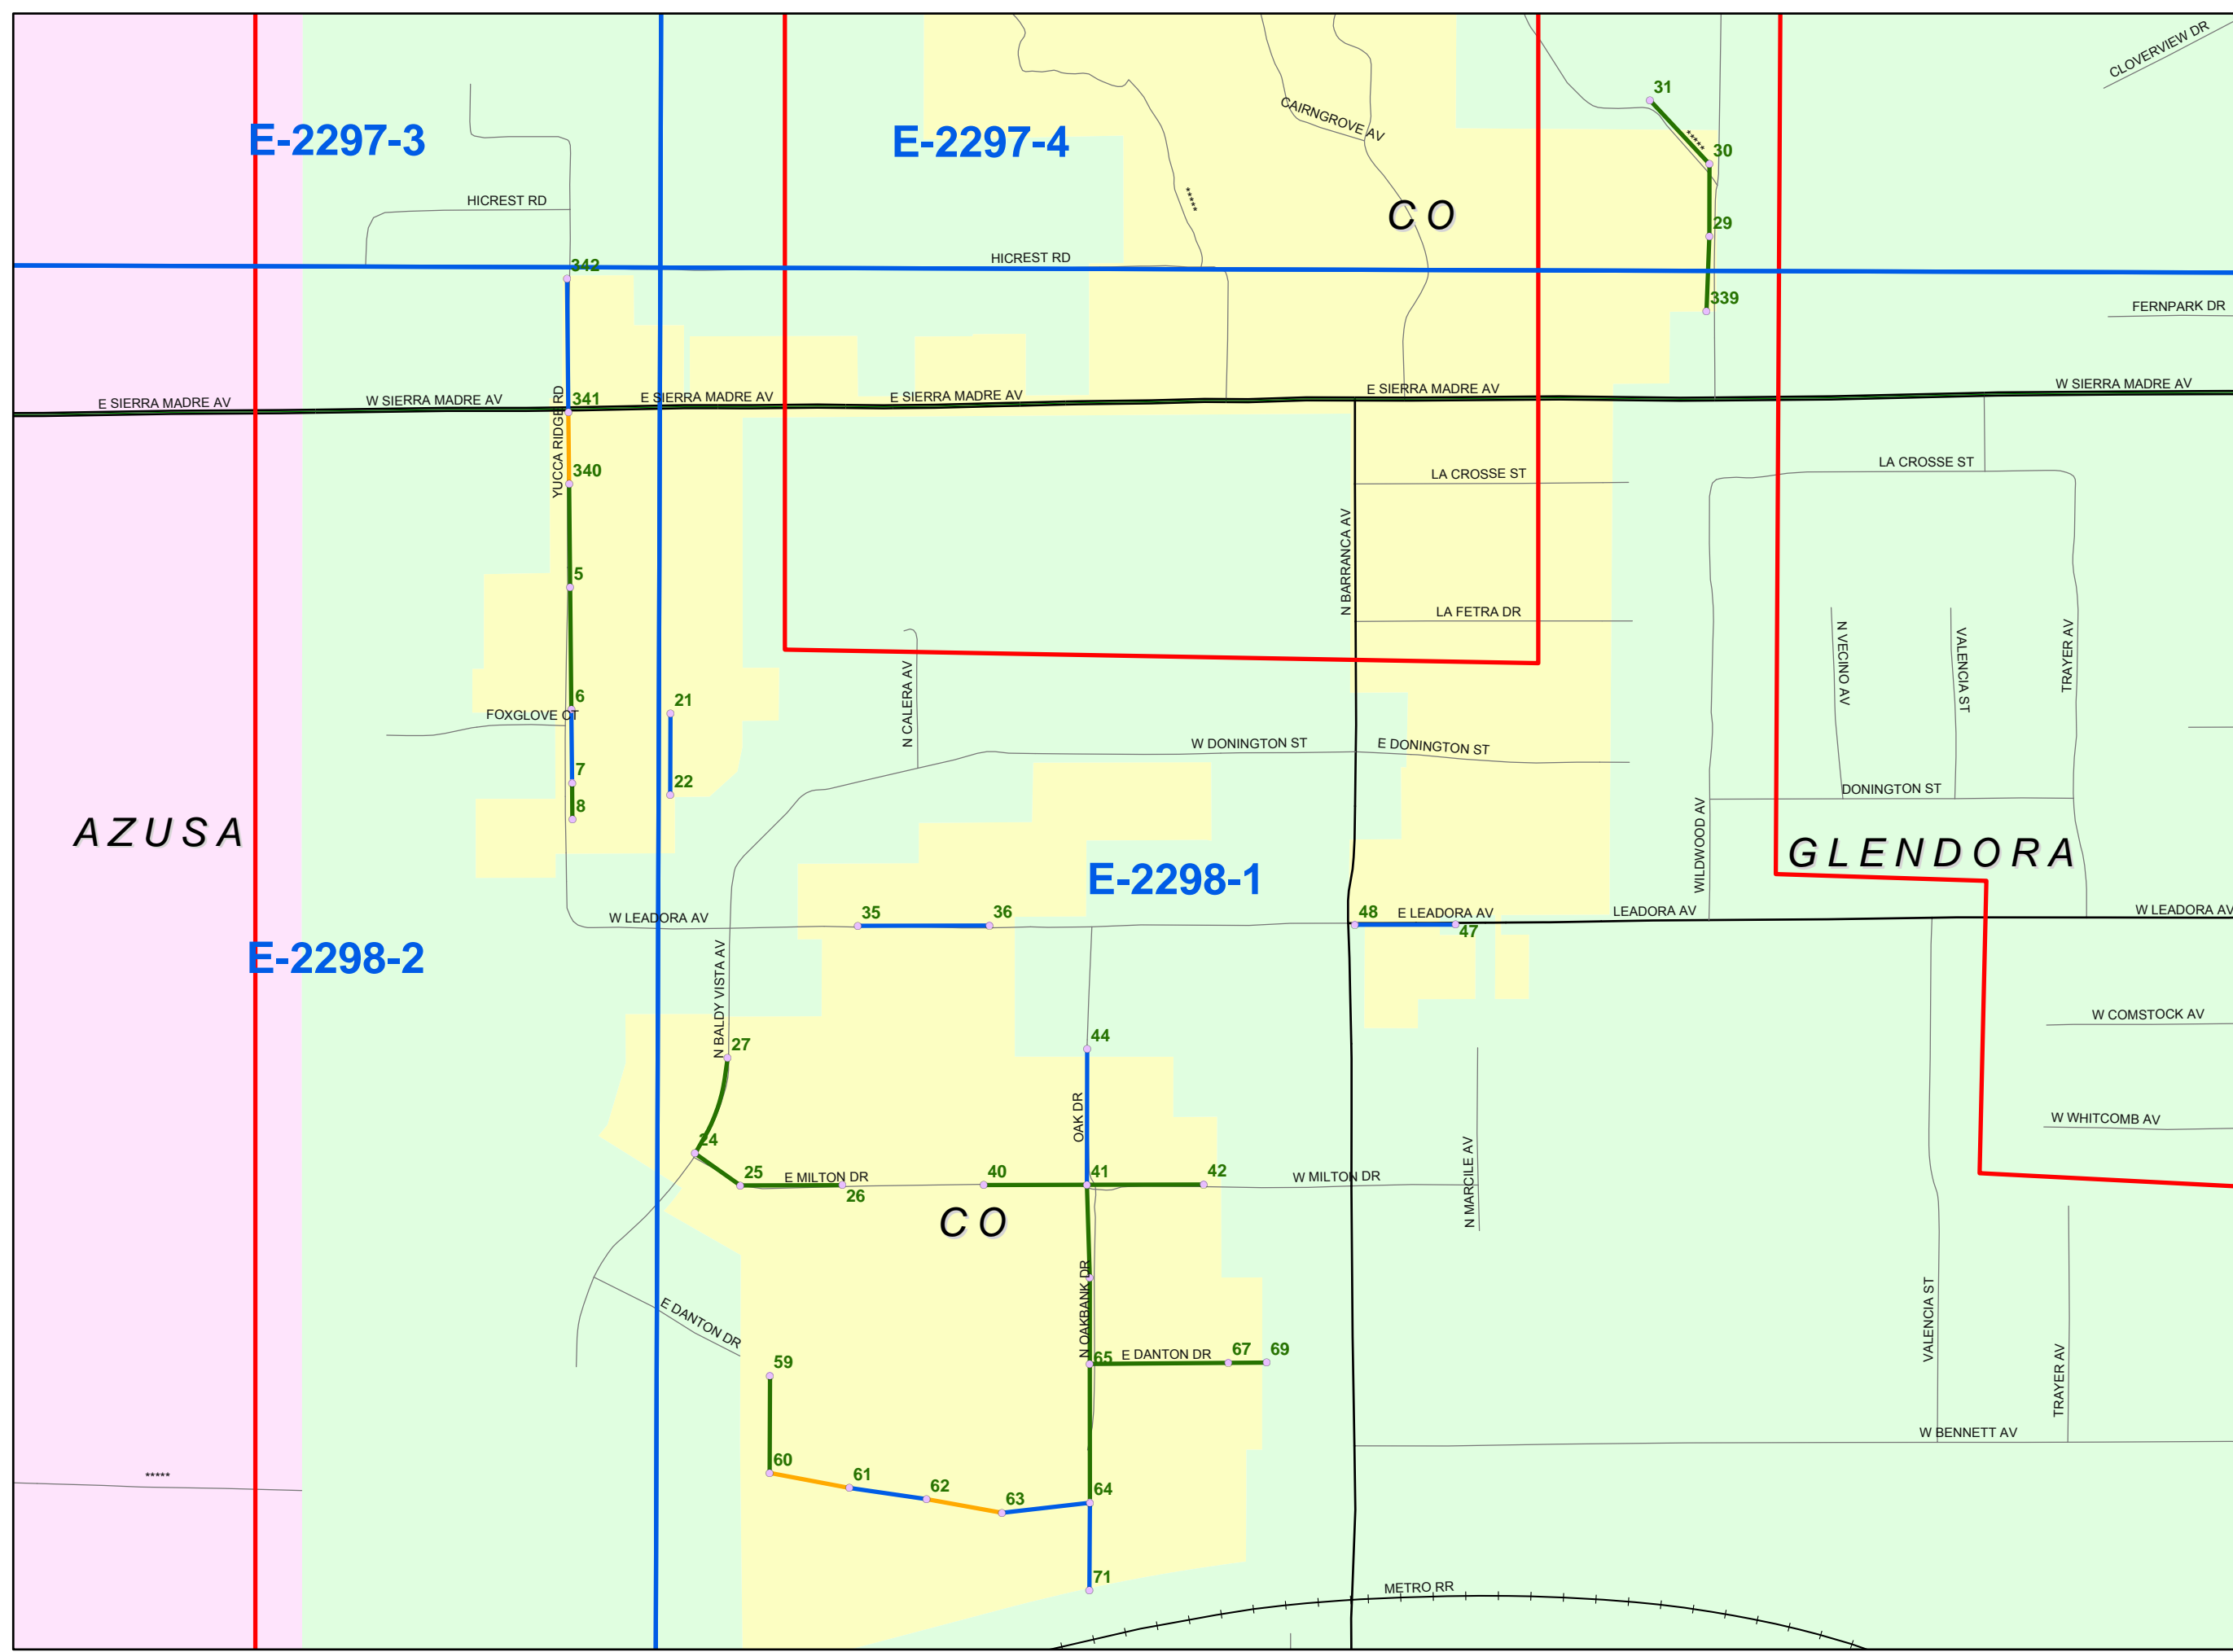
ENCLOSURE 2
 QUICK MAINTENANCE RATING REPORT PRIORITY LIST
 UNINCORPORATED LOS ANGELES COUNTY (Y0TV0506D)
 as of 08/14/06

Item No.	QMR	Start MH	End MH	Street	Observation	Corrective Action Taken
1	5141	2299-0232	2299-0115	MAUNALOA AVE	Roots	Rodder (completed 3/17/09)
2	5131	2299-0233	2299-0232	MAUNALOA AVE	Roots; grease	Rodder (completed 3/17/09)
3	5131	2299-0236	2299-0233	MAUNALOA AVE	Roots	Rodder (completed 3/17/09)
4	4231	2299-0276	2299-0272	GLENLYN DR	Roots	Rodder (completed 8/11/08)
5	4221	2299-0114	2299-CITY	MAUNALOA AVE	Roots	Rodder (completed 3/17/09)
6	4221	2428-0357	2428-CITYW	GLADSTONE ST	High water level	Hydrojet (completed 7/31/08)
7	4200	2428-0191	2428-0190	GAILLARD ST	Roots	Rodder (completed 7/23/08)
8	4132	2299-0243	2299-0242	HANLIN AVE	Roots	Rodder (completed 7/30/08)
9	4131	2299-0131	2299-0130	GLENLYN DR	Roots	Rodder (completed 7/30/08)
10	4131	2299-0258	2299-0257	RANGER DR	Roots	Rodder (completed 8/7/08)
11	4131	2298-0273	2298-0144	ORANGEPATH ST	Roots	Rodder (completed 3/17/09)
12	4131	2299-0115	2299-0114	MAUNALOA AVE	Roots	Rodder (completed 3/17/09)

13	4131	2299-0262	2299-0259	DUELL ST	Roots	Rodder (completed 3/17/09)
14	4123	2299-0234	2299-0233	CALERA AVE	Roots	Rodder (completed 7/30/08)
15	4122	2299-0263	2299-0129	PETUNIA ST	Roots	Rodder (completed 8/11/08)
16	4122	2299-0122	2299-0117	DUELL ST	Roots; obstacle	Rodder (completed 3/17/09)
17	4121	2428-0204	2428-TRNK	GHENT ST	Camera underwater	Hydrojet (completed 3/17/09)
18	4121	2428-0189	2428-0192	LYFORD DR	Roots	Rodder (completed 7/23/08)
19	4121	2428-0257	2428-0256	JUANITA ST	Roots	Rodder (completed 7/24/08)

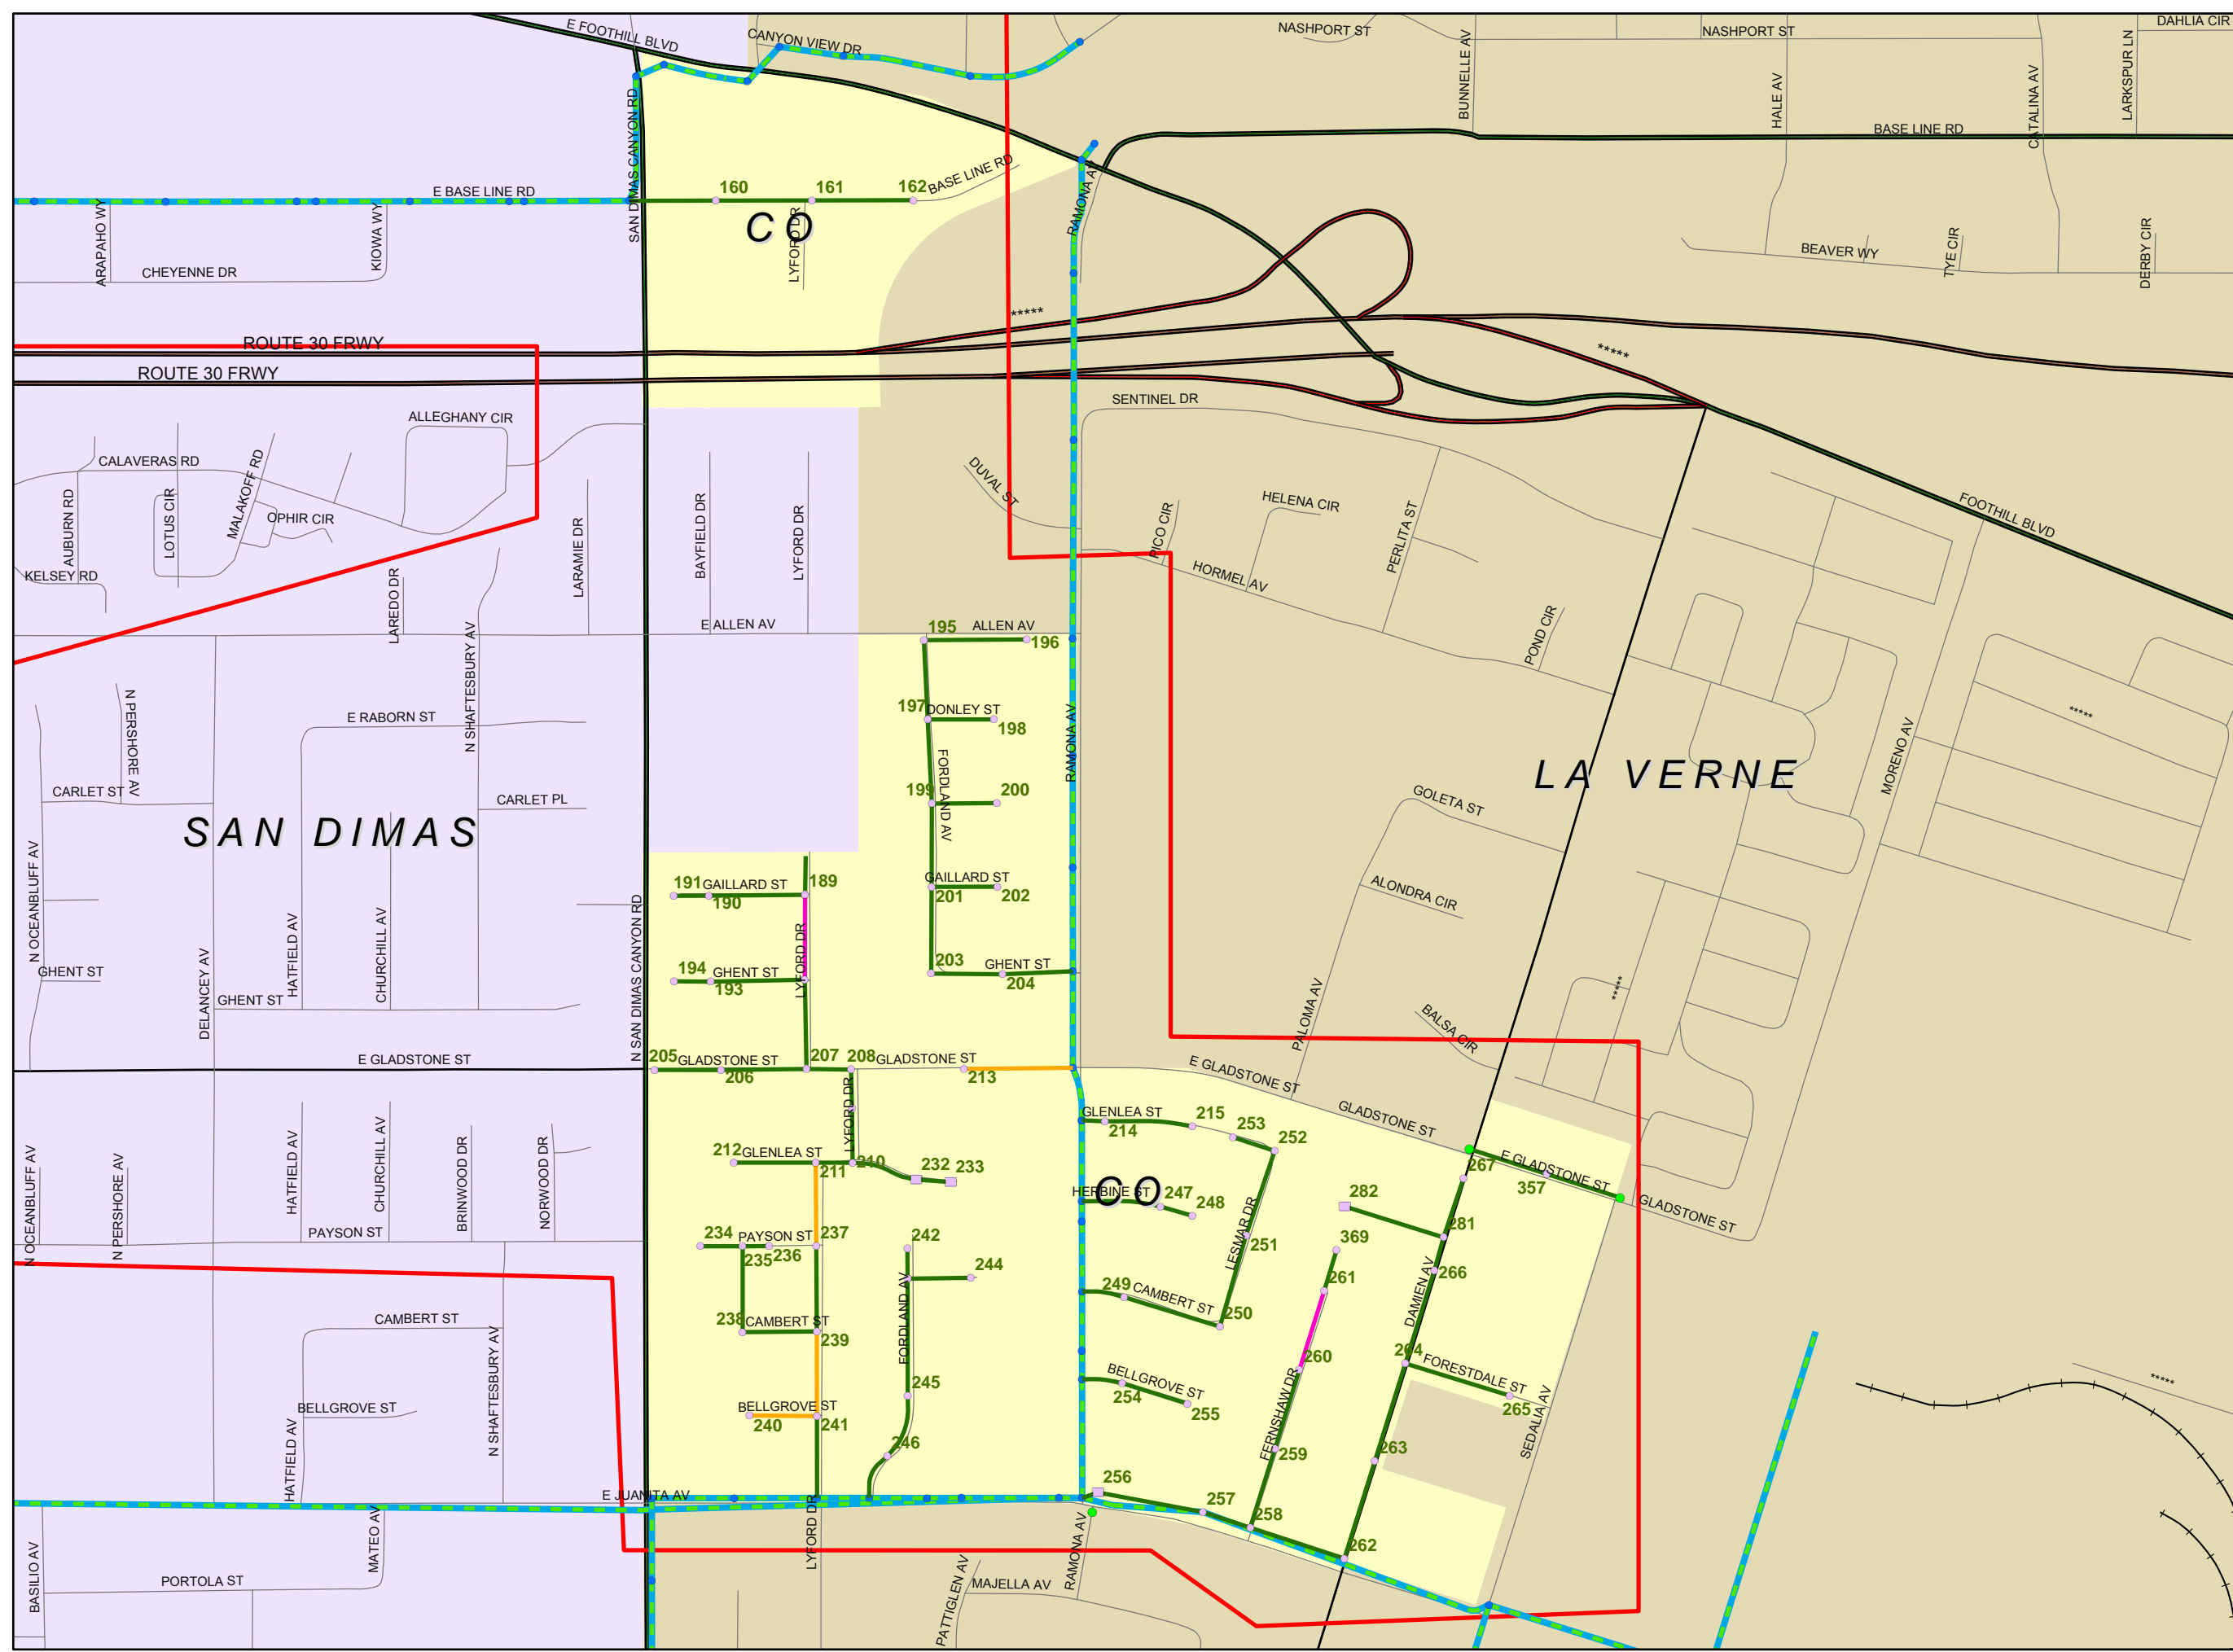
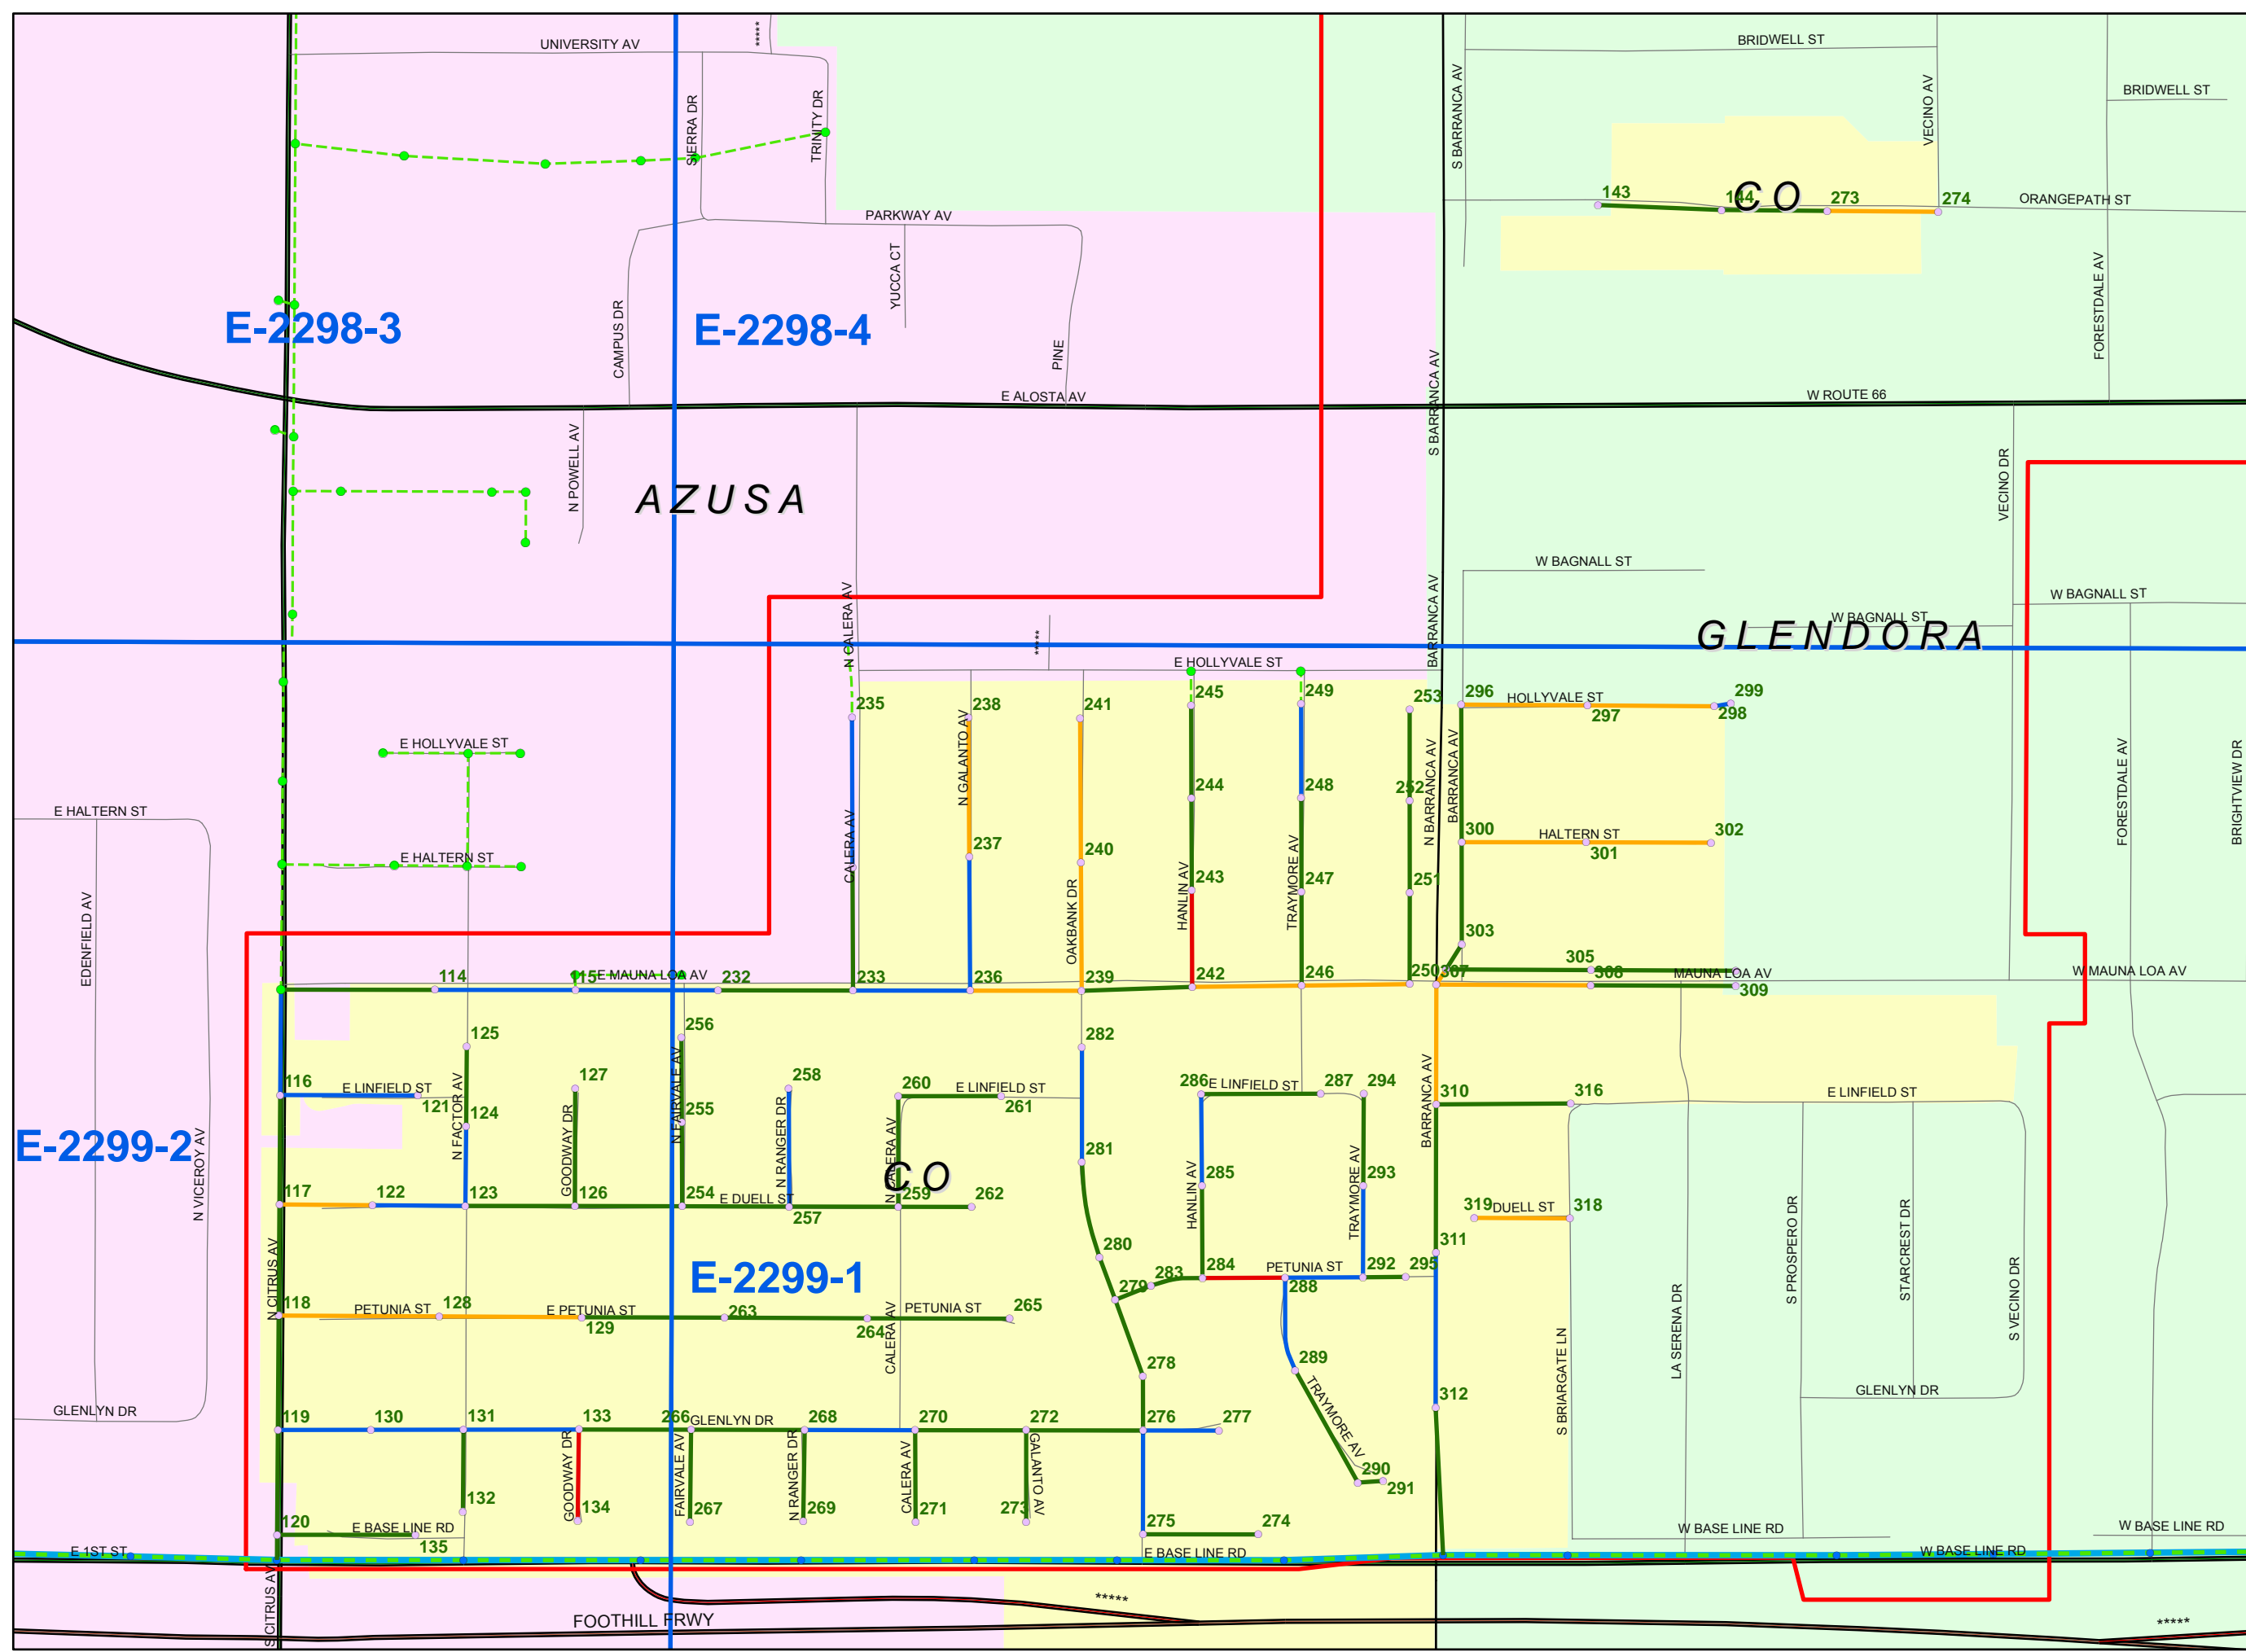
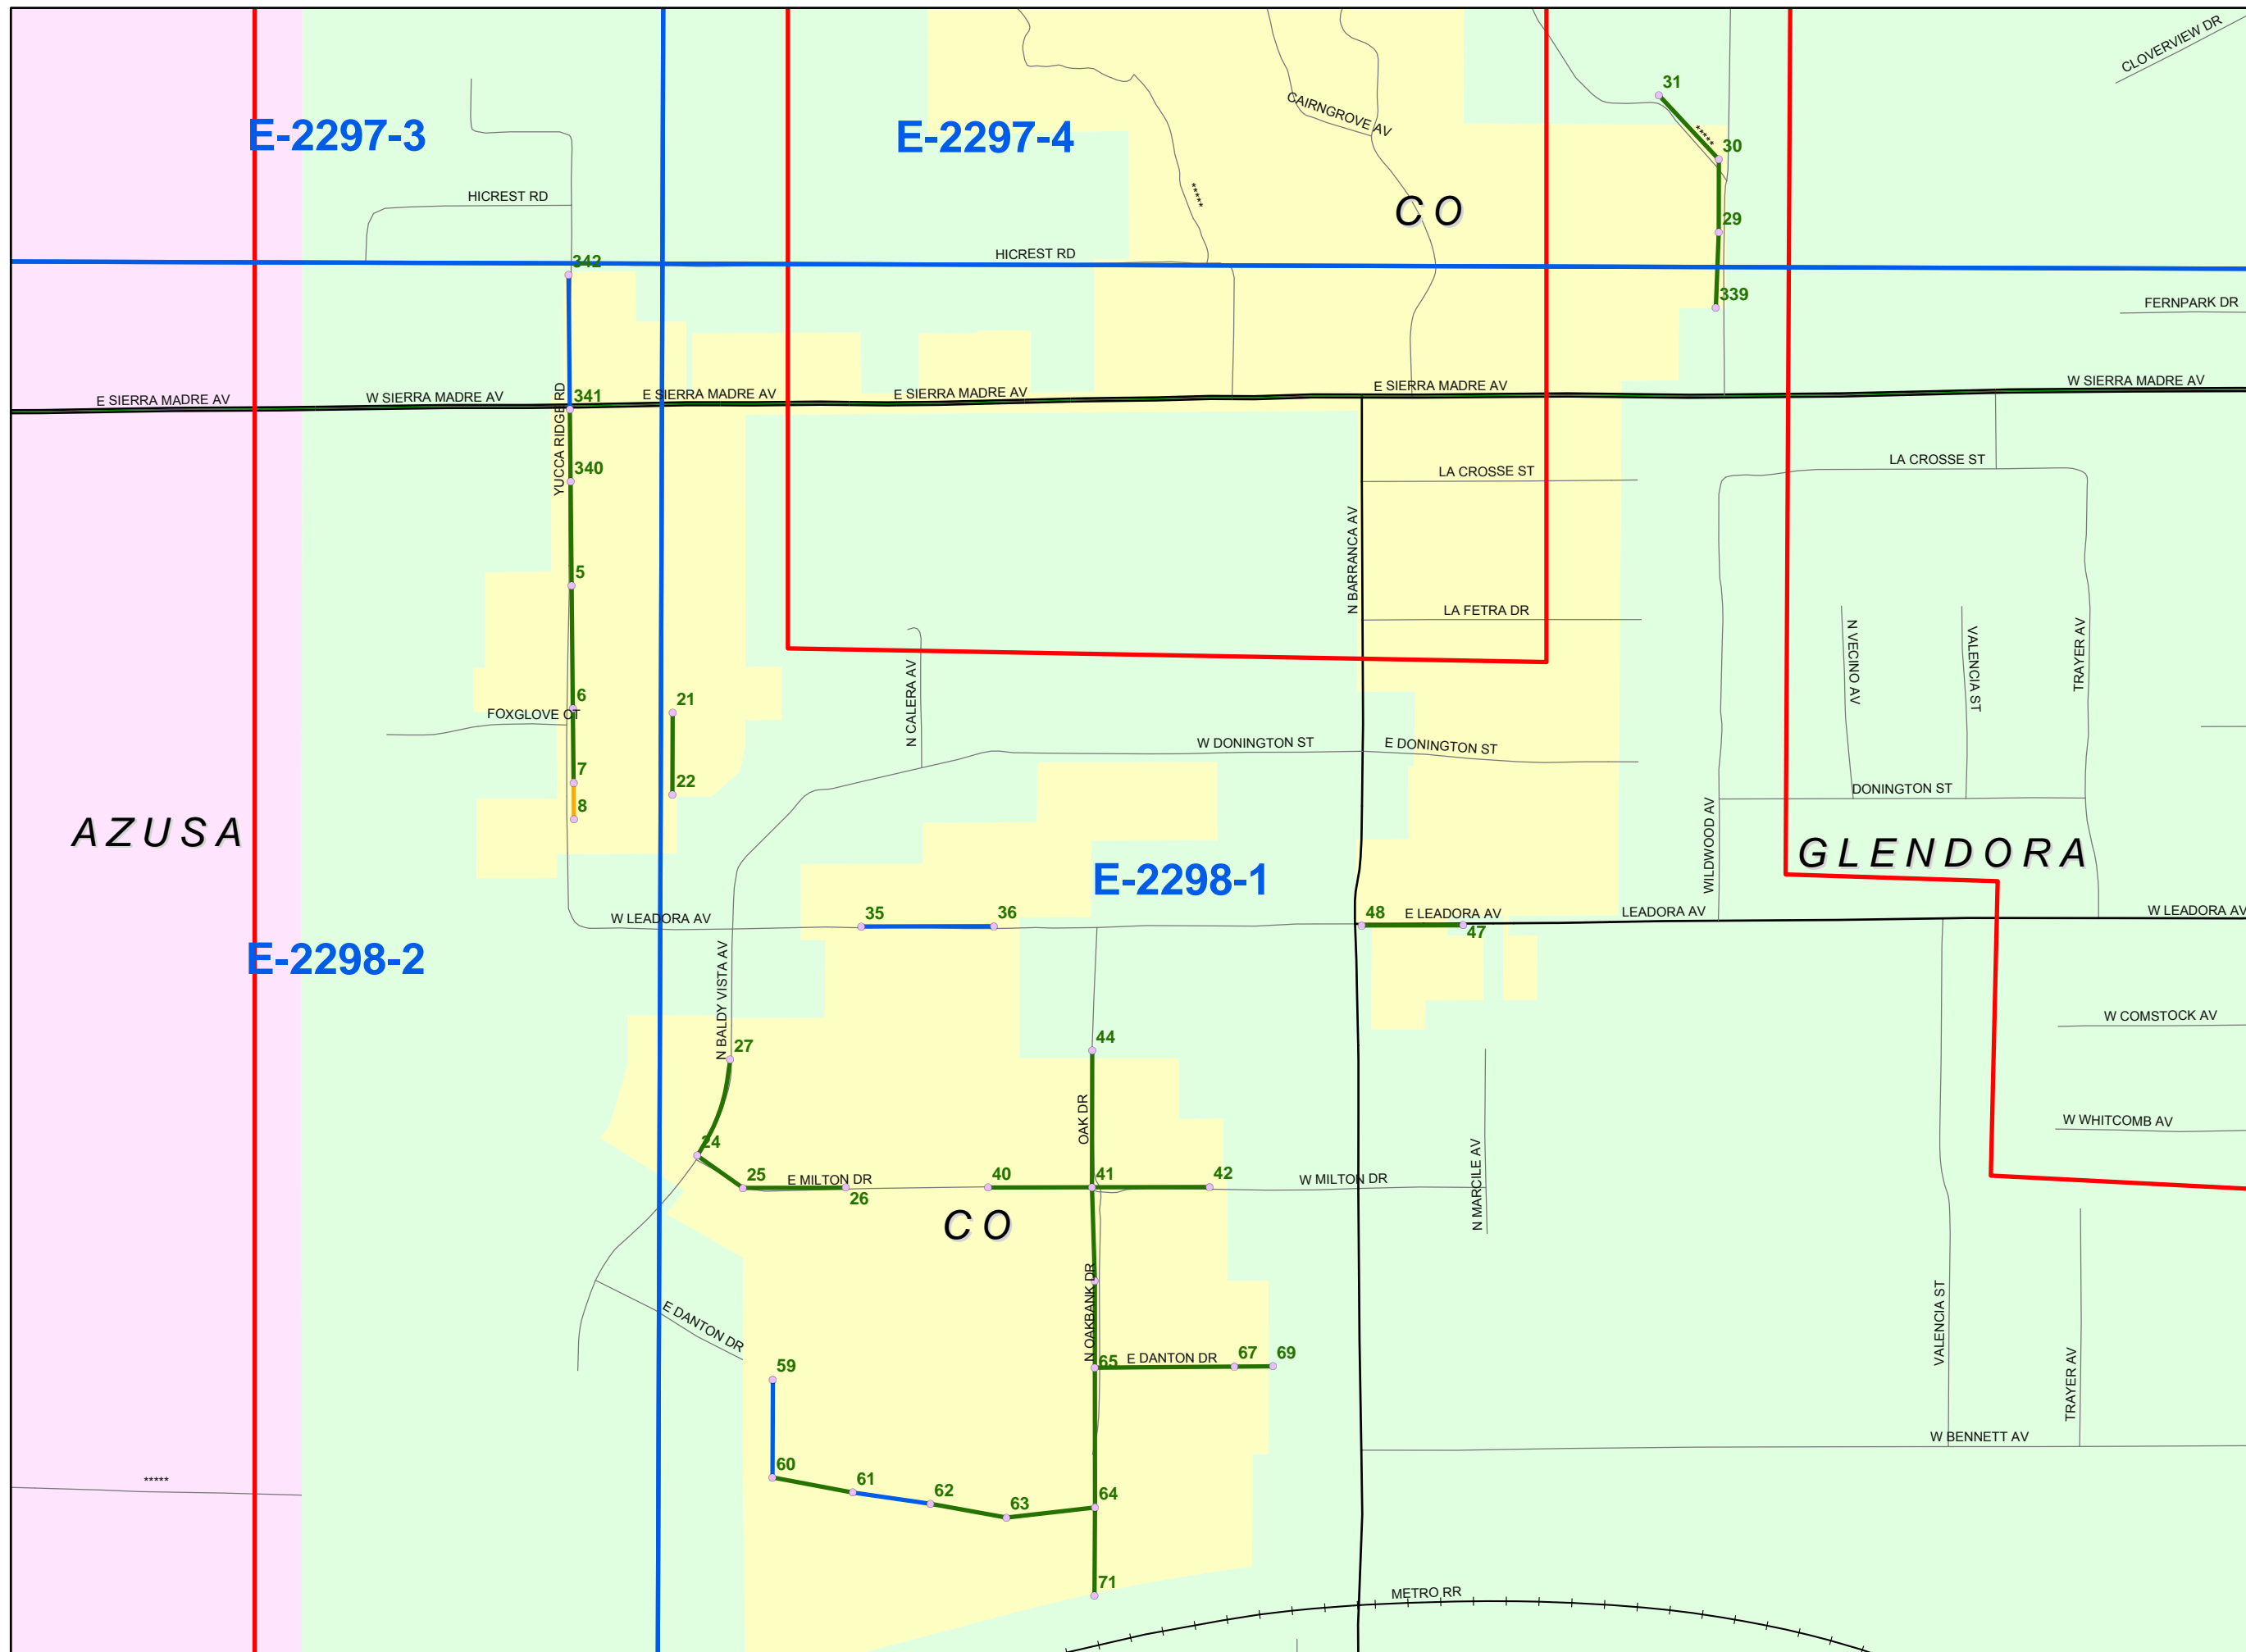
ENCLOSURE 3
 QUICK STRUCTURAL RATING REPORT PRIORITY LIST
 UNINCORPORATED LOS ANGELES COUNTY (Y0TV0506D)
 as of 8/14/06

Item No.	QSR	Start MH	End MH	Street	Observation: Location	Proposed Corrective Method	Length of Repair (FT)
1	5142	2299-0243	2299-0242	HANLIN AVE	Broken with soil visible and fractures: 163'; multiple fractures	Lining: MH to MH	265
2	5121	2299-0134	2299-0133	GOODWAY DR	Broken with soil visible: 95'	Structural integrity intact. No action needed.	-
3	511A	2299-0288	2299-0284	PETUNIA ST	Broken: 172'; multiple cracks	Structural integrity intact. No action needed.	-
4	4200	2428-0189	2428-0192	LYFORD DR	Multiple fractures: 88'	Point Repair	-
5	4100	2428-0261	2428-0260	FERNSHAW DR	Broken: 49'	Structural integrity intact. No action needed.	-
