**CONSOLIDATED SEWER MAINTENANCE DISTRICT
CONDITION ASSESSMENT PROGRAM REPORT
PROJECT Y0TV0809A**

**CONDITION ASSESSMENT REPORT
COUNTY OF LOS ANGELES DEPARTMENT OF PUBLIC WORKS
CONSOLIDATED SEWER MAINTENANCE DISTRICT**

PROJECT NAME:	Y0TV0809A	PROJECT MGR:	Phyo Kyaw
PROJECT DATE:	08/11/08-01/23/09	CONTACT NO:	(626) 300-3369
SUP. DISTRICT(S):	1 of 5	MAP PAGE(S):	1967,2020,2120,2121
Report By:	Hanna Kebede	Report Date:	11/4/2010

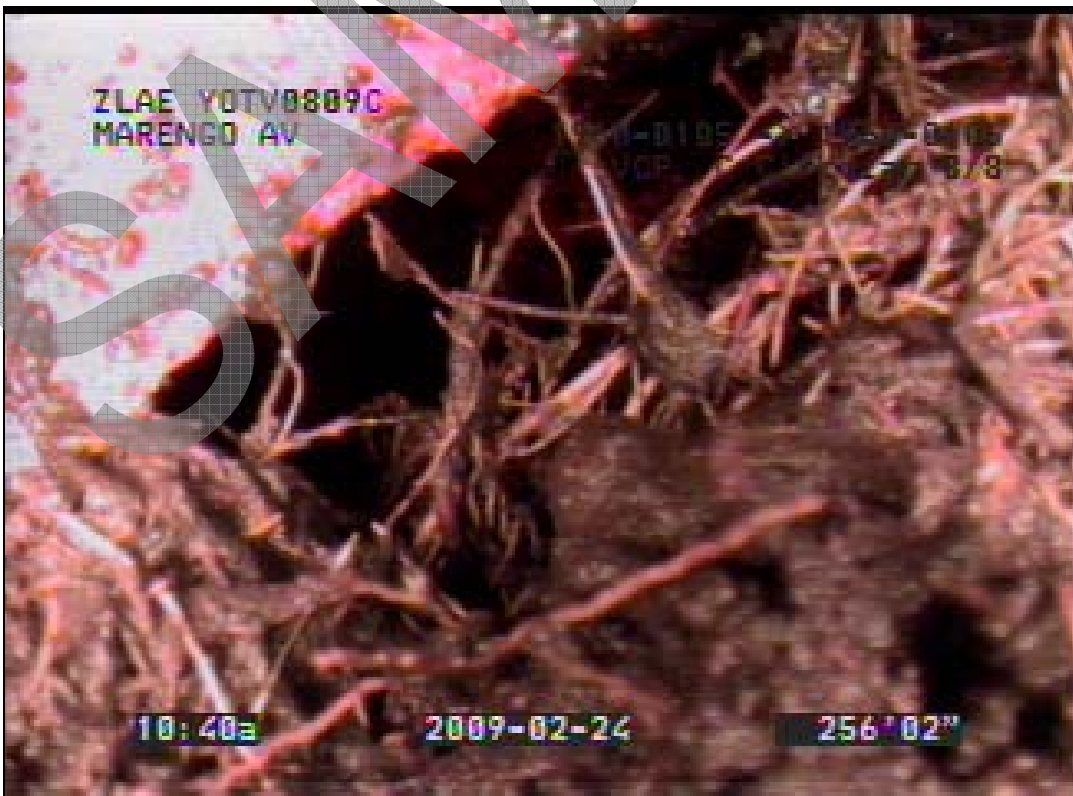
3476 MARENGO AVE
ALTADENA
Roots at Lateral Connection

For your reference, we have enclosed photos of your lateral connection showing the presence of the root blockage. Also enclosed are some literature on ways of minimizing sewer overflows and damage to your home.

your sewer lateral within 90 days to remove roots and any other obstructions that may cause a sewage backup. Failure to do so may result in future overflows and subject you to civil prosecution, reimbursement costs, and fines up to \$1,000. Reference 20.24.160 Violation - Penalty; 20.24.170 Continued violations; 20.32.690 Reimbursement for repairs and maintenance following violations.
