**CONSOLIDATED SEWER MAINTENANCE DISTRICT
CONDITION ASSESSMENT PROGRAM REPORT
UNINCORPORATED COUNTY**

**CONDITION ASSESSMENT REPORT
COUNTY OF LOS ANGELES DEPARTMENT OF PUBLIC WORKS
CONSOLIDATED SEWER MAINTENANCE DISTRICT**

PROJECT NAME:	Y0TV1011B	PROJECT MGR:	Hanna Kebede
PROJECT DATE:	02/14/11	CONTACT NO:	(626) 300-4686
SUP. DISTRICT(s):	1 & 4	MAP PAGE(S):	1860,1861,1914,1915
Report By:	Clement Khong	Report Date:	11/18/16

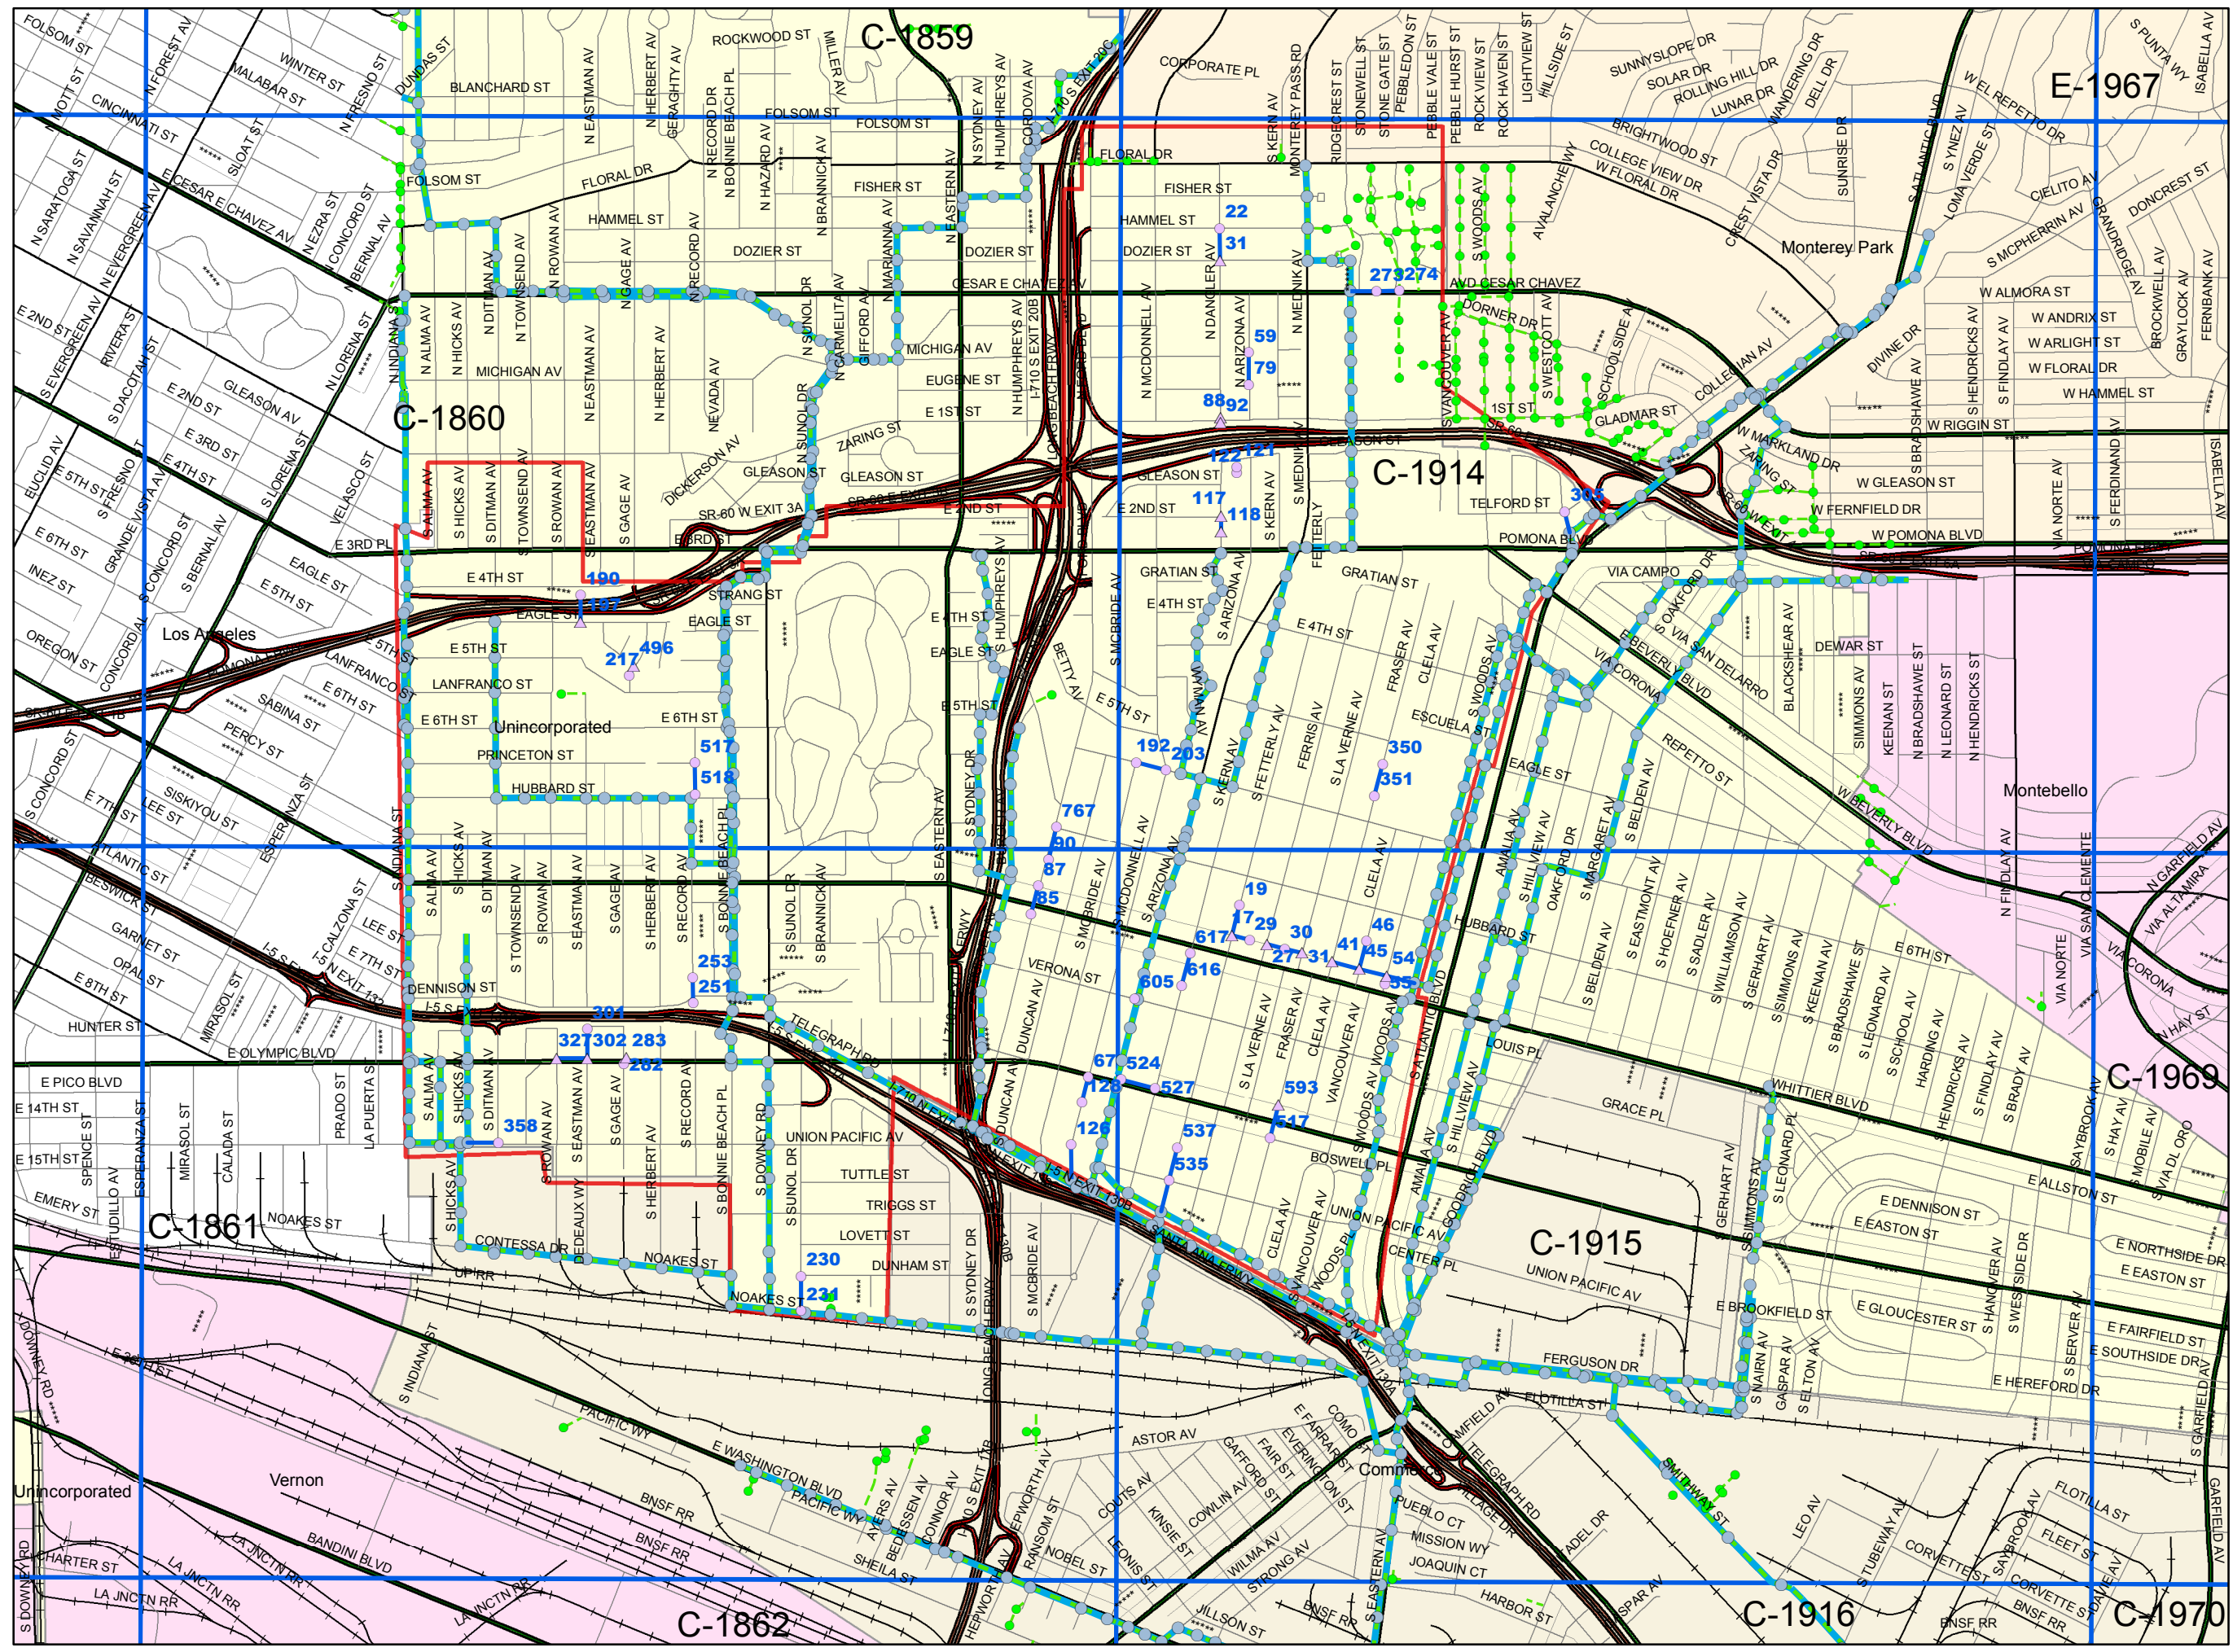
HIGH WATER LEVEL

All sewer pipes where the Water Level, Water Mark, and miscellaneous remarks of camera underwater or sags in the line are at or above 50 percent capacity have been listed and analyzed on the High Water Level table in Enclosure 2. The nature of these high water level conditions is also summarized on this table.

ITEM NO.	QMR	START MH	END MH	STREET	OBSERVATION (length of sag)
1	413E	1914-0022	1914-0031	DANGLER AV	High water level; sag (5')
2	3A11	1914-0305	1914-TRNK	EASEMENT	High water level; sag (20')
3	4333	1914-0350	1914-0351	FRASER AV	Sag (42')
4	4123	1915-0019	1915-0017	FETTERLY AV	Sag (10')
5	4131	1914-0059	1914-0079	ARIZONA AV	Water mark (55%)
6	4128	1914-0088	1914-0092	1ST ST	Water mark (50%)
7	4400	1914-0118B	1914-0118	DANGLER AV	Camera underwater; high water level
8	3221	1914-0192	1914-0203	6TH ST	Water mark (55%)
9	4231	1860-0767	1861-0090	FORD BV	Water mark (60%)
10	3211	1915-0605	1915-TRNK	ARIZONA AV	Water mark (65%)
11	5100	1914-0121	1914-0122	EASEMENT	Water mark (50%)
12	4227	1915-0617	1915-0616	KERN AV	Water mark (55%)
13	4100	1860-0217	1860-0496	GAGE AV	Water mark (55%)
14	311A	1861-0253	1861-0251	RECORD AV	Water mark (50%)
15	4112	1861-0283	1861-0282	OLYMPIC BV	Water mark (50%)
16	4121	1915-0046	1915-0045	CLELA AV	Water mark (50%)

17	412G	1915-0017	1915-0029	ALLEY	Water mark (55%)
18	472C	1915-0027	1915-0030	ALLEY	High water level
19	4115	1915-0041	1915-0045	ALLEY	Water mark (55%)
20	4112	1915-0045	1915-0054	ALLEY	Water mark (55%)
21	3113	1915-0054	1915-TRNK	ALLEY	Water mark (50%)
22	332A	1861-0054	1861-0055	OLYMPIC BV	Water mark (50%)
23	3224	1861-0301	1861-0302	EASTMAN AV	Water mark (80%)
24	3D15	1861-0302	1861-0327	OLYMPIC BV	Water mark (55%)
25	3111	1861-0087	1861-0085	FORD BV	High water level; sag (109')
26	3G2G	1915-0527	1915-0524	OLYMPIC BV	High water level; sag (150')
27	4335	1861-0358	1861-TRNK	UNION PACIFIC AV	High water level
28	3100	1861-0067	1861-0128	MC DONNELL AV	High water level; sag (63')
29	4536	1861-0126	1861-TRNK	MC DONNELL AV	High water level
30	3F11	1915-0537	1915-0535	FETTERLY AV	High water level; sag (32')
31	3300	1915-0535	1915-TRNK	FETTERLY AV	Sag (58')
32	452E	1915-0593	1915-0517	FRASER AV	High water level; water mark (60%)

33	4121	1861-0230	1861-0231	SUNOL DR	High water level
34	4A21	1860-0190	1860-0197	EASEMENT	High water level; sag (46')
35	3921	1914-0274	1914-0273	CESAR CHAVEZ AV	High water level; sag (46')
36	4E2J	1914-0273	1914-TRNK	CESAR CHAVEZ AV	High water level; sag (35')
37	4211	1860-0517	1860-0518	RECORD AV	High water level; sag (85')

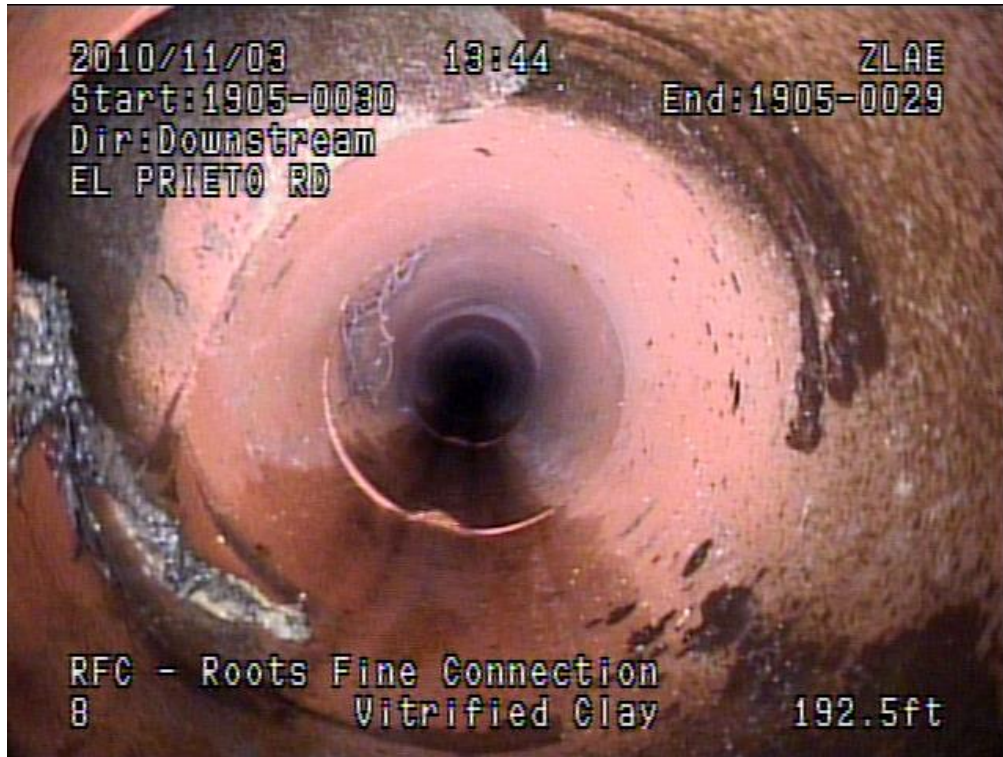
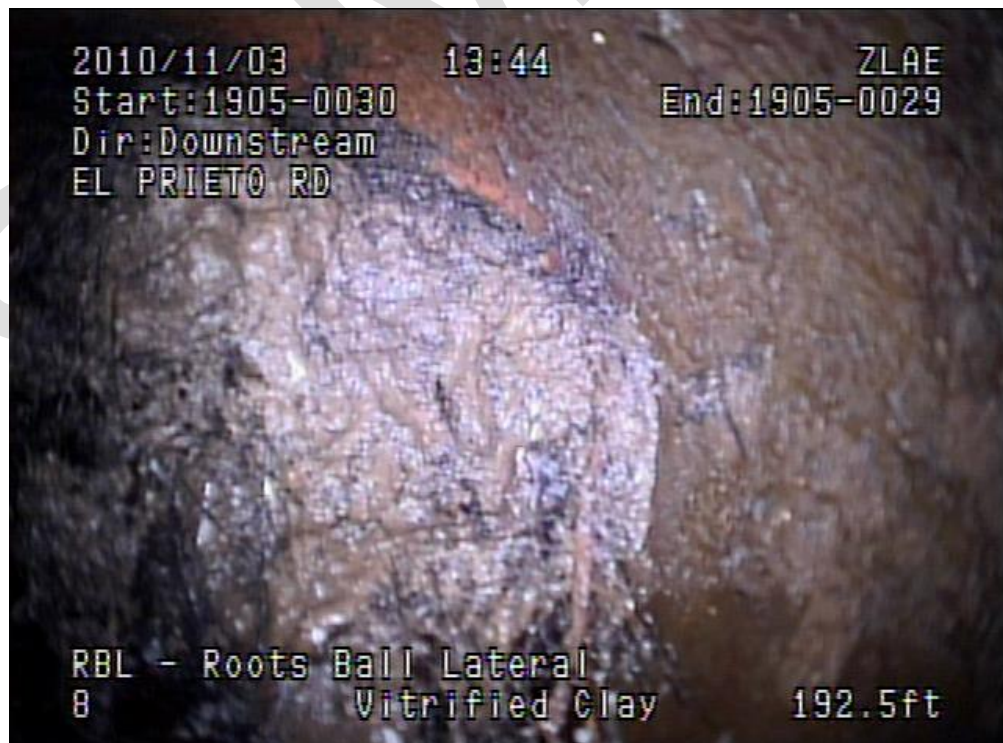
Roots at Lateral Connection

SEWER LATERAL ROOT INTRUSION

The County of Los Angeles Consolidated Sewer Maintenance District is responsible for the maintenance of the sanitary sewer system in your area. We recently televised the sewer mainline and discovered roots in your sewer lateral connection. The intrusion of the roots from your lateral may block the flow of sewage in the mainline sewer causing an overflow upstream of your property. You are hereby requested to perform maintenance on the private sewer lateral serving the property located at 4474 El Prieto Road, Altadena, California 91001.

We have enclosed photos of your lateral connection showing the root blockage. In addition, we have included literature on ways to minimize sewer overflows and damage to your home. Please consider establishing a routine cleaning schedule for your sewer lateral to minimize potential plumbing problems caused by root intrusion that are likely to reoccur.

As the property owner, you are responsible for the entire length of the sewer lateral, which includes the portion that extends beyond the property line into the public right of way. We request that you contact a licensed plumber to service your sewer lateral within 90 days to remove roots and any other obstructions that may cause a sewage backup.

Your licensed plumber is required to protect the District's sewer mainlines from dislodged roots and other debris by utilizing catcher baskets at the manhole downstream from your lateral connection. Prior to your plumber cleaning your lateral, please notify the District's sewer maintenance yard in your area at (626) 446-5227 to arrange for authorization to access the downstream manhole.

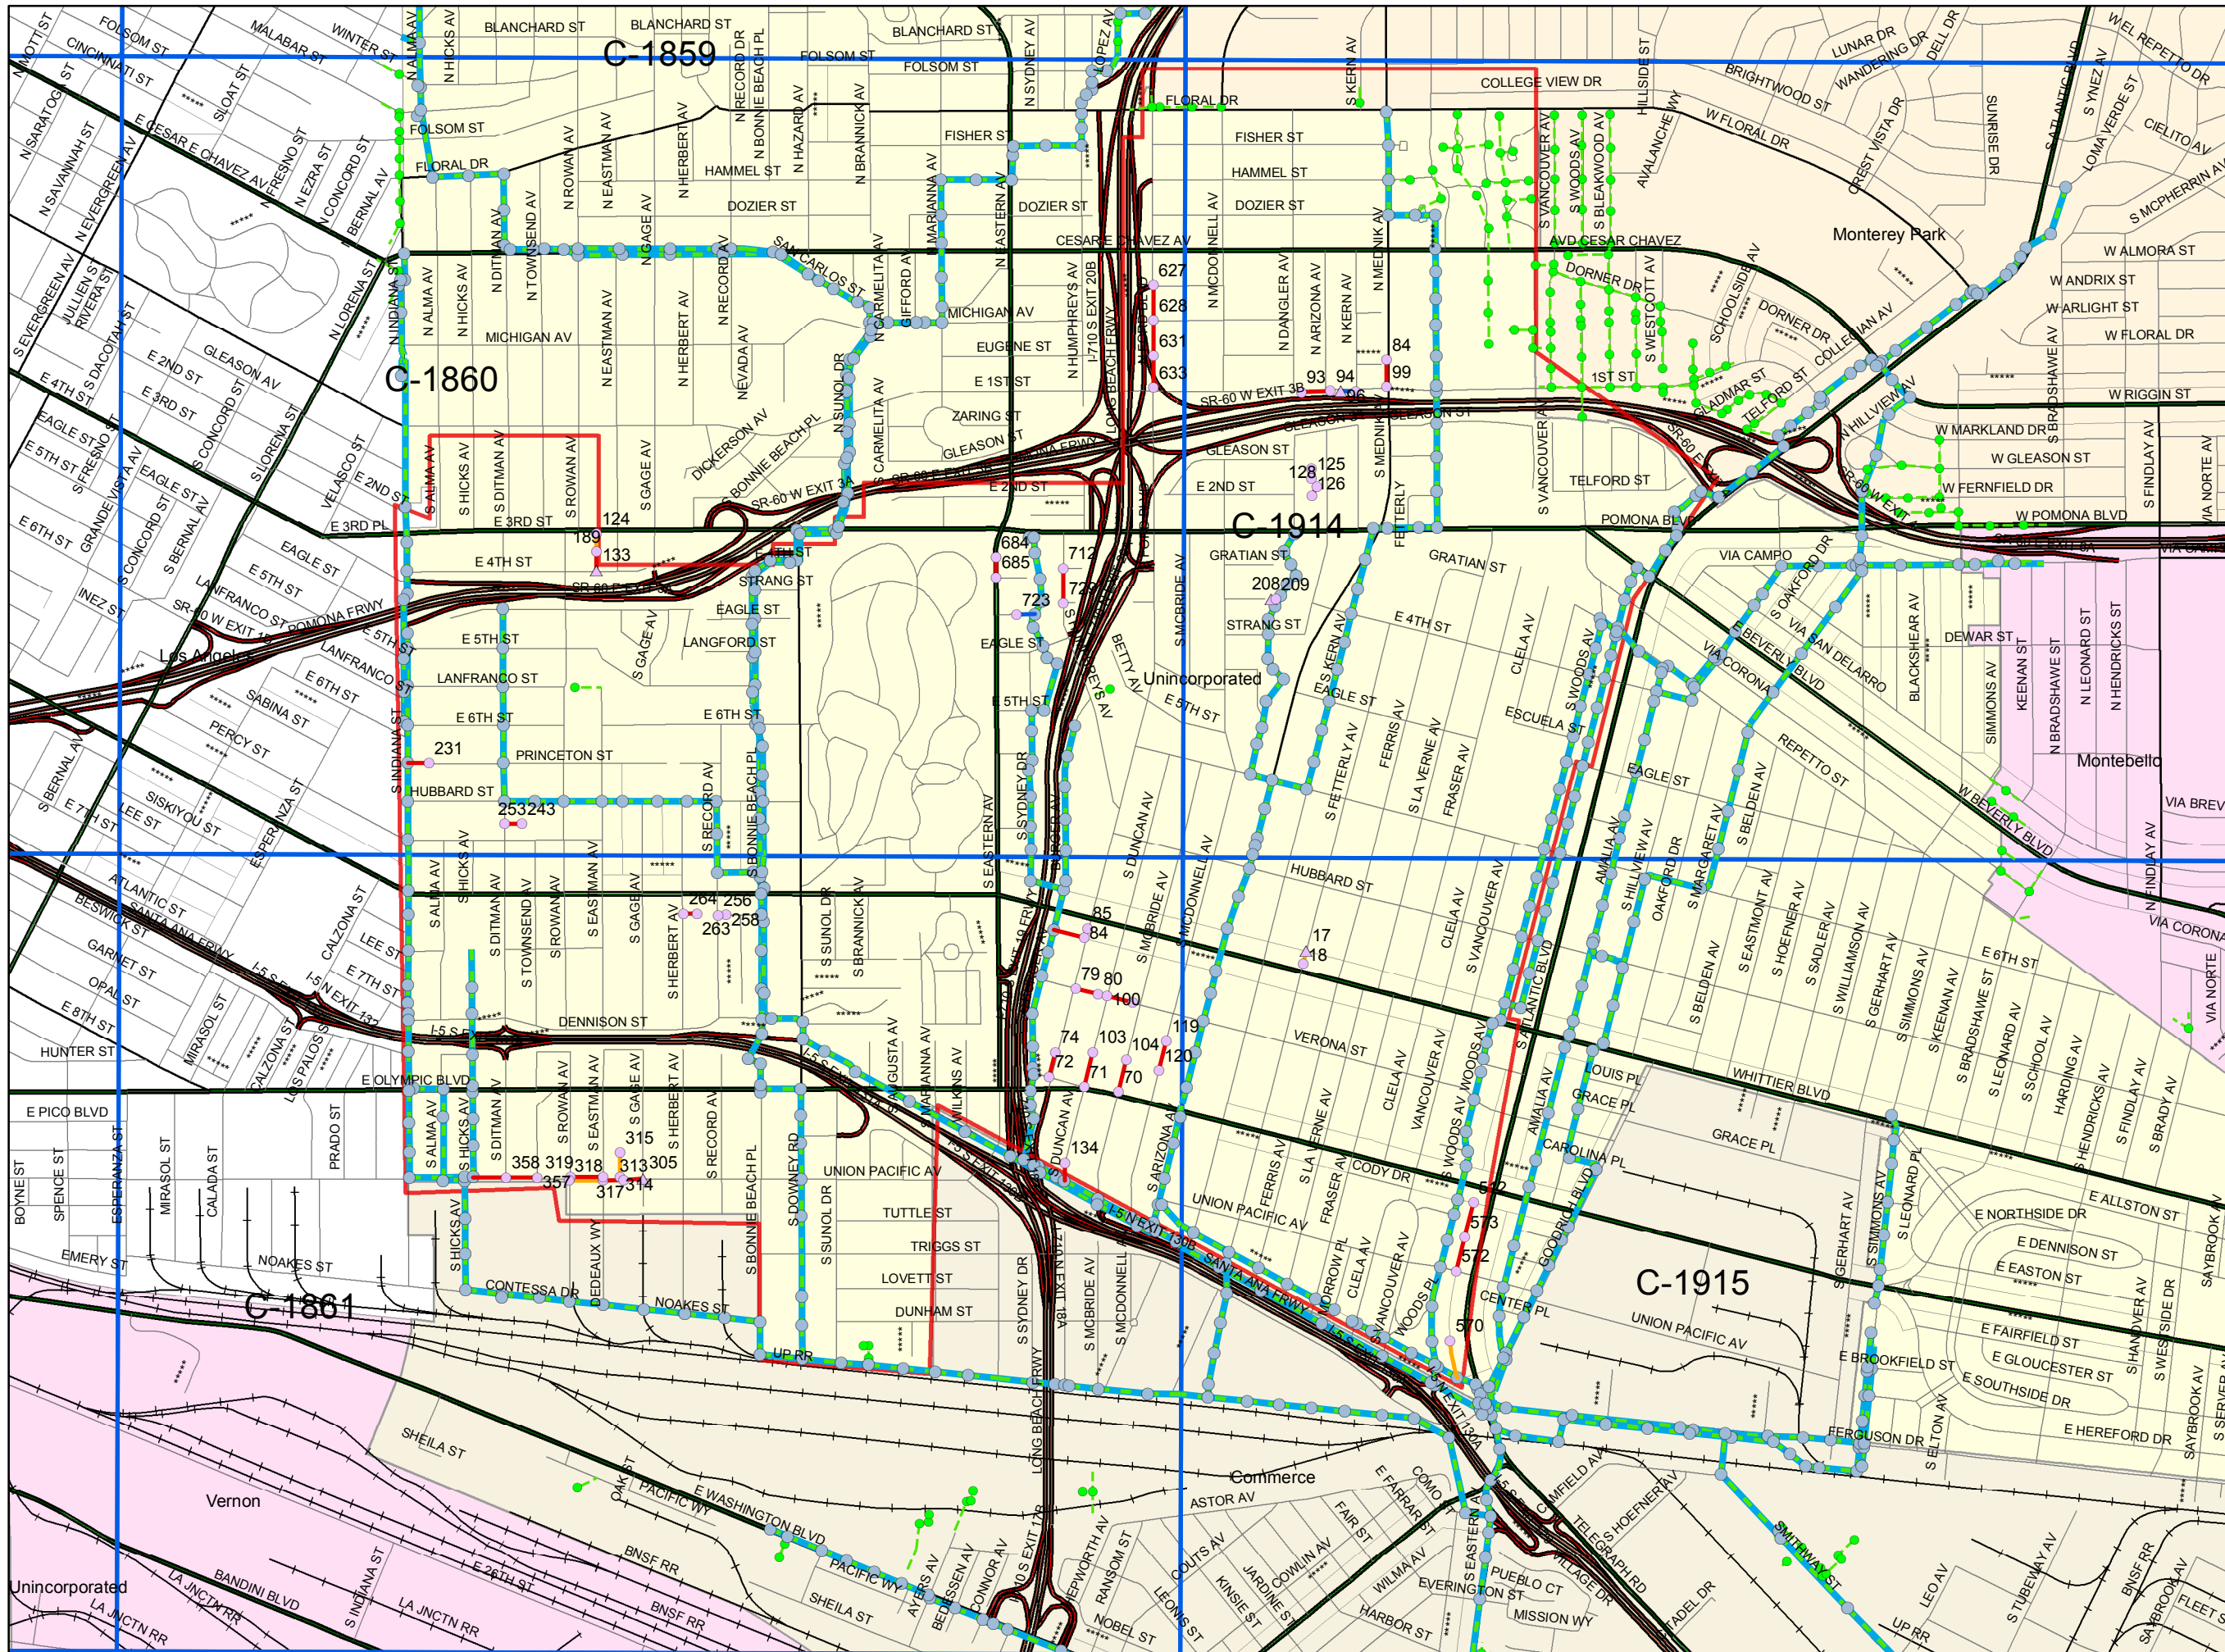
COUNTY UNINCORPORATED LINING & POINT REPAIR PROJECTS

ITEM NO.	QSR	START MH	END MH	STREET	OBSERVATION: LOCATION	PROPOSED CORRECTIVE METHOD	LENGTH OF REPAIR (FT)
1	5100	1914-TRNK	1914-0236	4TH ST	Hole (uncut lateral): 108' (lined concrete)	Structural integrity in tact. No action needed.	
2	5100	1915-0017	1915-0018	FETTERLY AV	Hole: 67' (concrete pipe); protruding lateral: 90'	Point Repair (core saw protruding lateral): 90'; Lining: MH to MH	92
3	5121	1861-0080	1861-0079	VERONA ST	Broken: 6' (concrete pipe)	Lining: MH to MH	202
4	5143	1861-0134	1861-TRNK	DUNCAN AV	Fractures: 18', 44', 80' (concrete pipe)	Lining: MH to MH	198
5	5112	1914-0082	1914-0083	KERN ST	Joint offset: 179'	Structural integrity in tact. No action needed.	
6	4121	1860-0712	1860-0729	HUMPHREYS AV	Fracture: 264' (concrete pipe)	Lining: MH to MH	315
7	513A	1860-0627	1860-0628	FORD BV	Broken/fractures: multiple locations (concrete pipe)	Lining: MH to MH	331
8	4K32	1860-0628	1860-0631	FORD BV	Fractures: 83', 103'; surface aggregate visible throughout (concrete)	Lining: MH to MH	333

9	4L00	1860-0631	1860-0633	FORD BV	Surface aggregate visible throughout (concrete pipe)	Lining: MH to MH	331
10	513D	1914-0093	1914-0094	1ST ST	Hole: 11', fractures: 197', 204', 221'	Lining: MH to MH	278
11	4131	1914-0084	1914-0099	MEDNIK AV	Fractures: 157', 282' (concrete pipe)	Lining: MH to MH	282
12	4100	1914-0098	1914-0099	1ST ST	Fractures: 279'	Structural integrity in tact. No action needed.	
13	4131	1914-0097	1914-0096	1ST ST	Broken: 155'	Point Repair	
14	5122	1914-0111	1914-0112	2ND ST	Fractures: 15', 175'	Structural integrity in tact. No action needed.	
15	5241	1914-0114	1914-0113	2ND ST	Broken: 2'	Structural integrity in tact. No action needed.	
16	5100	1914-0170	1914-0169	MC DONNELL AV	Hole (insided lateral): 14' (lined concrete pipe)	Structural integrity in tact. No action needed.	
17	4100	1914-0196	1914-0197	MC DONNELL AV	Wrinkled liner: 324'	Structural integrity in tact. No action needed.

ITEM NO.	QSR	START MH	END MH	STREET	OBSERVATION: LOCATION	PROPOSED CORRECTIVE METHOD	LENGTH OF REPAIR (FT)
30	4333	1861-0104	1861-0070	MCBRIDE AV	Deformed: 93' (concrete pipe)	Lining: MH to MH	323
31	5112	1914-0140	1914-0137	EASEMENT	Broken: 156'	Structural integrity in tact. No action needed.	
32	413A	1861-0103	1861-0071	DUNCAN AV	Fractures: 1', 20', 93' (concrete pipe)	Lining: MH to MH	291
33	514A	1861-0085	1861-0084	FORD BV	Fractures: 19', 29' (concrete pipe)	Lining: MH to MH	78
34	4100	1861-0087	1861-0088	ALLEY	Deformed (liner): 3'	Structural integrity in tact. No action needed.	
35	4D3L	1861-0084	1861-TRNK	ALLEY	Fractures: 3', 201', 294' (concrete pipe)	Lining: MH to MH	296
36	5121	1915-0600	1861-0492	ARIZONA AV	Broken: 38'	Structural integrity in tact. No action needed.	
37	4132	1914-0123	1914-0122	EASEMENT	Fractures: 88', 94'	Structural integrity in tact. No action needed.	
38	4538	1914-0124	1914-0125	EASEMENT	Fractures: 63', 115'-136'; deformed: 124'-140'	Lining: MH to MH	142

47	5B42	1861-0264	1861-0263	ALLEY	Fractures: 49', 52' (concrete pipe)	Lining: MH to MH	264
48	5200	1914-0208	1914-0209	EASEMENT	Hole: 113' (upper end)	Point Repair	
49	5121	1861-0258	1861-0256	ALLEY	Broken (inside lateral): 28' (concrete pipe)	Lining: MH to MH	110
50	4124	1861-0246	1861-0247	OLYMPIC BV	Fractures: 60', 153', 204'	Structural integrity in tact. No action needed.	
51	5132	1915-0512	1915-0573	ALLEY	Fractures: 194', 195' (concrete pipe)	Lining: MH to MH	328
52	5100	1915-0573	1915-0572	ALLEY	Broken: 231' (concrete pipe)	Lining: MH to MH	332
53	5100	1915-0570	1915-TRNK	ALLEY	Broken: 201'; (concrete pipe)	Point repair (remove broken pipe and retelevise); Lining: MH to MH	
54	413E	1861-0305	1861-0313	UNION PACIFIC AV	Fractures: multiple locations (concrete pipe)	Lining: MH to MH	204
55	5342	1861-0313	1861-0316	UNION PACIFIC AV	Hole: 19', 21; fractures: 52' (concrete pipe)	Lining: MH to MH	188
