**CONSOLIDATED SEWER MAINTENANCE DISTRICT
CONDITION ASSESSMENT PROGRAM REPORT
UNINCORPORATED COUNTY**

**CONDITION ASSESSMENT REPORT
COUNTY OF LOS ANGELES DEPARTMENT OF PUBLIC WORKS
CONSOLIDATED SEWER MAINTENANCE DISTRICT**

| PROJECT NAME: | Y0TV0809C | PROJECT MGR: | Kari Eskridge |

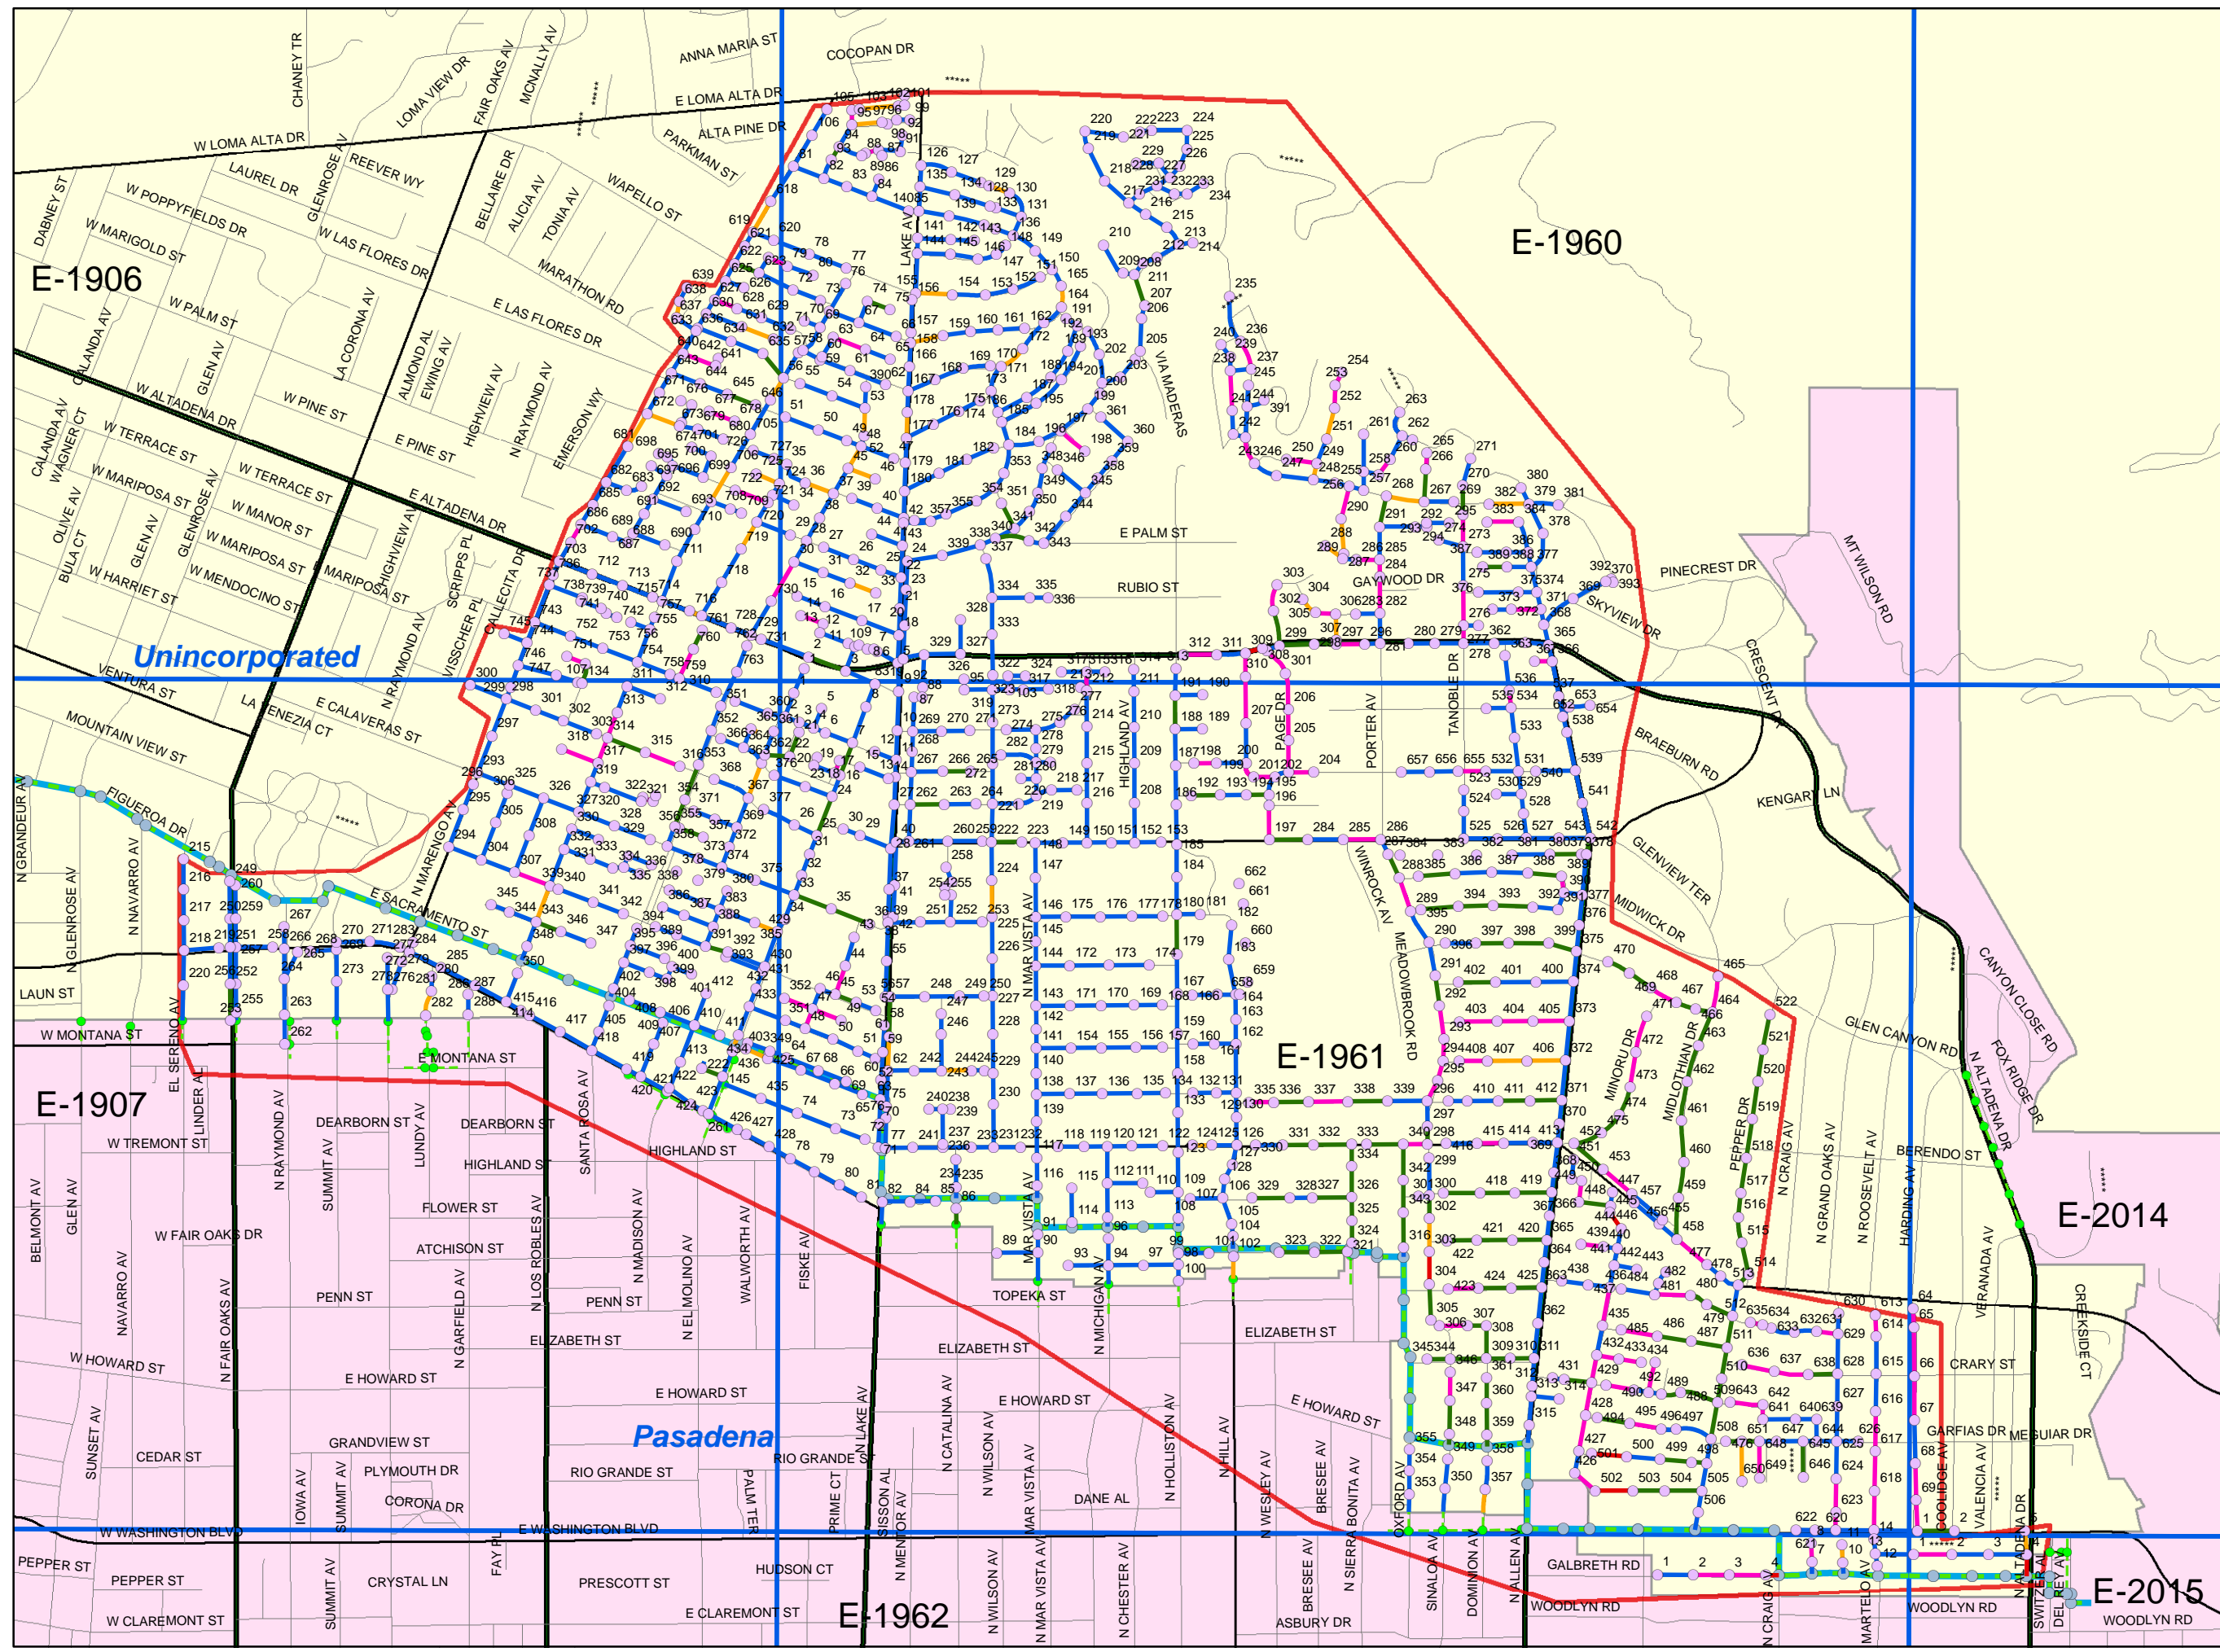
QUICK
MAINTENANCE
RATING
(QMR)

Our inspection revealed that approximately 78.2 percent of the system televised was free of blockages or restrictions that would impede sewer flows. However, the remaining 21.8 percent of the pipe segments within the unincorporated County had a PACP maintenance grade of 3, 4, or 5 as indicated in the Quick Maintenance Rating Table shown below. These segments have been incorporated into our routine cleaning schedule.

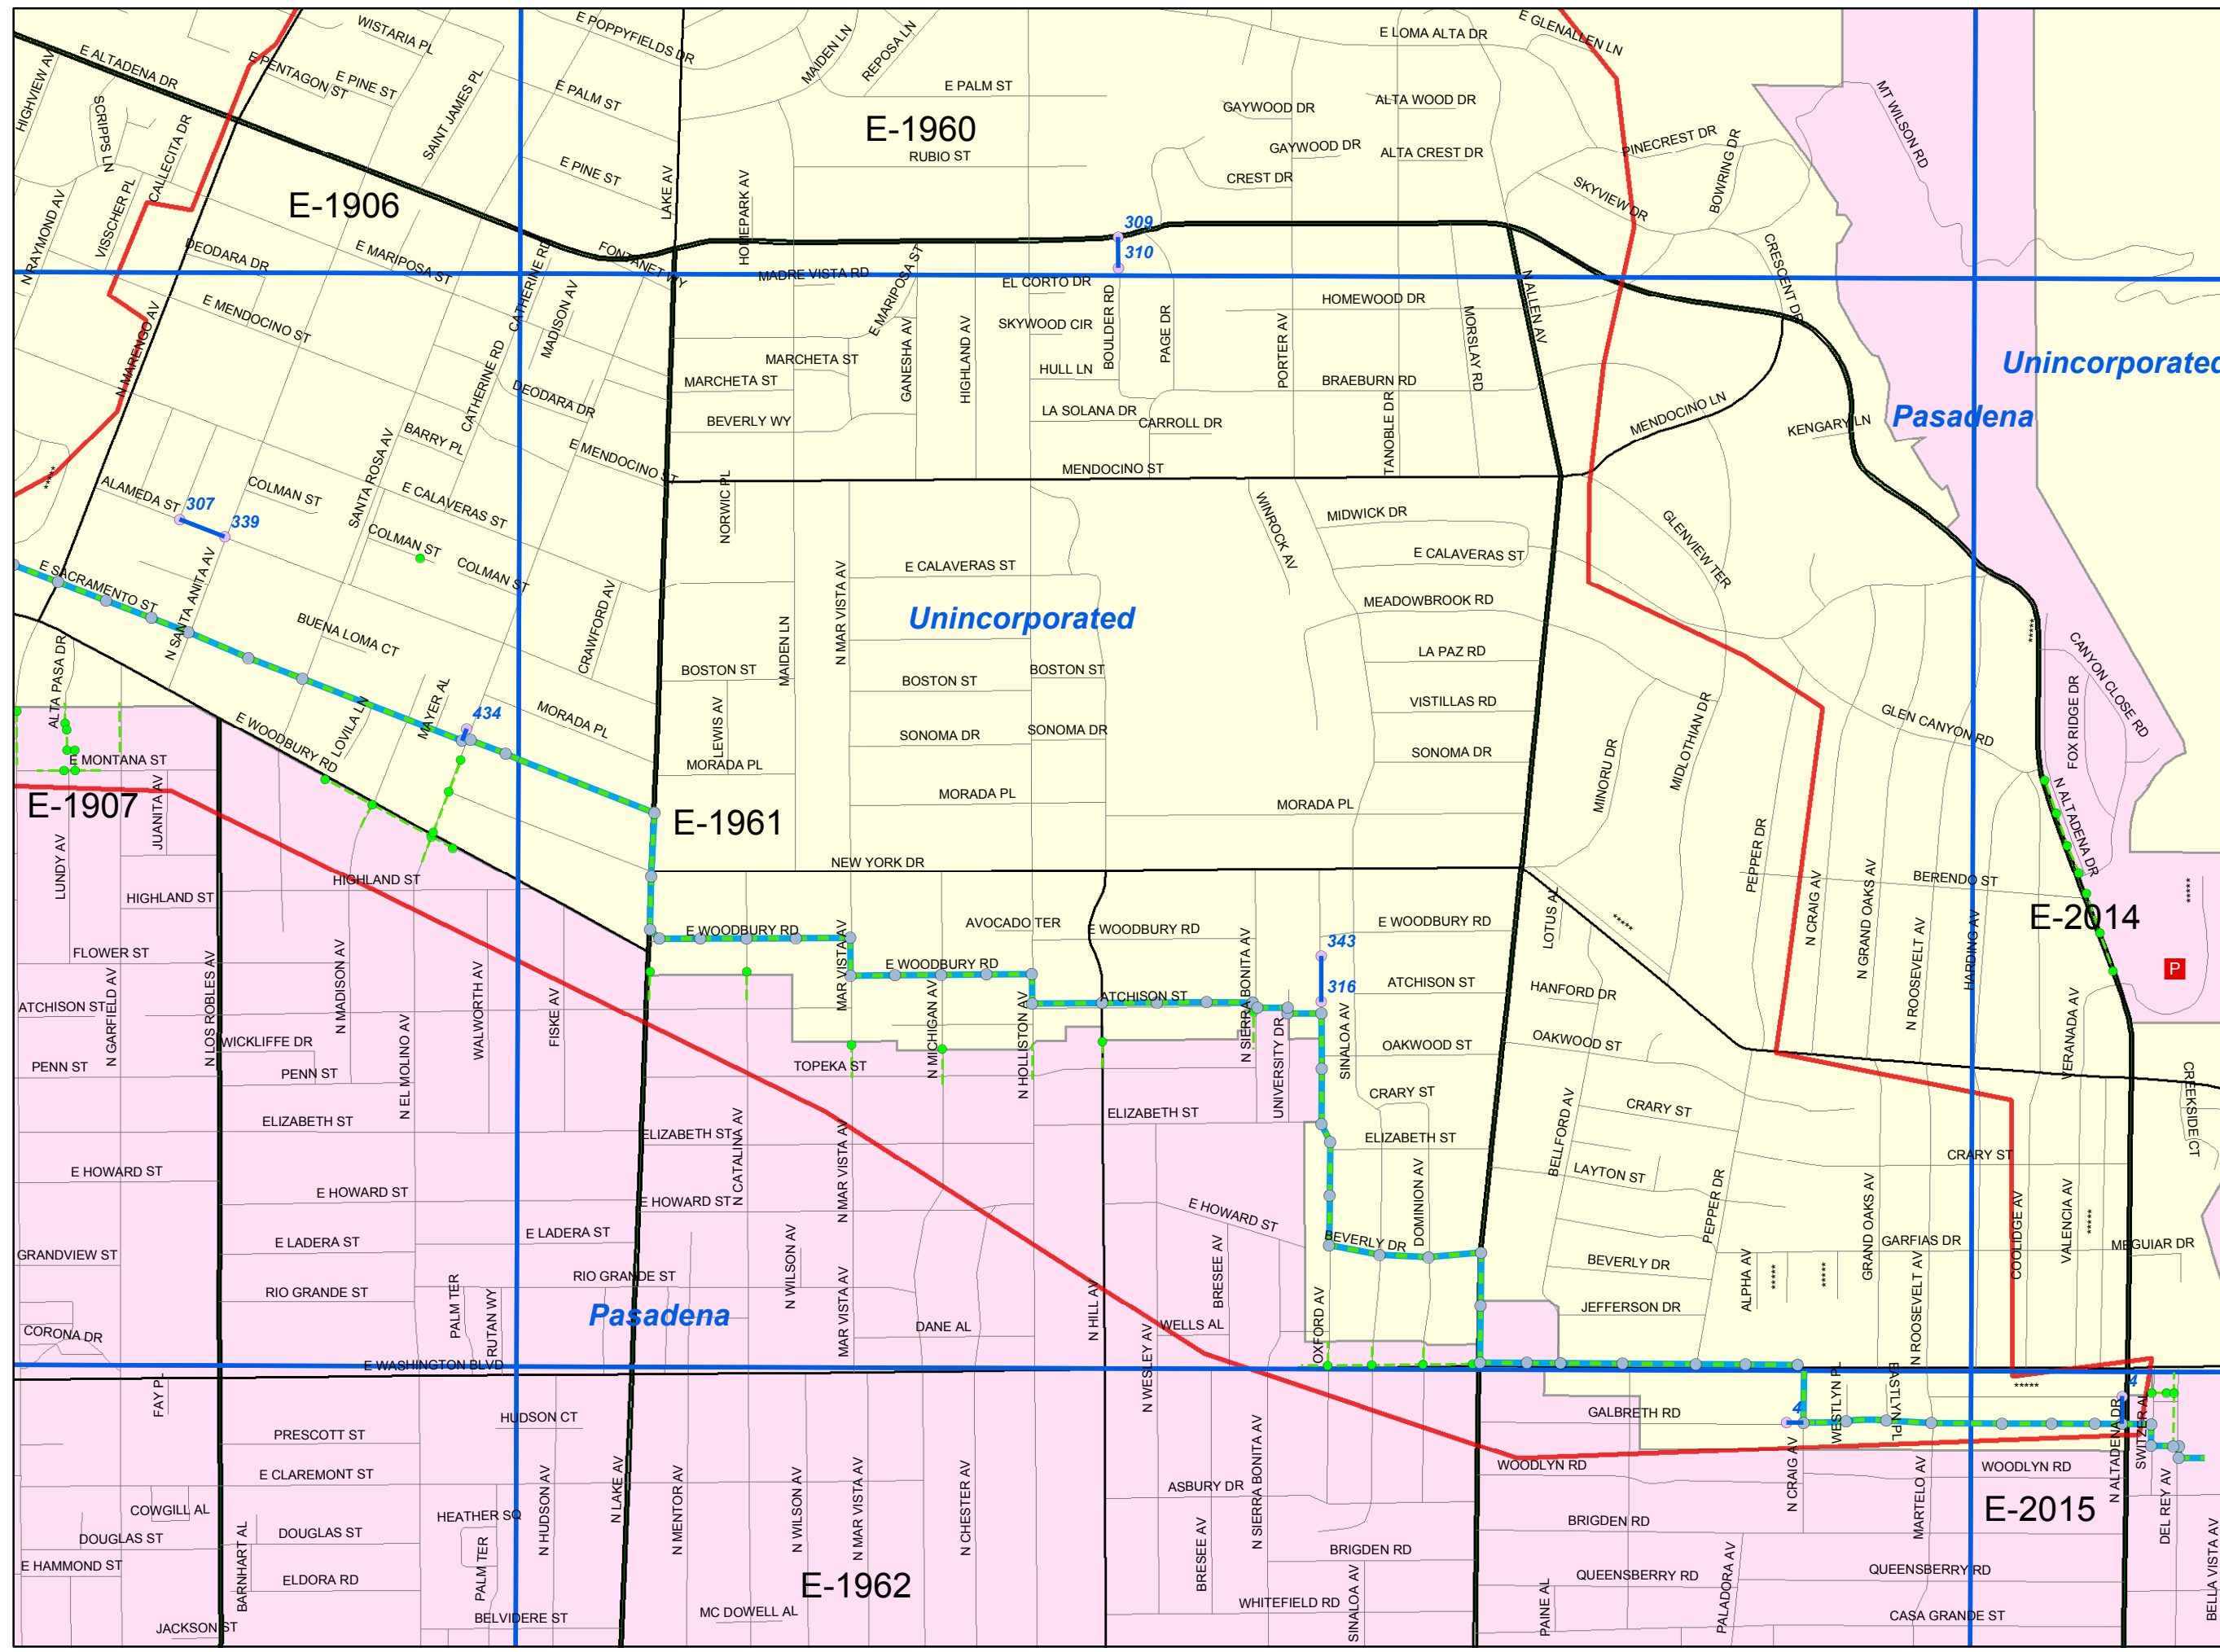
ENCLOSURE 2
CCTV PROJECT
YOTV0809C
COUNTY
UNINCORPORATED
HIGH WATER LEVEL

Our inspection revealed that approximately 99.5 percent of the system televised has adequate capacity. Approximately 0.5 percent of the segments inspected exhibited visual signs associated with high water levels. The capacity of the sewer pipe can be determined by analyzing several PACP codes, including Water Level, Water Mark, and miscellaneous remarks, which indicate the camera was underwater or there were sags in the line. A sewer pipe is considered at capacity when 50 percent of the diameter of sewer pipe is full of water. However, there are conditions in which the Water Level or Water Mark has reached 50 percent or greater due to heavy flows in adjoining pipes, a temporary stoppage caused by debris in the sewer lines, or a sag in the line. Therefore, additional review of these pipe segments was conducted to determine if any capacity issues exist.

All sewer pipes where the Water Level, Water Mark, and miscellaneous remarks of camera underwater or sags in the line are at or above 50 percent capacity have been listed and analyzed on the High Water Level table in Enclosure 2. The nature of these high water level conditions is also summarized on this table.

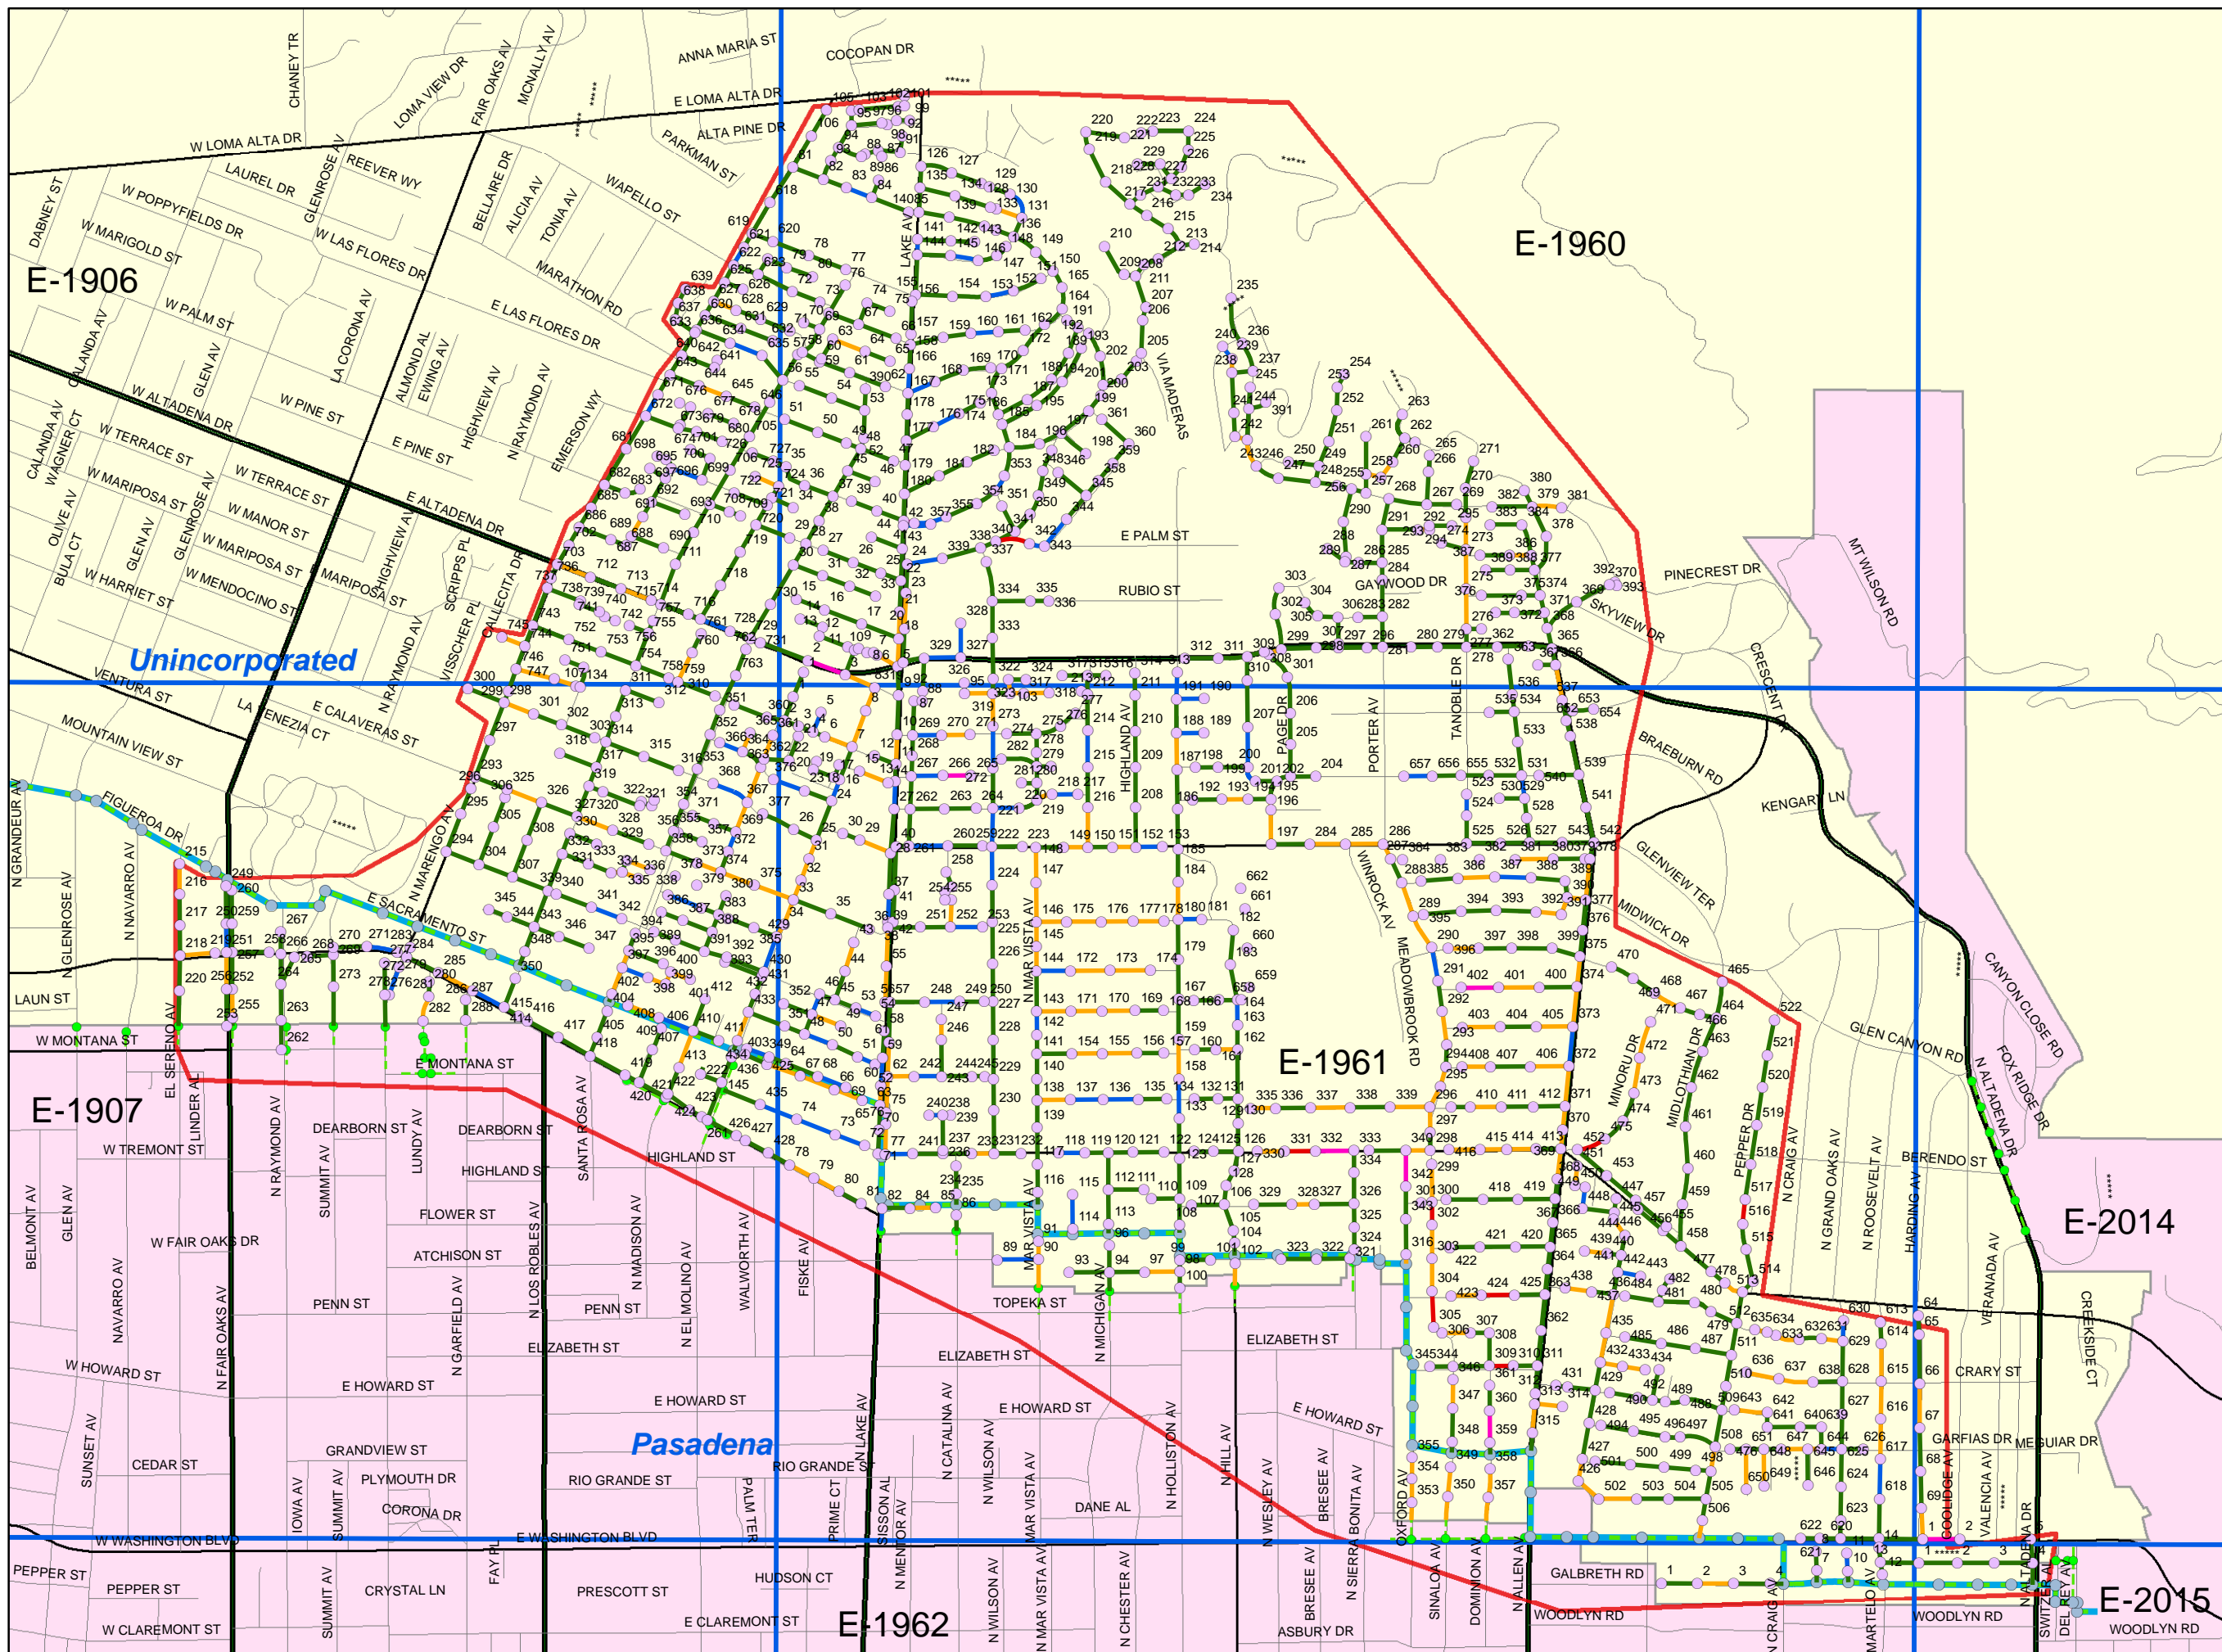
QUICK
STRUCTURAL
RATING
(QSR)

Our inspection revealed that approximately 88 percent of the inspected pipe segments within unincorporated County were free of severe structural defects. However, the remaining 12 percent of the inspected pipe segments had a PACP structural grade of 4 or 5 as indicated in the Quick Structural Rating Table shown on page 4. These segments have been placed on a priority list based on the severity and the need for action. For items 1 through 139 in the Quick Structural Rating Report Priority List (Enclosure 3) which require a corrective action, the proposed repair or replacement will be scheduled in the next 24 months as part of the ongoing Accumulative Capital Outlay Project. A color-coded map showing the Quick Structural Rating for each pipe segment is located in Enclosure 3. A map showing the sewer lines, which need lining and point repairs, is also provided in Enclosure 3.
