**CONSOLIDATED SEWER MAINTENANCE DISTRICT
CONDITION ASSESSMENT PROGRAM REPORT
UNINCORPORATED COUNTY**

**CONDITION ASSESSMENT REPORT
COUNTY OF LOS ANGELES DEPARTMENT OF PUBLIC WORKS
CONSOLIDATED SEWER MAINTENANCE DISTRICT**

| PROJECT NAME: | Y0TV0910C | PROJECT MGR: | Hanna Kebede |
| PROJECT DATE: | 01/27/2011 | CONTACT NO: | (626) 300-4686 |

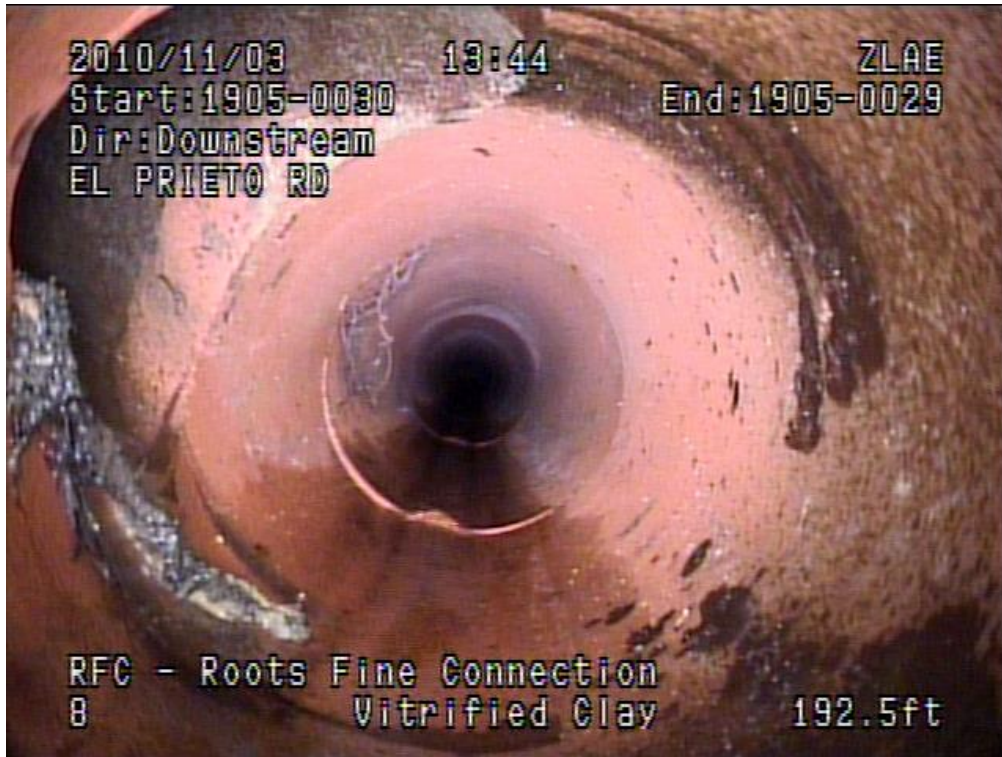
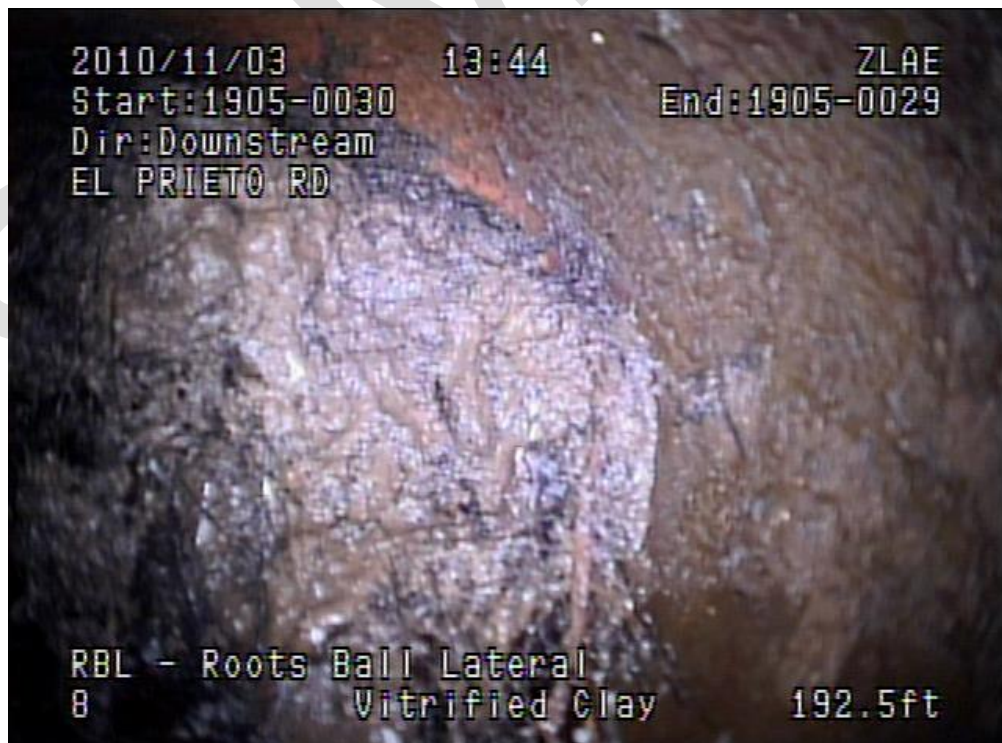
We have enclosed photos of your lateral connection showing the root blockage. In addition, we have included literature on ways to minimize sewer overflows and damage to your home. Please consider establishing a routine cleaning schedule for your sewer lateral to minimize potential plumbing problems caused by root intrusion that are likely to reoccur.

Roots at Lateral Connection

As the property owner, you are responsible for the entire length of the sewer lateral, which includes the portion that extends beyond the property line into the public right of way. We request that you contact a licensed plumber to service your sewer lateral within 90 days to remove roots and any other obstructions that may cause a sewage backup.
