**CONSOLIDATED SEWER MAINTENANCE DISTRICT
CONDITION ASSESSMENT PROGRAM REPORT
UNINCORPORATED COUNTY**

**CONDITION ASSESSMENT REPORT
LOS ANGELES COUNTY PUBLIC WORKS
CONSOLIDATED SEWER MAINTENANCE DISTRICT**

PROJECT NAME: Y0TV1011A	PROJECT MGR:	Eric Liu
PROJECT DATE: 02/01/11-07/30/011	CONTACT NO:	(626) 300-3390
SUP. DISTRICT(s): 5	MAP PAGE(S):	2349,2603,2305,2304,2348, 2220,2262,2263,2219,2221, & 2347
Report By: Jonathan Gonzalez	Report Date:	8/29/18

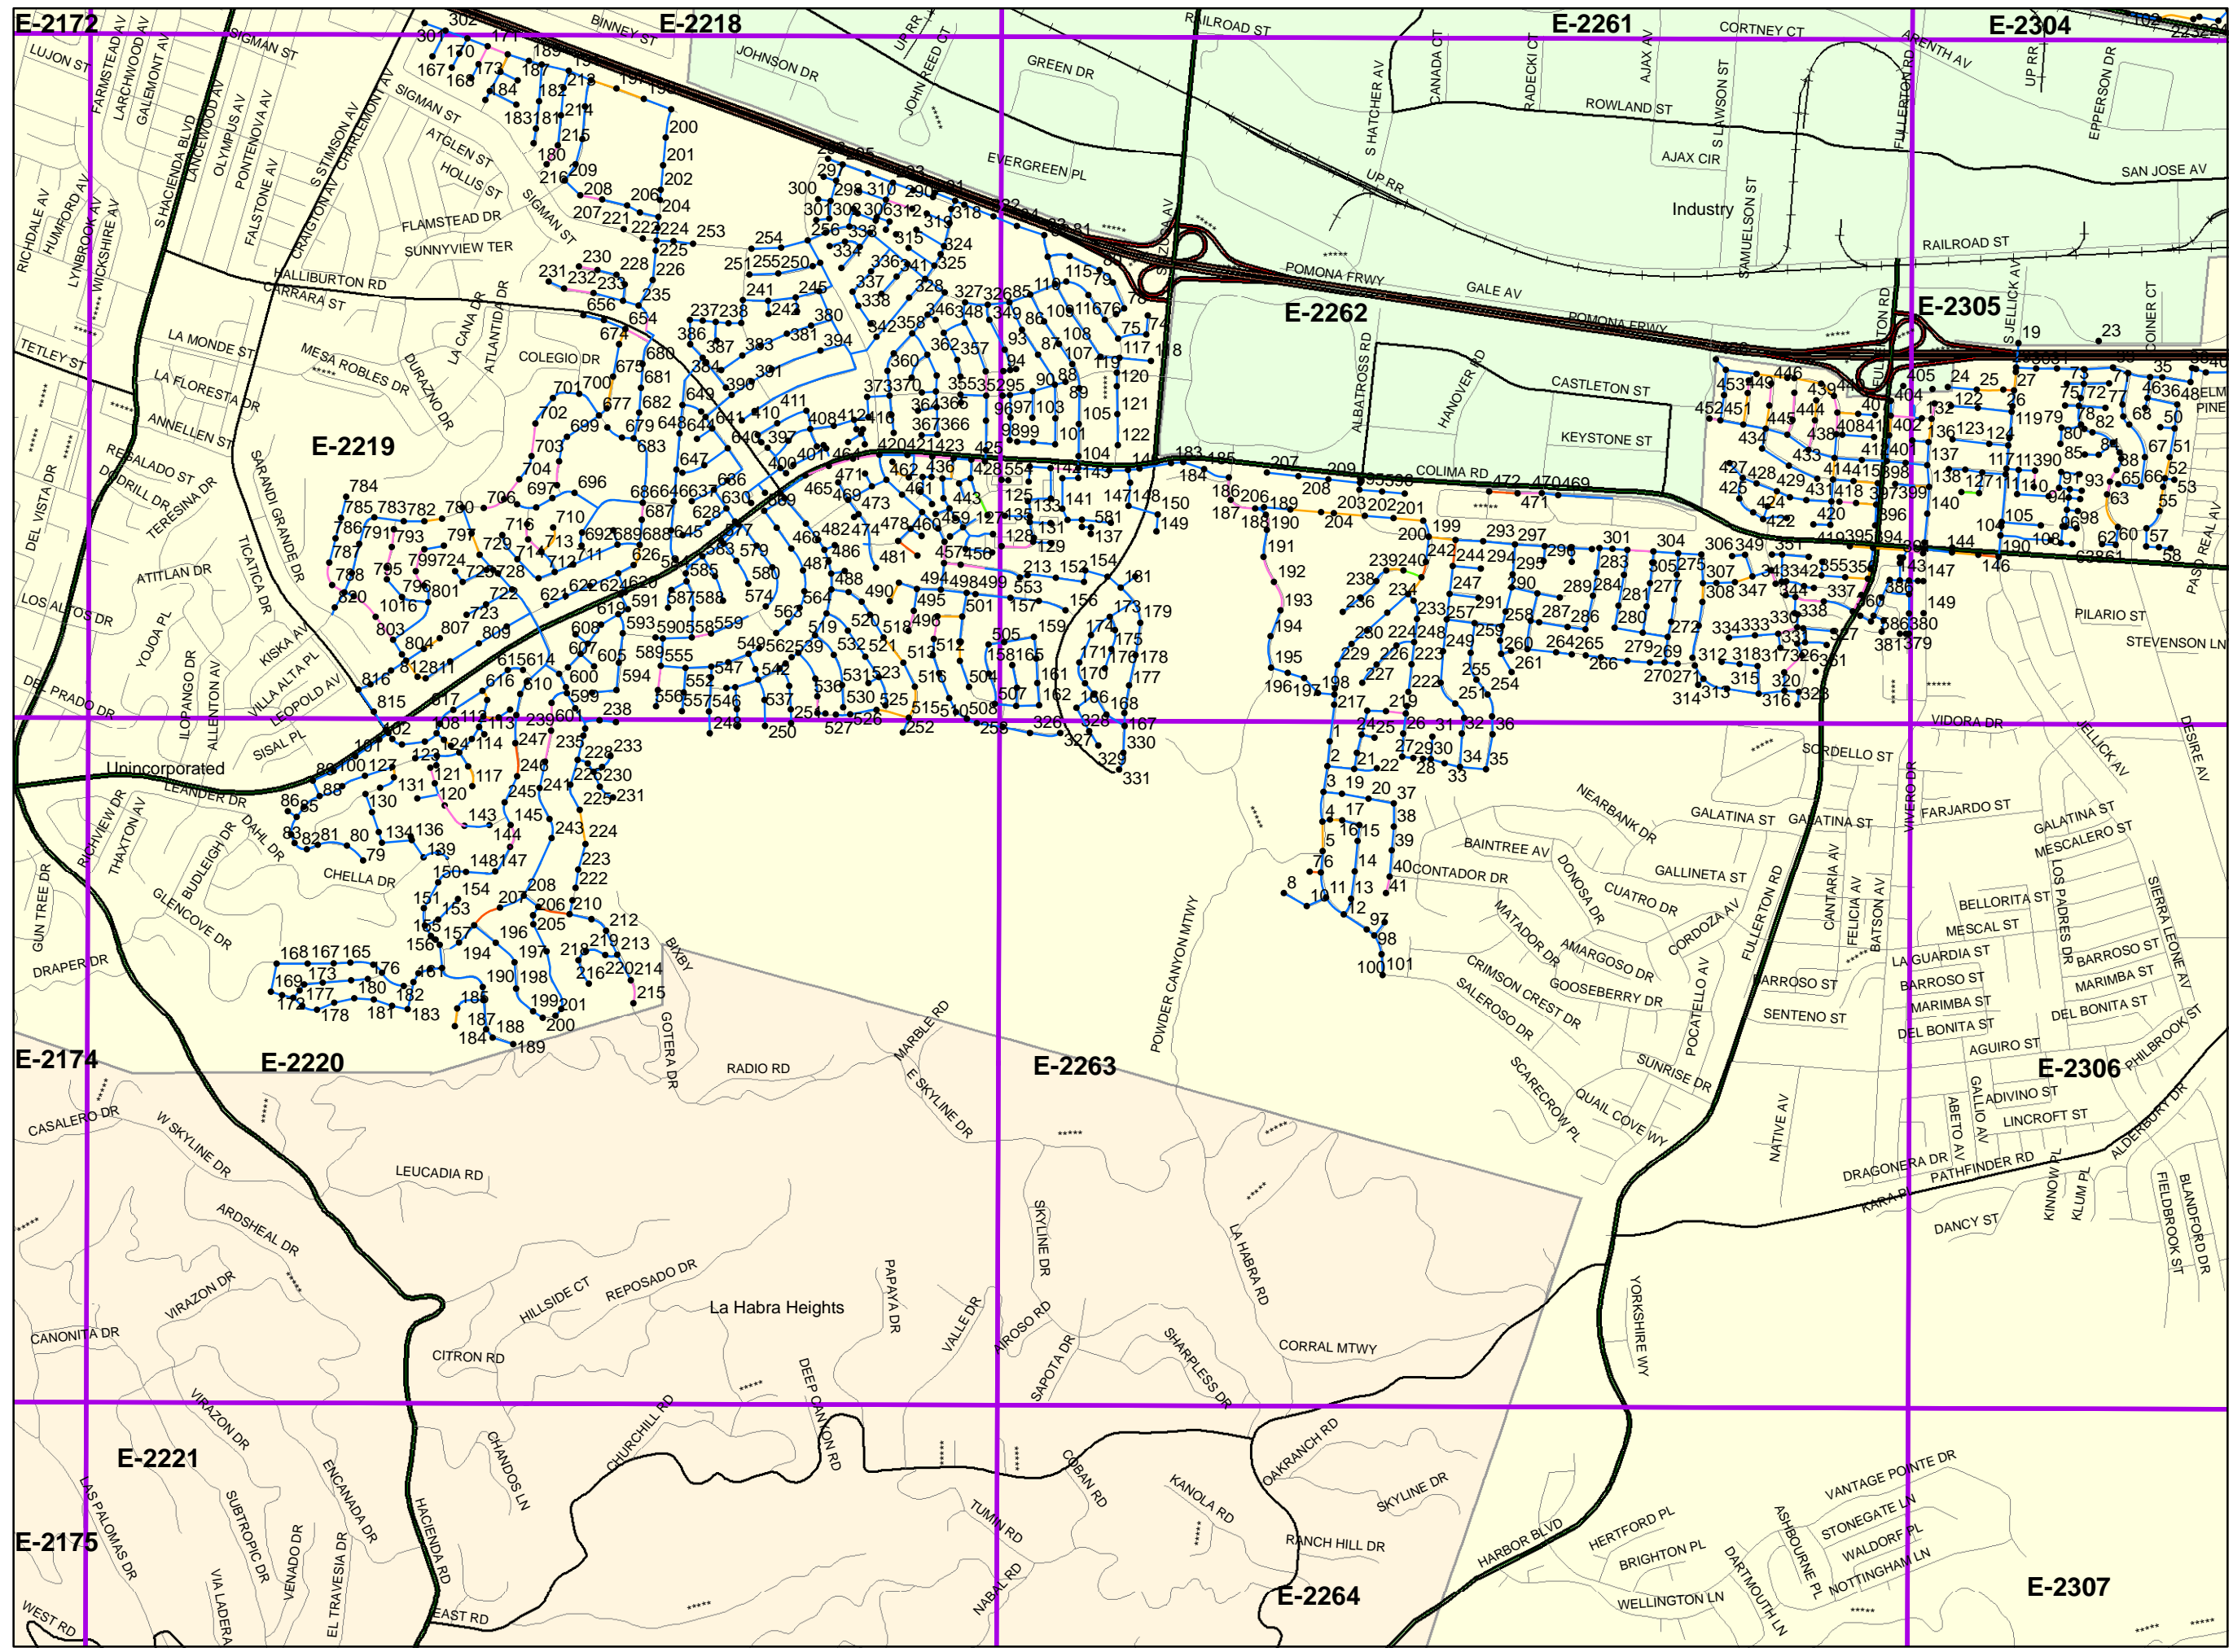
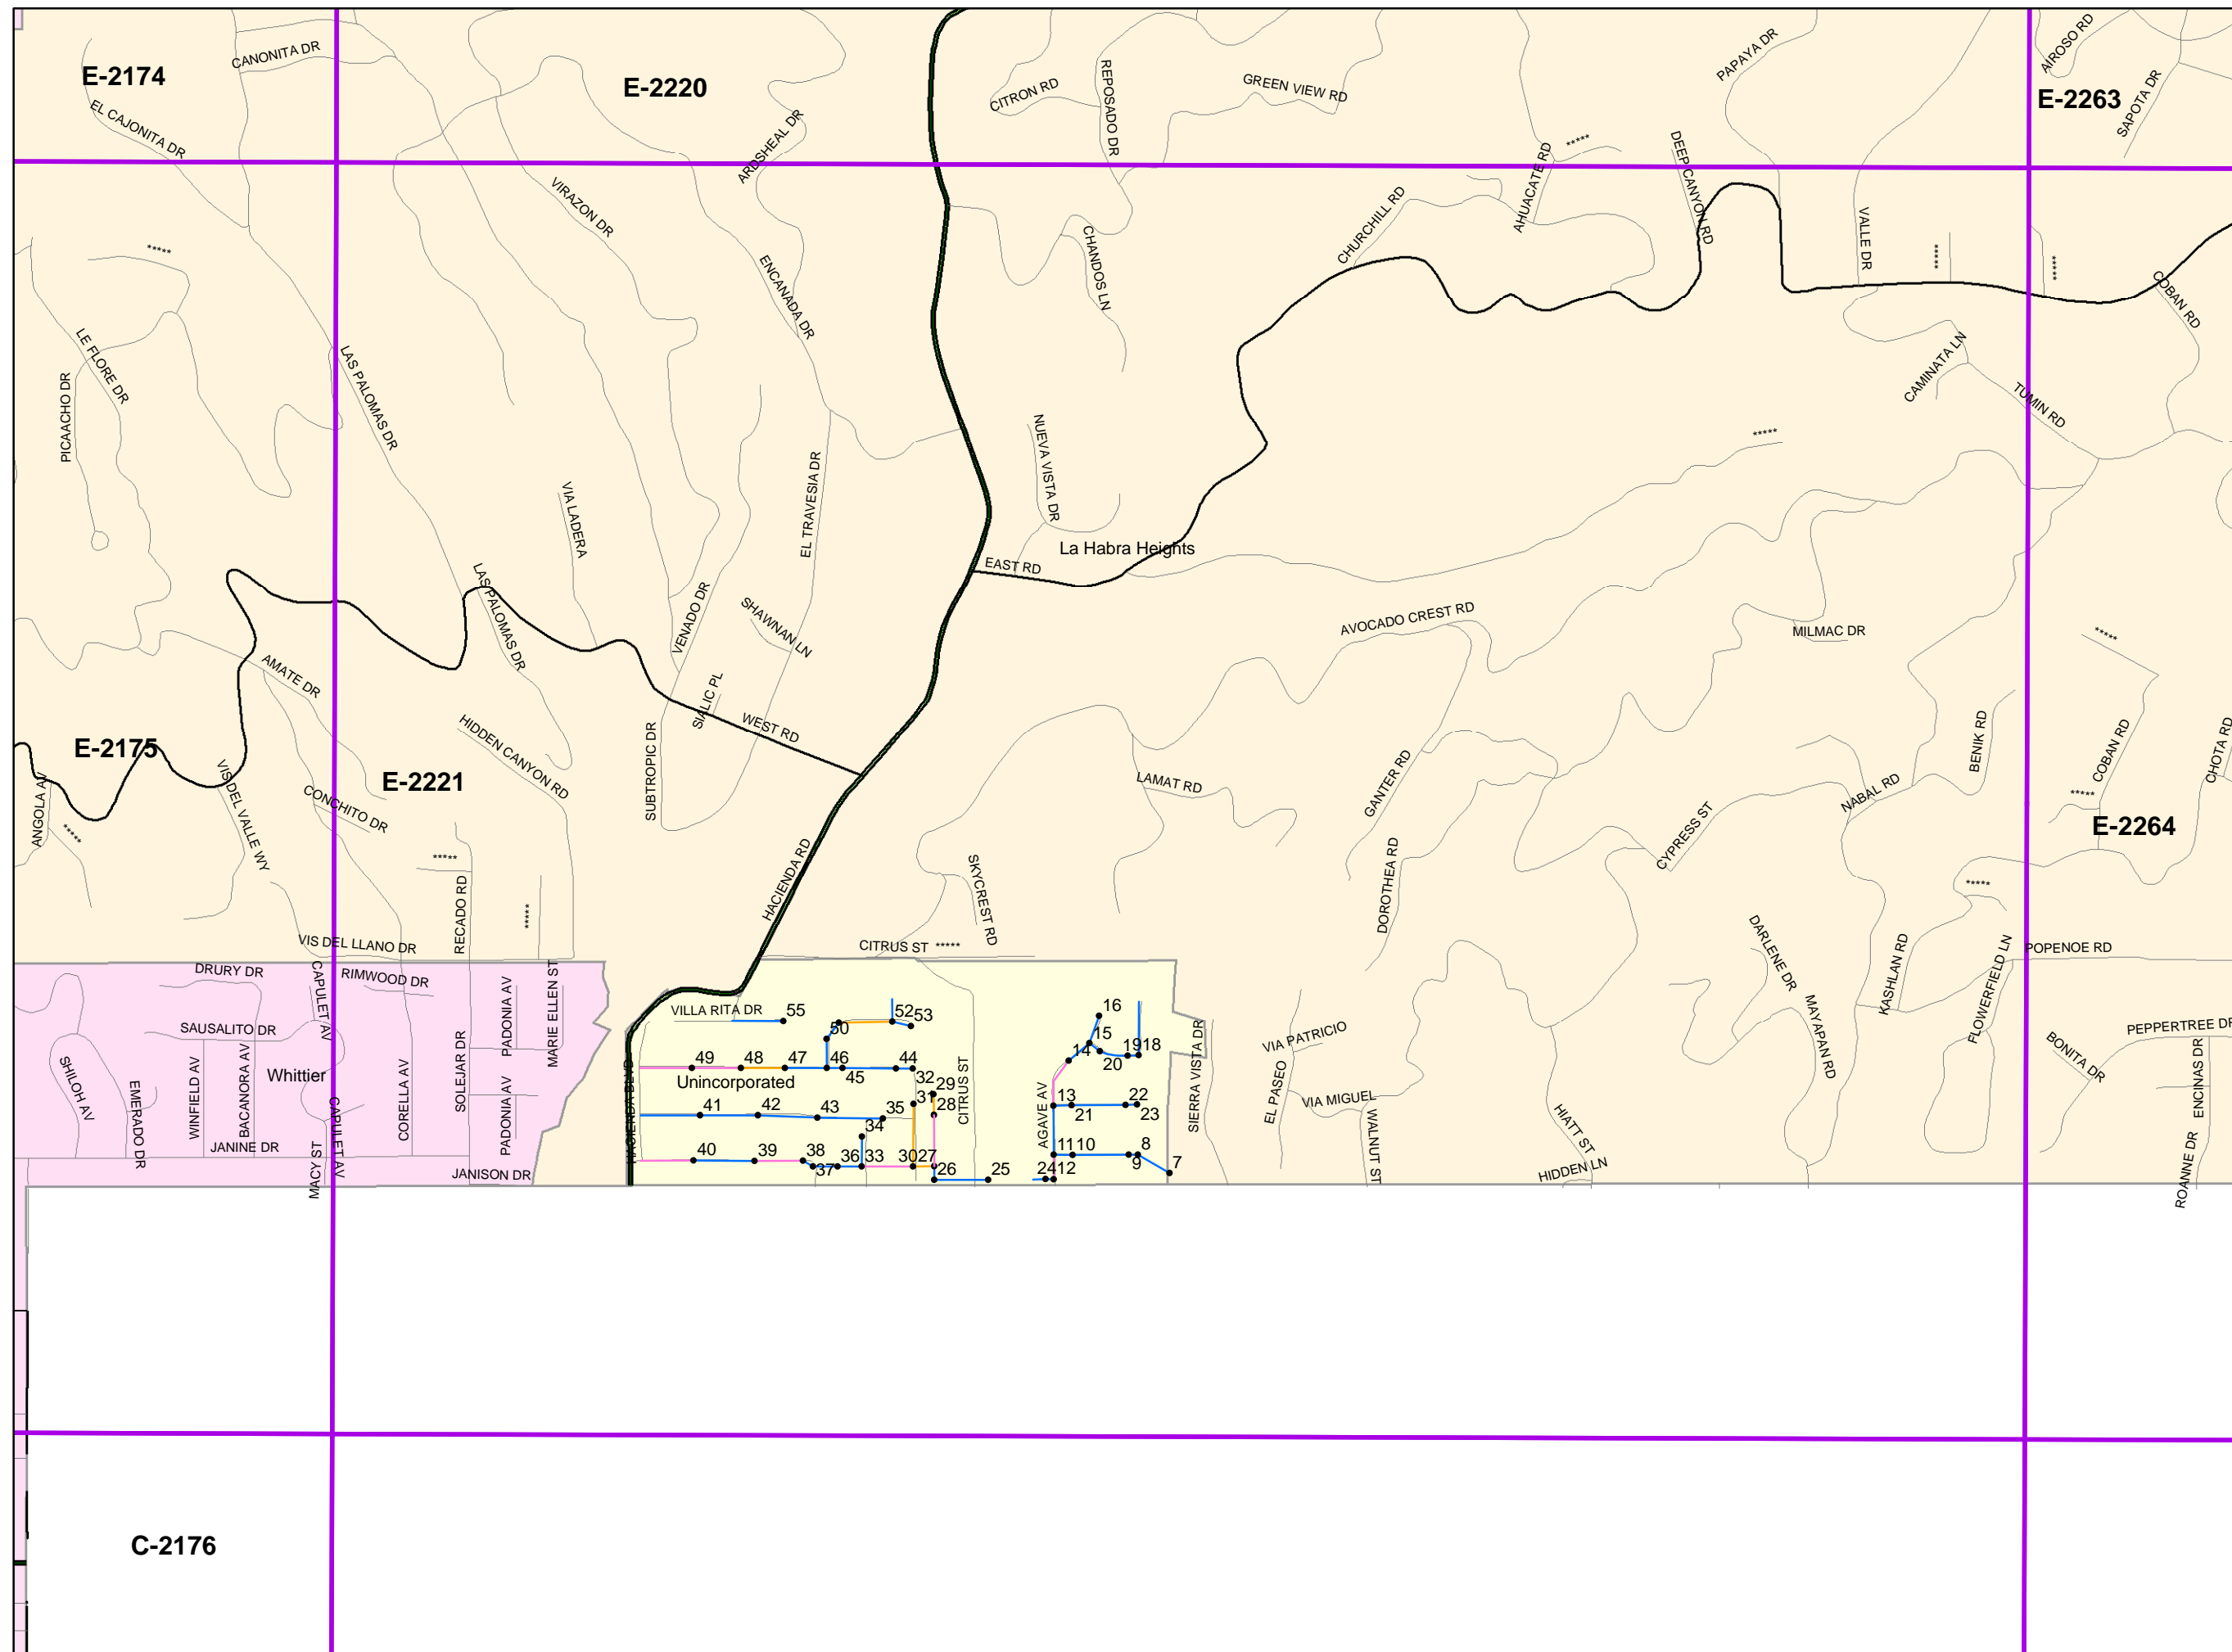
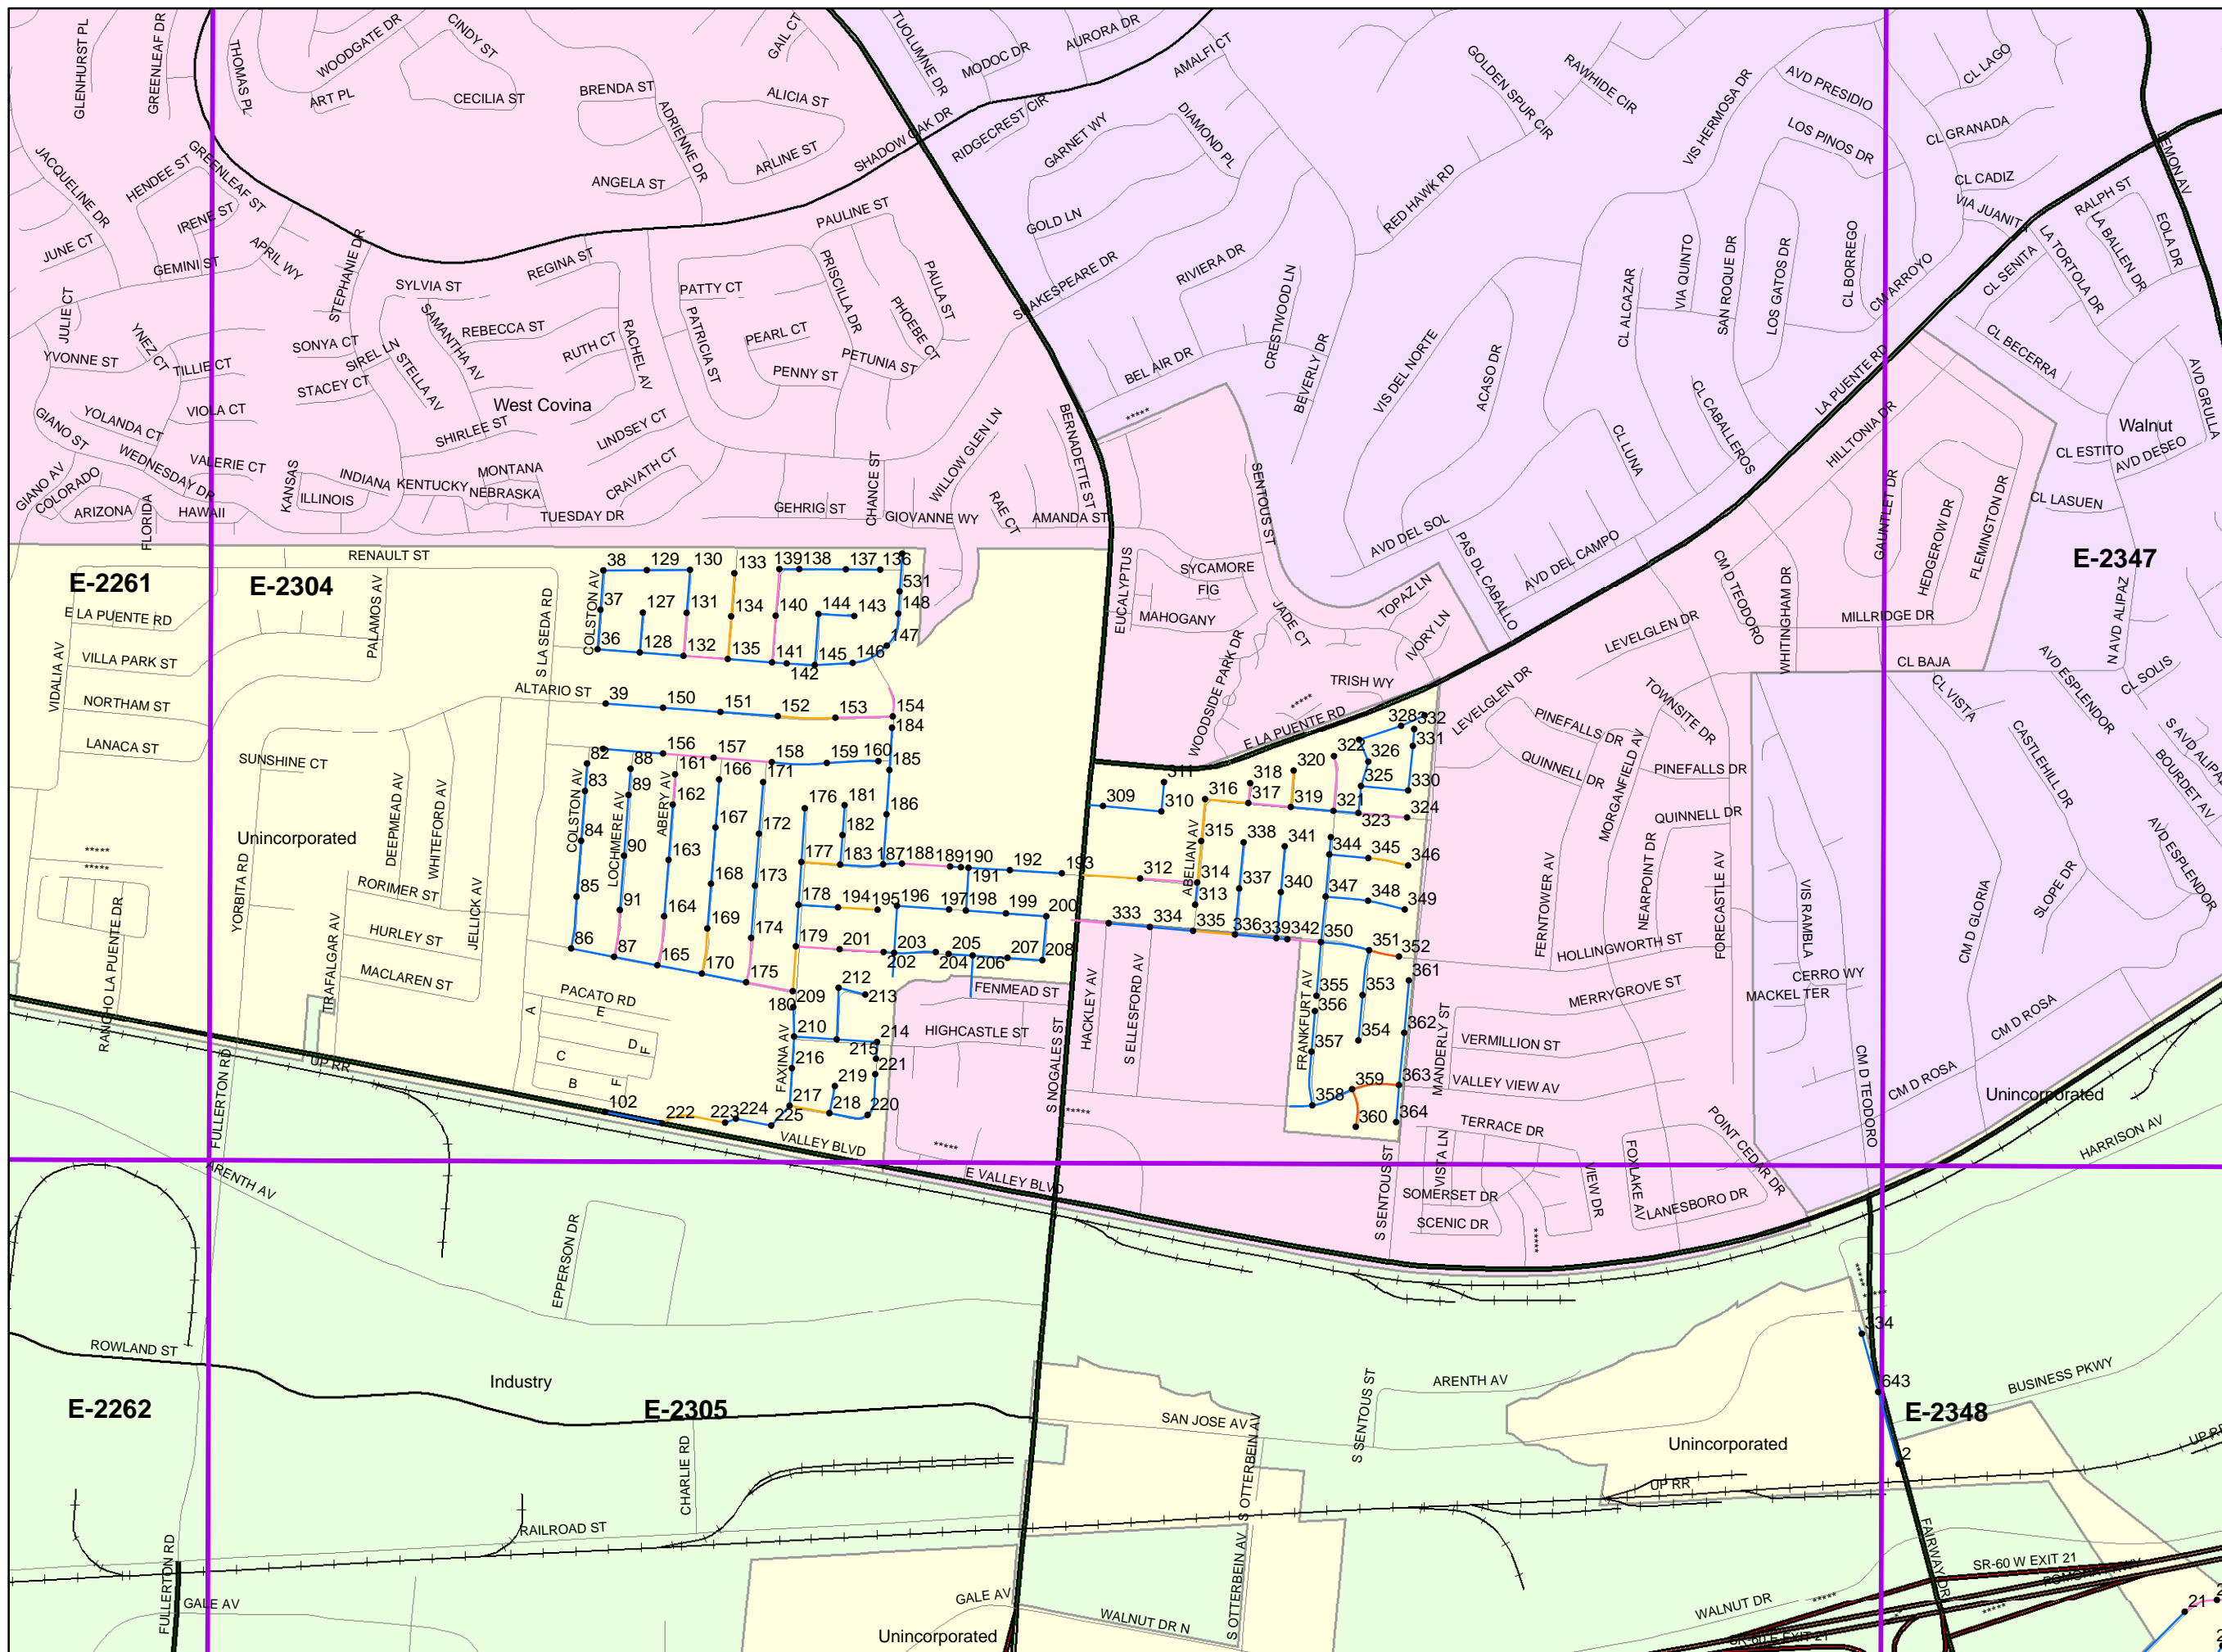
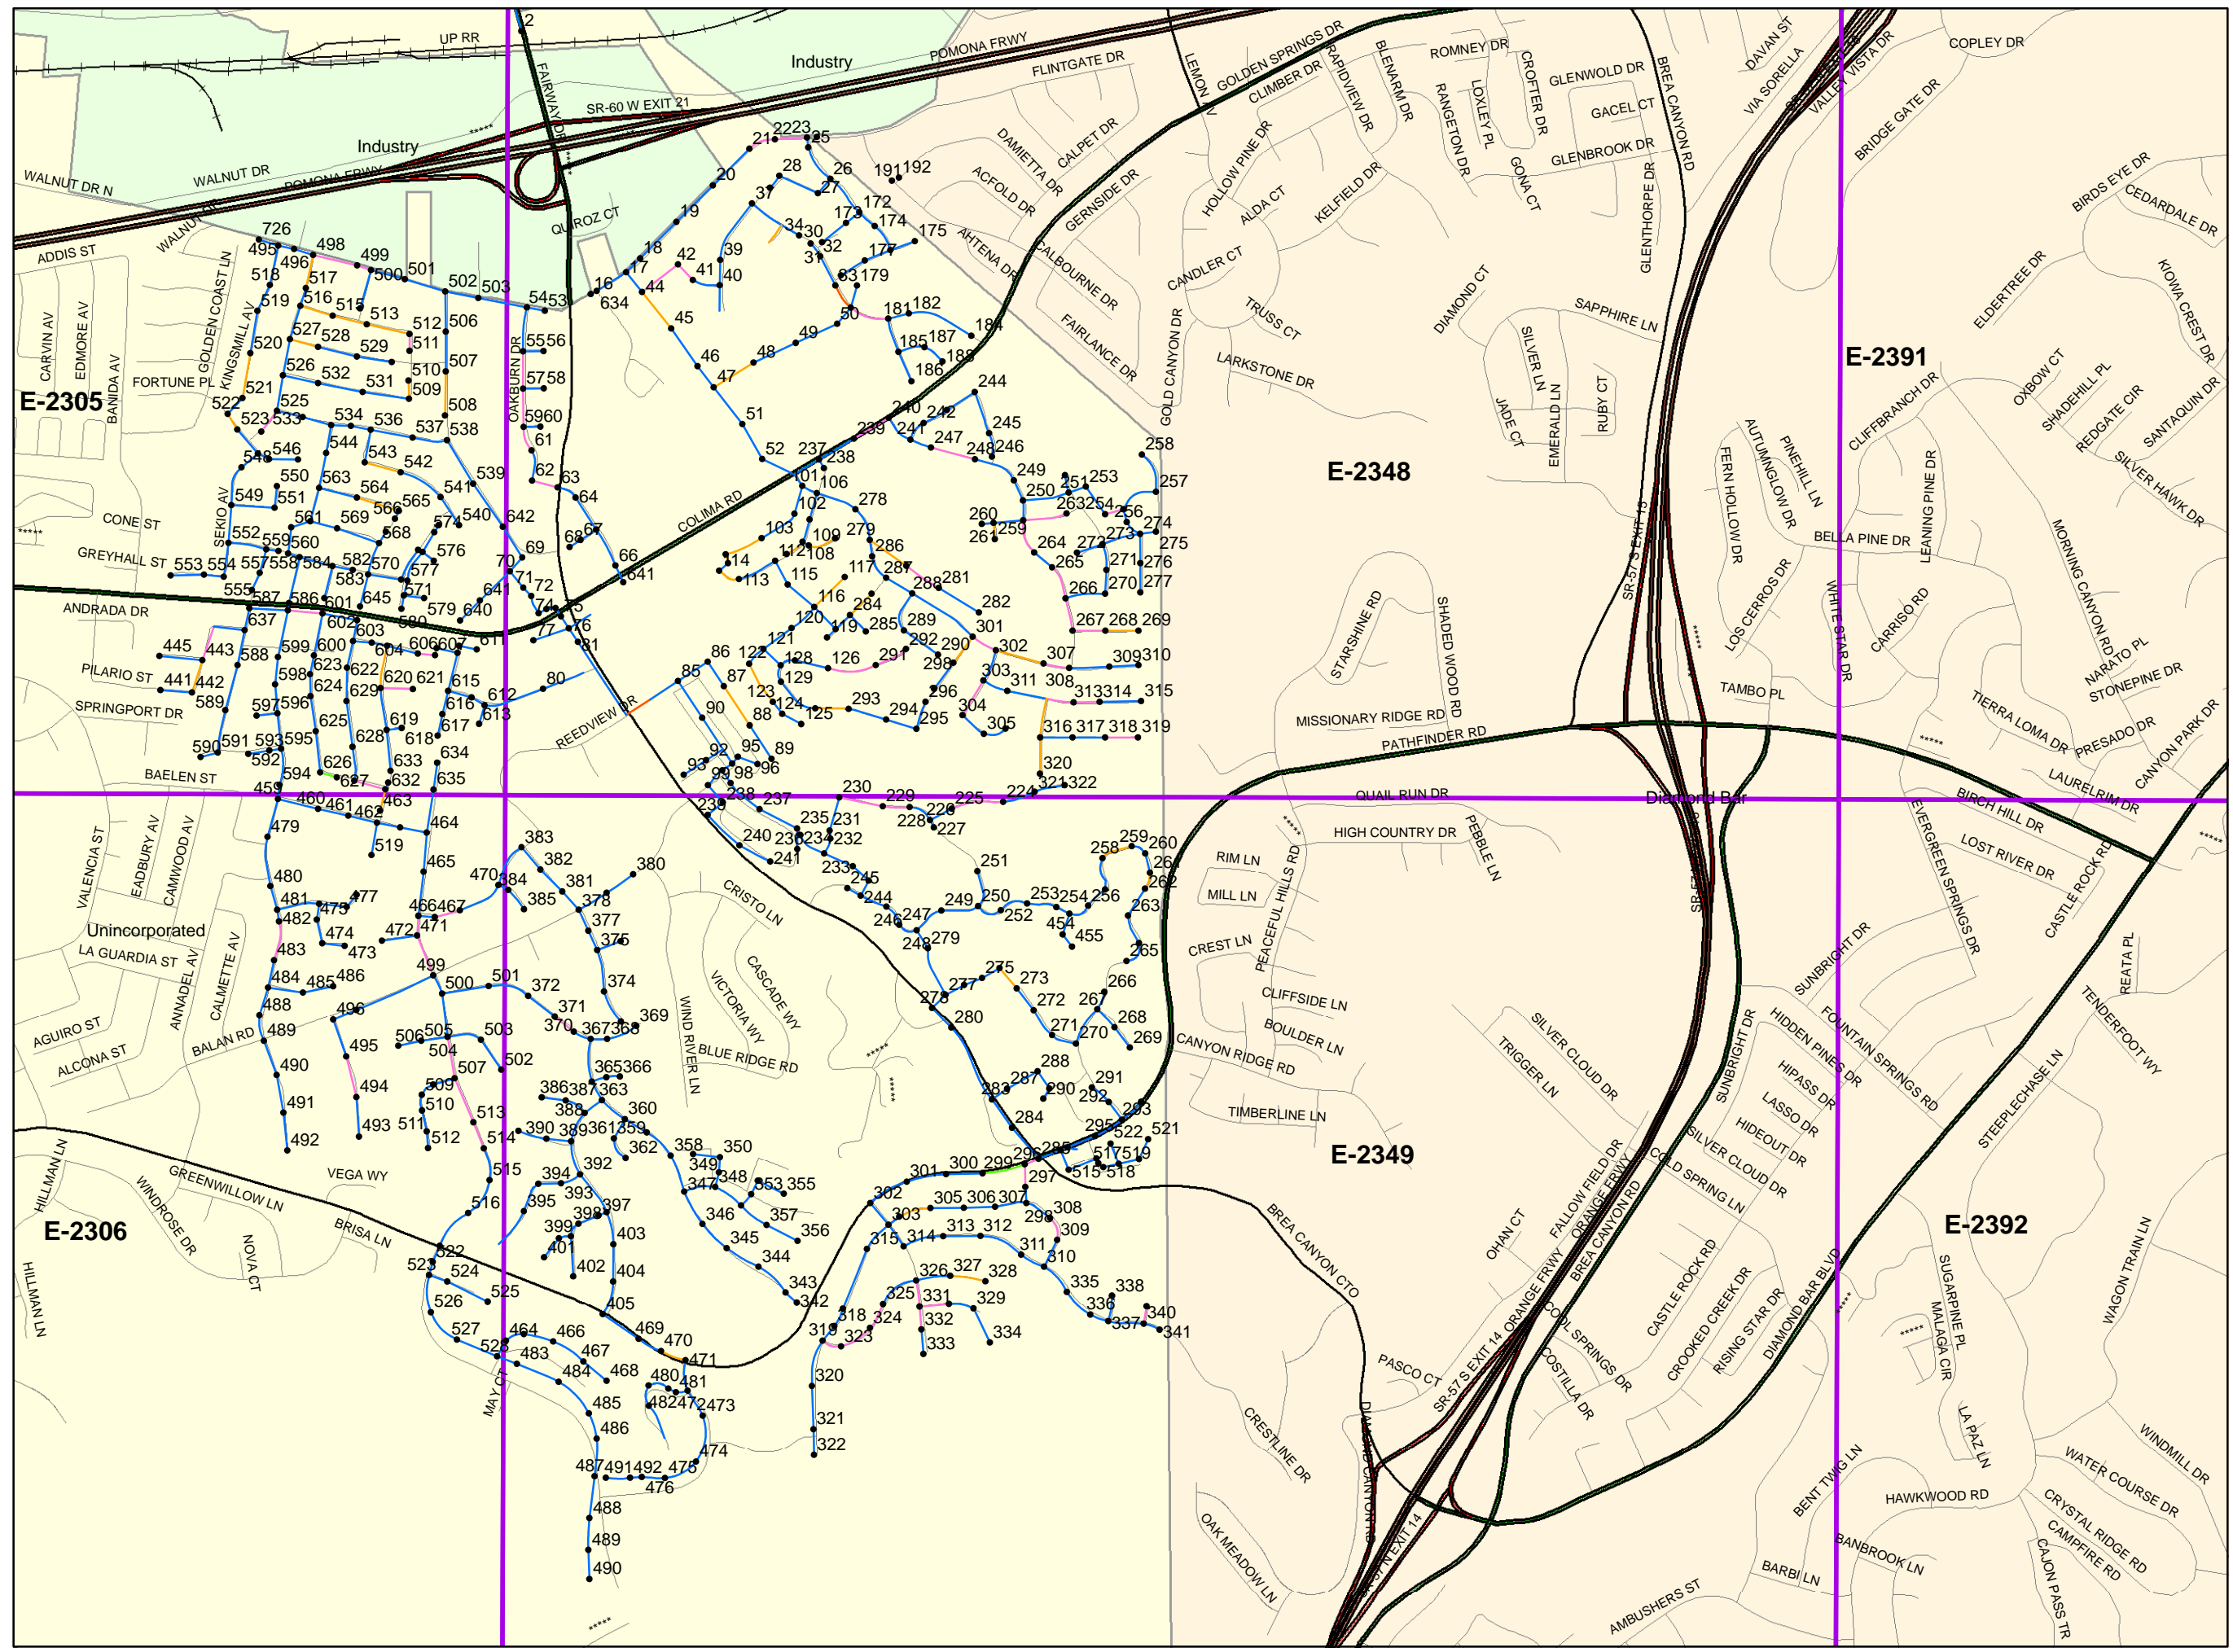
QUICK
MAINTENANCE
RATING

Our inspection revealed that approximately 83.7 percent of the system televised in unincorporated County as part of Project No. Y0TV10111A was free of significant blockages or restrictions that would impede sewer flows. However, the remaining 16.3 percent of the pipe segments within the unincorporated County had a PACP maintenance grade of 3, 4, or 5 as indicated in the Quick Maintenance Rating Table shown below. These segments have been incorporated into our routine cleaning schedule with corrective action taken.

A color-coded map showing the quick maintenance rating for each pipe segment is provided in Enclosure 2.

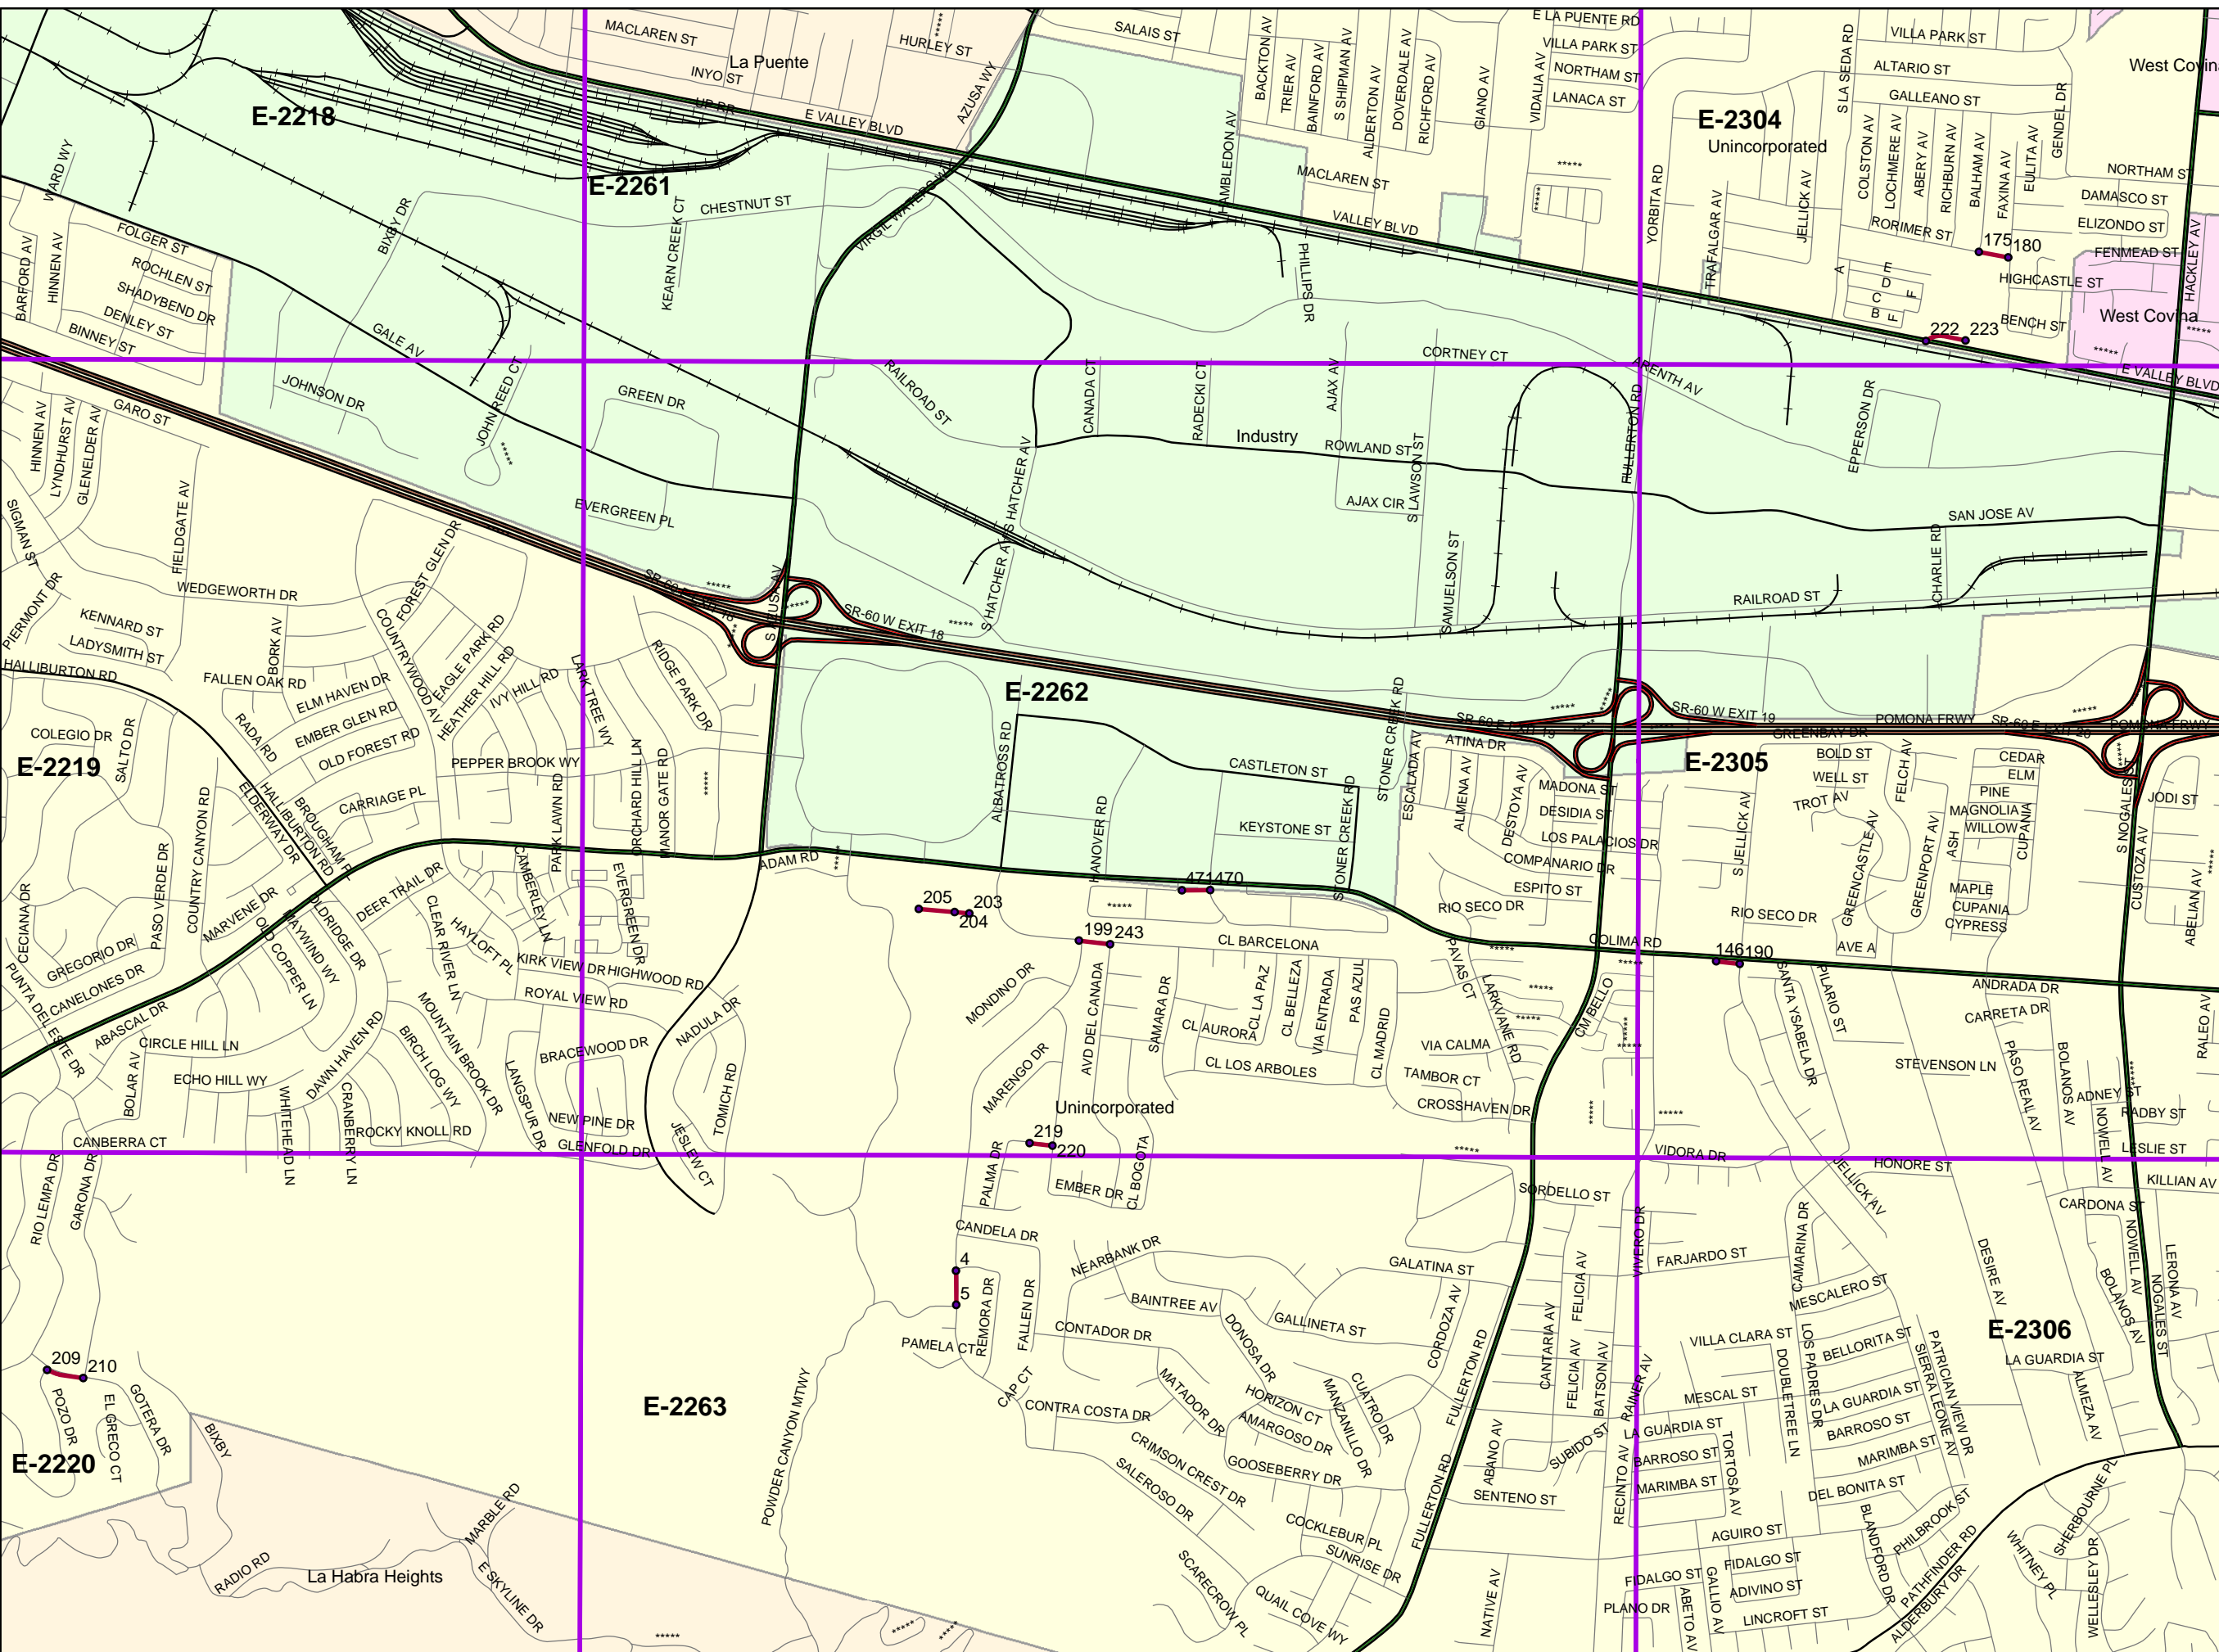
HIGH WATER
LEVEL

ITEM NO.	QMR	START MH	END MH	STREET	OBSERVATION: LOCATION	CAPACITY	CORRECTIVE ACTION
1	4131	2304-0180	2304-0175	RORIMER ST	Sag	NO	Hydrojet
2	3122	2304-0223	2304-0222	EASEMENT	Sag	NO	Hydrojet
3	3123	2263-0005	2263-0004	SALEROSO DR	Sag	NO	Hydrojet
4	4131	2262-0219	2262-0220	MORRO DR	Sag	NO	Hydrojet
5	3121	2262-0243	2262-0199	CALLE BARCELONA	Sag	NO	Hydrojet
6	4332	2262-0470	2262-0471	EASEMENT	Sag	NO	Hydrojet
7	5231	2305-0146	2305-0190	COLIMA RD	Water Mark 50 %	YES	Hydrojet
8	512B	2220-0210	2220-0209	GOTERA DR	Sag	NO	Hydrojet
9	3121	2262-0203	2262-0204		Sag	NO	Hydrojet
10	3121	2262-0204	2262-0205		Sag	NO	Hydrojet
