**CONSOLIDATED SEWER MAINTENANCE DISTRICT
CONDITION ASSESSMENT PROGRAM REPORT
UNINCORPORATED COUNTY**

**CONDITION ASSESSMENT REPORT
LOS ANGELES COUNTY PUBLIC WORKS
CONSOLIDATED SEWER MAINTENANCE DISTRICT**

PROJECT NAME: Y0TV1011A	PROJECT MGR:	Eric Liu
PROJECT DATE: 02/01/11-07/30/011	CONTACT NO:	(626) 300-3390
SUP. DISTRICT(s): 5	MAP PAGE(S):	2349,2603,2305,2304,2348, 2220,2262,2263,2219,2221, & 2347
Report By: Jonathan Gonzalez	Report Date:	8/29/18

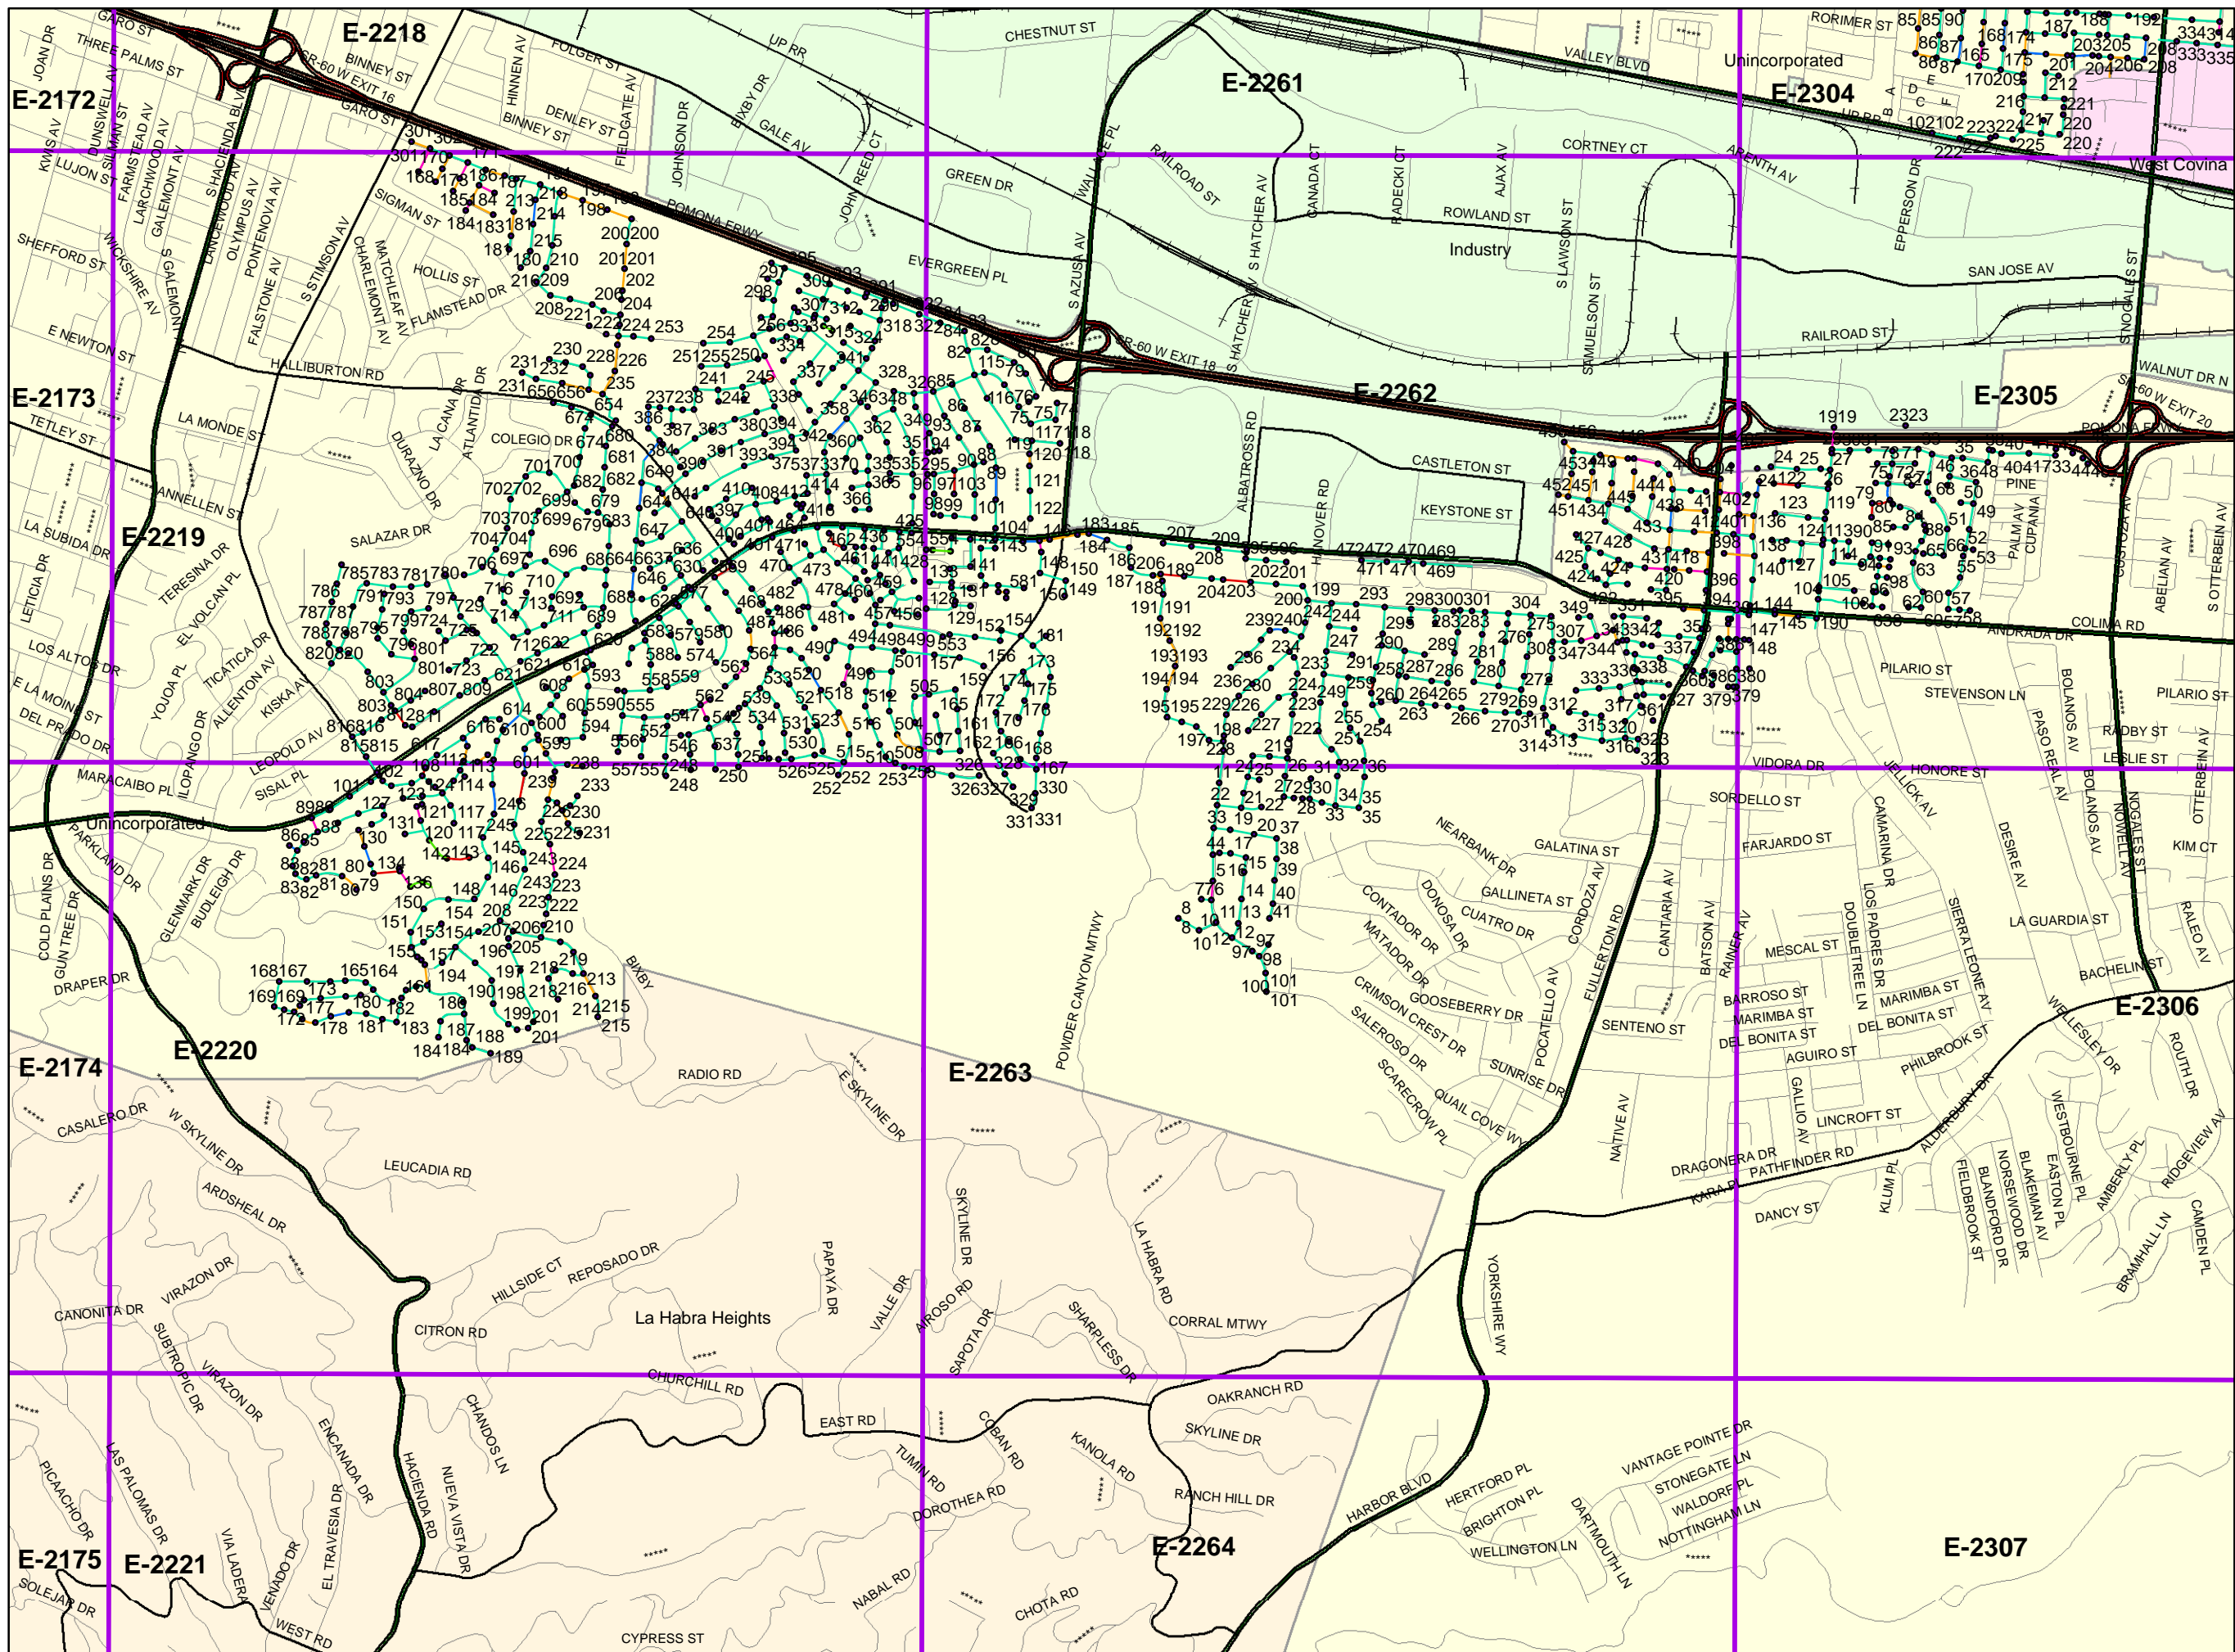
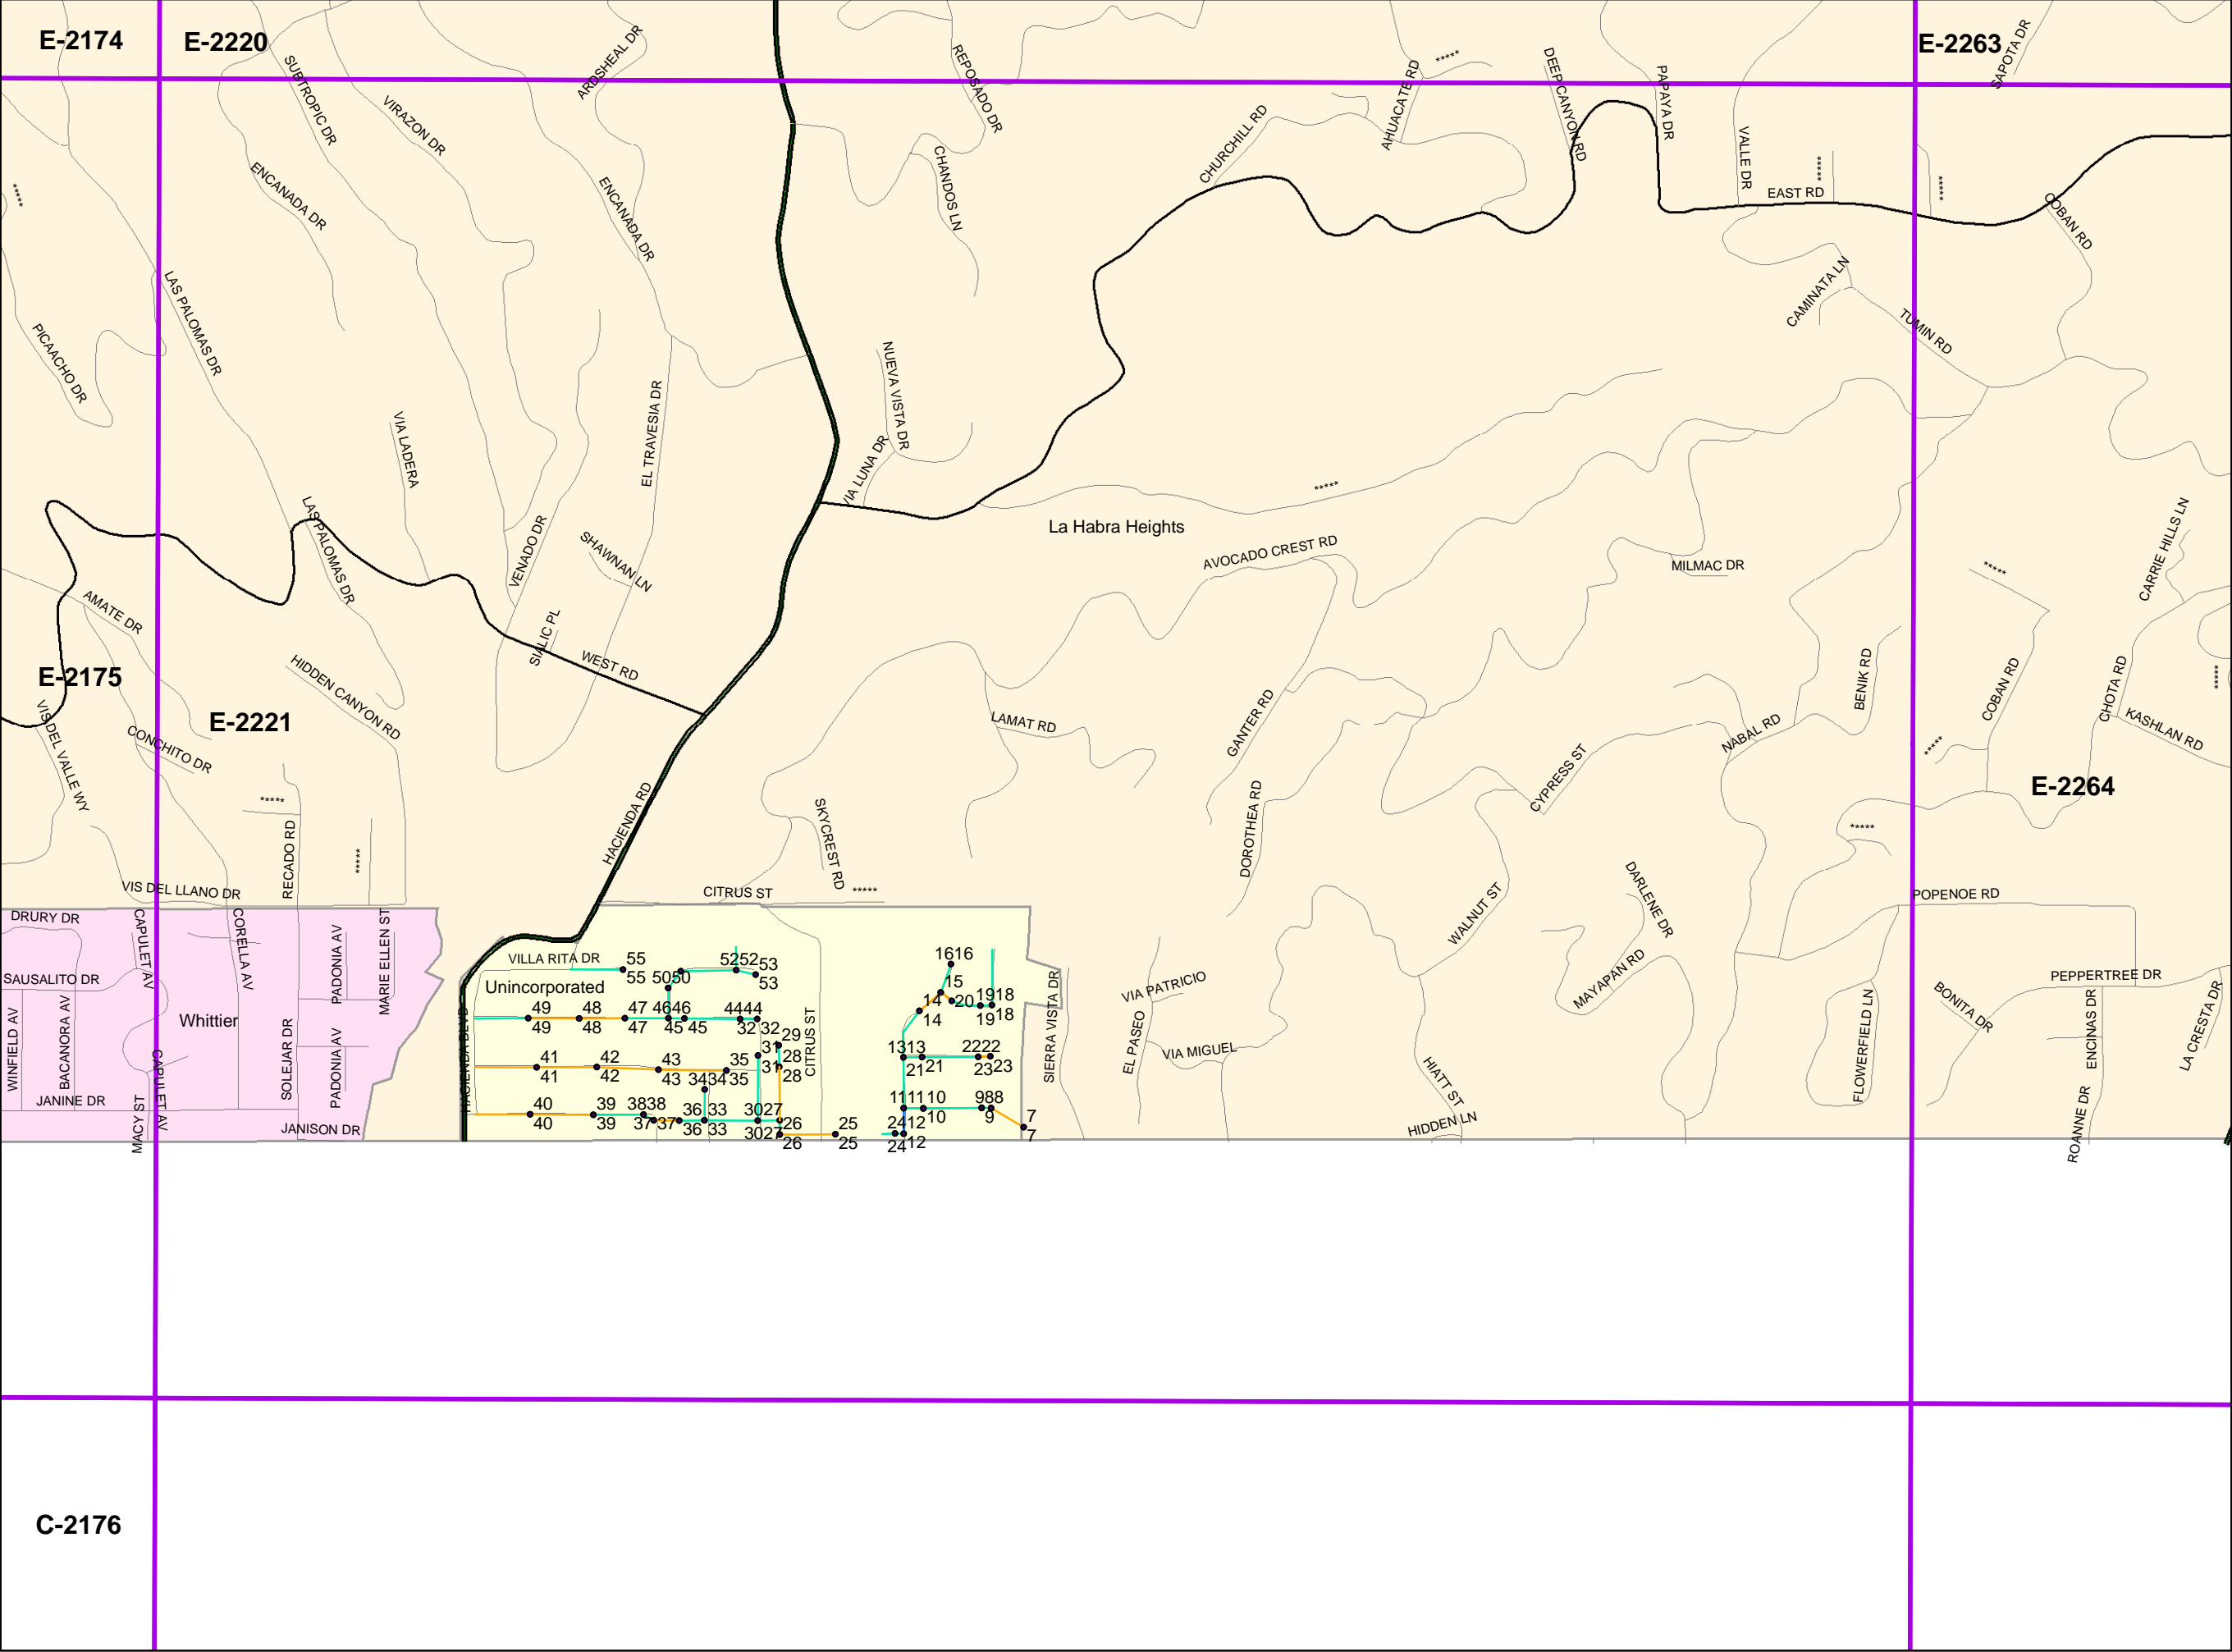
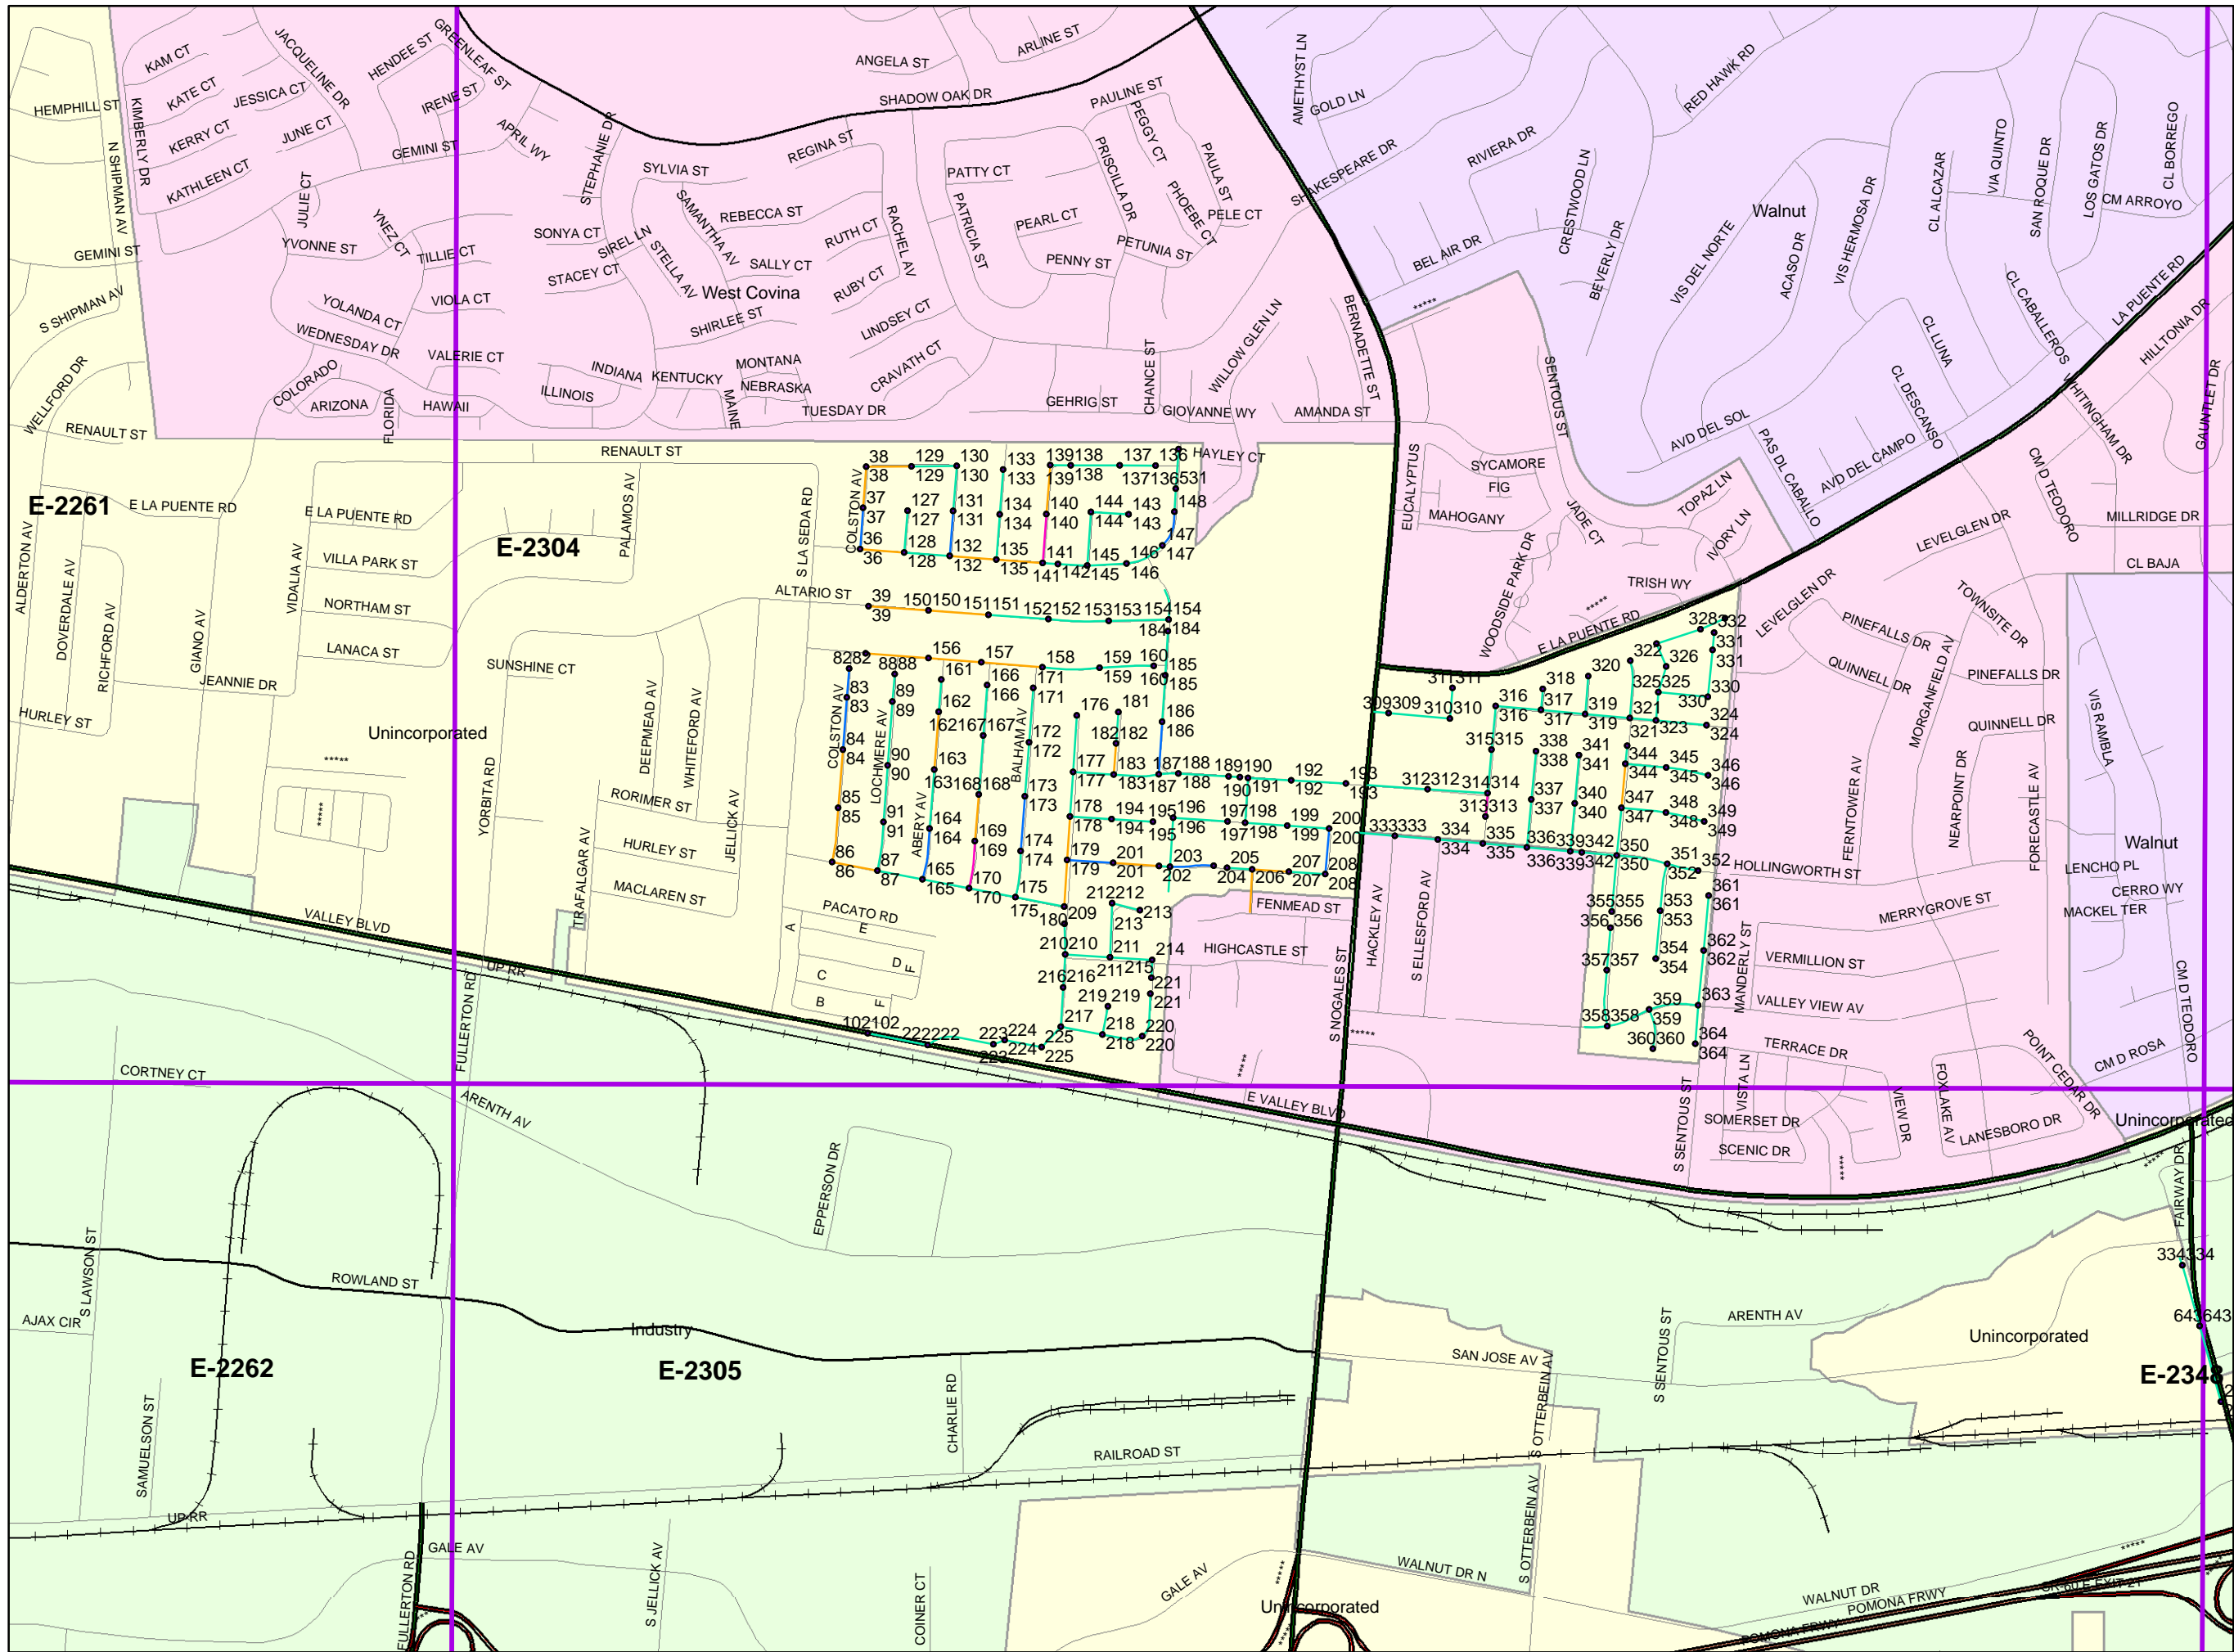
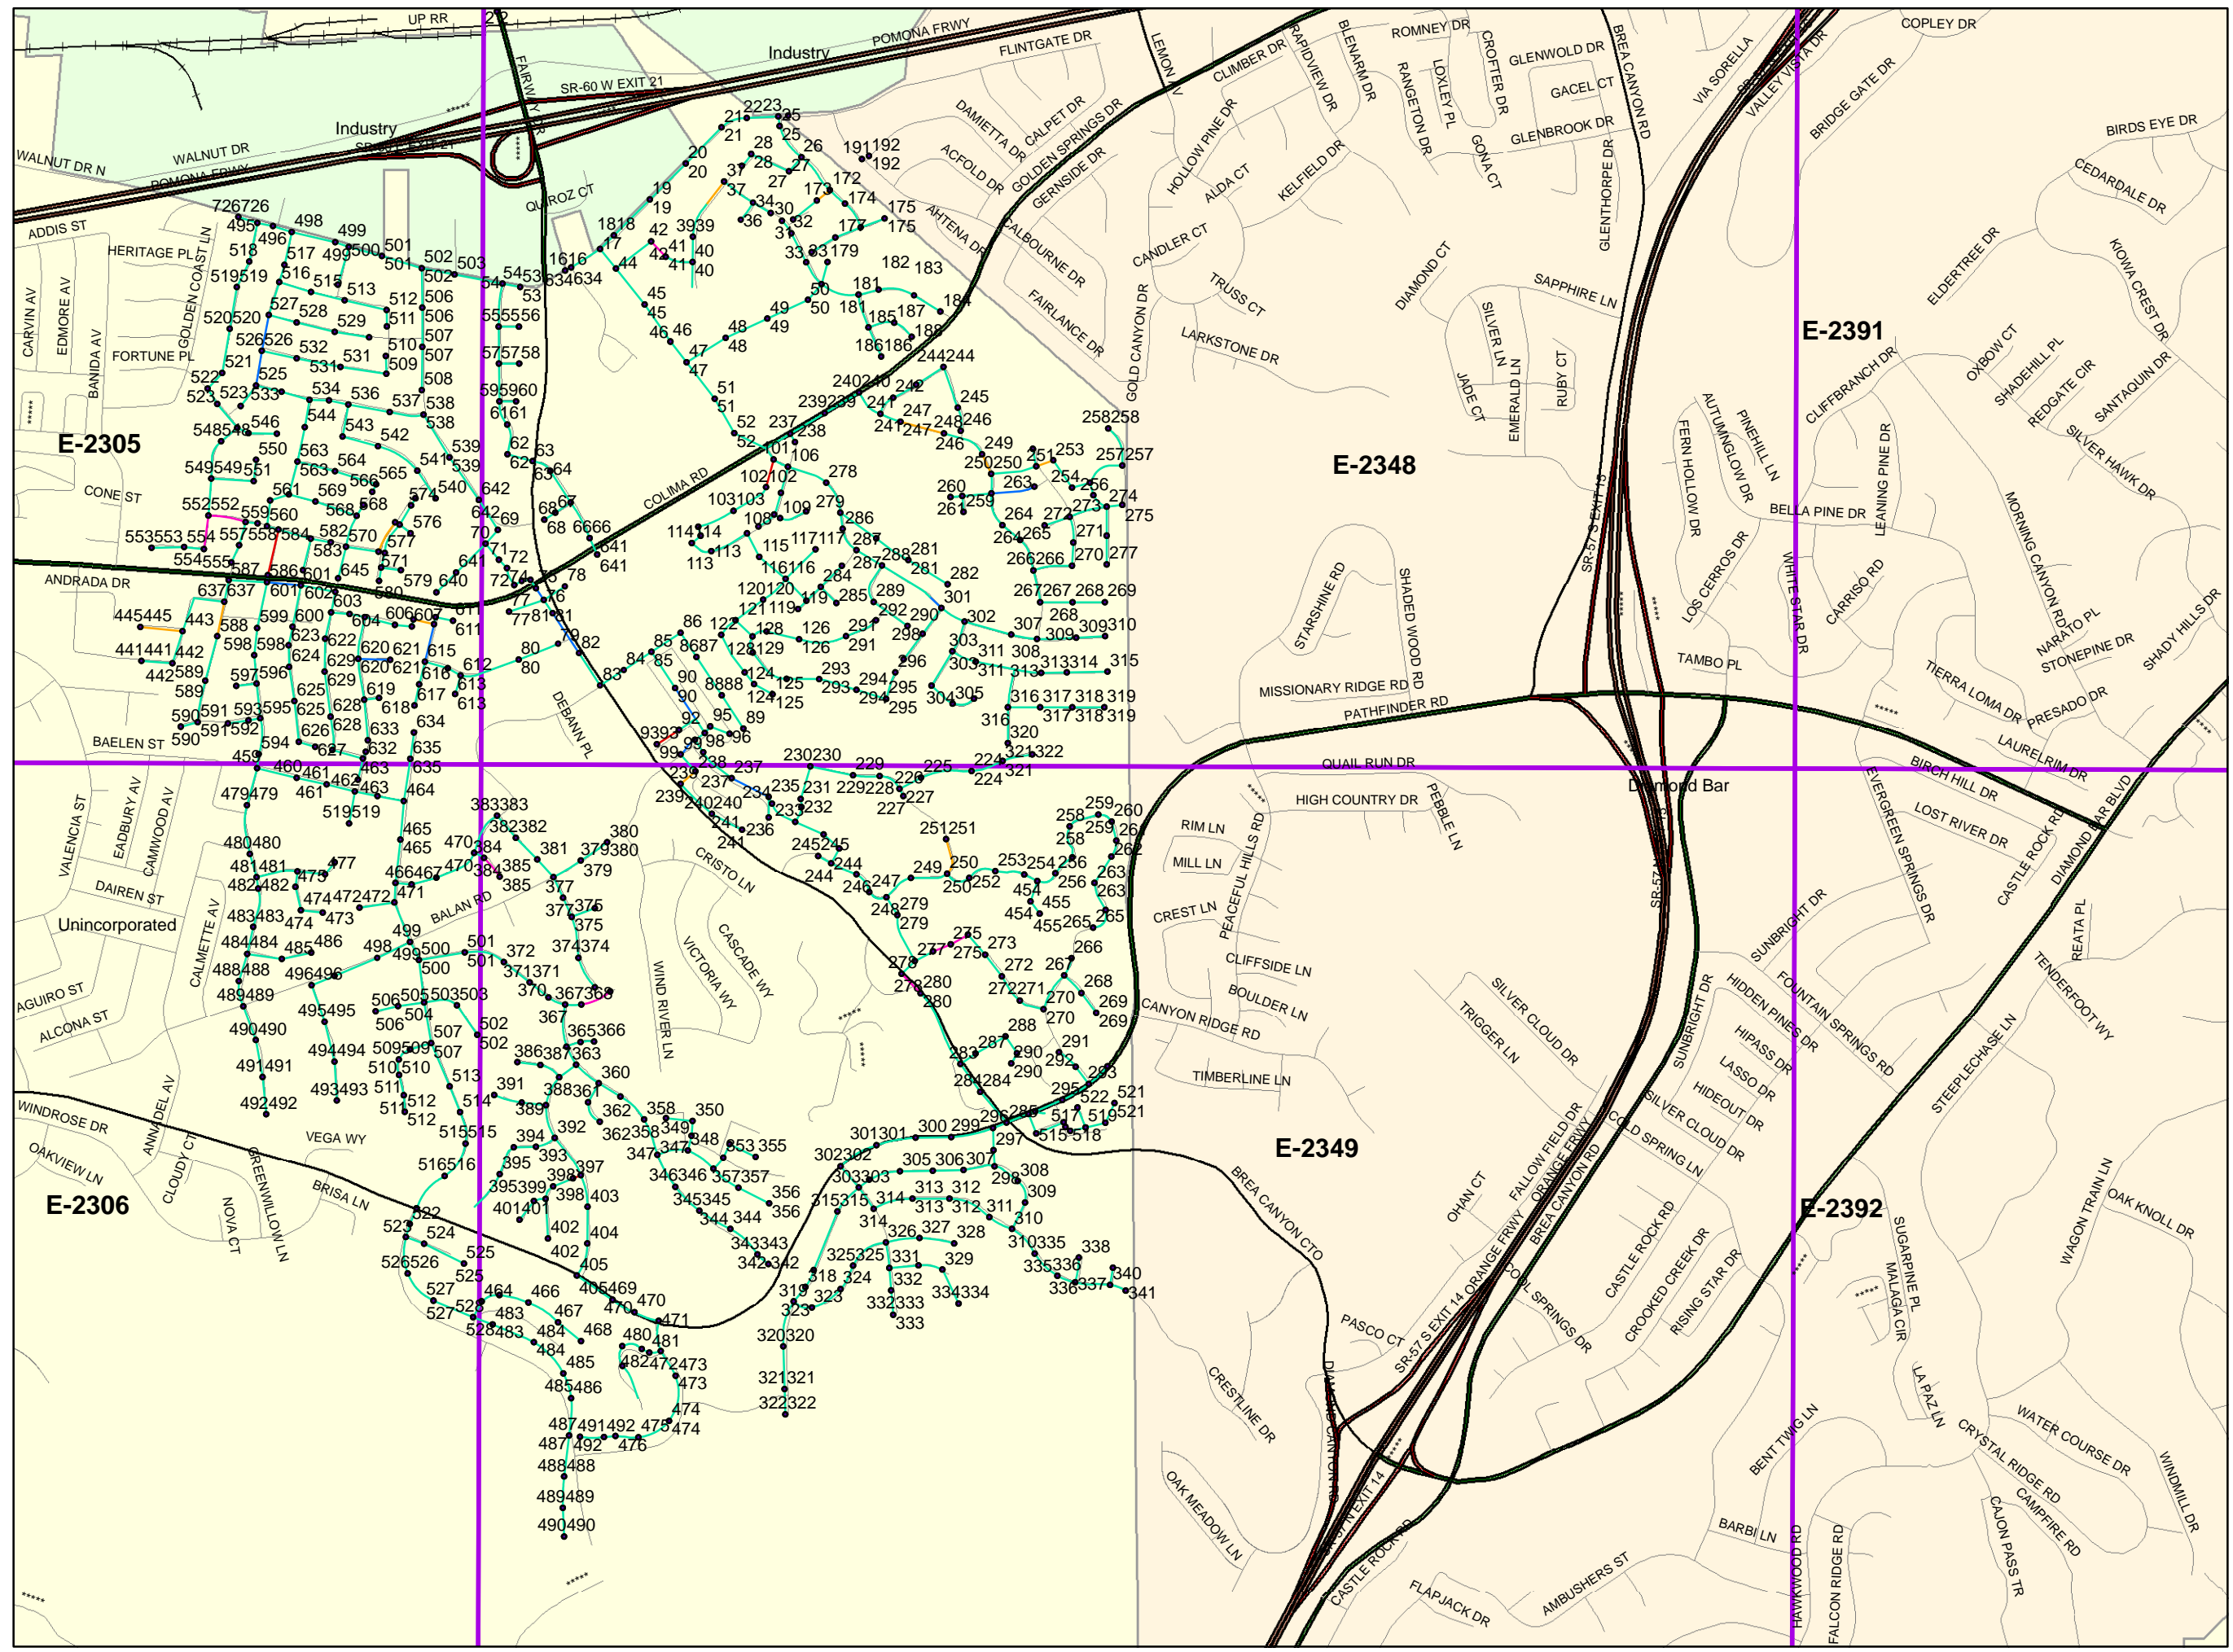
QUICK STRUCTURAL RATING

Our inspection revealed that approximately 97.5 percent of the inspected pipe segments within the unincorporated County were free of severe structural defects. However, the remaining 2.5 percent of the inspected pipe segments had a PACP structural grade of 4 or 5 as indicated in the Quick Structural Rating Table shown below. These segments have been placed on a priority list based on the severity and the need for action. For items 1 through 58 in the Quick Structural Rating Report Priority List (Enclosure 3), which

A color-coded map showing the Quick Structural Rating for each pipe segment is located in Enclosure 3.

warrant a corrective action, the proposed corrective action will be programmed in the next 24 months as part of the ongoing Accumulative Capital Outlay Program.
