**CONSOLIDATED SEWER MAINTENANCE DISTRICT
CONDITION ASSESSMENT PROGRAM REPORT
PROJECT Y0TV0809D**

**CONDITION ASSESSMENT REPORT
COUNTY OF LOS ANGELES DEPARTMENT OF PUBLIC WORKS
CONSOLIDATED SEWER MAINTENANCE DISTRICT**

PROJECT NAME:	Y0TV0809D	PROJECT MGR:	Eric Liu
PROJECT DATE:	07/08/2009	CONTACT NO:	(626) 300-3369
SUP. DISTRICT(s):	5	MAP PAGE(S):	1887
Report By:	Eric Liu	Report Date:	11/07/2010

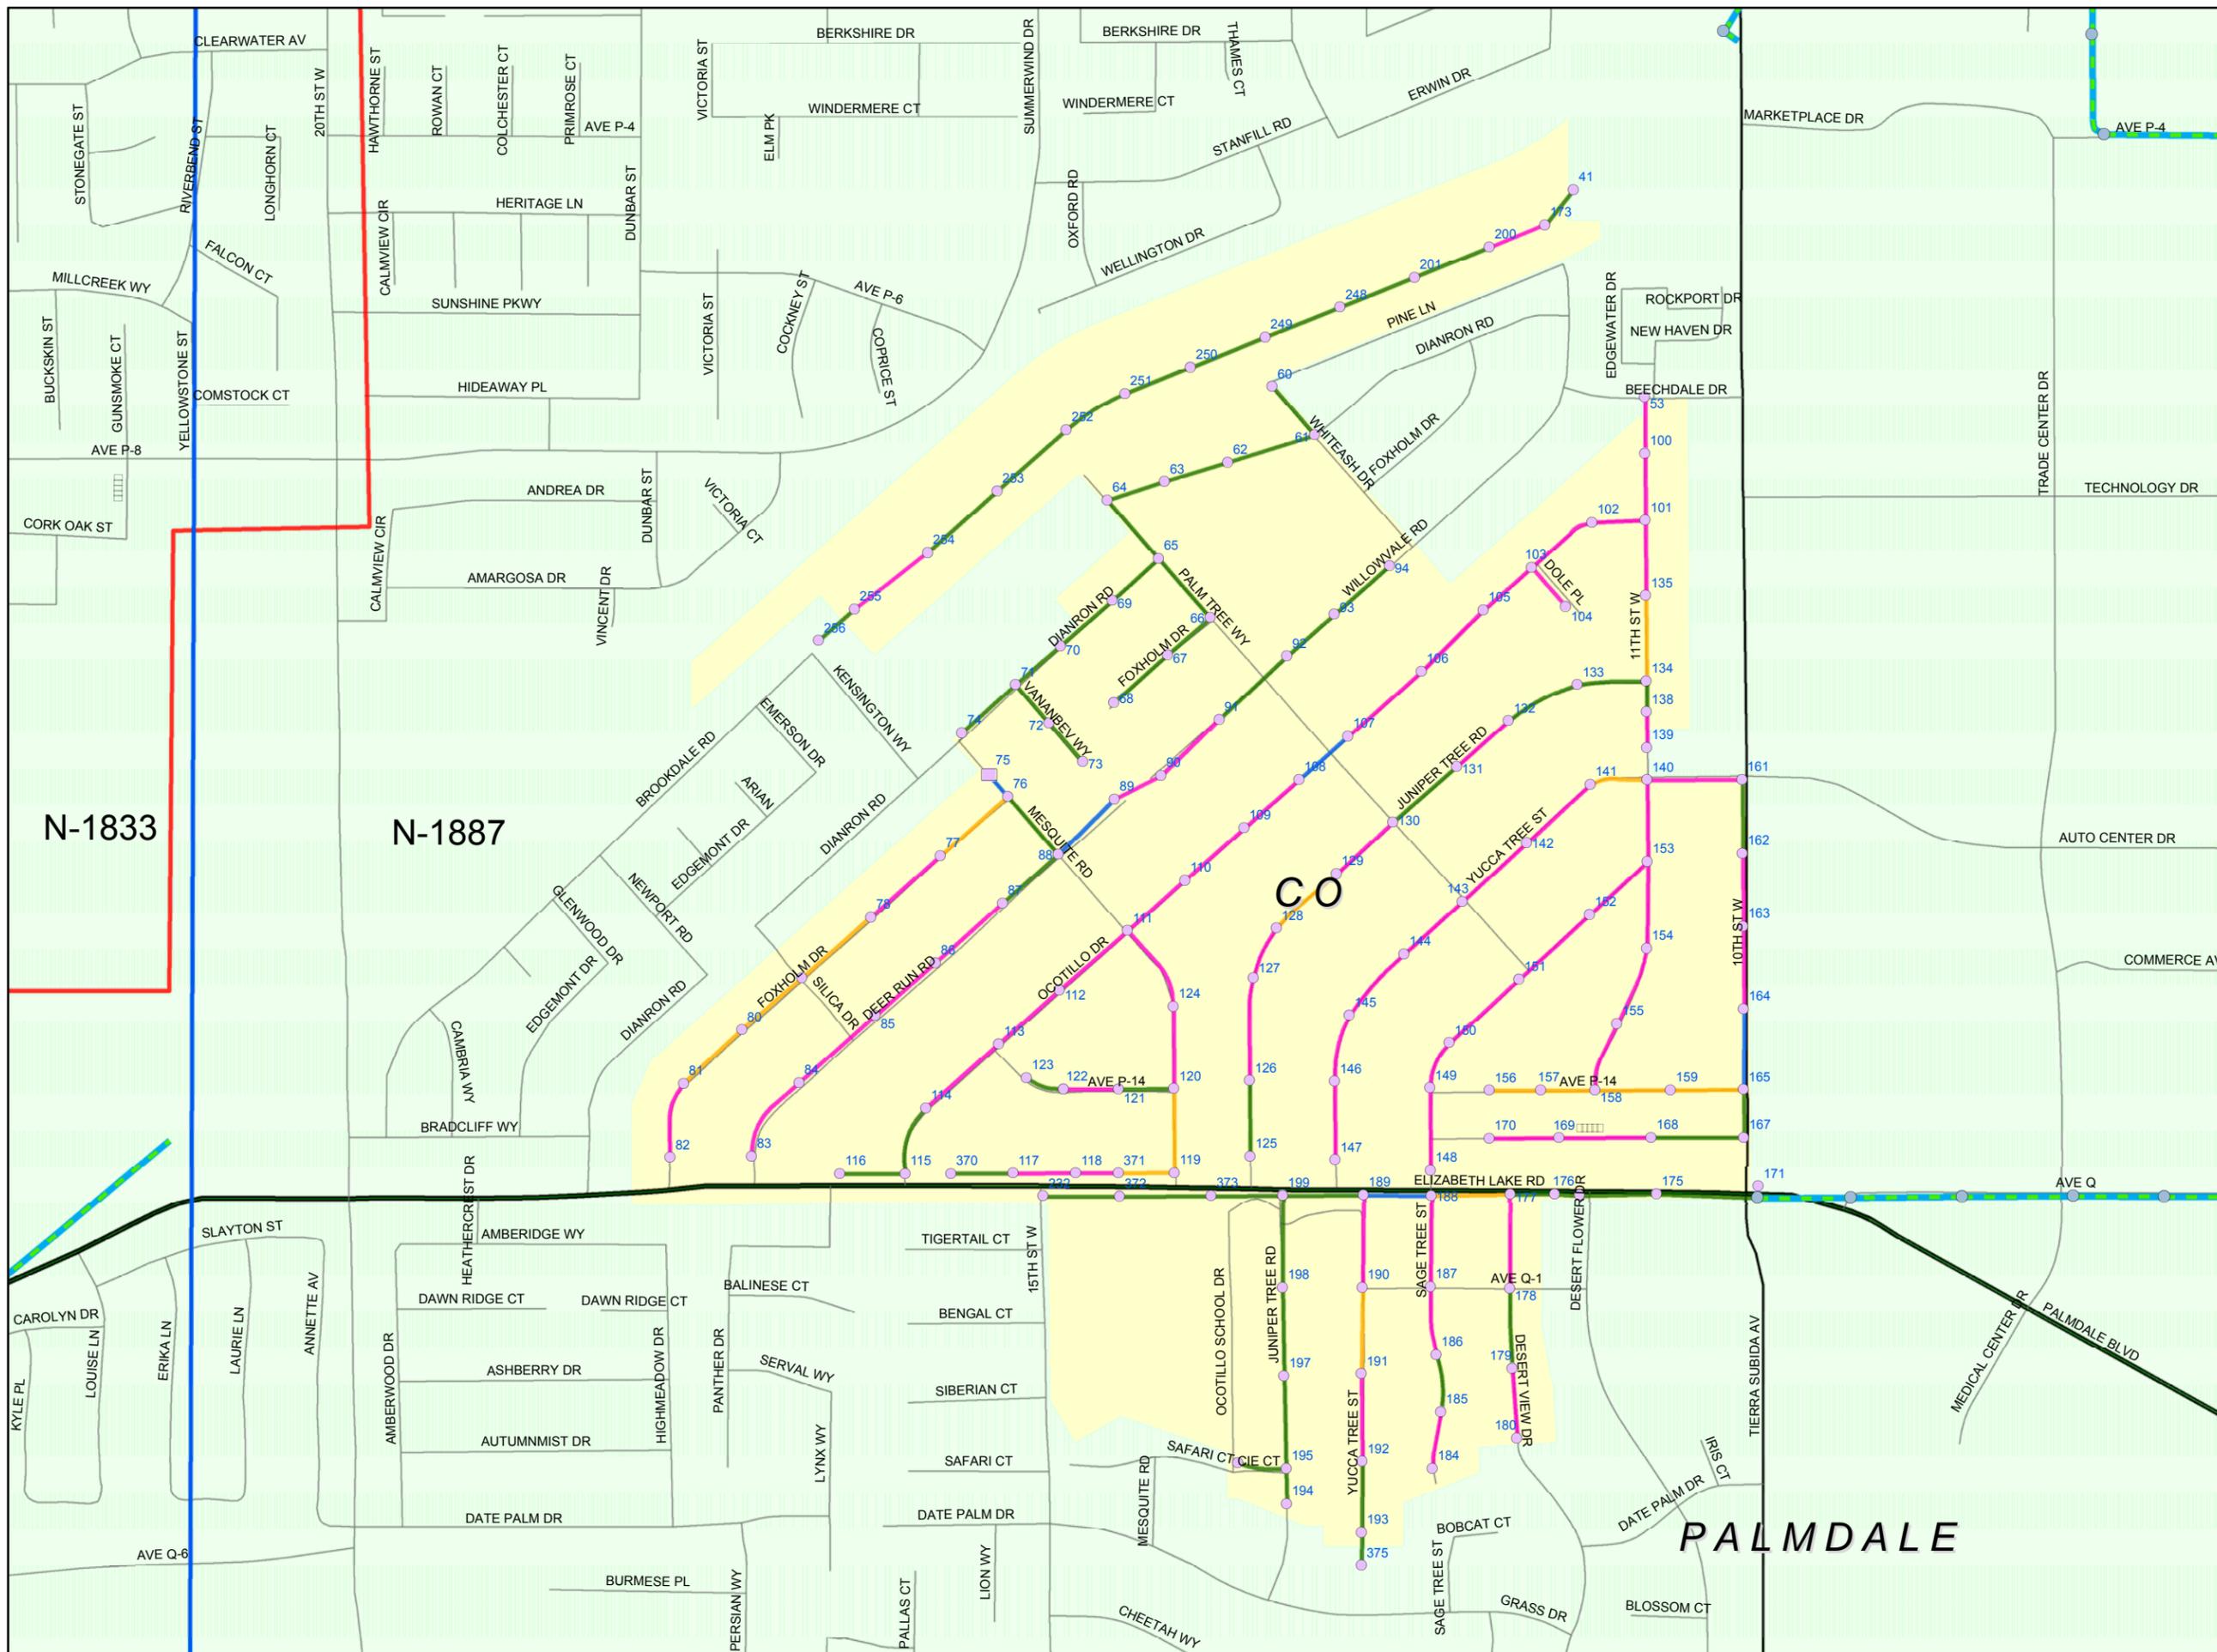
QUICK MAINTENANCE RATING (QMR)

ITEM NO.	QMR	START MH	END MH	STREET	OBSERVATION	CORRECTIVE ACTION TAKEN
1	4731	1887-0142	1887-0141	YUCCA TREE ST	Roots; Root ball lateral	Letter to homeowner; hydro (11/13/09)
2	4536	1887-0083	1887-0084	DEER RUN RD	Roots; Root ball lateral	Letter to homeowner; hydro (11/13/09)
3	4534	1887-0147	1887-0146	YUCCA TREE ST	Roots; Root ball lateral; Deposit settled	Letter to homeowner; hydro (11/13/09)
4	4531	1887-0145	1887-0144	YUCCA TREE ST	Root ball lateral	Letter to homeowner
5	4439	1887-0151	1887-0152	SAGE TREE ST	Roots; Root ball lateral	Letter to homeowner; hydro (11/20/09)
6	4435	1887-0143	1887-0142	YUCCA TREE ST	Roots; Root ball lateral	Letter to homeowner; hydro (11/13/09)
7	441A	1887-0155	1887-0158	11TH ST W	Root ball lateral	Letter to homeowner
8	4339	1887-0150	1887-0151	SAGE TREE ST	Roots; Root ball lateral	Letter to homeowner; hydro (11/20/09)
9	4338	1887-0086	1887-0087	DEER RUN RD	Roots; Root ball lateral	Letter to homeowner; hydro (12/22/09)

10	4337	1887-0085	1887-0086	DEER RUN RD	Roots; Root ball lateral	Letter to homeowner; hydro (11/13/09)
11	4333	1887-0107	1887-0106	OCOTILLO DR	Roots; Root ball lateral	Letter to homeowner; hydro (11/20/09)
12	4332	1887-0153	1887-0152	SAGE TREE ST	Roots; Root ball lateral	Letter to homeowner; hydro (11/20/09)
13	4331	1887-0106	1887-0105	OCOTILLO DR	Roots; Root ball lateral	Letter to homeowner; hydro (11/20/09)
14	4331	1887-0105	1887-0103	OCOTILLO DR	Roots; Root ball lateral	Letter to homeowner; hydro (11/20/09)
15	4331	1887-0127	1887-0128	JUNIPER TREE RD	Roots; Root ball lateral	Letter to homeowner; hydro (12/04/09)
16	431B	1887-0169	1887-0168	ALLEY	Roots; Root ball lateral	Letter to homeowner; hydro (12/11/09)
17	4315	1887-0135	1887-0101	11TH ST W	Roots; Root ball lateral; Hole: MH 101	Letter to homeowner; hydro (12/11/09)
18	4300	1887-0255	1887-0254	Easement by BROOKDALE & KENSINGTON	Camera under water (sag)	Hydro (12/24/09)

19	4233	1887-0109	1887-0108	OCOTILLO DR	Roots; Root ball lateral	Letter to homeowner; hydro (11/20/09)
20	4233	1887-0146	1887-0145	YUCCA TREE ST	Roots; Root ball lateral	Letter to homeowner; hydro (11/13/09)
21	4232	1887-0126	1887-0127	JUNIPER TREE RD	Roots; Root ball lateral	Letter to homeowner; hydro (12/04/09)
22	4232	1887-0114	1887-0113	OCOTILLO DR	Root ball lateral	Letter to homeowner
23	4231	1887-0139	1887-0138	11TH ST W	Roots; Root ball lateral	Letter to homeowner; hydro (12/11/09)
24	4231	1887-0154	1887-0153	11TH ST W	Deposits; Root ball lateral	Letter to homeowner; hydro (12/11/09)
25	4231	1887-0187	1887-0188	SAGE TREE ST	Root ball lateral	Letter to homeowner
26	4221	1887-0184	1887-0185	SAGE TREE ST	Deposit attached grease; Root ball lateral	Letter to homeowner; hydro (12/08/09)
27	4219	1887-0113	1887-0112	OCOTILLO DR	Root ball lateral	Letter to homeowner
28	4212	1887-0164	1887-0163	10TH ST W	Root ball lateral	Letter to homeowner

29	4137	1887-0084	1887-0085	DEER RUN RD	Roots; Root ball lateral	Letter to homeowner; hydro (12/08/09)
30	4136	1887-0082	1887-0081	FOXHOLM DR	Roots; Root ball lateral	Letter to homeowner; hydro (11/20/09)
31	4135	1887-0078	1887-0077	FOXHOLM DR	Roots; Root ball lateral	Letter to homeowner; hydro (12/04/09)
32	4134	1887-0090	1887-0091	DEER RUN RD	Roots; Debris; Camera under water (sag)	Hydro (12/22/09)
33	4134	1887-0148	1887-0149	SAGE TREE ST	Roots; Root ball lateral	Letter to homeowner; hydro (11/20/09)
34	4134	1887-0122	1887-0121	AVE P-14	Roots; Root ball lateral	Letter to homeowner; hydro (12/08/09)
35	4132	1887-0149	1887-0150	SAGE TREE ST	Roots; Root ball lateral	Letter to homeowner; hydro (11/20/09)
36	4132	1887-0124	1887-0111	MESQUITE RD	Roots; Root ball lateral	Letter to homeowner; hydro (12/11/09)
37	4132	1887-0131	1887-0132	JUNIPER TREE RD	Roots; Root ball lateral	Letter to homeowner; hydro (12/04/09)

38	4131	1887-0110	1887-0111	OCOTILLO DR	Roots; Root ball lateral	Letter to homeowner; hydro (11/20/09)

39	4131	1887-0110	1887-0109	OCOTILLO DR	Roots; Root ball lateral	Letter to homeowner; hydro (11/20/09)
40	4131	1887-0192	1887-0191	YUCCA TREE ST	Roots; Root ball lateral	Letter to homeowner; hydro (11/13/09)
41	4131	1887-0120	1887-0124	MESQUITE RD	Root ball lateral	Letter to homeowner
42	4131	1887-0103	1887-0102	OCOTILLO DR	Root ball lateral	Letter to homeowner
43	4131	1887-0101	1887-0100	11TH ST W	Root ball lateral	Letter to homeowner
44	4131	1887-0100	1887-0053	11TH ST W	Root ball lateral	Letter to homeowner
45	4131	1887-0162	1887-0163	10TH ST W	Root ball lateral	Letter to homeowner
46	4131	1887-0154	1887-0155	11TH ST W	Root ball lateral	Letter to homeowner
47	4127	1887-0186	1887-0187	SAGE TREE ST	Deposits; Grease	Letter to homeowner; hydro (12/08/09)
48	4122	1887-0089	1887-0090	Easement by DEERRUN & MESQUITE	Deposit attached grease; Root ball lateral	Letter to homeowner; hydro (12/08/09)
49	411E	1887-0180	1887-0179	DESERT VIEW DR	Roots; Root ball lateral	Letter to homeowner; hydro (12/22/09)

50	411C	1887-0143	1887-0144	YUCCA TREE ST	Roots; Root ball lateral	Letter to homeowner; hydro (11/13/09)
51	411B	1887-0190	1887-0189	YUCCA TREE ST	Root ball lateral	Letter to homeowner
52	411A	1887-0170	1887-0169	ALLEY	Root ball lateral	Letter to homeowner
53	411A	1887-0153	1887-0140	11TH ST W	Root ball lateral	Letter to homeowner
54	411A	1887-0178	1887-0177	DESERT VIEW DR	Root ball lateral	Letter to homeowner
55	4118	1887-0112	1887-0111	OCOTILLO DR	Roots; Root ball lateral	Letter to homeowner; hydro (11/20/09)
56	4114	1887-0103	1887-0104	DOLE PL	Root ball lateral	Letter to homeowner
57	4113	1887-0129	1887-0130	JUNIPER TREE RD	Root ball lateral	Letter to homeowner
58	4113	1887-0140	1887-0161	YUCCA TREE ST	Root ball lateral	Letter to homeowner
59	4112	1887-0117	1887-0118	ELIZABETH LAKE RD	Roots; Root ball lateral	Letter to homeowner; hydro (12/24/09)
60	4112	1887-0118	1887-0371	ELIZABETH LAKE RD	Intruding sealing	Hydro (12/24/09)

61	4100	1887-0200	1887-0173	EASEMENT by WILLOWVALE & PINE	Camera under water (sag); Plumber: 45'	Hydro (12/24/09)
62	4100	1887-0102	1887-0101	OCOTILLO DR	Root ball lateral	Letter to homeowner
63	361E	1887-0188	1887-0177	ELIZABETH LAKE RD	Roots; high water level (sag)	Hydro (12/24/09)
64	361B	1887-0080	1887-0081	FOXHOLM DR	Roots	Hydro (12/04/09)
65	3421	1887-0080	1887-0079	FOXHOLM DR	Roots	Hydro (12/04/09)
66	341F	1887-0078	1887-0079	FOXHOLM DR	Roots	Hydro (12/04/09)
67	3323	1887-0134	1887-0135	11TH ST W	Deposit attached grease; Roots; Root medium lateral	Letter to homeowner; hydro (12/11/09)
68	321B	1887-0141	1887-0140	YUCCA TREE ST	Roots; Root medium lateral	Letter to homeowner; hydro (11/13/09)
69	3219	1887-0156	1887-0157	AVE P-14	Root medium lateral	Letter to homeowner
70	311D	1887-0077	1887-0076	FOXHOLM DR	Roots; Deposit settled	Hydro (12/04/09)
71	311C	1887-0191	1887-0190	YUCCA TREE ST	Roots; Root medium lateral	Letter to homeowner; hydro (11/13/09)

72	311A	1887-0157	1887-0158	AVE P-14	Roots; Root medium lateral	Letter to homeowner; hydro (12/08/09)
73	3117	1887-0128	1887-0129	JUNIPER TREE RD	Root medium lateral	Letter to homeowner
74	3115	1887-0120	1887-0119	MESQUITE RD	Root medium lateral	Letter to homeowner
75	3114	1887-0159	1887-0165	AVE P-14	Roots; Root medium lateral; Fracture multiple: 230'	Letter to homeowner; hydro (12/08/09)
76	3113	1887-0371	1887-0119	ELIZABETH LAKE RD	Roots; Root medium lateral	Letter to homeowner; hydro (12/24/09)
77	3111	1887-0158	1887-0159	AVE P-14	Root medium lateral	Letter to homeowner

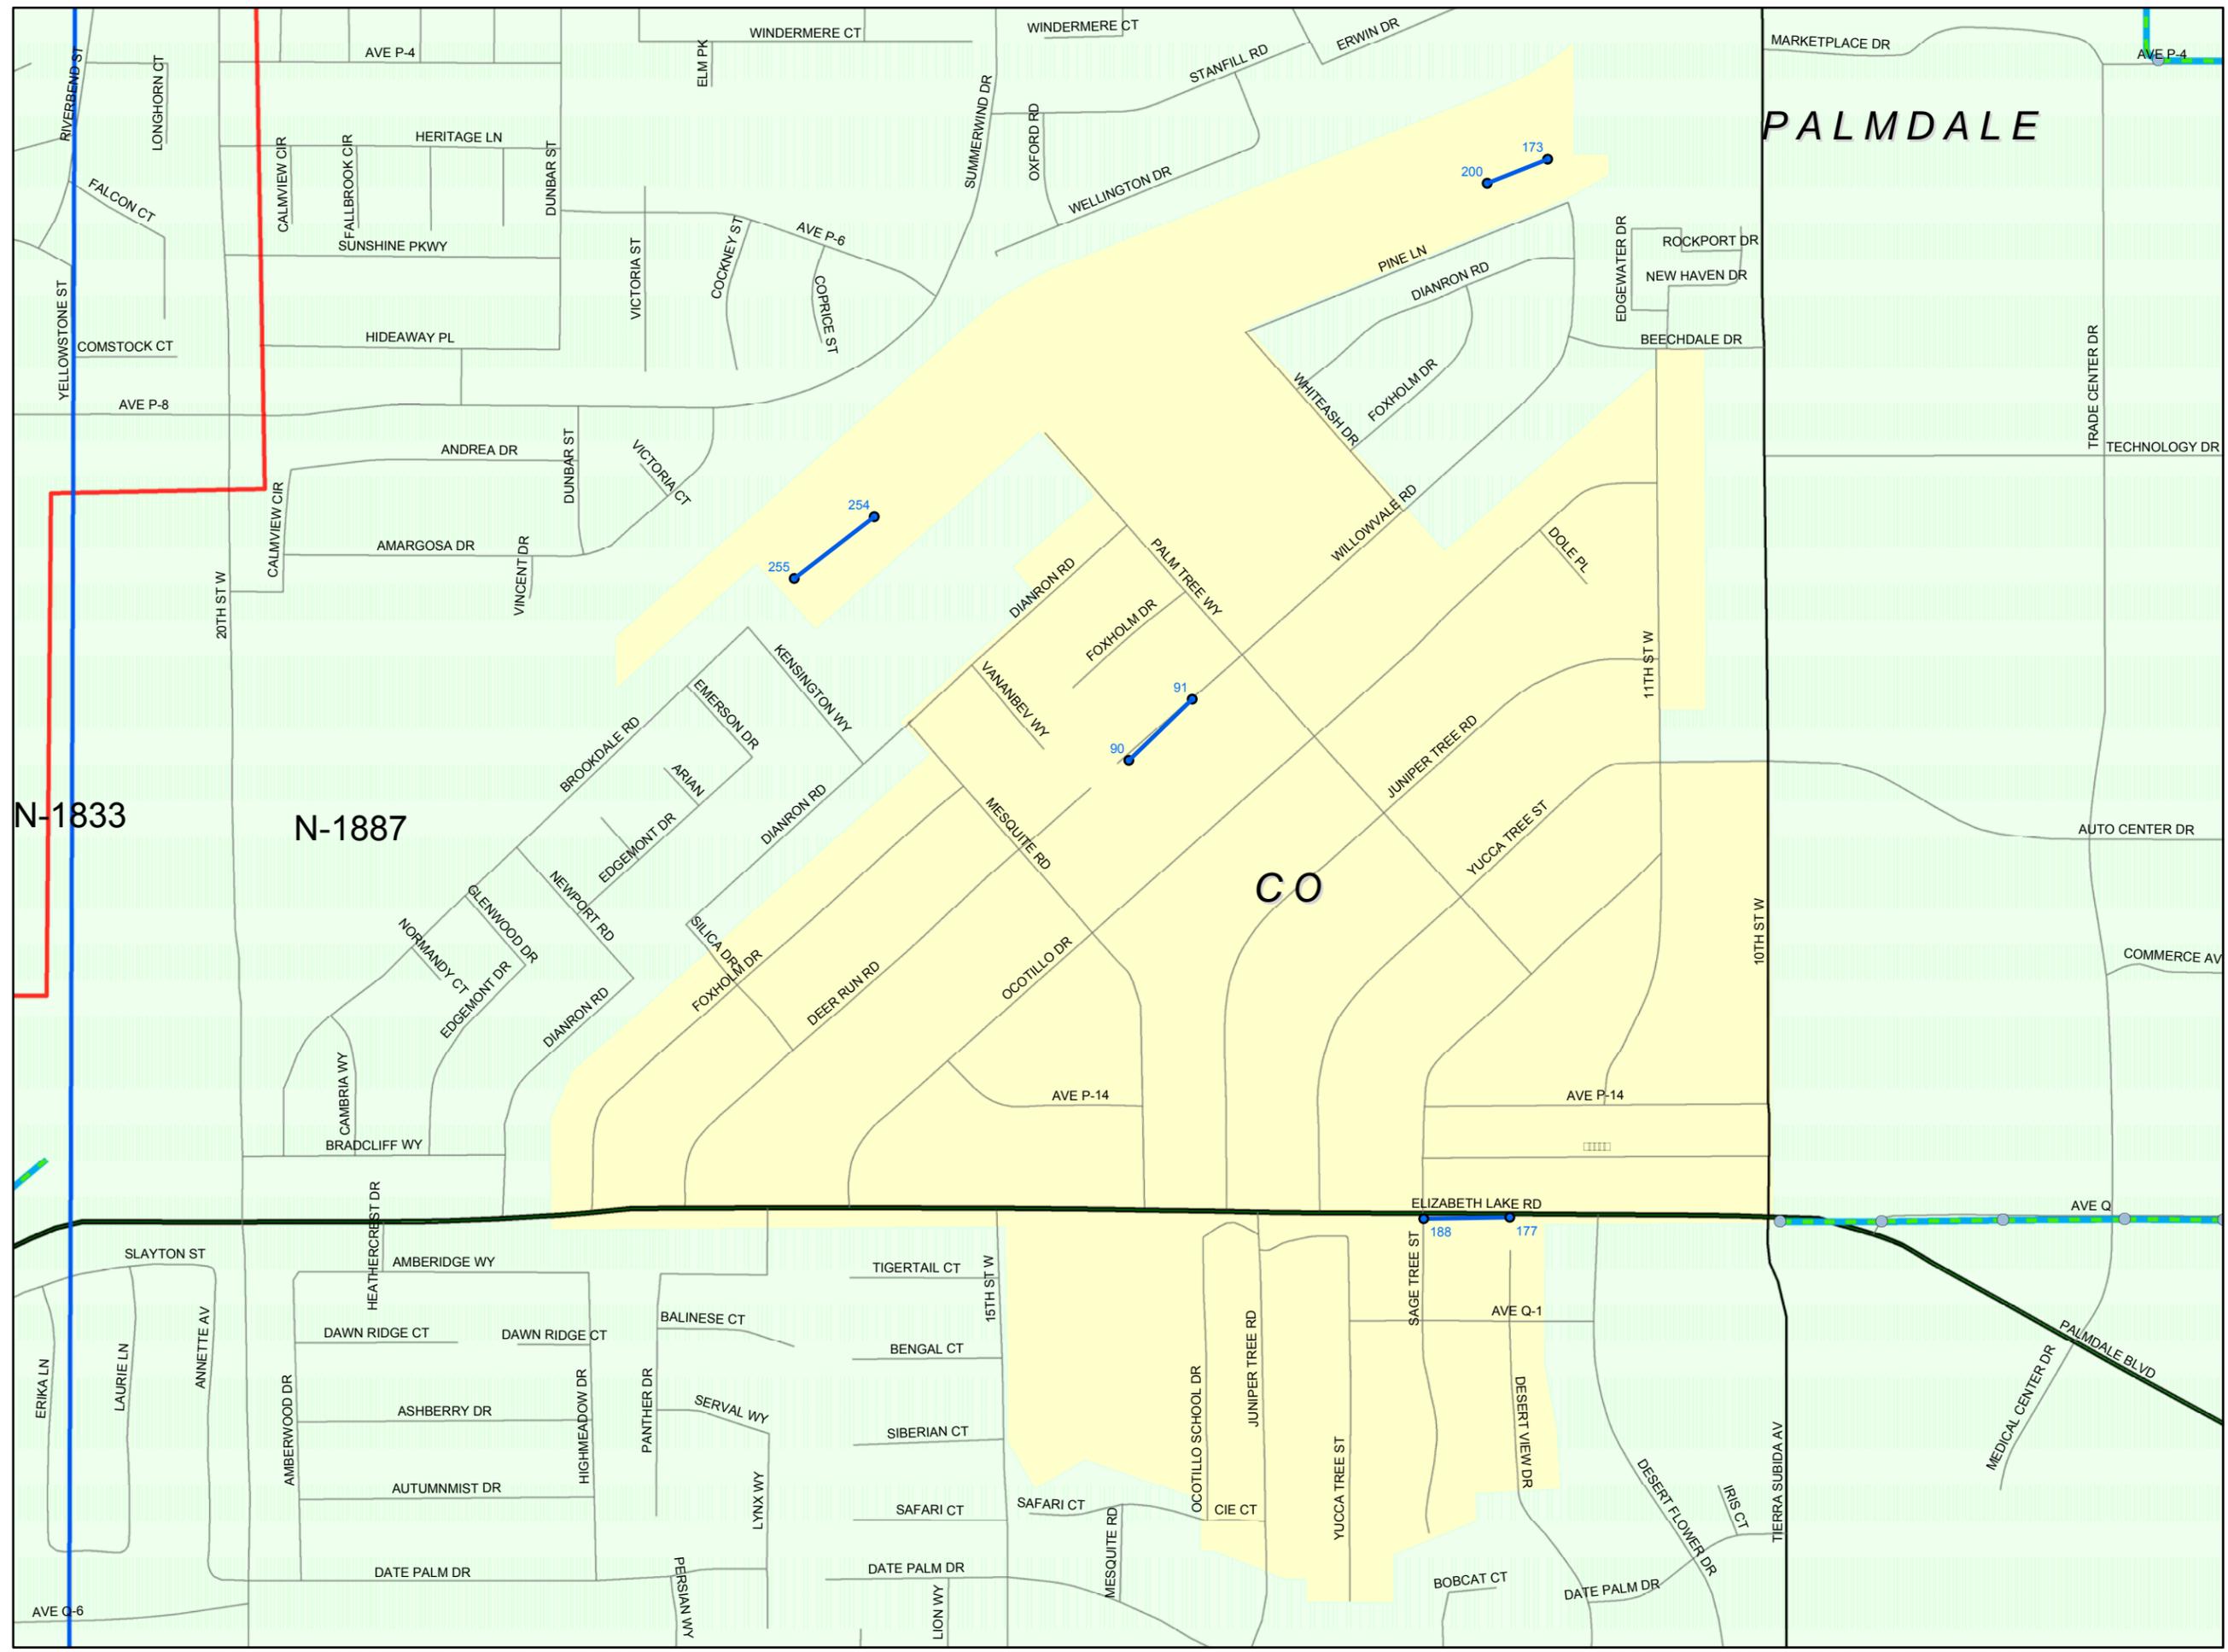
HIGH WATER LEVELS

Our inspection revealed that approximately 97.2 percent of the system televised has adequate capacity. However, the remaining 2.8 percent of the inspected segments included deficiencies associated with high water levels. Capacity of the sewer pipe can be determined by analyzing several PACP codes, including Water Level, Water Mark, and miscellaneous remarks of camera underwater or sags in the line. A sewer pipe can be considered at capacity when 50% of the diameter of sewer pipe is full of water. However, there are particular conditions in which the water level or water mark has reached 50% or greater due to heavy flows in adjoining pipes, a restriction due to debris in the sewer lines, or a sag in the line. Therefore, additional review of all pipe segments with such high water level concerns was conducted to determine capacity issues, if any. All sewer pipes where Water Level, Water Mark, and miscellaneous remarks of camera

underwater or sags in the line are at or above 50% capacity, have been outlined and analyzed on the High Water Level table in Enclosure 2. The nature of these high water level conditions is also summarized on this table.

Item No.	QMR	START MH	END MH	STREET	OBSERVATION	SAG (ft)
1	4300	1887-0255	1887-0254	Easement by BROOKDALE & KENSINGTON	High water level, camera under water(sag)	(30%-80%): 220'-307' 87
2	4134	1887-0090	1887-0091	DEER RUN RD	Camera under water(sag); high water mark	(30%-80%): 5'-105', 180'-260' 180
3	4100	1887-0200	1887-0173	EASEMENT by WILLOWVALE & PINE	Camera under water (sag)	(30%-80%): 65'-140' 75
4	361E	1887-0188	1887-0177	ELIZABETH LAKE RD	High water level (sag)	(30%-50%): 222'-240' 18

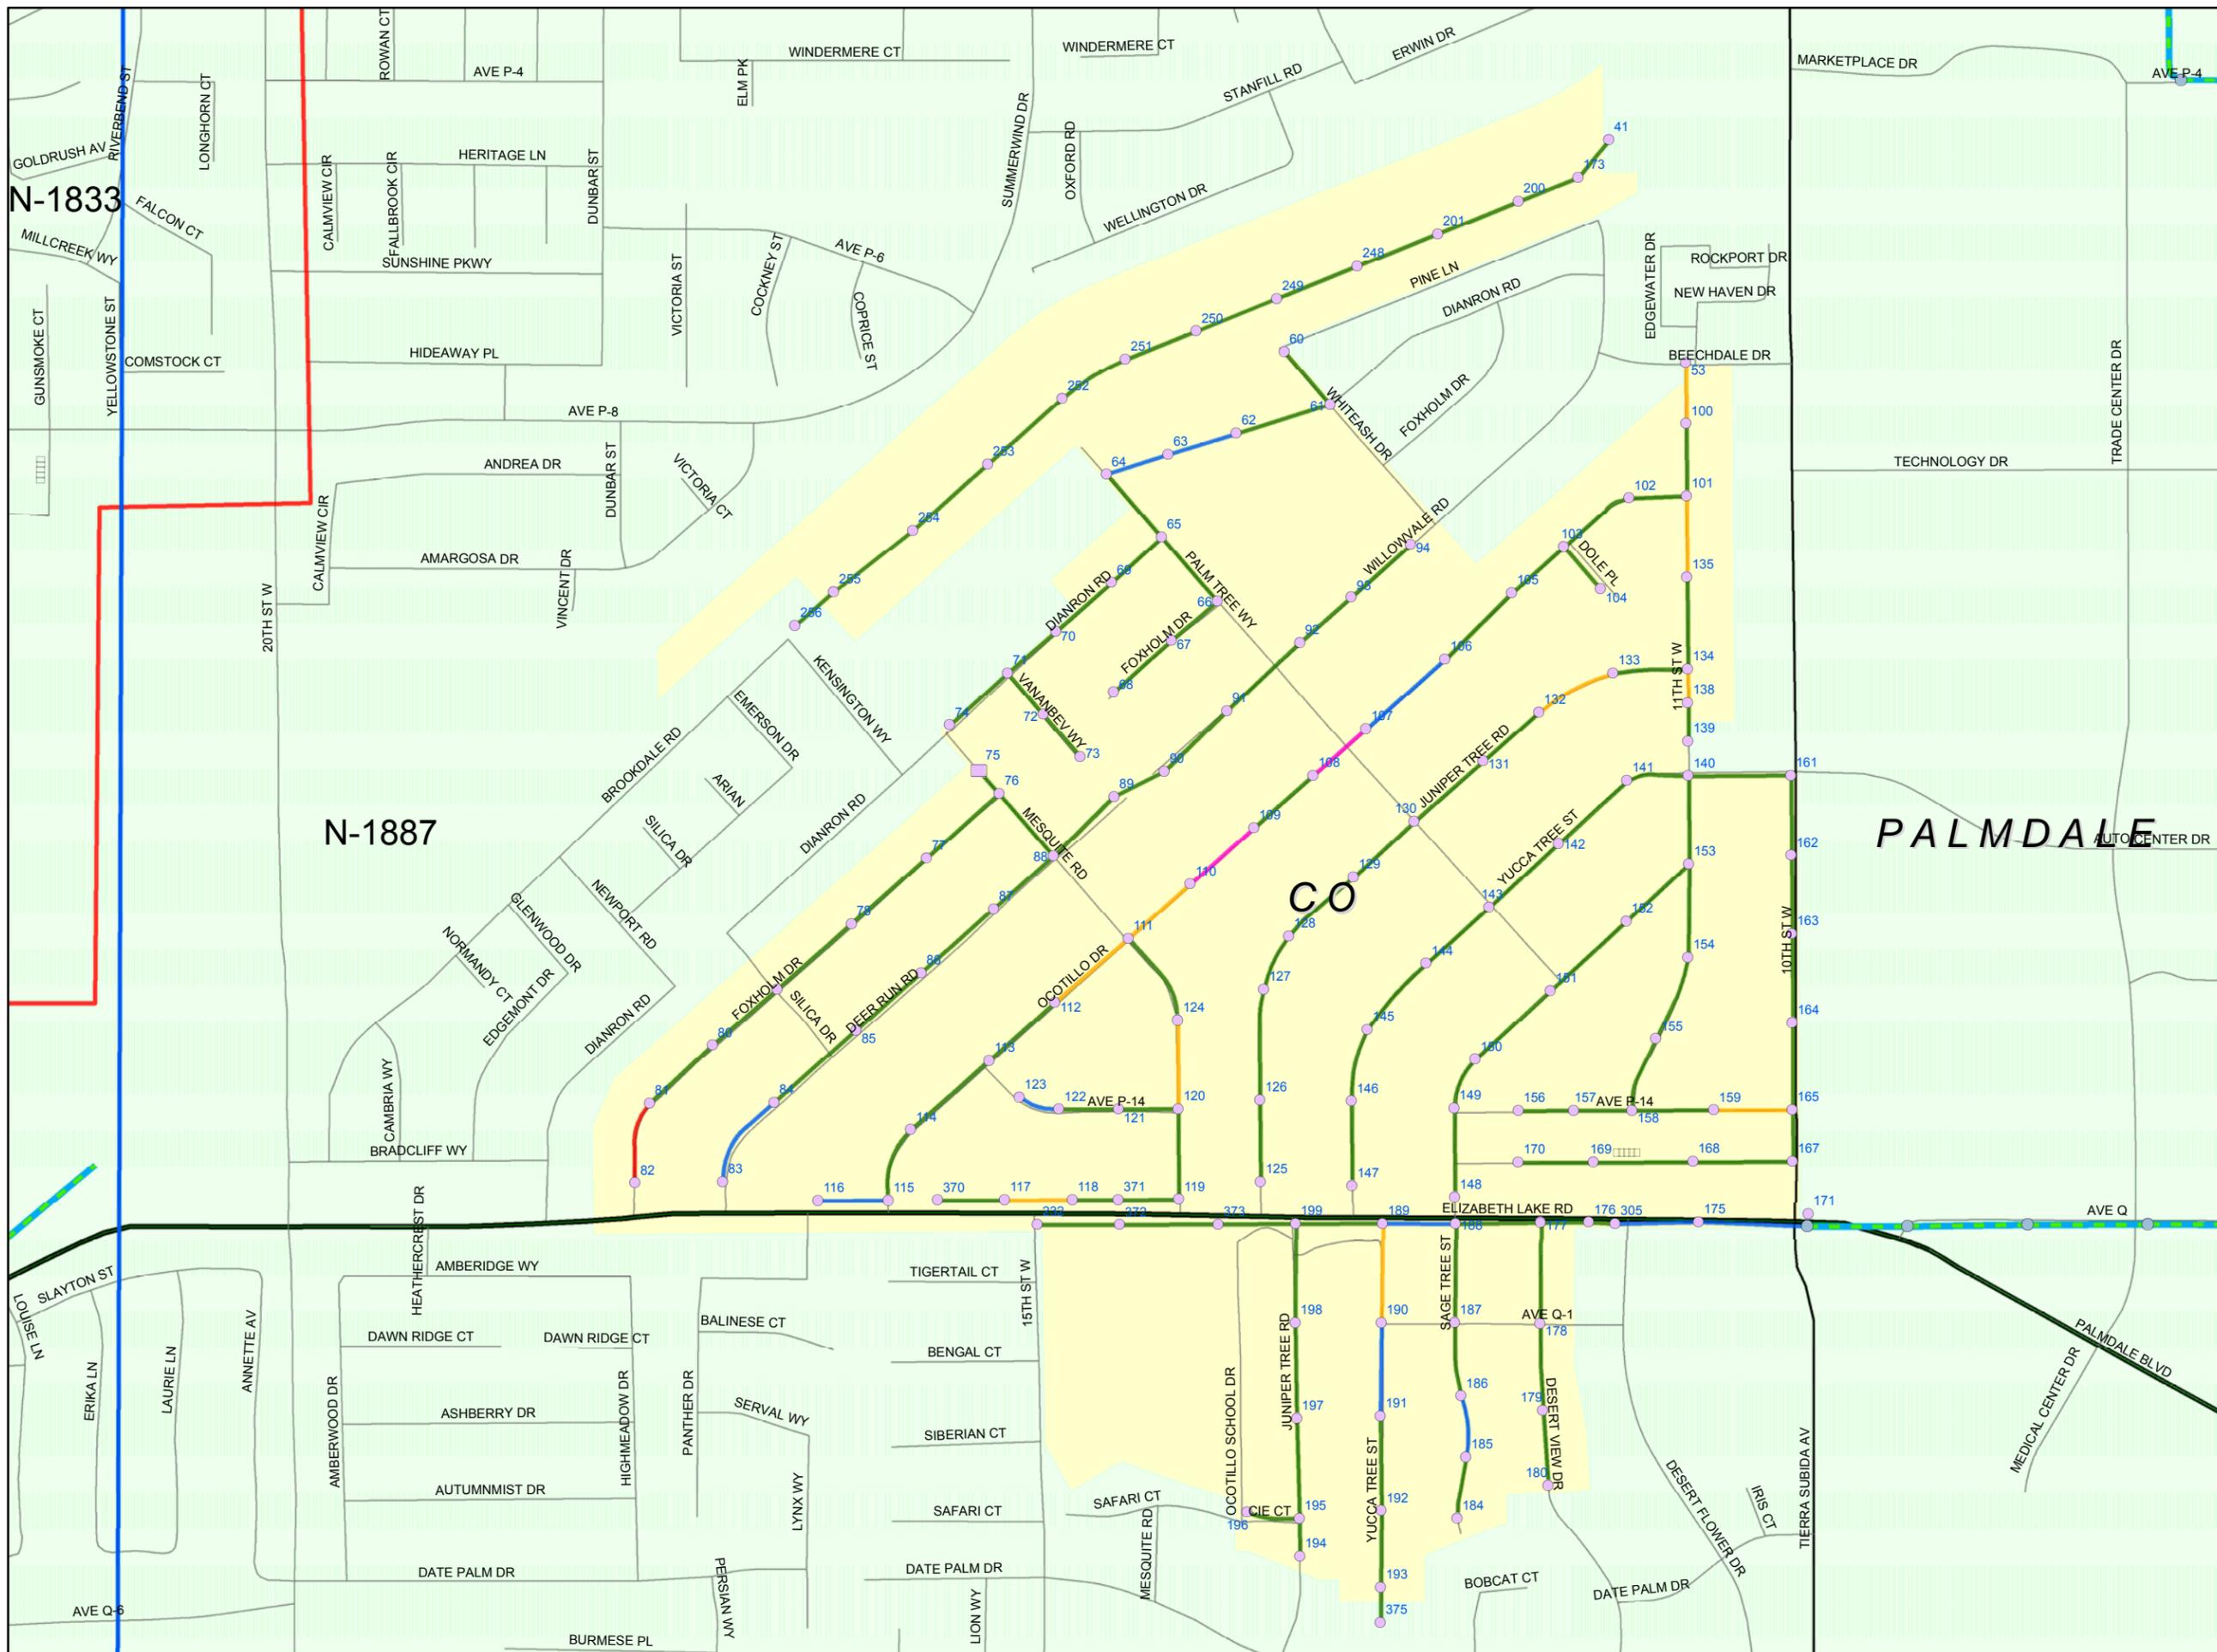
QUICK STRUCTURAL RATING (QSR)

Our inspection revealed that approximately 97.8 percent of the inspected pipe segments within the Unincorporated County of Los Angeles were free of severe structural defects. However, the remaining 2.2 percent of the inspected pipe segments had a PACP structural grade of 4 and 5 as indicated in the Quick Structural Rating Table shown below. These segments have been placed on a priority list based on the severity and the need for action. Items 1 through 3 in the Quick Structural Rating Report Priority List (Enclosure 3) which require a corrective action, the proposed corrective method will be scheduled in the next 24 months as part of the ongoing Accumulative Capital Outlay Project. A color-coded map showing the Quick Structural Rating for each pipe segment is located in Enclosure 3. Copies of the actual inspection report for these 3 segments are included in Enclosure 4.

ITEM NO.	QSR	START MH	END MH	STREET	OBSERVATION: LOCATION	PROPOSED CORRECTIVE METHOD	LENGTH OF REPAIR (FT)
1	5100	1887-0082	1887-0081	FOXHOLM DR	Hole and broken with soil visible: 20'	Point Repair (North Yard)	
2	4112	1887-0110	1887-0109	OCOTILLO DR	Fractures: 5'	Structural integrity intact. No action needed.	
3	4131	1887-0108	1887-0107	OCOTILLO DR	Broken fractures: 60'	Point Repair (North Yard)
