**CONSOLIDATED SEWER MAINTENANCE DISTRICT
CONDITION ASSESSMENT PROGRAM REPORT
PROJECT Y0TV0506D**

**CONDITION ASSESSMENT REPORT
COUNTY OF LOS ANGELES DEPARTMENT OF PUBLIC WORKS
CONSOLIDATED SEWER MAINTENANCE DISTRICT**

PROJECT NAME:	Y0TV0506D	PROJECT MGR:	Kari Eskridge
PROJECT DATE:	4/17/06-8/14/06	CONTACT NO:	(626) 300-3390
SUP. DISTRICT(s):	5	MAP PAGE(S):	2297, 2298, 2299
Report By:	Phyo Kyaw	Report Date:	03/24/09

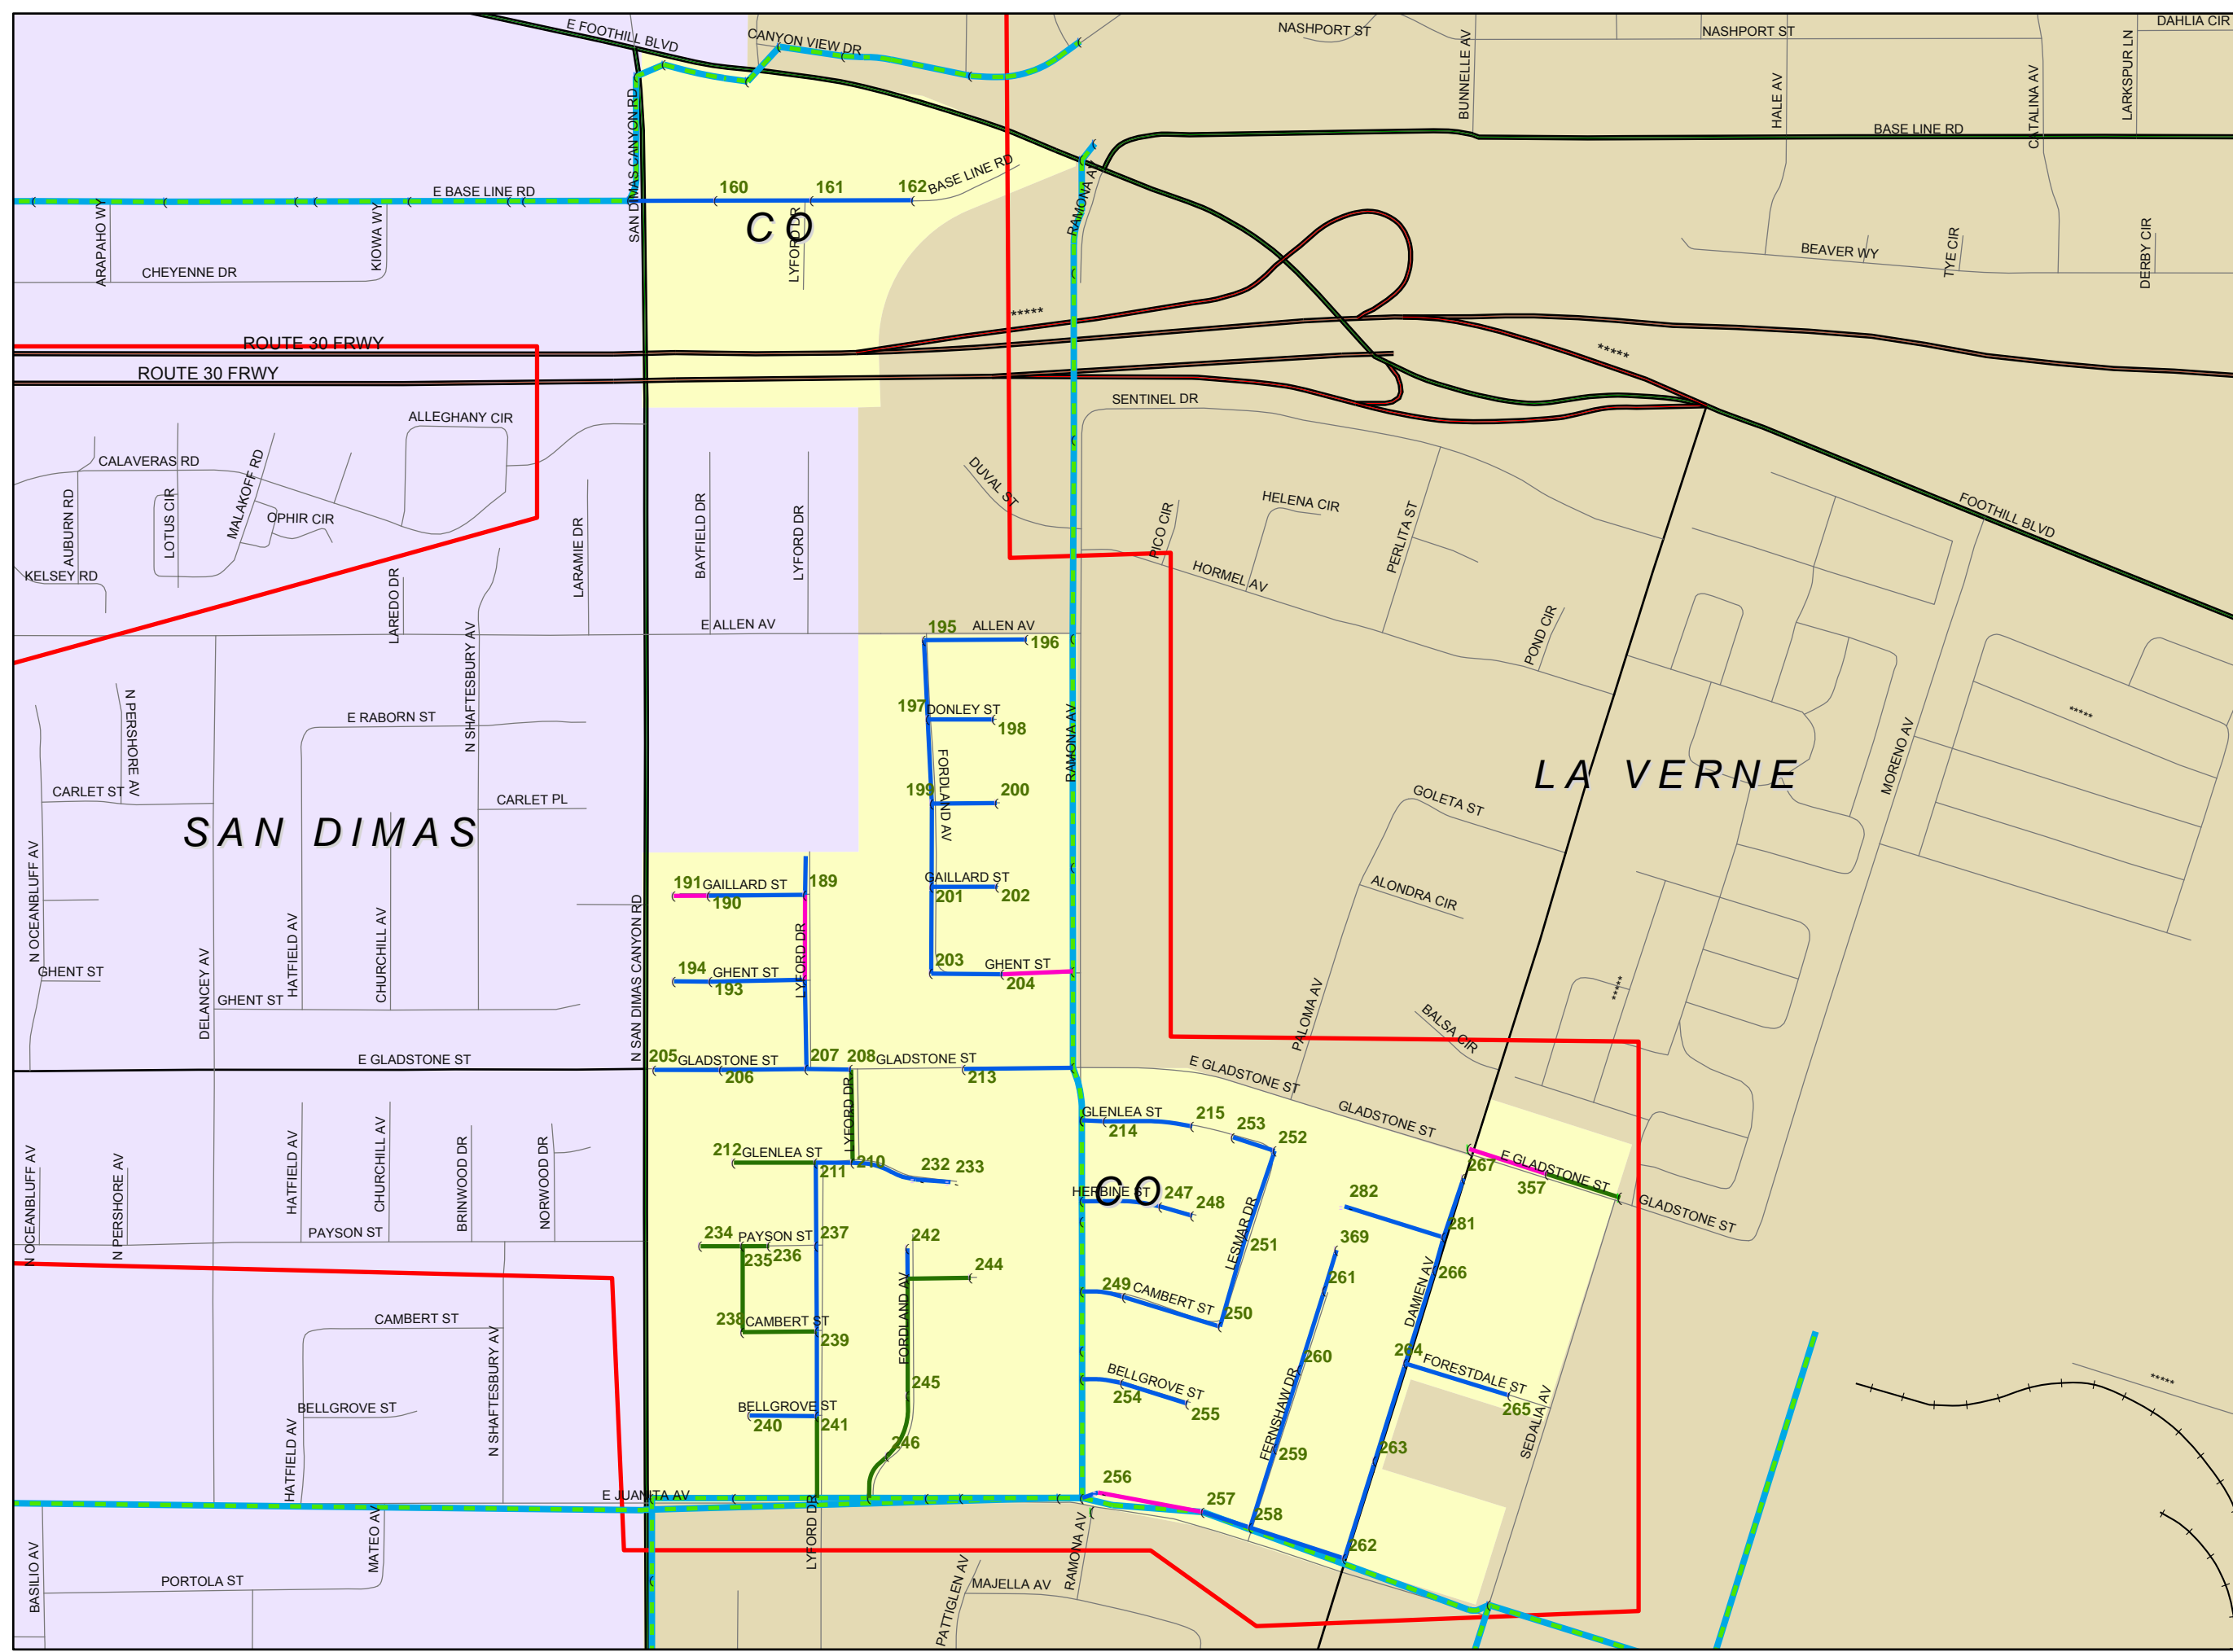
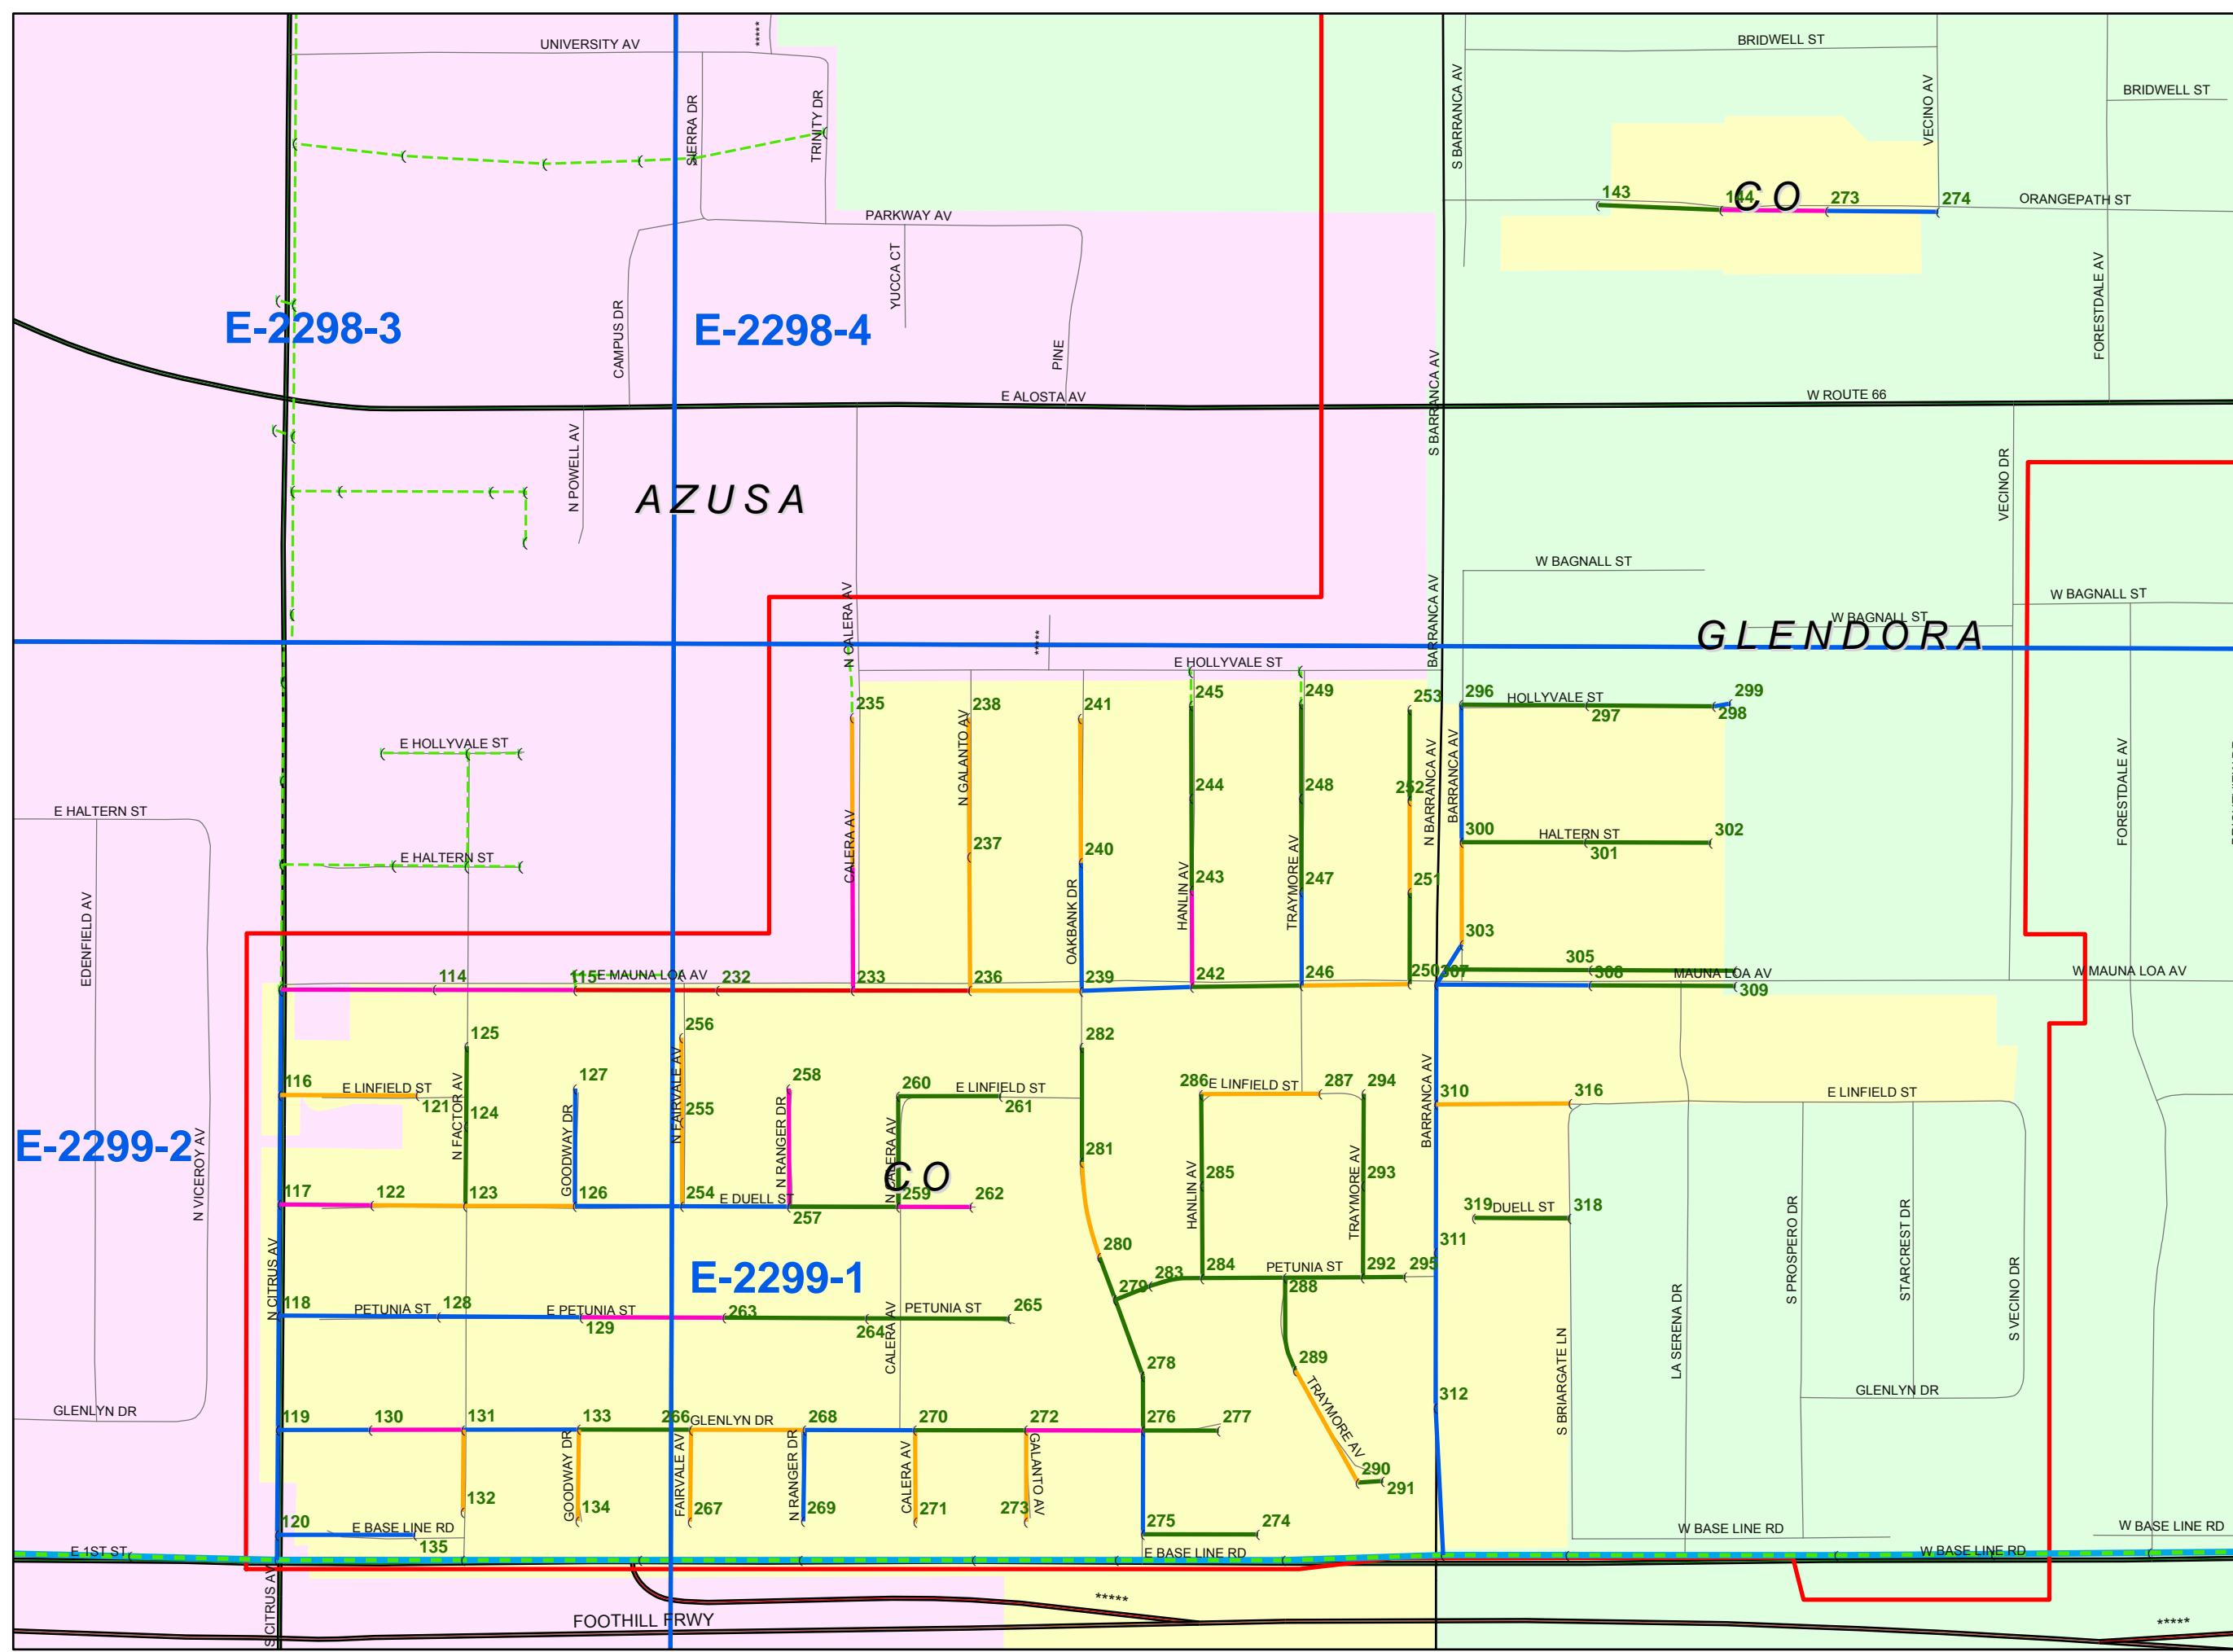
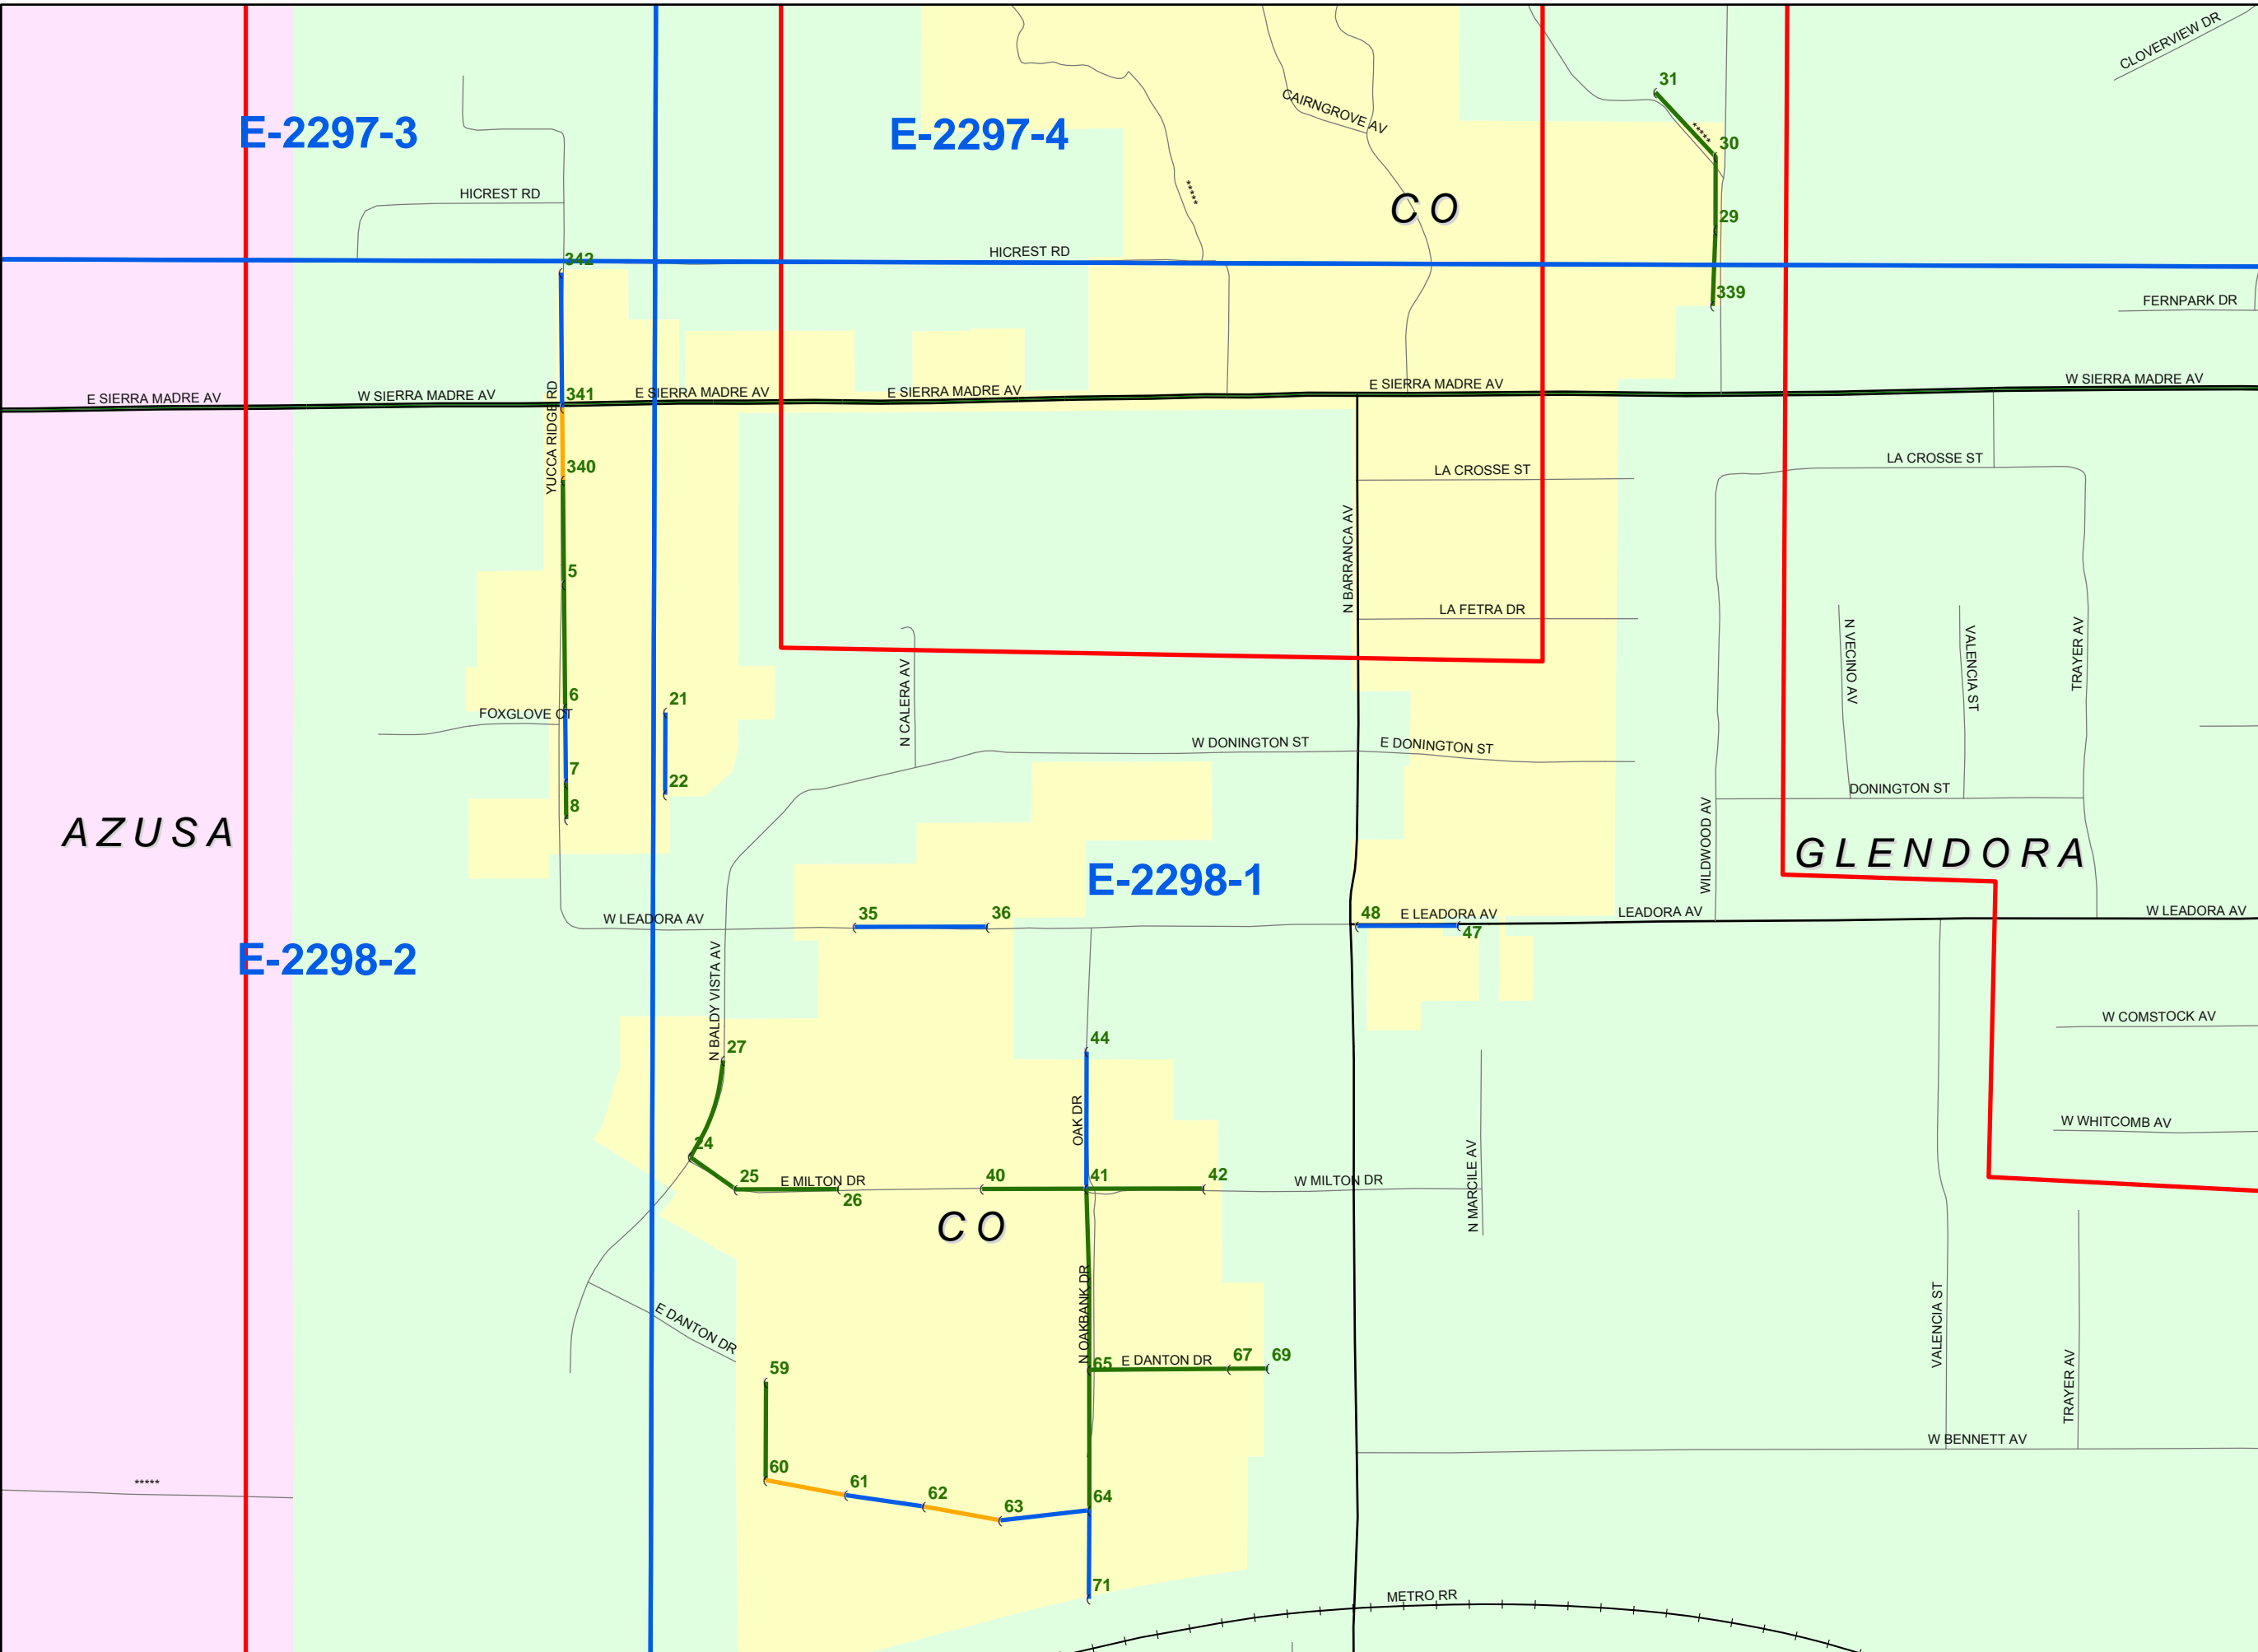
QUICK
 MAINTENANCE
 RATING
 (QMR)

Our inspection revealed that approximately 89.9 percent of the system televised was free of blockages or restrictions that would impede sewer flows. However, the remaining 10.1 percent of the inspected pipe segments within the Unincorporated Los Angeles County area had a PACP maintenance grade of 4 or 5 as indicated in the Quick Maintenance Rating Table shown below. These segments have been incorporated into our routine cleaning schedule with corrective action taken as noted on the Quick Maintenance Rating Report Priority List (Enclosure 2). Also included is a color-coded map showing the quick maintenance rating for each pipe segment.

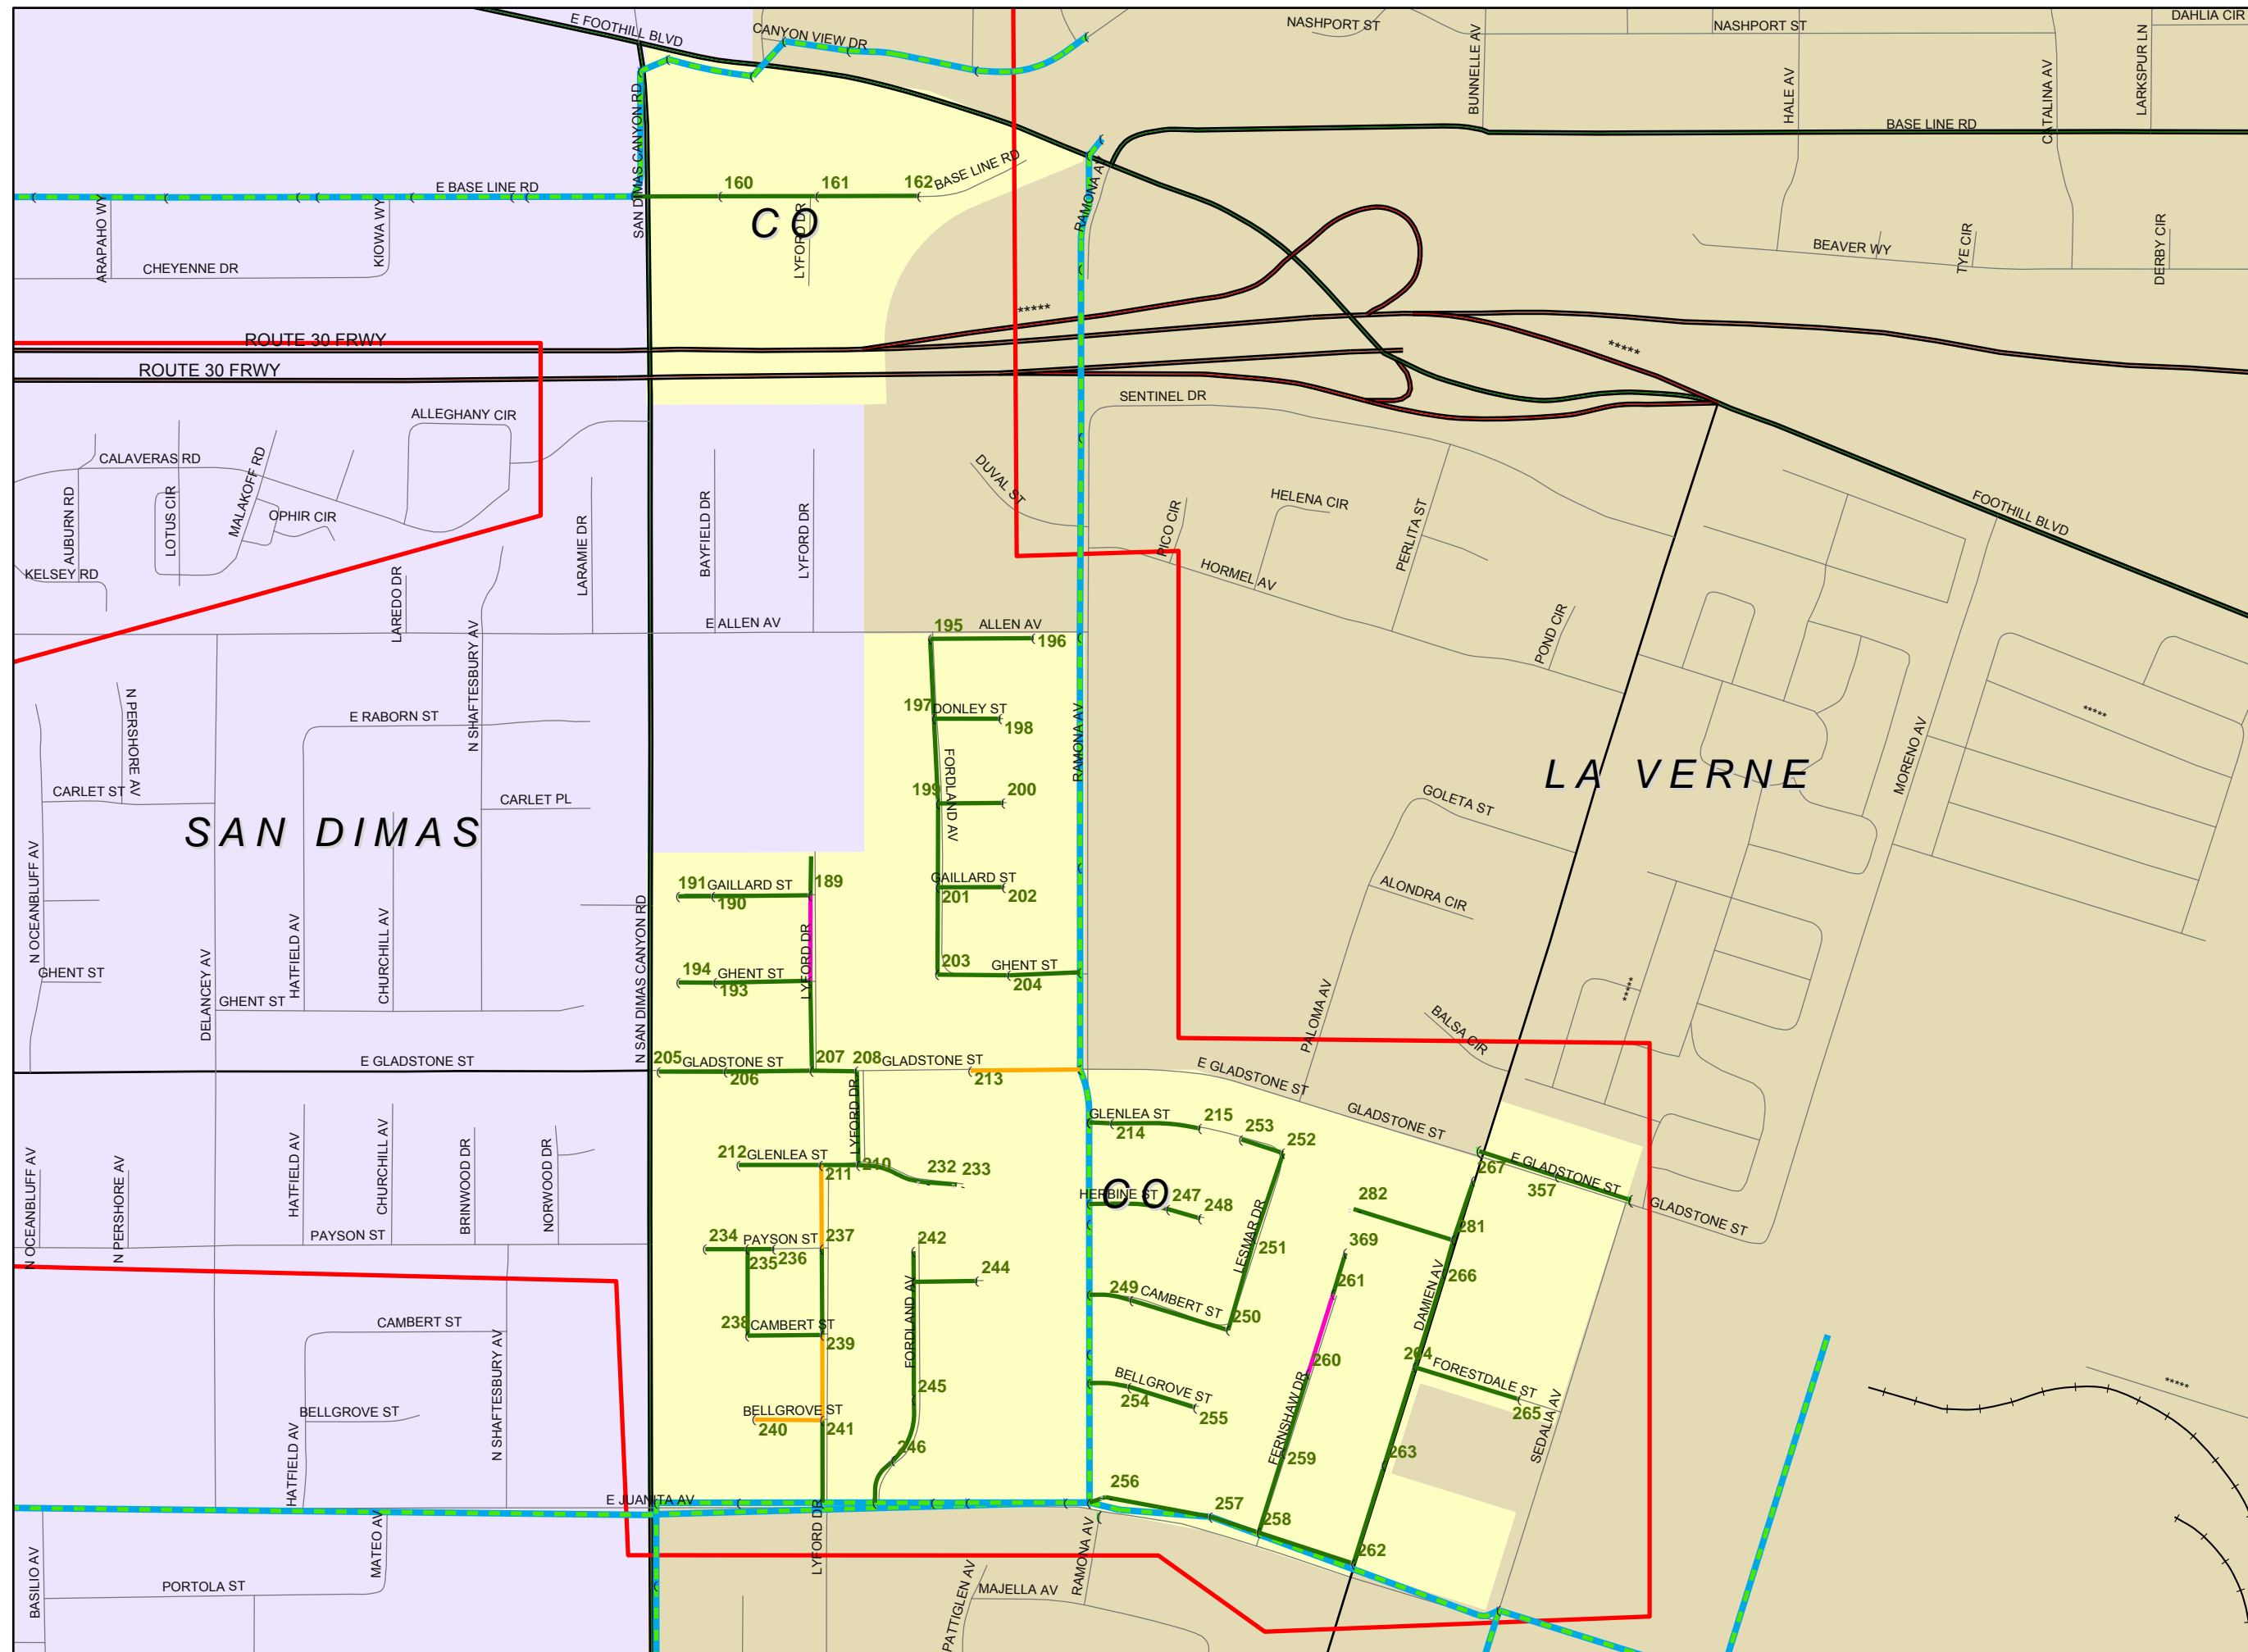
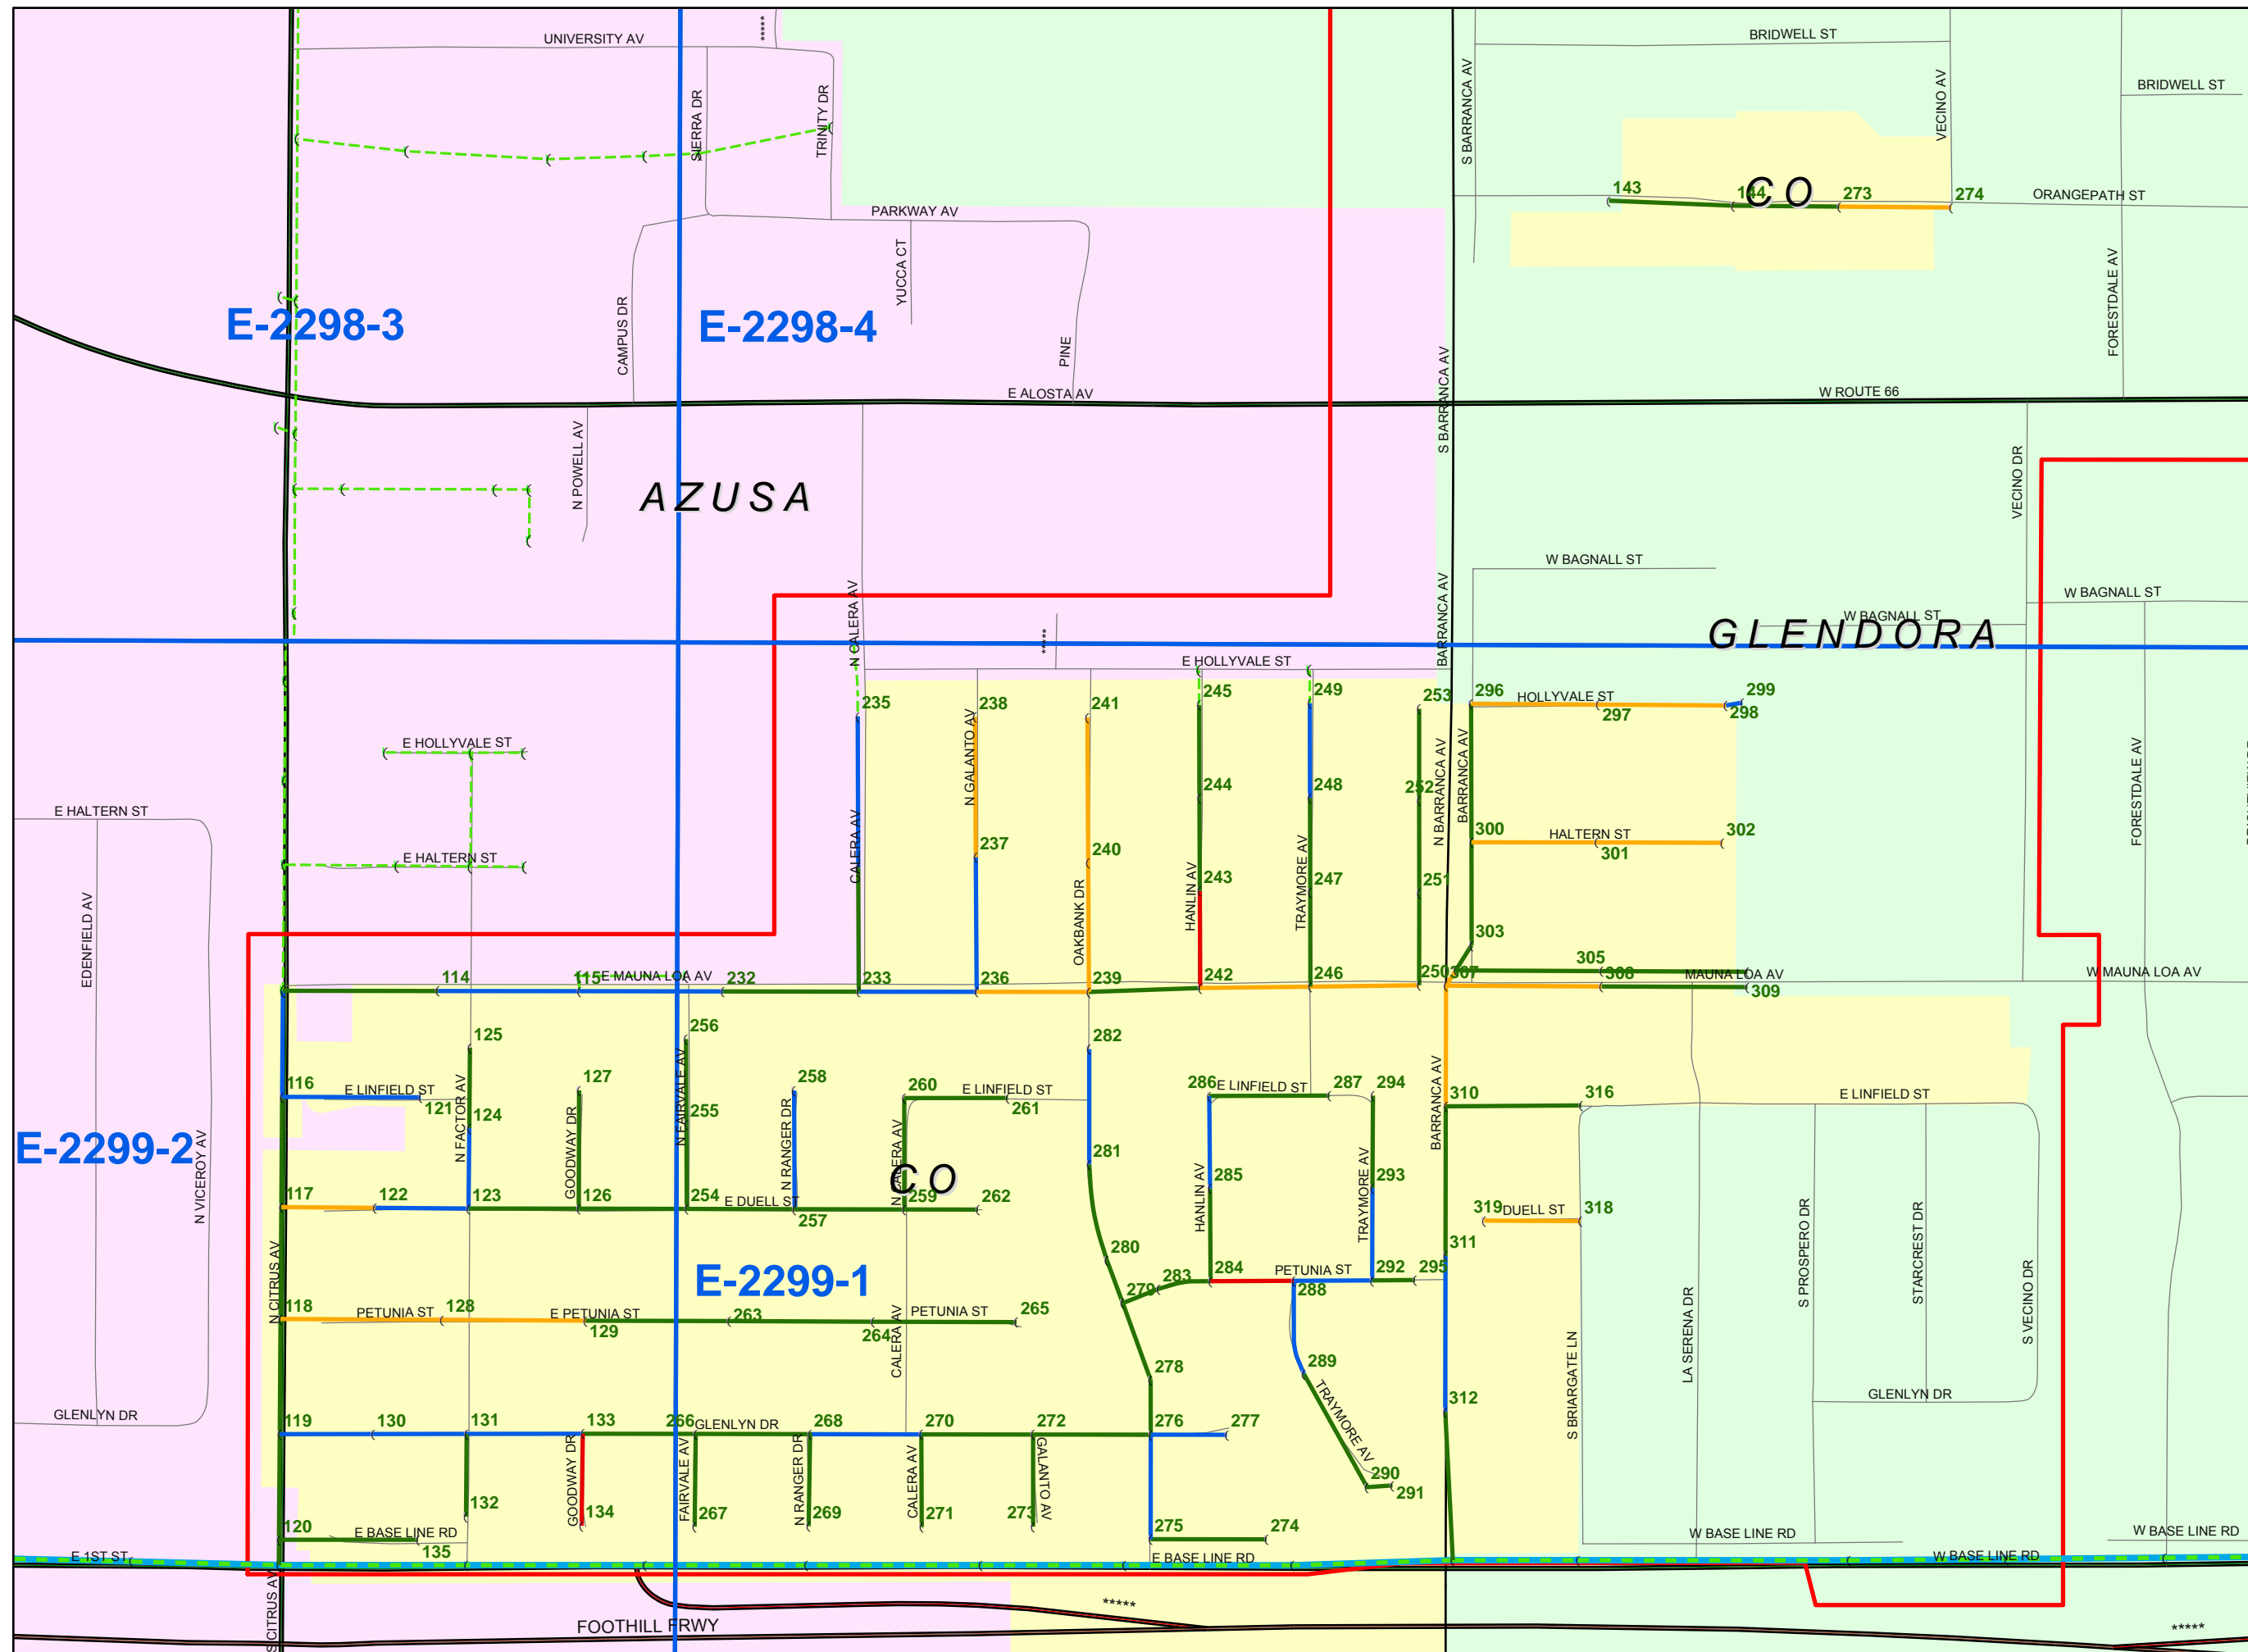
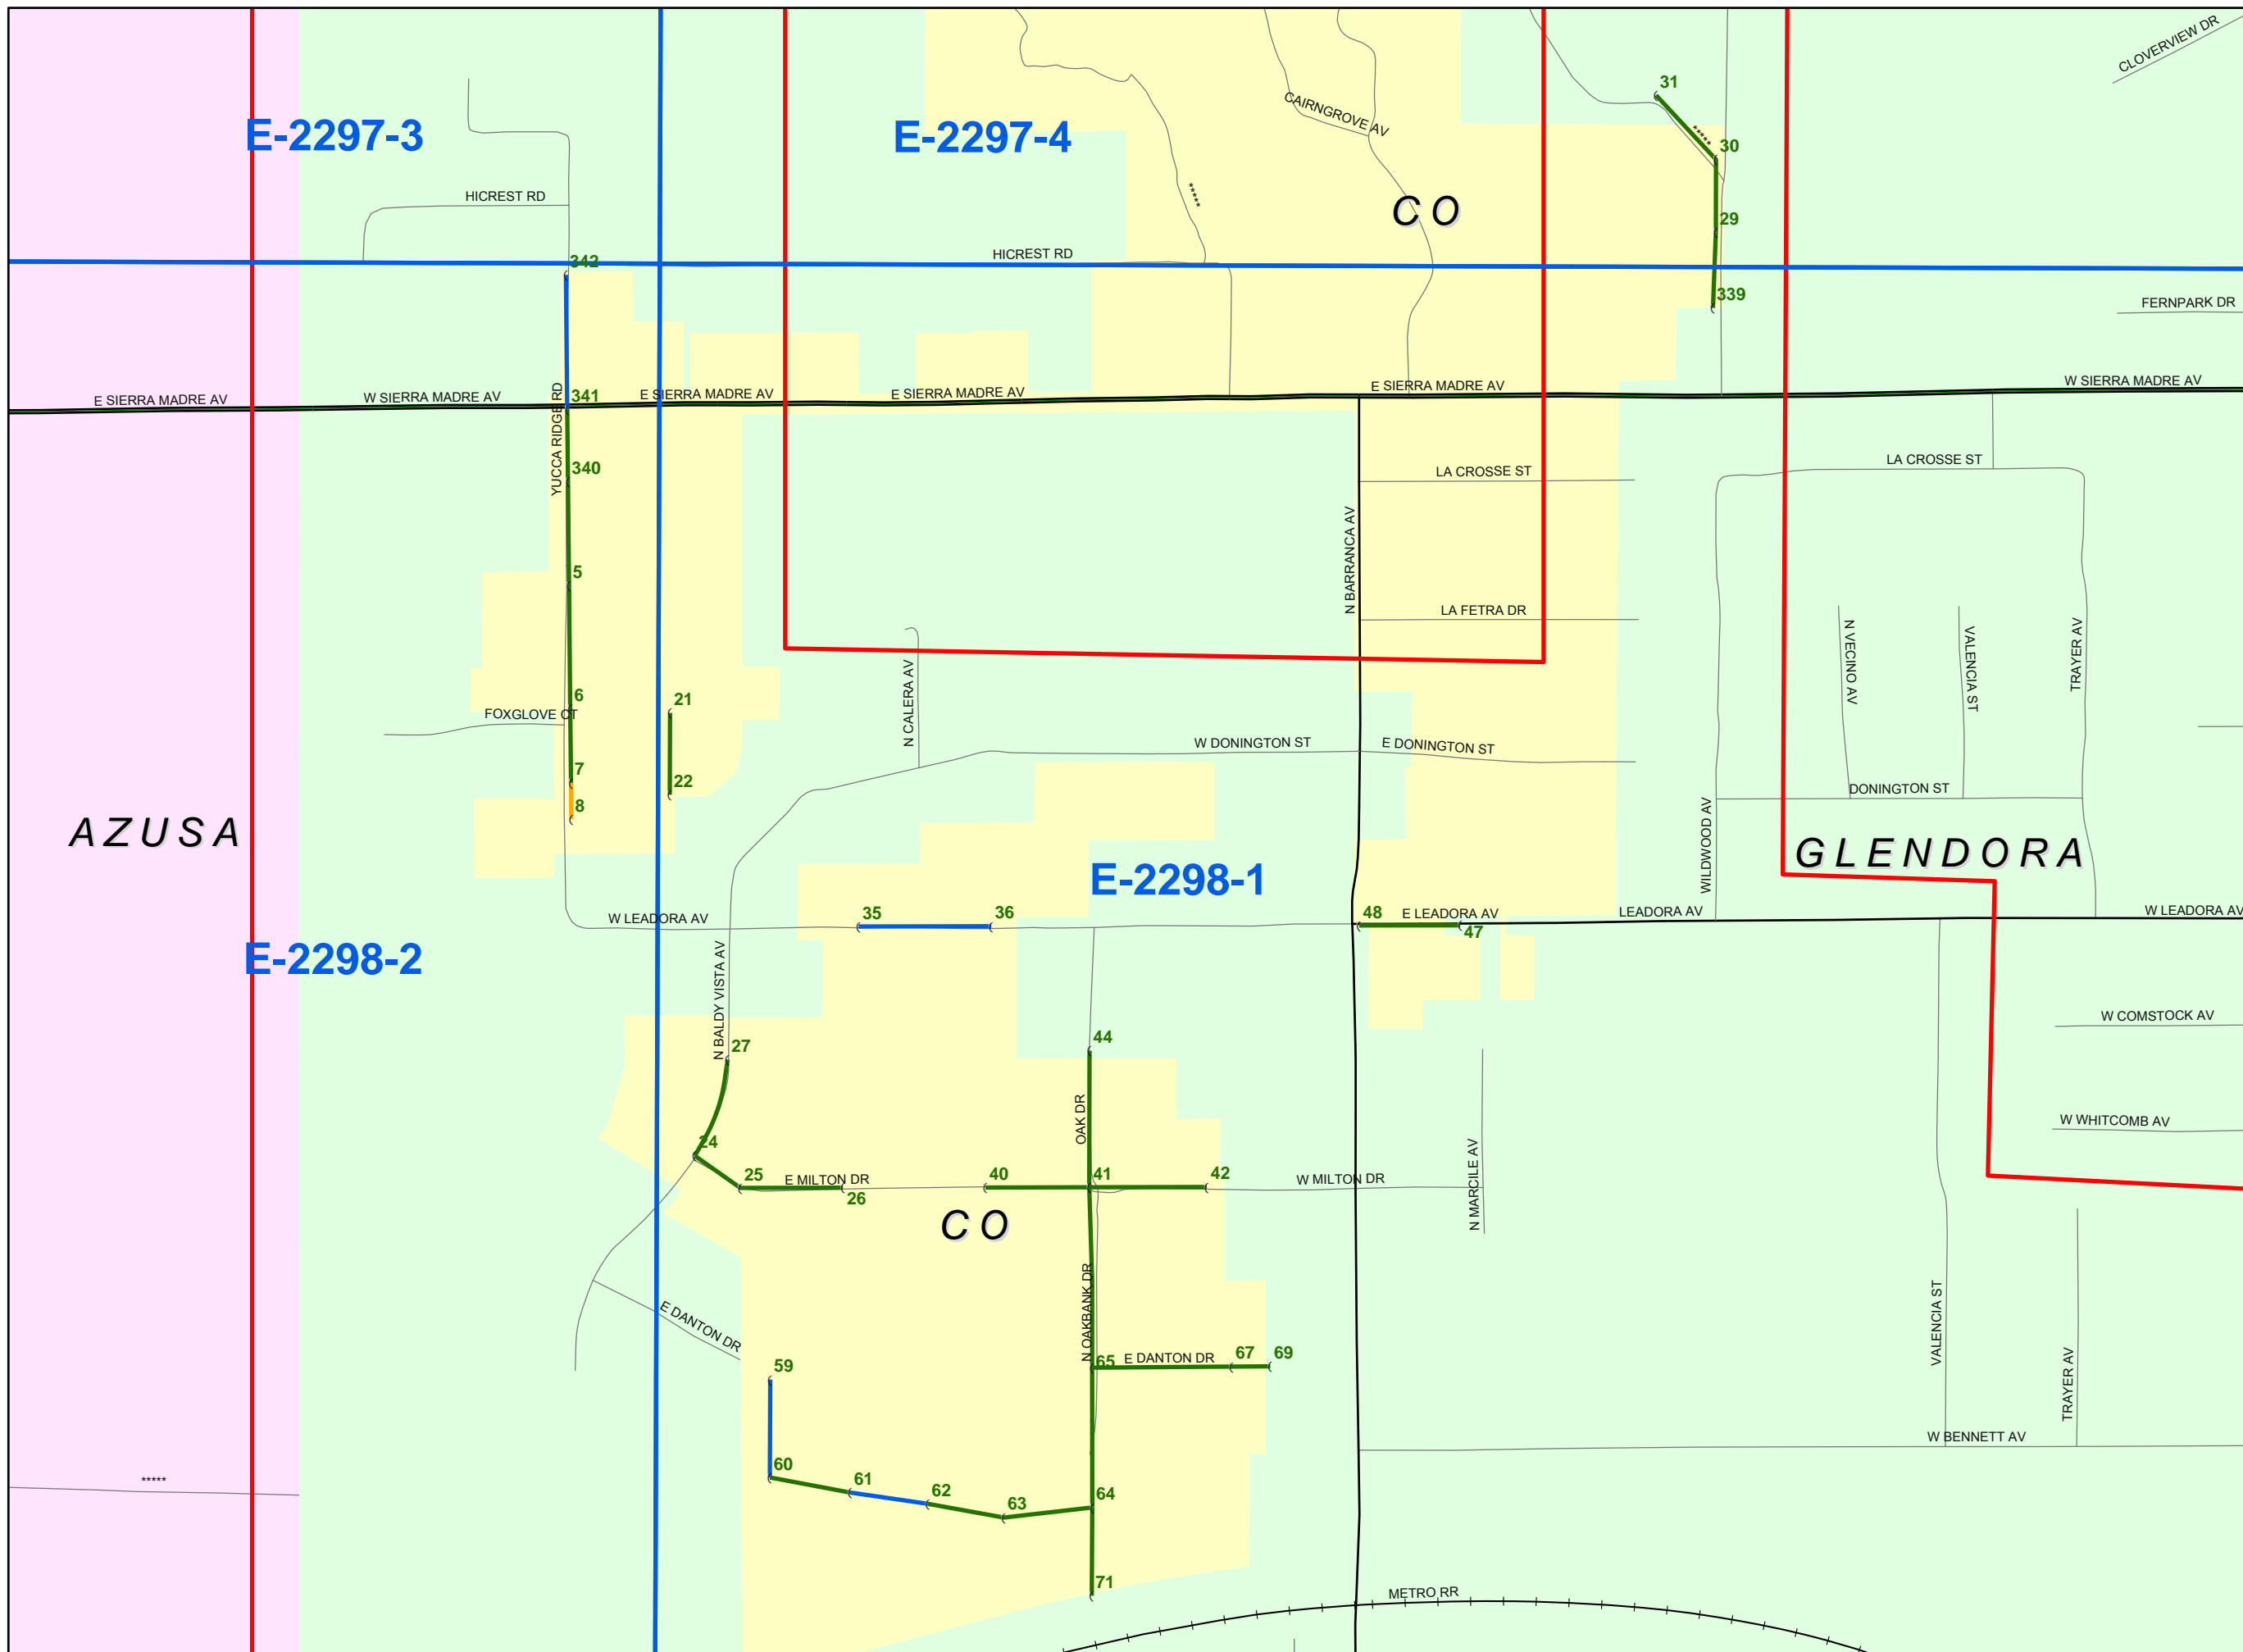
QUICK
STRUCTURAL
RATING
(QSR)

Our inspection revealed that approximately 97.7 percent of the inspected pipe segments within the Unincorporated Los Angeles County were free of severe structural defects. However, the remaining 2.3 percent of the inspected pipe segments had a PACP structural grade of 4 or 5 as indicated in the Quick Structural Rating Table shown below. These segments have been placed on a priority list based on the severity and the need for action. For Items 1 through 5 in the Quick Structural Rating Report Priority List (Enclosure 3) which require a corrective action, the proposed corrective method will be scheduled in the next 24 months as part of the ongoing Accumulative Capital Outlay Project. A color-coded map showing the Quick Structural Rating for each pipe segment is located in Enclosure 3. Copies of the actual inspection reports for these five segments are included in Enclosure 4.
