CONSOLIDATED SEWER MAINTENANCE DISTRICT CONDITION ASSESSMENT PROGRAM REPORT PROJECT Y0TV0506F

CONDITION ASSESSMENT REPORT COUNTY OF LOS ANGELES DEPARTMENT OF PUBLIC WORKS CONSOLIDATED SEWER MAINTENANCE DISTRICT

PROJECT NAME:
 Y0TV0506F
 PROJECT MGR:
 Fernando Villaluna

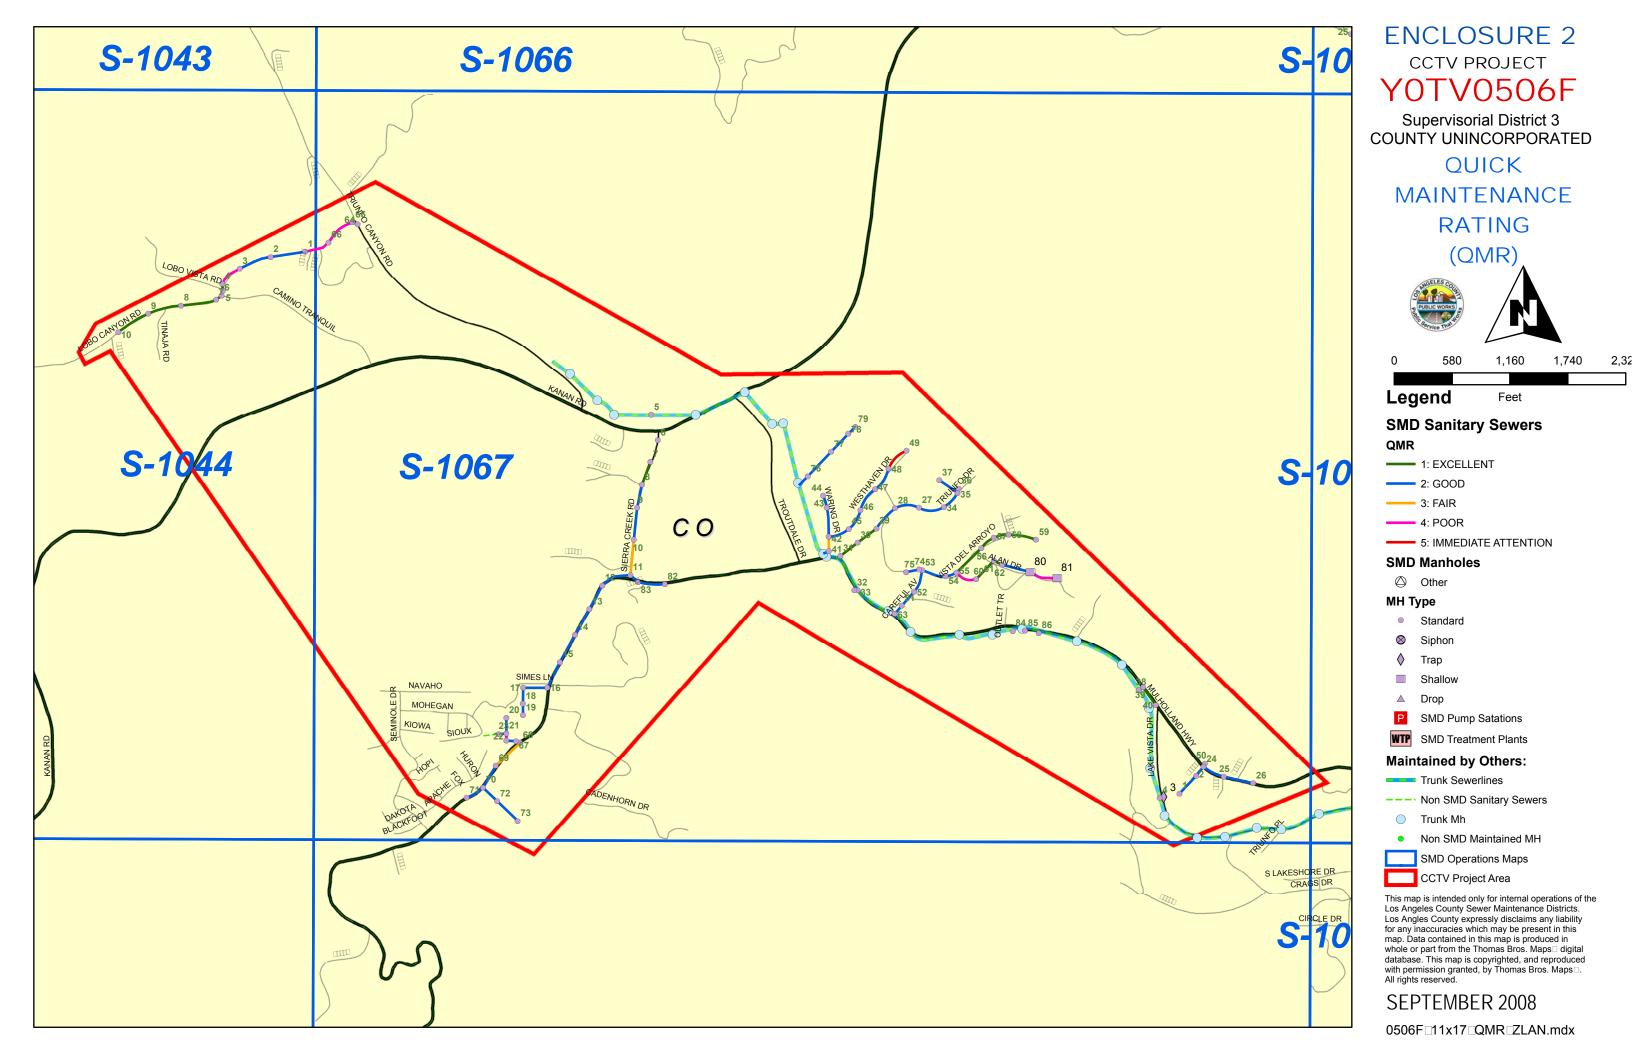
ENCLOSURE 2 QUICK MAINTENANCE RATING REPORT PRIORITY LIST UNINCORPORATED LOS ANGELES COUNTY SUPERVISORIAL DISTRICT 3 (Y0TV0506F) as of 08:04:06

Item No.	QMR	Start MH	End MH	Street	Observation	Corrective Action Taken
1	5121	1067-0048	1067-0049	WESTHAVEN DR	Deposits: End MH 1067-0049	Remove deposit and clean MH (Completed 11 12 08)
2	4123	1067-0081	1067-0080	ALAN DR	Roots; Debris	Hyrojet (Completed 11 12 108)
3	4121	1067-0022	1067-0021	MULHOLLAND HWY	Pipe alignment change	No action needed.
4	4100	1044-0001	1067-0066	ALAN DR	Pipe alignment change	No action needed.
5	4100	1044-0004	1044-0003	LOBO CYN RD	Pipe alignment change	No action needed.
6	4100	1067-0066	1067-0065	LOBO CYN RD	Pipe alignment change	No action needed.

The following line segment received a Quick Maintenance Rating of above 4000 due to the observation of Root Ball or Deposit inside the lateral connection. CSMD does not maintain lateral lines: it is the responsibility of the parcel owner to maintain their respective lateral lines to facilitate the flow of wastewater from their property to the mainline. Therefore, the line was not included on the Prioirty List above identified with maintenance deficiencies in need of immediate attention by CSMD.

ltem No.	QMR	Start MH	End MH	Street	Observation
1	4121	1067-0060	1067-0055	TRIUNFO DR	Roots in lateral

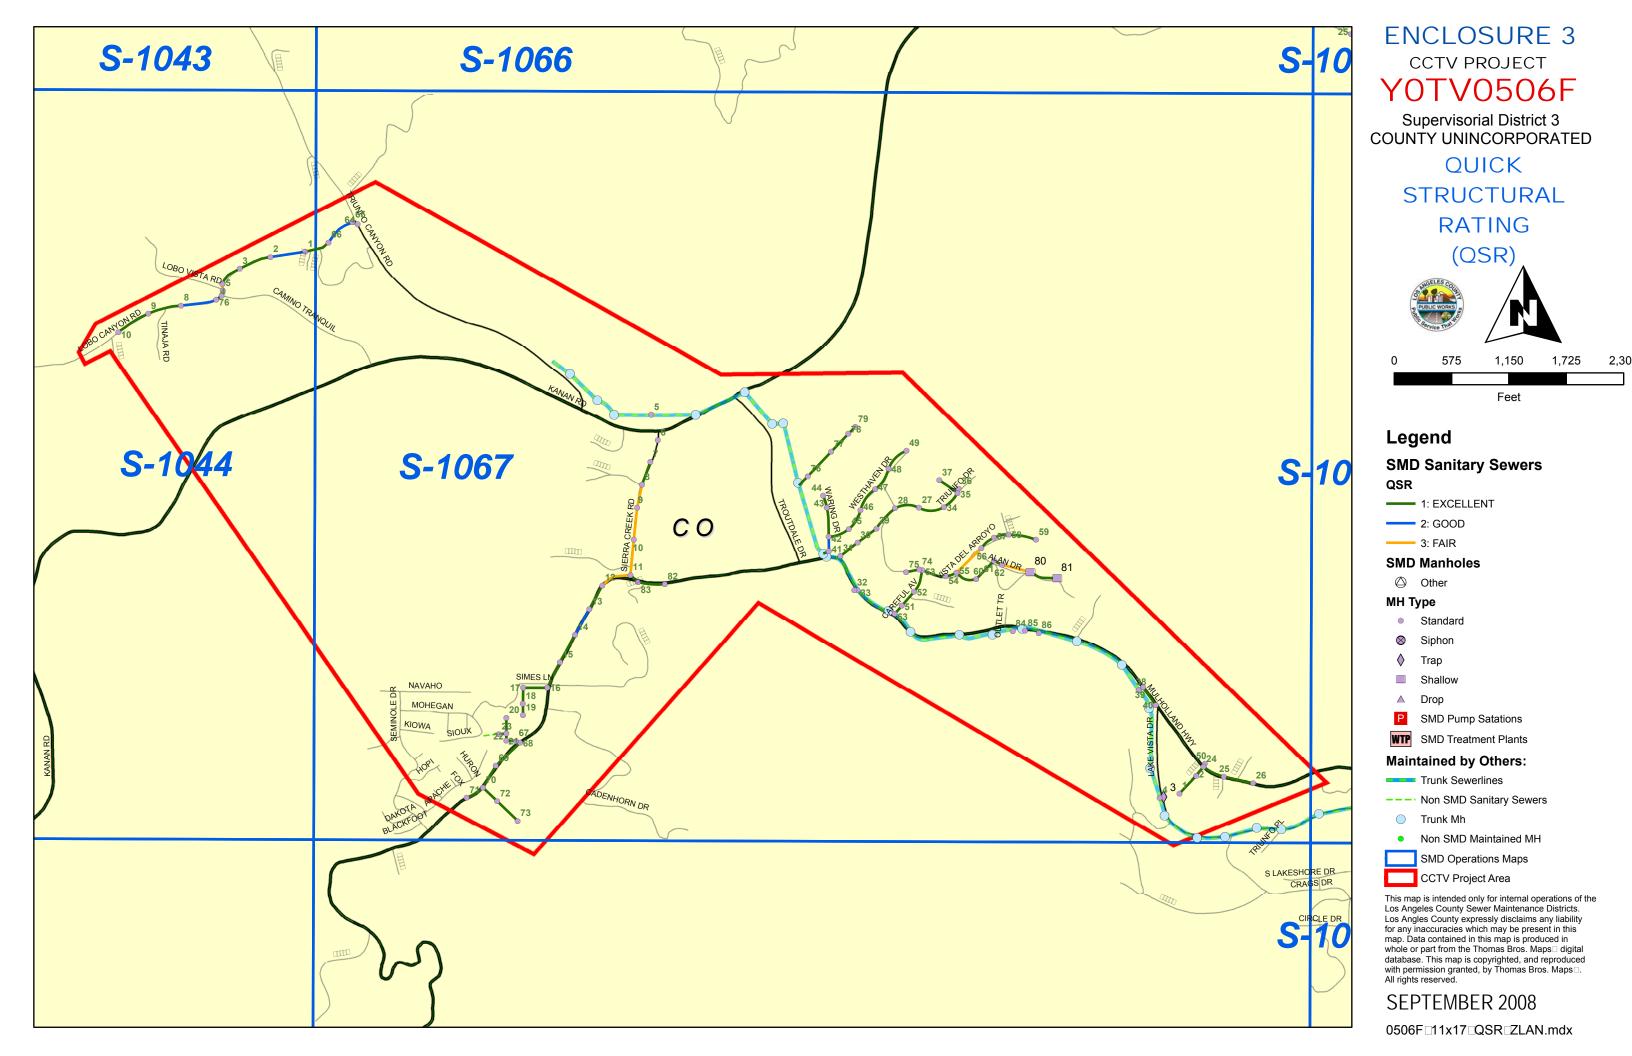
Quick Structural Rating Map

Our inspection revealed that 100 percent of the inspected pipe segments within the Unincorporated County of Los Angeles were free of severe structural defects as indicated in the Quick Structural Rating Table shown below. A color-coded map showing the Quick Structural Rating for each pipe segment is located in Enclosure 3.
