**CONSOLIDATED SEWER MAINTENANCE DISTRICT
CONDITION ASSESSMENT PROGRAM REPORT
PROJECT Y0TV0607A**

**CONDITION ASSESSMENT REPORT
COUNTY OF LOS ANGELES DEPARTMENT OF PUBLIC WORKS
CONSOLIDATED SEWER MAINTENANCE DISTRICT**

PROJECT NAME:	Y0TV0607A	PROJECT MGR:	Kari Eskridge
PROJECT DATE:	01/15/07-03/26/07	CONTACT NO:	(626) 300-3390
SUP. DISTRICT(s):	2	MAP PAGE(S):	1593, 1646, 1647 & 1701
Report By:	Phyo Kyaw	Report Date:	12/14/09

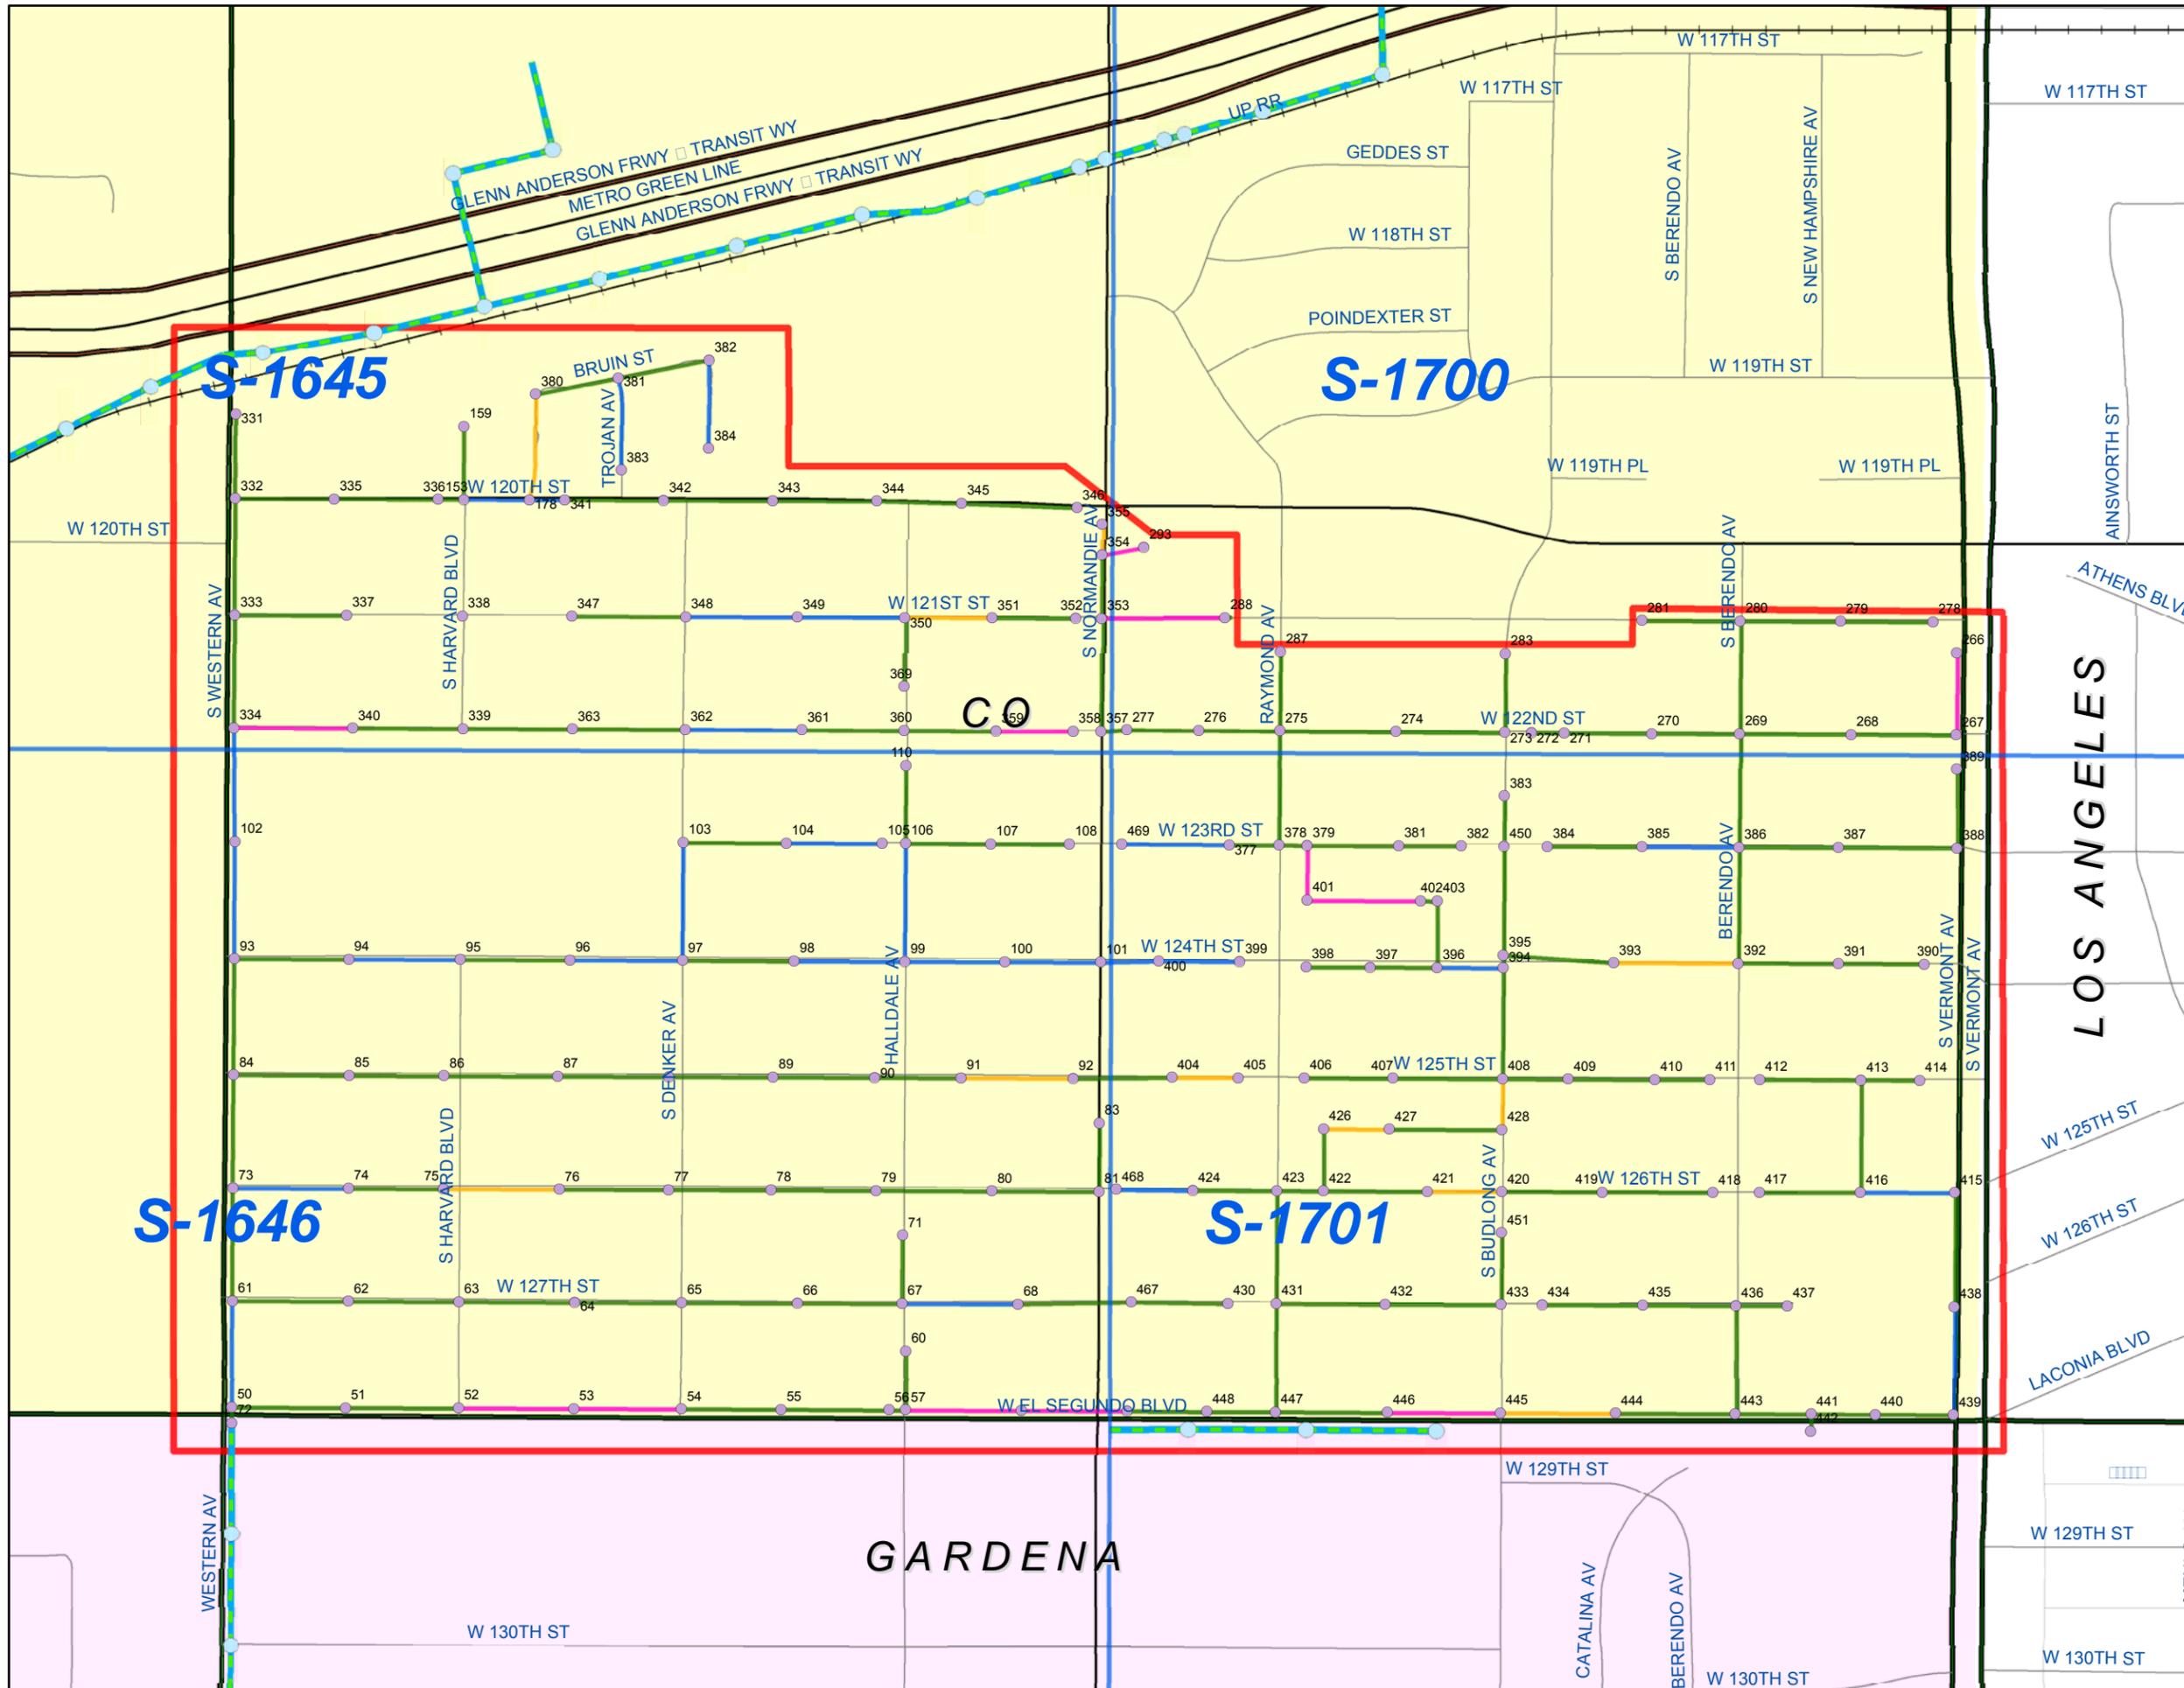
Our inspection revealed that approximately 93.4 percent of the system televised was free of blockages or restrictions that would impede sewer flows. However, the remaining 6.6 percent of the inspected pipe segments within the Unincorporated County of Los Angeles area had a PACP maintenance grade of 4 or 5 as indicated in the Quick Maintenance Rating Table shown below. These segments have been incorporated into our routine cleaning schedule with corrective action taken as noted on the Quick Maintenance Rating Report Priority List (Enclosure 2). Also included is a color-coded map showing the quick maintenance rating for each pipe segment.

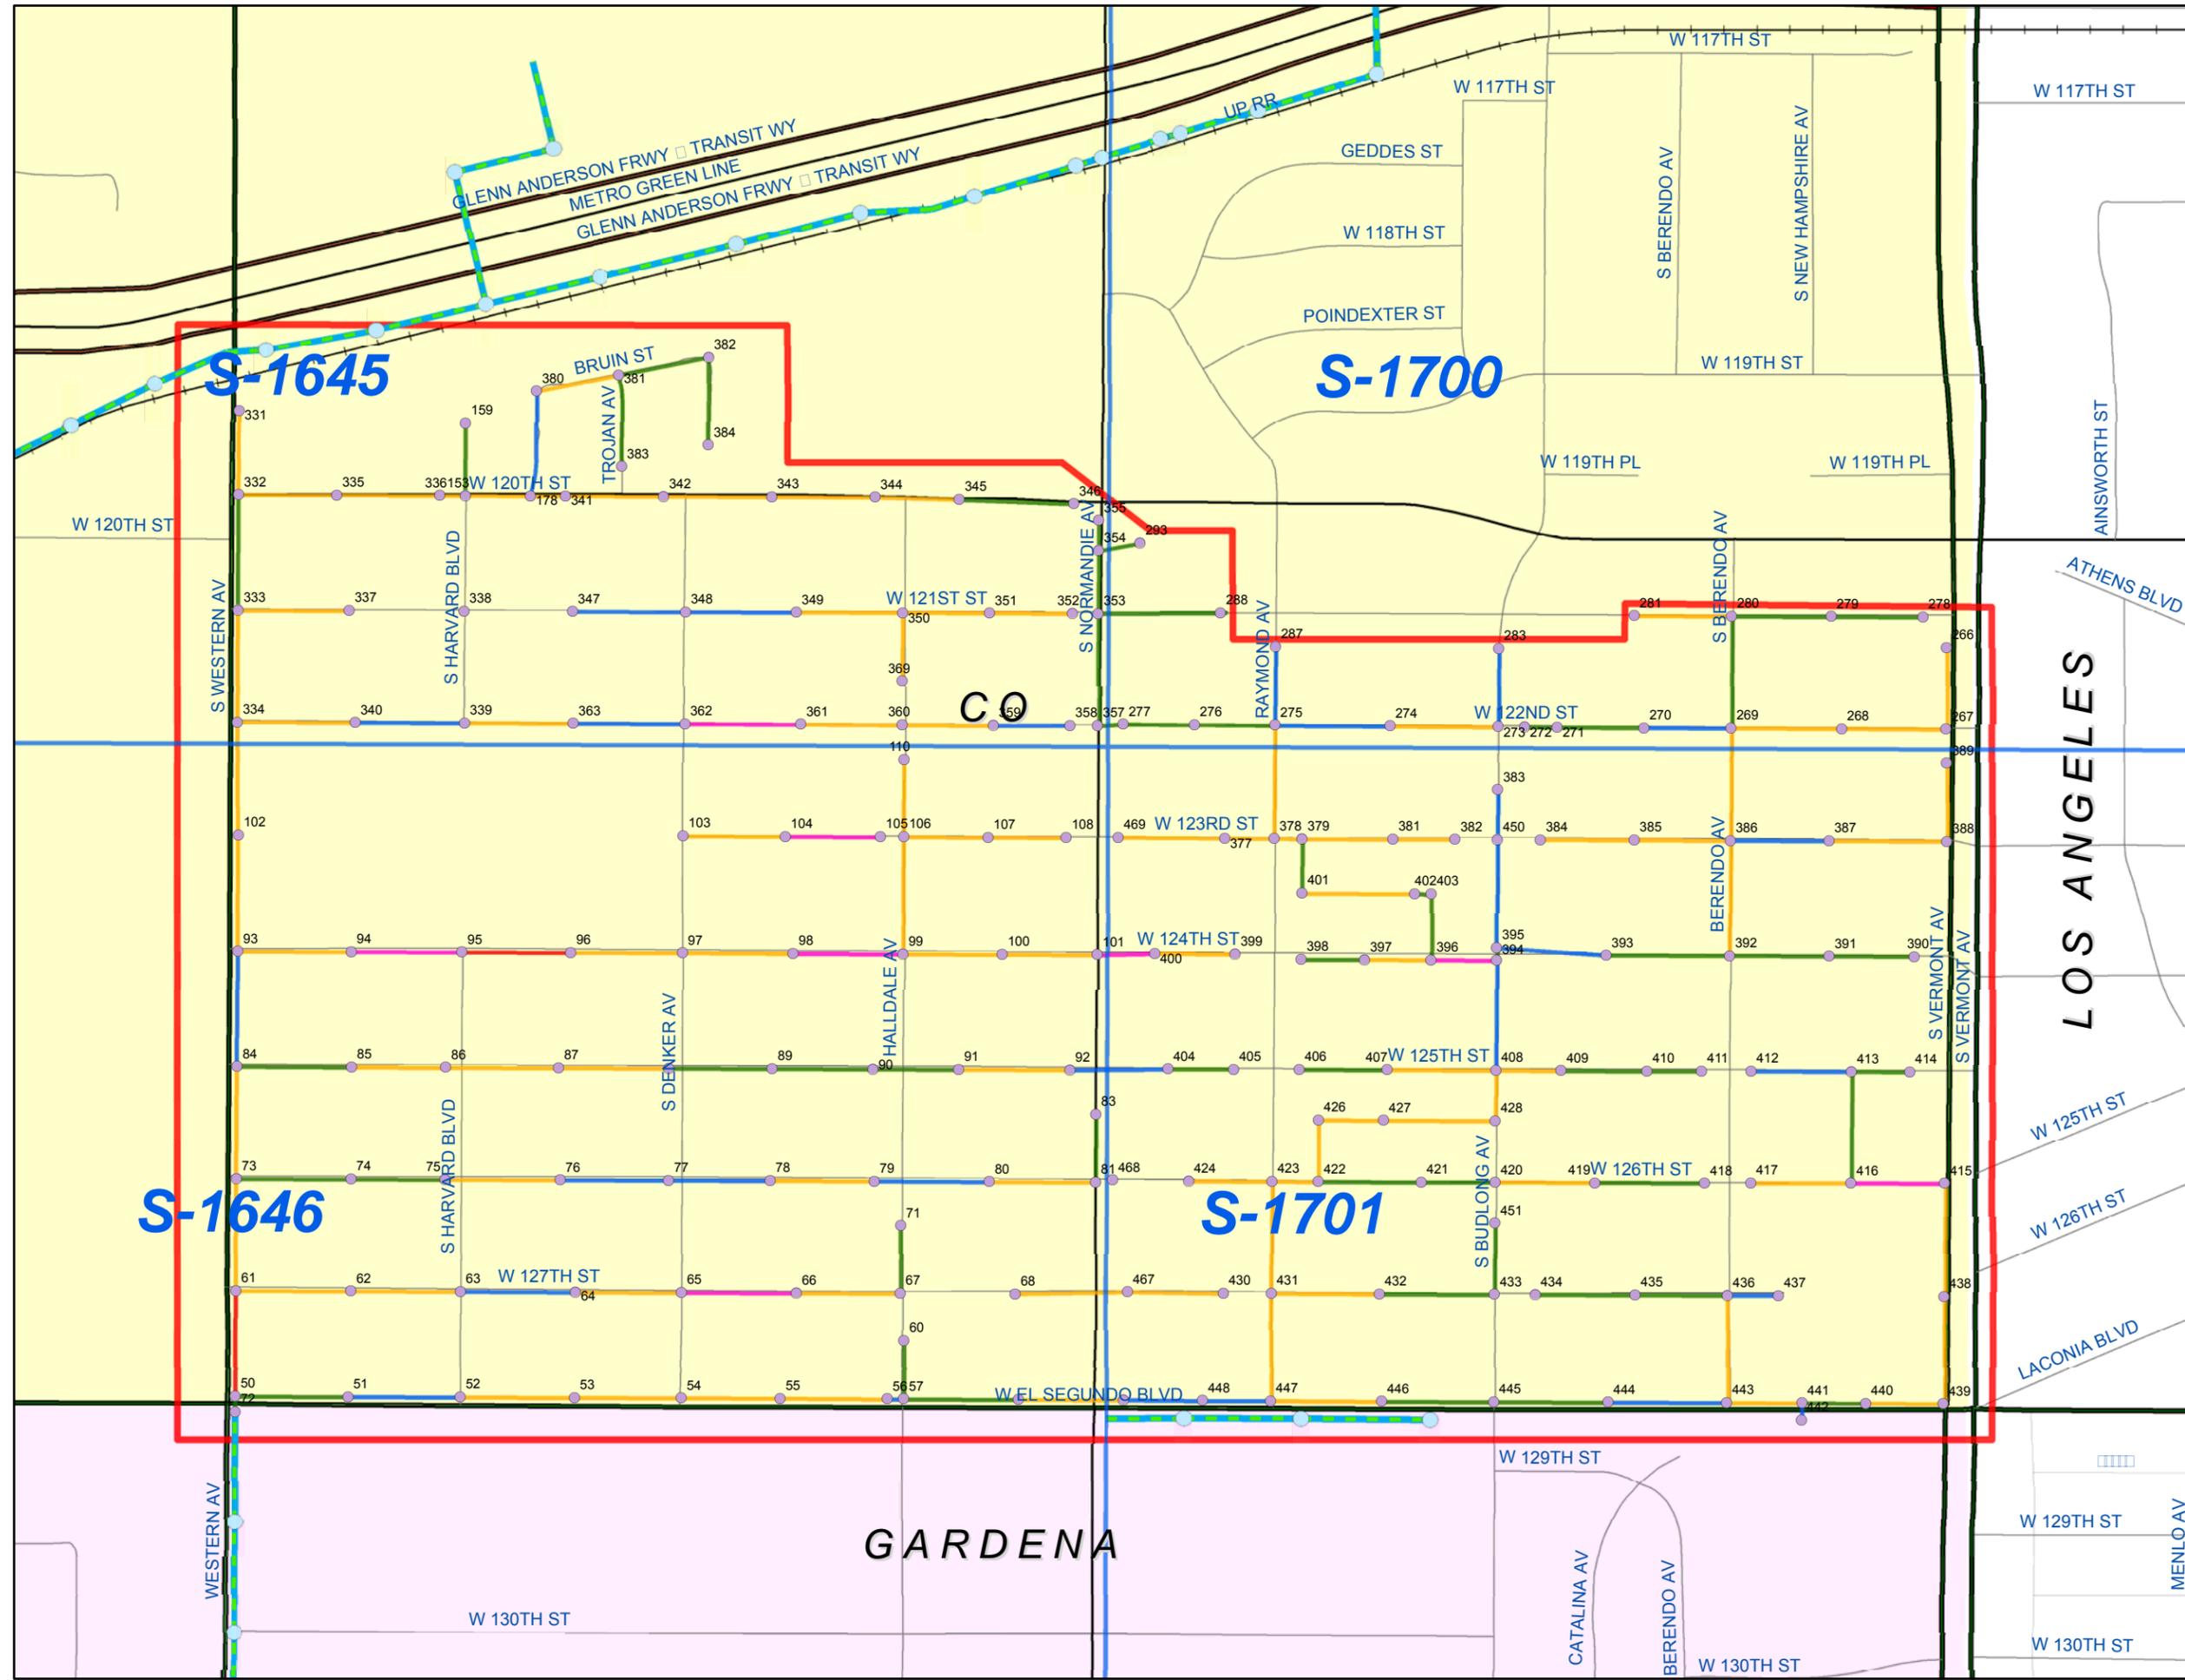
Our inspection revealed that approximately 87.0 percent of the inspected pipe segments within the Unincorporated County of Los Angeles were free of severe structural defects. However, the remaining 13.0 percent of the inspected pipe segments had a PACP structural grade of 4 or 5 as indicated in the Quick Structural Rating Table shown below. These segments have been placed on a priority list based on the severity and the need for action. For Items 1 through 60 in the Quick Structural Rating Report Priority List (Enclosure 3) which require a corrective action, the proposed corrective method will be scheduled in the next 24 months as part of the ongoing Accumulative Capital Outlay Project. A color-coded map showing the Quick Structural Rating for each pipe segment is located in Enclosure 3. Copies of the actual inspection report for these 60 segments are included in Enclosure 4.
