**CONSOLIDATED SEWER MAINTENANCE DISTRICT
CONDITION ASSESSMENT PROGRAM REPORT
PROJECT Y0TV0910A**

**CONDITION ASSESSMENT REPORT
COUNTY OF LOS ANGELES DEPARTMENT OF PUBLIC WORKS
CONSOLIDATED SEWER MAINTENANCE DISTRICT**

PROJECT NAME:	Y0TV0910A	PROJECT MGR:	Eric Liu
PROJECT DATE:	07/10/09	CONTACT NO:	(626) 300-3369
SUP. DISTRICT(s):	5	MAP PAGE(S):	1025,1066,1091&1092
Report By:	Hanna Kebede	Report Date:	08/13/2012

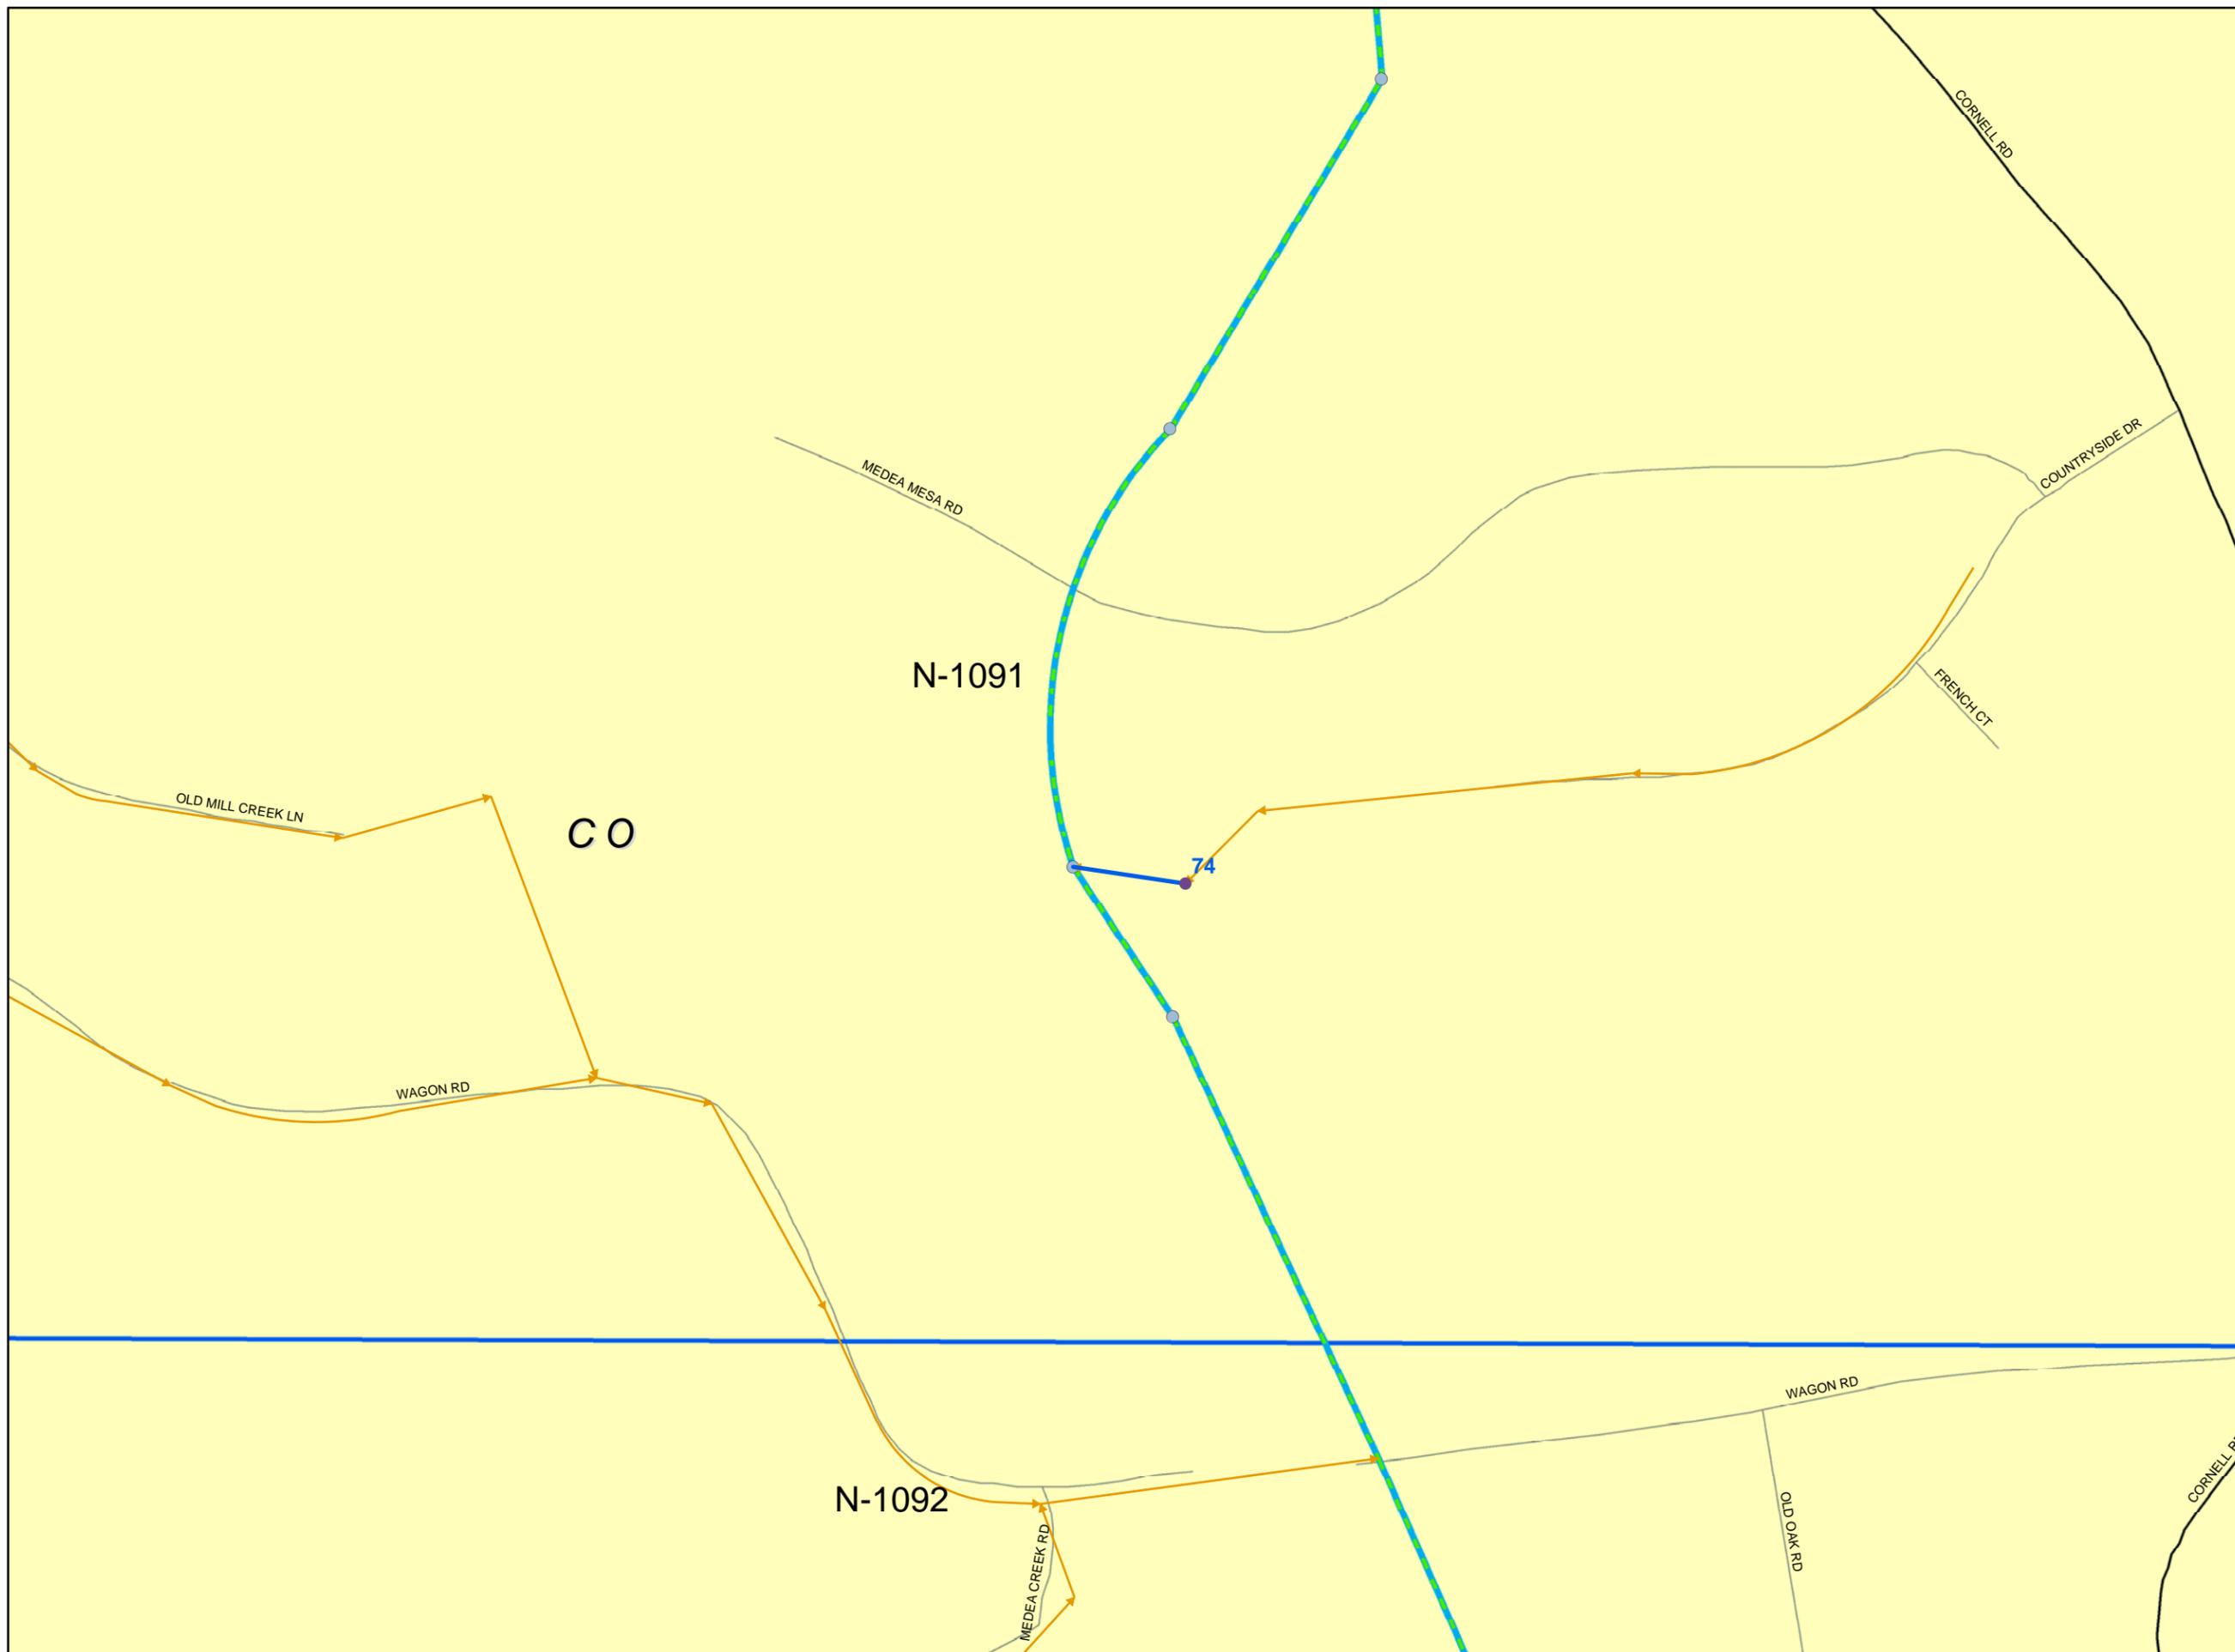
HIGH WATER LEVEL

Item No.	QMR	Start MH	End MH	Street	Observation	
1	4231	1091-0074	1091-0075	EASEMENT	High water level	Entire Segment
