May 4, 2026
(2022-226.03)

Re: *Devil's Gate Reservoir Restoration Project – Phase 3 Restoration Qualitative Monitoring Conducted on March 26, 2026*

1.0 INTRODUCTION

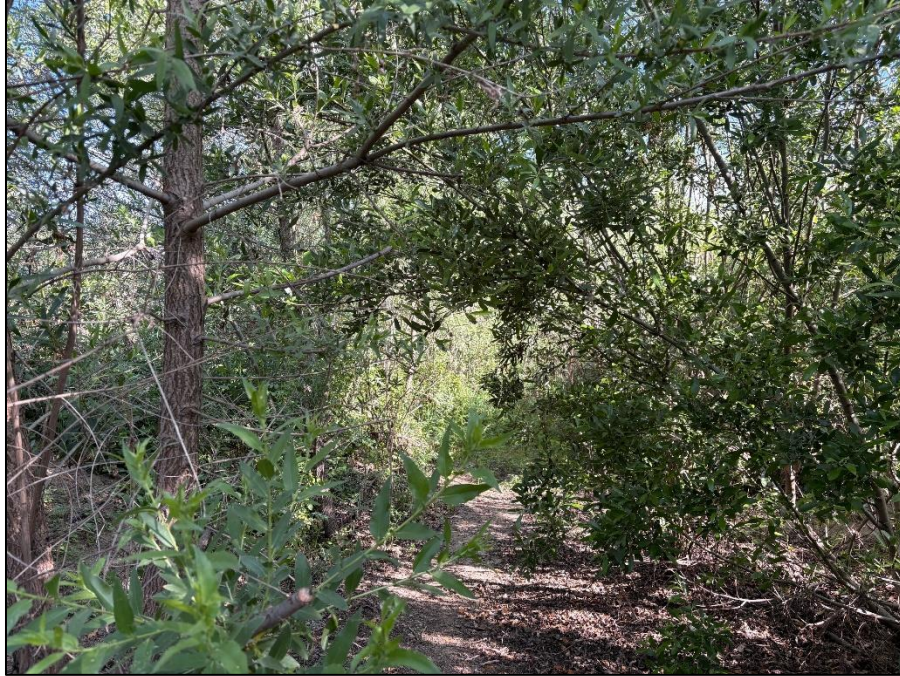
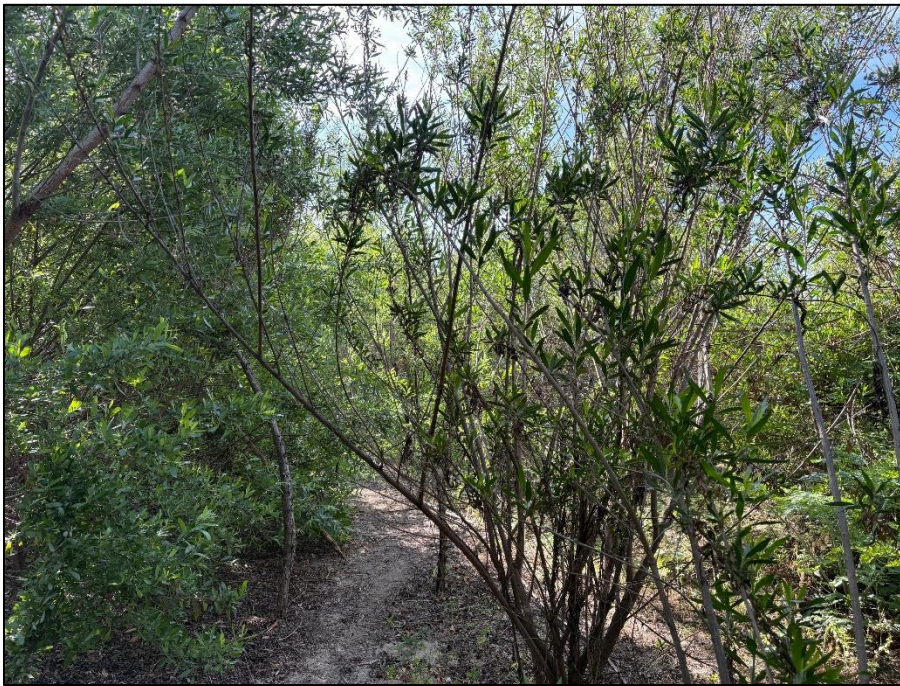
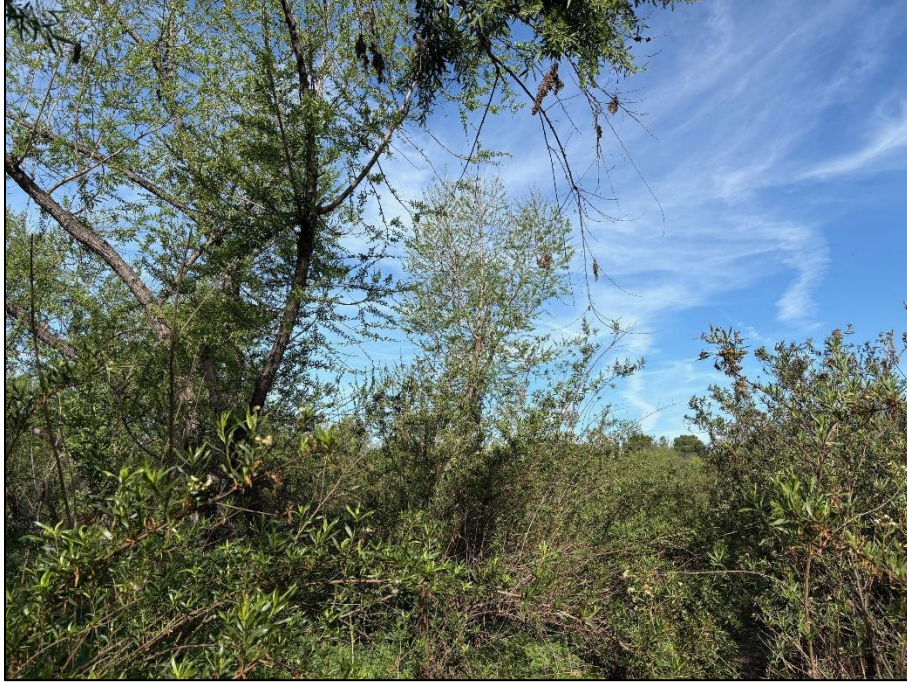
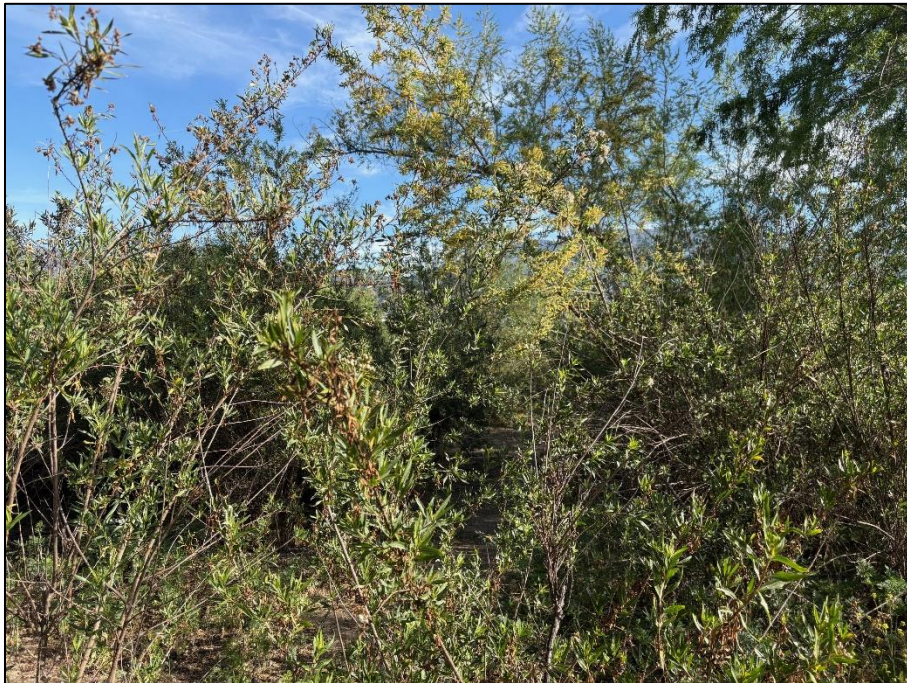
The overall health of the container plants in DG-4 WOUS and DG-4 WOUS Connections was noted as being good. Approximately 5 to 10 percent of the container plants and stakes in DG-4 WOUS and DG-4 WOUS Connections were noted as showing signs of stress and a negligible amount were noted as being dead or missing. This is approximately 5 percent higher than the percentage of plants that were showing stress during the previous monitoring visit. Stress may be occurring as a result of 1) herbivory by rabbits or other wildlife, 2) competition from nonnative and invasive weeds, 3) misplaced emitters, 4) recreational traffic through the mitigation areas, and/or 5) drought stress from recent high temperatures. Portions of the DG-4 WOUS Connections mitigation area adjacent to the Mining Pit mitigation area that were inundated during the previous monitoring visit were no longer inundated during the March 26 visit. Photos 1 through 4 (Appendix B) document the mitigation areas during the monitoring visit.

Native plant germination from seed application and natural recruitment was noted throughout the DG-4 WOUS and DG-4 WOUS Connections mitigation areas. The native species observed sprouting in the DG-4 WOUS and DG-4 WOUS Connections mitigation areas included mugwort (*Artemisia douglasiana*), caterpillar phacelia (*Phacelia cicutaria*), common phacelia (*Phacelia distans*), Mexican elderberry (*Sambucus mexicana*), and stinging nettle (*Urtica gracilis* [formerly *Urtica dioica*]). Native cover was estimated to be approximately 80 percent during the monitoring visit.

Nonnative weed cover in DG-4 WOUS and DG-4 WOUS Connections was estimated at approximately 15 to 20 percent, which is approximately 5 percent higher than the percentage of weed cover that was observed during the previous monitoring visit. Nonnative species observed included black mustard (*Brassica nigra*), poison hemlock (*Conium maculatum*), petty spurge (*Euphorbia peplus*), perennial pepperweed (*Lepidium latifolium*), and dwarf nettle (*Urtica urens*). Most of the nonnative weeds observed in these mitigation areas were just starting to germinate, however, some of the black mustard and poison hemlock were starting to go to flower and should be removed from the mitigation areas prior to seed production. As weed abatement continues in the mitigation areas, it is anticipated that the seed bank of nonnative and invasive weeds will decrease.

Photo 1. Overview DG-4 WOUS & WOUS Connections

Photo 2. Overview DG-4 WOUS & WOUS Connections

Photo 3. Overview DG-4 WOUS & WOUS Connections

Photo 4. Overview DG-4 WOUS & WOUS Connections

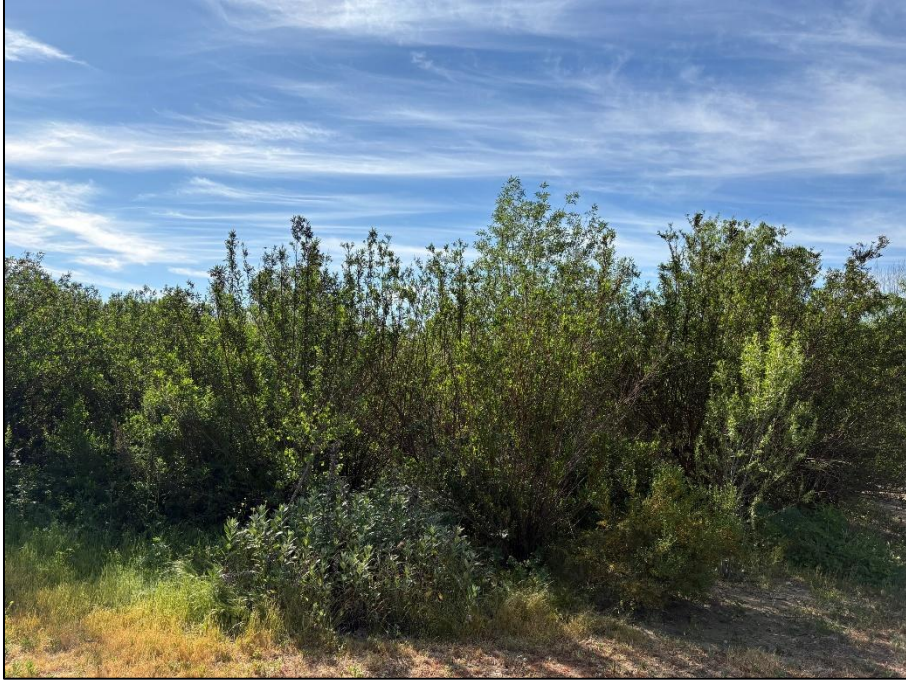
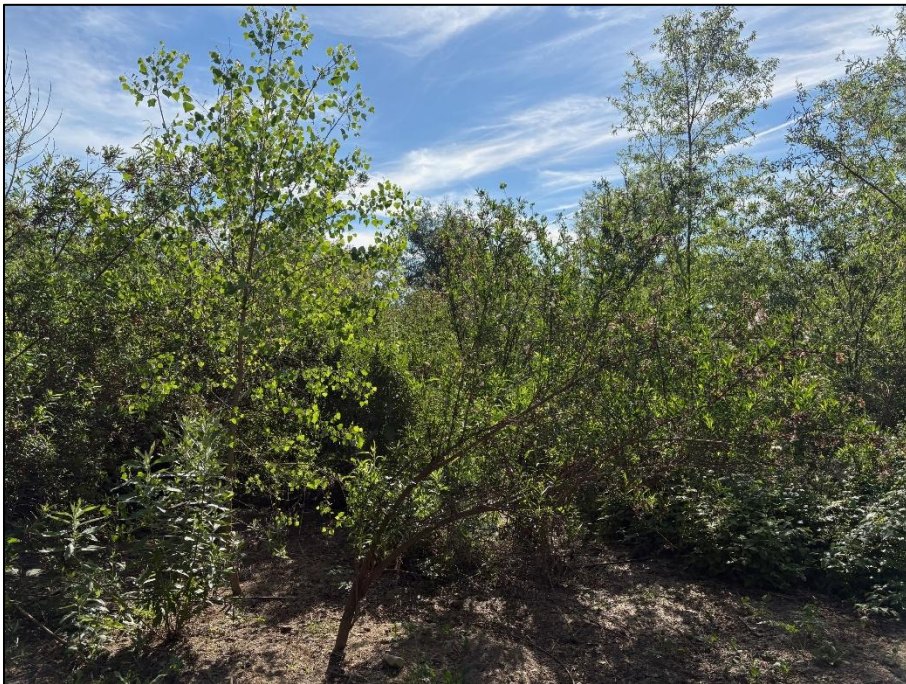
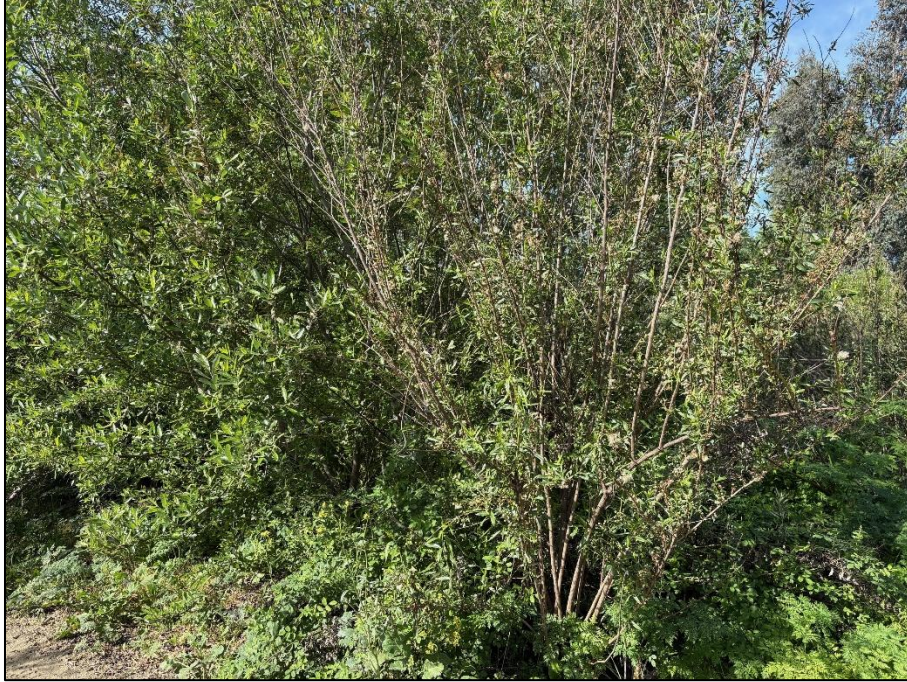
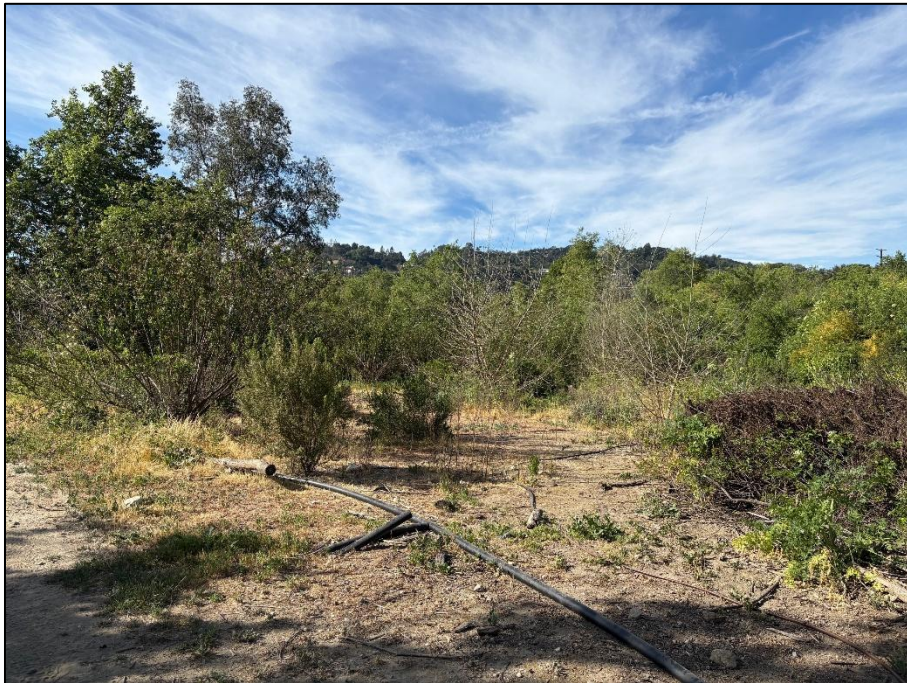
The overall health of the container plants in DG-4A was noted as being good and this mitigation area is becoming well established. Approximately 5 to 10 percent of the container plants and stakes in DG-4A were noted as showing signs of stress which is approximately the same percentage of plants which were showing signs of stress during the previous monitoring visit. This included the remaining container plants from the first installation and the container plants that were installed to replace the original container plants and stakes planted in the middle section of DG-4A that appeared to be dead or in a condition unlikely to recover during previous monitoring visits. Stress may be occurring due to similar reasons described for DG-4 WOUS and DG-4 WOUS Connections. The southern portions of the DG-4A mitigation area that were inundated during the previous monitoring visit were no longer inundated during the March 26 visit. Photos 5 through 8 in Appendix B document the mitigation area during the monitoring visit.

Native plant germination from seed application and natural recruitment was noted throughout the DG-4A mitigation area. Native plants such as mugwort, coyote brush (*Baccharis pilularis*), cobweb thistle (*Cirsium occidentale*), common phacelia (*Phacelia distans*), ladies' tobacco (*Pseudognaphalium californicum*), California blackberry (*Rubus ursinus*), poison oak (*Toxicodendron diversilobum*), and stinging nettle were observed sprouting in the mitigation area. Native cover was estimated to be approximately 80 percent during the monitoring visit.

Nonnative weed cover in the DG-4A mitigation area was estimated at approximately 15 percent during the monitoring visit, which is approximately 10 percent lower than what was observed during the previous monitoring visit. Nonnative species observed included black mustard, poison hemlock, red-stemmed filaree (*Erodium cicutarium*), perennial pepperweed, and prickly sow thistle (*Sonchus asper*). Most of the nonnative weeds observed in these mitigation areas were just starting to germinate, however, some of the black mustard and poison hemlock were starting to go to flower and should be removed from the

mitigation areas prior to seed production. As weed abatement continues in the mitigation areas, it is anticipated that the seed bank of nonnative and invasive weeds will decrease, however, perennial pepperweed easily resprouts from rhizomatous roots that can be difficult to fully remove with hand tools.

Photo 5. Overview DG-4A

Photo 6. Overview DG-4A

Photo 7: Overview DG-4A

Photo 8: Overview DG-4A

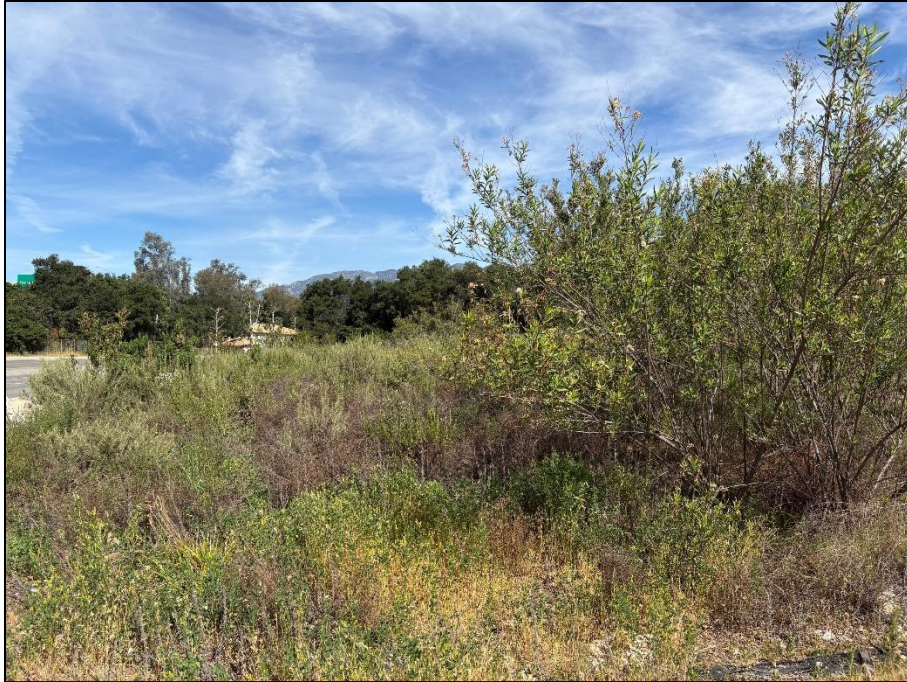
The overall health of the container plants in the Tire Wash mitigation area was noted as being good. Less than 5 percent of the container plants were noted as showing varied levels of stress, which is the same percentage of plants that were showing stress during the previous monitoring visit. This included the remaining container plants from the first installation and the replacement container plants that were installed to replace the container plants that were either missing or appeared to be dead or in a condition unlikely to recover during previous monitoring visits. Stress may be occurring due to similar reasons described for DG-4 WOUS and DG-4 WOUS Connections. In addition, some of the container plants are being smothered by deerweed (*Acmispon glaber*), which is proliferating in this area. The irrigation system was found to be functioning properly within this mitigation area. Photo 9 in Appendix B documents the mitigation area during the monitoring visit.

Native plant germination from natural recruitment was noted throughout the Tire Wash mitigation area. Native plants such as deerweed, California sagebrush (*Artemisia californica*), mulefat (*Baccharis salicifolia*), longstem buckwheat (*Eriogonum elongatum*), telegraph weed (*Heterotheca grandiflora*), and ladies' tobacco were observed sprouting in the mitigation area. Native cover was estimated to be approximately 90 percent during the monitoring visit.

Nonnative weed cover in the Tire Wash mitigation area was estimated at approximately 5 to 10 percent, which is approximately 5 percent more than the percentage of nonnative cover that was observed during the previous monitoring visit. Nonnative species observed included black mustard, red brome (*Bromus madritensis*), sourclover (*Melilotus indicus*), and prickly sow thistle. Most of the nonnative weeds observed in this mitigation area were just starting to germinate, however, some black mustard was starting to flower and should be removed prior to seed production. As weed abatement continues in the mitigation areas, it is anticipated that the seed bank of nonnative and invasive weeds will decrease.

Photo 9: Overview Tire Wash

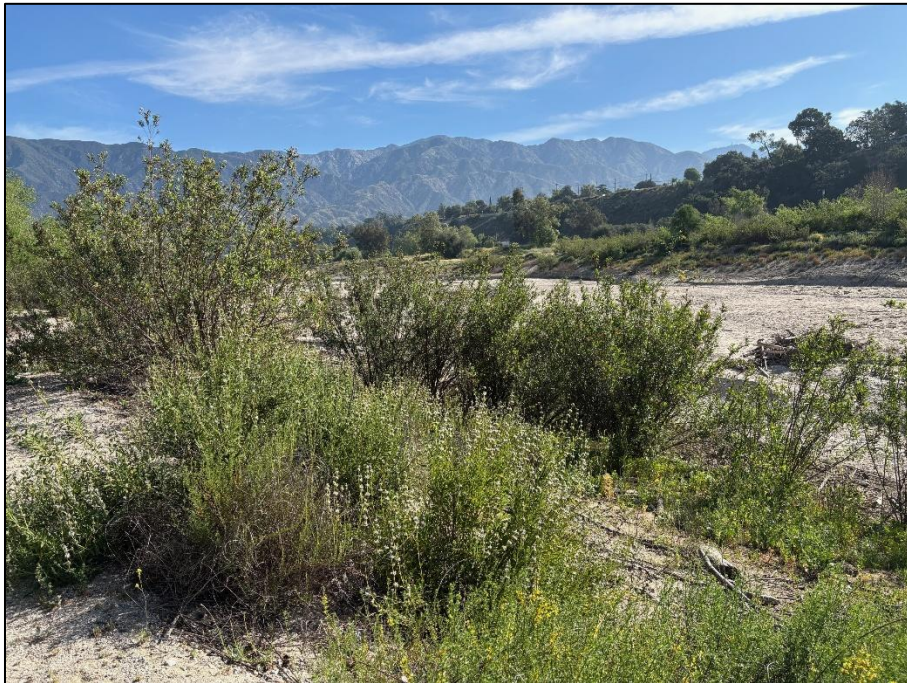
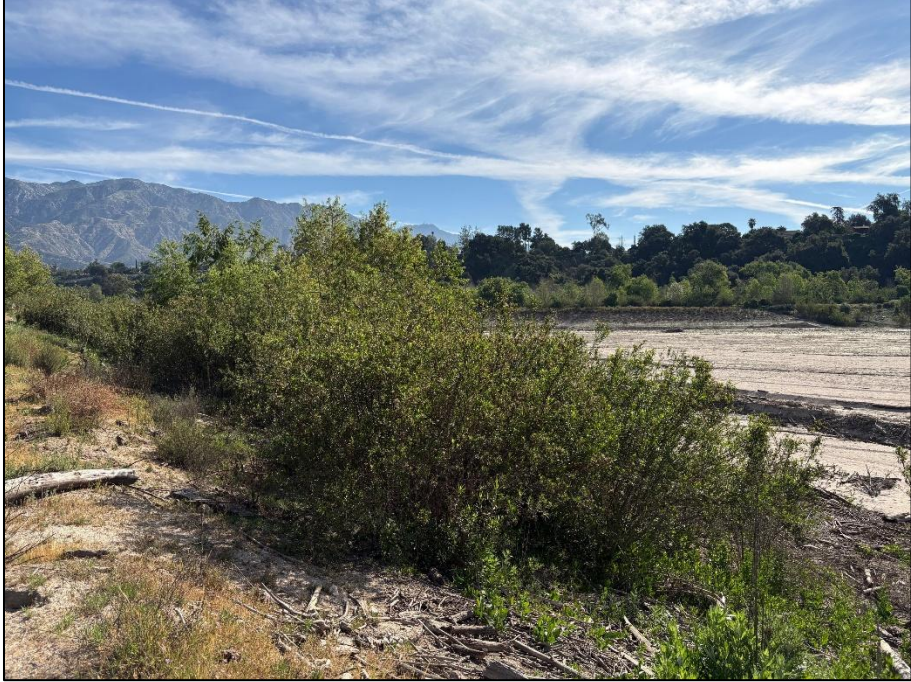
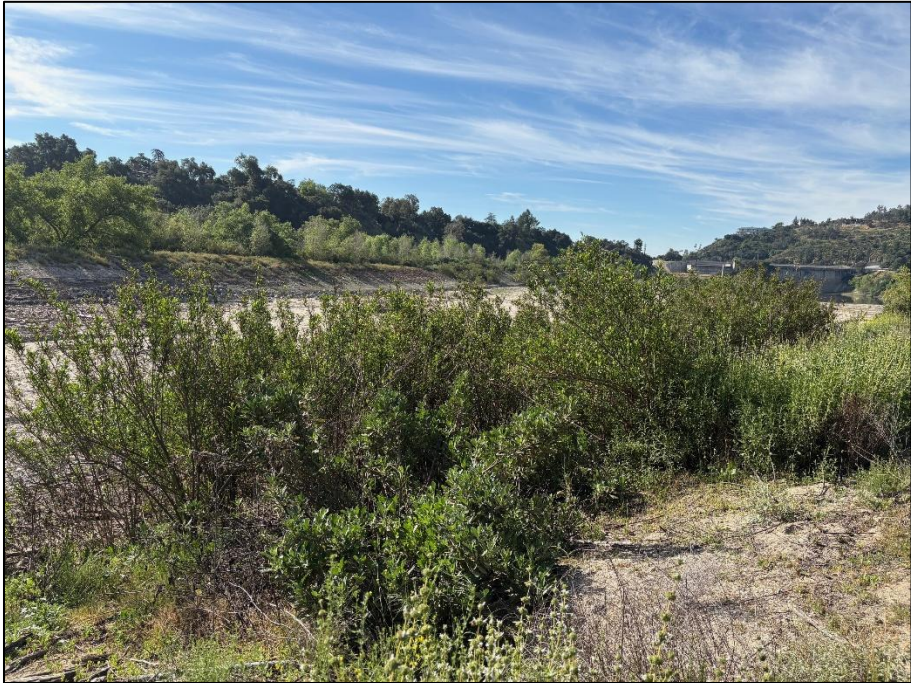
Container plants were not installed on the Side Slopes or in Flint Wash, but these areas were seeded with native plant species. Native plant growth was noted throughout the Side Slopes and Flint Wash, likely both from natural recruitment and from seeding. Minor to moderate erosion was present at the base of the Side Slopes and the hydroseeded portions of the Side Slopes where previous erosion had occurred showed minimal germination; however, the level of native cover continues to increase and some areas appear to be stabilizing. The lower level of germination on these portions of the Side Slopes could be due to lack of soil nutrients, lack of organic matter, and/or incorrect compaction levels. Native plants such as deerweed, mugwort, mulefat, California buckwheat (*Eriogonum fasciculatum*), black willow (*Salix gooddingii*), and black sage (*Salvia mellifera*) were observed sprouting on the Side Slopes and in Flint Wash. Overall native cover was estimated to be approximately 65 percent during the monitoring visit;

however, portions of the Side Slopes that have previously had erosion issues had a lower level of cover. Photos 10 through 12 in Appendix B document the Side Slopes during the monitoring visit.

Nonnative weed cover on the Side Slopes and Flint Wash was estimated at approximately 10 to 15 percent overall, which is approximately 5 percent lower than the percentage of weed cover that was observed during the previous monitoring visit. Nonnative species observed on the Side Slopes and Flint Wash included black mustard, poison hemlock, perennial pepperweed, and tree tobacco (*Nicotiana glauca*). Most of the nonnative weeds observed in this mitigation area were just starting to germinate and were not going to flower nor producing seed. As weed abatement continues in the mitigation areas, it is anticipated that the seed bank of nonnative and invasive weeds will decrease; however, perennial pepperweed easily resprouts from rhizomatous roots that can be difficult to fully remove with hand tools.

Photo 10: Overview Side Slopes

Photo 11: Overview Side Slopes

Photo 12: Overview Side Slopes

Portions of the Side Slopes which were previously noted as having significant erosion that occurred as a result of heavy rainfall during the 2023 wet season and following the tropical storm which occurred in late August 2023 were noted as having been repaired during previous monitoring visits. These areas were included in the supplemental seeding effort which was completed in November of 2023. Some additional erosion was observed at the toe of the Side Slopes in these areas and has the potential to worsen. As more perennial plants become established on the Side Slopes, erosion should become less of an issue; however, action will need to be taken to repair the damage caused by the erosion and measures should be taken to reduce damage from erosion in the future. In addition, if the supplemental seeding effort does not produce germination on the previously eroded Side Slopes, adaptive management techniques will likely be warranted. During future monitoring events, erosion should continue to be monitored in all planted areas and if warranted, erosion Best Management Practices should be installed in appropriate areas. This may only require the installation of straw wattles at select locations to prevent existing rills from becoming larger.
