**Re: *Devil's Gate Reservoir Restoration Project – Phase 1 Restoration Qualitative Monitoring Conducted on May 19, 2022***

## **1.0 INTRODUCTION**

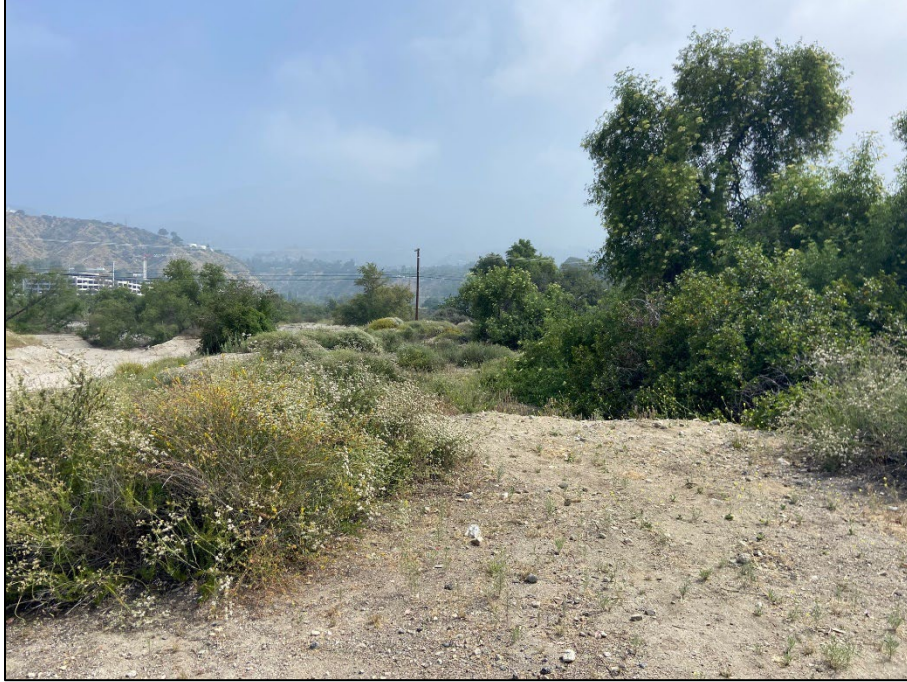
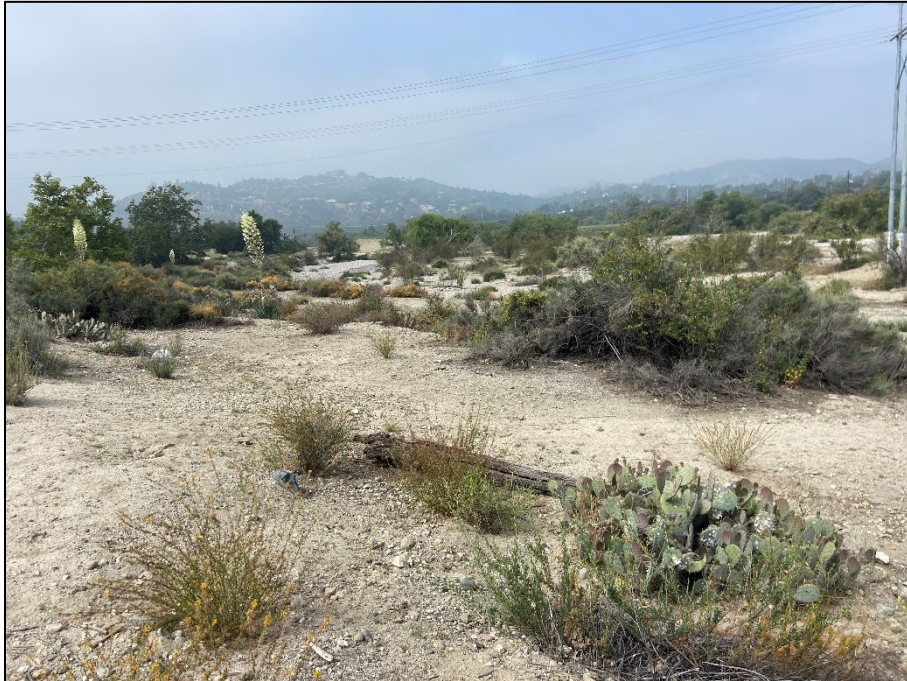
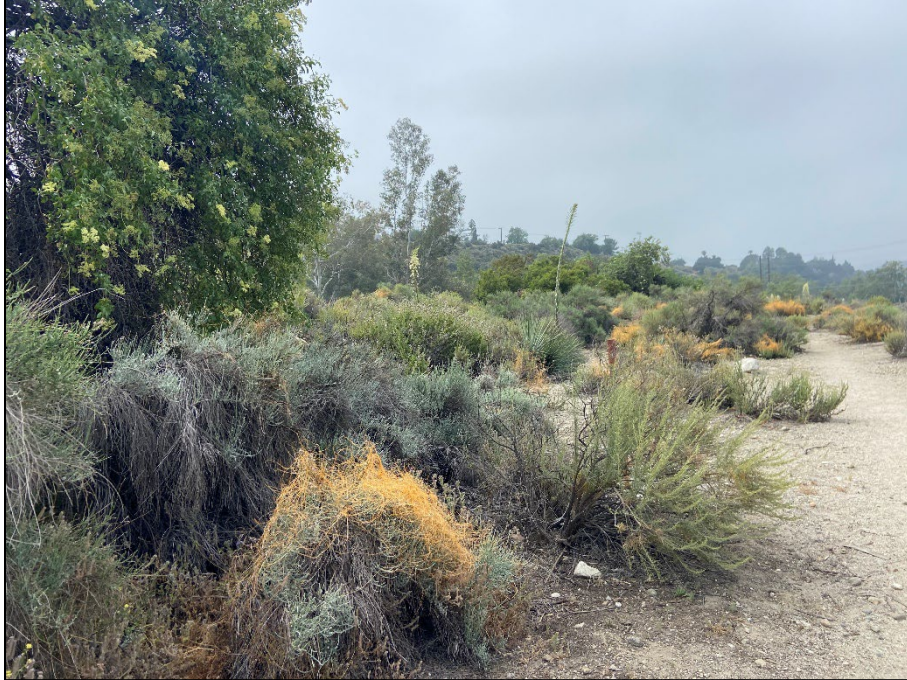
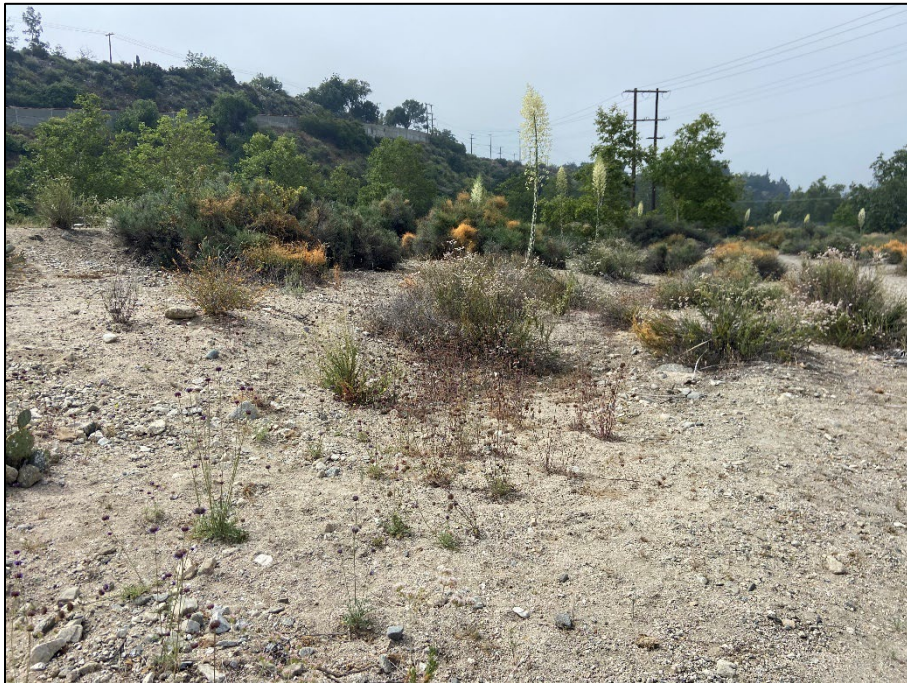
Container plants were not installed in the DG-1 or DG-1 WOUS mitigation areas, but these areas were seeded with native plant species. Native plant growth was noted throughout the DG-1 and DG-1 WOUS mitigation areas, likely both from natural recruitment and from seeding; however, germination was observed to be very minimal in most of these mitigation areas. Portions of DG-1 WOUS were noted as being scoured during the 2020 wet season and had minimal plant growth. Native plants such as deerweed (*Acmispon glaber*), annual bursage (*Ambrosia acanthicarpa*), California sagebrush (*Artemisia californica*), mulefat (*Baccharis salicifolia*), miniature suncup (*Camissoniopsis micrantha*), Canada horseweed (*Erigeron canadensis*), California buckwheat (*Eriogonum fasciculatum*), wild cucumber (*Mara macrocarpa*), common phacelia (*Phacelia distans*), and chia (*Salvia columbariae*) were observed sprouting in the DG-1 and DG-1 WOUS mitigation areas. Dodder (*Cuscuta sp.*) was observed growing on many of the shrubs in this mitigation area. Native cover for the DG-1 and DG-1 WOUS mitigation areas was estimated to be approximately 65 percent with some areas having relatively dense cover and other areas being scoured and/or having minimal cover. Photos 1 through 4 in Attachment B document the mitigation area during the monitoring visit.

Nonnative weed cover in DG-1 and DG-1 WOUS was estimated at approximately less than five percent, which is approximately three percent greater than the level of weed cover that was observed during the previous qualitative monitoring event. Nonnative species observed in DG-1 and DG-1 WOUS included black mustard (*Brassica nigra*), red brome (*Bromus rubens*), tocalote (*Centaurea melitensis*), red-stemmed filaree (*Erodium cicutarium*), and Indian plantain (*Plantago arenaria*). Most nonnative weeds were just starting to germinate and had not gone to flower or seed.

Photo 1: Overview Mitigation Area DG-1

Photo 2: Overview Mitigation Area DG-1

Photo 3: Overview Mitigation Area DG-1

Photo 4: Overview Mitigation Area DG-1

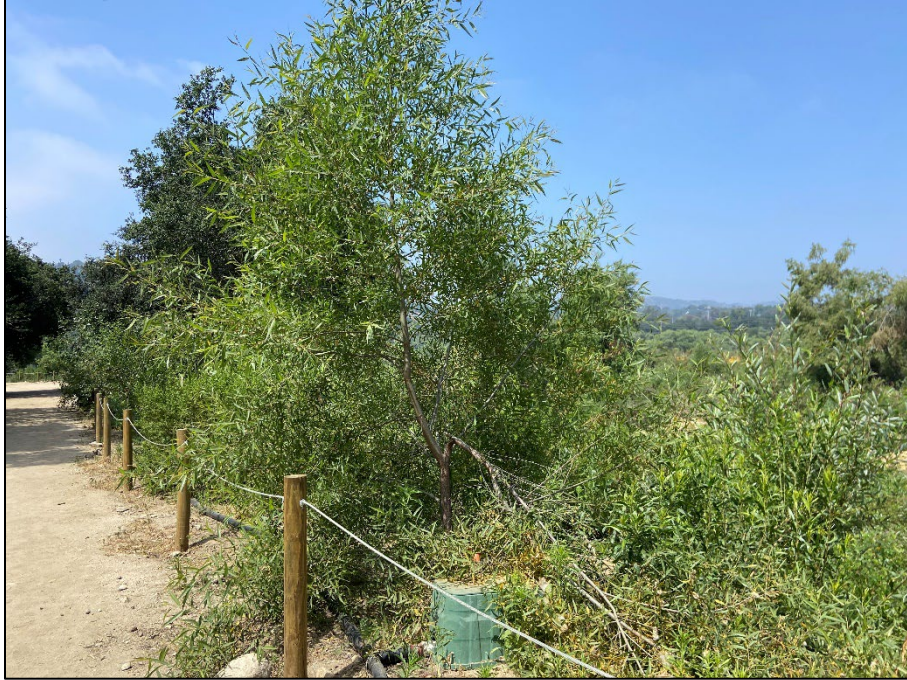
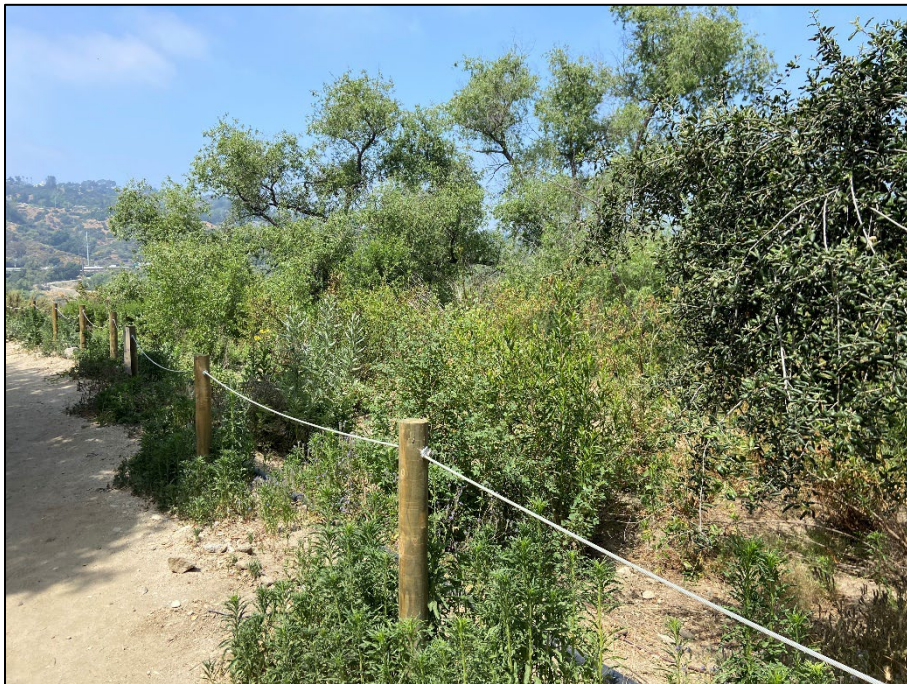
The overall health of the container plants in DG-2A was noted as being good. Approximately less than five percent of the container plants in DG-2A were noted as showing varied levels of stress, which is approximately the same as the percentage of container plants that were showing stress during the previous qualitative monitoring event. Stress may be occurring as a result of 1) herbivory by rabbits or other wildlife, 2) competition from nonnative and invasive weeds, 3) misplaced emitters, or 4) recreational traffic through the mitigation areas. There were no additional container plants noted as being missing or dead. Formal mortality counts were taken for DG-2A during the 2020 quantitative monitoring and were included in the 2020 annual reporting. Most of the willows (*Salix* sp.) and Fremont's cottonwoods (*Populus fremontii*) were no longer showing signs of seasonal dieback. Some of the planting basins were observed to have minor erosion and should be repaired. The installation of plants in the DG-2A mitigation area appears to have been completed successfully. The current issues identified during the monitoring visit are not expected to have an effect on the continued growth of the plants in the mitigation area. Photos 5 through 6 in Attachment B document the mitigation area during the monitoring visit.

Native plant growth was noted throughout the DG-2A mitigation area, likely both from natural recruitment and from seeding. Native plants such as western ragweed (*Ambrosia psilostachya*), mugwort (*Artemisia douglasiana*), Canada horseweed, telegraph weed (*Heterotheca grandiflora*), evening primrose (*Oenothera elata*), common phacelia, and stinging nettle (*Urtica dioica*) were observed sprouting in the DG-2A mitigation area. Native cover for the DG-2A mitigation area was estimated to be 65 percent.

Nonnative weed cover in DG-2A was estimated at approximately less than two percent, which is approximately one percent greater than the level of weed cover that was observed during the previous qualitative monitoring event. This site appeared to have been recently weeded during the monitoring visit. Nonnative species observed in DG-2A included rip-gut brome (*Bromus diandrus*) and Mediterranean grass (*Schismus barbatus*). Most nonnative weeds were just starting to germinate and had not gone to flower or seed.

Photo 5: Overview Mitigation Area DG-2A

Photo 6: Overview Mitigation Area DG-2A

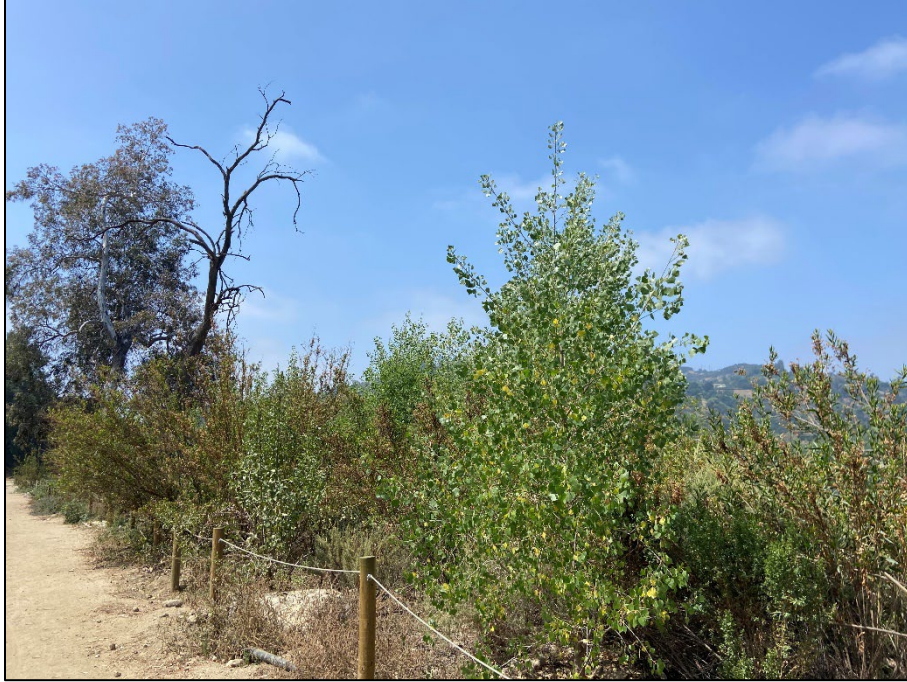
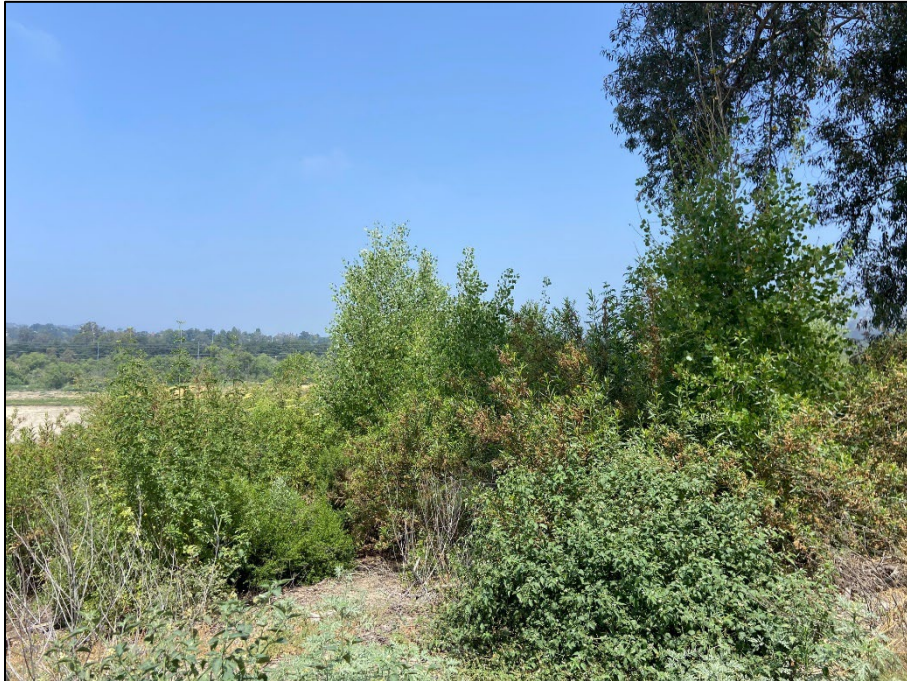
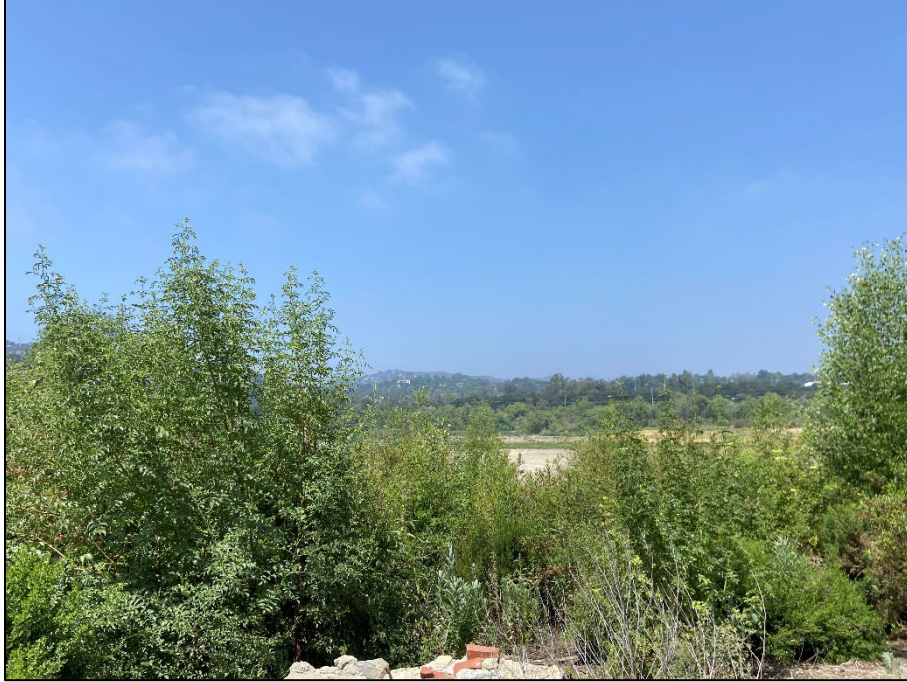
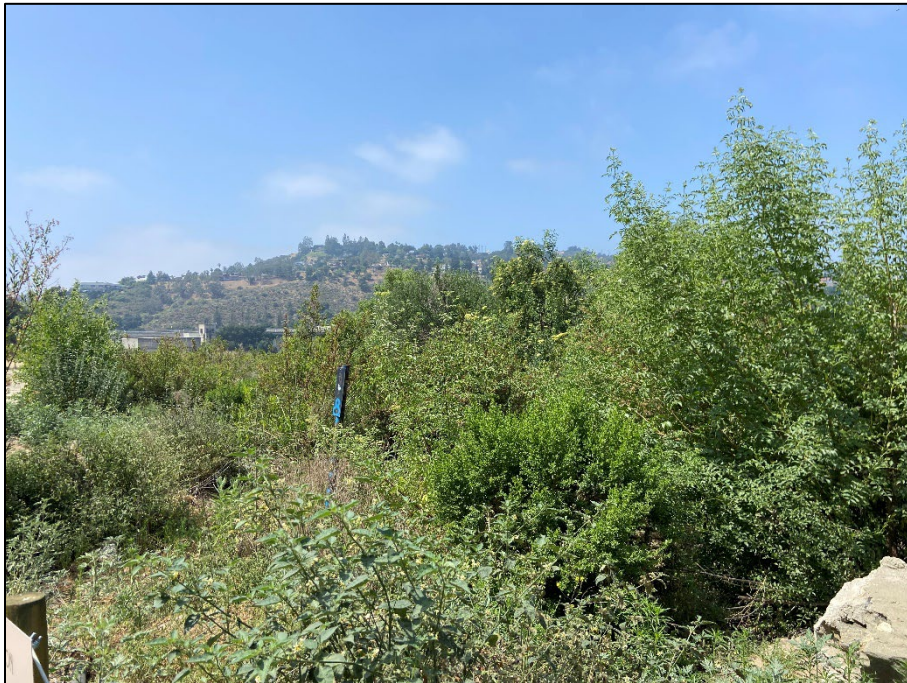
The overall health of the container plants in DG-2B was noted as being good. Approximately less than five percent of the container plants in DG-2B were noted as showing varied levels of stress, which is approximately the same percentage of container plants that were showing stress during the previous qualitative monitoring event. Stress was likely due to the same reasons as those described for DG-2A. In addition, insect galls were observed on several of the willow species. Formal mortality counts were taken for DG-2B during the 2020 quantitative monitoring and were included in the 2020 annual reporting. Similar to DG-2A, most of the willows and Fremont's cottonwoods were no longer showing signs of seasonal dieback. Some of the planting basins were observed to have minor erosion and should be repaired. The installation of the plants in the DG-2B mitigation area appears to have been successfully completed. The current issues identified during the monitoring visit are not expected to have an effect on the continued growth of plants in the mitigation area. Photos 7 through 10 in Attachment B document the mitigation area during the monitoring visit.

Native plant growth was noted throughout the DG-2B mitigation area, likely both from natural recruitment and from seeding. Native plants such as annual bursage, mugwort, miniature suncup, Canada horseweed, Douglas' nightshade (*Solanum douglasii*), and stinging nettle were observed sprouting in the DG-2B mitigation area. Native cover for the DG-2B mitigation area was estimated to be 70 to 75 percent.

Nonnative weed cover in DG-2B was estimated at approximately less than five percent, which is approximately four percent greater than the percent that was observed during the previous qualitative monitoring event. Nonnative species observed in DG-2B included black mustard and poison hemlock (*Conium maculatum*). Most nonnative weeds were just starting to germinate and had not gone to flower or seed.

Photo 7: Overview Mitigation Area DG-2B

Photo 8: Overview Mitigation Area DG-2B

Photo 9: Overview Mitigation Area DG-2B

Photo 10: Overview Mitigation Area DG-2B

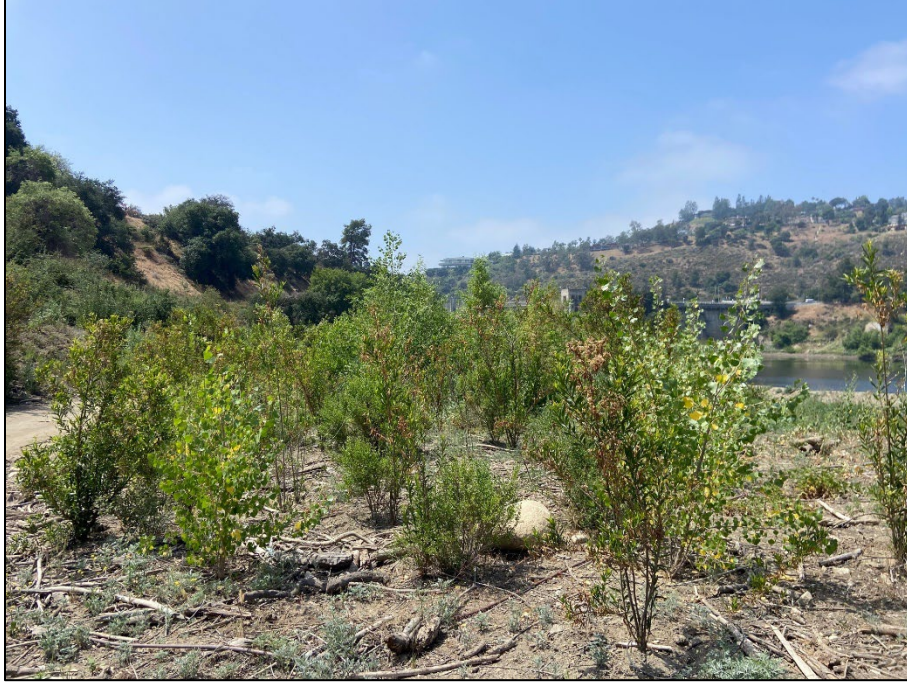
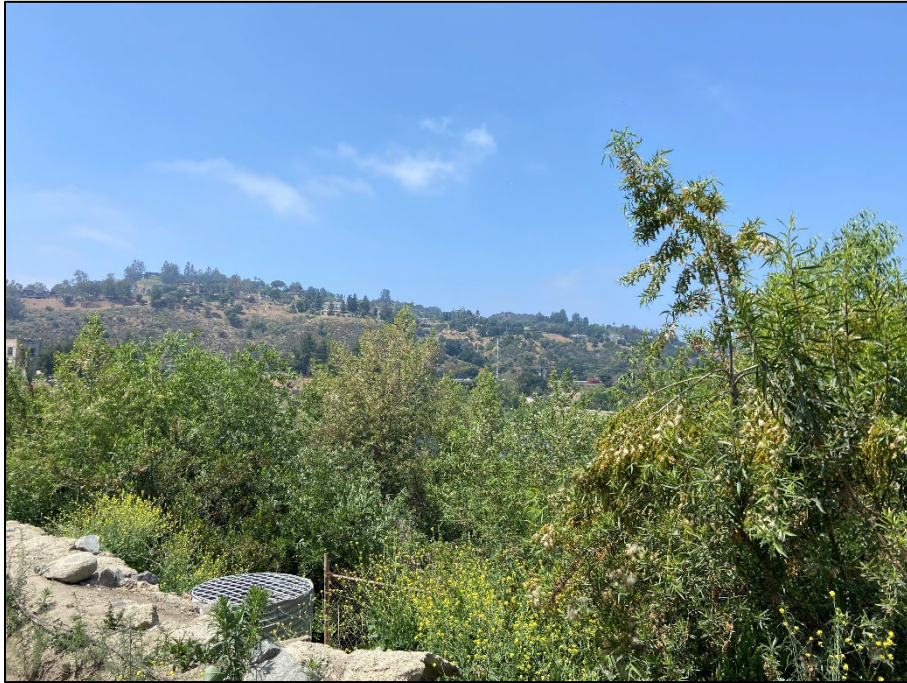
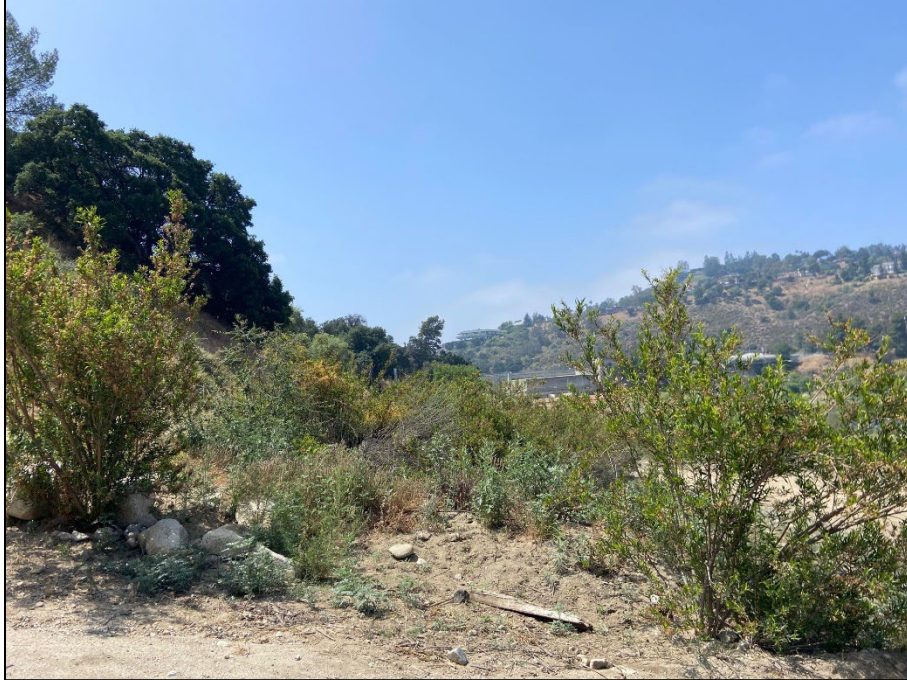
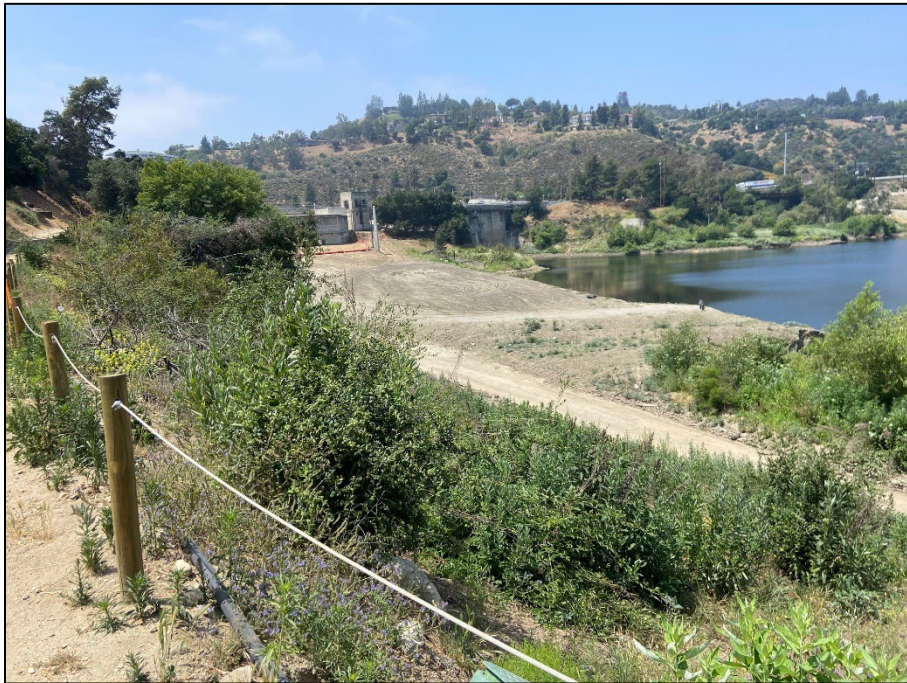
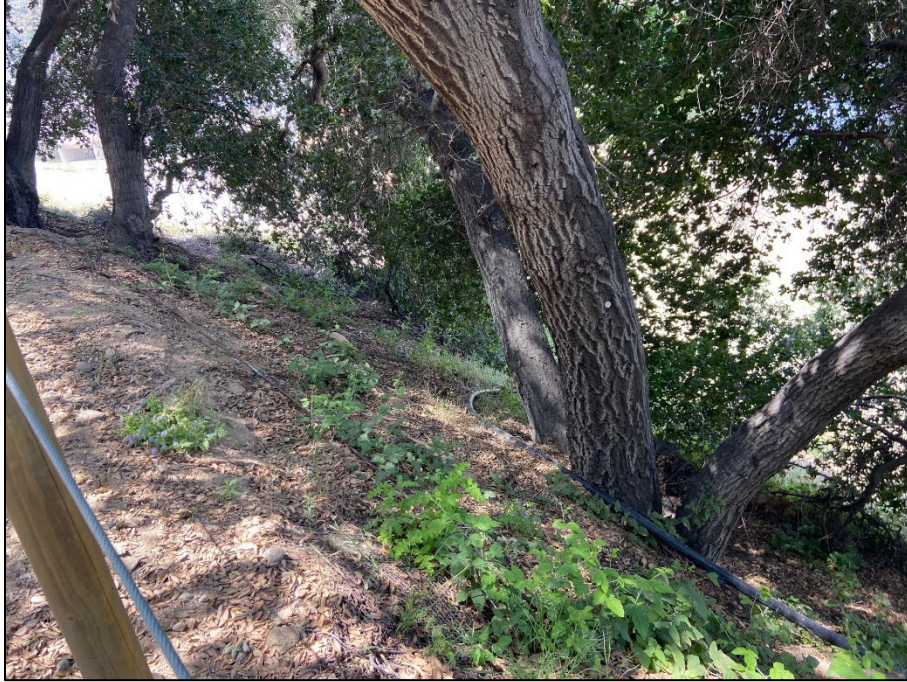
The overall health of the container plants in DG-3A was noted as being good. Approximately five percent of the container plants in the Coast Live Oak Woodland portions of DG-3A were noted as showing varied levels of stress, which is approximately the same as the percentage of container plants that were showing stress during the previous qualitative monitoring event. Approximately less than five percent of the container plants in the Mulefat Thickets portions of DG-3A were noted as showing varied levels of stress, which is approximately five percent lower than the container plants were showing during the previous qualitative monitoring event. Formal mortality counts were taken for DG-3A during the 2020 quantitative monitoring and were included in the 2020 annual reporting. The types of stress the plants were exhibiting are the same as those described for the plants in DG-2A. However, erosion is also a problem in some areas of DG-3A. In addition, the Mulefat Thickets portions of DG-3A experienced approximately 18-days of inundation following heavy storm events in December of 2021. Most of the container plants appear to have fully recovered from the inundation. Some of the planting basins were observed to have varied levels of erosion and should be repaired. The willow and mulefat stakes were observed to be thriving in this mitigation area. During the monitoring visit, the planted coast live oak acorns were inspected for survivorship and health. Approximately 20 germinated coast live oak acorns appear to still be present in DG-3A. The majority of the germinated acorns appear to be in good health. During the monitoring, it was noted that an existing coast live oak tree (Tree Tag #39) was experiencing severe branch failure for multiple branches. The cause of the branch failure was unclear and further investigation is being conducted. The installation of the plants in the DG-3A mitigation area appears to have been completed successfully. The current issues noted during the monitoring are not expected to have an effect on the continued growth of the plants in the mitigation area. Photos 11 through 15 in Attachment B document the mitigation area during the monitoring visit.

Native plant growth was noted throughout the DG-3A mitigation area, likely both from natural recruitment and from seeding. Native plants such as annual bursage, mugwort, mulefat, Jimson weed (*Datura wrightii*) Canada horseweed, California poppy (*Eschscholzia californica*), telegraph weed, common phacelia, and stinging nettle were observed sprouting in the DG-3A mitigation area. Native cover for the DG-3A mitigation area was estimated to be approximately 65 percent in the both the mulefat thickets and coast live oak woodland portions of the mitigation area.

Nonnative weed cover in DG-3A was estimated at approximately 10 to 15 percent, which is approximately the same percentage of nonnative cover that was observed during the previous qualitative monitoring event. Nonnative species observed in DG-3A included black mustard, poison hemlock, prickly lettuce (*Lactuca serriola*), perennial pepperweed (*Lepidium latifolium*), rabbitsfoot grass (*Polypogon monspeliensis*), wild radish (*Raphanus sativus*), and curly dock (*Rumex crispus*). Most nonnative weeds were just starting to germinate and had not gone to flower or seed.

Photo 11: Overview Mitigation Area DG-3A Altadena Drain

Photo 12: Overview Mitigation Area DG-3A Altadena Drain

Photo 13: Overview Mitigation Area DG-3A Oak Woodland

Photo 14: Overview Mitigation Area DG-3A Oak Woodland

Photo 15: Overview Mitigation Area DG-3A Oak Woodland

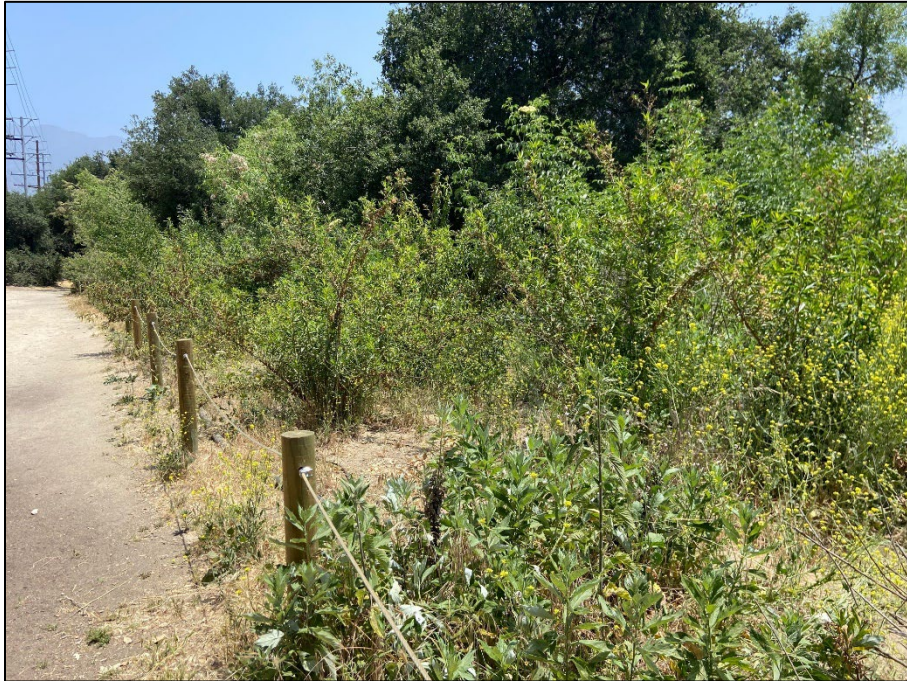
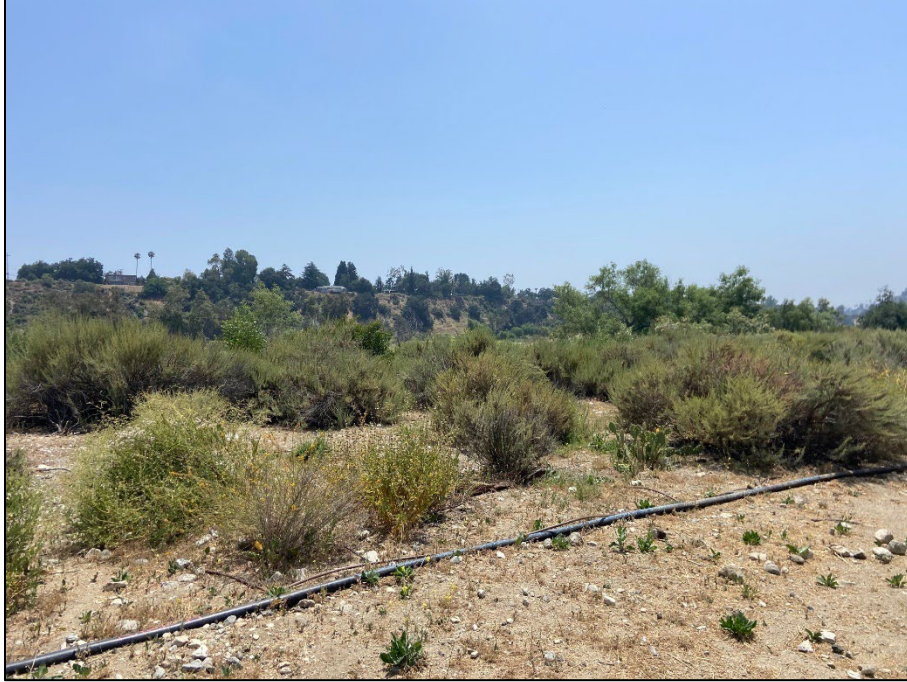
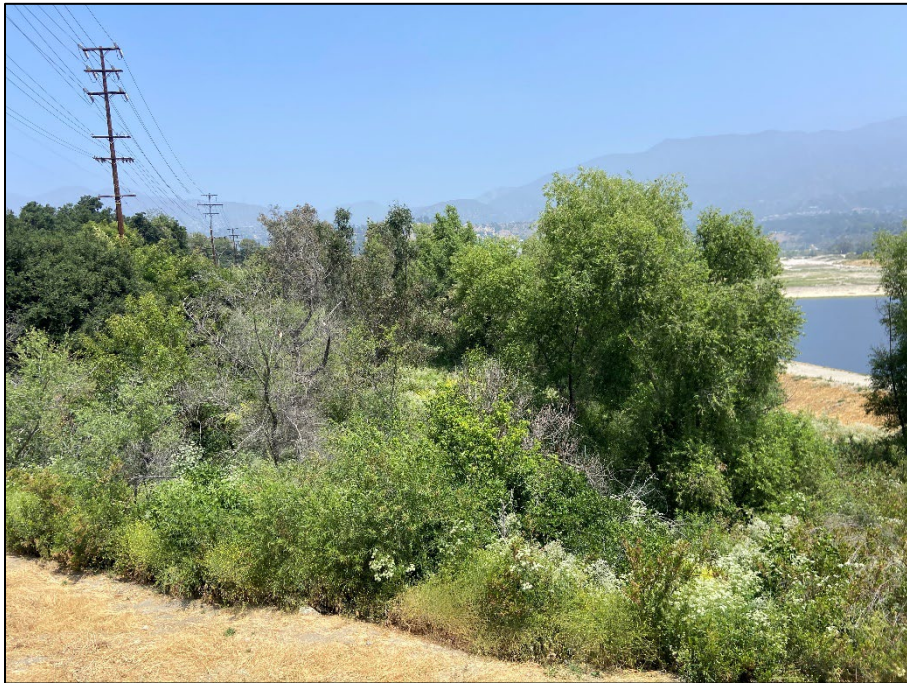
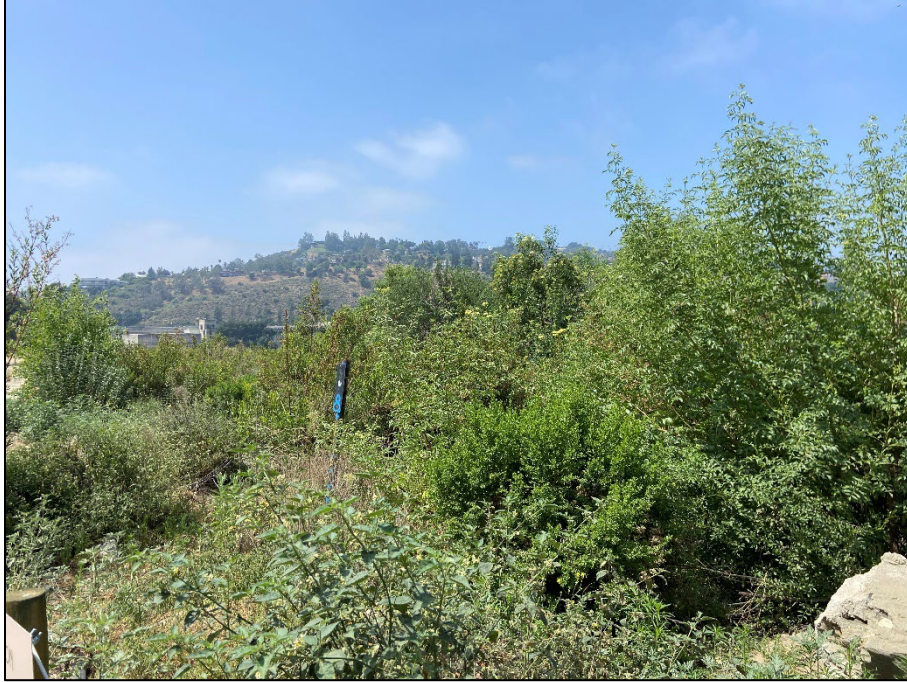
The overall health of the container plants in mitigation area DG-4 was noted as being good. Approximately five percent of container plants in the coastal sage scrub portions of DG-4 were showing varied levels of stress which is approximately the same percentage of plants showing stress during the previous qualitative monitoring event. Approximately five percent of container plants in most of the riparian portions of DG-4 were showing varied levels of stress, which is approximately the same as the percentage of plants showing stress during the previous qualitative monitoring event. It should be noted that approximately 25 percent of the container plants in the southern sections of DG-4, where extended inundation occurred following heavy storm events in December 2021 and where nonnative weeds are currently proliferating, were showing signs of moderate stress. Other causes of stress appear to be mostly due to the same reasons described in DG-2A. For most portions of DG-4, only a negligible number of container plants were noted as being missing or dead. Formal mortality counts were taken for DG-4 during the 2020 quantitative monitoring and were included in the 2020 annual reporting. Similar to DG-2A, the willows and Fremont's cottonwoods were no longer showing signs of seasonal dieback. Some of the planting basins were observed to have minor erosion and should be repaired. The installation of plants in the DG-4 mitigation area appears to have been completed successfully and the issues noted during the monitoring are not expected to have an impact on the continued growth of the plants. Photos 16 through 19 in Attachment B document the mitigation area during the monitoring visit.

Native plant growth was noted throughout the DG-4 mitigation area, likely both from natural recruitment and from seeding. Native plants such as deerweed (*Acmispon glaber*), California sagebrush, mugwort, mulefat, beardless wildrye (*Elymus triticoides*), Canada horseweed, California poppy, telegraph weed, common phacelia, and Parry's phacelia (*Phacelia parryi*) and stinging nettle were observed sprouting in the DG-4 mitigation area. Native cover for the DG-4 mitigation area was estimated to be approximately 50 to 70 percent in the riparian portion of the mitigation area and 50 percent in the coastal sage scrub portion.

Nonnative weed cover in DG-4 was estimated at approximately 20 to 50 percent, which is approximately 10 percent higher than the percentage of nonnative cover that was observed during the previous qualitative monitoring event and weeds were observed to be proliferating in the southern section of this mitigation area. Nonnative species observed in DG-4 included black mustard, cheatgrass (*Bromus tectorum*), poison hemlock, red-stemmed filaree, perennial pepperweed, and prickly sowthistle (*Sonchus asper*). Nonnative weed cover, especially perennial pepperweed, is a significant problem in portions of the DG-4 mitigation area. Because perennial pepperweed can produce dense colonies through seed germination and underground rhizomes (rhizomatous roots), removal of this species without the use of systemic herbicide is very difficult. Most nonnative weeds in the northern and middle sections of the

mitigation area were just starting to germinate and had not gone to flower or seed; however, many of the weeds in the southern area were proliferating and beginning to produce seed.

Photo 16: Overview Mitigation Area DG-4

Photo 17: Overview Mitigation Area DG-4

Photo 18: Overview Mitigation Area DG-4

Photo 19: Overview Mitigation Area DG-4

Nonnative weed cover ranged from approximately less than 2 percent to 50 percent in the various mitigation areas and it was noted that weed cover was highest in the southern section of DG-4. It should be noted that many of the nonnative weeds observed during the monitoring were just starting to germinate and had not gone to flower or seed. Regular maintenance and removal of nonnative weeds is of the highest priority for all of the mitigation areas to reduce competition between native and nonnative plants. In addition, eucalyptus stumps that are starting to re-sprout should be trimmed back frequently. A focus should be placed on removing the weeds and nonnatives from the basins of each of the container plants and cuttings; however, nonnative weeds just outside of the planting areas can migrate into the planting areas via seed dispersal. Outside of the nesting bird season, a focus should also be made to remove nonnative weeds in areas where least Bell's vireos are likely to nest during the breeding season (i.e. in the vicinity of the least Bell's vireo nest that was active in 2020). Nonnative plants and weeds that have gone to seed should be bagged and removed from the mitigation area. Without the use of herbicides, control of the nonnatives will be extremely difficult so the frequency and level of effort will need to be increased to provide control until the native plants and seedlings have a chance to grow and outcompete the nonnatives. In particular, it is important to maintain long-term perennial pepperweed management to reduce competition and allow for native plants to germinate. In addition, dodder should be removed from container plants in the mitigation areas. Although many species of dodder are native, this parasitic plant can be harmful to younger shrubs and trees that are not yet established and can even cause mortality.

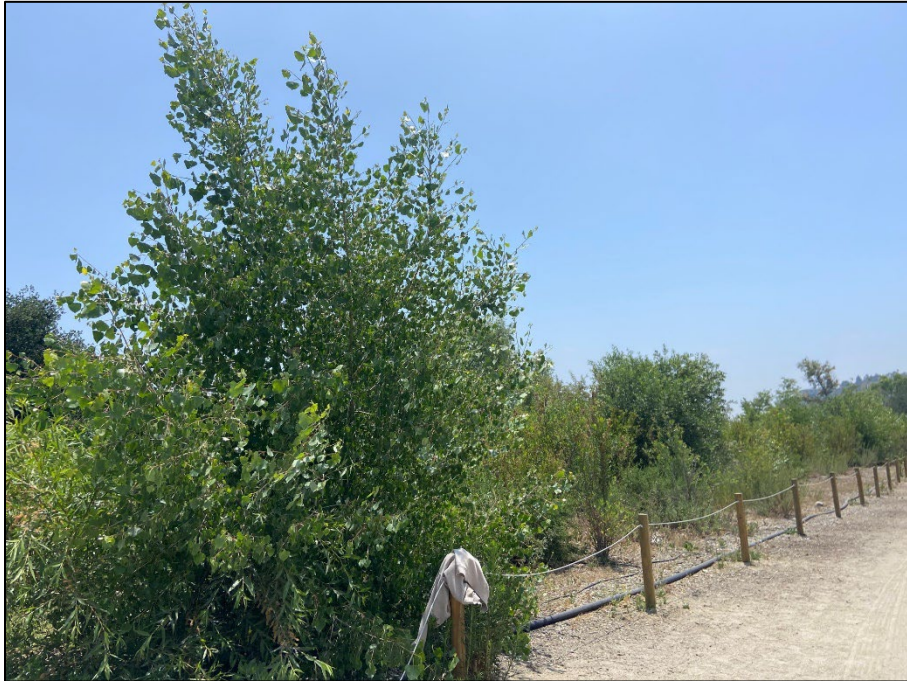
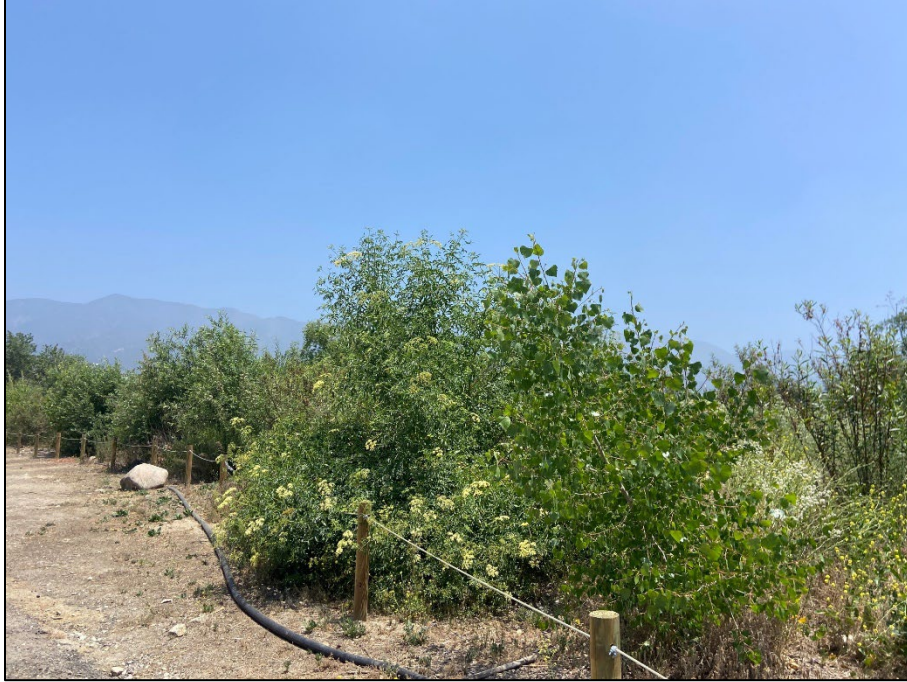
The overall health of the container plants in mitigation area DG-4B was noted as being good and this mitigation area is becoming well established. Approximately less than five percent of container plants were showing stress which is approximately the same percentage of plants that were stressed during the previous qualitative monitoring event. The types of stress the plants were exhibiting are the same as those described for the plants in DG-2A. A negligible number of container plants were noted as being missing or dead. Formal mortality counts were taken for DG-4B during the 2020 quantitative monitoring and were included in the 2020 annual reporting. Some of the planting basins were observed to have minor erosion and should be repaired. The installation of plants in the DG-4B mitigation area appears to have been completed successfully and the issues noted during the monitoring are not expected to have an impact on the continued growth of the plants. Photos 20 and 21 in Attachment B document the mitigation area during the monitoring visit.

Native plant growth was noted throughout the DG-4B mitigation area, likely both from natural recruitment and from seeding. Native plants such as mugwort, mulefat, cobweb thistle (*Cirsium occidentale*), California poppy, beardless wildrye, and common phacelia were observed sprouting in the DG-4B mitigation area. Native cover for the DG-4B mitigation area was estimated to be approximately 80 to 85 percent.

Nonnative weed cover in DG-4B was estimated to be approximately 10 to 15 percent, which is approximately five percent more than the percentage of nonnative cover that was observed during the previous qualitative monitoring event. Nonnative species observed in DG-4B included black mustard, poison hemlock, red-stemmed filaree, and perennial pepperweed. Most nonnative weeds were just starting to germinate and had not gone to flower or seed.

Photo 20: Overview Mitigation Area DG-4B

Photo 21: Overview Mitigation Area DG-4B

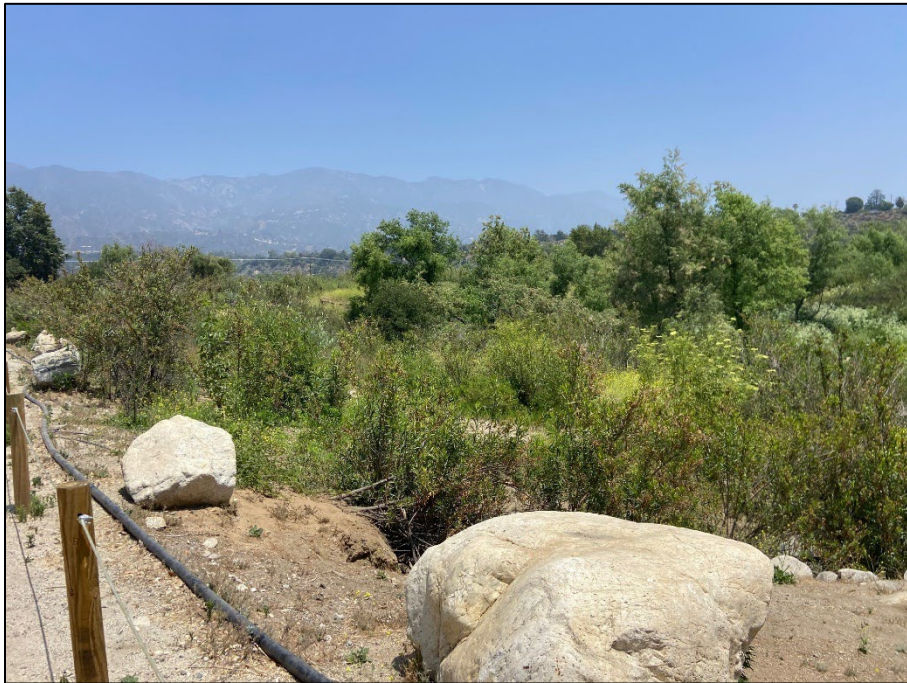
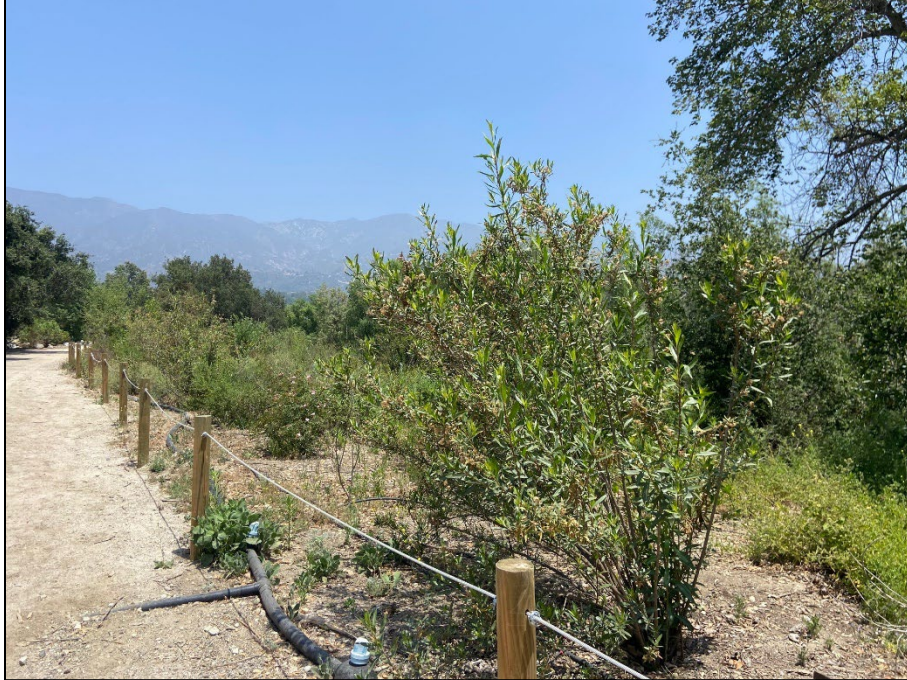
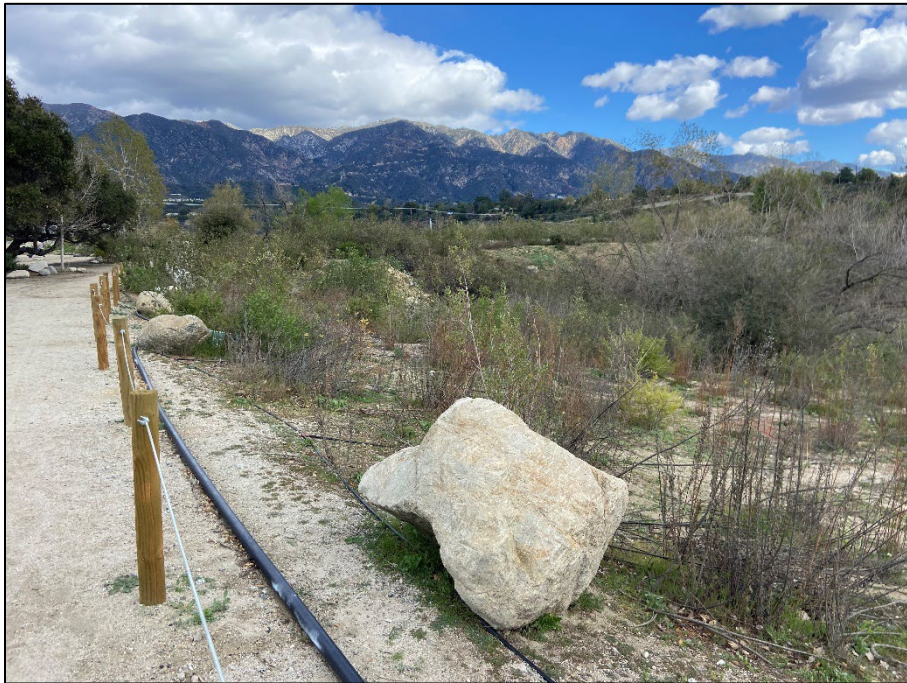
The overall health of the container plants in mitigation area DG-4C was noted as being good. Approximately less than five percent of all container plants were noted as showing minor levels of stress, which is approximately five percent less than percentage of plants that were showing stress during the previous qualitative monitoring event. The types of stress the plants were exhibiting are the same as those described for the plants in DG-2A. A negligible number of container plants were noted as being missing or dead. Formal mortality counts were taken for DG-4C during the 2020 quantitative monitoring and were included in the 2020 annual reporting. Some of the planting basins were observed to have minor erosion and should be repaired. The installation of plants in the DG-4C mitigation area appears to have been completed successfully and the issues noted during the monitoring are not expected to have an impact on the continued growth of the plants. Photos 22 to 24 in Attachment B document the mitigation area during the monitoring visit.

Native plant growth was noted throughout the DG-4C mitigation area, likely both from natural recruitment and from seeding. Native plants such as annual bursage, mugwort, Canada horseweed,

telegraph weed, and common phacelia were observed sprouting in the DG-4C mitigation area. Native cover for the DG-4C mitigation area was estimated to be approximately 65 to 70 percent.

Nonnative weed cover in DG-4C was estimated at approximately 15 to 20 percent, which is approximately 5 to 10 percent higher than the percentage of nonnative cover that was observed during the previous qualitative monitoring event. Nonnative species observed in DG-4C included black mustard, poison hemlock, red-stemmed filaree, and foxtail barley (*Hordeum murinum*). Most nonnative weeds were just starting to germinate and had not gone to flower or seed

Photo 22: Overview Mitigation Area DG-4C

Photo 23: Overview Mitigation Area DG-4C

Photo 24: Overview Mitigation Area DG-4C

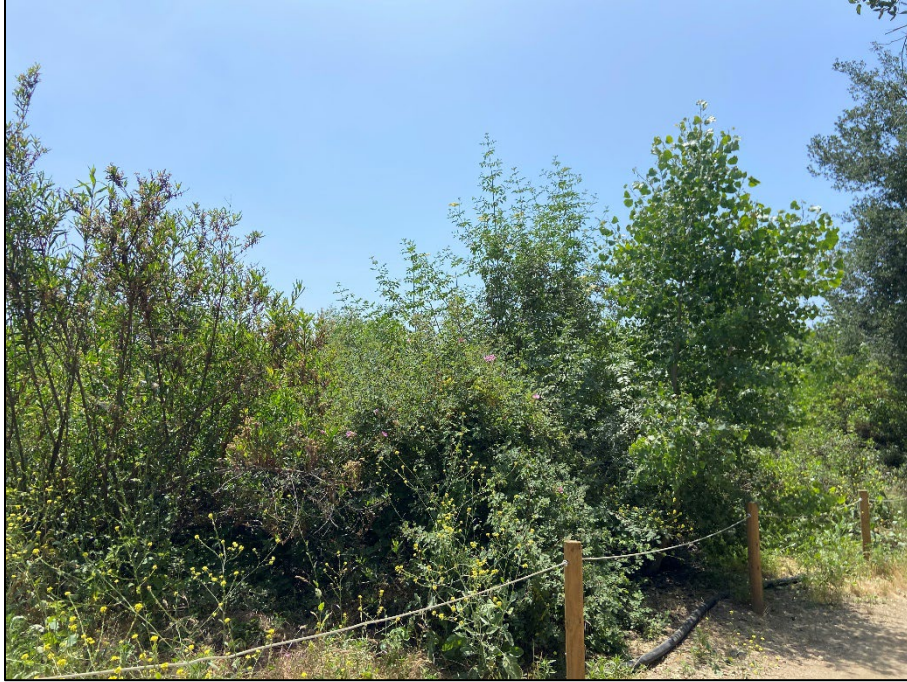
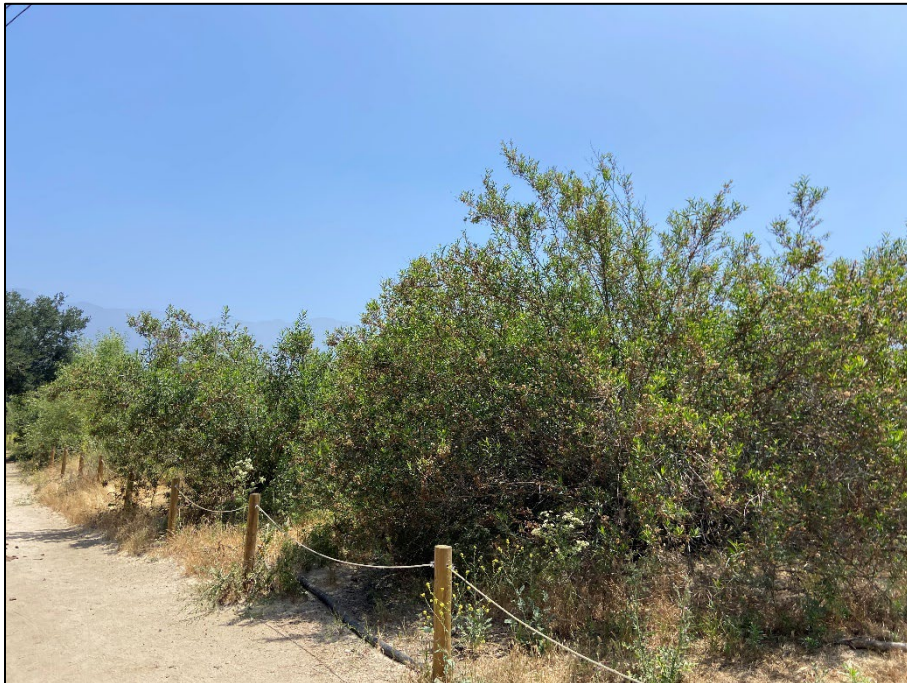
The overall health of the container plants in the DG-5 mitigation area was noted as being good. Approximately less than five percent of all container plants were noted as showing varied levels of stress, which is approximately the same as the percentage of plants that were showing stress during the previous qualitative monitoring event. Formal mortality counts were taken for DG-5 during the 2020 quantitative monitoring and were included in the 2020 annual reporting. Some of the planting basins were observed to have minor erosion and should be repaired. Similar to DG-2A, the willows and Fremont's cottonwoods were no longer showing signs of seasonal dieback. The installation of plants in the DG-5 mitigation area appears to have been completed successfully and the issues noted during the monitoring are not expected to have a negative impact on the continued growth of the plants. Photos 25 and 26 in Attachment B document the mitigation area during the monitoring visit.

Native plant growth was noted throughout the DG-5 mitigation area, likely both from natural recruitment and from seeding. Native plants such as Canada horseweed, California poppy, common phacelia, Parry's phacelia, and stinging nettle were observed sprouting in the DG-5 mitigation area. Native cover for the DG-5 mitigation area was estimated to be approximately 75 percent and the site is thriving.

Nonnative weed cover in DG-5 was estimated at approximately 25 to 30 percent, which is approximately 5 percent higher than the percentage of nonnative weed cover that was observed during the previous qualitative monitoring event. Nonnative species observed in DG-5 included black mustard, Italian thistle (*Carduus pycnocephalus*), poison hemlock, and perennial pepperweed. Most nonnative weeds were just starting to germinate and had not gone to flower or seed

Photo 25: Overview Mitigation Area DG-5

Photo 26: Overview Mitigation Area DG-5
