**Re: *Devil's Gate Reservoir Restoration Project – Phase 2 Restoration Qualitative Monitoring Conducted on November 15, 2021***

## 1.0 INTRODUCTION

Qualitative monitoring was conducted by Carley Lancaster on November 15, 2021. Field data collected during the monitoring event is provided as Attachment A. This report documents the third monthly qualitative monitoring visit for the Phase 2 mitigation areas.

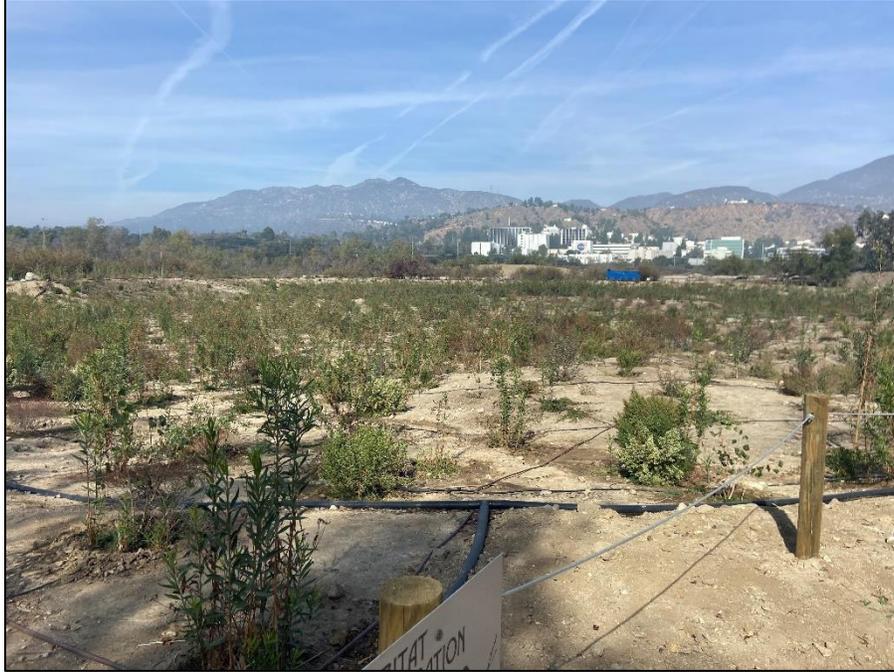
The overall health of the container plants in DG-W-1 was noted as being good. Approximately five percent of the container plants in DG-W-1 were noted as showing varied levels of stress and a negligible number were noted as being dead or missing. This is approximately 5 to 10 percent less than the percentage of plants that were showing stress during the last monitoring event. Stress may be occurring as a result of 1) transplant shock 2) herbivory by rabbits or other wildlife, 3) competition from nonnative and invasive weeds, 4) misplaced emitters, or 5) recreational traffic through the mitigation areas. Formal mortality counts were taken for DG-W-1 during the 2021 quantitative monitoring and will be included in the 2021 annual reporting. Some of the container plants were noted as lacking well defined basins and should have their basins properly constructed and/or repaired. The irrigation line appeared to be functioning properly during the monitoring visit. The installation of plants in the DG-W-1 mitigation area appears to have been completed successfully. The current issues identified during the monitoring visit are not expected to have an effect on the continued growth of the plants in the mitigation area. Photos 1 through 3 in Attachment B document the mitigation area during the monitoring visit.

Photo 1: Overview Mitigation Area DG-W-1 (Johnson Field)

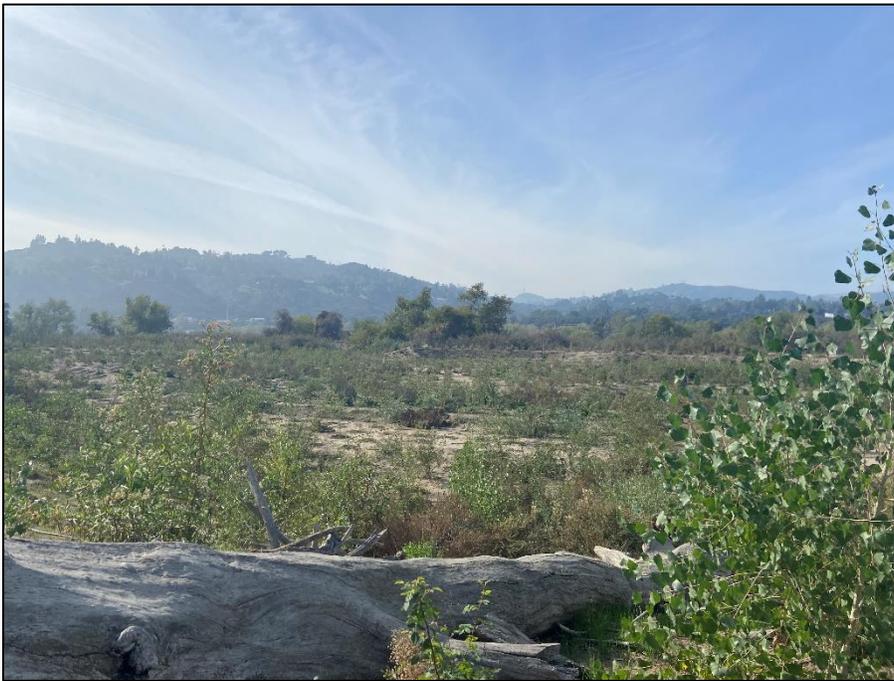
Photo 2: Overview Mitigation Area Overview Mitigation Area DG-W-1 (Johnson Field)

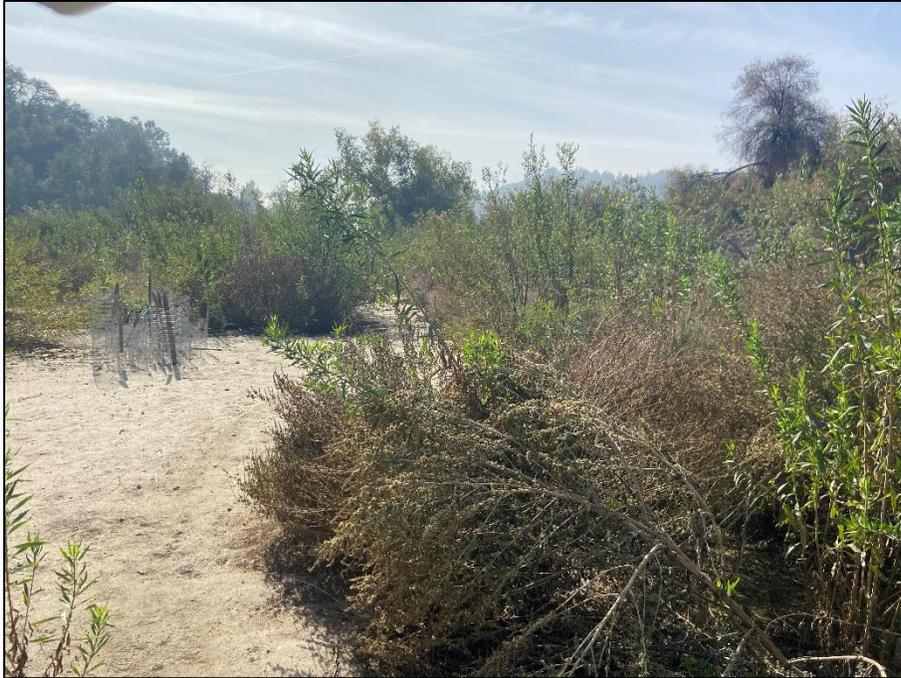
Photo 3: Overview Mitigation Area Overview Mitigation Area DG-2 & DG-2 New Channels

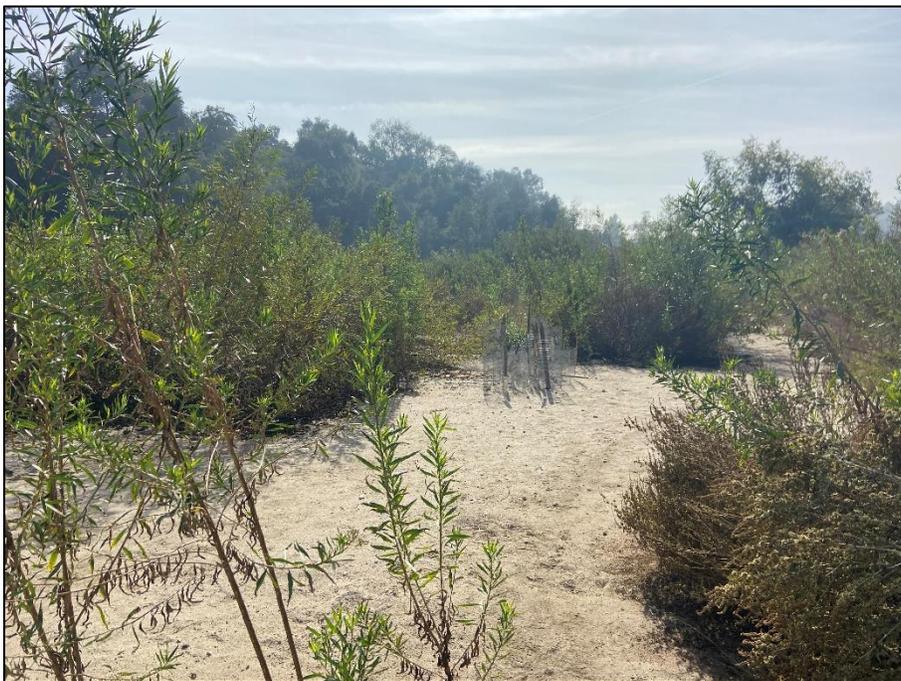
Photo 4: Overview Mitigation Area DG-2 & DG-2 New Channels

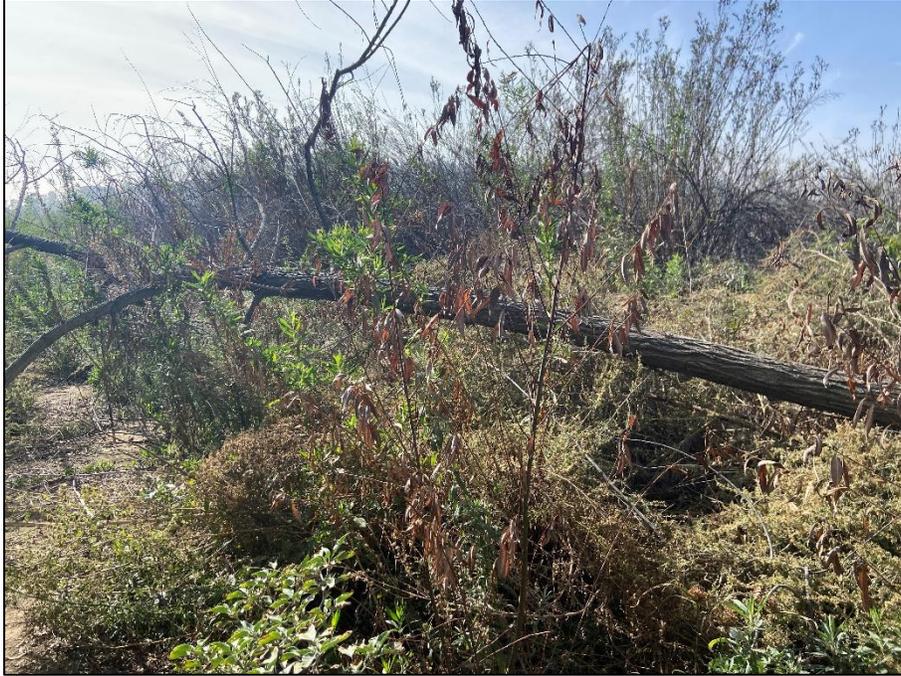
Photo 5: Overview Mitigation Area DG-2

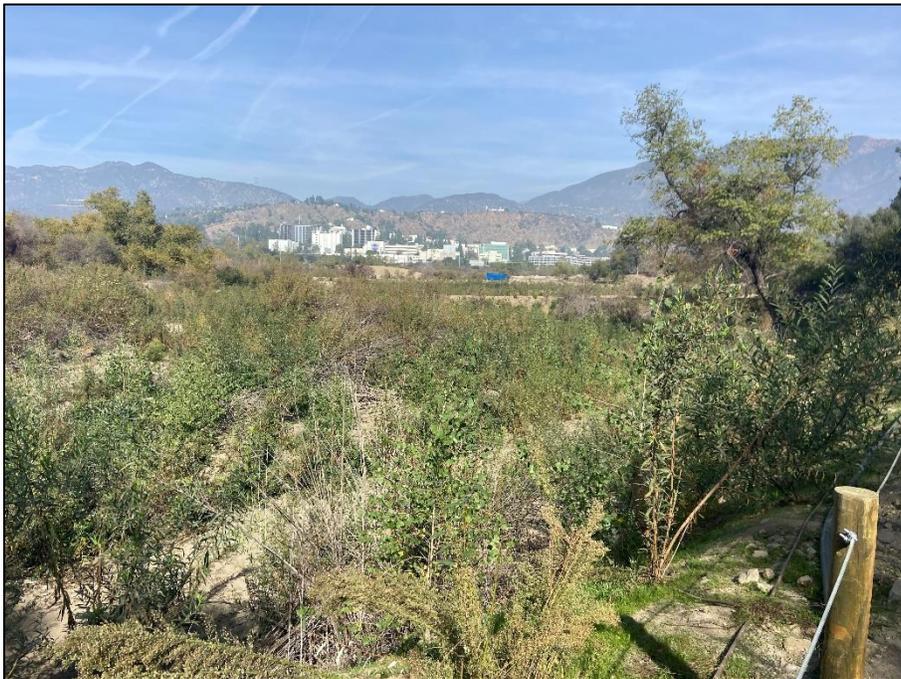
Photo 6: Overview Mitigation Area DG-2, DG-2 New Channels, DG-2 WOUS

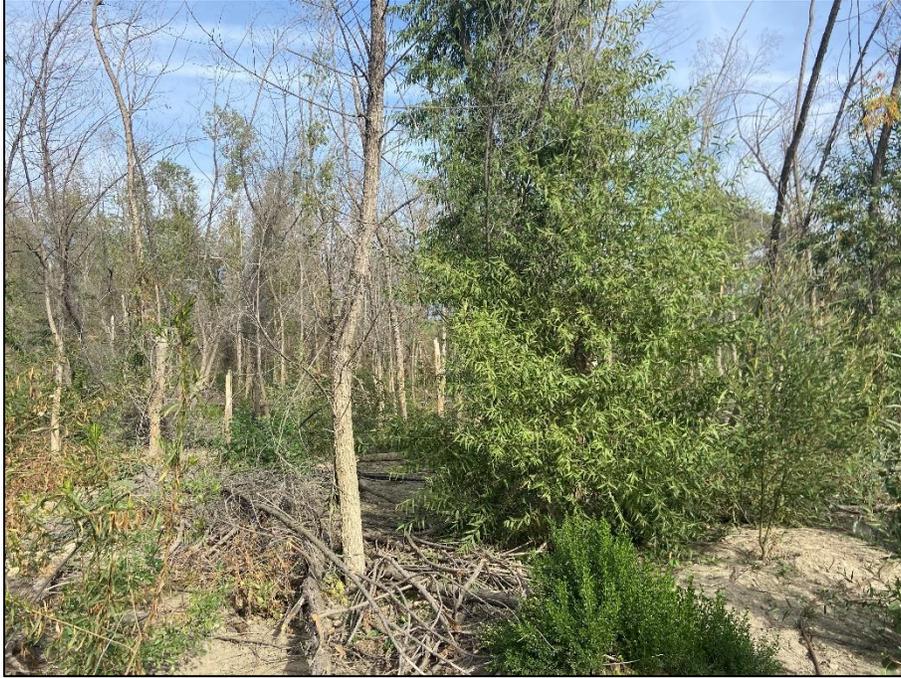
Photo 7: Overview Mitigation Area DG-W-2 (Mining Pit)

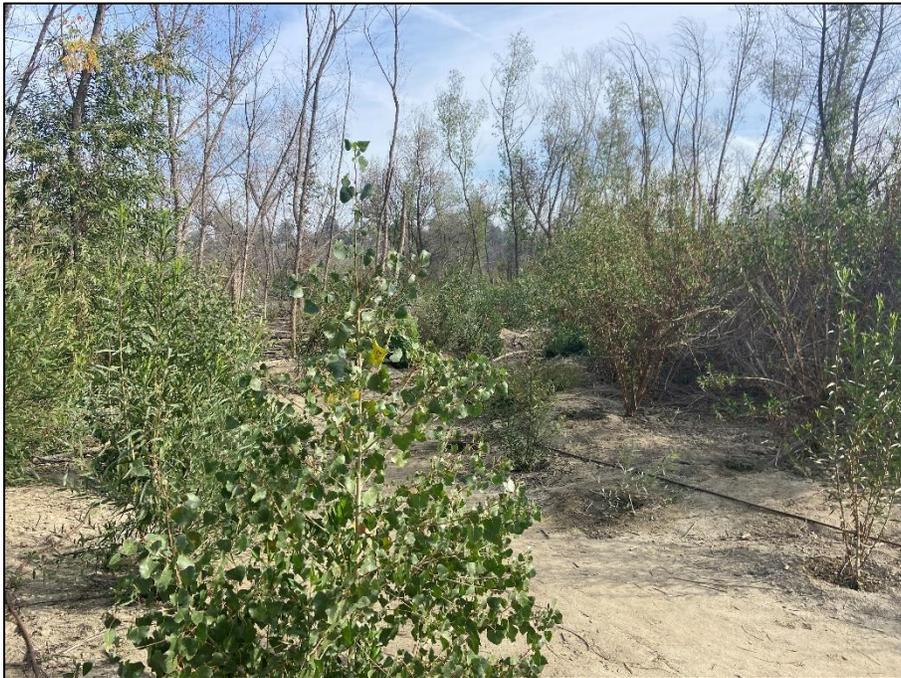
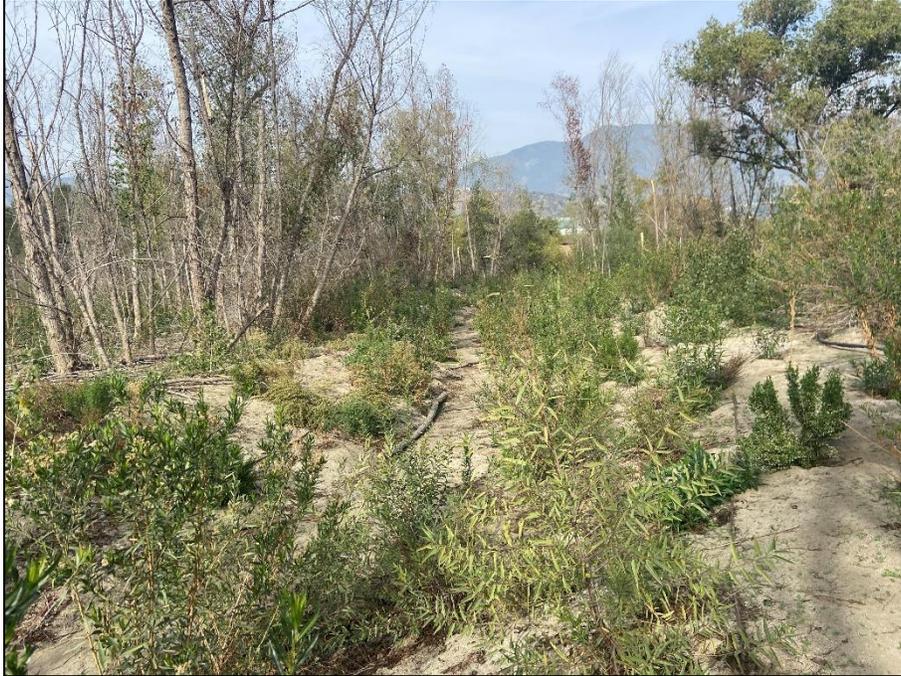
During the monitoring visit, it was noted that many of the existing mature black willow (*Salix gooddingii*) in this mitigation area that were showing signs of beetle infestation during previous monitoring visits had fallen over during recent high winds. Signs of infestation noted during previous monitoring visits included entry/exit holes, frass, galleries, fungal residue, and branch failure. Further investigation into this issue is being conducted with the help from the Los Angeles County Department of Agricultural Commissioner/Weights & Measures (ACWM). It should be noted that evidence of infestation was only noted on existing mature willows and not on any of the recently installed container plants. It should also be noted that many of the existing willows showing dieback were beginning to sprout from the base.

Photo 8: Fallen Trees Mitigation Area DG-W-2 (Mining Pit)

Photo 9: Fallen Trees Mitigation Area DG-W-2 (Mining Pit)

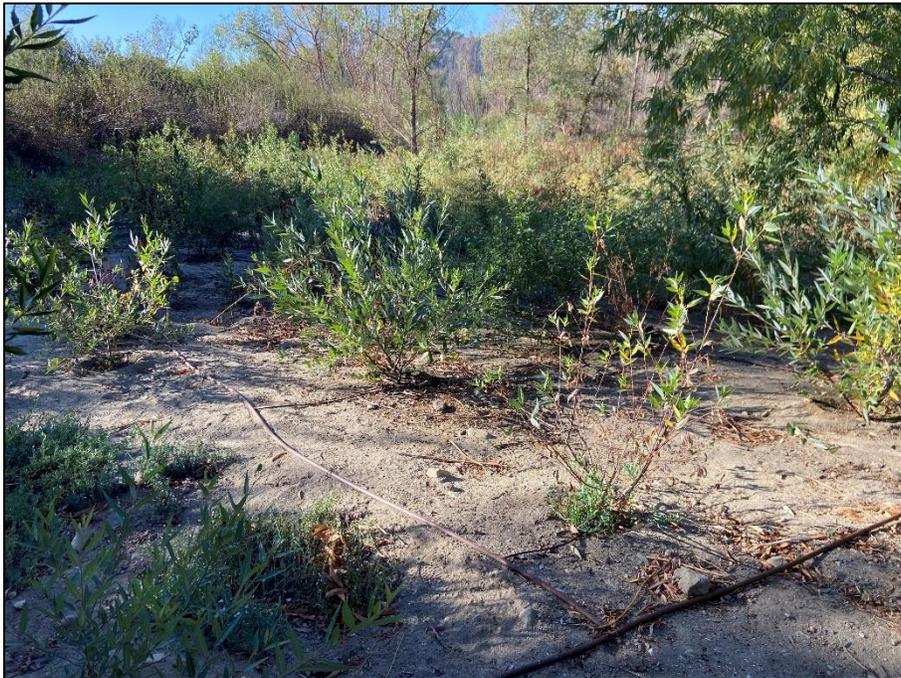
Photo 10: Overview Mitigation Area DG-W-2 (Mining Pit)

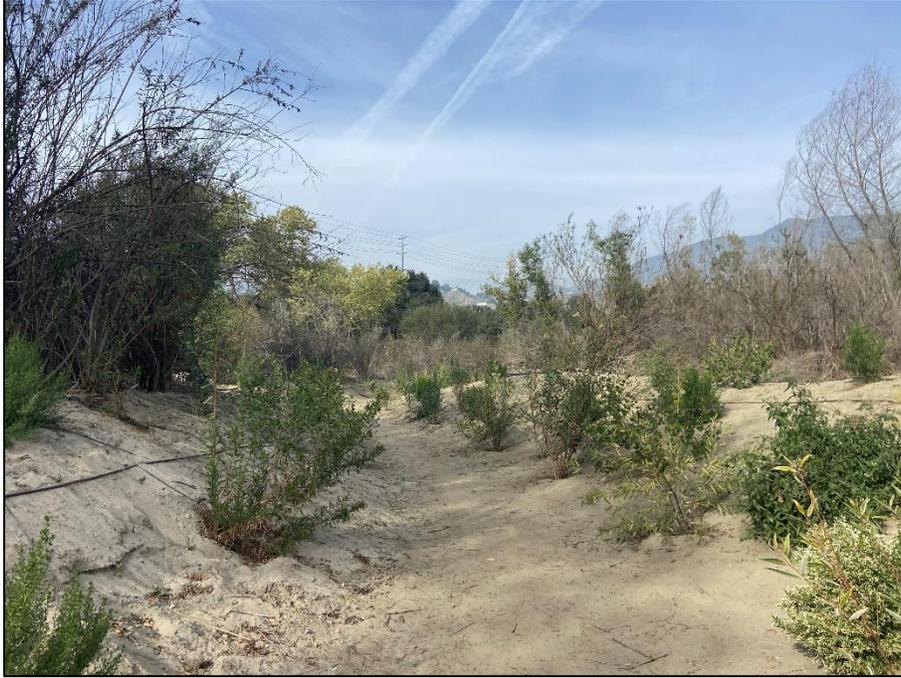
Photo 11: Overview Mitigation Area DG-W-2 (Mining Pit Outlet)

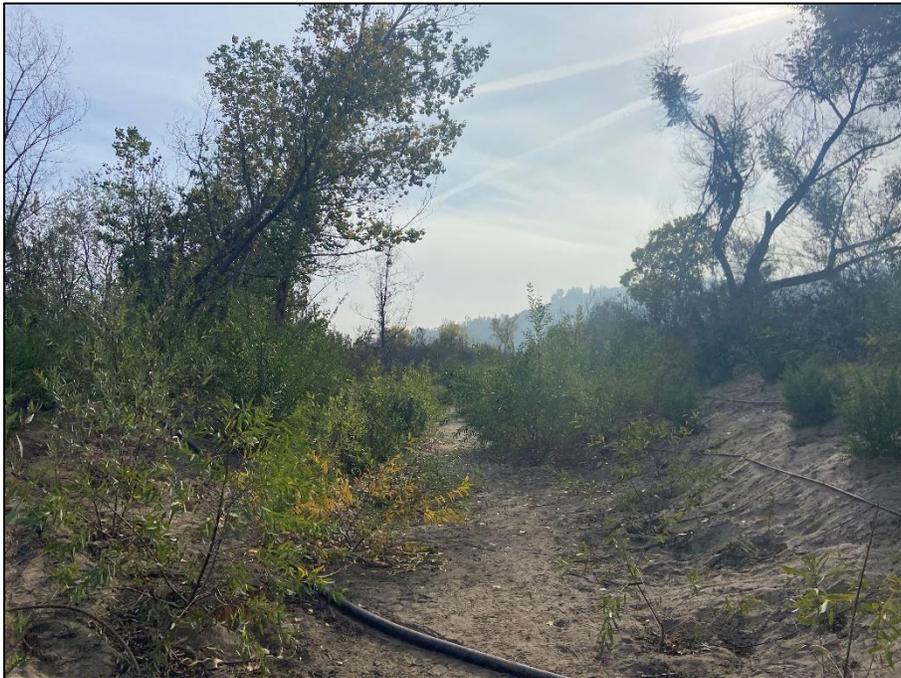
Photo 12: Overview Mitigation Area DG-W-2 (Mining Pit Outlet)

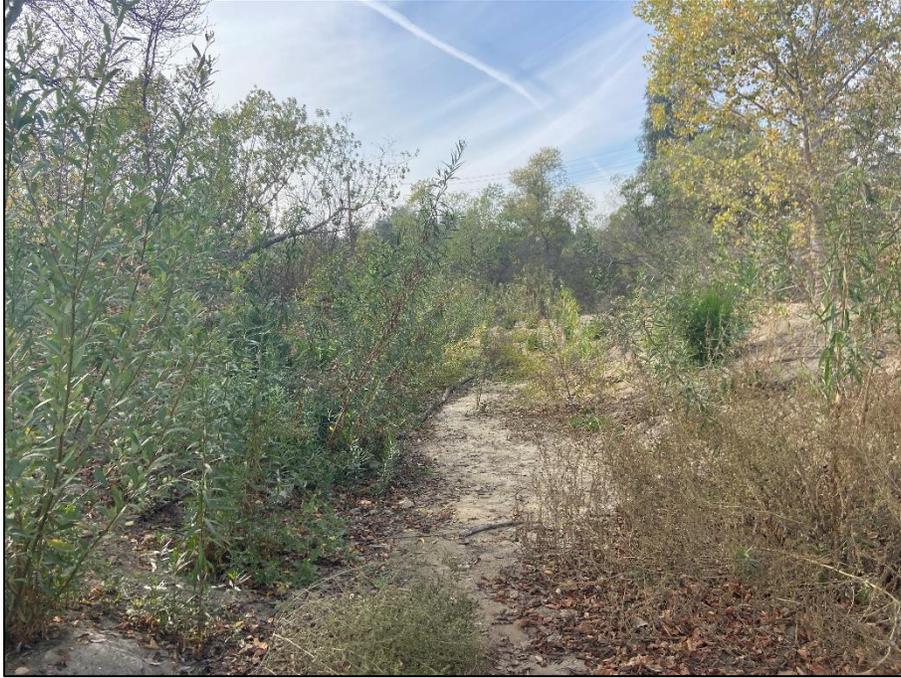
Photo 13: Overview Mitigation Area DG-W-2 (Mining Pit Outlet)

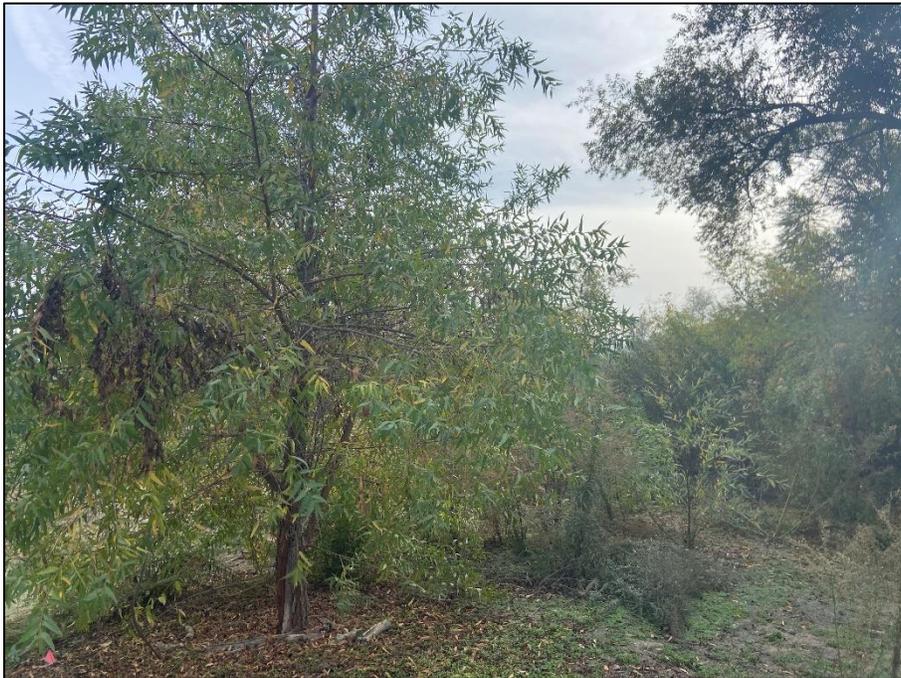
Photo 14: Overview Mitigation Area DG-4 Sheet Flow/DG-SF-1
