June 18, 2025  
2023-005.07

Ms. Mitzi Kim Rios  
Los Angeles County Public Works  
900 South Fremont Avenue, 2nd Floor  
Alhambra, California 91803

**Re: *Devil's Gate Reservoir Restoration Project – Phase 1 Restoration Qualitative Monitoring  
Conducted on February 10, 2025***

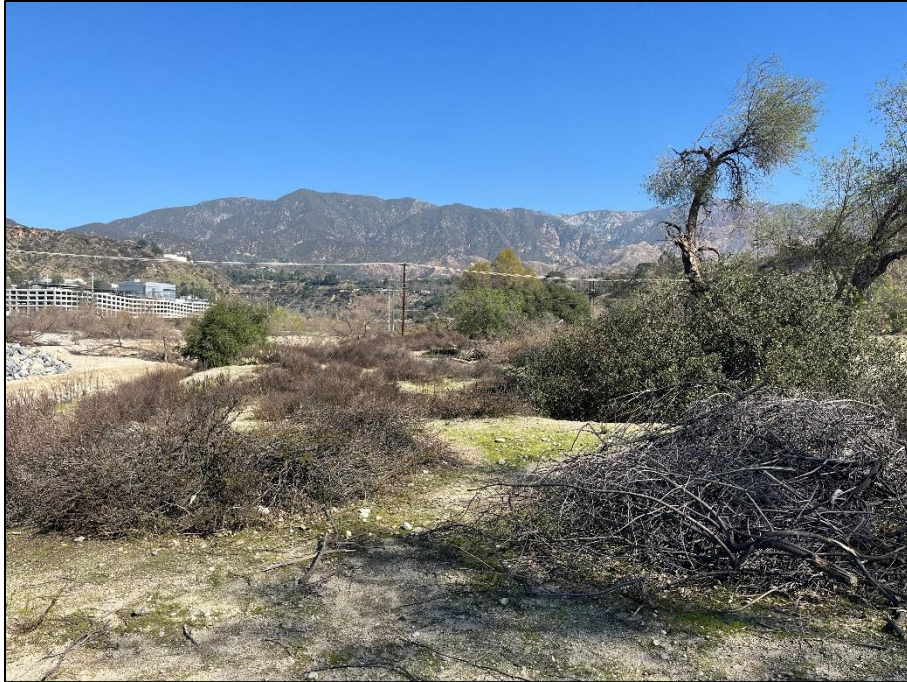
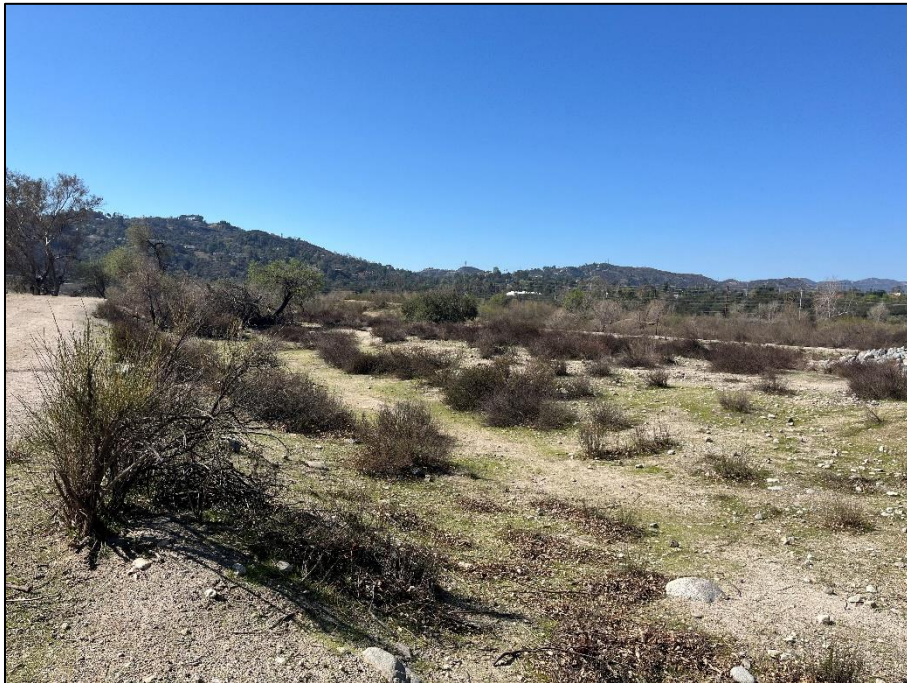
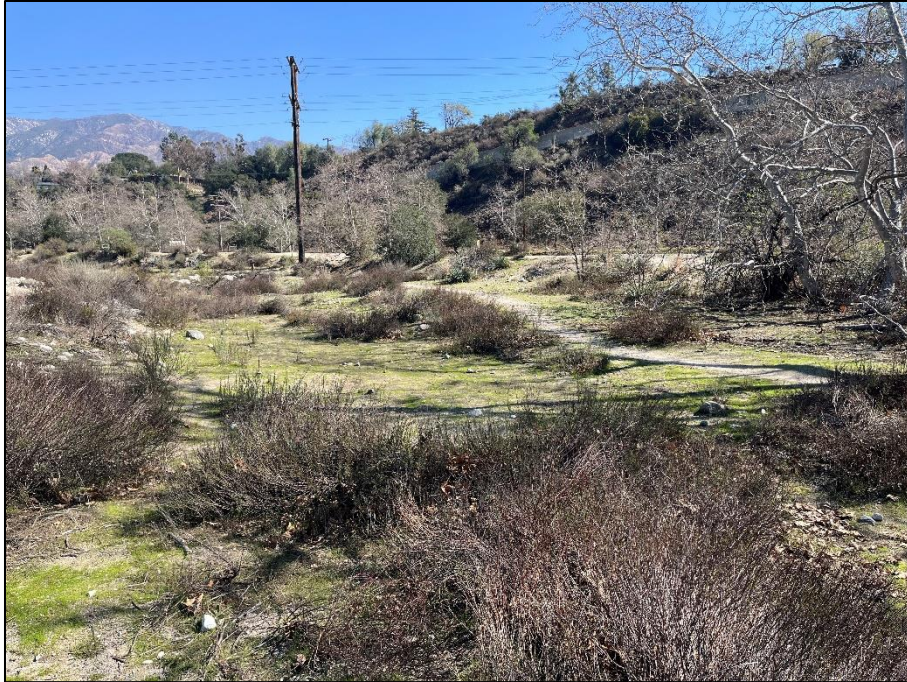
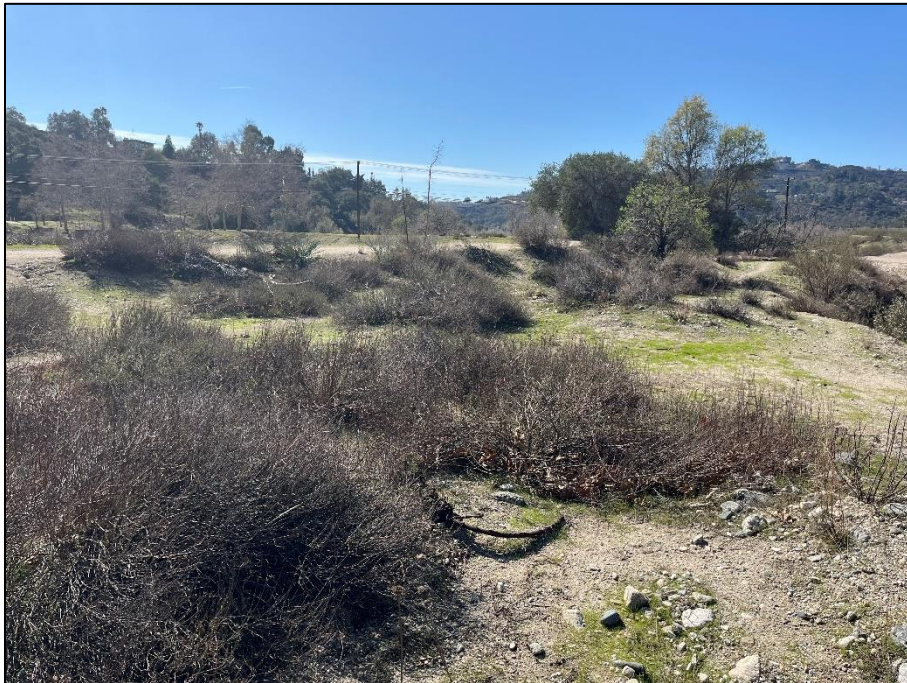
Container plants were not installed in the DG-1 or DG-1 WOUS mitigation areas, but these areas were seeded with native plant species. Native plant growth, including perennials and annuals, was noted throughout the DG-1 and DG-1 WOUS mitigation areas, likely both from natural recruitment and from seeding. The majority of DG-1 WOUS was noted as being scoured during the 2020, 2021, 2022, 2023, 2024, and 2025 wet seasons and had minimal plant growth. Native plants such as California sagebrush (*Artemisia californica*), mulefat (*Baccharis salicifolia*), Canada horseweed (*Erigeron canadensis*), California buckwheat (*Eriogonum fasciculatum*), telegraph weed (*Heterotheca grandiflora*), scale broom (*Lepidospartum squamatum*), and chia sage (*Salvia columbariae*) were observed sprouting in the DG-1 and DG-1 WOUS mitigation areas. Native cover for the DG-1 and DG-1 WOUS mitigation areas was estimated to be approximately 60 to 65 percent with some areas having relatively dense cover and other areas being

scoured and/or having minimal cover. Photos 1 through 4 in Attachment B document the status of the mitigation areas during the monitoring visit.

Nonnative weed cover in DG-1 and DG-1 WOUS was estimated to be approximately 2 percent, which is approximately 1 percent higher than the level of weed cover that was observed during the previous qualitative monitoring event. Nonnative species observed in DG-1 and DG-1 WOUS during the monitoring visit included black mustard (*Brassica nigra*) and nonnative grasses. Most nonnative weeds were just starting to germinate and had not gone to flower or seed.

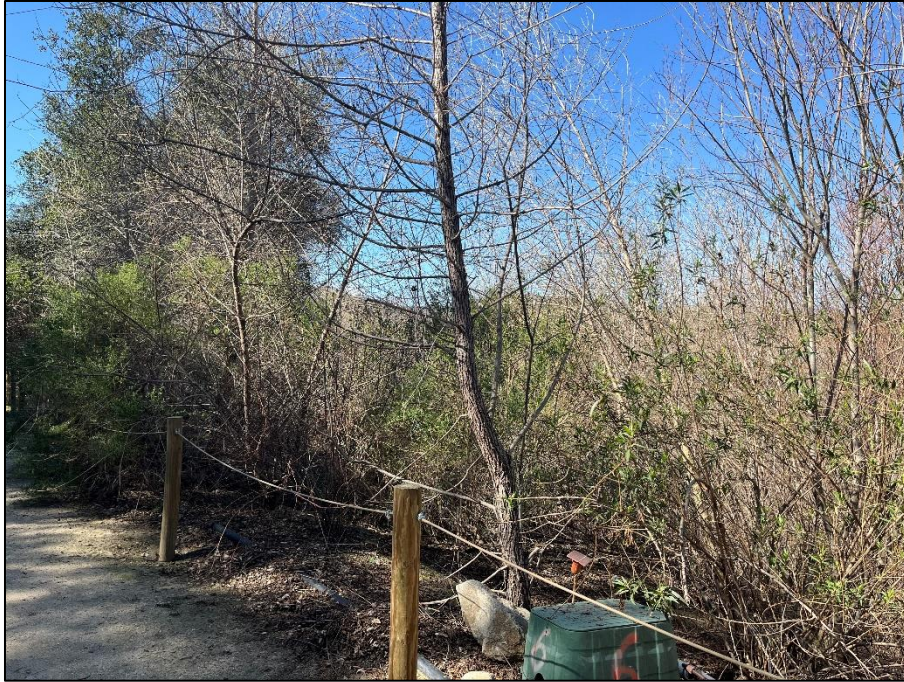
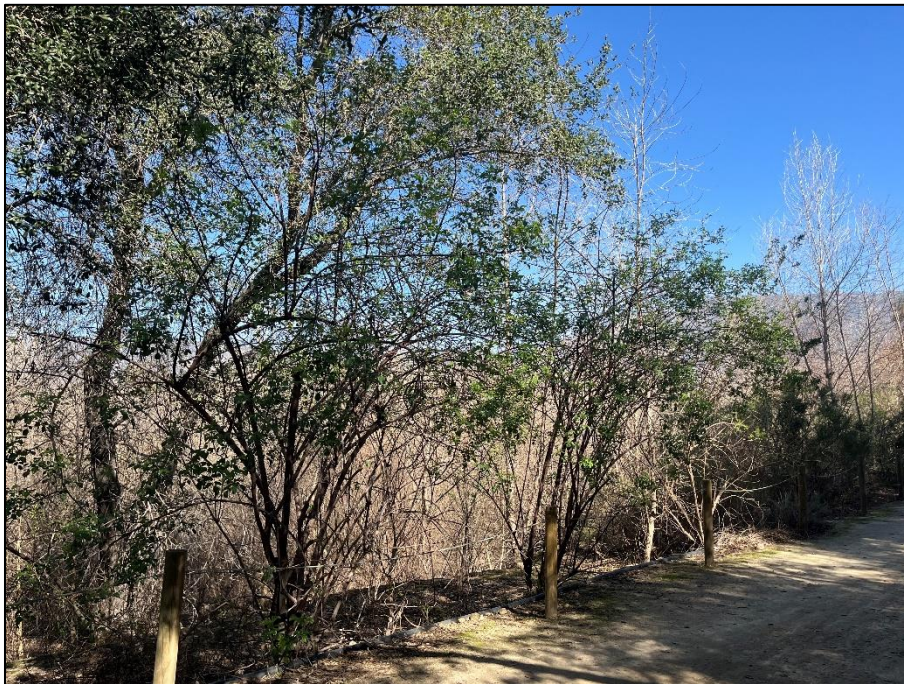
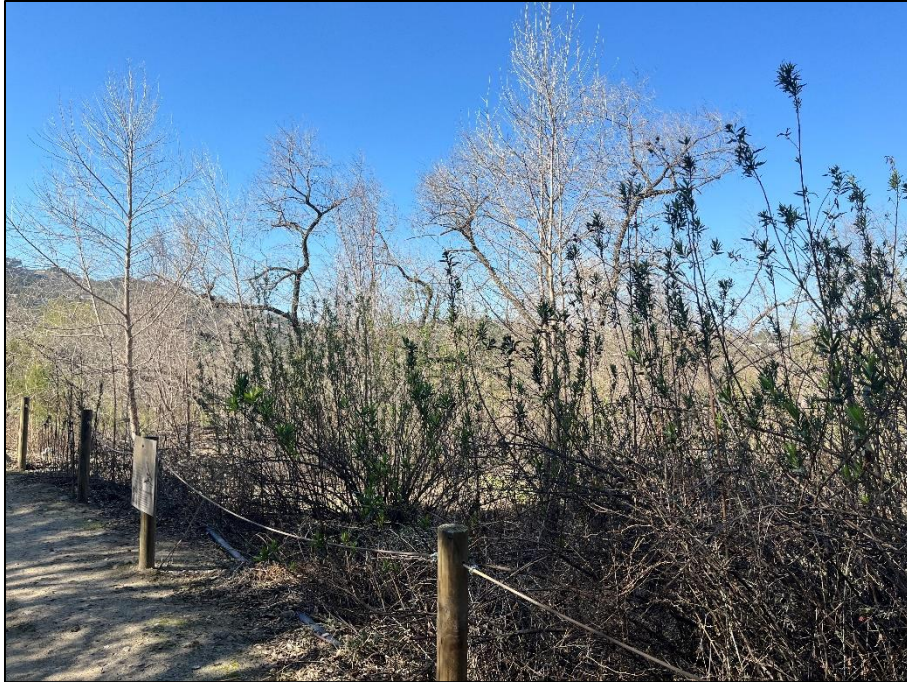
The overall health of the container plants in DG-2A was noted as being good. Approximately less than 5 percent of the container plants in DG-2A were noted as showing varied levels of stress, which is approximately the same as the percentage of container plants that were showing stress during the previous qualitative monitoring event. Stress may be occurring as a result of 1) competition from nonnative and invasive weeds or 2) recreational traffic through the mitigation areas. Additional missing or dead container plants were not observed. Photos 5 through 7 in Attachment B document the status of the mitigation area during the monitoring visit.

Native plant growth was noted throughout the DG-2A mitigation area, likely both from natural recruitment and from seeding. Native plants such as California sagebrush, mugwort (*Artemisia douglasiana*), mulefat, tall flatsedge (*Cyperus eragrostis*), Canada horseweed, and Douglas' nightshade (*Solanum douglassi*) were observed sprouting in the DG-2A mitigation area. Native cover for the DG-2A mitigation area was estimated to be 75 to 80 percent.

Nonnative grasses were starting to germinate at less than 1 percent cover within the DG-2A mitigation area during the monitoring visit and evidence of recent weed abatement was observed.

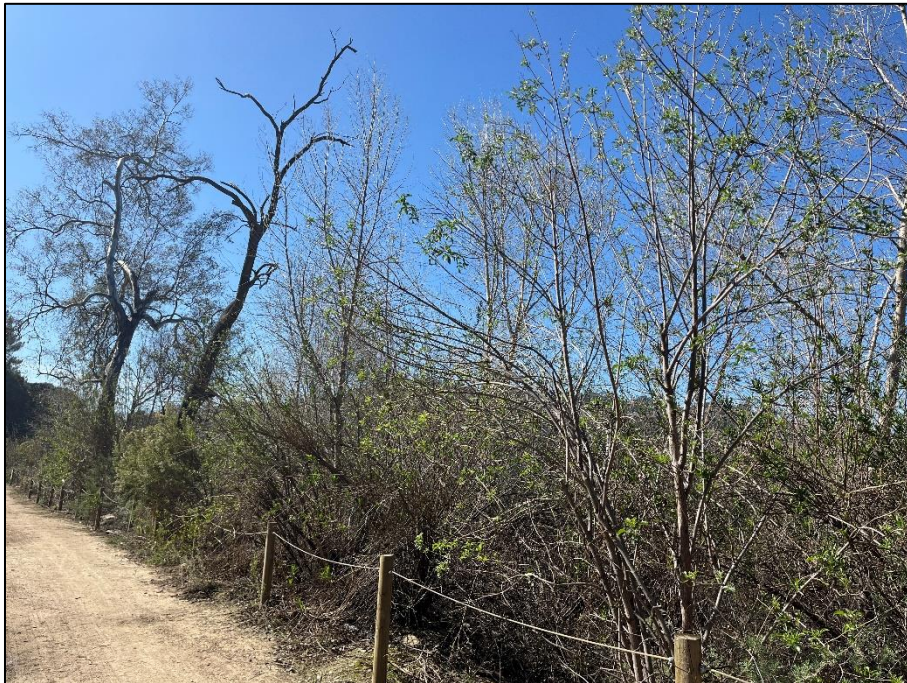
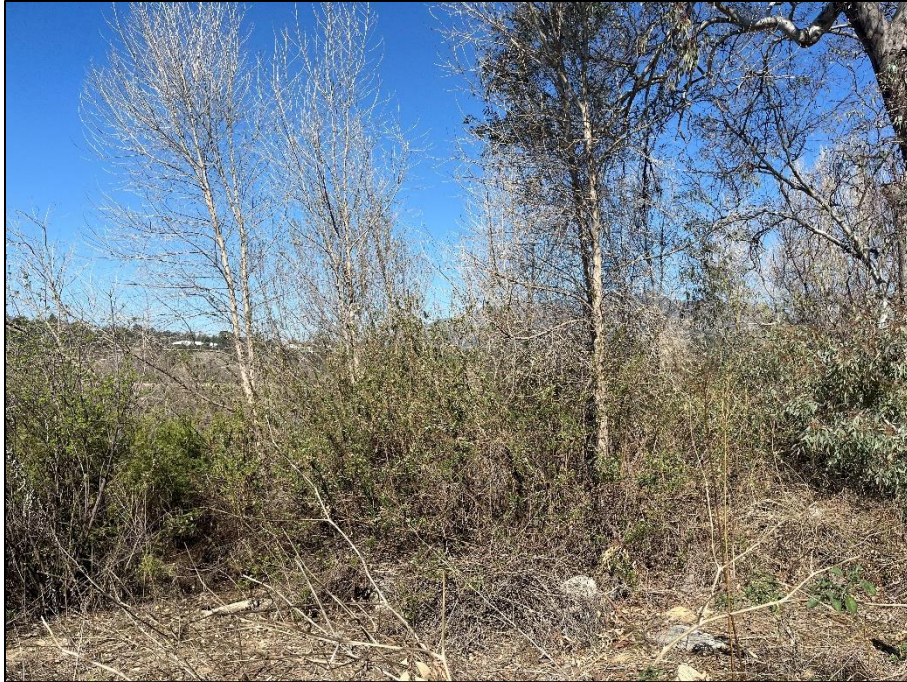
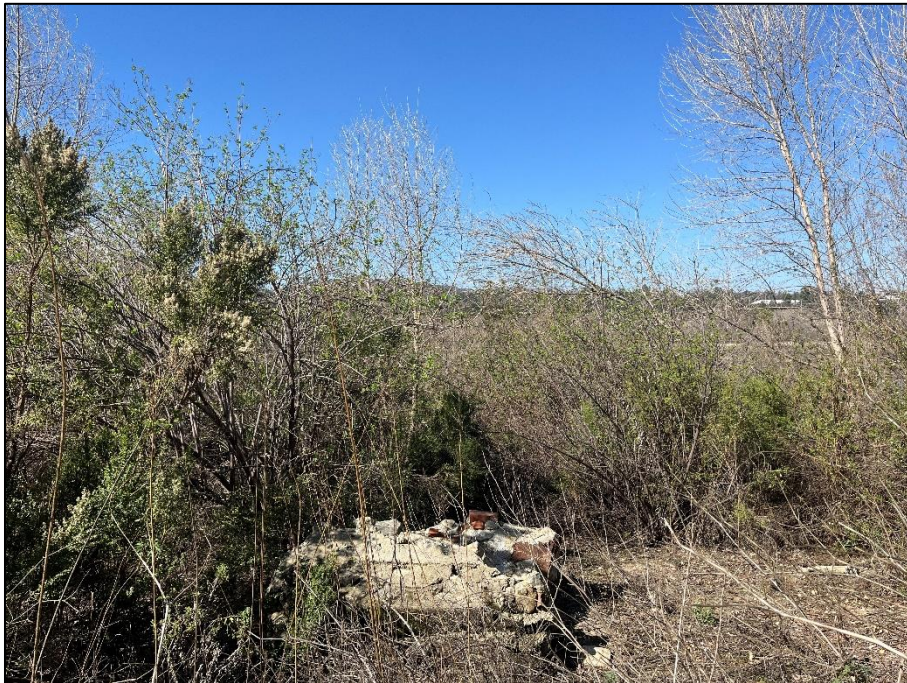
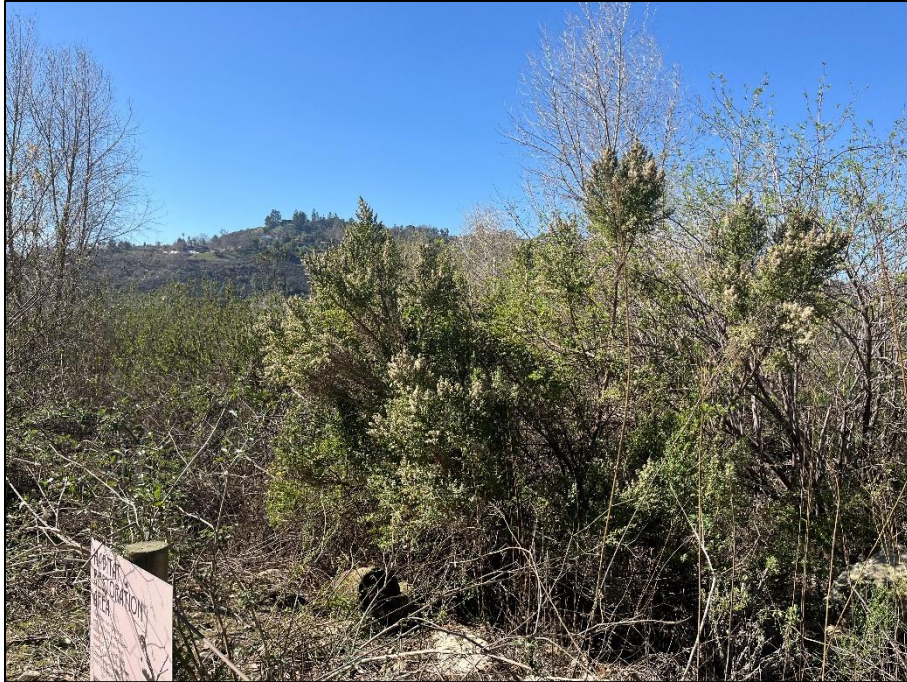
The overall health of the container plants in DG-2B was noted as being good. Approximately less than 5 percent of the container plants in DG-2B were noted as showing varied levels of stress, which is approximately the same percentage of container plants that were showing stress during the previous qualitative monitoring event. Stress was likely due to the same reasons as those described for DG-2A. Photos 8 through 11 in Attachment B document the status of the mitigation area during the monitoring visit.

Native plant growth was noted throughout the DG-2B mitigation area, likely both from natural recruitment and from seeding. Native plants such as mugwort, California sagebrush, mulefat, Douglas' nightshade, and stinging nettle (*Urtica dioica*) were observed sprouting in the DG-2B mitigation area. Native cover for the DG-2B mitigation area was estimated to be 80 to 85 percent.

Nonnative weed cover in DG-2B was estimated at approximately 1 percent, which is approximately the same level of nonnative cover that was observed during the previous qualitative monitoring event. Poison hemlock (*Conium maculatum*) was the only nonnative species observed in DG-2B during the monitoring visit. Most nonnative weeds were just starting to germinate and had not gone to flower or seed.

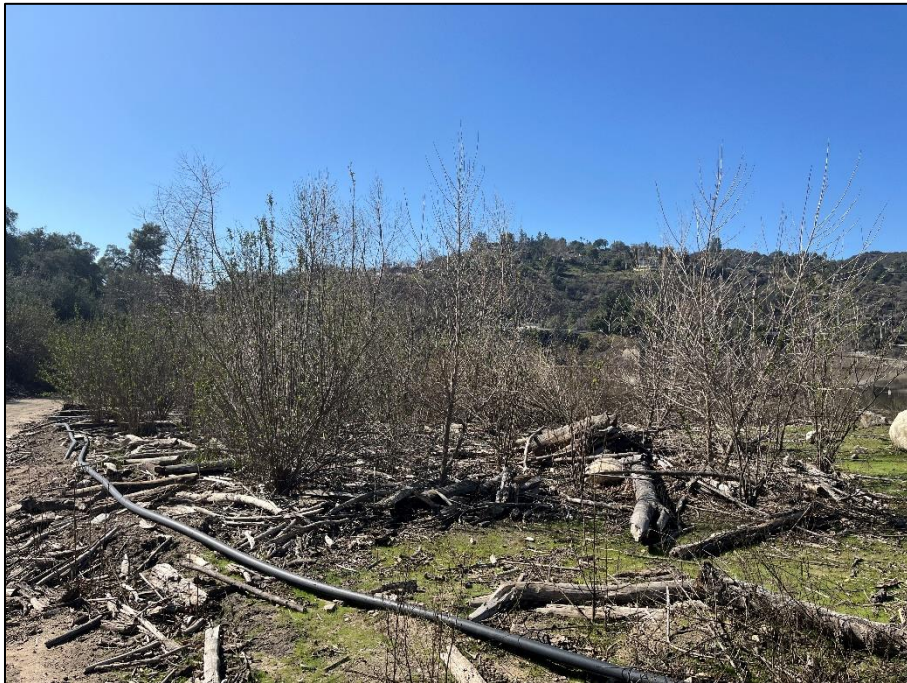
Photo 12: Overview Mitigation Area DG-3A Altadena Drain

During the monitoring visit, approximately 5 percent of the container plants in the mulefat thickets portions of DG-3A were noted as showing varied levels of stress. Some of the stress was likely due to the same reasons as those described for DG-2A; however, this area was noted as being inundated during previous qualitative monitoring visits and some of the plants still appear to be recovering. In addition, erosion is also a problem in some areas of DG-3A. The willow and mulefat stakes were observed to be thriving in this mitigation area during the monitoring visit. Photos 12 through 18 in Attachment B document the status of the mitigation area during the monitoring visit.

Minor erosion to planting basins was observed throughout the Phase 1 mitigation areas. The severe erosion noted in DG-3A near Altadena Drain during previous monitoring visits did not show any signs of worsening. Due to the steepness of the slope in the coast live oak woodland portion of the DG-3A mitigation area, erosion will likely continue to be somewhat of an issue in this area; however, jute nettings

are currently in place on the slope and will help to lessen the severity of erosion issues. As native cover increases in this area, erosion issues should lessen. The severity of the erosion should continue to be monitored in all planted areas and if warranted, erosion Best Management Practices (BMPs) should be installed in appropriate areas. This may only require the installation of straw wattles at select sites to prevent existing rills from becoming larger. However, until more native perennial plants become established in these areas, there is the potential that intense rainfall may create additional erosion problems.

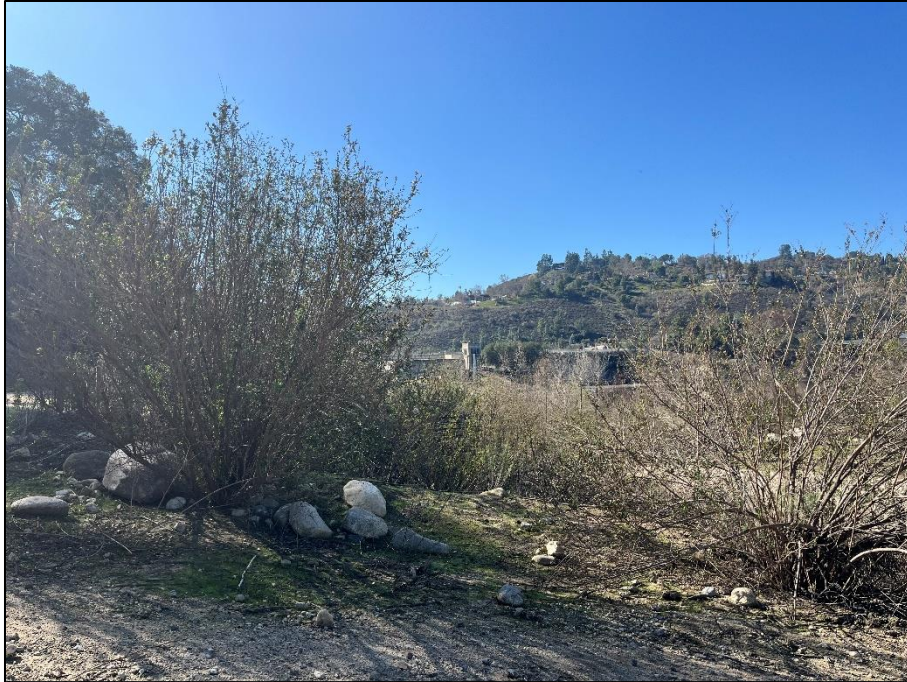
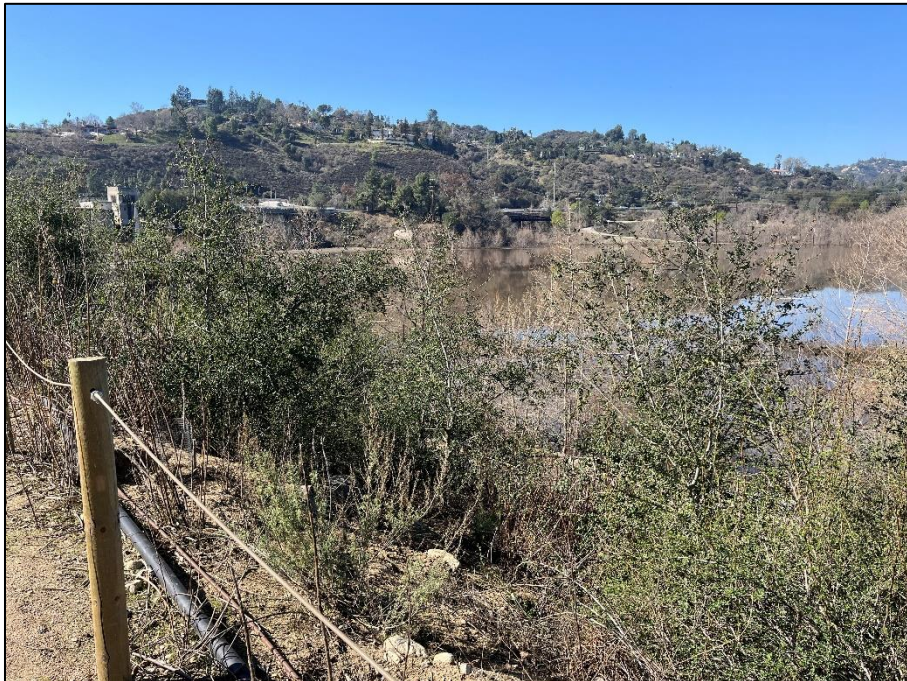
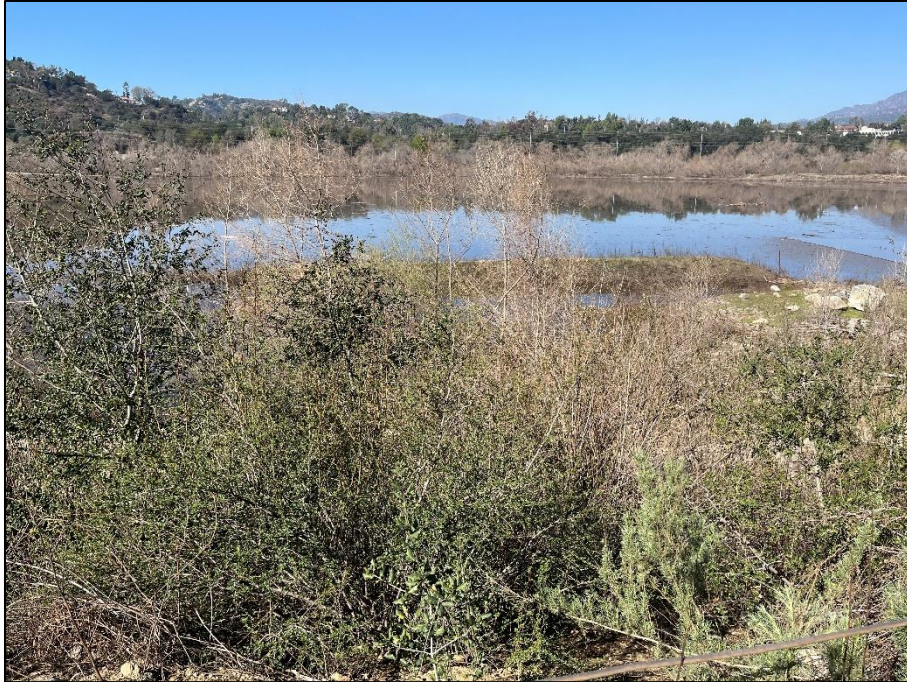
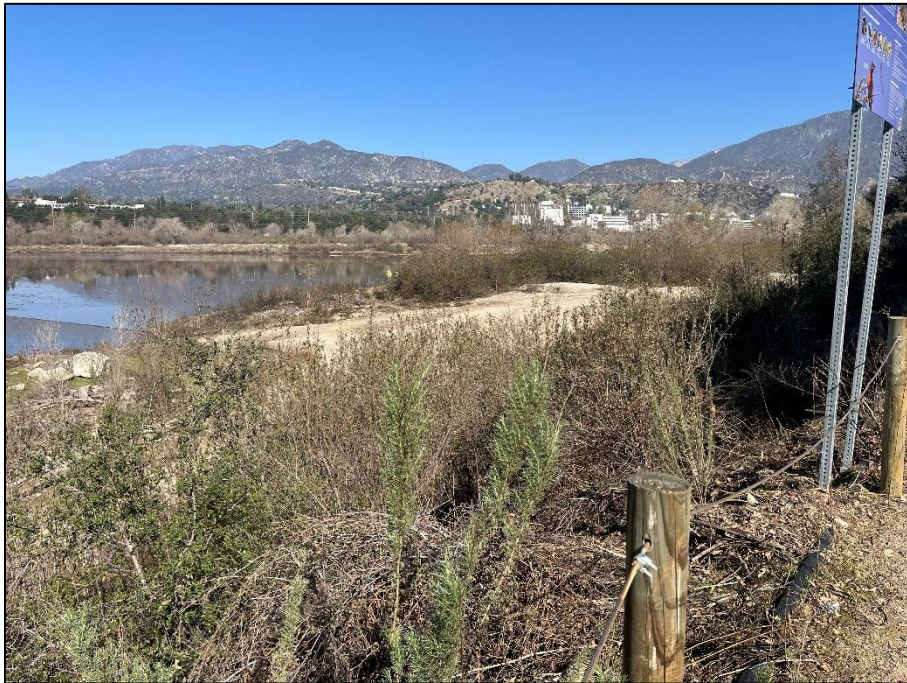
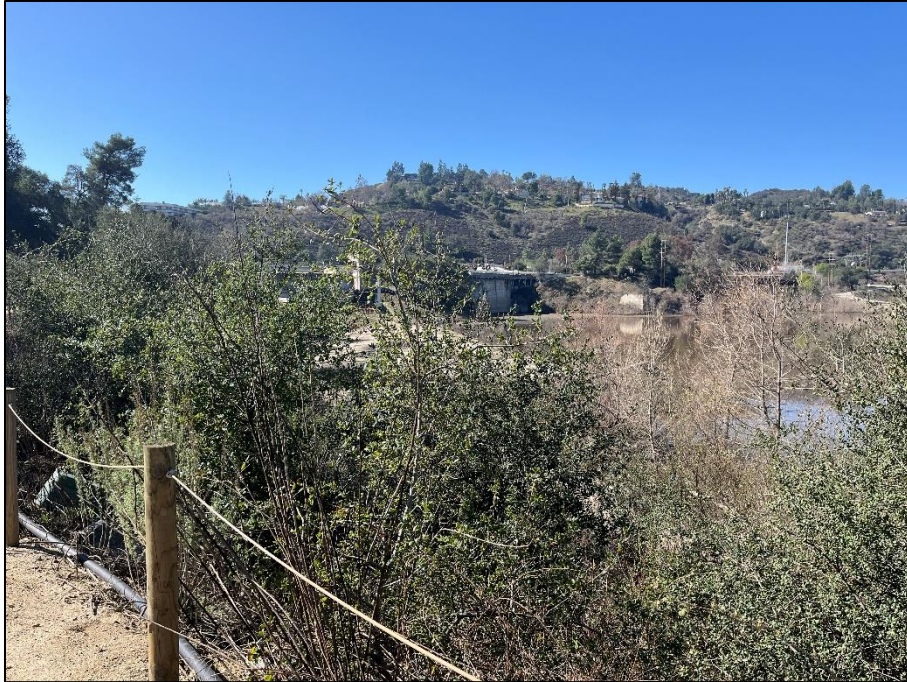
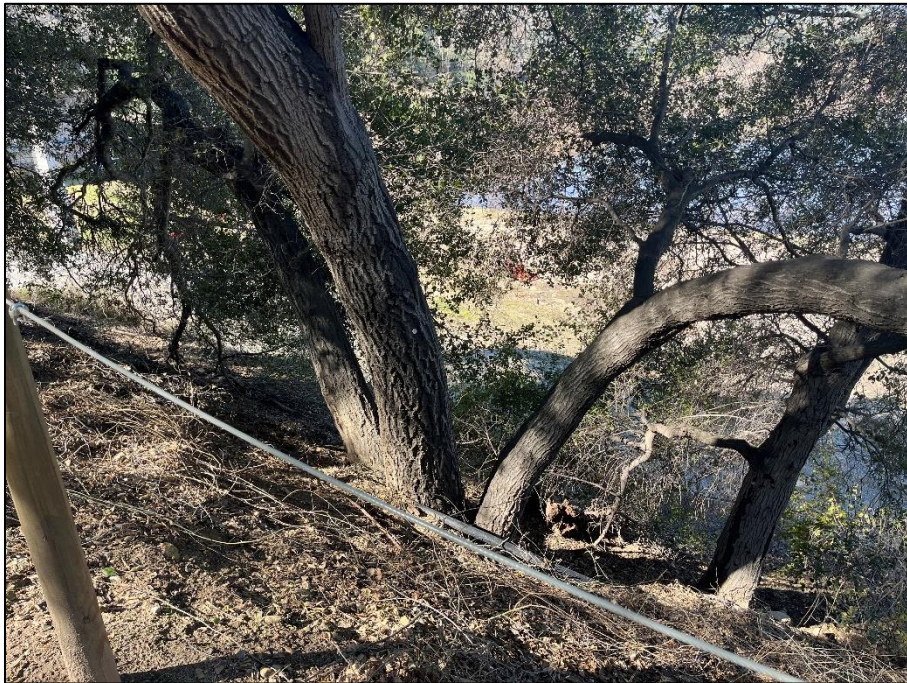
The overall health of the container plants in DG-3A was noted as being good. Approximately 5 percent of the container plants in the coast live oak woodland portions of DG-3A were noted as showing varied levels of stress, which is approximately the same percentage of container plants that were showing stress during the previous qualitative monitoring event. During the monitoring visit, the planted coast live oak (*Quercus agrifolia*) acorns were inspected for survivorship and health. Approximately 20 germinated coast live oak acorns appear to still be present in DG-3A and are approximately five to seven feet tall. Most of the germinated acorns appear to be in good health. During the monitoring, previously documented branch failure on an existing coast live oak tree (Tree Tag #39) was still present; however, no new branch failure or damage was observed. The cause of the previously documented branch failure was unclear.

Native plant growth was noted throughout the DG-3A mitigation area, likely both from natural recruitment and from seeding. Native plants such as annual bursage (*Ambrosia acanthicarpa*), California sagebrush, mugwort, Canada horseweed, telegraph weed, and chilicothe (*Marah macrocarpa*) were observed sprouting in the DG-3A mitigation area. Native cover for the DG-3A mitigation area was estimated to be approximately 65 percent in the coast live oak woodland portion of the mitigation area and 75 percent in the mulefat thickets portion of the mitigation area.

Nonnative weed cover in DG-3A was estimated at approximately 1 percent, which is approximately the same level of nonnative cover that was observed during the previous qualitative monitoring event. Nonnative species observed in DG-3A included brome grasses (*Bromus* spp.). Most nonnative weeds were just starting to germinate and had not gone to flower or seed.

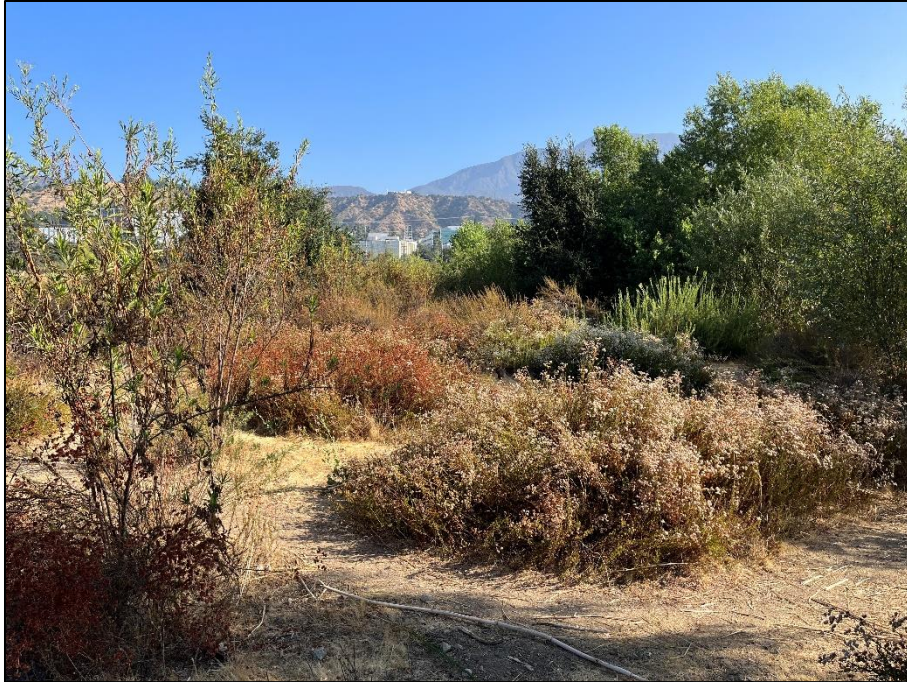
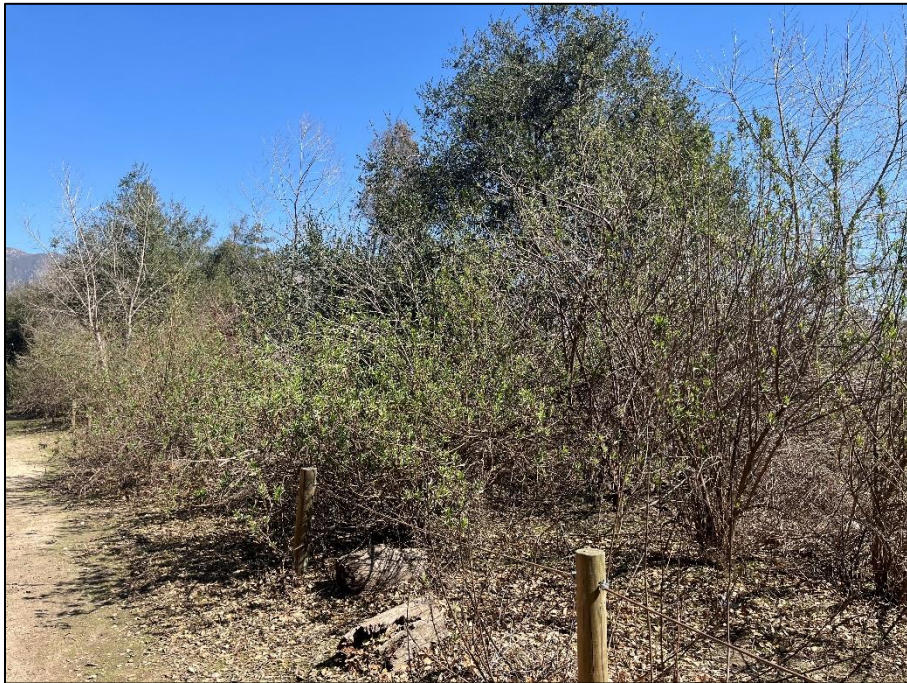
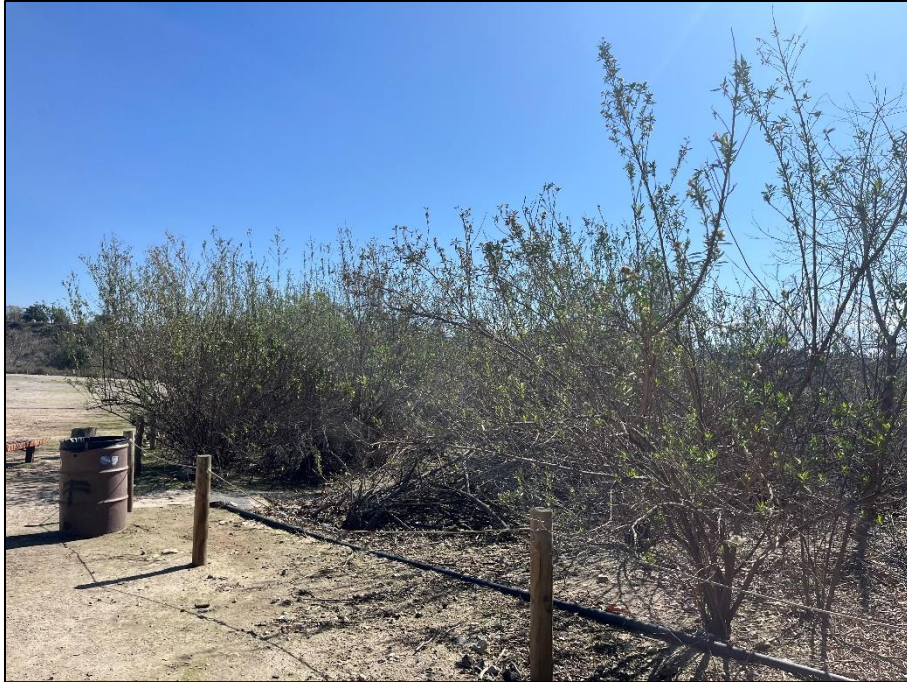
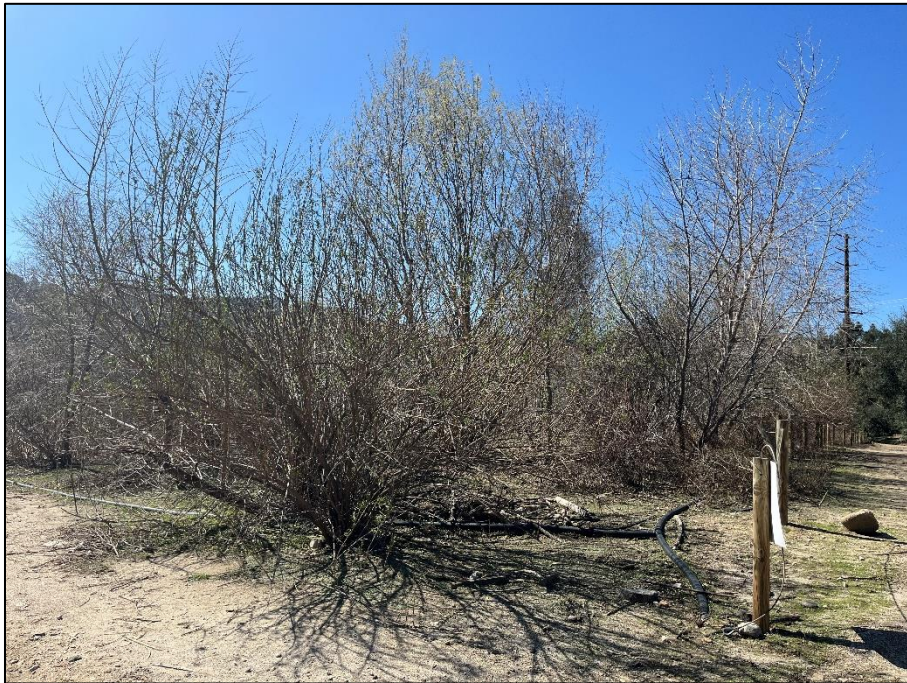
The overall health of the container plants in mitigation area DG-4 was noted as being good. Approximately 5 percent of container plants in the coastal sage scrub portions of DG-4 and approximately 5 percent of container plants in the riparian portions of DG-4 showed varied levels of stress which is approximately the same percentage of plants showing stress during the previous qualitative monitoring event. The causes of stress appear to be mostly due to the same reasons described in DG-2A. In addition, the southern portions of DG-4 continue to experience periods of inundation during the wet season. Photos 19 through 22 in Attachment B document the status of the mitigation area during the monitoring visit.

flatsedge, California buckwheat, common phacelia (*Phacelia distans*), and stinging nettle were observed sprouting in the DG-4 mitigation area. Native cover for the DG-4 mitigation area was estimated to be approximately 75 percent in the riparian portion of the mitigation area and 65 to 70 percent in the coastal sage scrub portion.

Nonnative weed cover in DG-4 was estimated at approximately 5 percent, which is approximately 5 to 10 percent lower than the percentage of nonnative cover that was observed during the previous qualitative monitoring event. Nonnative species observed in DG-4 included black mustard, poison hemlock, perennial pepperweed (*Lepidium latifolium*), and white horehound (*Marrubium vulgare*). Nonnative weed cover, especially perennial pepperweed, is a significant problem in portions of the DG-4 mitigation area. Because perennial pepperweed can produce dense colonies through seed germination and underground rhizomes (rhizomatous roots), removal of this species without the use of systemic herbicide is very difficult. Most nonnative weeds were just starting to germinate and had not gone to flower or seed.

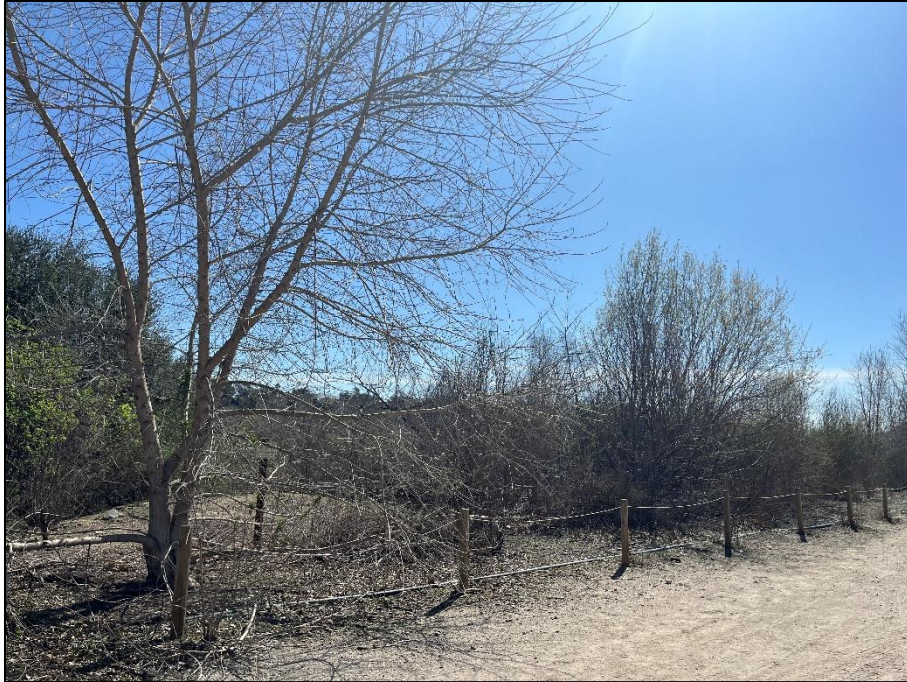
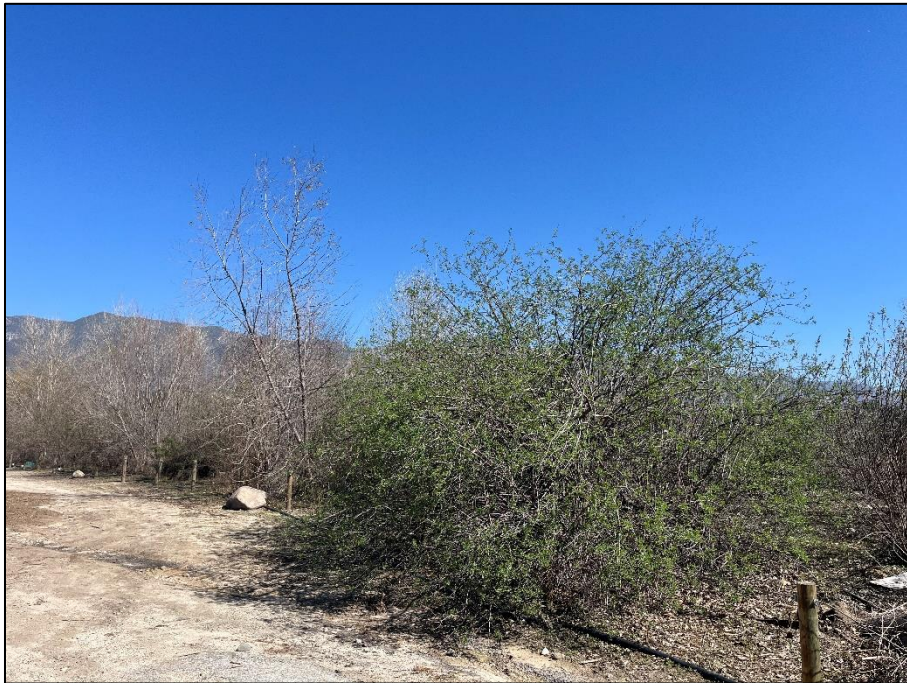
The overall health of the container plants in mitigation area DG-4B was noted as being good and this mitigation area is becoming well established. Approximately less than 5 percent of container plants were showing varied levels stress which is approximately the same percentage of plants that were stressed during the previous qualitative monitoring event. The types of stress the plants were exhibiting are the same as those described for the plants in DG-2A. A negligible number of container plants were noted as being missing or dead. Photos 23 and 24 in Attachment B document the current status of the mitigation area during the monitoring visit.

Native plant growth was noted throughout the DG-4B mitigation area, likely both from natural recruitment and from seeding. Native plants such as mugwort, mulefat, tall flatsedge, common phacelia, and stinging nettle were observed sprouting in the DG-4B mitigation area. Native cover for the DG-4B mitigation area was estimated to be approximately 75 percent.

Nonnative weed cover in DG-4B was estimated to be approximately 1 percent, which is the same level of nonnative cover that was observed during the previous qualitative monitoring event. Nonnative species observed in DG-4B included black mustard and perennial pepperweed. Most nonnative weeds were just starting to germinate and had not gone to flower or seed.

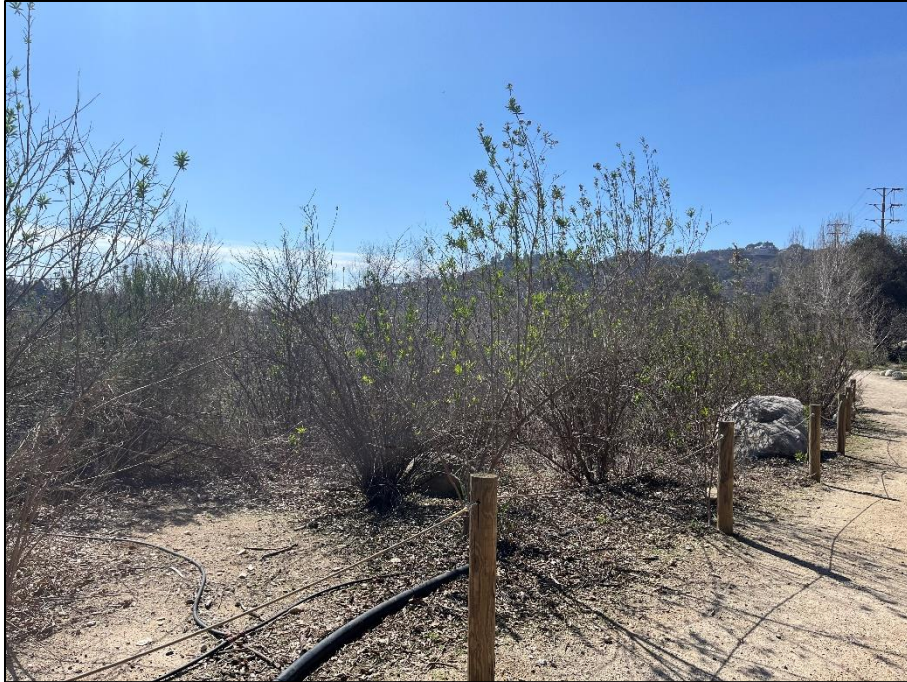
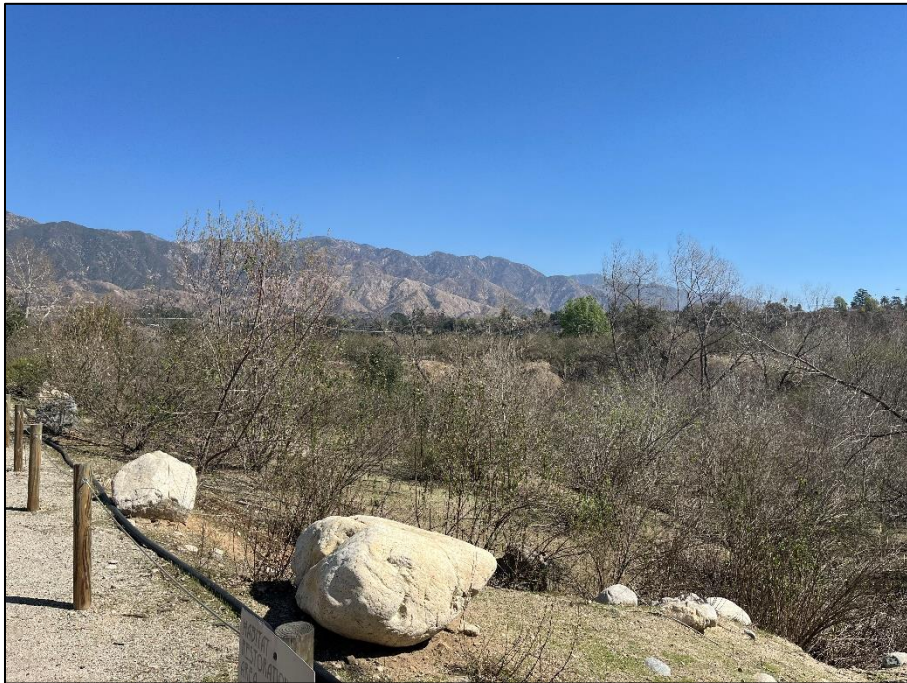
The overall health of the container plants in mitigation area DG-4C was noted as being good. Approximately less than 5 percent of all container plants were noted as showing minor levels of stress, which is approximately the same percentage of plants that were showing stress during the previous qualitative monitoring event. The types of stress the plants were exhibiting are the same as those described for the plants in DG-2A. A negligible number of container plants were noted as being missing or dead. Photos 25 and 26 in Attachment B document the status of the mitigation area during the monitoring visit.

Native plant growth was noted throughout the DG-4C mitigation area, likely both from natural recruitment and from seeding. Native plants such as mugwort, mulefat, tall flatsedge, and common phacelia were observed sprouting in the DG-4C mitigation area. Native cover for the DG-4C mitigation area was estimated to be approximately 70 percent.

Nonnative weed cover in DG-4C was estimated at approximately 2 percent, which is approximately 1 percent higher than the percentage of nonnative cover that was observed during the previous qualitative monitoring event. Nonnative species observed in DG-4C included black mustard and poison hemlock. Most nonnative weeds were just starting to germinate and had not gone to flower or seed.

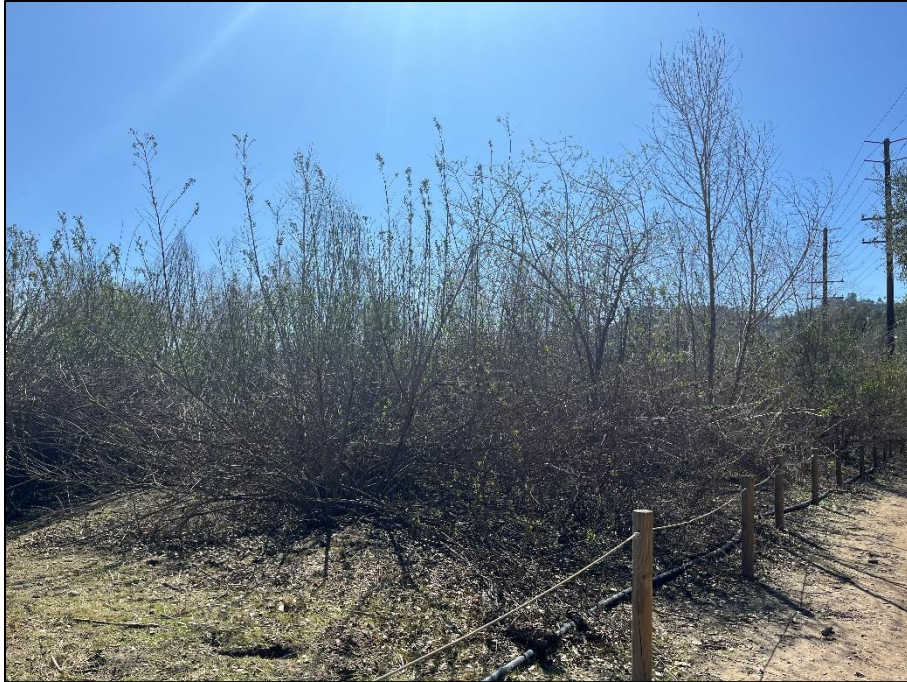
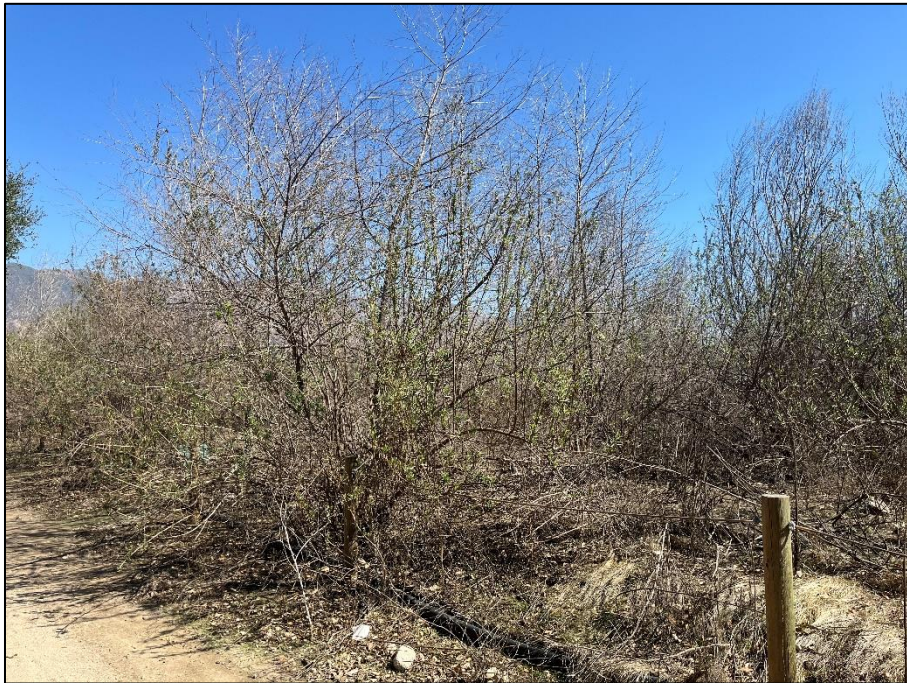
The overall health of the container plants in the DG-5 mitigation area was noted as being good. Approximately less than 5 percent of all container plants were noted as showing varied levels of stress, which is approximately the same as the percentage of plants that were showing stress during the previous qualitative monitoring event. Photos 27 and 28 in Attachment B document the status of the mitigation area during the monitoring visit.

Native plant growth was noted throughout the DG-5 mitigation area, likely both from natural recruitment and from seeding. Native plants such as mugwort, mulefat, Hooker's evening primrose (*Oenothera elata*), and stinging nettle were observed sprouting in the DG-5 mitigation area. Native cover for the DG-5 mitigation area was estimated to be approximately 80 to 85 percent and the site is thriving.

Nonnative weed cover in DG-5 was estimated at approximately 2 percent, which is approximately 3 percent lower than the percentage of nonnative weed cover that was observed during the previous qualitative monitoring event. Nonnative species observed in DG-5 included black mustard, poison hemlock, and perennial pepperweed. Most nonnative weeds were just starting to germinate and had not gone to flower or seed.
