**BOARD MOTION OF MARCH 1, 2011, AGENDA ITEM 60-C  
DEVIL'S GATE DAM AND RESERVOIR POSTFIRE SEDIMENT REMOVAL  
SHORT-TERM SOLUTION REPORT FOR SEDIMENT ACCUMULATION ALONG THE  
FACE OF THE DAM**

***DEVIL'S GATE DAM AND  
RESERVOIR POSTFIRE SEDIMENT  
REMOVAL***

***SHORT-TERM SOLUTION REPORT  
FOR SEDIMENT ACCUMULATION  
ALONG THE FACE OF THE DAM***

March 2011

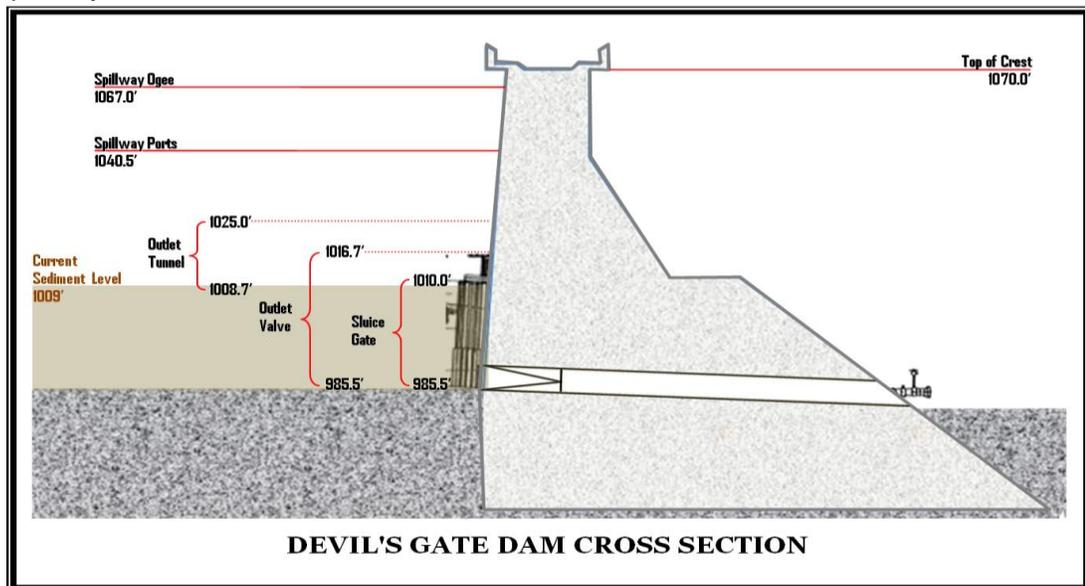
Figure 1

Devil's Gate Dam and Reservoir attenuates peak storm runoff, and impounds sediment and debris during storm events to prevent high flow rates from overwhelming the downstream system. Outflow from Devil's Gate Dam is controlled by three outlet corridors; a sluice gate, the outlet valve, and the outlet tunnel gates (Figure 1). The outlet valve and tunnel gates are used to make controlled releases when the reservoir has impounded storm water. The sluice gate is used to drain the reservoir after storm flows recede, or due to an emergency condition.

During small storms and the early stages of larger storms, the sluice gate is left open so that the storm flow along with its accompanying sediment passes through the dam. During larger storm events when more flow enters the reservoir than exits through the sluice gate, stormwater and sediment begin to accumulate at the dam face. When that occurs, the sluice gate is closed so that a pond develops in the reservoir. This pond, referred to as a buffer pool, prevents more sediment from accumulating at the face of the dam. As sediment-laden storm flows from the watershed enter the reservoir and reach the buffer pool, they slow down and the sediment settles to the bottom of the pool away from the dam. As the storm continues, water is released from the outlet valves and tunnel gates at a rate that maintains the buffer pool.

If the rate of storm inflow exceeds the capacity of the outlet valves and tunnel gates, the reservoir will continue to rise until it reaches the spillway ports (ungated openings below the main spillway). During major storm events, the reservoir may continue to rise even higher and flow will go over the main spillway.

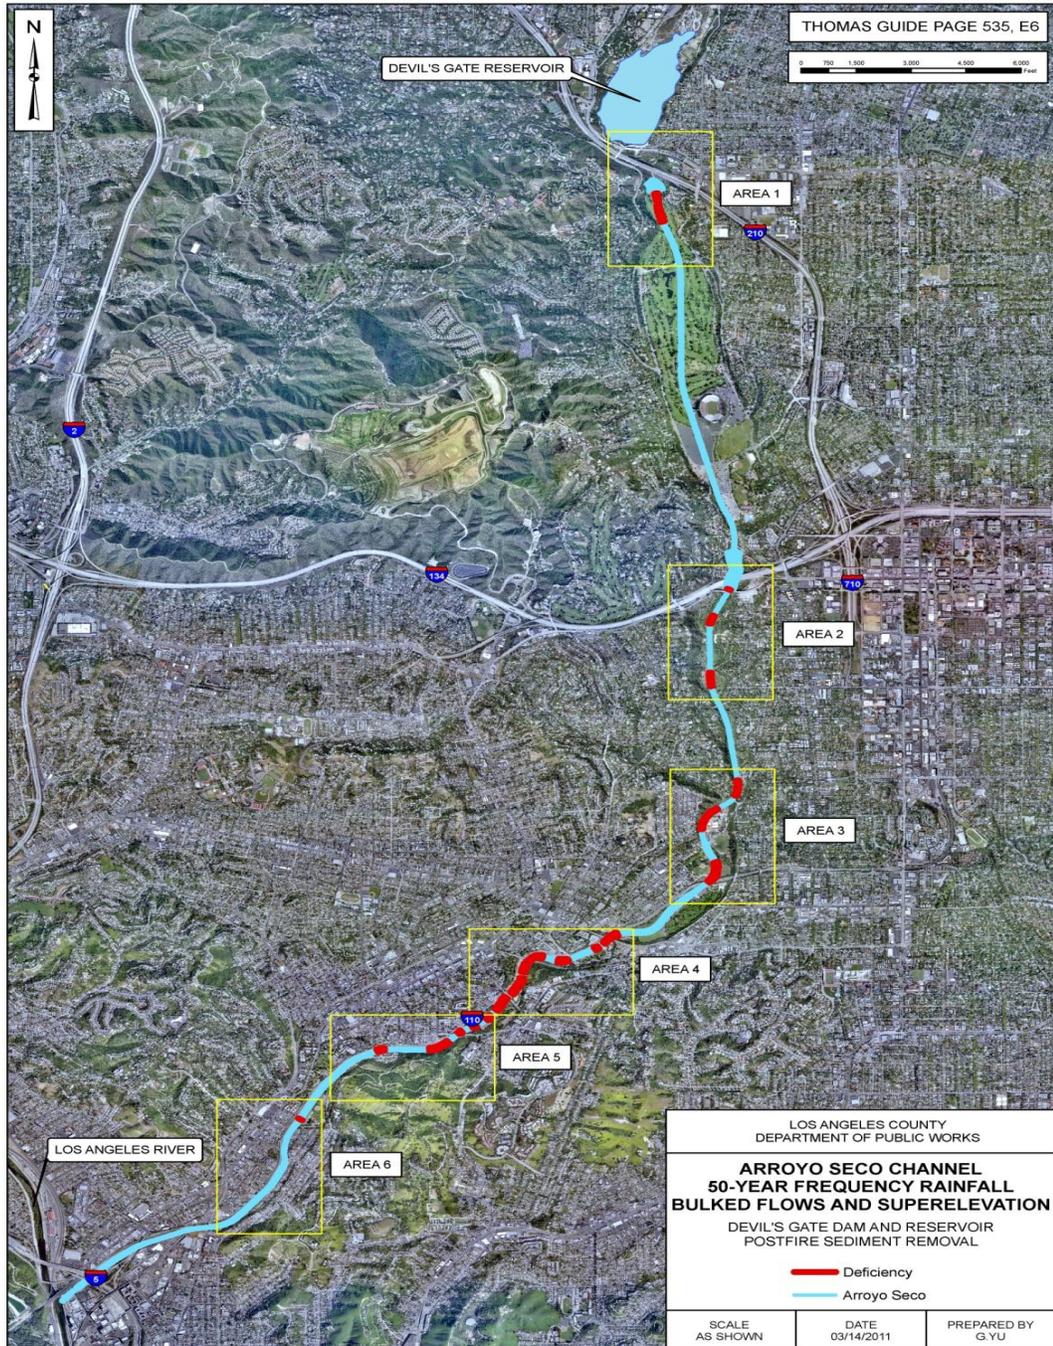
Figure 2 Arroyo Seco Overtopping Locations

sediment load in the storm flows leaving Devil's Gate Reservoir will severely impact the capacity of our downstream flood control channel. The combination of losing capacity to sedimentation in the reservoir and the inability to properly operate any of the dam's outlet works affects the facility's capability for flood and debris control. The channel, which protects property from flood damage downstream of the dam, was not designed to handle heavy sediment flows from the watershed above the dam. Consequently, the following locations shown on Figure 2 will potentially be inundated with storm flows and debris during large storm events:

The locations shown in Figure 2 will be monitored by channel observers during storms when the channel reaches 2/3 full. A notification list will be developed with affected agencies and residents for road closures and evacuations when warranted.

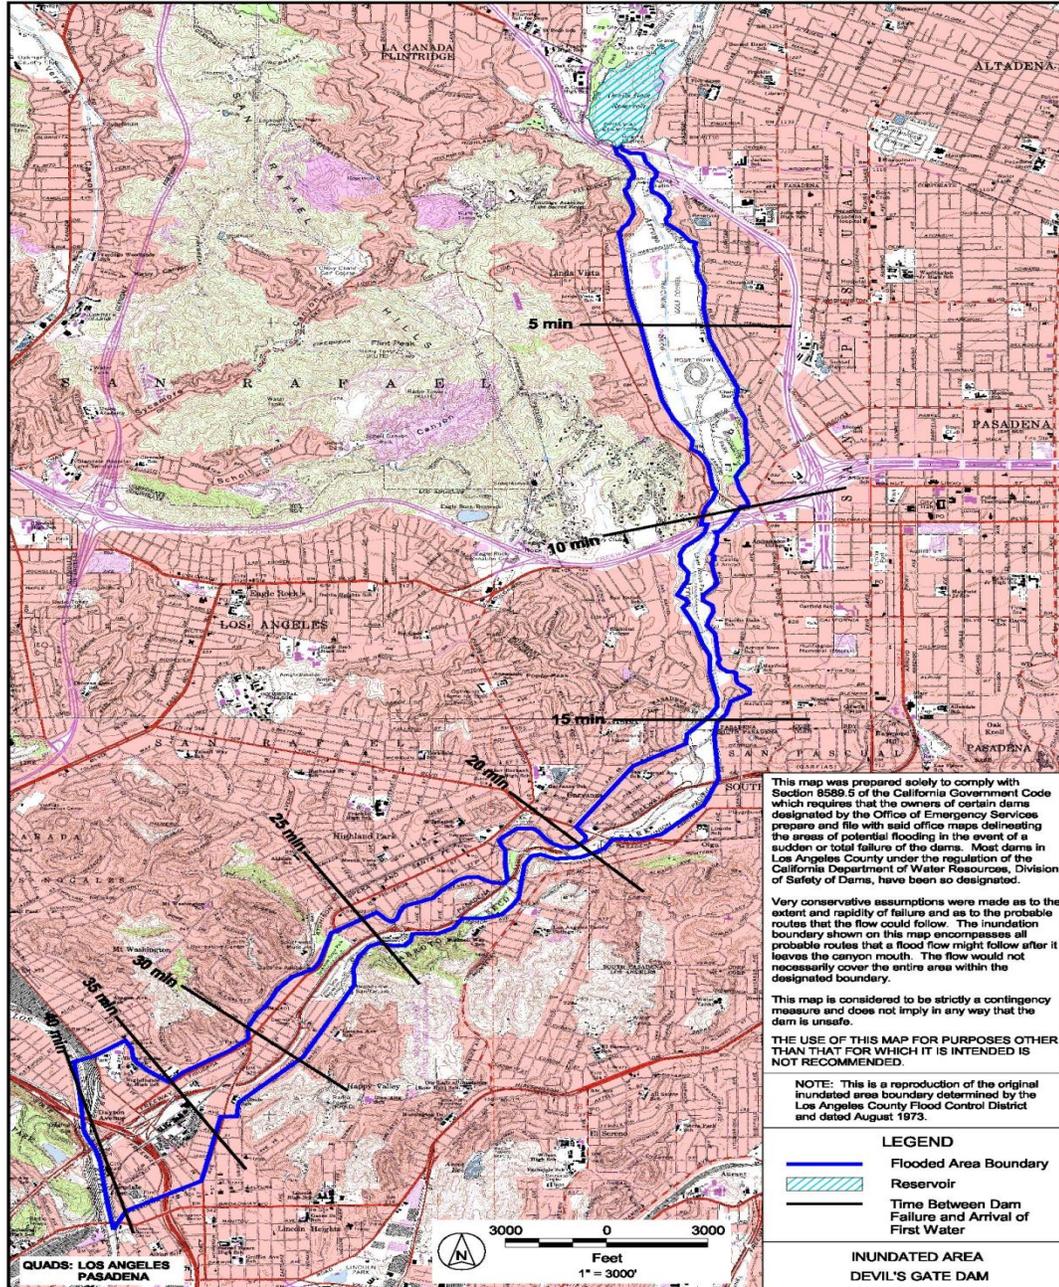
Figure 3 Arroyo Seco Dam Failure Inundated Area

In the unlikely event of a dam safety emergency, the outlets would be required to safely drain the dam. If all the outlets become inoperable, emergency dewatering of the reservoir would be impossible. Figure 3 illustrates the inundation area, which would potentially be flooded if the dam were to fail before being dewatered.

Figure 3 illustrates the inundation area that would be flooded in the unlikely event of a dam failure. A current list exists for notifying emergency responders of imminent or actual dam failure. The list will be updated, and we will meet with emergency responders to clarify notification protocols and to encourage them to develop road closure and evacuation plans.

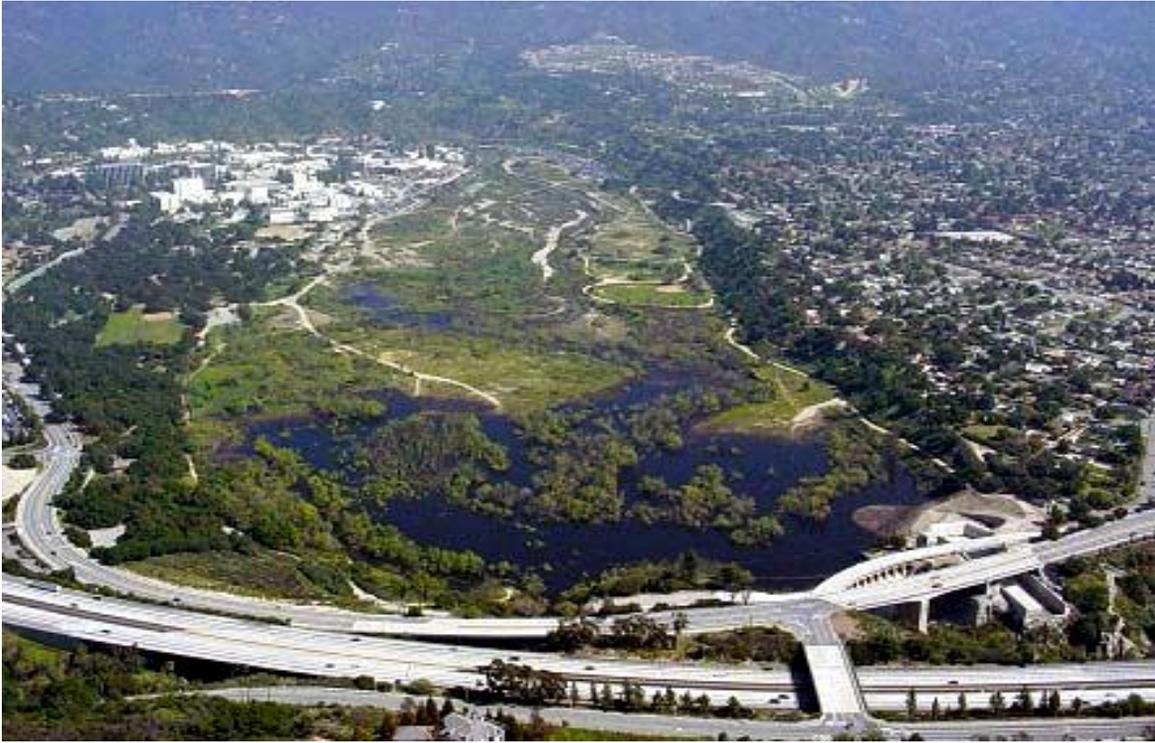
A-1 Pre-Station Fire

As a result of this sudden sediment accumulation, the reservoir storage capacity has been significantly reduced (See Attachments A-1 and A-2). Additionally, the outlet valve is plugged and inoperable. During the March 4, 2011, storm, we attempted to utilize the sluice gate during storm operations, but it quickly became partially plugged and we could not close it until maintenance crews cleaned the trashrack around the sluice gate (See Attachments A-3 and A-4). The top of the sluice gate trashrack is at elevation 1,010 feet. When debris exceeds this level, the trashrack will plug and the sluice gate will be inoperable. The operability of the sluice gate is crucial as it is the only outlet that has the ability to drain the reservoir for maintenance, inspection, and emergencies. The outlet tunnel invert is at elevation 1,007 feet behind a trashrack. The top of this trashrack is at elevation 1,025 feet. When sediment reaches this elevation, the gates will be inoperable. The current sediment elevation is at 1,010 feet and could inundate the sluice gate during the next storm. Additionally, the recent 2010 DSOD inspection report recommends the silt and sediment buildup in the reservoir be removed.

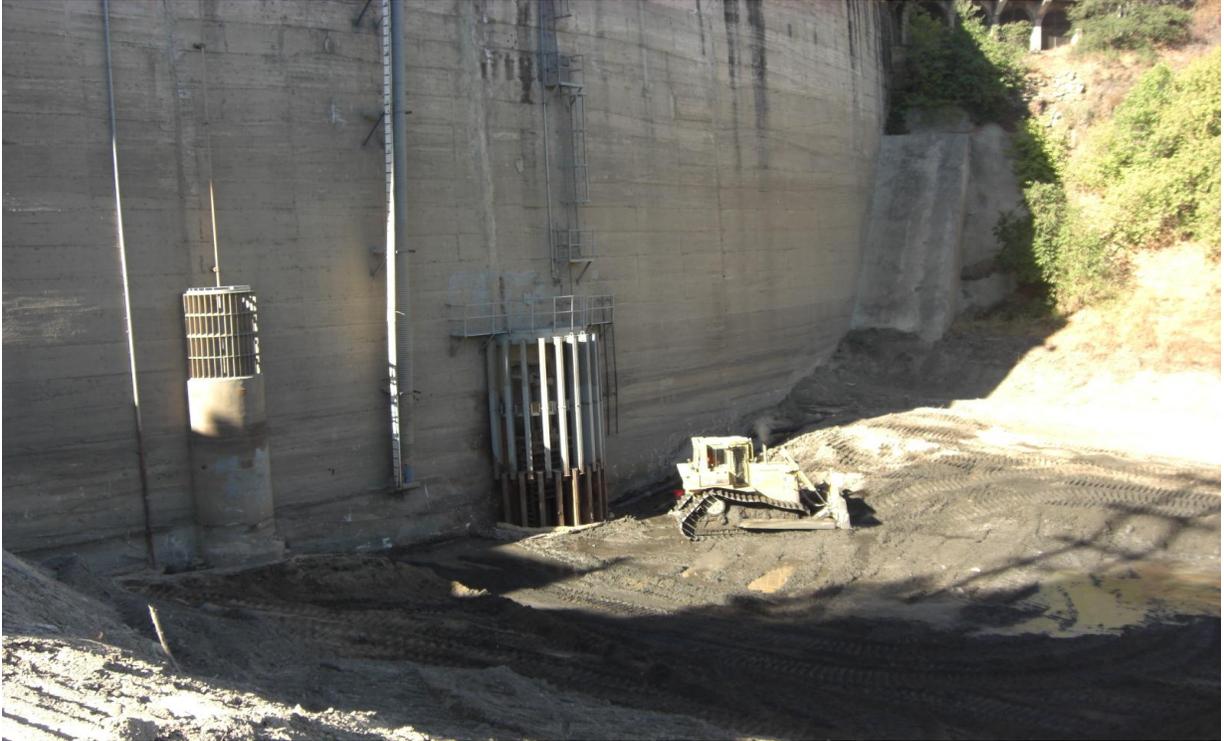
A-3 Intake Structures Cleared Pre-Station Fire

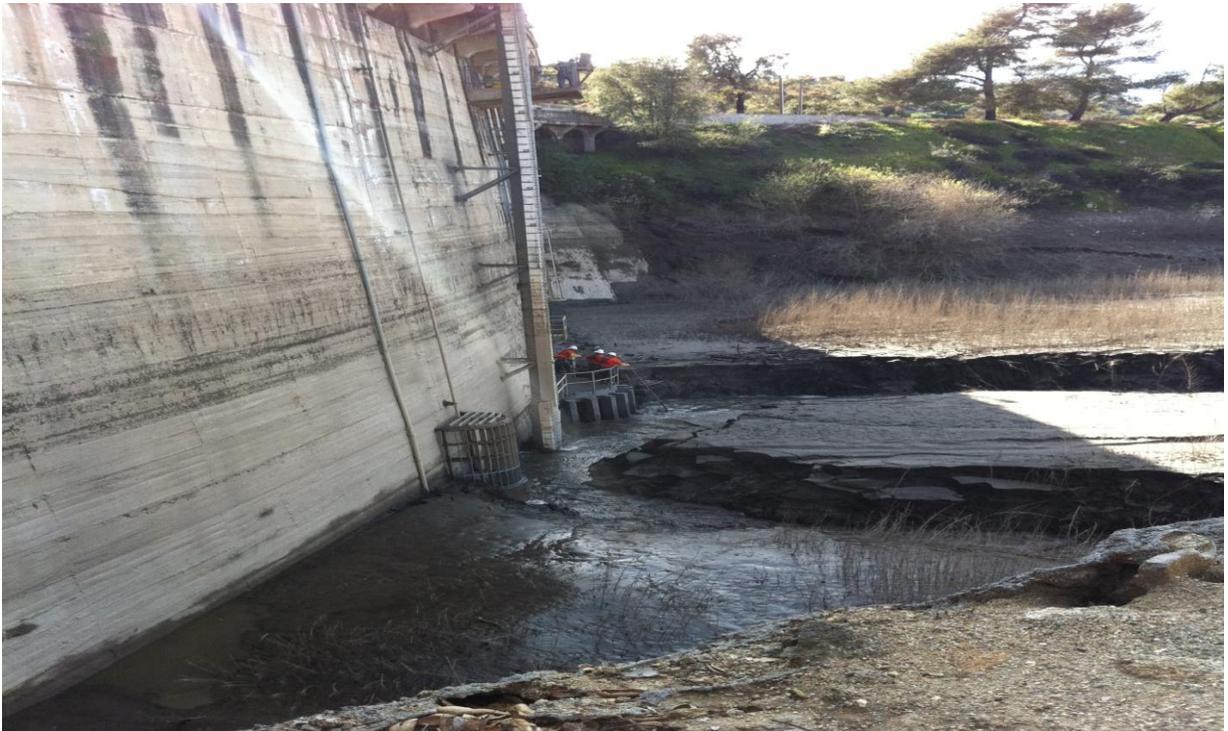
This sudden sediment accumulation buried one of the dam's outlet gates and now threatens to block the other outlets and spillway ports. Additionally, the sediment has reduced the reservoir's volume, and it no longer has capacity to safely contain another major debris event.

A-4 Sediment Threatening Sluice Gate Post-Station Fire

1. Modify the existing sluice gate trashrack to reduce the bar opening width and help to keep large debris from breaching the protection of the trashrack. This measure is aimed to reduce damage and/or interference with the sluice gate’s operation. The estimated cost is \$100,000.
2. Extend the existing sluice gate trashrack by approximately 32 feet up to the spillway port holes at an elevation of 1,040.5 feet. This measure is aimed to alleviate a potential scenario where the sluice gate trashrack becomes completely clogged by debris or sediment, and the District has no other means to drain the reservoir. The estimated cost is \$500,000.
3. Install 200 feet of new catwalk on the upstream face of the spillway approximately 10 feet above the top elevation of the spillway port

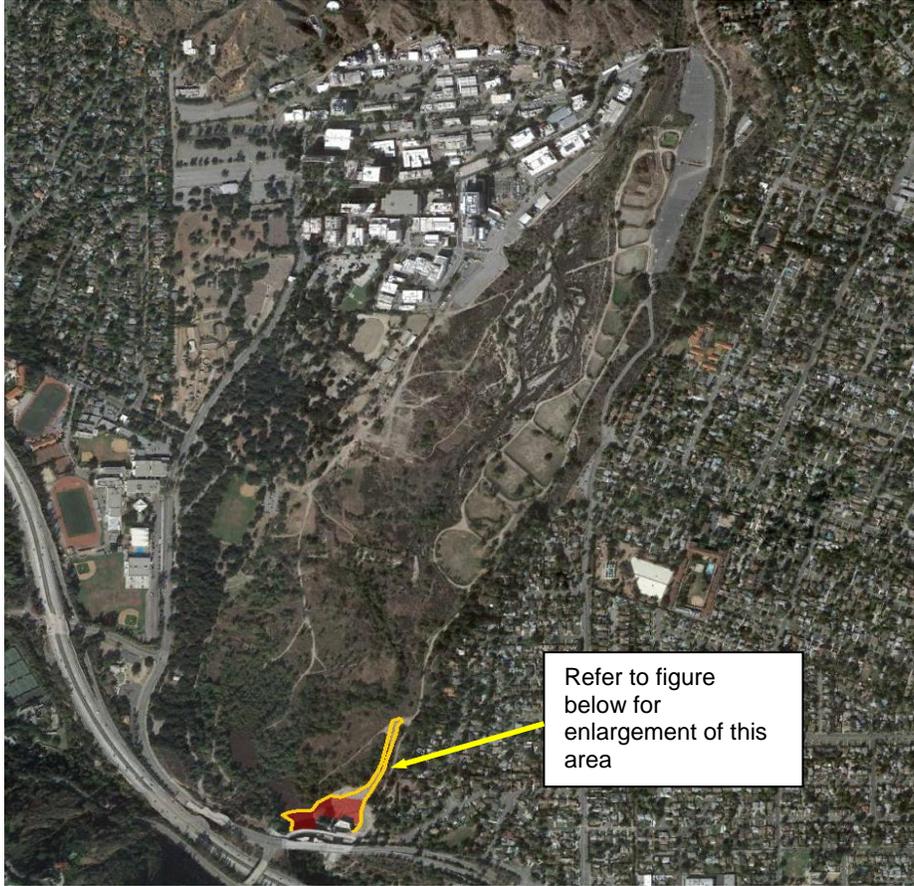
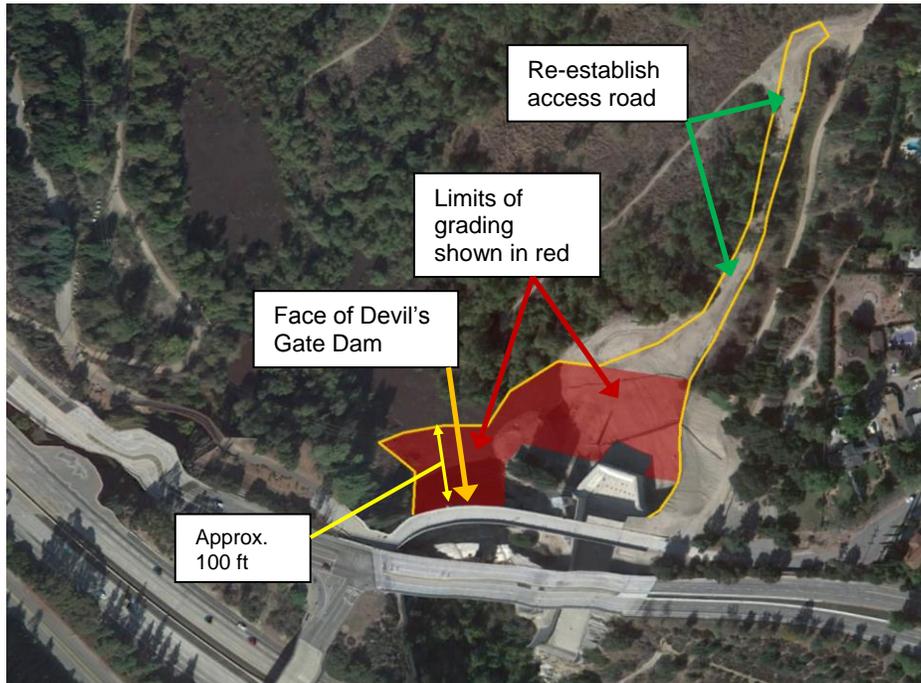
A-5 Boundary limits for interim measures  
No vegetation will be removed

4. Clear an estimated 25,000 CY of sediment from an area approximately 100 feet upstream of the dam to minimize clogging and/or other impacts to dam operations prior to each storm season and haul the material to Scholl landfill at an estimated annual cost for labor, equipment, and dump fees of \$750,000 (\$30 per CY). This amount is the estimated volume expected to migrate to the face of the dam even though a buffer pool will be maintained. It will be removed without impacting existing willow trees by positioning a crane on the crest of the dam to “clamshell” wet debris and sediment accumulation from in front of the sluice gate when the reservoir is drained at the end of each storm season. This would result in approximately 150 to 200 truck trips per day for four weeks, which is not expected to disrupt traffic in the area. Removal of the initial 25,000 CY is critical to the completion of all remaining measures. The limits of sediment removal are shown on Attachment A-5.

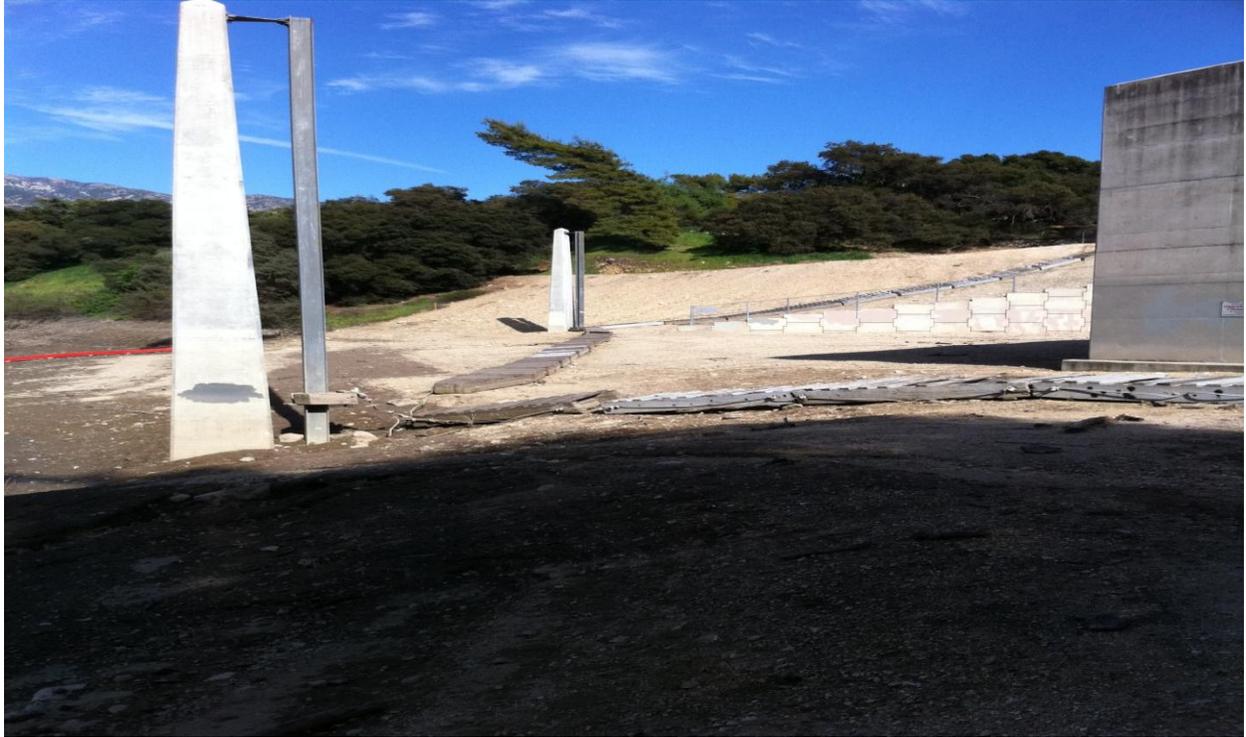
A-6 Wooden Boom Logs

1. Regrade the access road from the left abutment of the dam down to the sluice gate area in front of the dam. This measure will provide maintenance crews access to the reservoir invert area in front of the dam to perform required maintenance activities. The estimated cost is \$30,000.
2. Replace the existing wooden boom logs (wood plank and frame – See Attachment A-6) that are deployed upstream of the dam to trap floating debris. The wooden logs are more than 50 years old and

many are now dilapidated. In addition, the wood logs become very heavy and extremely difficult to handle when water-logged. This measure will replace the wooden logs with modern foam/plastic boom logs that are equipped with a short chain “skirt” hanging below the water surface in order to retain the floating debris more efficiently. The estimated cost is \$40,000.
