August 30, 2019

**Subject:** Status Report for the Oak Woodland Habitat Revegetation/Mitigation Program for the Santa Anita Dam Riser Modification and Reservoir Sediment Removal Project, Los Angeles County, California

**ATTACHMENT A**  
**SITE PHOTOGRAPHS**

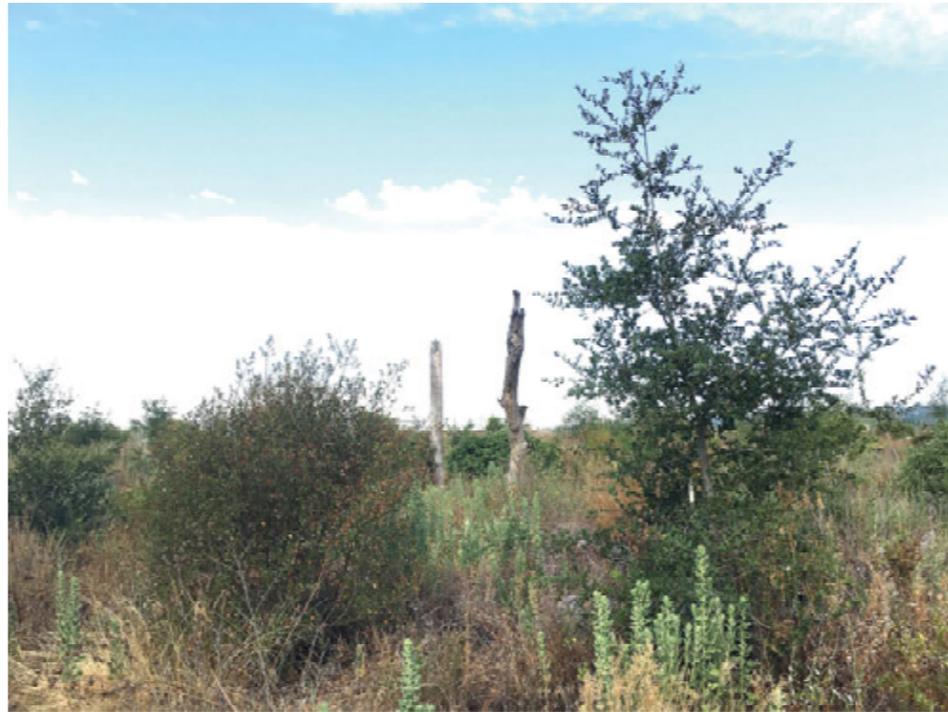
**August 2019.** A planted coast live oak sapling exhibits robust growth, amid native shrubs and perennials with normal/varying degrees of drought-dormancy. Acorn woodpeckers nested in the placed natural snags (background of photo) for multiple years since they were placed on the site in 2013.

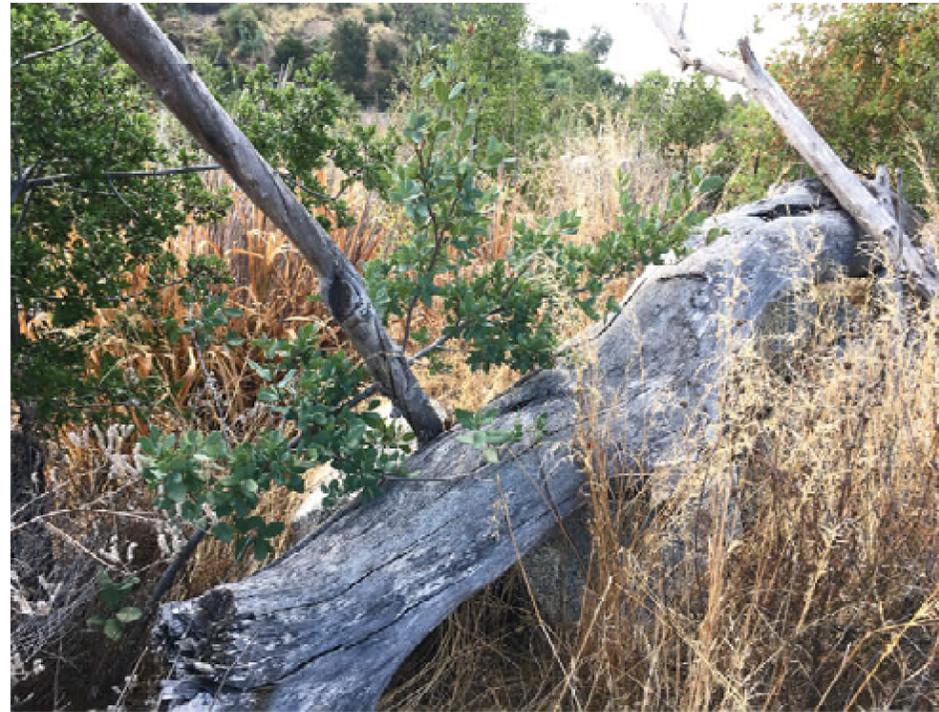
**August 2019.** An Engelmann oak sapling is growing alongside placed coarse woody debris. There is an understory of multiple species of native perennial bunchgrasses and native broadleaf herbs.

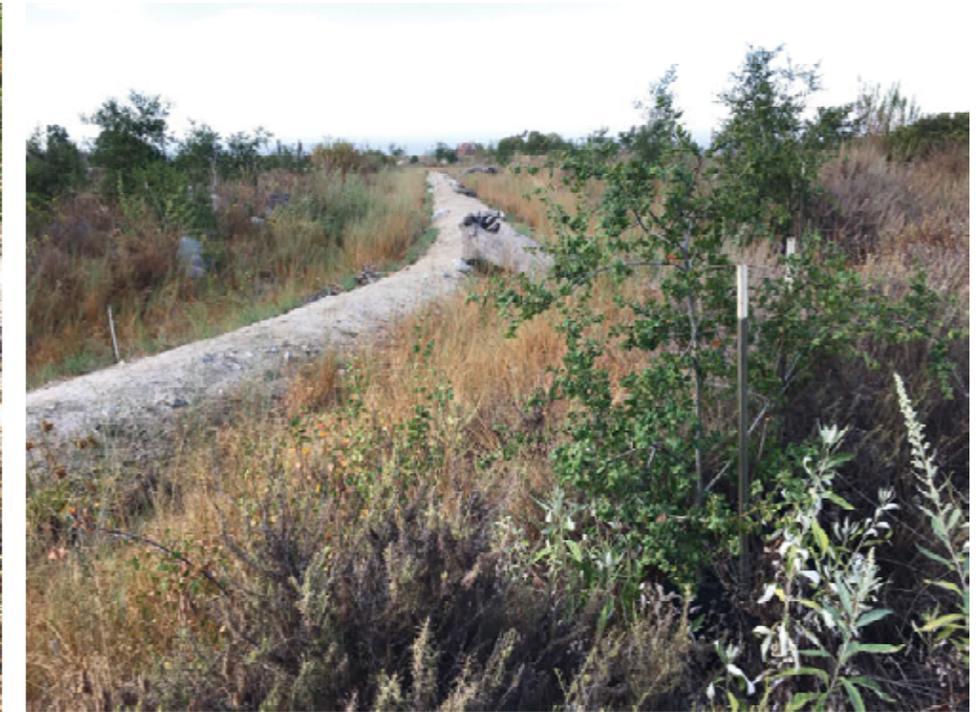
**August 2019.** The canopies of the maturing planted oaks will eventually extend over the naturalistic, spiraling drainages that traverse the site. A diversity of planted/seeded riparian herbs occur within the drainages.

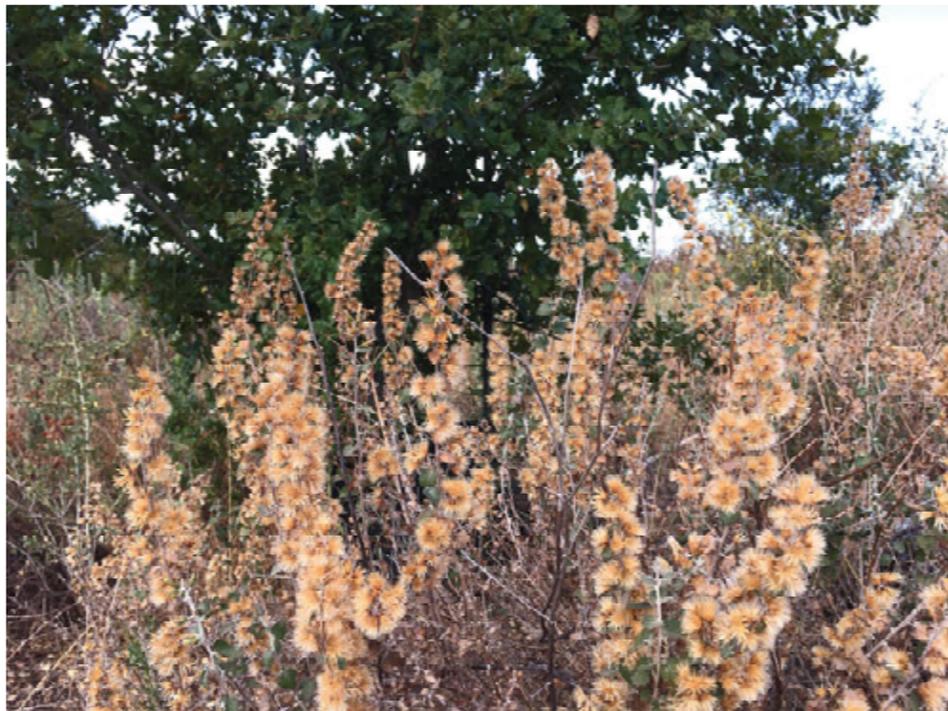
**August 2019.** There are abundant seeds on this California brickellbush--a native shrub that was established via seeding. In the background is a healthy planted coast live oak sapling.

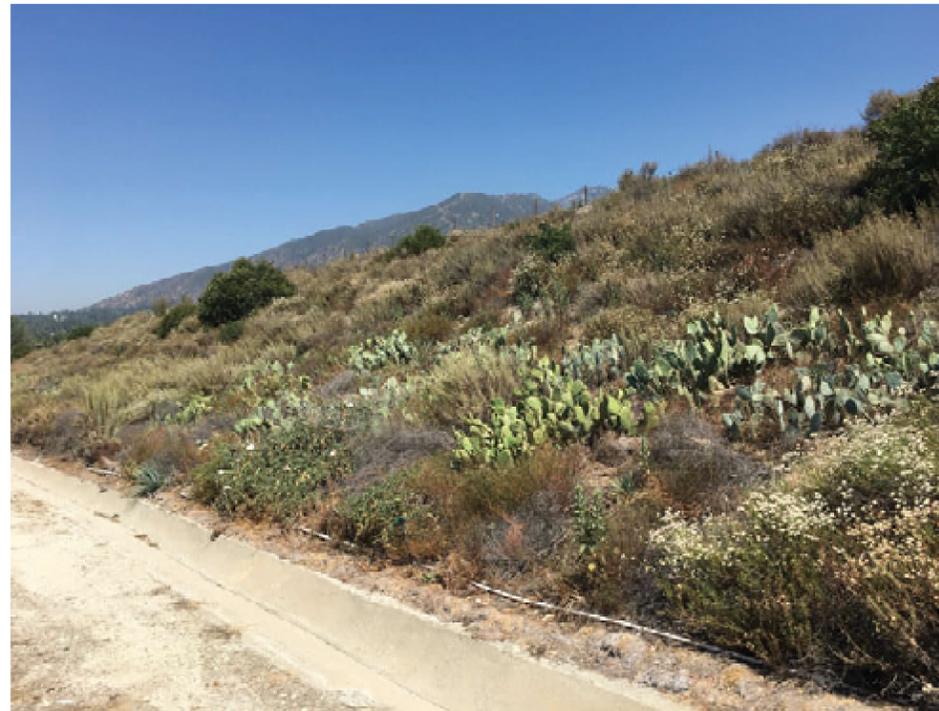
**July 2019.** The coastal sage scrub mitigation site includes areas that were planted with spiniferous species (cactus and yucca) to improve vegetative diversity. The Restoration Contractor (Nakae & Associates, Inc.) regularly removes sediment and debris from the concrete drainages on the Lower Sediment Placement Site (SPS).

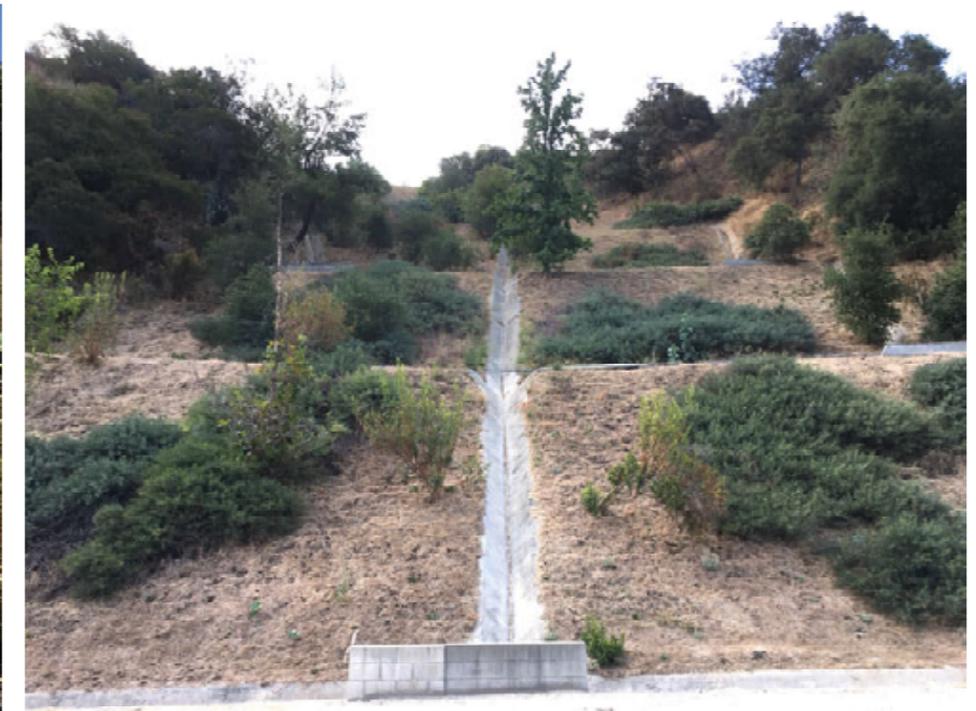
**August 2019.** Public Works recently initiated voluntary weed abatement in an additional area to the north of the Lower SPS, to reduce fire fuel and to eliminate a source of weed seeds adjacent to the mitigation site.
