Subject: Status Report for the Oak Woodland Habitat Revegetation/Mitigation Program for the Santa Anita Dam Riser Modification and Reservoir Sediment Removal Project, Los Angeles County, California

Status Report: Oak Woodland Habitat Revegetation/Mitigation Program;
 Santa Anita Dam Riser Modification and Reservoir Sediment Removal Project

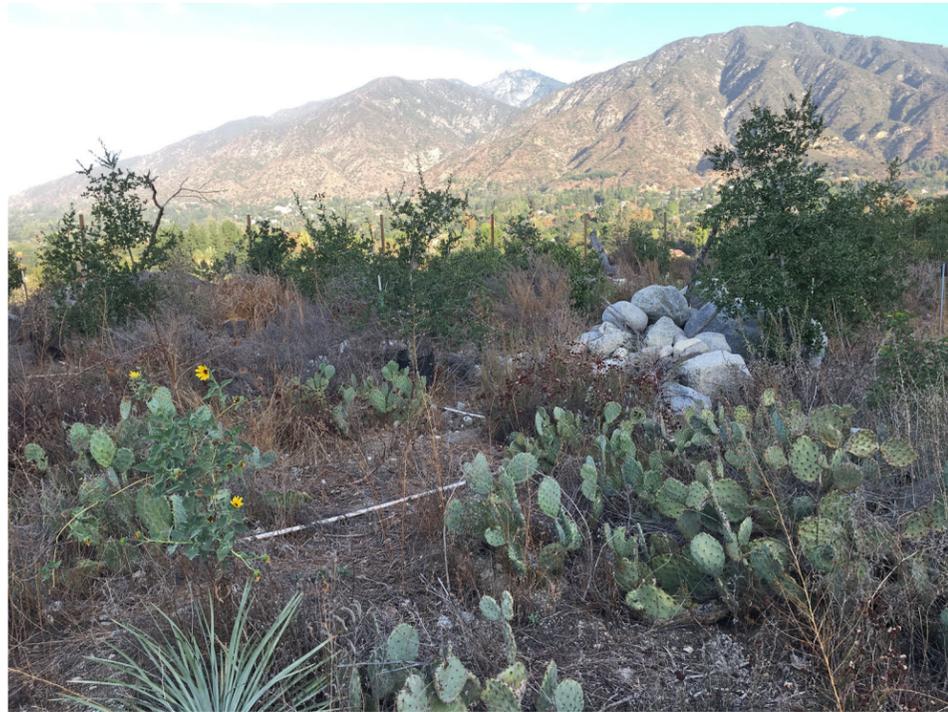
November 2019. Healthy planted coast live oak saplings on the deck of the Lower Sediment Placement Site. The planted/seeded vegetative understory includes spiniferous species (e.g., Vasey's prickly pear; chaparral yucca) on portions of the mitigation site.

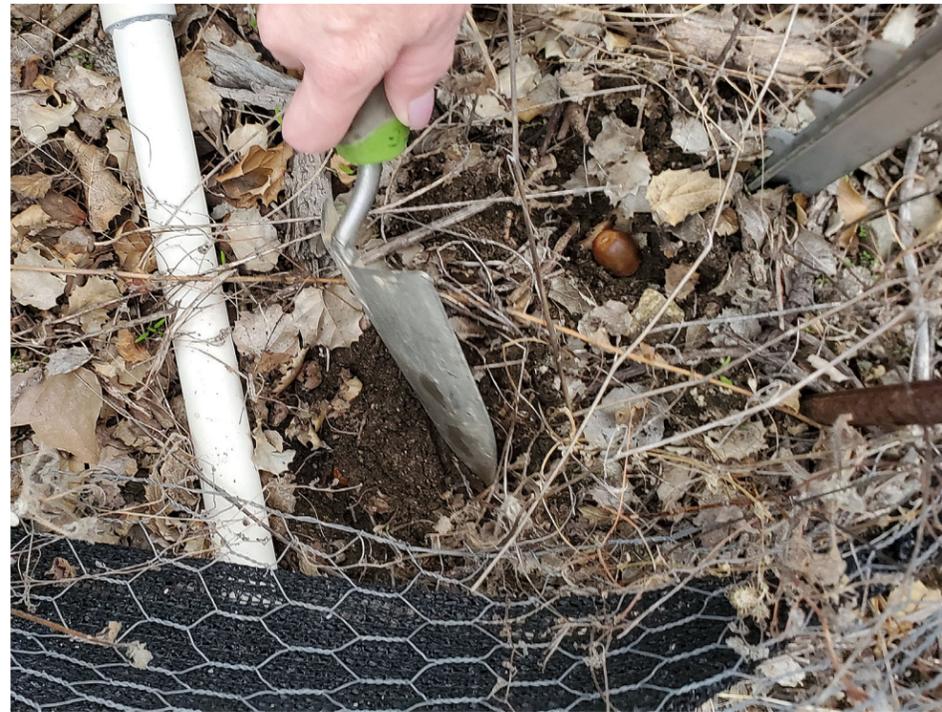
December 2019. Psomas' Restoration Ecologist is installing supplemental acorns of Engelmann oak. Psomas collected the acorns within the local Santa Anita Wash – Rio Hondo subwatershed in October 2019.

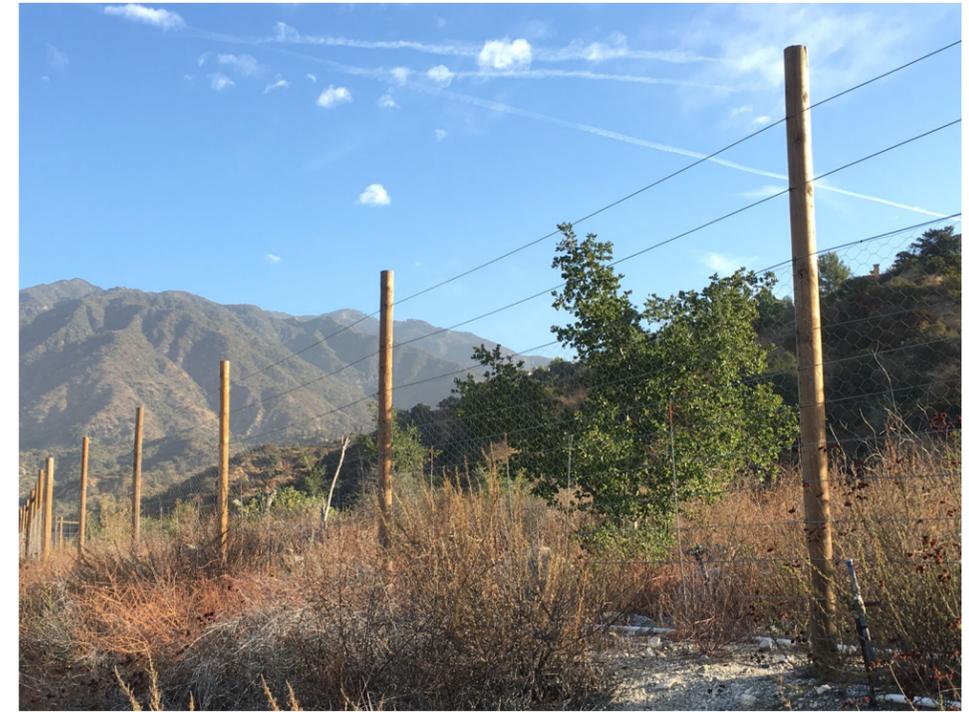
November 2019. There is well-established coastal sage scrub vegetation on the slopes (foreground), and a healthy planted coast live oak is visible behind the enclosure fence.

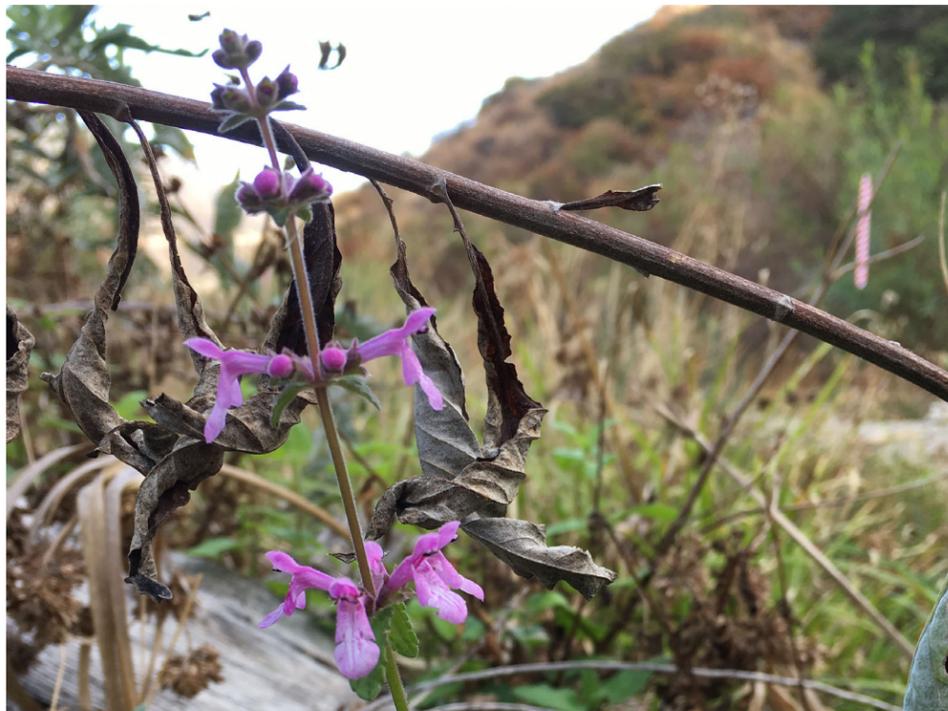
November 2019. A very late bloom was observed on this puckered hedge-nettle plant — a native perennial herb that was installed on the site in 2014.

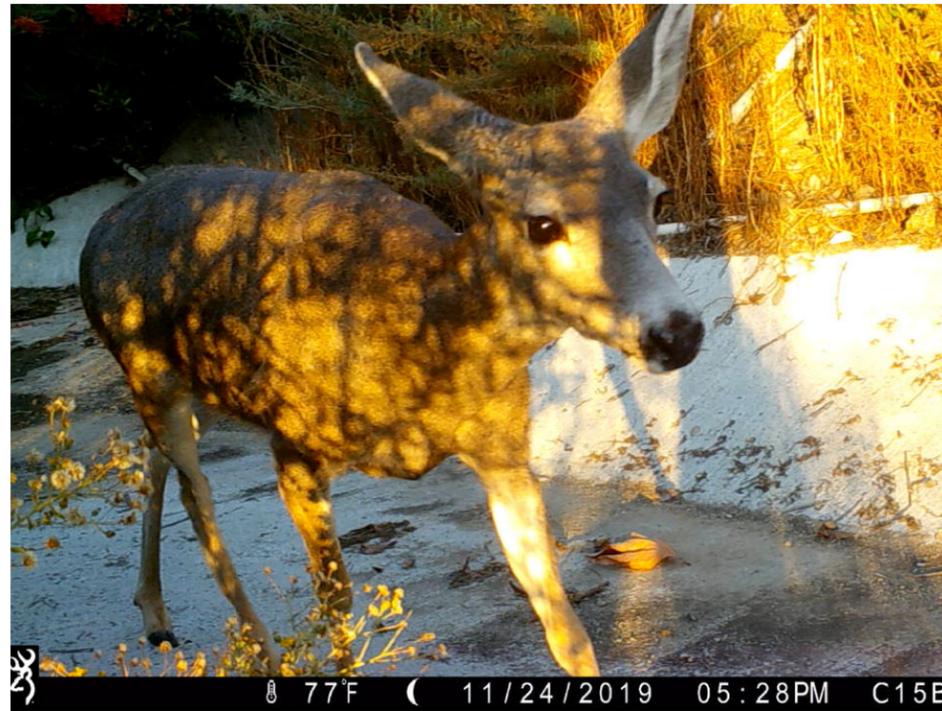
November 2019. A mule deer has been captured via one of several 'camera traps' that were placed at various locations on the Lower SPS. The enclosure fence continues to deter unwanted entry by deer to the oak woodland mitigation site at this stage of the maintenance period.

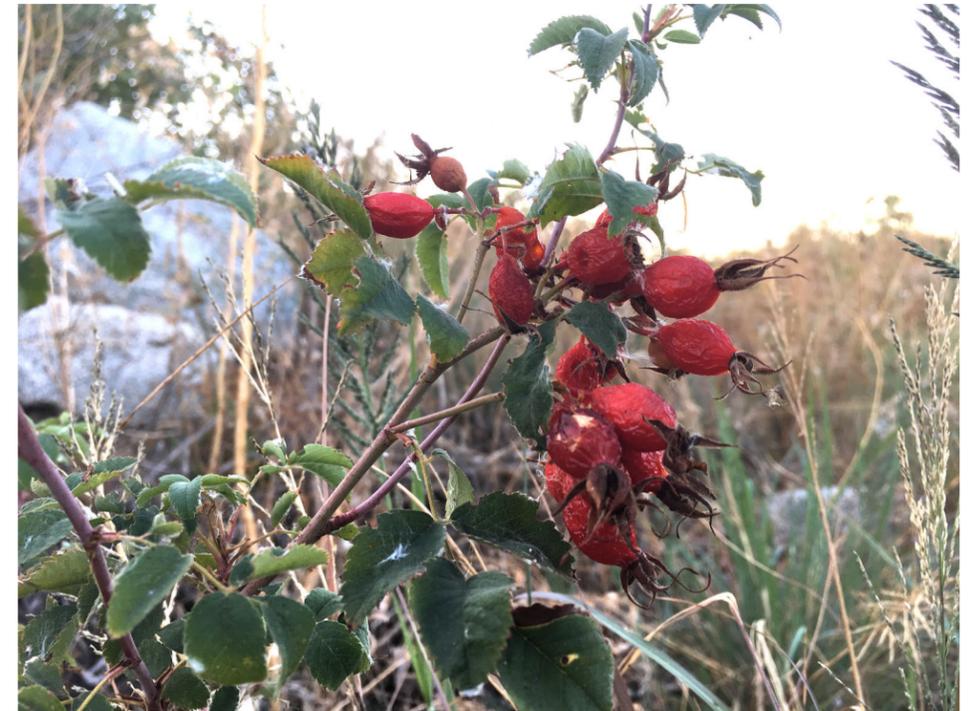
November 2019. There are ripening fruits on this planted California rose. This native shrub is among several plant species that were introduced to the site on a supplemental basis (i.e., not a part of the initial plant installations) to improve biological diversity.
