# Devil's Gate Reservoir Restoration Project Fourth Quarter Compliance Report Activities Occurring Between October 2022 and December 2022

March 2023

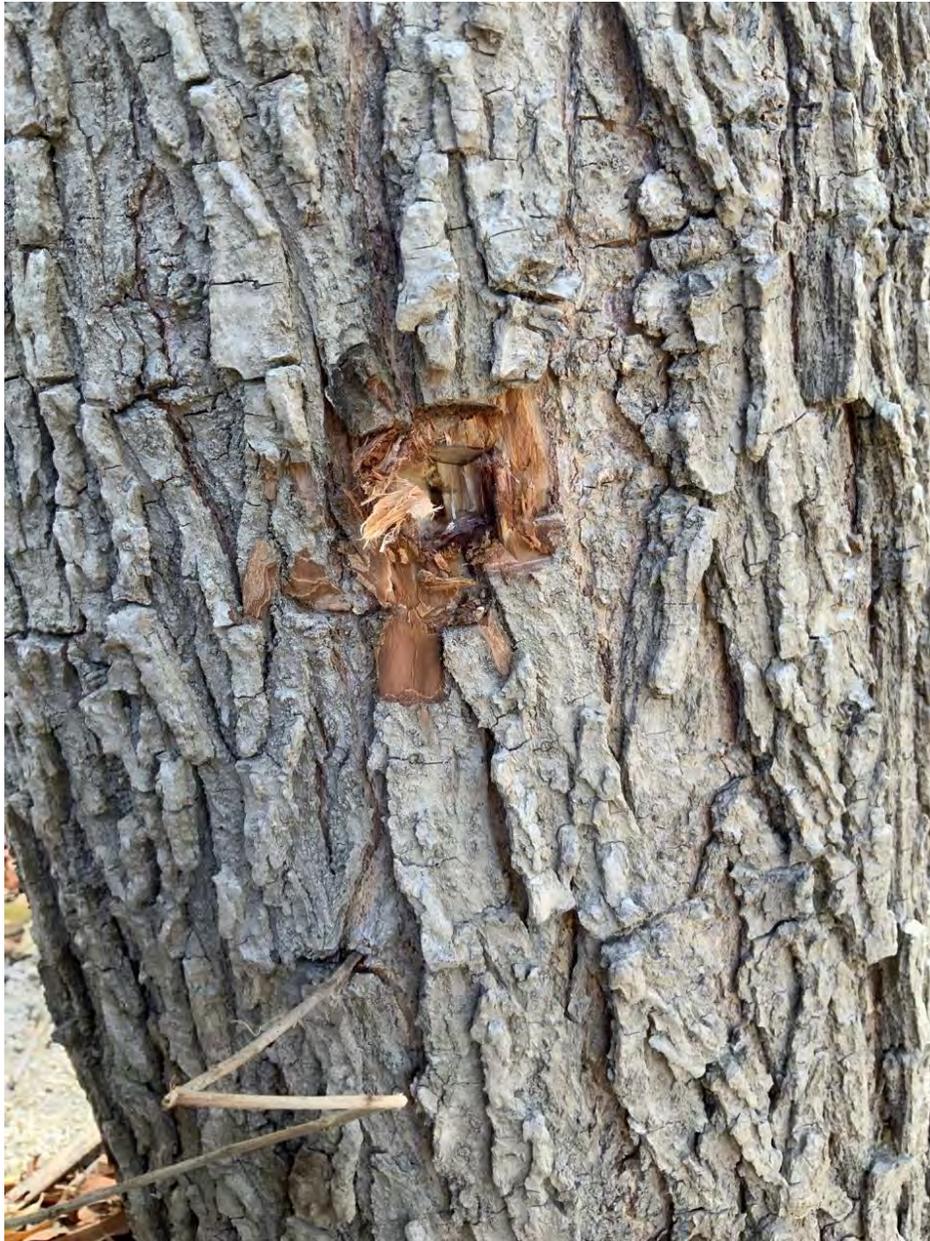
Photograph 1. This larger DBH black willow had a low ISHB infestation. It was found in the Black Willow Forest 1. A wood sample was taken and sent to the CDFA for analysis. The dark fusarium fungus can be seen in the tree's sapwood.

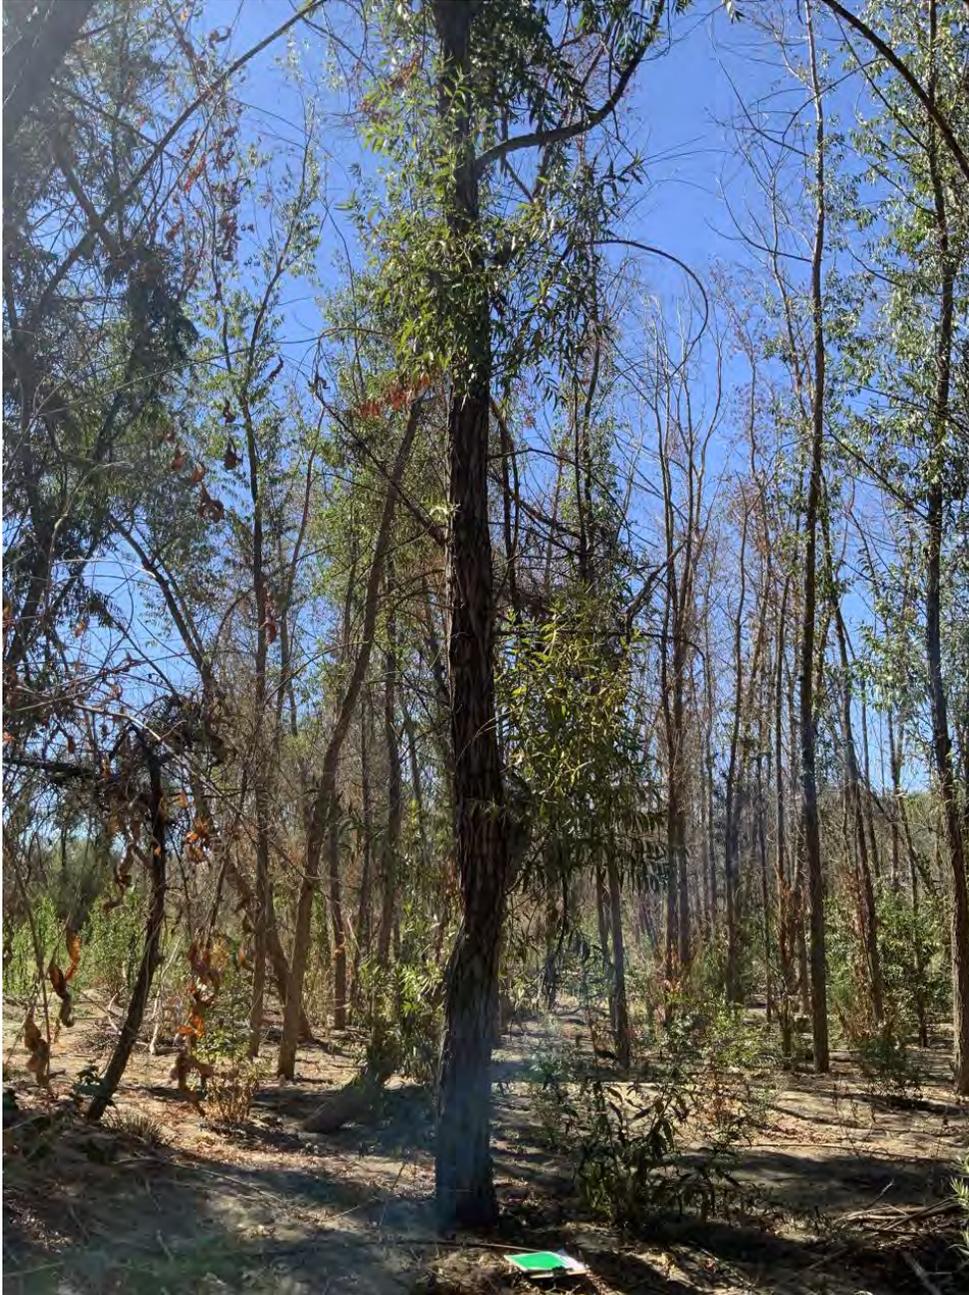
Photograph 2. View of the Black Willow Forest 1 looking north. Note numerous small, dead willows.

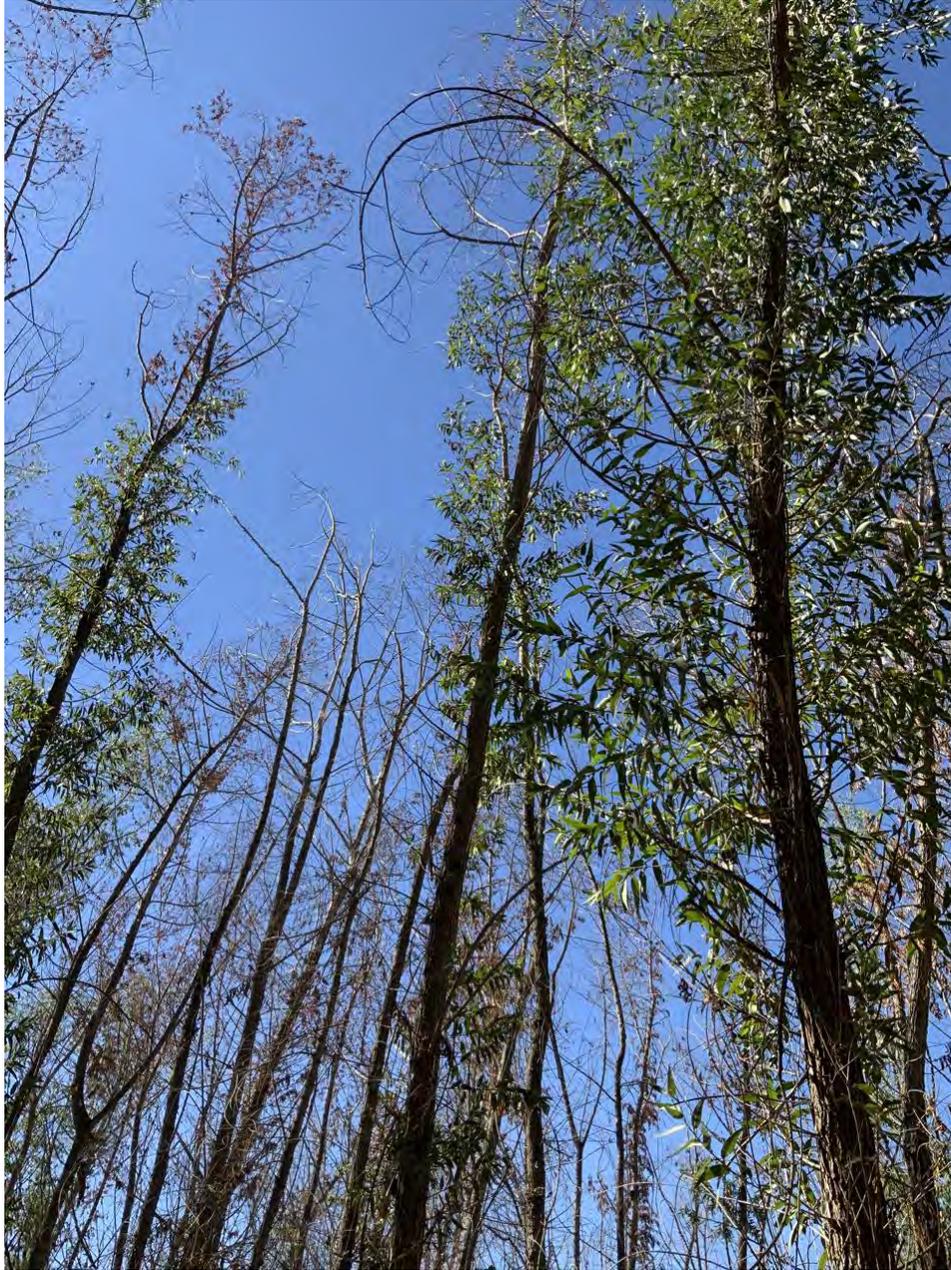
Photograph 3. View looking up into the canopy of the Black Willow Forest 1. Note numerous dead trees but also trees that experienced canopy dieback in the upper portions.

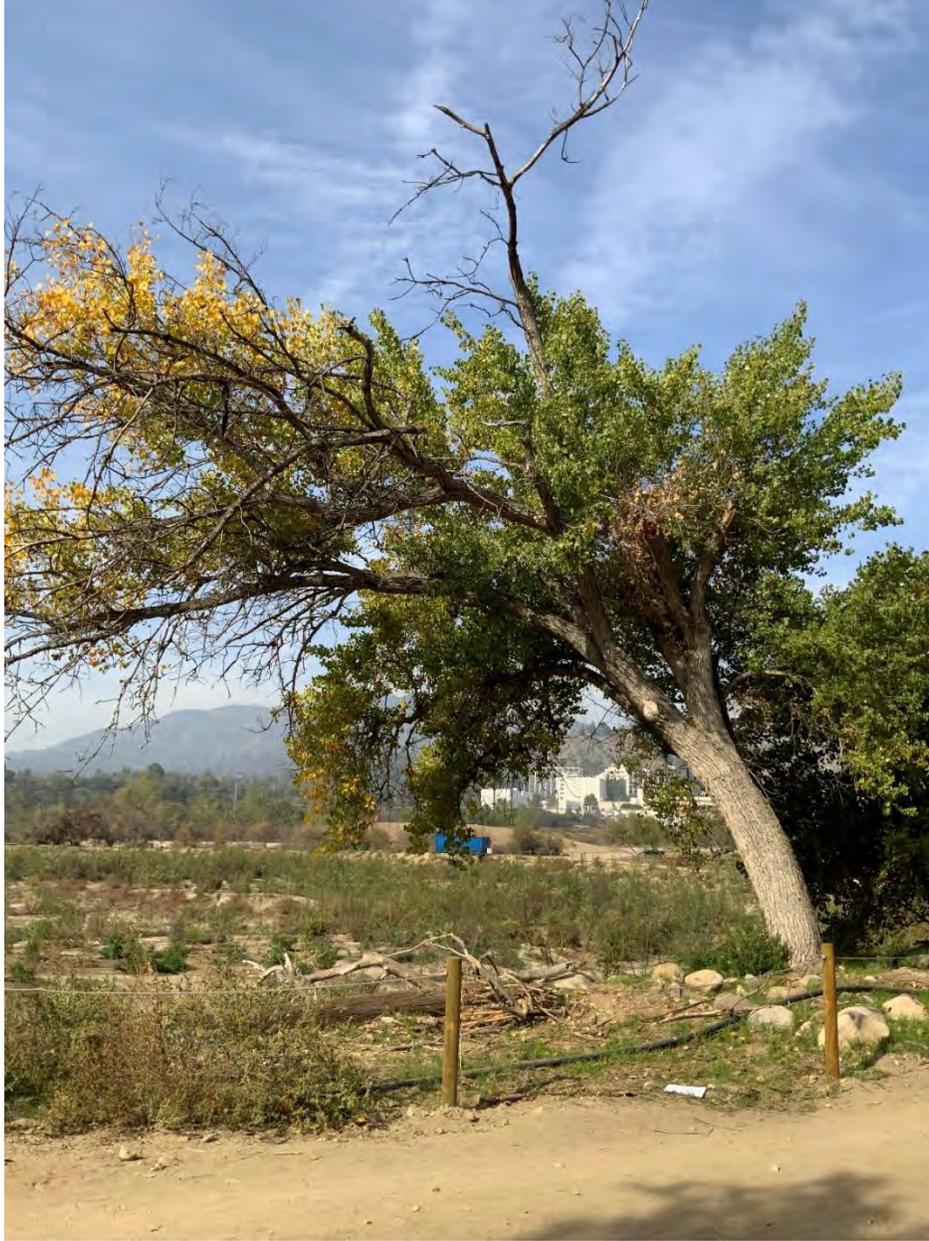
Photograph 4. This Fremont cottonwood experienced canopy dieback and limb loss due to a heavy ISHB infestation. Note large branches on the ground. The tree is now in recovery. Trimming off dead branches will help its recovery and help protect park users visiting this trail.

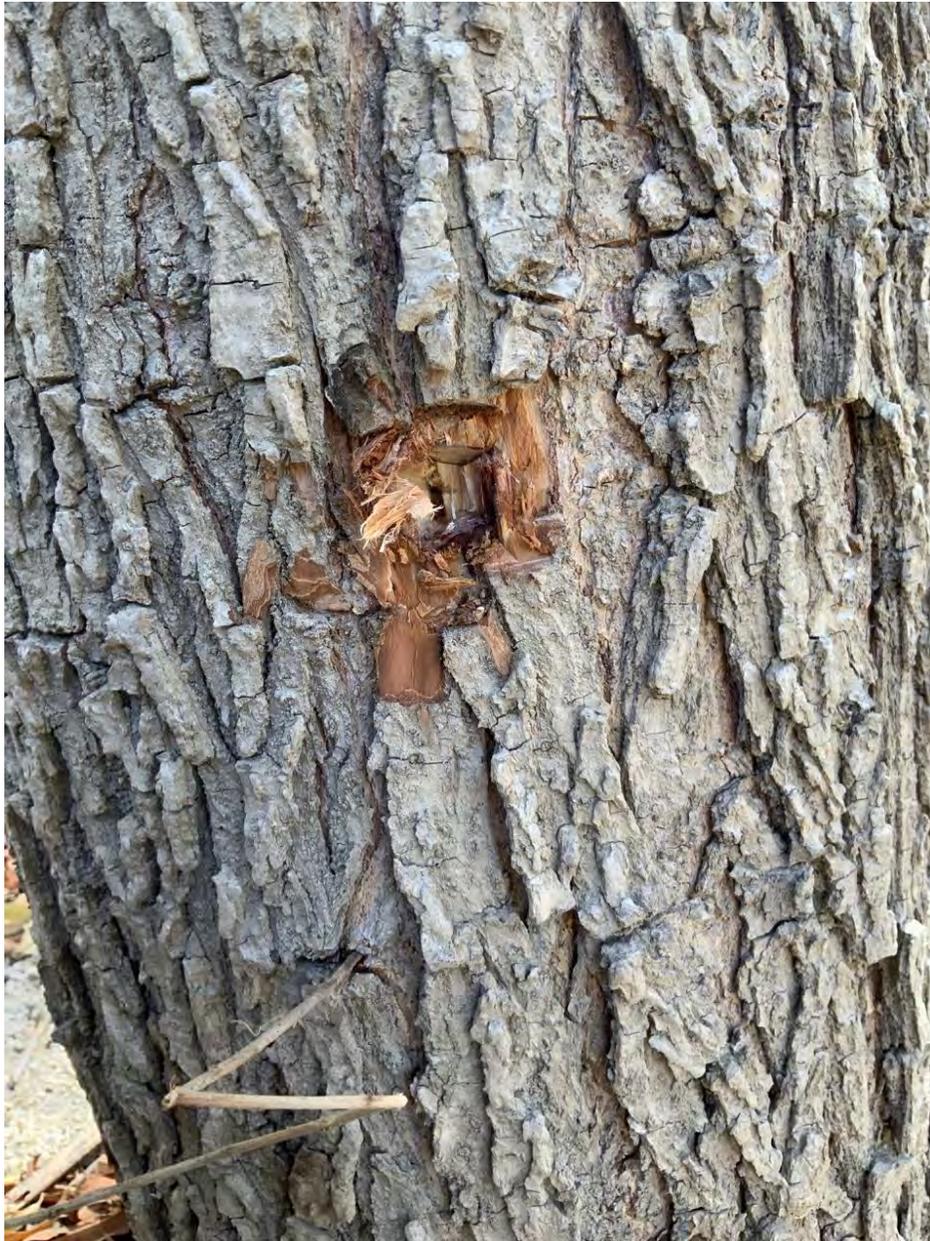
Photograph 1. This larger DBH black willow had a low ISHB infestation. It was found in the Black Willow Forest 1. A wood sample was taken and sent to the CDFA for analysis. The dark fusarium fungus can be seen in the tree's sapwood.

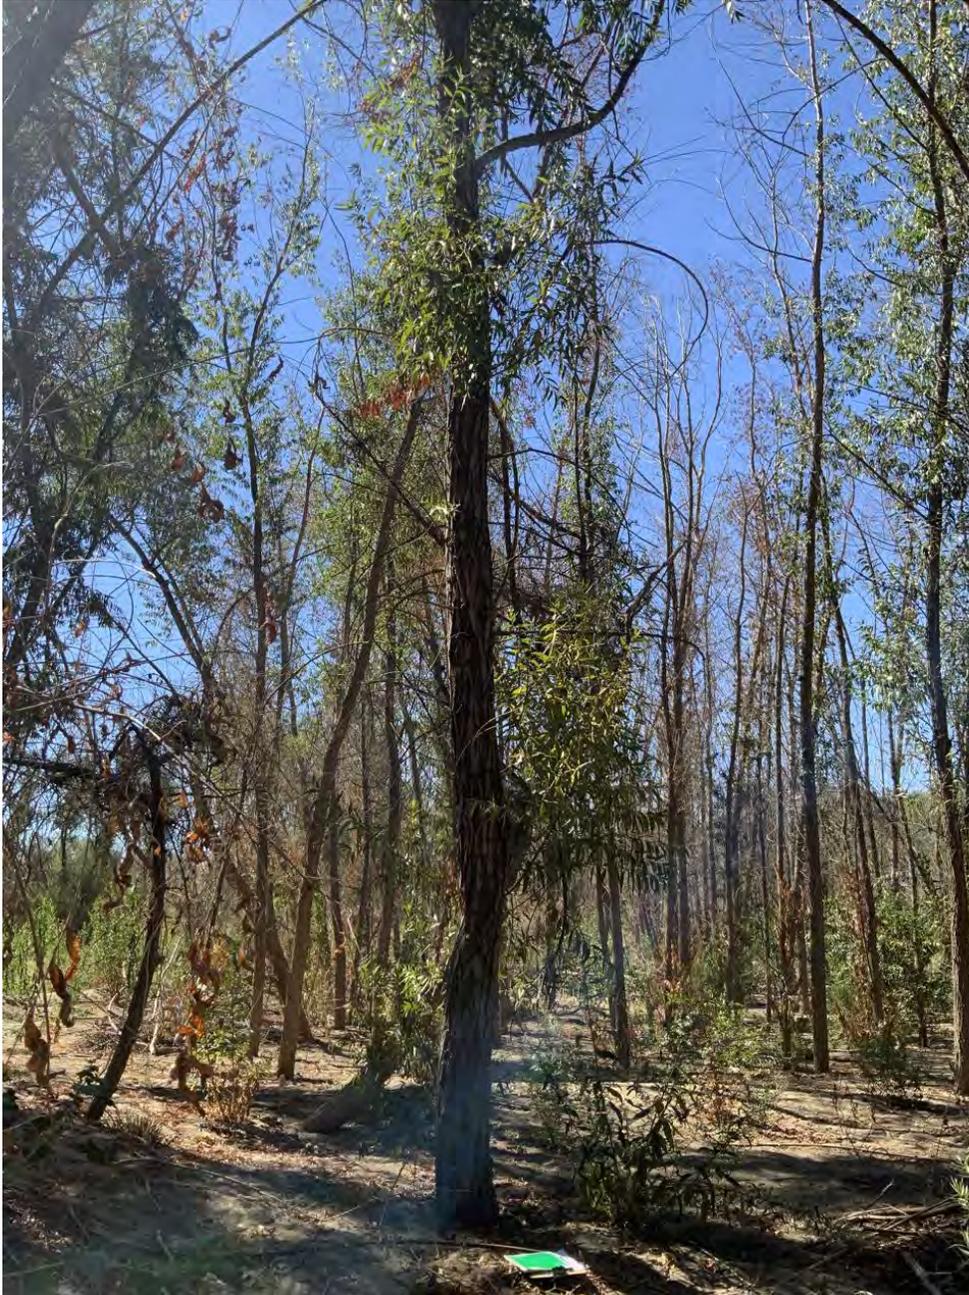
Photograph 2. View of the Black Willow Forest 1 looking north. Note numerous small, dead willows.

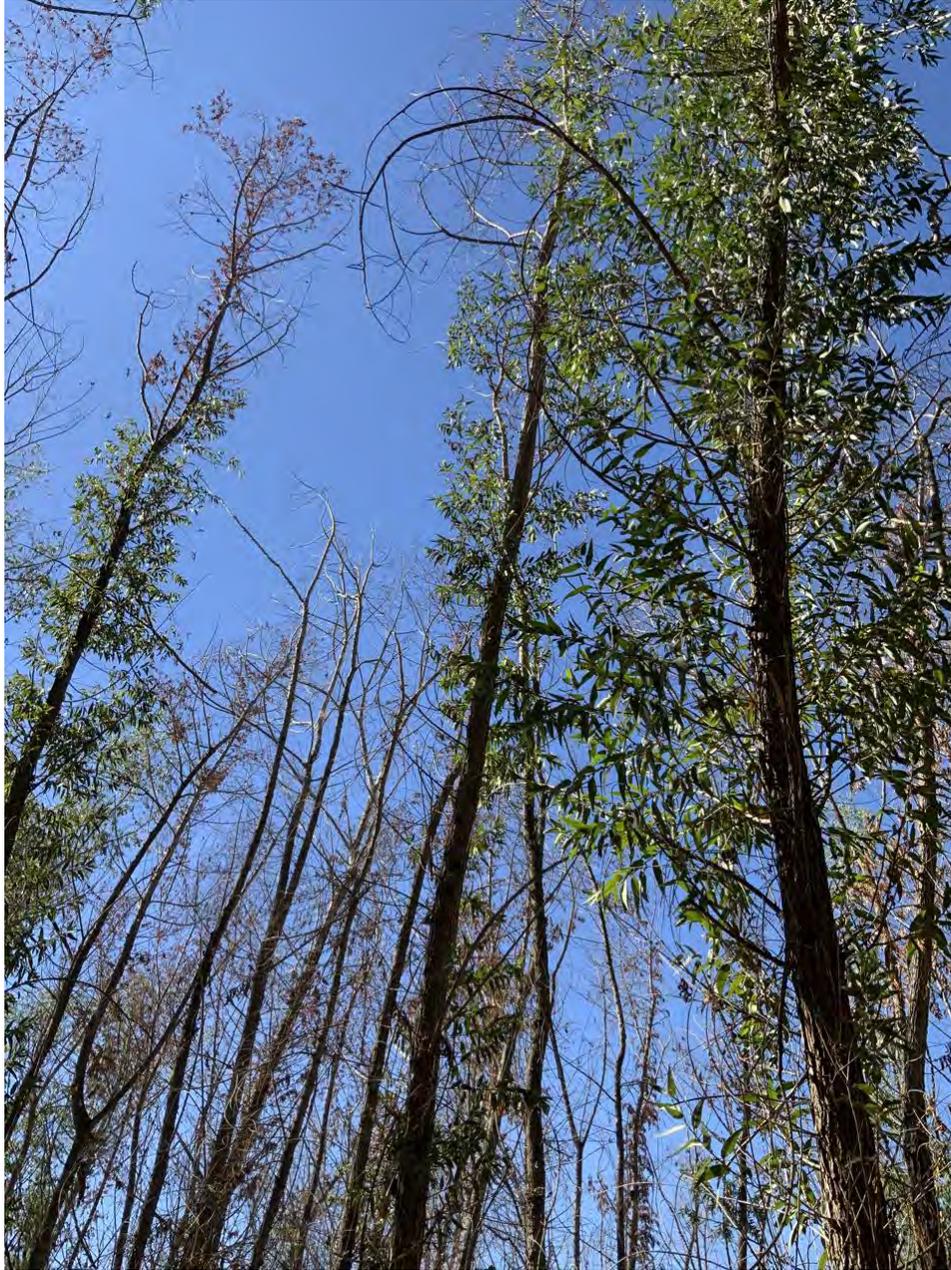
Photograph 3. View looking up into the canopy of the Black Willow Forest 1. Note numerous dead trees but also trees that experienced canopy dieback in the upper portions.

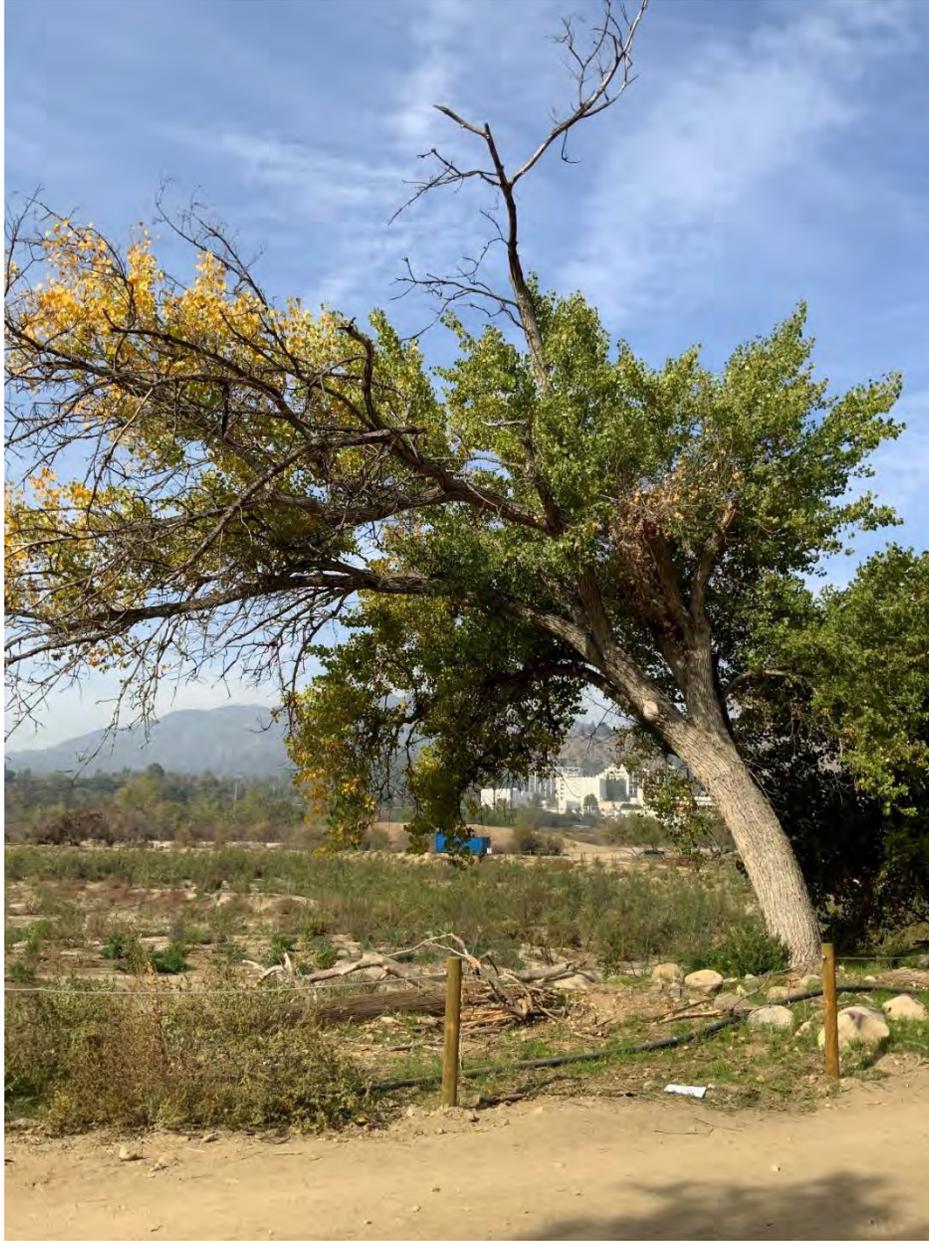
Photograph 4. This Fremont cottonwood experienced canopy dieback and limb loss due to a heavy ISHB infestation. Note large branches on the ground. The tree is now in recovery. Trimming off dead branches will help its recovery and help protect park users visiting this trail.
