January 3, 2025  
(2023-005.07)

**Re: *Devil's Gate Reservoir Restoration Project – Phase 3 Restoration Qualitative Monitoring Conducted on December 11, 2024***

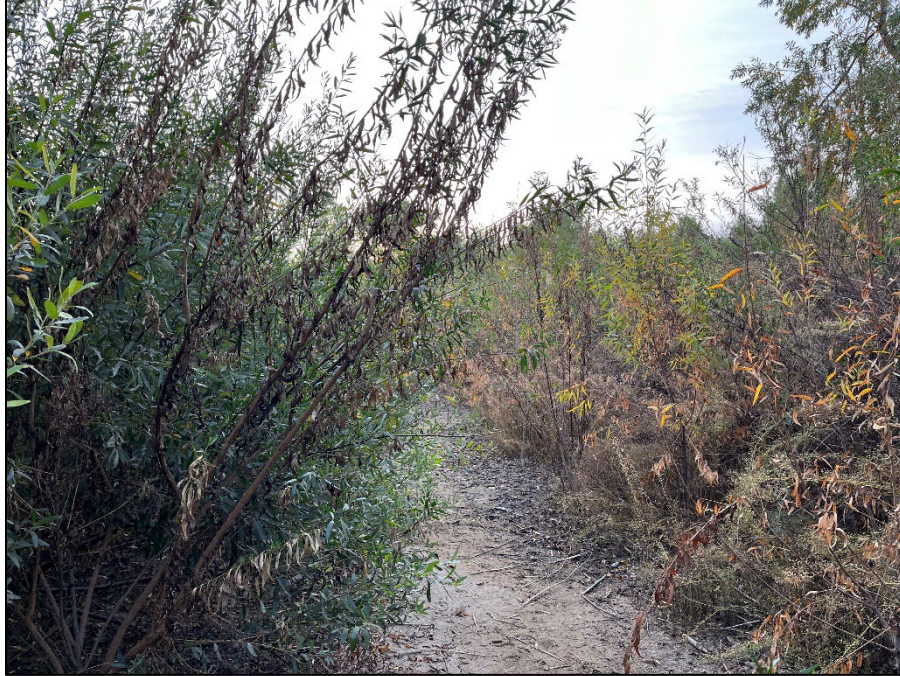
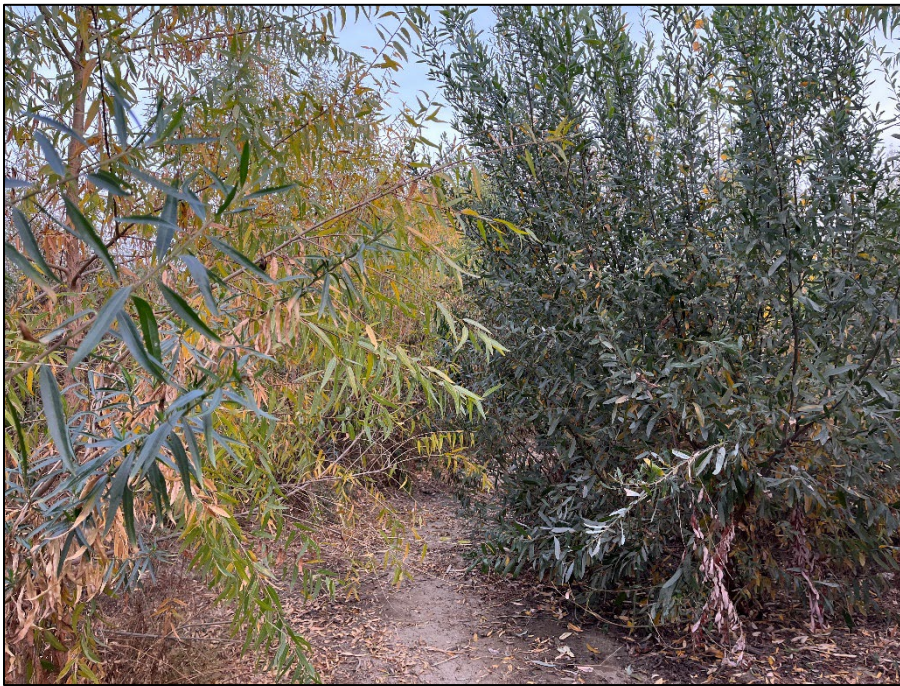
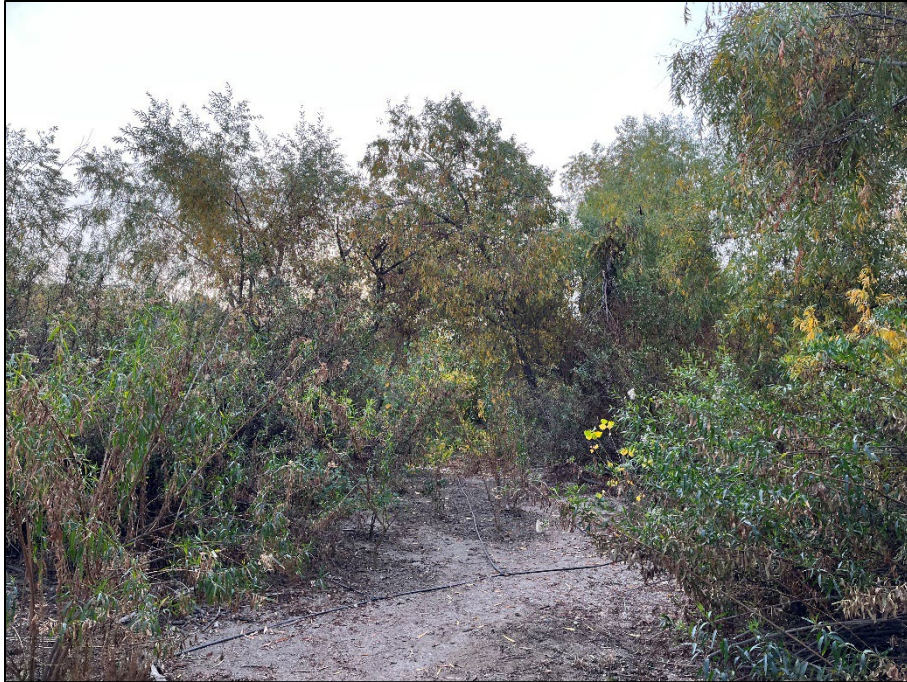
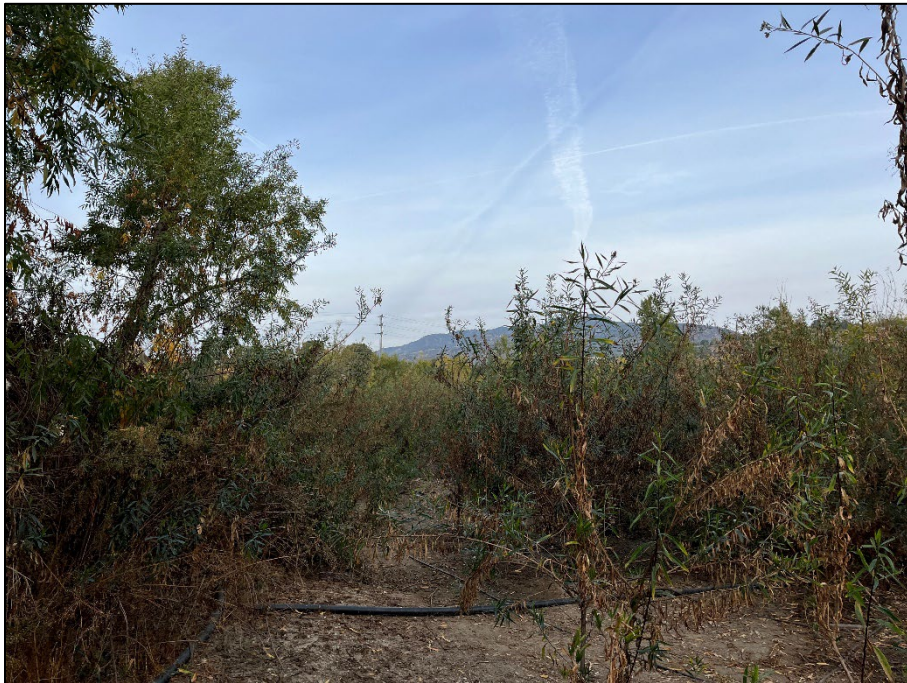
The overall health of the container plants in DG-4 WOUS and DG-4 WOUS Connections was noted as being good. Approximately less than 5 percent of the container plants and stakes in DG-4 WOUS and DG-4 WOUS Connections were noted as showing signs of stress and a negligible amount were noted as being dead or missing. This is slightly less than the percentage of plants that were showing stress during the previous monitoring visit. Stress may be occurring as a result of 1) transplant shock, 2) herbivory by rabbits or other wildlife, 3) competition from nonnative and invasive weeds, 4) misplaced emitters, or 5) recreational traffic through the mitigation areas. Photos 1 through 4 in Appendix B document the mitigation areas during the monitoring visit.

Photo 1. Overview DG-4 WOUS & WOUS Connections

Photo 2. Overview DG-4 WOUS & WOUS Connections

Photo 3. Overview DG-4 WOUS & WOUS Connections

Photo 4. Overview DG-4 WOUS & WOUS Connections

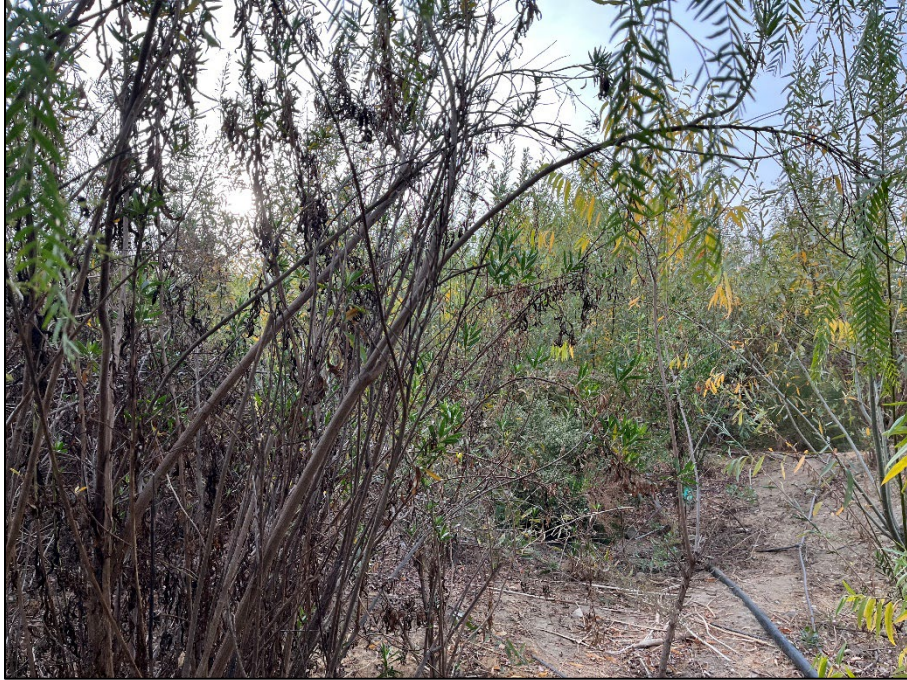
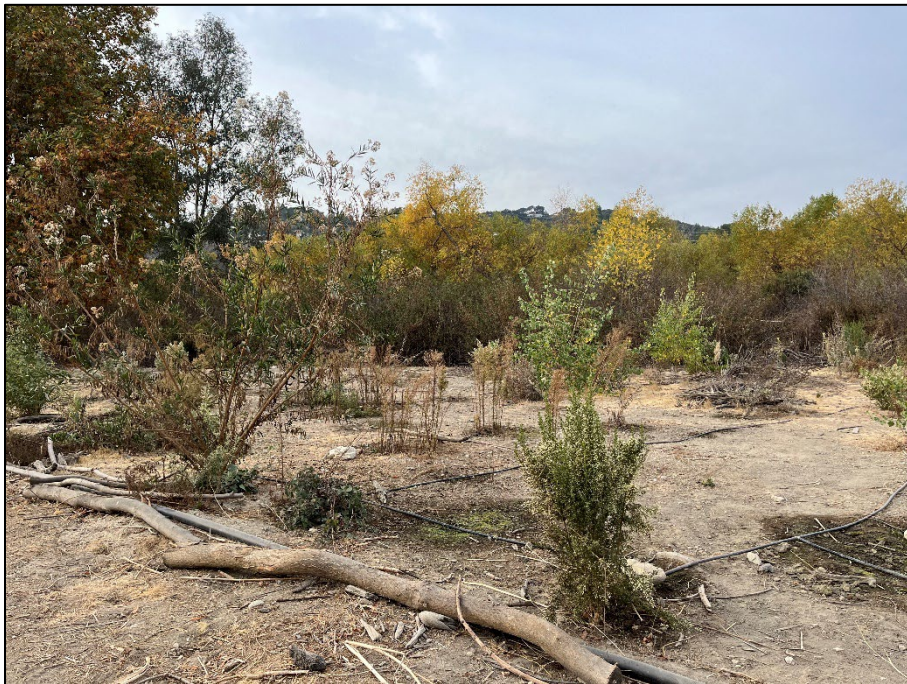
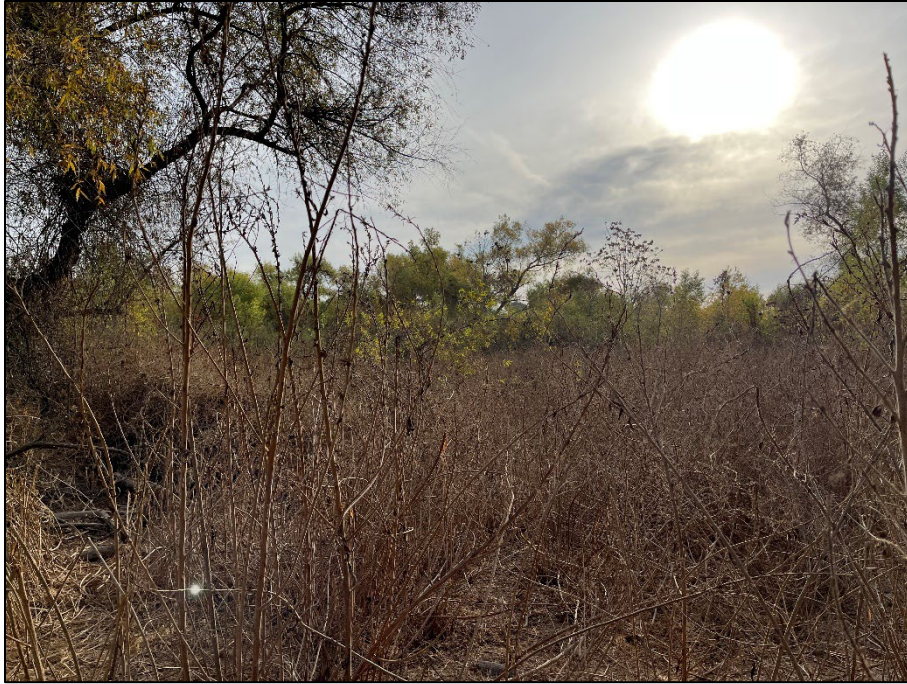
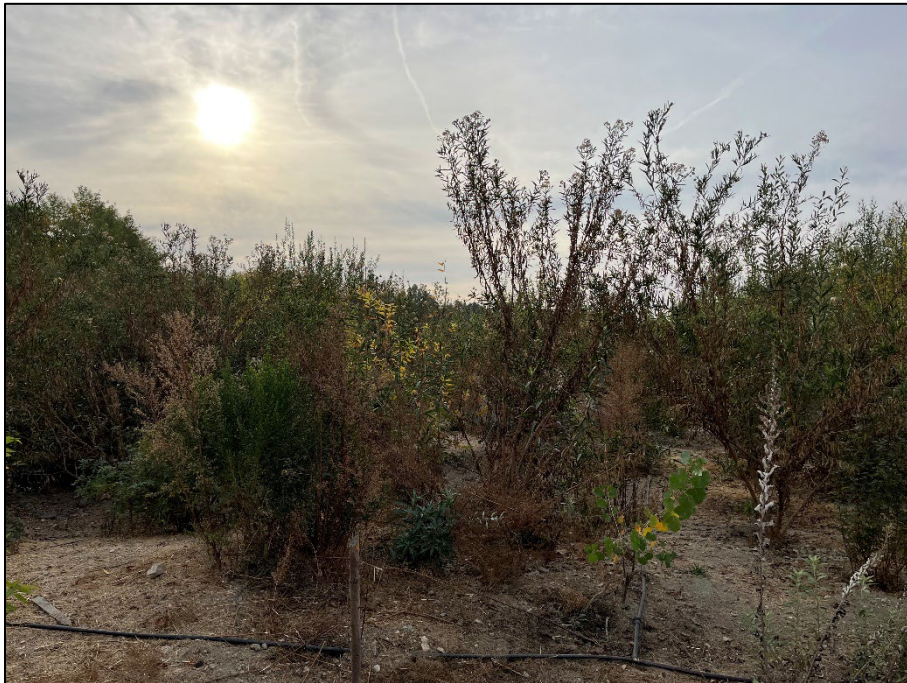
The overall health of the container plants in DG-4A was noted as being good and this mitigation area is becoming well established. Approximately 5 percent of the container plants and stakes in DG-4A were noted as showing signs of stress which is approximately the same percentage of plants were showing signs of stress during the previous monitoring visit. This included the remaining container plants from the first installation and the container plants that were installed to replace the container plants and stakes planted in the middle section of DG-4A that appeared to be dead or in a condition unlikely to recover during previous monitoring visits. Stress may be occurring due to similar reasons described for DG-4 WOUS and DG-4 WOUS Connections. Photos 5 through 8 in Appendix B document the mitigation area during the monitoring visit.

Photo 5. Overview DG-4A

Photo 6. Overview DG-4A

Photo 7: Overview DG-4A

Photo 8: Overview DG-4A

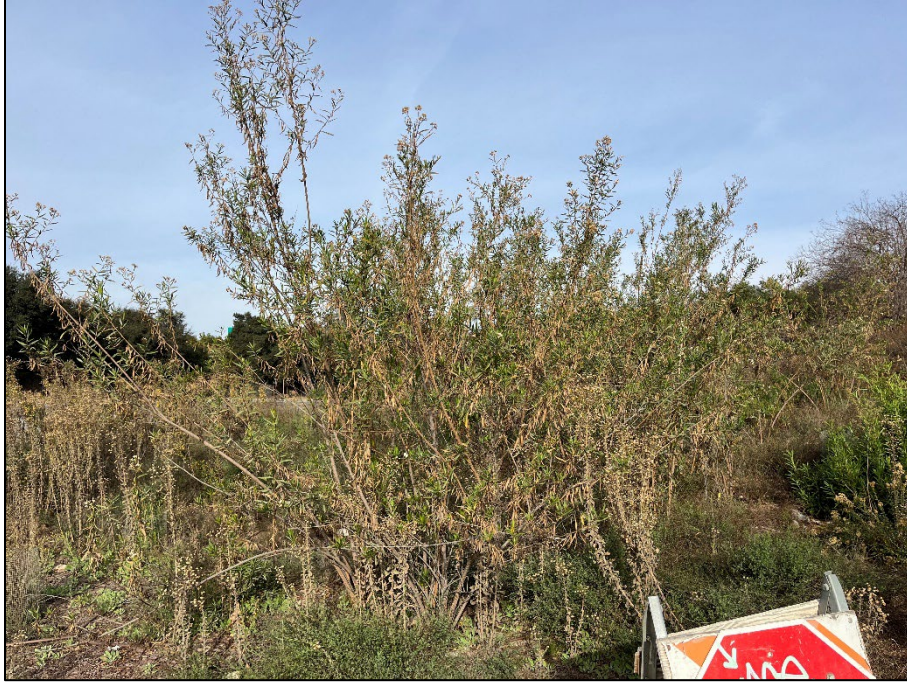
The overall health of the container plants in the Tire Wash mitigation area was noted as being good. Approximately less than 5 percent of the container plants were noted as showing varied levels of stress, which is slightly lower than the percentage of plants that were showing stress during the previous monitoring visit. This included the remaining container plants from the first installation and the replacement container plants that were installed to replace the container plants that were either missing

or appeared to be dead or in a condition unlikely to recover during previous monitoring visits. Most of the stress was observed on the recently installed container plants. Stress may be occurring due to similar reasons described for DG-4 WOUS and DG-4 WOUS Connections. In addition, some of the container plants are being smothered by deerweed (*Acmispon glaber*), which is proliferating in this area. The irrigation was found to be functioning properly for this mitigation area. Photo 9 in Appendix B documents the mitigation area during the monitoring visit.

Photo 9: Overview Tire Wash

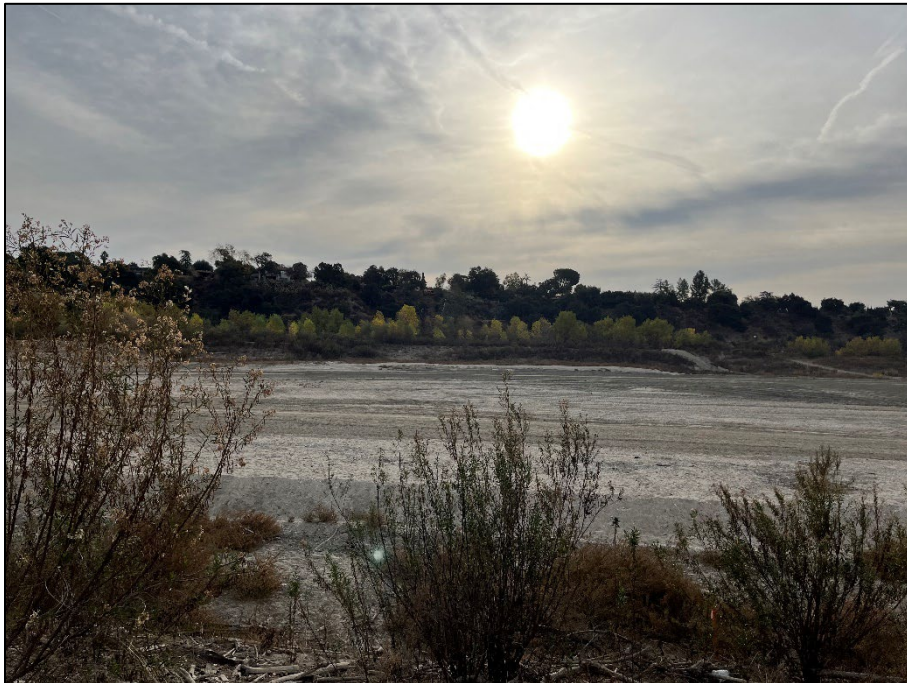
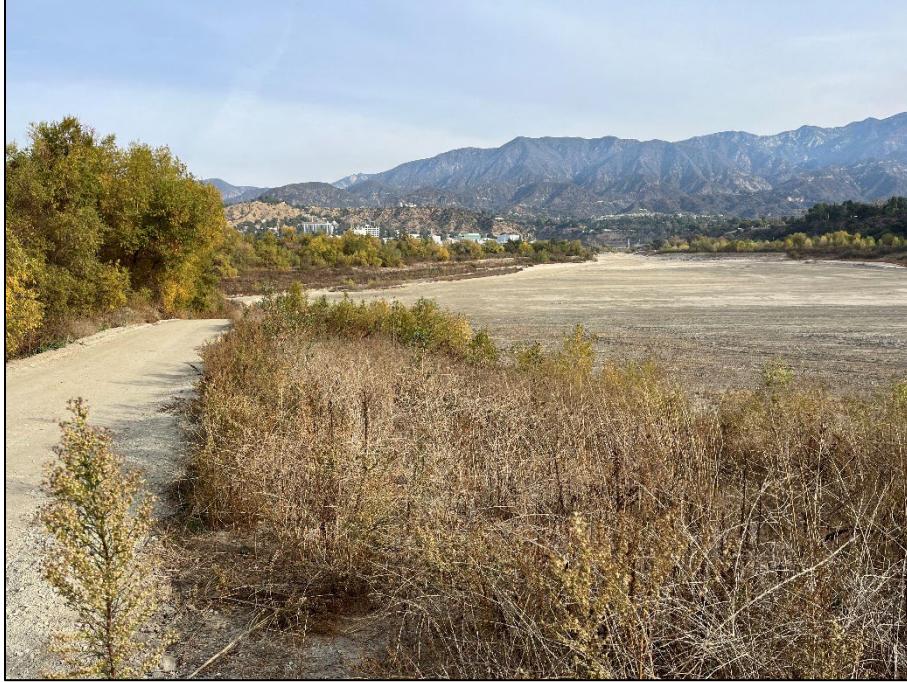
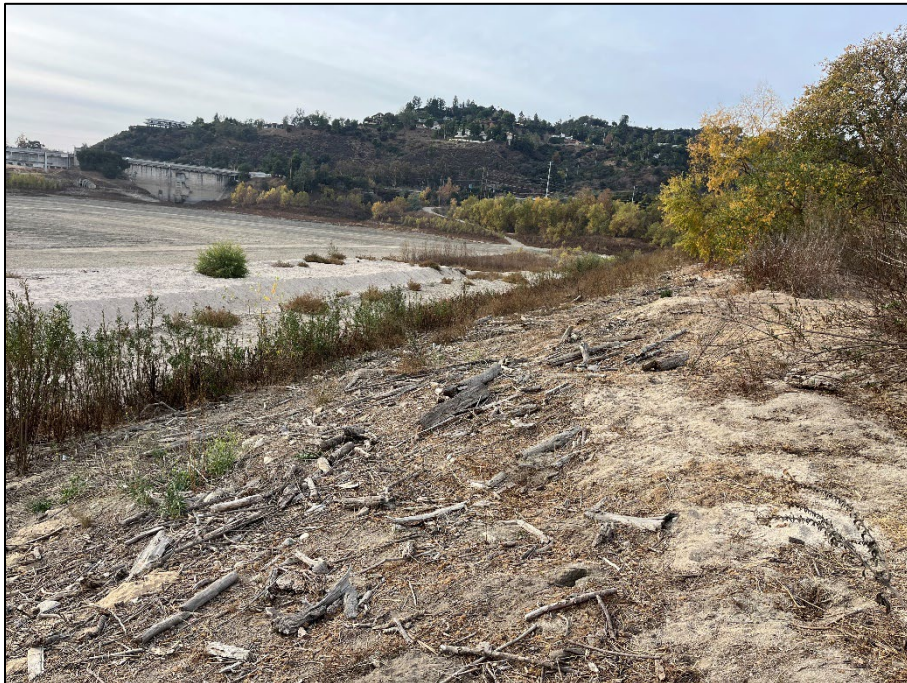
Container plants were not installed on the Side Slopes or in Flint Wash, but these areas were seeded with native plant species. Native plant growth was noted throughout the Side Slopes and Flint Wash, likely both from natural recruitment and from seeding. Portions of the Side Slopes that were previously noted as having significant erosion that occurred as a result of heavy rainfall during the 2023 wet season and following the tropical storm that occurred in late August 2023 were noted as having been repaired during previous monitoring visits and were included in the supplemental seeding effort initiated in November of 2023. During the monitoring visit, the hydroseeded portions of the Side Slopes where previous erosion had occurred showed minimal germination; however, the level of native cover was observed to be higher in these areas during the December monitoring visit than during previous monitoring visits and some areas appear to be stabilizing. The lower level of germination on these portions of the Side Slopes could be due to lack of soil nutrients, lack of organic matter, and/or incorrect compaction levels. Native plants such as mugwort, mulefat, Canada horseweed, telegraph weed, grape-soda lupine (*Lupinus excubitus*), and black willow (*Salix gooddingii*) were observed sprouting on the Side Slopes and in Flint Wash. Overall native cover was estimated to be approximately 45 to 50 percent during the monitoring visit; however, portions of the Side Slopes that have previously had erosion issues had a lower level of cover. Photos 10 through 12 in Appendix B document the Side Slopes during the monitoring visit.

Photo 10: Overview Side Slopes

Photo 11: Overview Side Slopes

Photo 12: Overview Side Slopes

Portions of the Side Slopes that were previously noted as having significant erosion that occurred as a result of heavy rainfall during the 2023 wet season and following the tropical storm that occurred in late August 2023 were noted as having been repaired during previous monitoring visits and were included in the supplemental seeding effort which was completed in November of 2023. Some additional erosion was observed at the toe of the Side Slopes in these areas and has the potential to worsen. In addition, one area of severe erosion that was noted on the eastern Side Slopes at the southwestern extent of DG-2 WOUS during the previous monitoring visit was still present and had not been repaired. As more perennial plants become established on the Side Slopes, erosion should become less of an issue; however, action will need to be taken to repair the damage caused by the erosion and measures should be taken to reduce damage from erosion in the future. In addition, if the supplemental seeding effort does not produce germination on the previously eroded Side Slopes, adaptive management techniques will likely be warranted. During future monitoring events, erosion should continue to be monitored in all planted areas and if warranted, erosion Best Management Practices should be installed in appropriate areas. This may only require the installation of straw wattles at select sites to prevent existing rills from becoming larger.
