November 18, 2024
2023-005.07

Re: *Devil's Gate Reservoir Restoration Project – Phase 2 Restoration Qualitative Monitoring Conducted on August 30, 2024*

1.0 INTRODUCTION

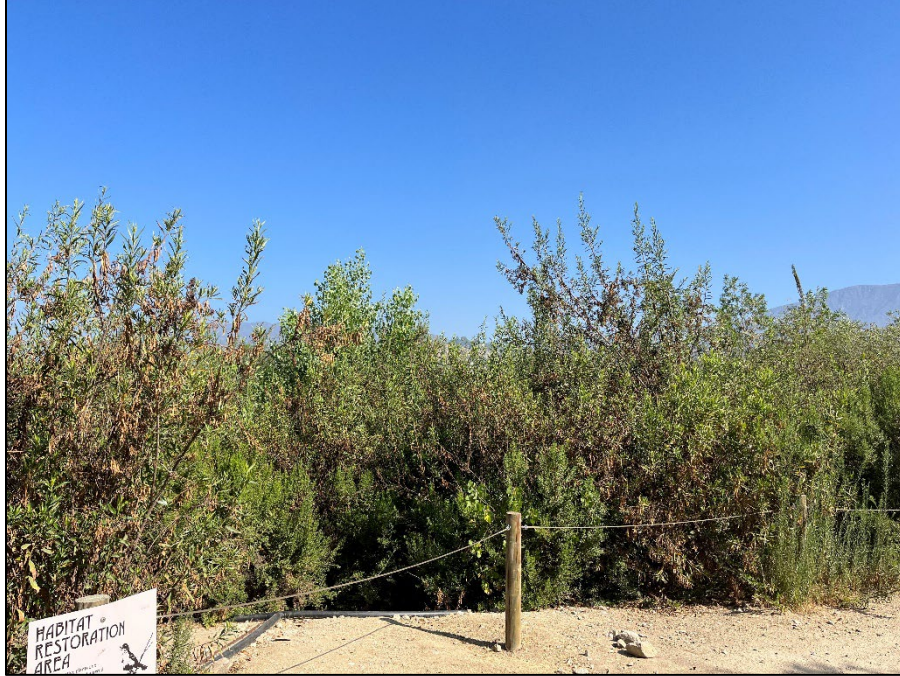
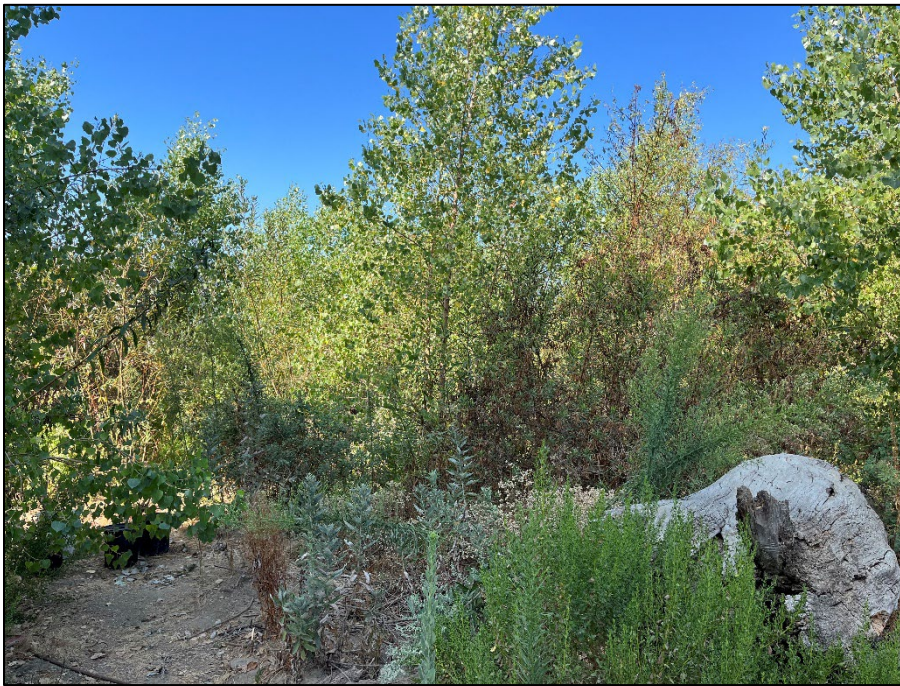
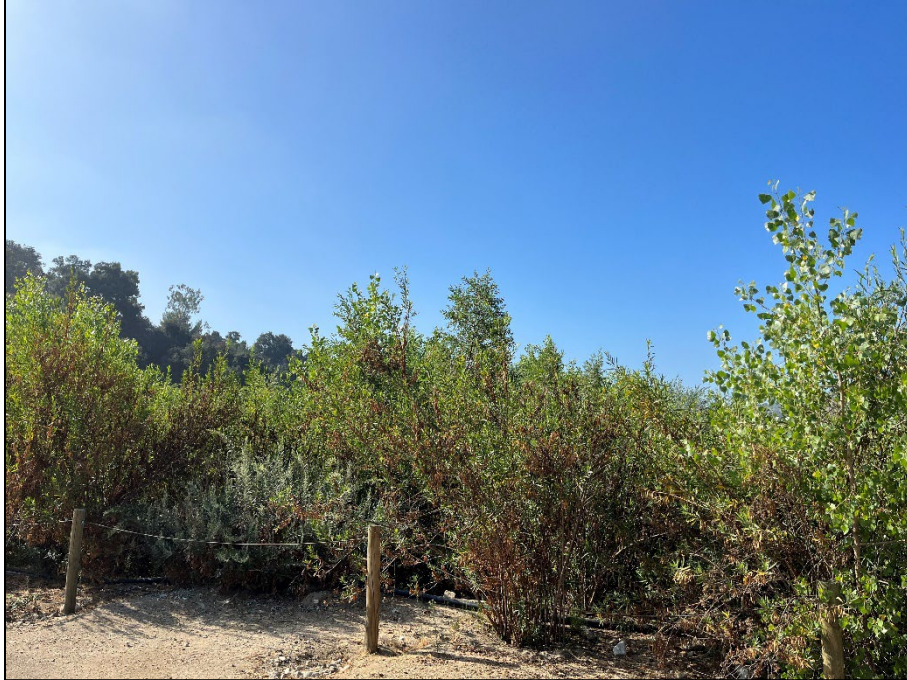
The overall health of the container plants in DG-W-1 was noted as being good. Approximately less than 5 percent of the container plants in DG-W-1 were noted as showing varied levels of stress and a negligible number were noted as being dead or missing. This is approximately the same percentage of plants that were showing stress during the last monitoring event. Stress may be occurring as a result of 1) competition from nonnative and invasive weeds, 2) recent high temperatures, or 3) recreational traffic through the mitigation areas. Photos 1 through 3 in Attachment B document the mitigation area during the monitoring visit.

Native plant growth was noted throughout the DG-W-1 mitigation area, likely from both natural recruitment and from seeding. Native plants such as mugwort (*Artemisia douglasiana*), coyote brush (*Baccharis pilularis*), mulefat (*Baccharis salicifolia*), tall flatsedge (*Cyperus eragrostis*), Canada horseweed (*Erigeron canadensis*), telegraph weed (*Heterotheca grandiflora*), Hooker's evening primrose (*Oenothera elata*), and Douglas' nightshade (*Solanum douglasii*) were observed sprouting in the DG-W-1 mitigation area. Native cover was estimated to be approximately 85 percent in the DG-W-1 mitigation area.

Nonnative weed cover in DG-W-1 was estimated at approximately less than 1 percent, which is approximately 4 percent lower than the level of weed cover that was observed during the previous monitoring visit. Black mustard (*Brassica nigra*) and perennial pepperweed (*Lepidium latifolium*) were the only nonnative species observed in DG-W-1. Most of the nonnative weeds observed in this mitigation area were still vegetative and just beginning to germinate.

Photo 1: Overview Mitigation Area DG-W-1 (Johnson Field)

Photo 2: Overview Mitigation Area DG-W-1 (Johnson Field)

Photo 3: Overview Mitigation Area DG-W-1 (Johnson Field)

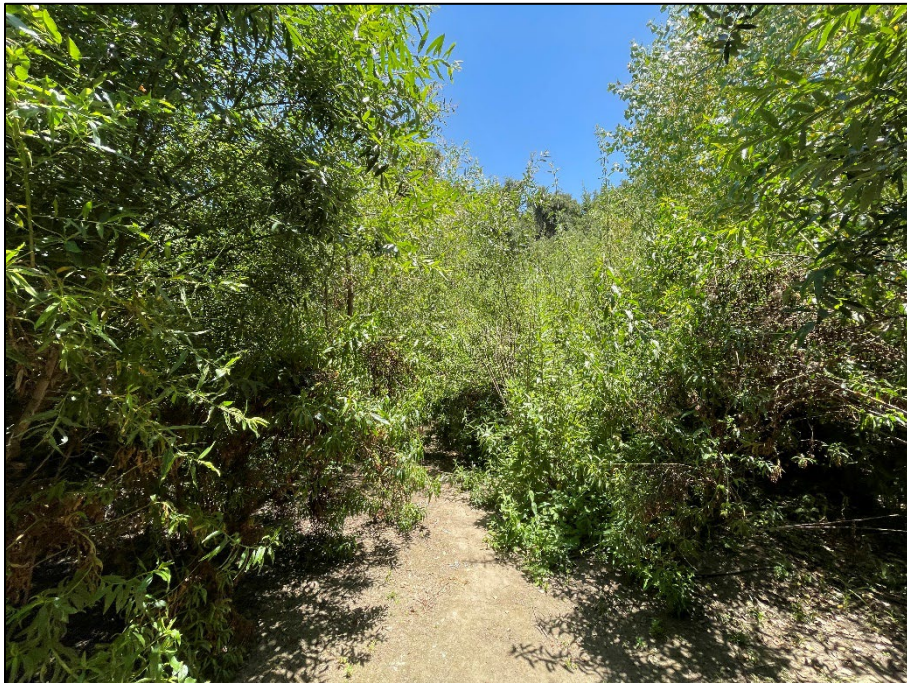
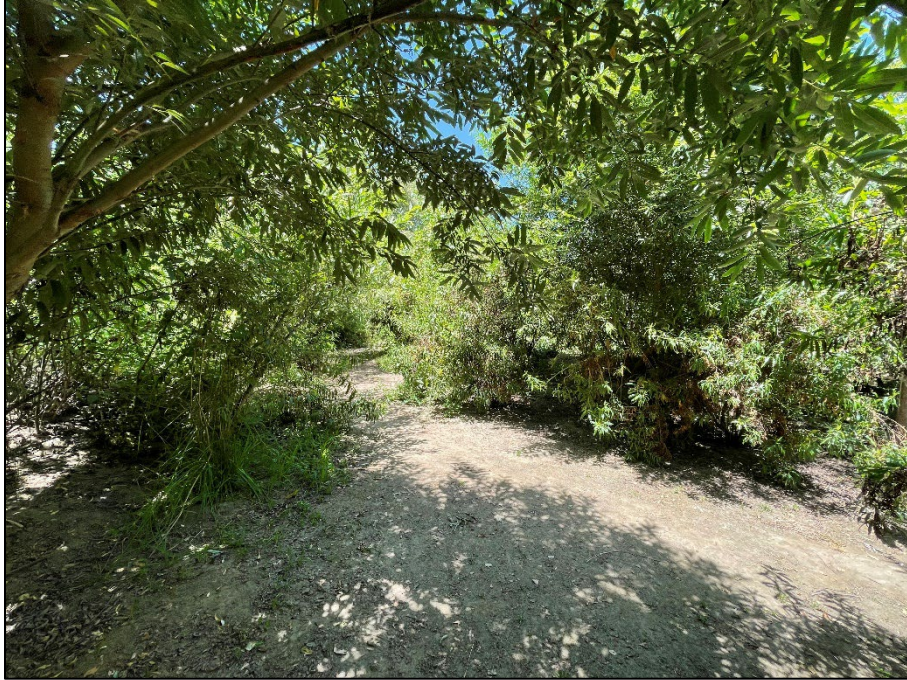
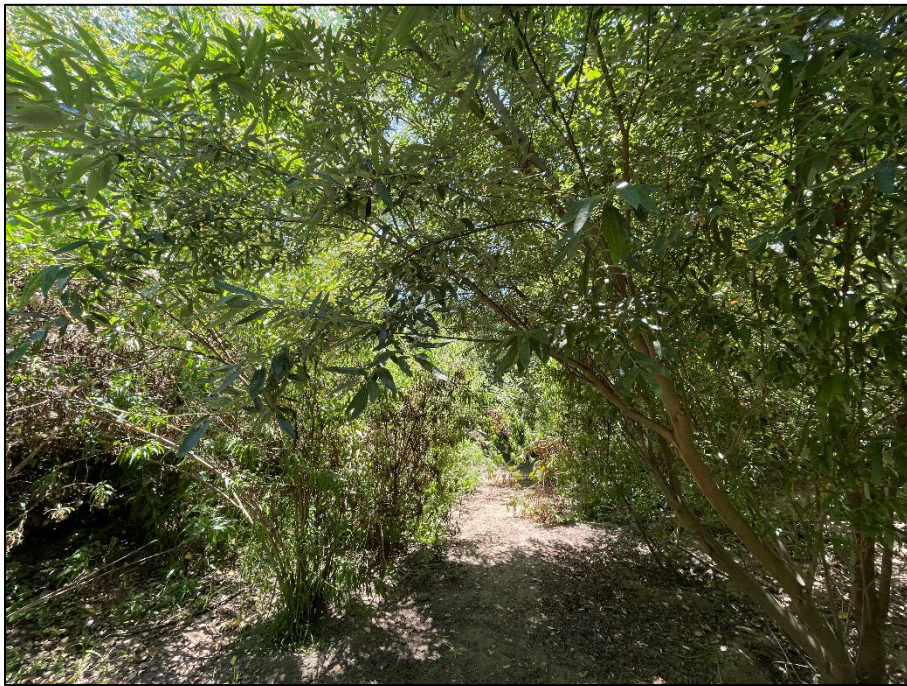
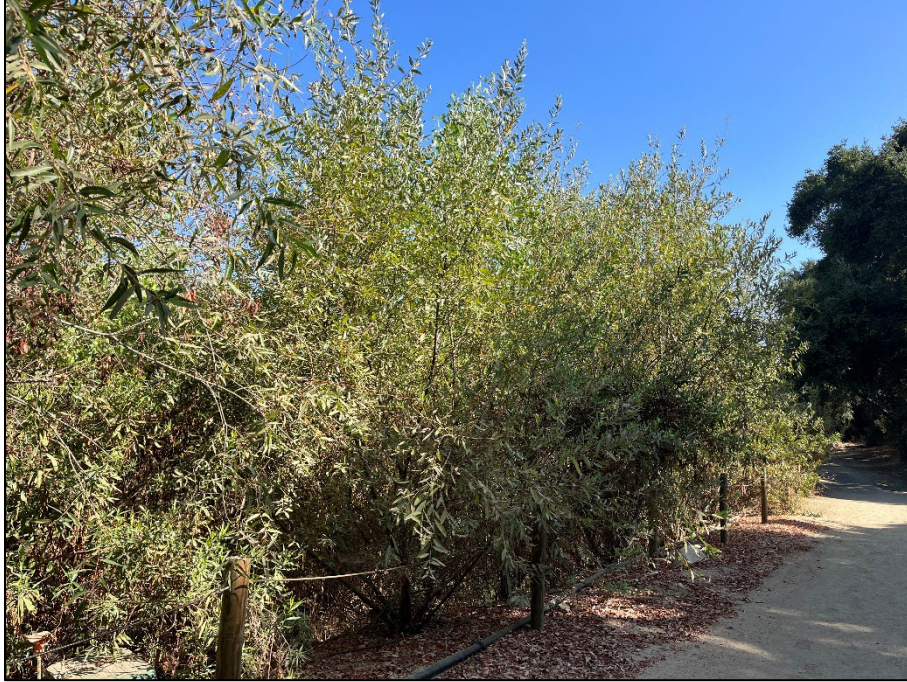
The overall health of the container plants in DG-2, DG-2 New Channels, and DG-2 WOUS was noted as being good. Approximately less than 5 percent of the container plants were noted as showing varied levels of stress and a negligible number were noted as being dead or missing. This is approximately the same percentage of plants that were showing stress during the last monitoring event. Stress may be occurring due to similar reasons described for DG-W-1. During the monitoring visit, the grade control structure that was installed at the northern end of DG-2 New Channels where the channels connect to DG-W-1 was inspected for erosion. Minor erosion was observed, mostly towards the western end of the structure; however, no major erosion issues were observed, and the structure appears to be functioning properly. Photos 4 through 7 in Attachment B document the mitigation areas during the monitoring visit.

Native plant growth was noted throughout the DG-2, DG-2 New Channels, and DG-2 WOUS mitigation areas, likely from both natural recruitment and from seeding. Native plants such as mugwort, mulefat, Jimson weed (*Datura wrightii*), Canada horseweed, coast live oak (*Quercus agrifolia*), common phacelia (*Phacelia distans*), and stinging nettle (*Urtica dioica*) were observed sprouting in the mitigation areas. Native cover was estimated to be approximately 80 percent in the DG-2, DG-2 New Channels, and DG-2 WOUS mitigation areas.

Nonnative weed cover in the DG-2, DG-2 New Channels, and DG-2 WOUS mitigation areas was estimated at approximately less than 1 percent, which is approximately 2 to 4 percent lower than the percentage that was observed during the last monitoring visit. Poison hemlock (*Conium maculatum*) and perennial pepperweed were the only nonnative species observed in this mitigation area. Most of the nonnative weeds observed in this mitigation area were vegetative and just starting to germinate.

Photo 4: Overview Mitigation Area DG-2 & DG-2 New Channels

Photo 5: Overview Mitigation Area DG-2 & DG-2 New Channels

Photo 6: Overview Mitigation Area DG-2 & DG-2 WOUS

Photo 7: Overview Mitigation Area DG-2 & DG-2 WOUS

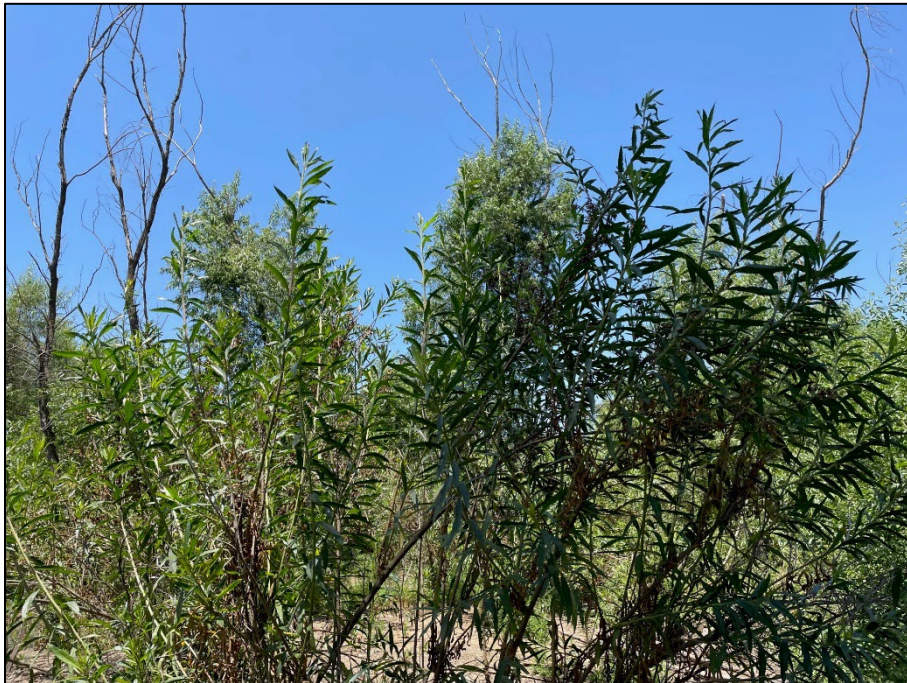
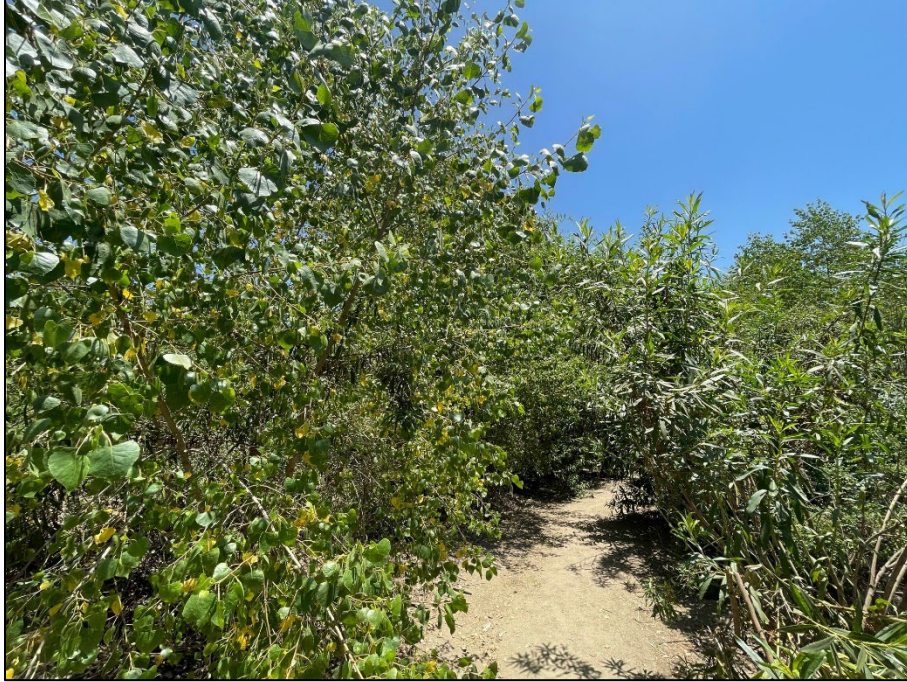
The overall health of the container plants in mitigation area DG-W-2 was noted as being good. Approximately less than 5 percent of the container plants were noted as showing varied levels of stress and a negligible number were noted as being dead or missing. This is approximately the same percentage of plants that were showing stress during the last monitoring event. Stress may be occurring due to similar reasons described for DG-W-1. Photos 8 and 9 in Attachment B document the mitigation area during the monitoring visit.

During the monitoring visit, it was noted that many of the remaining mature black willows (*Salix gooddingii*) in this mitigation area were continuing to show signs of recovery, such as sprouting vigorously from the base, from the polyphagous shot-hole borer (PSHB) infestation that was confirmed by the Los Angeles County Department of Agricultural Commissioner/Weights & Measures in December of 2021. Most of the dead and hazardous black willows in this mitigation area were removed in October of 2022.

Black willows that were determined to have the potential to recover were left in place and will continue to be monitored during the qualitative monitoring visits.

Native plant growth was noted throughout the DG-W-2 mitigation area, and what was present is likely from both natural recruitment and from seeding. Native plants such as mugwort, tall flatsedge, Canada horseweed, and stinging nettle were observed sprouting in the DG-W-2 mitigation area. Native cover was estimated to be approximately 65 to 70 percent in the DG-W-2 mitigation area.

Nonnative weed cover in DG-W-2 was estimated at approximately less than 1 percent in the mitigation area, which is approximately 24 to 29 percent less than the level of nonnative cover that was observed during the last monitoring event. Poison hemlock and perennial pepperweed were the only nonnative species observed in this mitigation area. Most of the nonnative weeds observed in this mitigation area were vegetative and just starting to germinate.

Photo 8: Overview Mitigation Area DG-W-2 (Mining Pit)

Photo 9: Overview Mitigation Area DG-W-2 (Mining Pit)

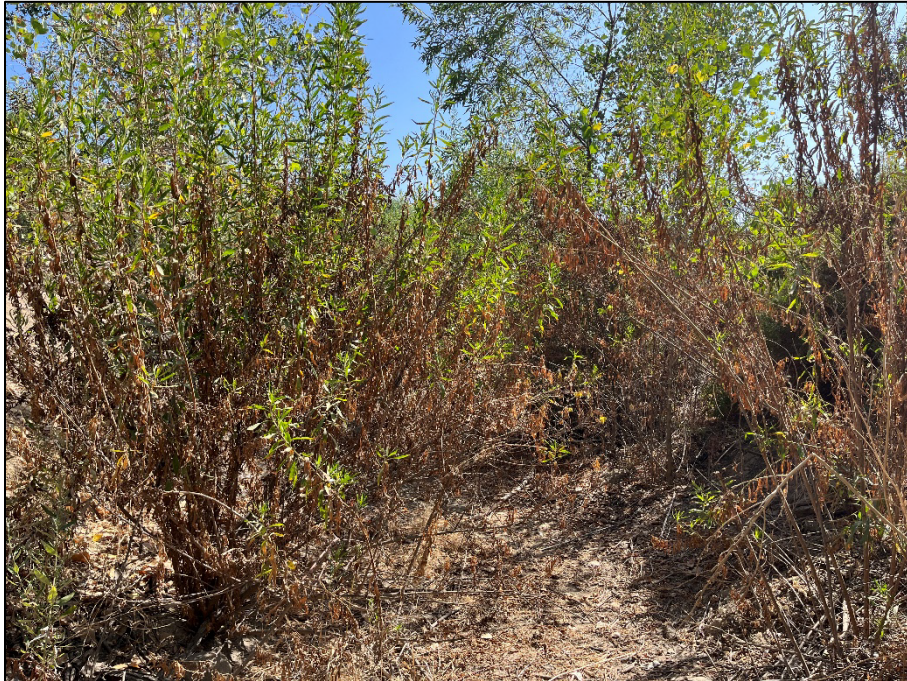
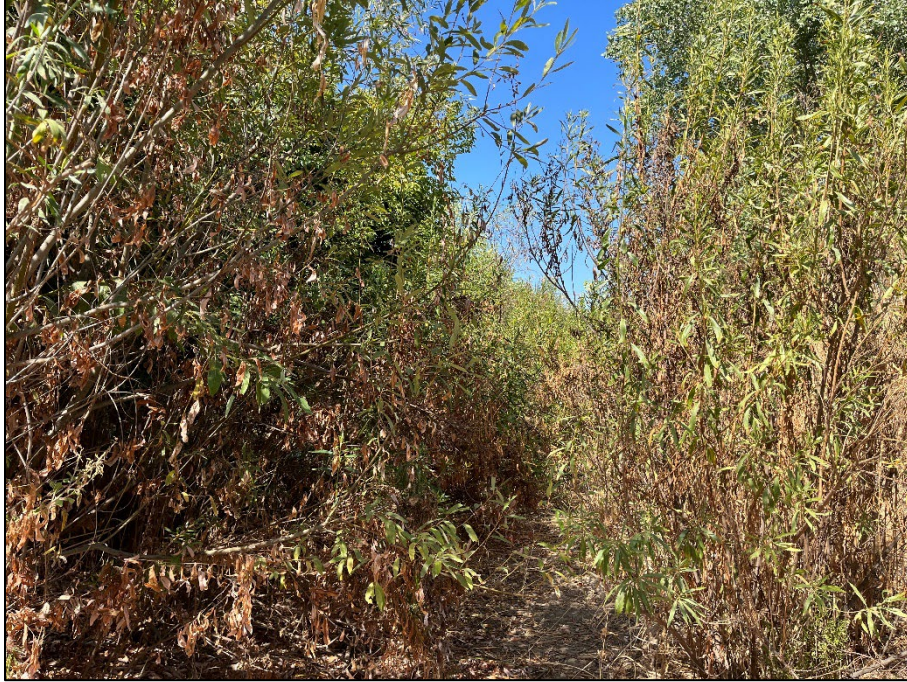
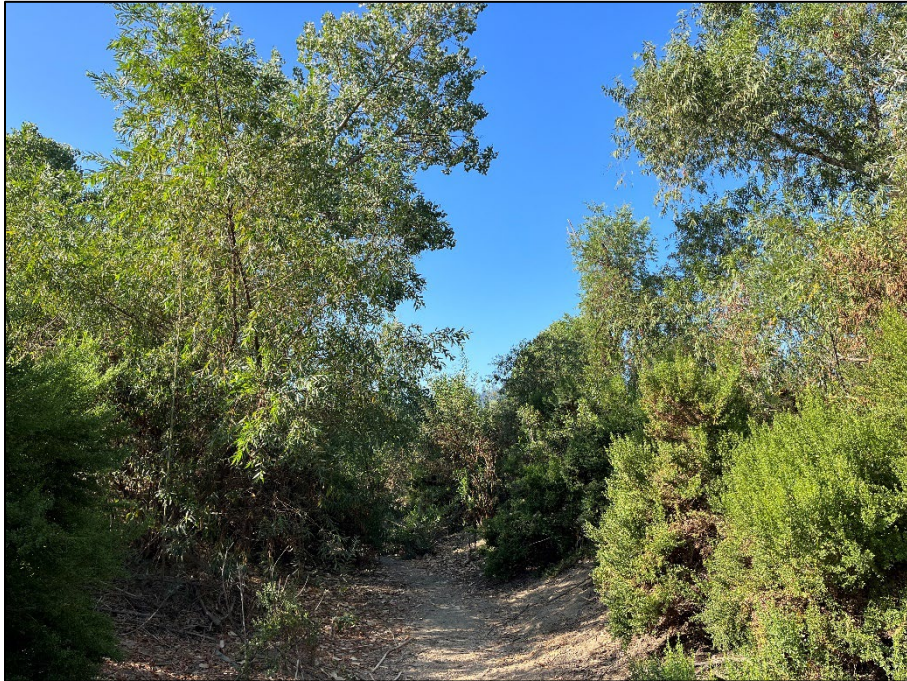
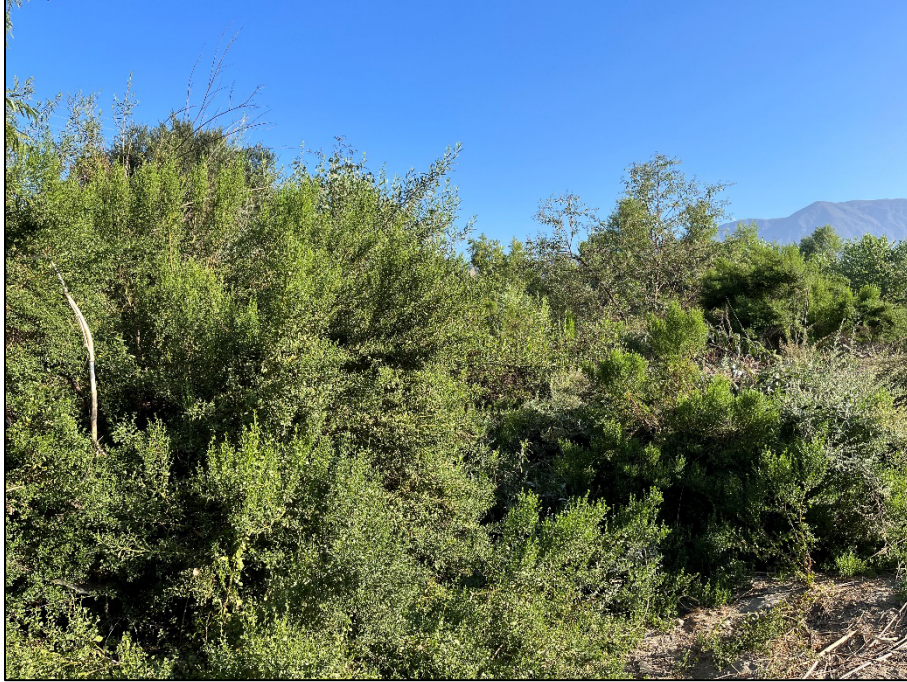
The overall health of the container plants in mitigation area DG-W-2 Outlet was noted as being good. Approximately 5 percent of the container plants were noted as showing varied levels of stress and a negligible number were noted as being dead or missing. This is approximately the same as the percentage of plants that were showing stress during the last monitoring event. Stress may be occurring due to similar reasons described for DG-W-1. Photos 10 through 13 in Attachment B document the mitigation area during the monitoring visit.

Native plant growth was noted throughout the DG-W-2 Outlet mitigation area, and what was present is likely from both natural recruitment and from seeding. Native plants such as mugwort, mulefat, tall flatsedge, Hooker's evening primrose were observed sprouting in the DG-W-2 Outlet mitigation area. Native cover was estimated to be approximately 70 percent in the DG-W-2 Outlet mitigation area.

Nonnative weed cover in DG-W-2 Outlet was estimated to be approximately 5 percent, which is approximately 10 to 15 percent less than the percentage of weed cover that was observed during the previous monitoring visit. Poison hemlock and perennial pepperweed were the only nonnative species observed during the monitoring visit. Most of the nonnative weeds observed in this mitigation area were vegetative and just starting to germinate.

Photo 10: Overview Mitigation Area DG-W-2 Outlet

Photo 11: Overview Mitigation Area DG-W-2 Outlet

Photo 12: Overview Mitigation Area DG-W-2 Outlet

Photo 13: Overview Mitigation Area DG-W-2 Outlet

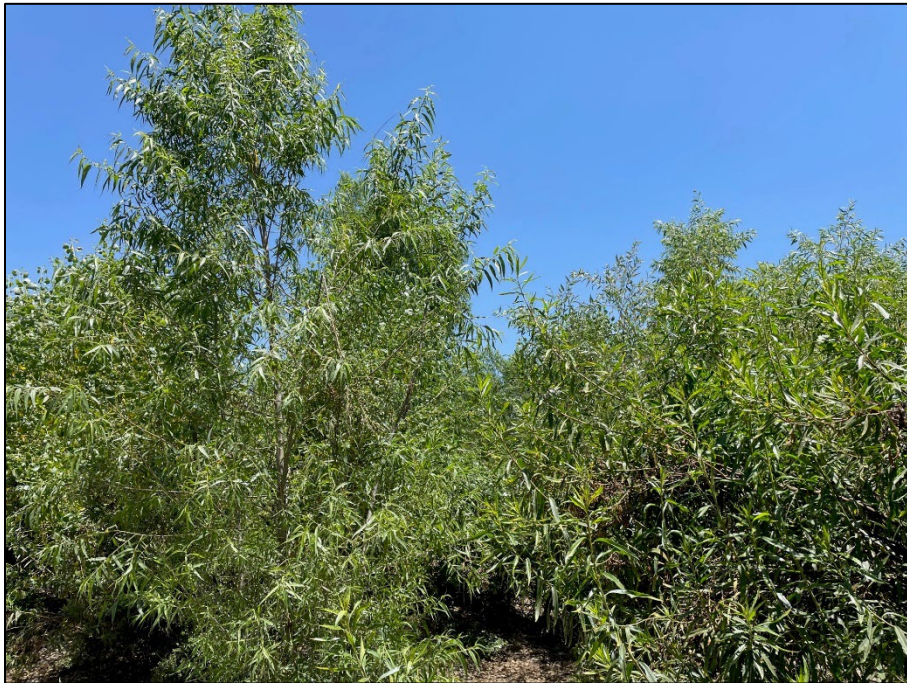
The overall health of the container plants in mitigation areas DG-4 Sheet Flow (northern) and DG-SF-1 was noted as being good. Approximately less than 5 percent of container plants were showing varied levels of stress which is approximately the same percentage of container plants that were showing stress during the previous monitoring event. Stress may be occurring due to similar reasons described for DG-W-1. Photo 14 in Attachment B document the mitigation area during the monitoring visit.

Minimal native plant germination was noted throughout the DG-4 Sheet Flow and DG-SF-1 mitigation area, and what was present is likely from both natural recruitment and from seeding. Native plants such as mugwort, tall flatsedge, and Douglas' nightshade were observed sprouting in the DG-4 Sheet Flow and

DG-SF-1 mitigation areas. Native cover was estimated to be approximately 60 percent in the DG-4 Sheet Flow/DG-SF-1 mitigation area.

Nonnative weed cover in DG-4 Sheet Flow and DG-SF-1 was estimated at approximately 5 percent, which is approximately 10 to 15 percent less than the level of weed cover that was observed during the previous monitoring visit. Nonnative species observed in DG-4 Sheet Flow and DG-SF-1 included black mustard (*Brassica nigra*) and perennial pepperweed. Most of the nonnative weeds observed in this mitigation area were vegetative and just starting to germinate.

Photo 14: Overview Mitigation Area DG-SF-1
