Re: *Devil's Gate Reservoir Restoration Project – Phase 3 Restoration Qualitative Monitoring Conducted on March 27, 2024*

1.0 INTRODUCTION

Qualitative monitoring was conducted by Carley Adams on March 27, 2024. Field data collected during the monitoring event is provided as Appendix A. This report documents the fifth monthly qualitative monitoring visit for the Phase 3 mitigation areas.

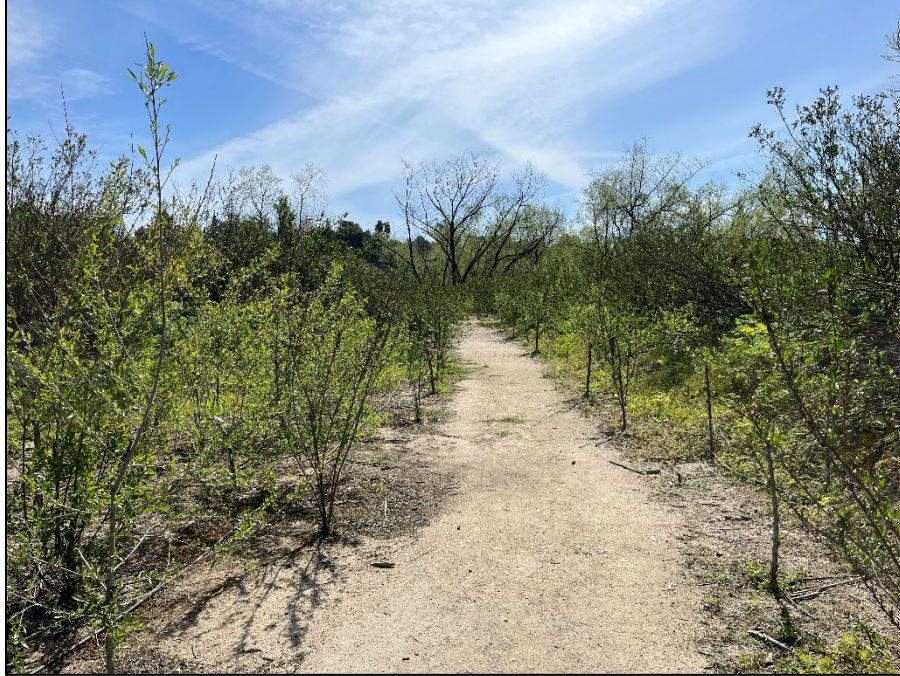
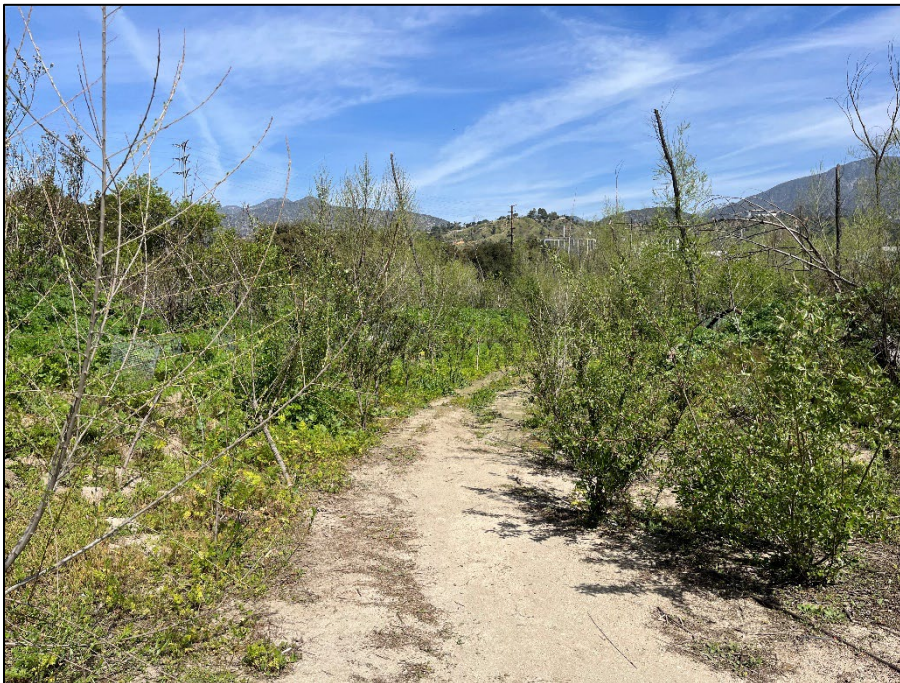
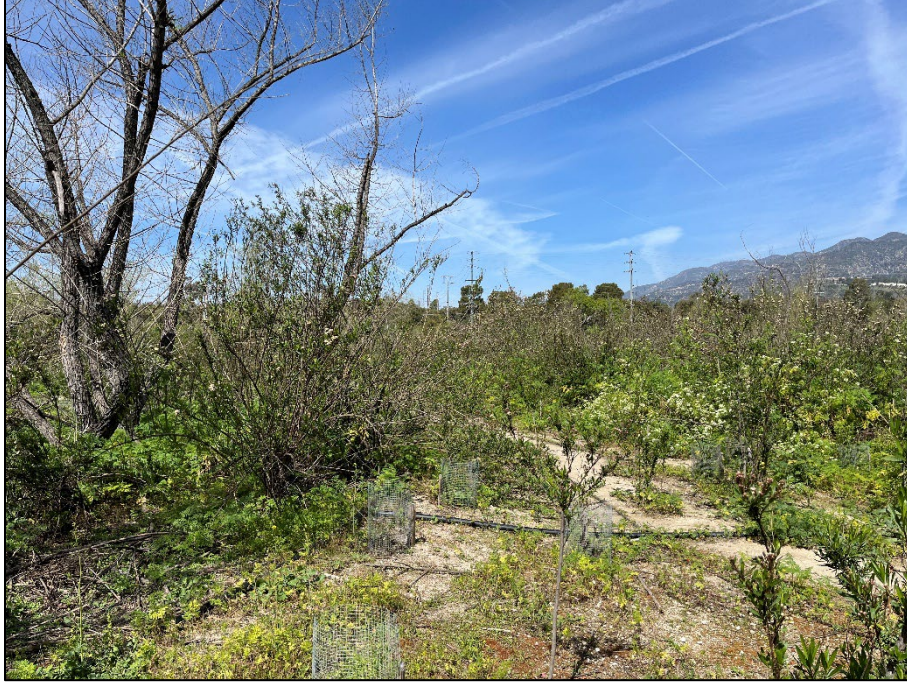
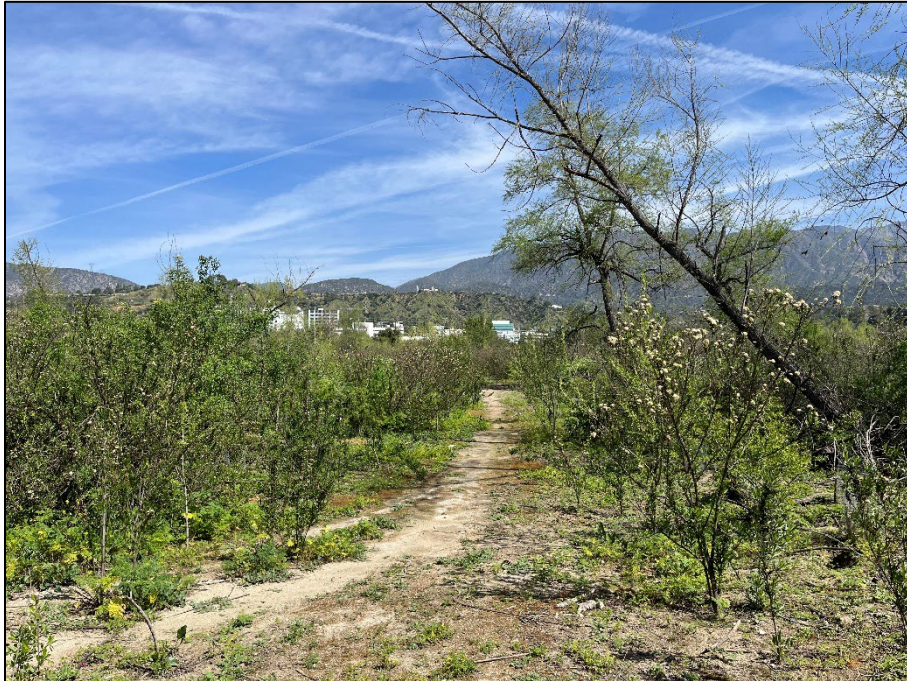
The overall health of the container plants in DG-4 WOUS and DG-4 WOUS Connections was noted as being good. Less than 10 percent of the container plants and stakes in DG-4 WOUS and DG-4 WOUS Connections were noted as showing signs of stress and a negligible amount were noted as being dead or missing. This is the same percentage of plants that were showing stress during the previous monitoring visit. Stress may be occurring as a result of 1) transplant shock, 2) herbivory by rabbits or other wildlife, 3) competition from nonnative and invasive weeds, 4) misplaced emitters, or 5) recreational traffic through the mitigation areas. During the monitoring visit, the Fremont's cottonwoods (*Populus fremontii*) and willows (*Salix* spp.) were noted as coming out of seasonal dormancy and were no longer showing signs of seasonal dieback. Formal mortality counts will be taken for DG-4 WOUS and DG-4 WOUS Connections during the 2024 quantitative monitoring and will be included in the 2024 annual reporting. The majority of the recently planted mulefat (*Baccharis salicifolia*) and willow stakes were noted as showing signs of new growth. Some of the container plants were noted as lacking well defined basins and should have their basins properly constructed and/or repaired. The installation of plants in the DG-4 WOUS and DG-4 WOUS Connections mitigation areas appears to have been completed successfully. The current issues identified during the monitoring visit are not expected to have an effect on the continued growth of the plants in the mitigation area. Photos 1 through 4 in Appendix B document the mitigation areas during the monitoring visit.

Photo 1. Overview DG-4 WOUS & WOUS Connections

Photo 2. Overview DG-4 WOUS & WOUS Connections

Photo 3. Overview DG-4 WOUS & WOUS Connections

Photo 4. Overview DG-4 WOUS & WOUS Connections

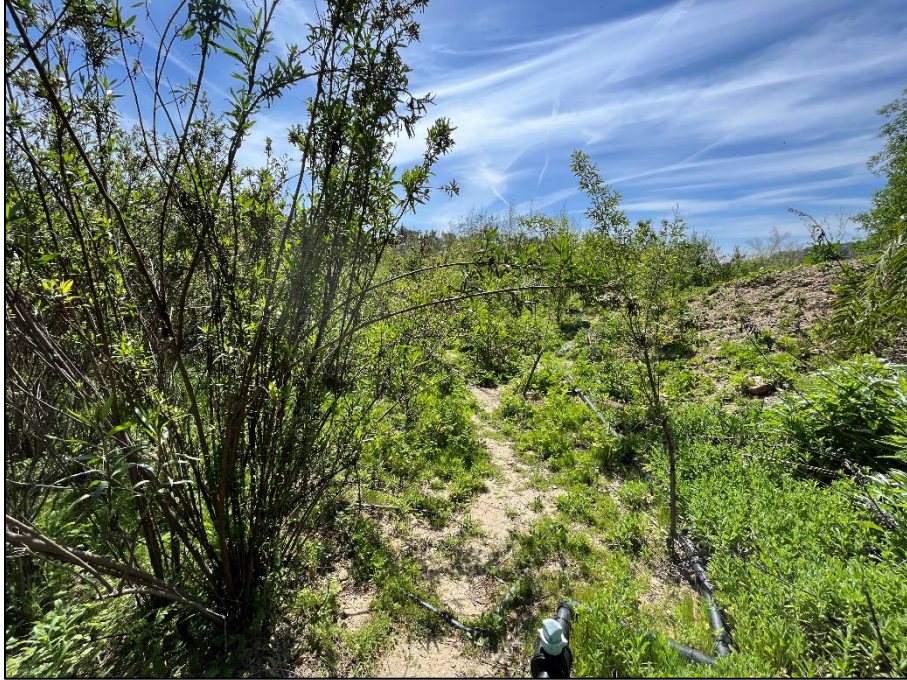
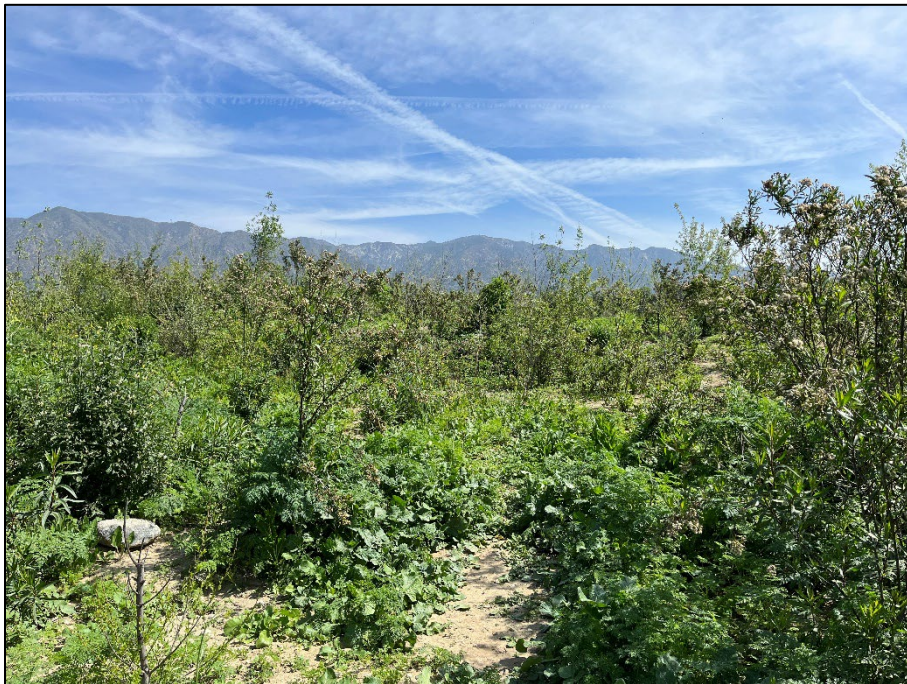
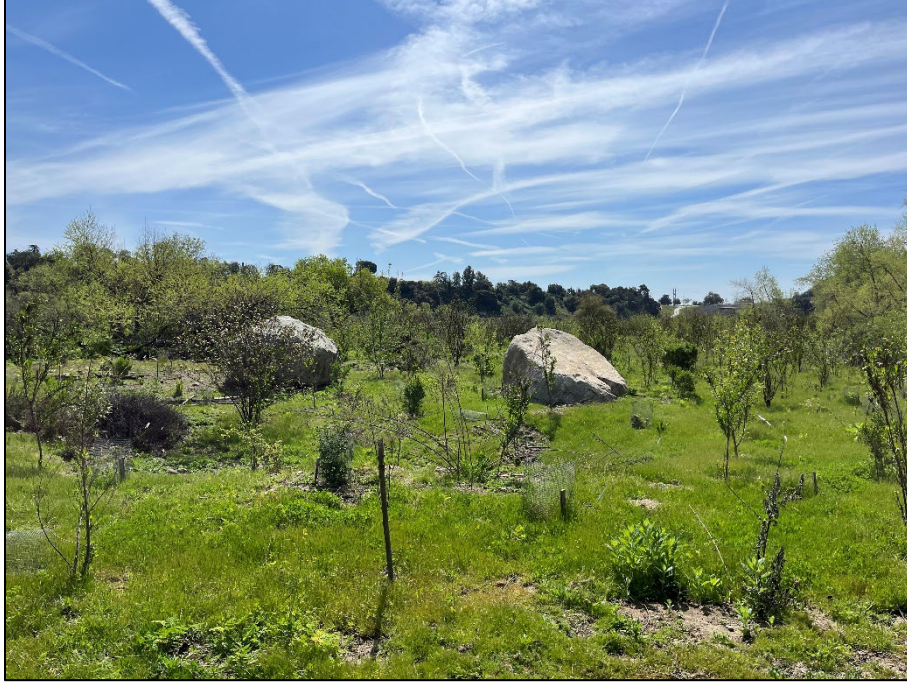
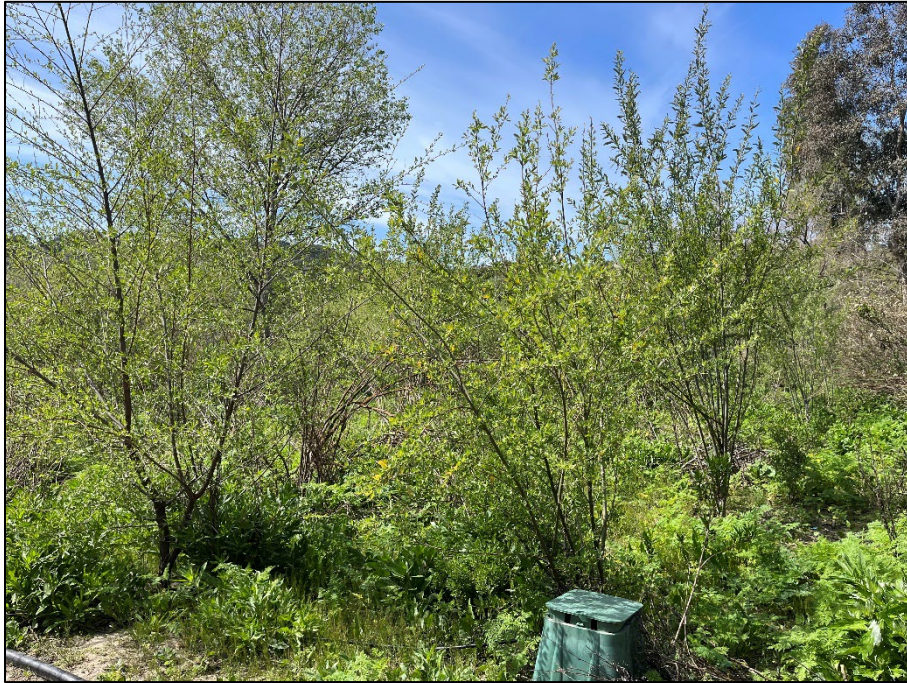
The overall health of the container plants in DG-4A was noted as being good. Less than 10 percent of the container plants and stakes in DG-4A were noted as showing signs of stress and a negligible amount were noted as being dead or missing. This is approximately the same percentage of plants that were showing stress during the previous monitoring visit. This included the remaining container plants from the first installation and the replacement container plants that were installed to replace the container plants and stakes planted in the middle section of DG-4A that appeared to be dead or in a condition unlikely to recover during previous monitoring visits. Stress may be occurring due to similar reasons described for DG-4 WOUS and DG-4 WOUS Connections. Formal mortality counts will be taken for DG-4A during the 2024 quantitative monitoring and will be included in the 2024 annual reporting. The majority of the recently planted mulefat and willow stakes were noted as showing signs of new growth; however, some were showing signs of seasonal dieback. Some of the container plants were noted as lacking well defined basins and should have their basins properly constructed and/or repaired. The installation of plants in the DG-4A mitigation area appears to have been completed successfully and the installation of the replacement container plants should increase native cover. The current issues identified during the monitoring visit are not expected to have an effect on the continued growth of the plants in the mitigation area. Photos 5 through 8 in Appendix B document the mitigation area during the monitoring visit.

Photo 5. Overview DG-4A

Photo 6. Overview DG-4A

Photo 7: Overview DG-4A

Photo 8: Overview DG-4A

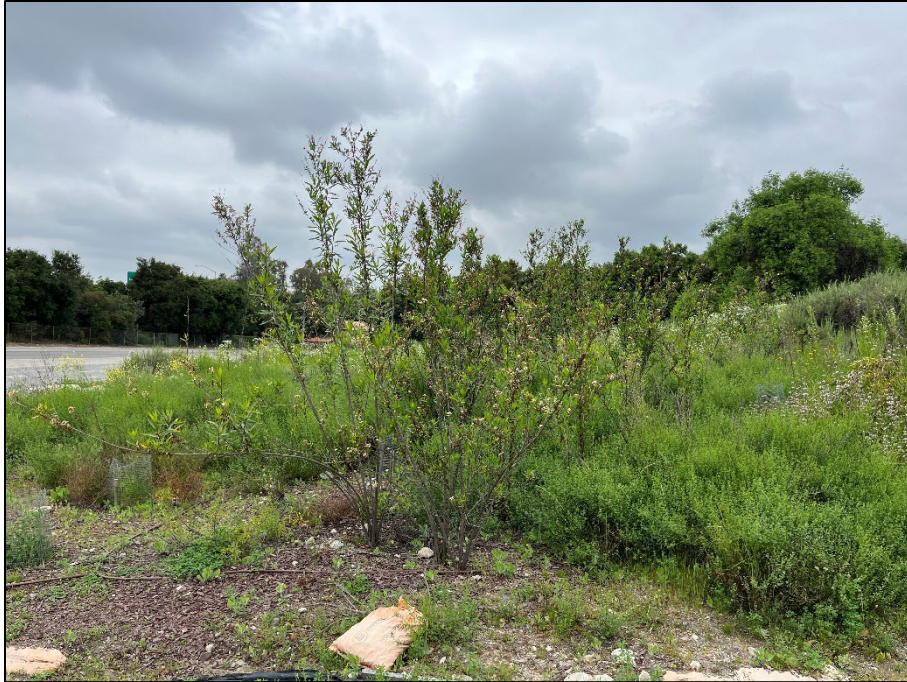
Photo 9: Overview Tire Wash

The overall health of the container plants in the Tire Wash mitigation area was noted as being good. Approximately 5 percent of the container plants were noted as showing varied levels of stress, which is approximately 5 percent lower than the percentage of plants that were showing stress during the previous monitoring visit. This included the remaining container plants from the first installation and the replacement container plants that were installed to replace the container plants that were either missing or appeared to be dead or in a condition unlikely to recover during previous monitoring visits. Most of the stress was observed on the recently installed container plants. Stress may be occurring due to similar reasons described for DG-4 WOUS and DG-4 WOUS Connections. The irrigation was found to be functioning properly for this mitigation area. Formal mortality counts will be taken for the Tire Wash during the 2024 quantitative monitoring and will be included in the 2024 annual reporting. Some of the container plants were noted as lacking well defined basins and should have their basins properly constructed and/or repaired. The installation of plants in the Tire Wash mitigation area appears to have been completed successfully. The current issues identified during the monitoring visit are not expected to have an effect on the continued growth of the plants in the mitigation area. Photo 9 in Appendix B documents the mitigation area during the monitoring visit.

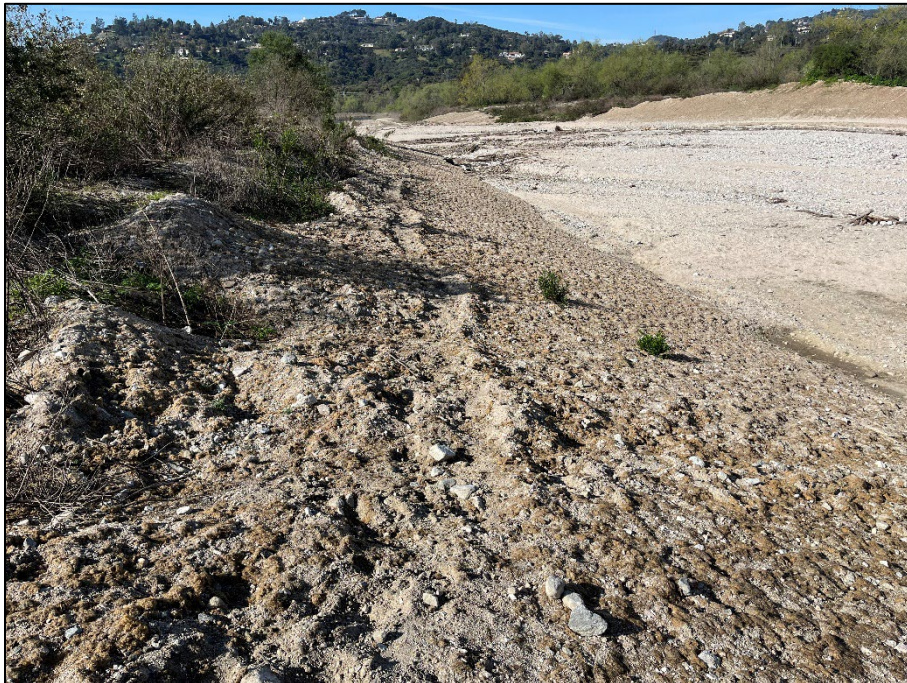
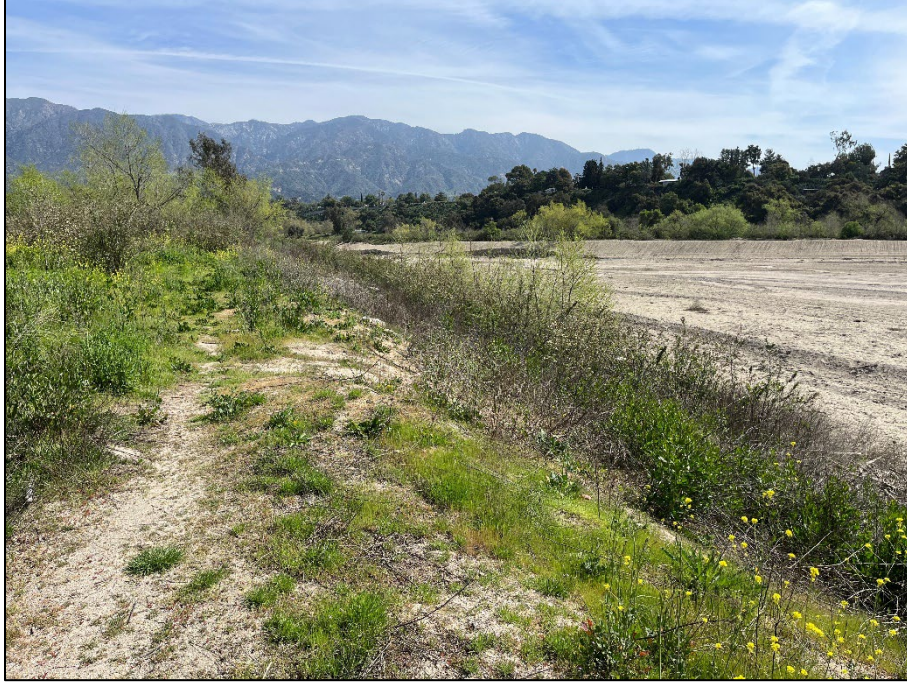
Container plants were not installed on the Side Slopes or in Flint Wash, but these areas were seeded with native plant species. Native plant growth was noted throughout the Side Slopes and Flint Wash, likely both from natural recruitment and from seeding. Portions of the Side Slopes that were previously noted as having significant erosion that occurred as a result of heavy rainfall during the 2023 wet season and following the tropical storm that occurred in late August 2023 were noted as having been repaired during previous monitoring visits and were included in the supplemental seeding effort initiated in November of 2023. During the monitoring visit, the recently hydroseeded portions of the Side Slopes where previous erosion had occurred showed very minimal germination. Lack of germination on these portions of the Side Slopes could be due to lack of soil nutrients, lack of organic matter, and/or incorrect compaction levels. Native plants such as annual bursage (*Ambrosia acanthicarpa*), mulefat, black willow (*Salix gooddingii*), and cocklebur (*Xanthium strumarium*) were observed sprouting on the Side Slopes. Overall native cover was estimated to be approximately 35 percent during the monitoring visit; however, the portions of the Side Slopes that were recently repaired and hydroseeded were noted as having very low cover. A portion of the Side Slopes near the southwestern extent of DG-2 WOUS was noted as having significant erosion during the monitoring visit. Photos 10 and 11 in Appendix B document the Side Slopes during the monitoring visit and Photo 12 documents the erosion observed at the southwestern extent of DG-2 WOUS.

Photo 10: Overview Side Slopes

Photo 11: Overview Side Slopes

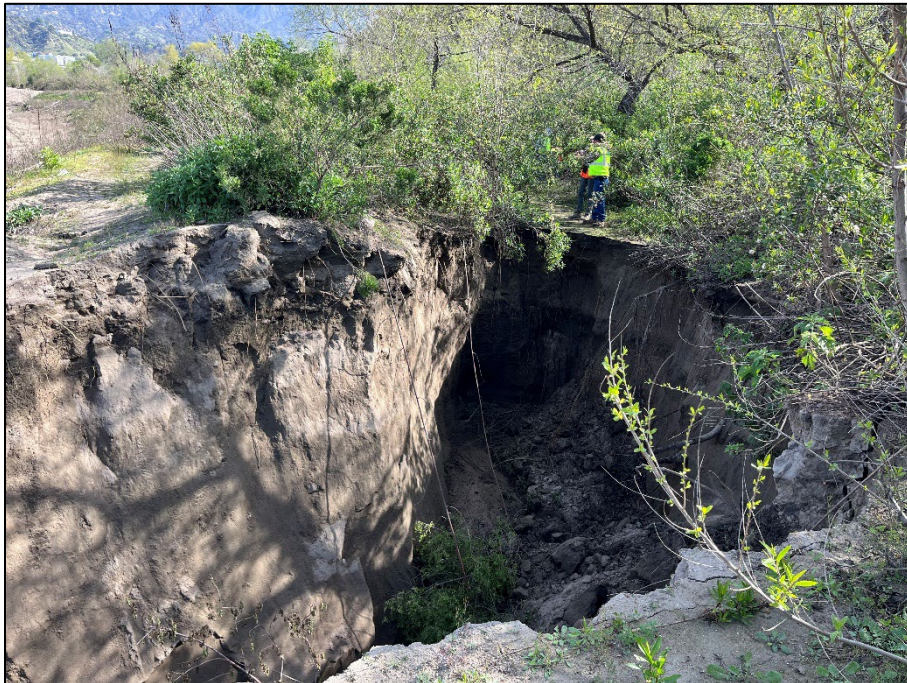
Portions of the Side Slopes that were previously noted as having significant erosion that occurred as a result of heavy rainfall during the 2023 wet season and following the tropical storm that occurred in late August 2023 were noted as having been repaired during previous monitoring visits and were included in the supplemental seeding effort which was completed in November of 2023. Some additional erosion was observed at the toe of the Side Slopes in these areas and has the potential to worsen. In addition, an area of severe erosion was noted on the eastern Side Slopes at the southwestern extent of DG-2 WOUS. As more perennial plants become established on the Side Slopes, erosion should become less of an issue; however, action will need to be taken to repair the damage caused by the erosion and measures should be taken to reduce damage from erosion in the future. In addition, if the supplemental seeding effort does not produce germination on the previously eroded Side Slopes, adaptive management techniques will likely be warranted. During future monitoring events, erosion should continue to be monitored in all

Photo 12: Erosion to Side Slopes

planted areas and if warranted, erosion Best Management Practices should be installed in appropriate areas. This may only require the installation of straw wattles at select sites to prevent existing rills from becoming larger.
