July 10, 2025  
(2023-005.13)

**Re: *Devil's Gate Reservoir Restoration Project – Phase 3 Restoration Qualitative Monitoring Conducted on March 24, 2025***

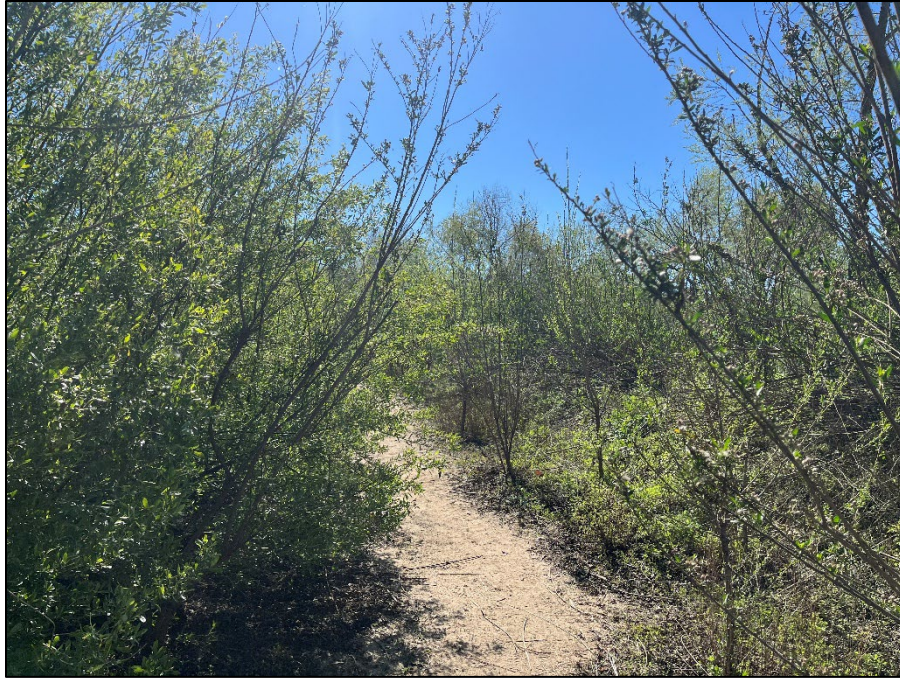
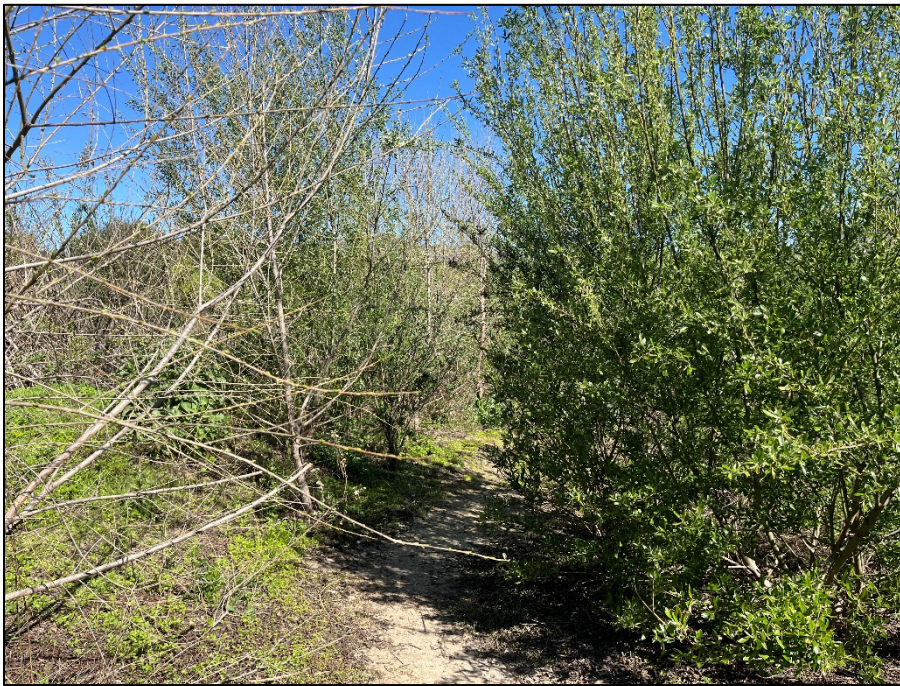
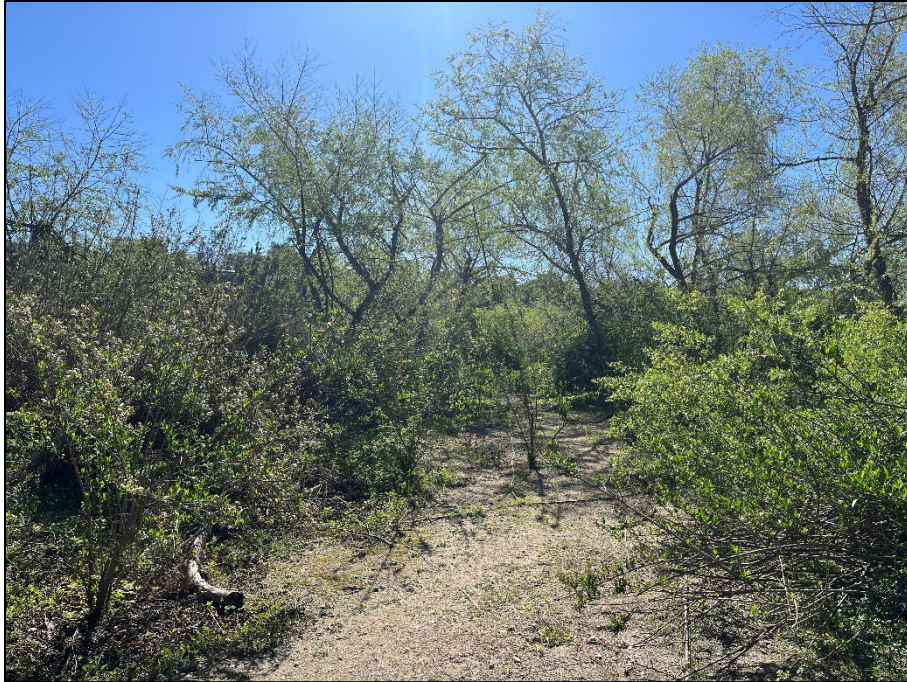
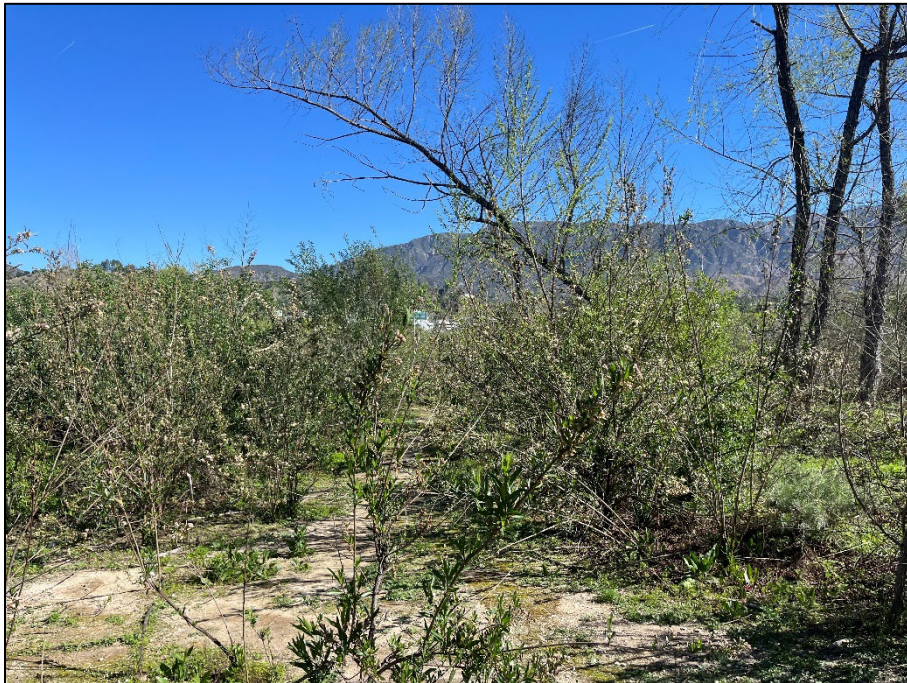
Photo 1. Overview DG-4 WOUS & WOUS Connections

The overall health of the container plants in DG-4 WOUS and DG-4 WOUS Connections was noted as being good. Approximately less than 5 percent of the container plants and stakes in DG-4 WOUS and DG-4 WOUS Connections were noted as showing signs of stress and a negligible amount were noted as being dead or missing. This is the same percentage of plants that were showing stress during the previous monitoring visit. Stress may be occurring as a result of: 1) herbivory by rabbits or other wildlife, 2) competition from nonnative and invasive weeds, 3) misplaced emitters, or 4) recreational traffic through the mitigation areas. Photos 1 through 4 (Appendix B) document the mitigation areas during the monitoring visit.

Nonnative weed cover in DG-4 WOUS and DG-4 WOUS Connections was estimated at approximately 35 to 40 percent, which is approximately 33 to 38 percent higher than the percentage of weed cover that was observed during the previous monitoring visit. This is likely because nonnative weeds tend to proliferate during the spring and summer. Nonnative species observed included black mustard (*Brassica nigra*), hairy bitter cress (*Cardamine hirsuta*), poison hemlock (*Conium maculatum*), and perennial pepperweed (*Lepidium latifolium*). Most of the nonnative weeds observed in these mitigation areas were just starting to germinate and had not gone to flower or started to produce seed. As weed abatement continues in the mitigation areas, it is anticipated that the seed bank of nonnative and invasive weeds will decrease.

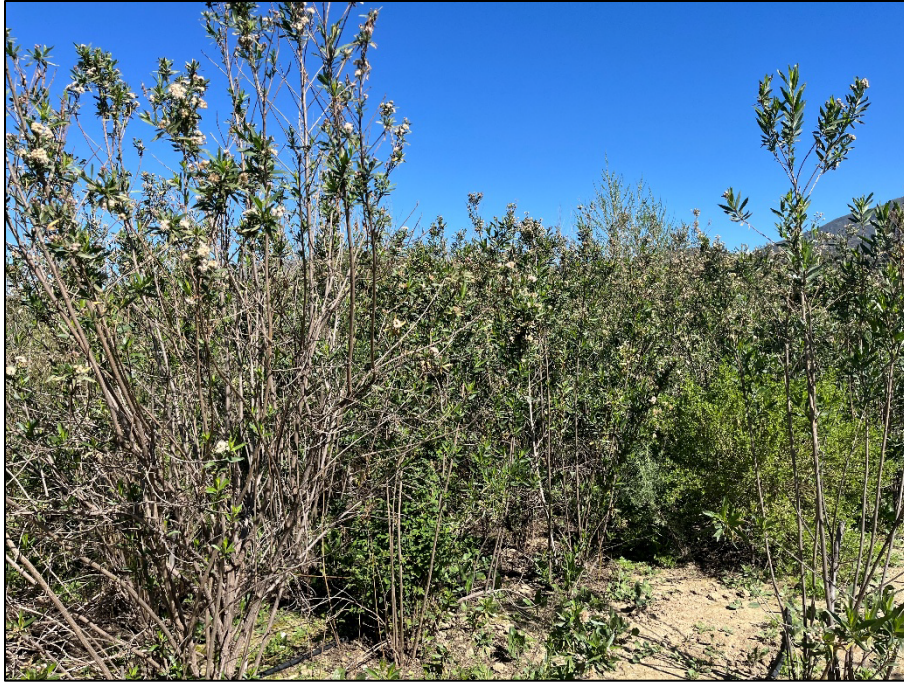
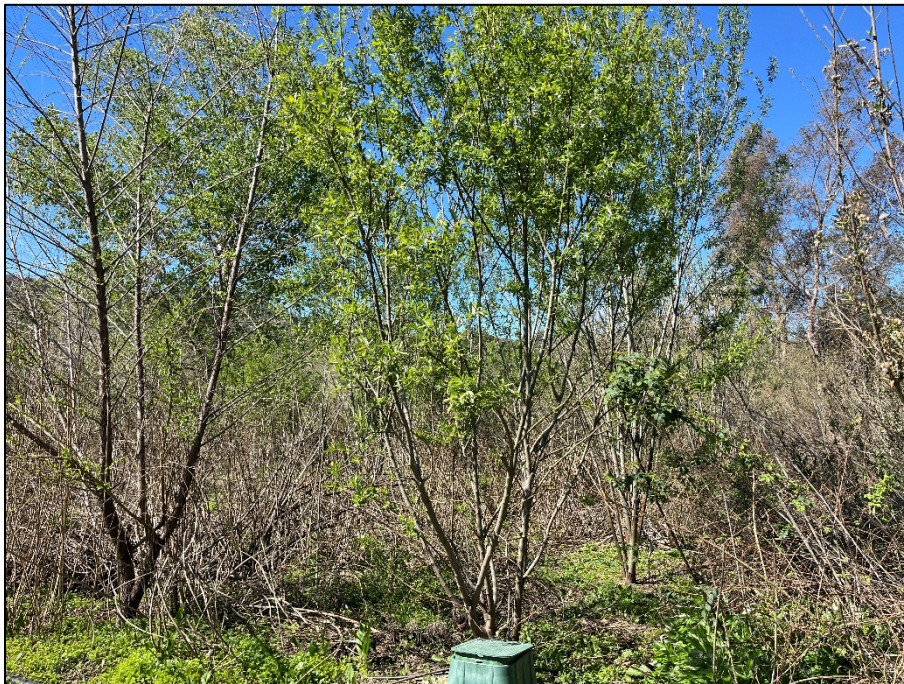
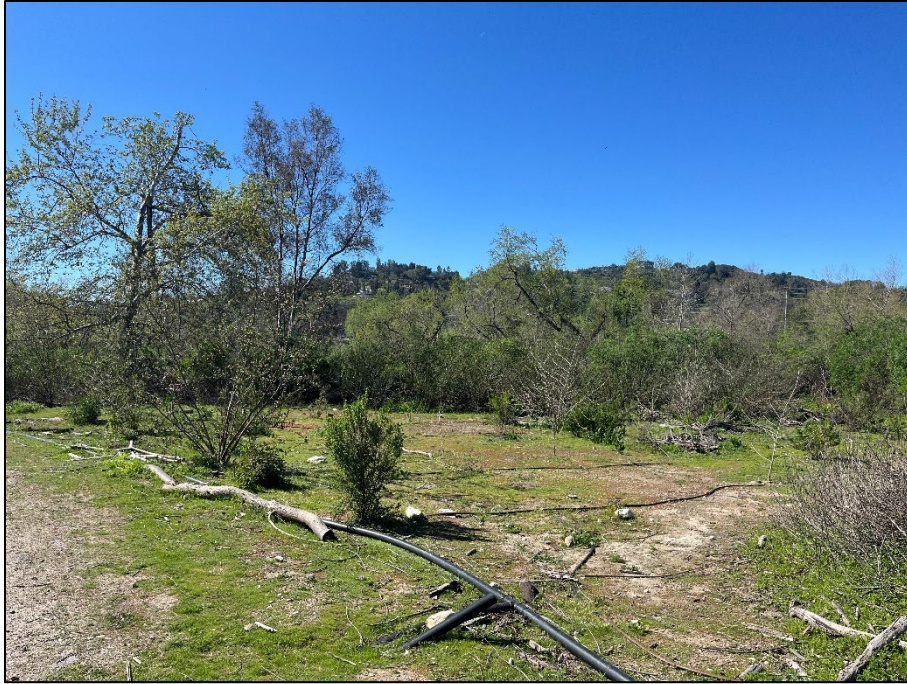
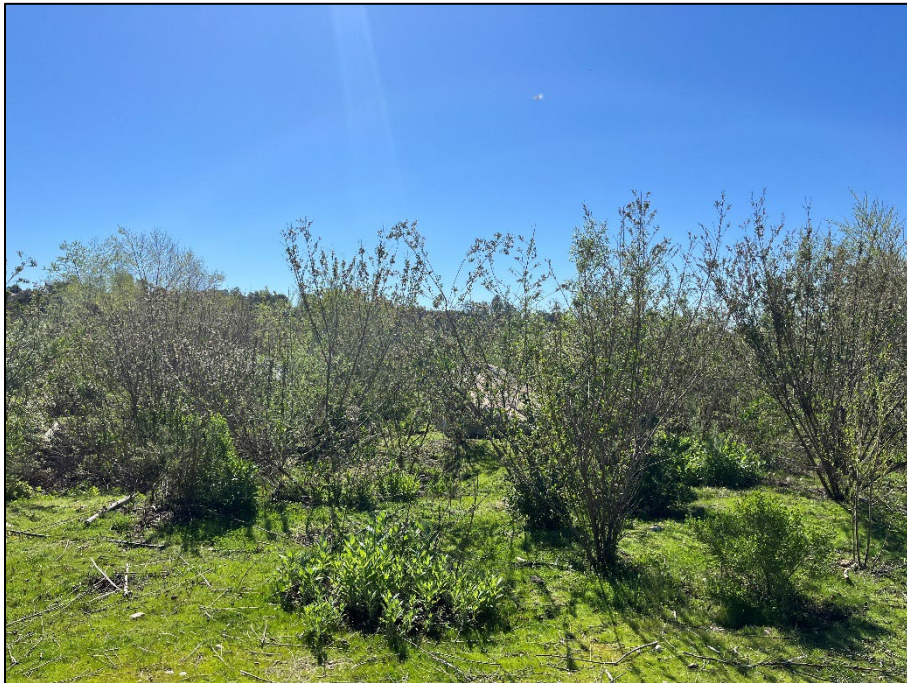
Photo 5. Overview DG-4A

The overall health of the container plants in DG-4A was noted as being good and this mitigation area is becoming well established. Approximately less than 5 percent of the container plants and stakes in DG-4A were noted as showing signs of stress which is approximately the same percentage of plants which were showing signs of stress during the previous monitoring visit. This included the remaining container plants from the first installation and the container plants that were installed to replace the original container plants and stakes planted in the middle section of DG-4A that appeared to be dead or in a condition unlikely to recover during previous monitoring visits. Stress may be occurring due to similar reasons described for DG-4 WOUS and DG-4 WOUS Connections. Photos 5 through 8 in Appendix B document the mitigation area during the monitoring visit.

Nonnative weed cover in the DG-4A mitigation area ranged from approximately 25 to 40 percent during the monitoring visit, which is approximately 15 to 30 percent higher than what was observed during the previous monitoring visit. This is likely because nonnative weeds tend to proliferate during the spring and summer. Nonnative species observed included black mustard, poison hemlock, and perennial pepperweed. Most of the nonnative weeds observed in these mitigation areas were just starting to germinate and had not gone to flower or started to produce seed. As weed abatement continues in the mitigation areas, it is anticipated that the seed bank of nonnative and invasive weeds will decrease; however, perennial pepperweed easily resprouts from rhizomatous roots that can be difficult to fully remove with hand tools.

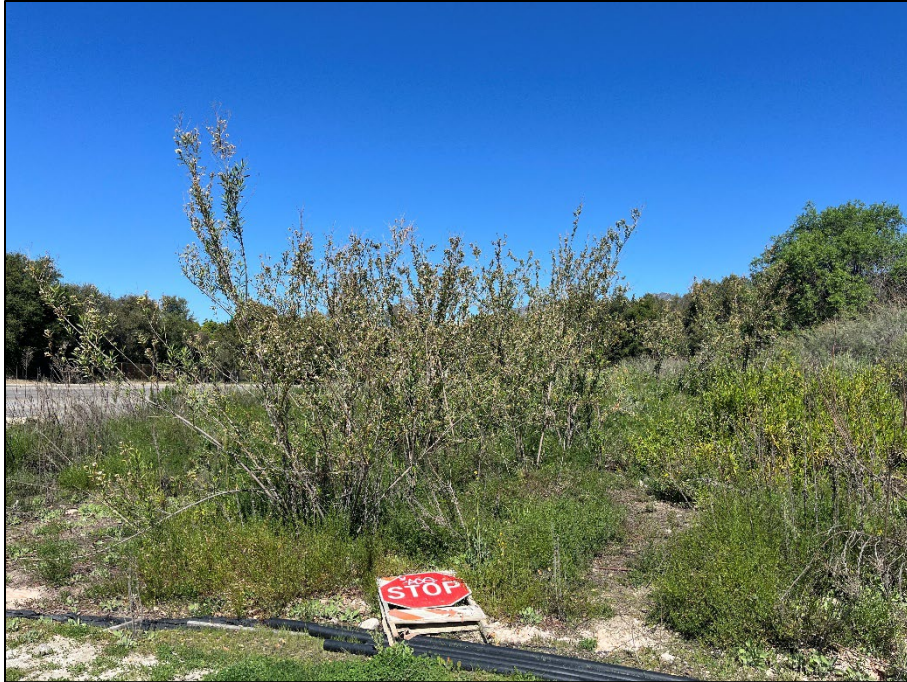
Photo 9: Overview Tire Wash

The overall health of the container plants in the Tire Wash mitigation area was noted as being good. Less than 5 percent of the container plants were noted as showing varied levels of stress, which is the same percentage of plants that were showing stress during the previous monitoring visit. This included the remaining container plants from the first installation and the replacement container plants that were

installed to replace the container plants that were either missing or appeared to be dead or in a condition unlikely to recover during previous monitoring visits. Stress may be occurring due to similar reasons described for DG-4 WOUS and DG-4 WOUS Connections. In addition, some of the container plants are being smothered by deerweed (*Acmispon glaber*), which is proliferating in this area. The irrigation system was found to be functioning properly within this mitigation area. Photo 9 in Appendix B documents the mitigation area during the monitoring visit.

Nonnative weed cover in the Tire Wash mitigation area was estimated at approximately 5 to 10 percent, which is approximately 4 to 9 percent higher than the percentage of nonnative cover that was observed during the previous monitoring visit. Nonnative species observed included black mustard, red-stemmed filaree (*Erodium cicutarium*), and Spanish broom (*Spartium junceum*). Most of the nonnative weeds observed in this mitigation area were just starting to germinate and were not going to flower or producing seed. As weed abatement continues in the mitigation areas, it is anticipated that the seed bank of nonnative and invasive weeds will decrease.

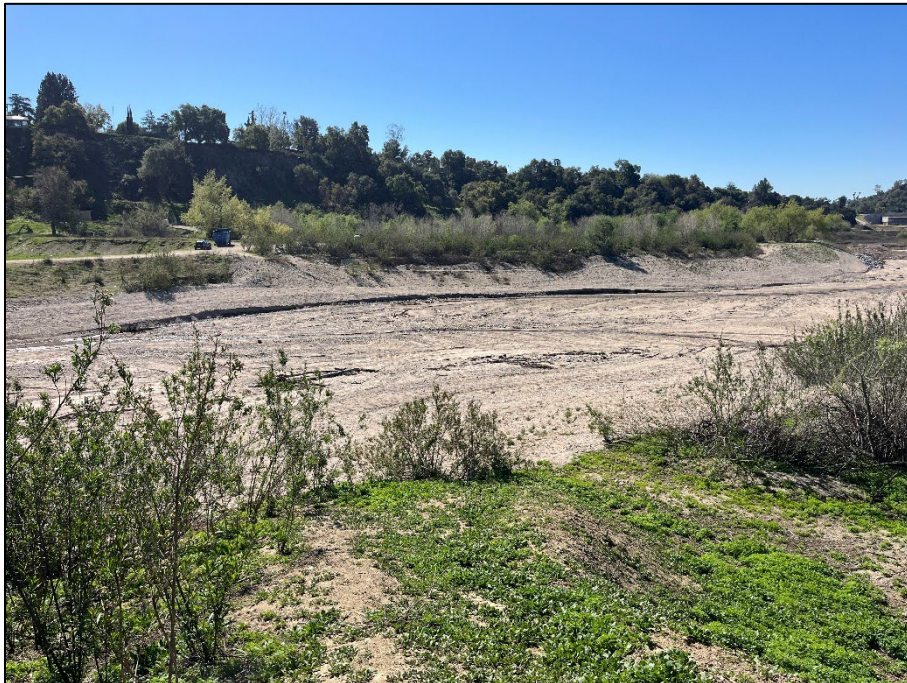
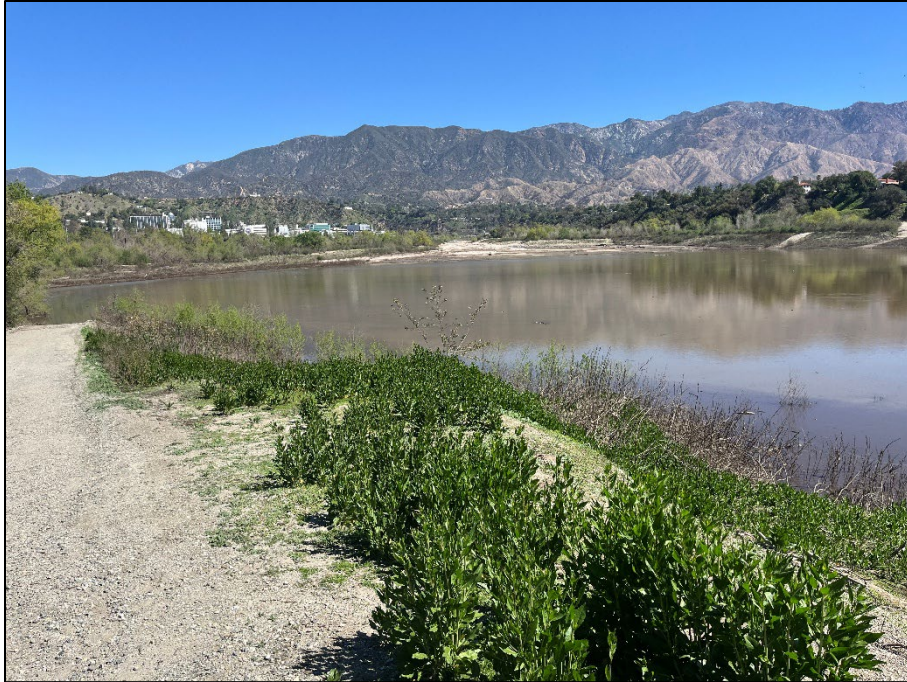
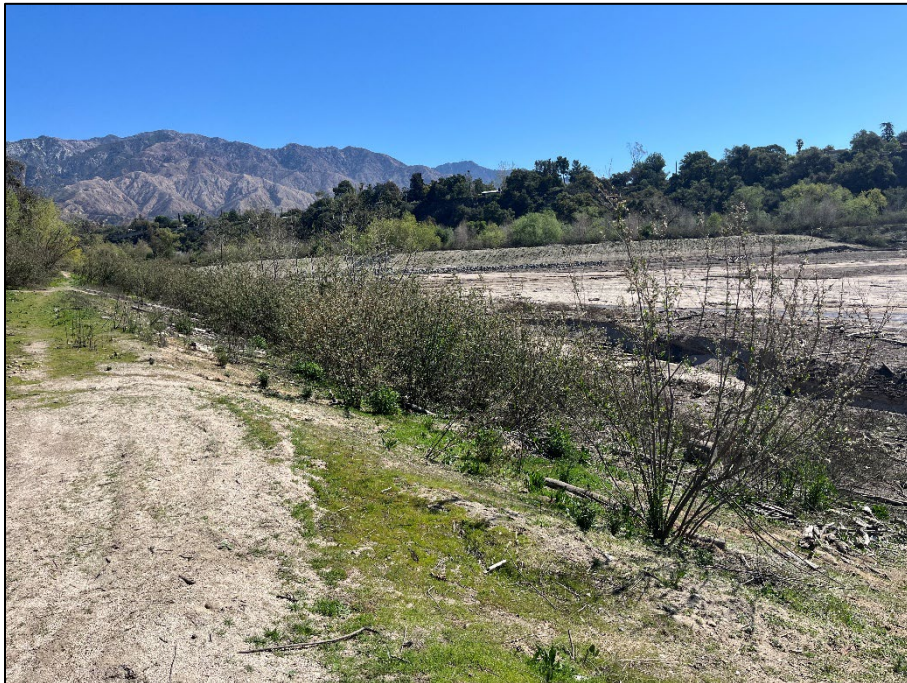
Photo 10: Overview Side Slopes

Container plants were not installed on the Side Slopes or in Flint Wash, but these areas were seeded with native plant species. Native plant growth was noted throughout the Side Slopes and Flint Wash, likely both from natural recruitment and from seeding. Minor to moderate erosion was present at the base of the Side Slopes and the hydroseeded portions of the Side Slopes where previous erosion had occurred showed minimal germination; however, the level of native cover was observed to be higher in these areas during the March monitoring visit than during previous monitoring visits and some areas appear to be stabilizing. The lower level of germination on these portions of the Side Slopes could be due to lack of soil nutrients, lack of organic matter, and/or incorrect compaction levels. Native plants such as mugwort, mulefat, California buckwheat (*Eriogonum fasciculatum*), Hooker's evening primrose, black willow (*Salix gooddingii*), and black sage (*Salvia mellifera*) were observed sprouting on the Side Slopes and in Flint Wash. Overall native cover was estimated to be approximately 50 to 55 percent during the monitoring visit; however, portions of the Side Slopes that have previously had erosion issues had a lower level of cover. Photos 10 through 12 in Appendix B document the Side Slopes during the monitoring visit.

Nonnative weed cover on the Side Slopes and Flint Wash was estimated at approximately 25 percent overall, which is approximately 20 percent higher than the percentage of weed cover that was observed during the previous monitoring visit. This is likely because nonnative weeds tend to proliferate during the spring and summer. Nonnative species observed on the Side Slopes and Flint Wash included black mustard, poison hemlock, red-stemmed filaree, and perennial pepperweed. Most of the nonnative weeds observed in this mitigation area were just starting to germinate; however, some were starting to flower and will soon go to seed. These areas should be weeded prior to seed production. As weed abatement

Portions of the Side Slopes which were previously noted as having significant erosion that occurred as a result of heavy rainfall during the 2023 wet season and following the tropical storm in late August 2023 were noted as having been repaired during previous monitoring visits and were included in the supplemental seeding effort which was completed in November of 2023. Some additional erosion was observed at the toe of the Side Slopes in these areas and has the potential to worsen. As more perennial plants become established on the Side Slopes, erosion should become less of an issue; however, action will need to be taken to repair the damage caused by the erosion and measures should be taken to reduce damage from erosion in the future. In addition, if the supplemental seeding effort does not produce germination on the previously eroded Side Slopes, adaptive management techniques will likely be warranted. During future monitoring events, erosion should continue to be monitored in all planted areas and if warranted, erosion Best Management Practices should be installed in appropriate areas. This may only require the installation of straw wattles at select sites to prevent existing rills from becoming larger.
