January 21, 2026
(2022-226.02)

Re: *Devil's Gate Reservoir Restoration Project – Phase 3 Restoration Qualitative Monitoring Conducted on January 7, 2026*

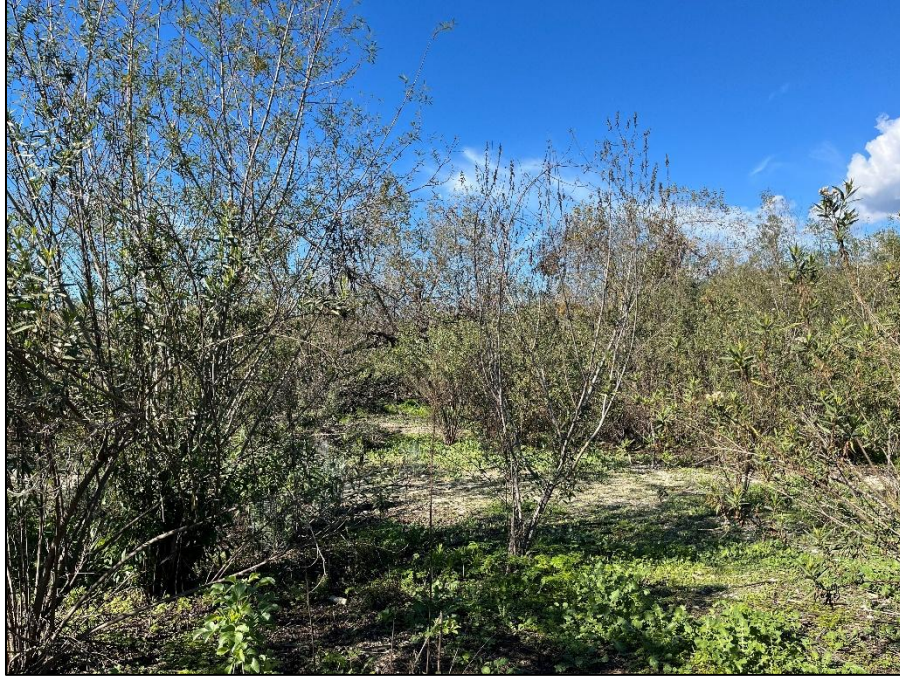
Photo 1. Overview DG-4 WOUS & WOUS Connections

The overall health of the container plants in DG-4 WOUS and DG-4 WOUS Connections was noted as being good. Approximately 5 percent of the container plants and stakes in DG-4 WOUS and DG-4 WOUS Connections were noted as showing signs of stress and a negligible amount were noted as being dead or missing. This is approximately the same percentage of plants that were showing stress during the previous monitoring visit. Stress may be occurring as a result of 1) herbivory by rabbits or other wildlife, 2) competition from nonnative and invasive weeds, 3) misplaced emitters, 4) recreational traffic through the mitigation areas, and/or 5) drought stress from recent high temperatures. Additionally, portions of the DG-4 WOUS Connections mitigation area adjacent to the Mining Pit mitigation area were inundated from recent storm events. Photos 1 through 4 (Appendix B) document the mitigation areas during the monitoring visit.

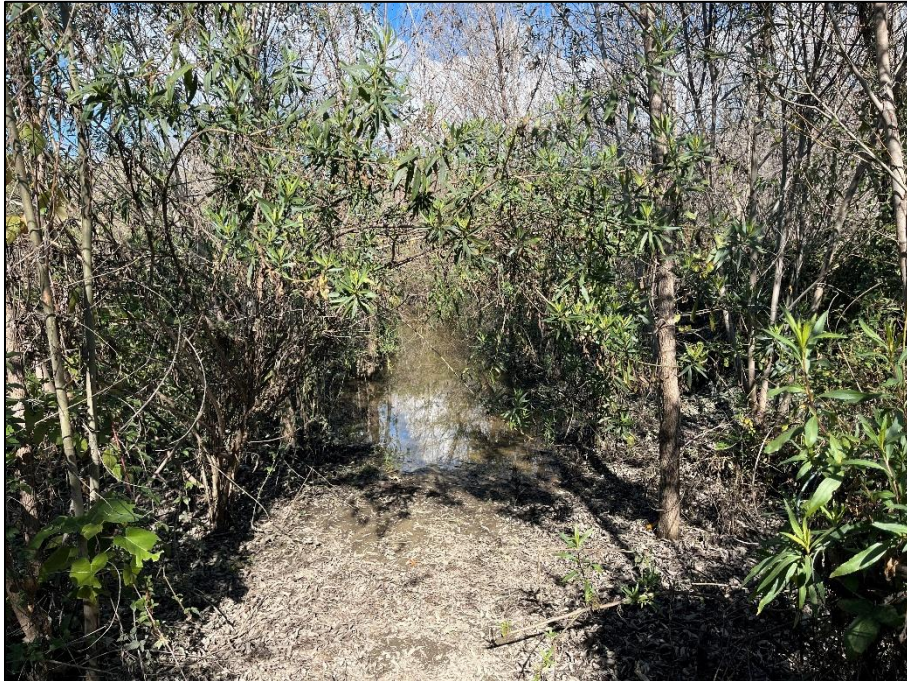
Photo 4. Inundation DG-4 WOUS & WOUS Connections

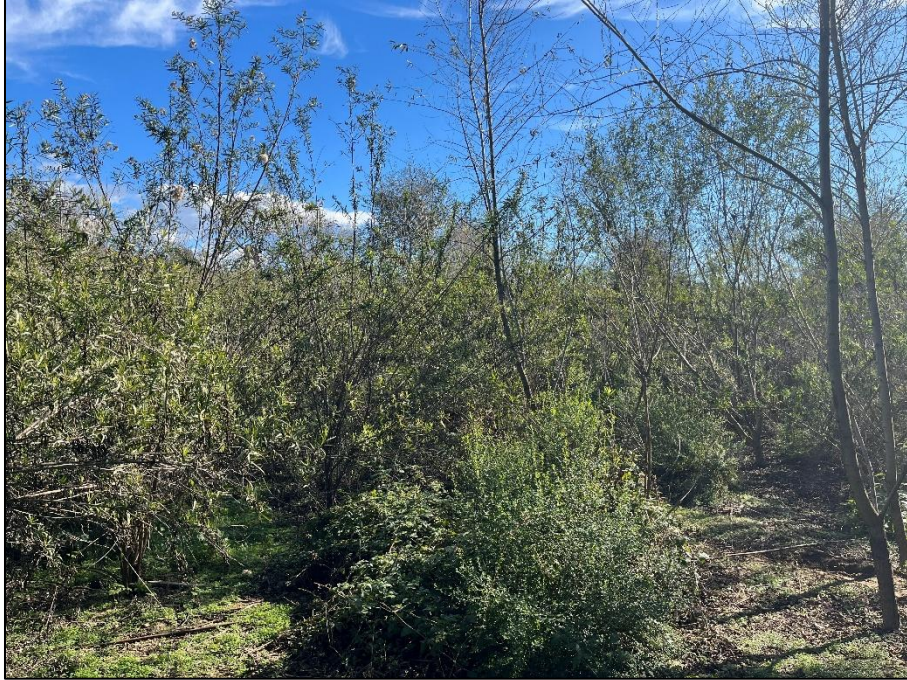
Photo 5. Overview DG-4A

The overall health of the container plants in DG-4A was noted as being good and this mitigation area is becoming well established. Approximately 5 to 10 percent of the container plants and stakes in DG-4A were noted as showing signs of stress which is approximately 5 percent higher than the percentage of plants which were showing signs of stress during the previous monitoring visit. This included the remaining container plants from the first installation and the container plants that were installed to replace the original container plants and stakes planted in the middle section of DG-4A that appeared to be dead or in a condition unlikely to recover during previous monitoring visits. Stress may be occurring due to similar reasons described for DG-4 WOUS and DG-4 WOUS Connections. Additionally, the southern portions of the DG-4A mitigation area were inundated during recent storm events. Photos 5 through 7 in Appendix B document the mitigation area during the monitoring visit.

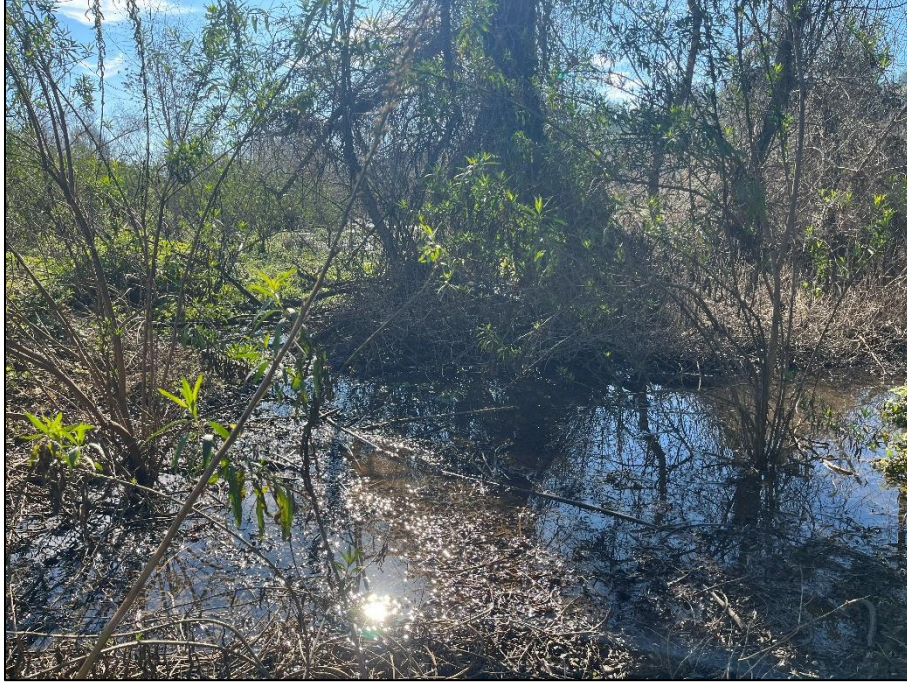
Photo 7: Inundation DG-4A

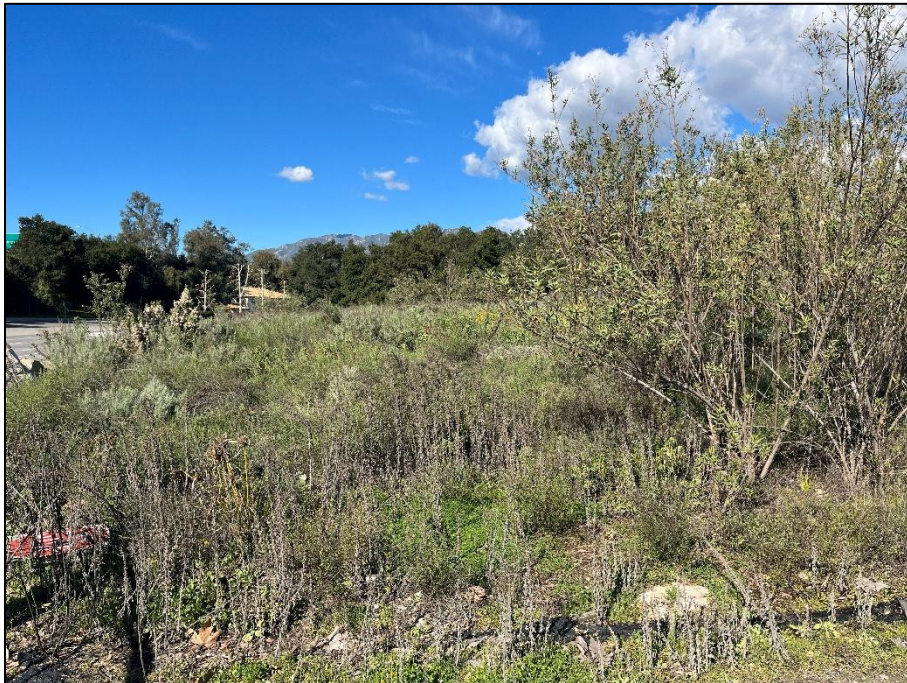
Photo 8: Overview Tire Wash

The overall health of the container plants in the Tire Wash mitigation area was noted as being good. Less than 5 percent of the container plants were noted as showing varied levels of stress, which is the same percentage of plants that were showing stress during the previous monitoring visit. This included the remaining container plants from the first installation and the replacement container plants that were installed to replace the container plants that were either missing or appeared to be dead or in a condition unlikely to recover during previous monitoring visits. Stress may be occurring due to similar reasons described for DG-4 WOUS and DG-4 WOUS Connections. In addition, some of the container plants are being smothered by deerweed (*Acmispon glaber*), which is proliferating in this area. The irrigation system was found to be functioning properly within this mitigation area. Photo 8 in Appendix B documents the mitigation area during the monitoring visit.

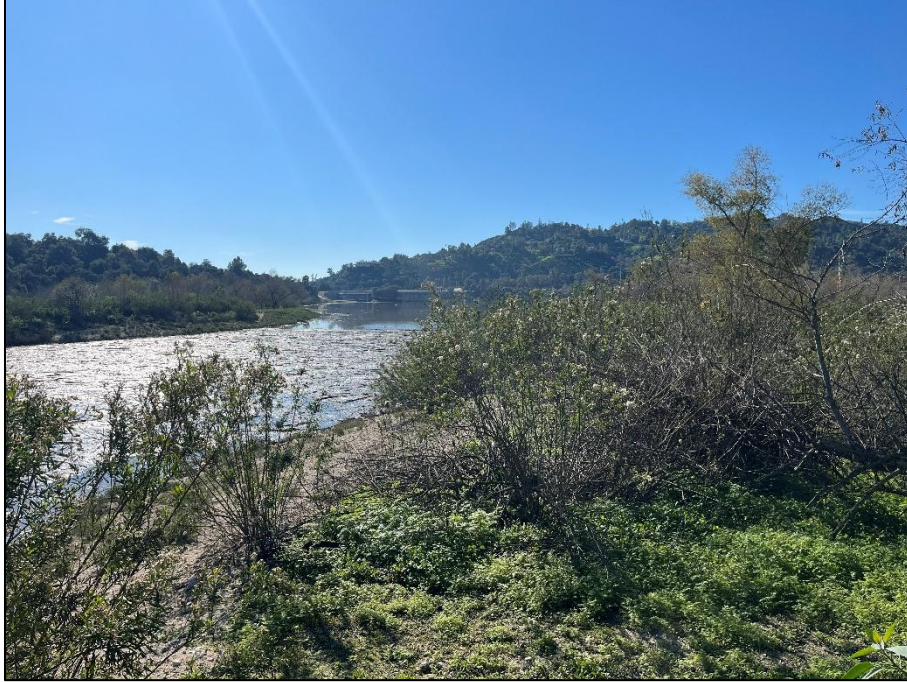
Photo 9: Overview Side Slopes

Container plants were not installed on the Side Slopes or in Flint Wash, but these areas were seeded with native plant species. Native plant growth was noted throughout the Side Slopes and Flint Wash, likely both from natural recruitment and from seeding. Minor to moderate erosion was present at the base of the Side Slopes and the hydroseeded portions of the Side Slopes where previous erosion had occurred showed minimal germination; however, the level of native cover continues to increase and some areas appear to be stabilizing. The lower level of germination on these portions of the Side Slopes could be due to lack of soil nutrients, lack of organic matter, and/or incorrect compaction levels. Native plants such as deerweed, mugwort, mulefat, Canada horseweed, California buckwheat (*Eriogonum fasciculatum*), black willow (*Salix gooddingii*), and black sage were observed sprouting on the Side Slopes and in Flint Wash. Overall native cover was estimated to be approximately 60 to 65 percent during the monitoring visit; however, portions of the Side Slopes that have previously had erosion issues had a lower level of cover. Photos 9 through 12 in Appendix B document the Side Slopes during the monitoring visit.

Portions of the Side Slopes which were previously noted as having significant erosion that occurred as a result of heavy rainfall during the 2023 wet season and following the tropical storm which occurred in late August 2023 were noted as having been repaired during previous monitoring visits. These areas were included in the supplemental seeding effort which was completed in November of 2023. Some additional erosion was observed at the toe of the Side Slopes in these areas and has the potential to worsen. As more perennial plants become established on the Side Slopes, erosion should become less of an issue; however, action will need to be taken to repair the damage caused by the erosion and measures should be taken to reduce damage from erosion in the future. In addition, if the supplemental seeding effort does not produce germination on the previously eroded Side Slopes, adaptive management techniques will likely be warranted. During future monitoring events, erosion should continue to be monitored in all planted areas and if warranted, erosion Best Management Practices should be installed in appropriate areas. This may only require the installation of straw wattles at select sites to prevent existing rills from becoming larger.
