Devil's Gate Monitoring Log

Devil's Gate Reservoir Restoration Project - 2018-047.00

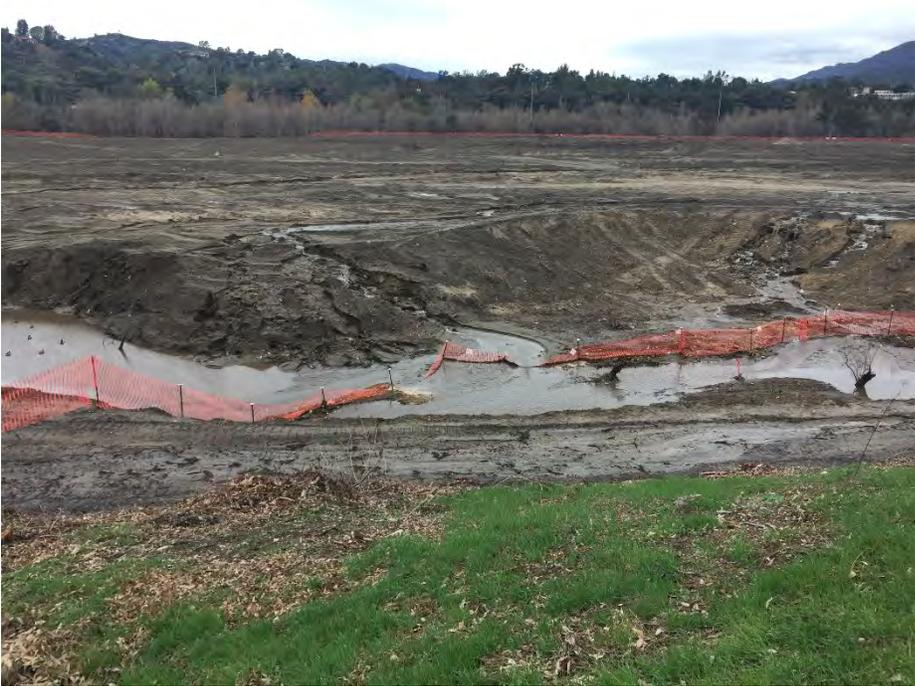
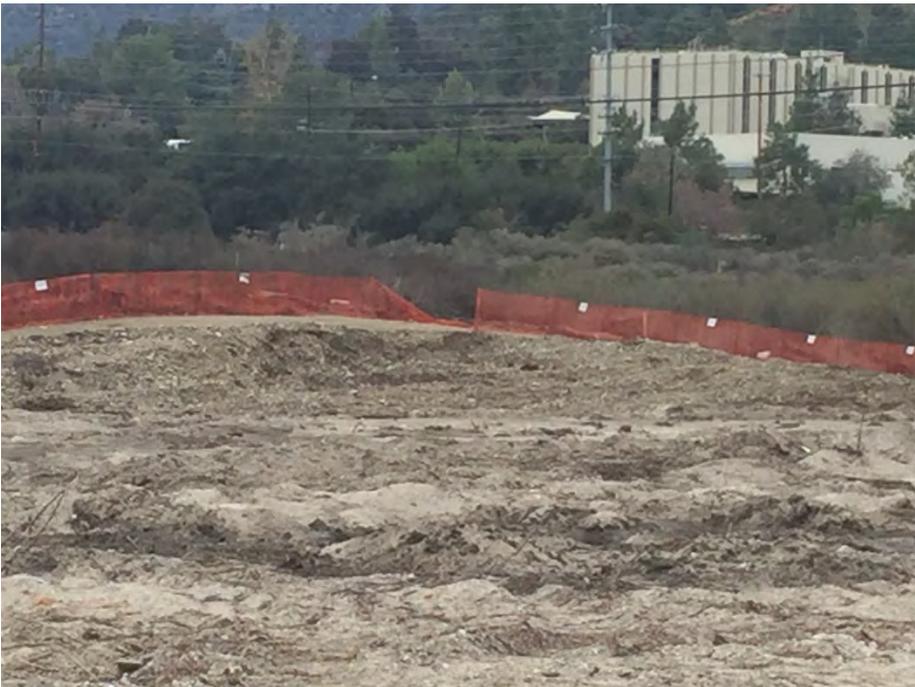
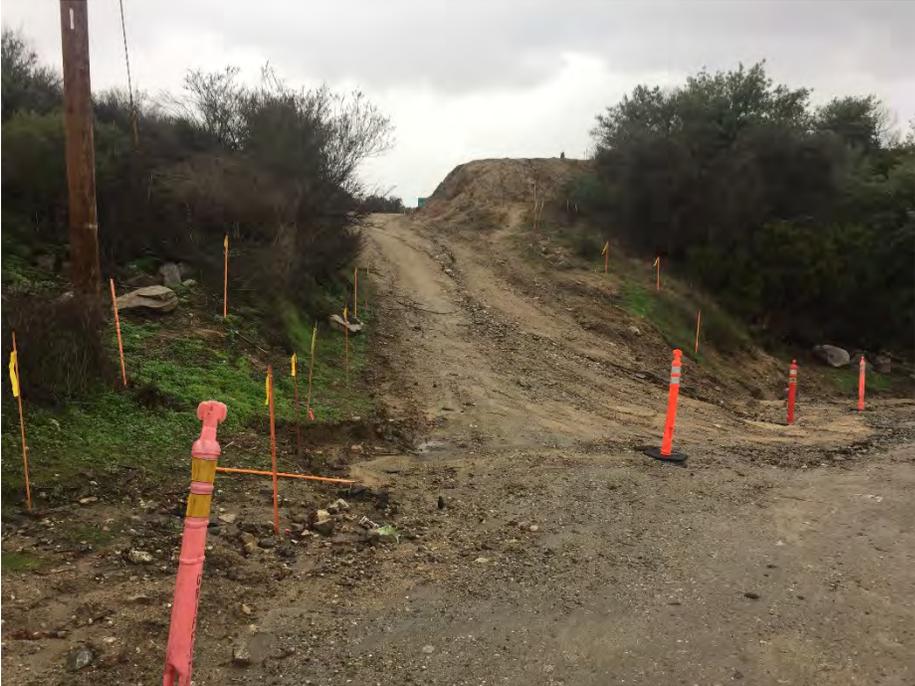
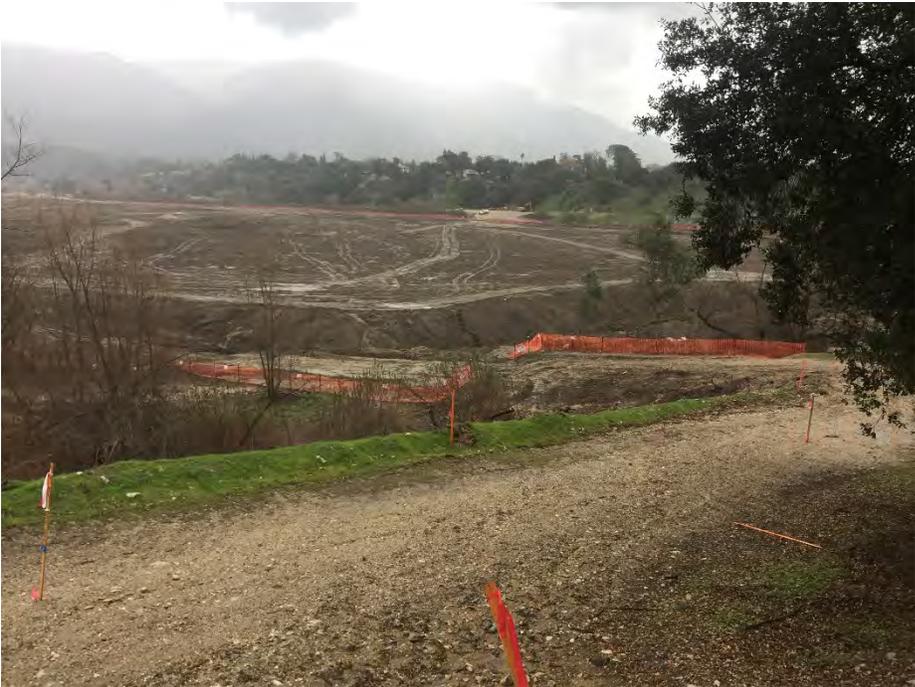
1200 onsite for 2x weekly site visit. No construction activities taking place due to rain. Areas where fence is damaged noted. Several 10+ ESA signs retrieved from trail/reservoir. Overall no major issues on-site. All vegetation has been removed, only small amounts of twig debris and dirt piles remain. 1400 left site.

Fix damaged fencing in NW corner and near Alta Dena Drain. Replace ESA signs with something weather proof.

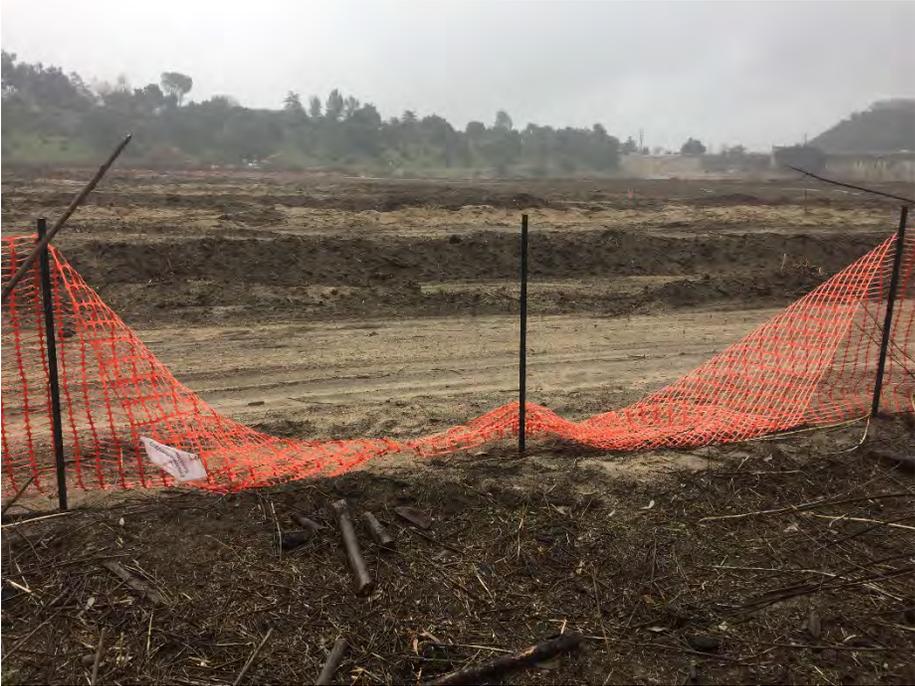
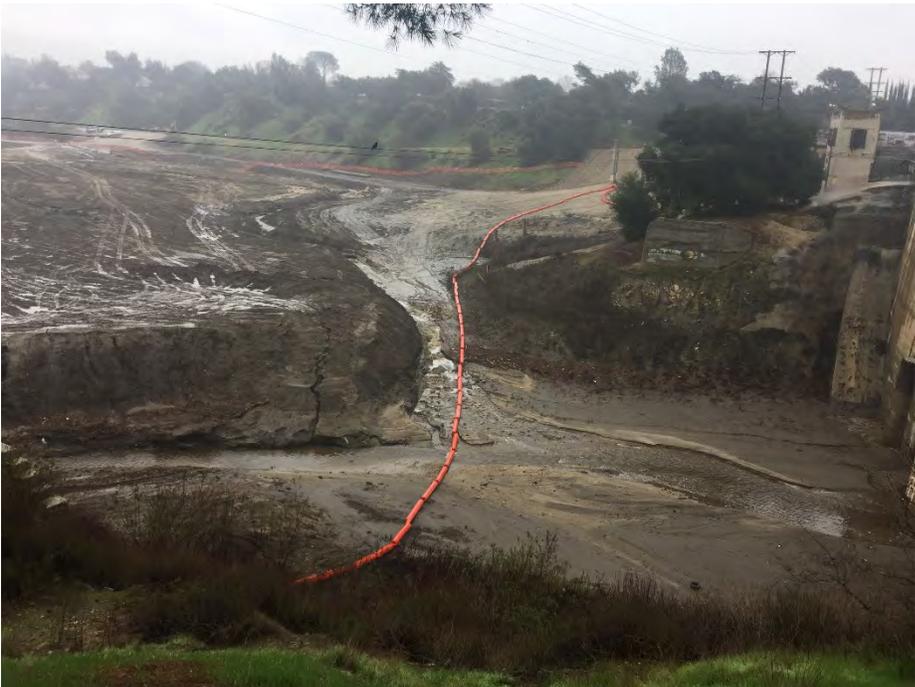
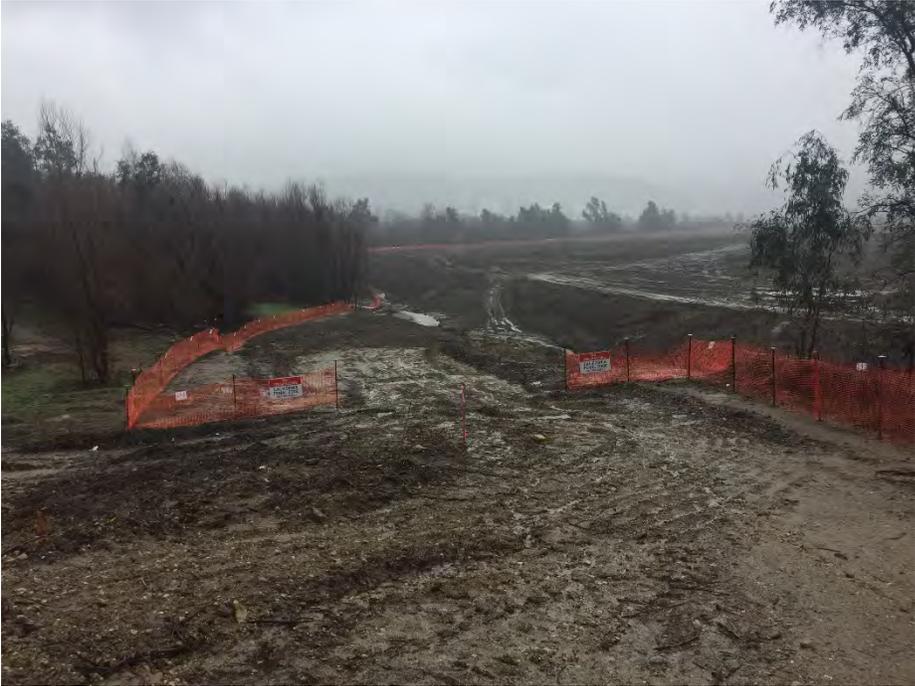
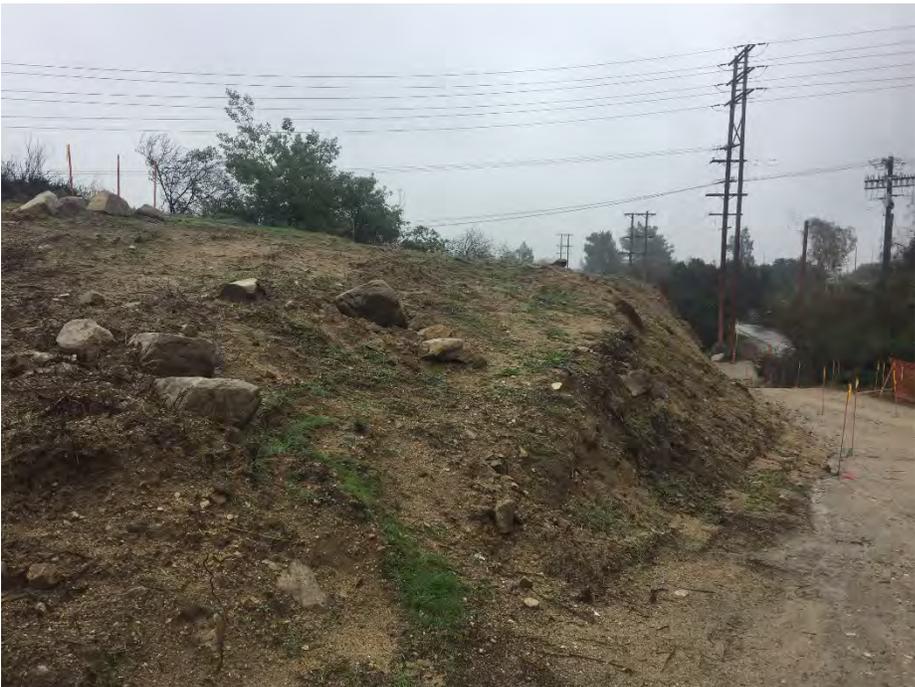
1140 arrived on site for 2nd of twice weekly site visits. Openings in fence noted along southwest side. 1330 left site, no bio issues observed. Minor fence repairs needed.

Minor fence repairs needed.

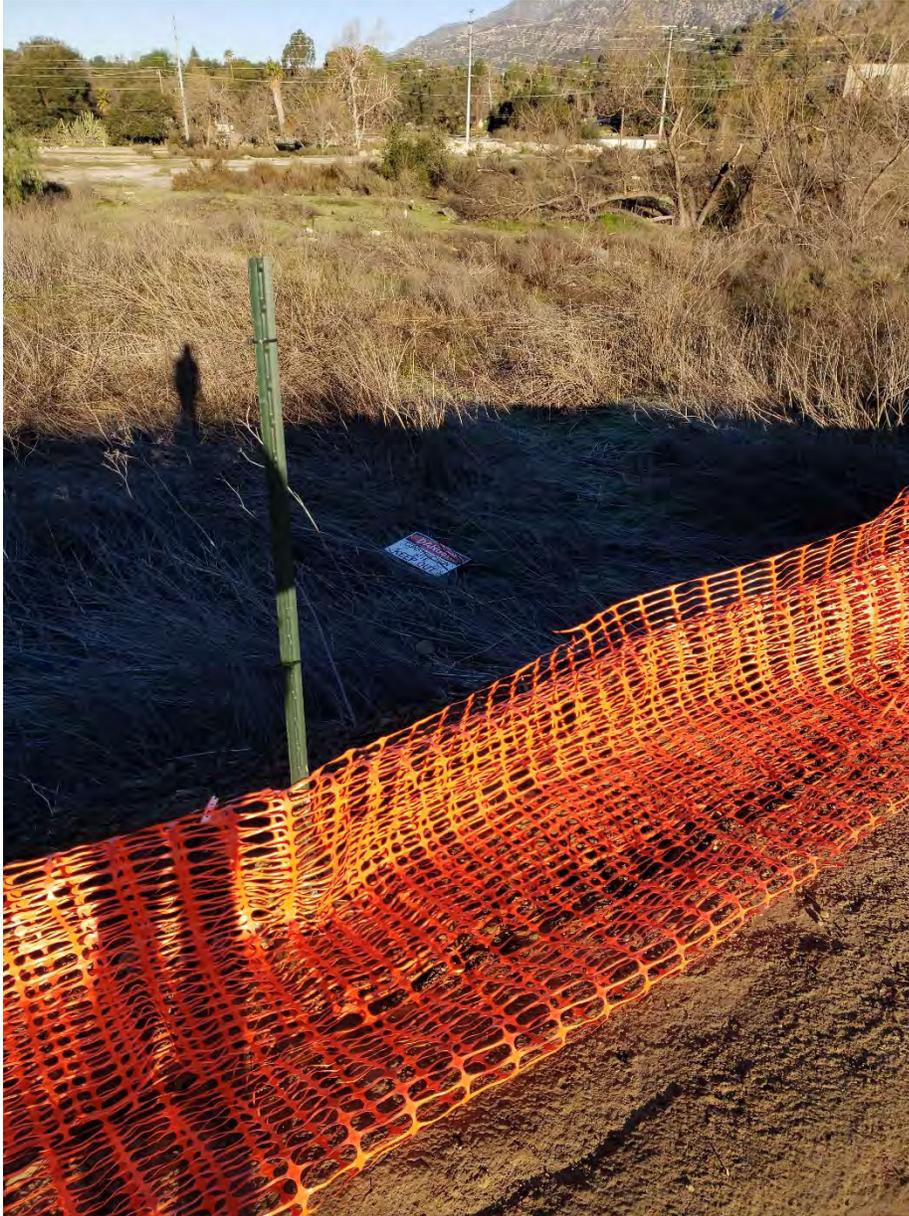
Log Entry #5 Photo A

Project signs along fence have washed out of sediment removal area.

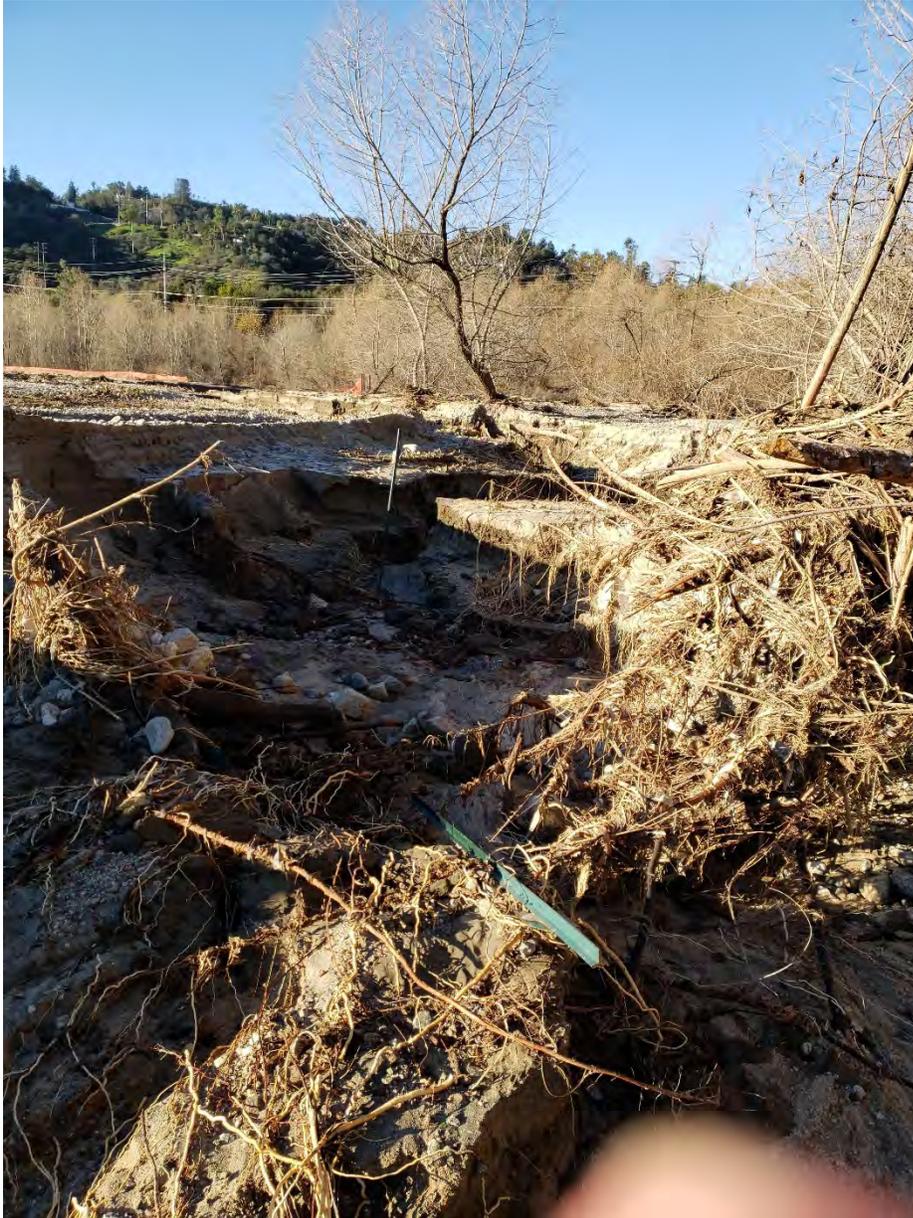
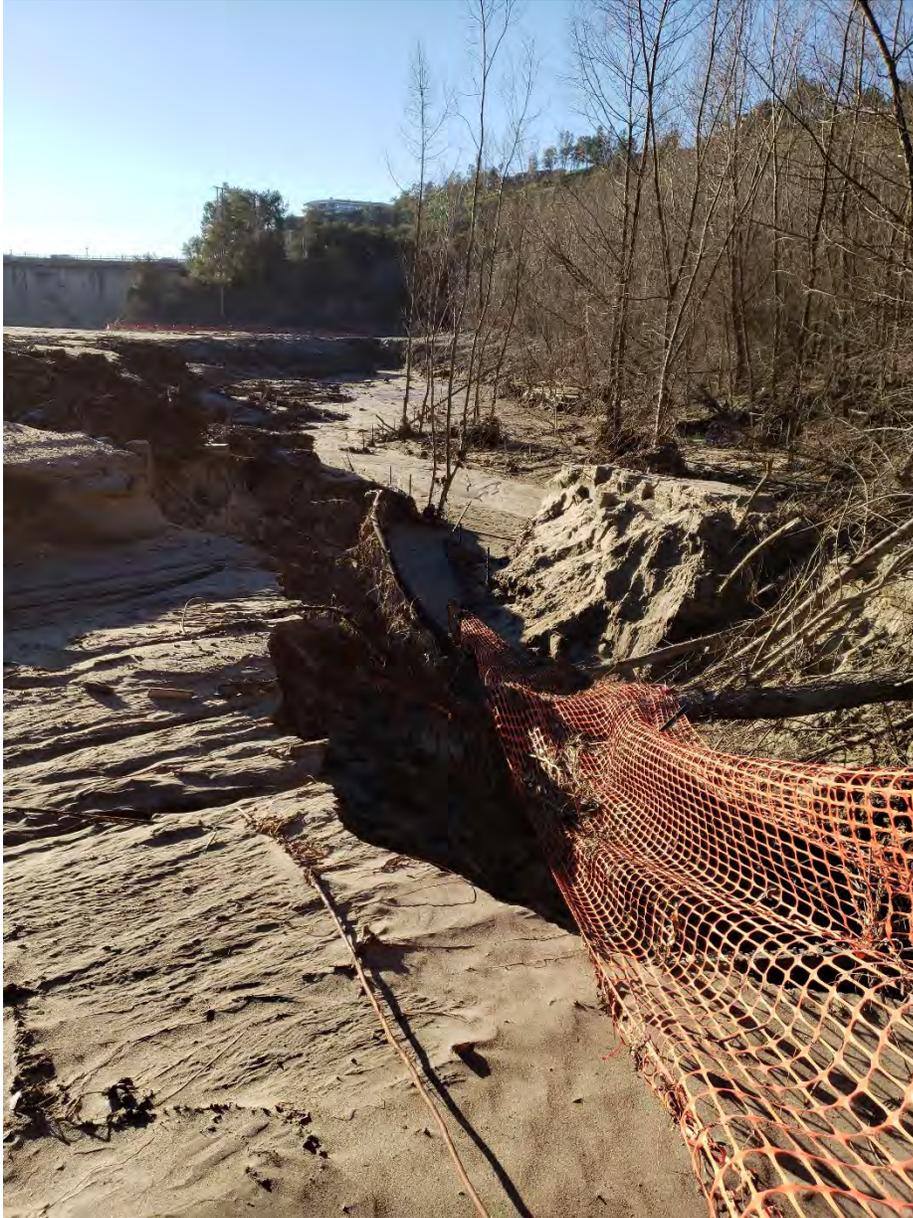
Fence completely washed out along west side toward southern end.

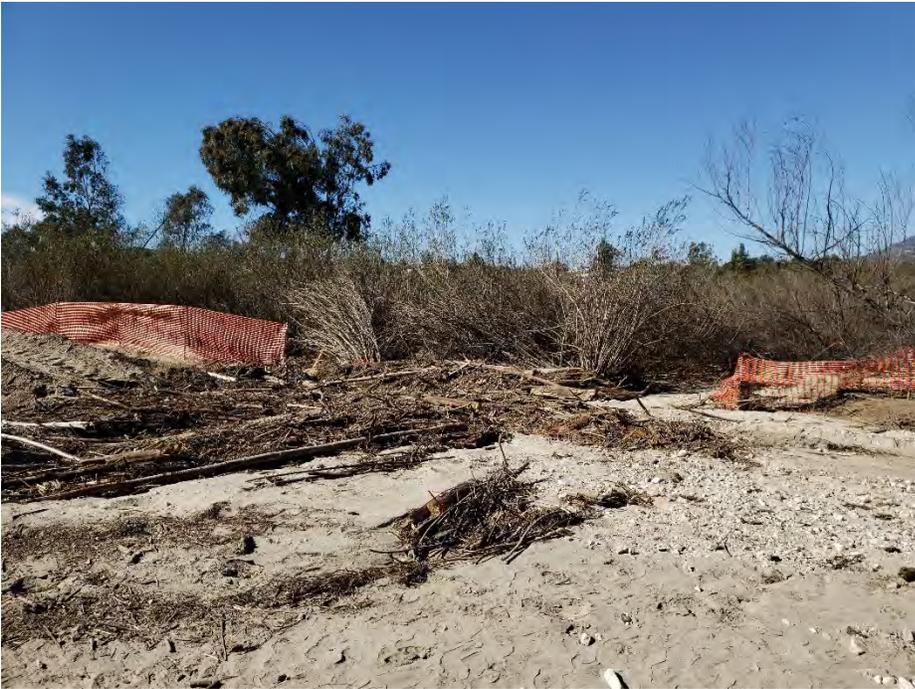
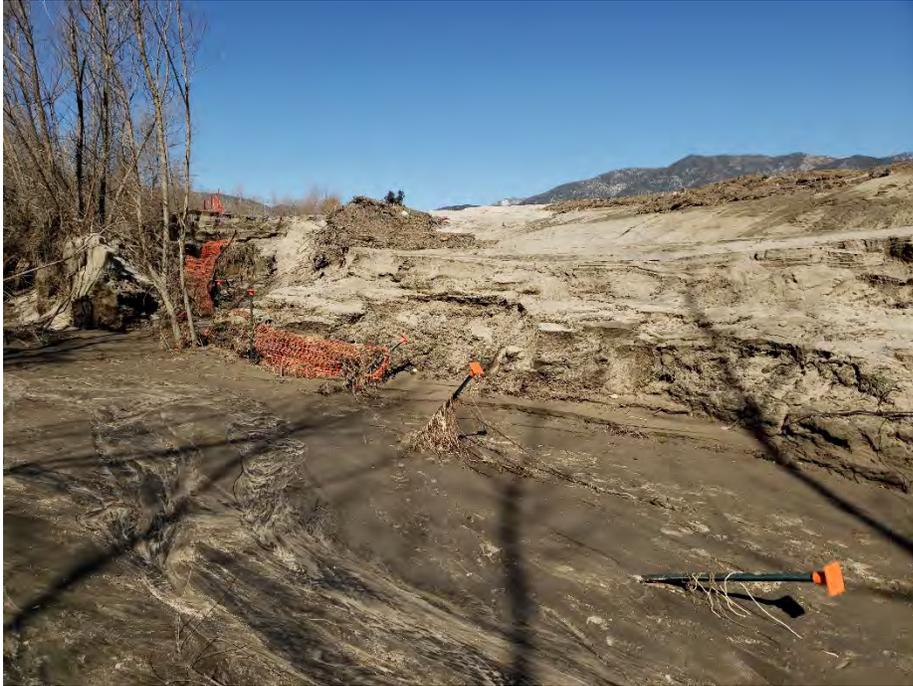
Multiple areas of downed fence, particularly on western boundary. A major section along the southwestern boundary is missing/washed out and is in need of replacement. Appears to be in same state as site check on Wednesday.

Fence is need of repair/replacement.
