**Re: *Devil's Gate Reservoir Restoration Project – Phase 1 Restoration Qualitative Monitoring Conducted on May 17, 2021***

## **1.0 INTRODUCTION**

Qualitative monitoring was conducted by Carley Lancaster and Joshua Harris on May 17, 2021. Field data collected during the monitoring event is provided as Attachment A. This report documents the first quarterly qualitative monitoring visit for the Phase 1 mitigation areas.

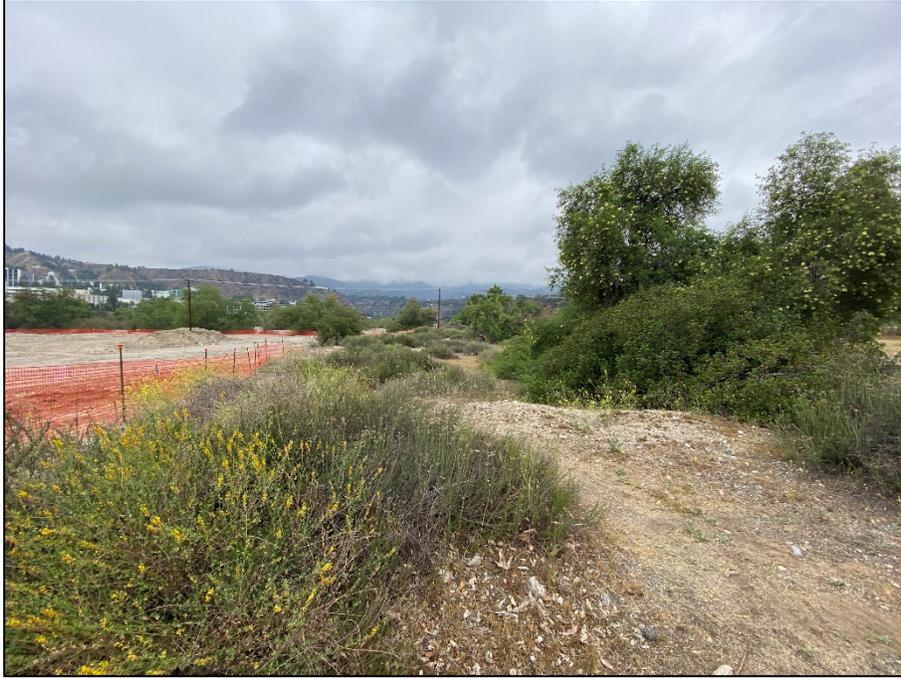
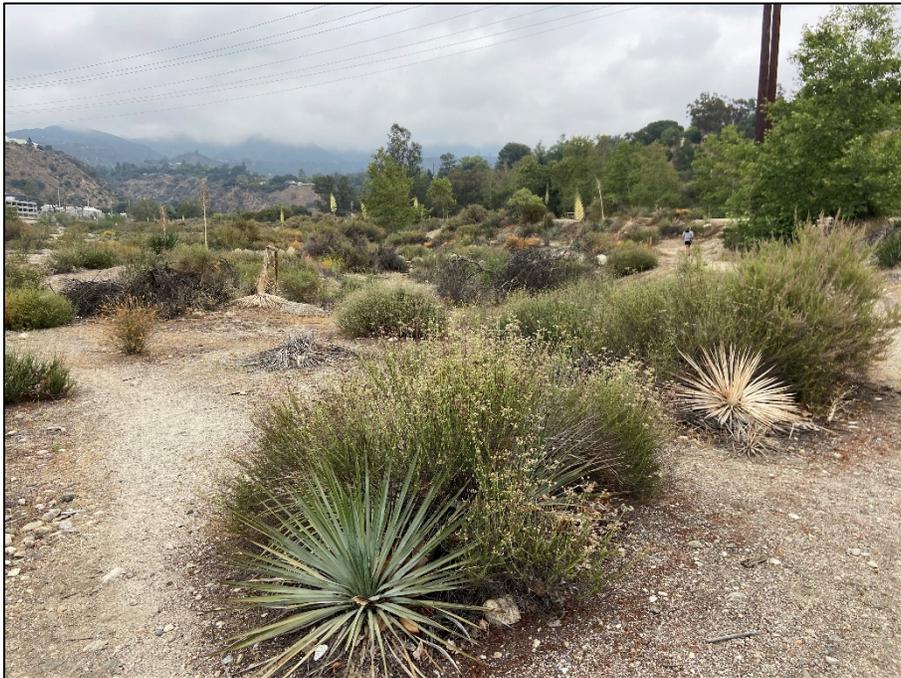
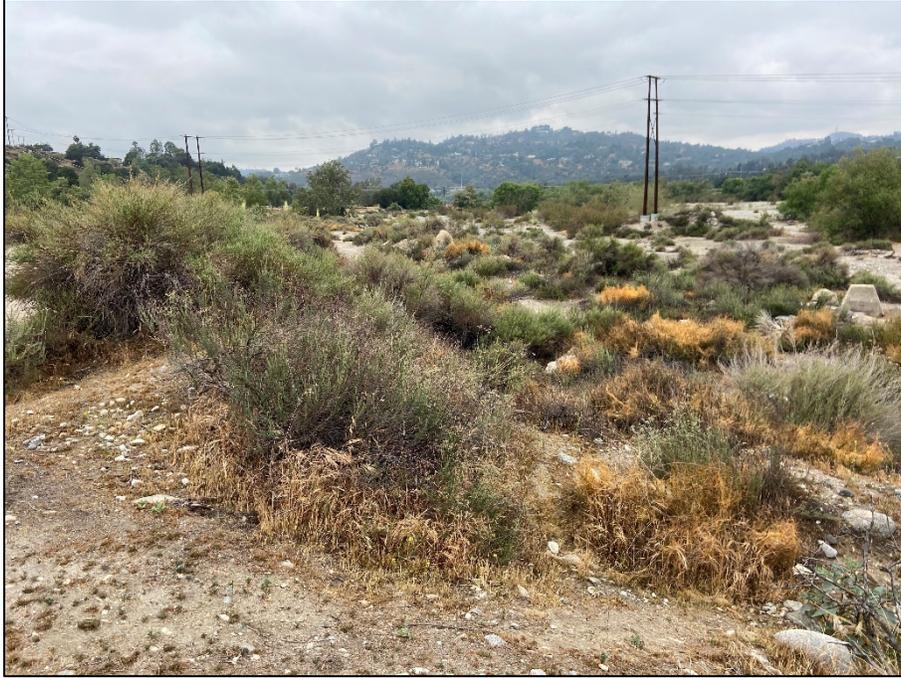
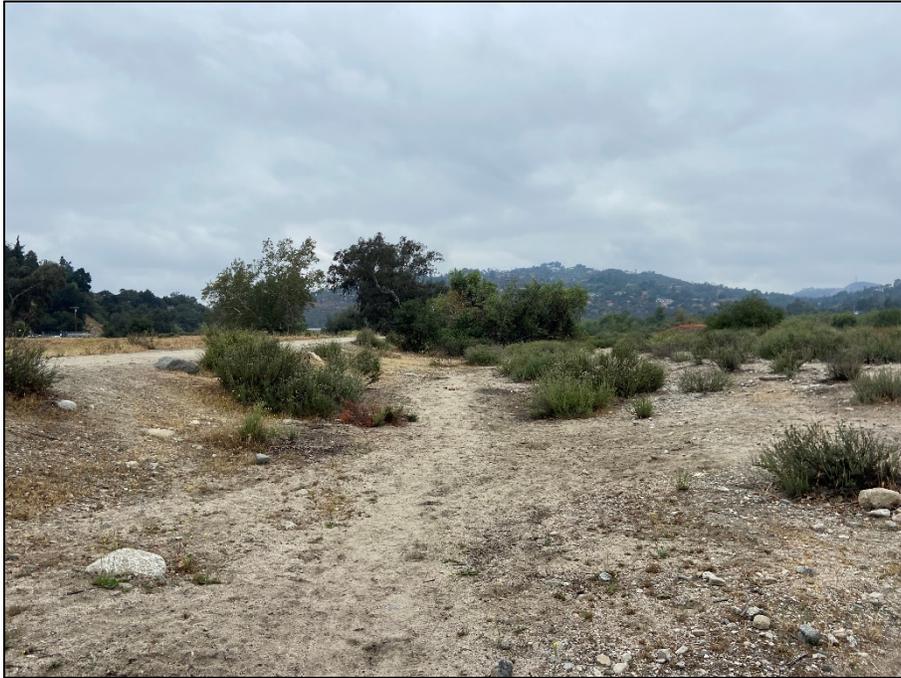
Container plants were not installed in the DG-1 or DG-1 WOUS mitigation areas, but these areas were seeded with native plant species. Native plant growth was noted throughout the DG-1 and DG-1 WOUS mitigation areas, likely both from natural recruitment and from seeding; however, germination was observed to be very minimal in the majority of these mitigation areas. Portions of DG-1 WOUS were noted as being scoured during the previous wet season and had minimal plant growth. Native plants such as deerweed (*Acmispon glaber*), common sandaster (*Corethrogyne filaginifolia*), California buckwheat (*Eriogonum fasciculatum*), scale broom (*Lepidospartum squamatum*), caterpillar phacelia (*Phacelia cicutaria*), and ladies' tobacco (*Pseudognaphalium californicum*) were observed sprouting in the DG-1 and DG-1 WOUS mitigation areas. In addition, dodder (*Cuscuta sp.*) was observed growing on some of the shrubs in this mitigation area, which could lead to future decline of these shrubs. Photos 1 through 4 in Attachment B document the mitigation area during the monitoring visit.

Nonnative weed cover in DG-1 and DG-1 WOUS was estimated at approximately 5 to 10 percent, if the dead annual weeds are excluded, which is approximately 5 percent lower than the level of weed cover that was observed during the previous qualitative monitoring event. Nonnative weeds are starting to germinate in some portions of DG-1. While most nonnative weeds were observed to be vegetative, some were observed to be in flower. Nonnative species observed germinating in DG-1 and DG-1 WOUS included black mustard (*Brassica nigra*), red brome (*Bromus madritensis ssp. rubens*), tocalote (*Centaurea melitensis*), red-stemmed filaree (*Erodium cicutarium*), and tree tobacco (*Nicotiana glauca*).

Photo 1: Overview Mitigation Area DG-1

Photo 2: Overview Mitigation Area DG-1

Photo 3: Overview Mitigation Area DG-1

Photo 4: Overview Mitigation Area DG-1

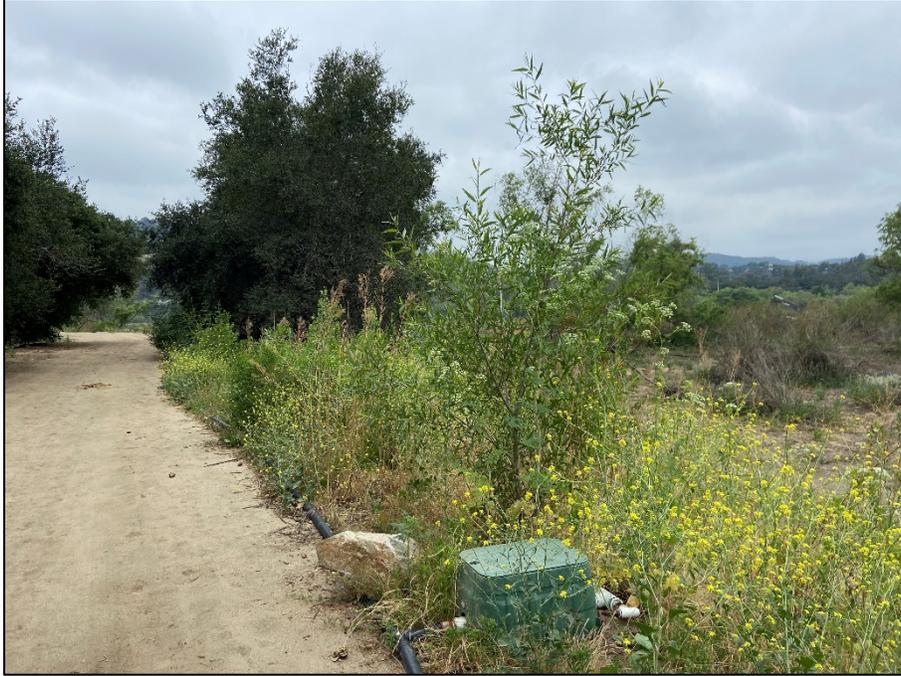
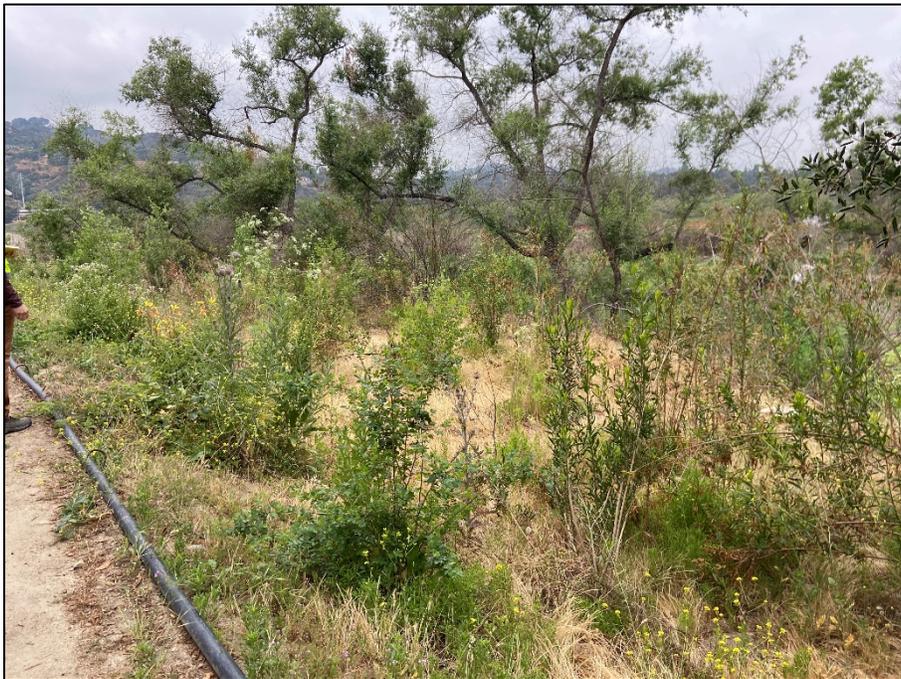
The overall health of the container plants in DG-2A was noted as being good. Only minimal stress was observed, and the majority of the remaining container plants are becoming well established. A negligible number of container plants appeared stressed, while approximately five percent were showing stress

during the previous qualitative monitoring event. Stress may be occurring as a result of 1) herbivory by rabbits or other wildlife, 2) competition from nonnative and invasive weeds, 3) misplaced emitters, or 4) recreational traffic through the mitigation areas. There were no additional container plants noted as being missing or dead. Formal mortality counts were taken for DG-2A during the 2020 quantitative monitoring and were included in the 2020 annual reporting. The willow species (*Salix sp.*) and Fremont's cottonwoods (*Populus fremontii*) in the mitigation areas were no longer showing signs of seasonal dieback. Some of the planting basins were observed to have minor erosion and should be repaired. The installation of plants in the DG-2A mitigation area appears to have been completed successfully. The current issues identified during the monitoring visit are not expected to have an effect on the continued growth of the plants in the mitigation area. Photos 5 through 6 in Attachment B document the mitigation area during the monitoring visit.

Nonnative weed cover in DG-2A was estimated at approximately 45 percent, which is approximately 30 percent higher than the level of weed cover that was observed during the previous qualitative monitoring event. Nonnative species observed in DG-2A included black mustard, poison hemlock (*Conium maculatum*), red-stemmed filaree, perennial pepperweed (*Lepidium latifolium*), white horehound (*Marrubium vulgare*), and curly dock (*Rumex crispus*). Many of the nonnative weeds observed in this mitigation area are starting to flower and will soon go to seed. Weed abatement should be conducted for this mitigation area as soon as possible.

Photo 5: Overview Mitigation Area DG-2A

Photo 6: Overview Mitigation Area DG-2A

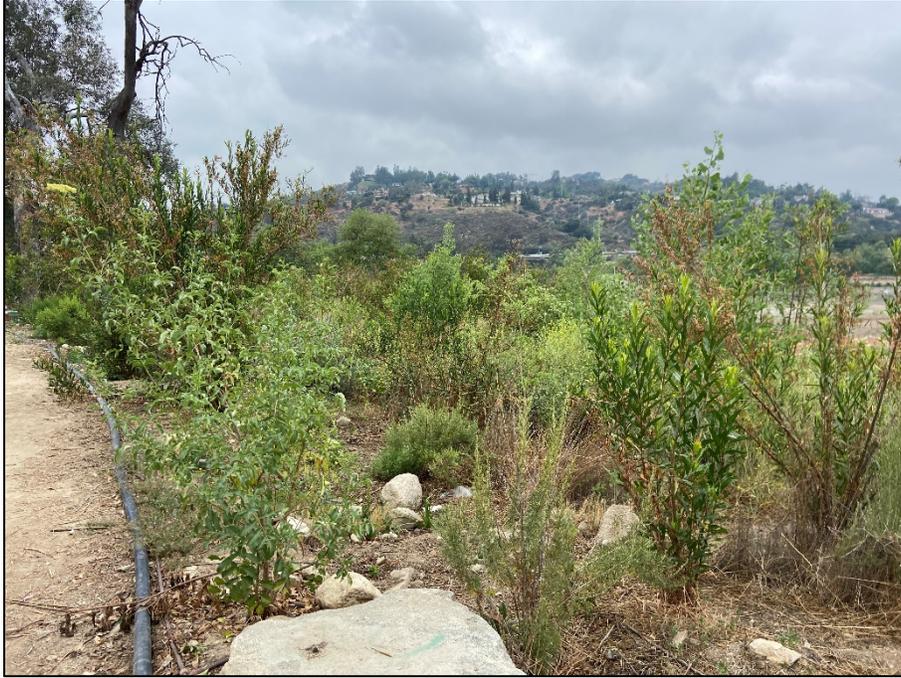
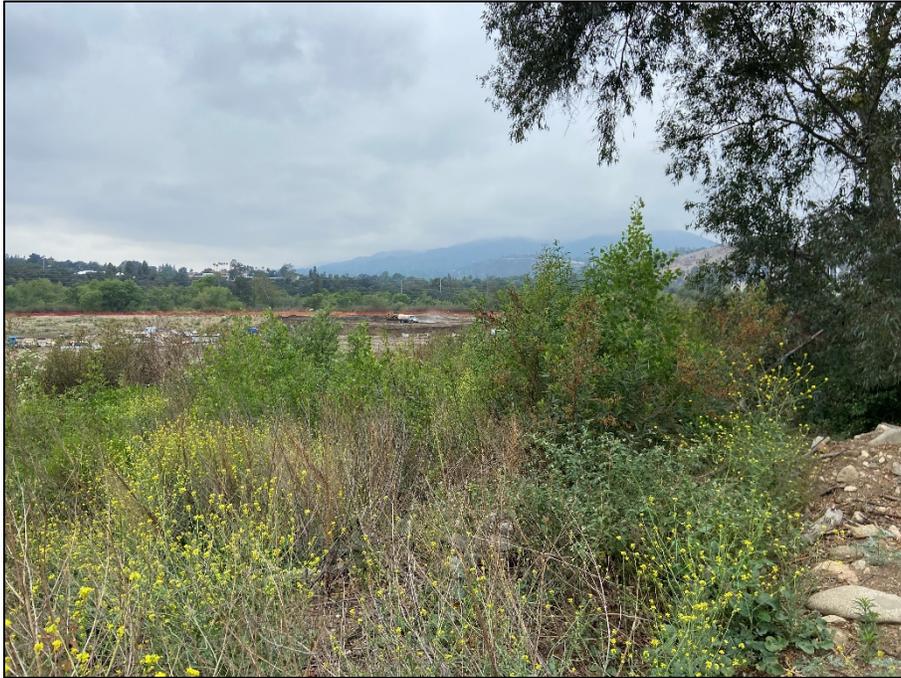
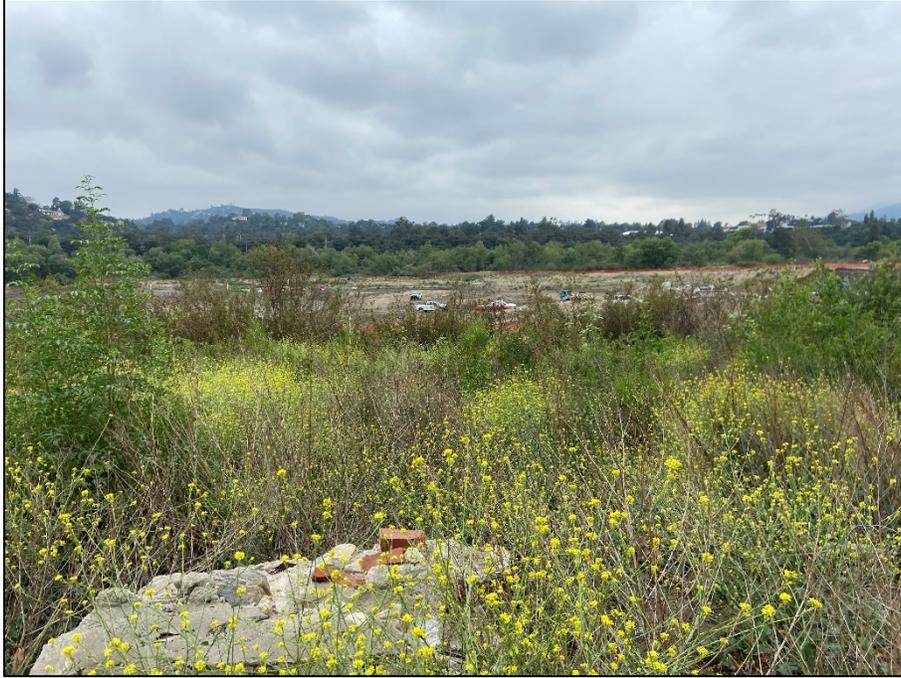
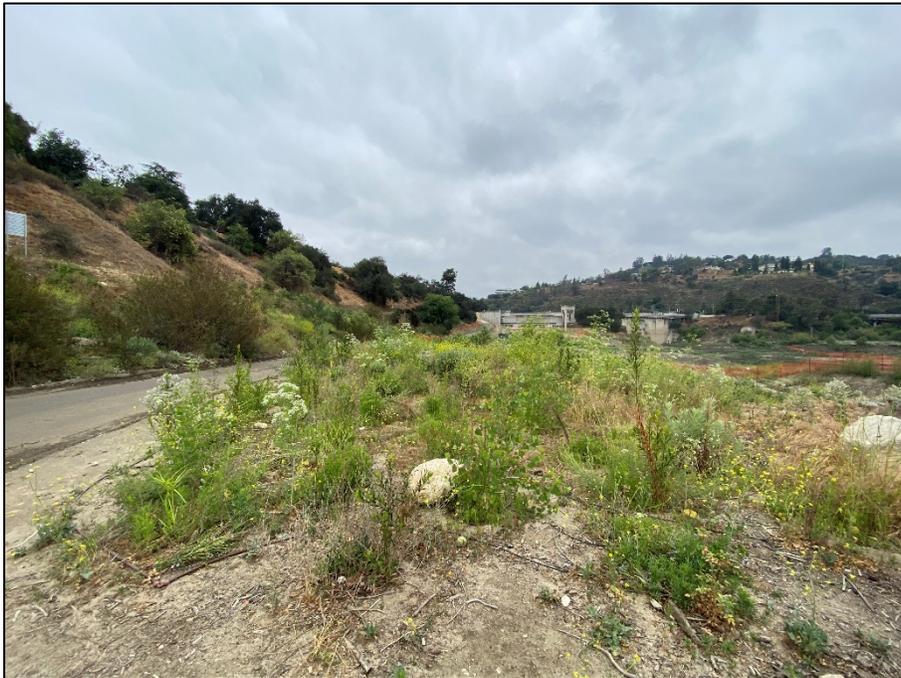
The overall health of the container plants in DG-2B was noted as being good. A negligible number of container plants appeared stressed, while approximately five percent were showing stress during the previous qualitative monitoring event. Stress was likely due to the same reasons as those described for DG-2A. In addition, insect galls were observed on several of the willow species. Formal mortality counts were taken for DG-2B during the 2020 quantitative monitoring and were included in the 2020 annual reporting. Similar to DG-2A, the willow species and Fremont's cottonwoods were no longer showing signs of seasonal dieback. Some of the planting basins were observed to have minor erosion and should be repaired. The installation of the plants in the DG-2B mitigation area appears to have been successfully completed. The current issues identified during the monitoring visit are not expected to have an effect on the continued growth of plants in the mitigation area. Photos 7 through 10 in Attachment B document the mitigation area during the monitoring visit.

mitigation area. In addition, dodder was observed growing on some of the shrub and tree species in this mitigation area which could lead to future decline of these shrubs.

Nonnative weed cover in DG-2B was estimated at approximately 30 percent, which is approximately 10 to 15 percent more than what was observed during the previous qualitative monitoring event. Nonnative weeds are starting to germinate and proliferate in some portions of DG-2B. Nonnative species observed in DG-2B included black mustard, poison hemlock, red-stemmed filaree, perennial pepperweed, curly dock, and black nightshade (*Solanum nigrum*). Many of the nonnative weeds observed in this mitigation area are starting to flower and will soon go to seed. Weed abatement should be conducted for this mitigation area as soon as possible.

Photo 7: Overview Mitigation Area DG-2B

Photo 8: Overview Mitigation Area DG-2B

Photo 9: Overview Mitigation Area DG-2B

Photo 10: Overview Mitigation Area DG-2B

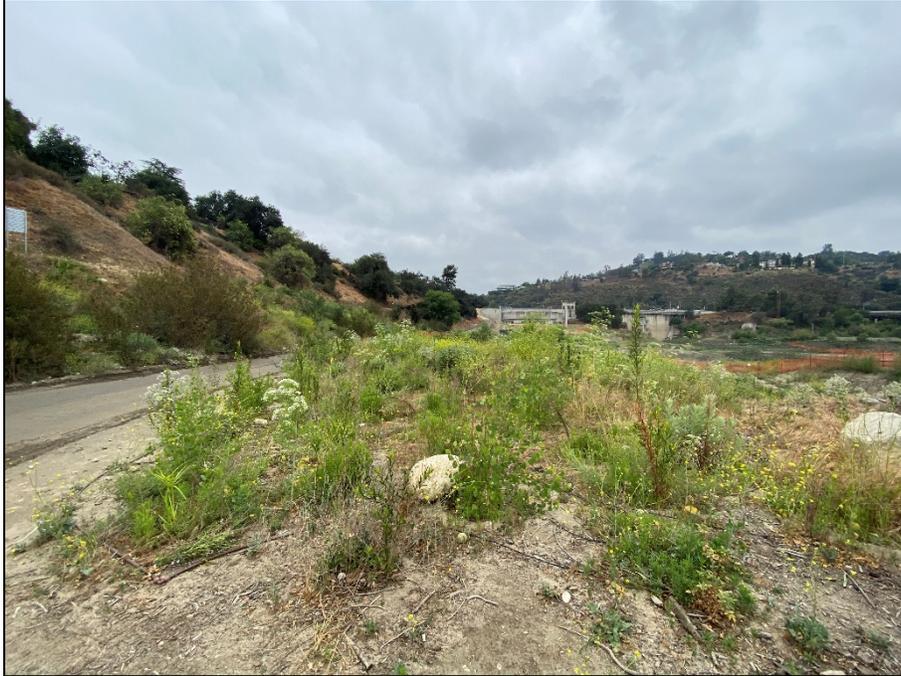
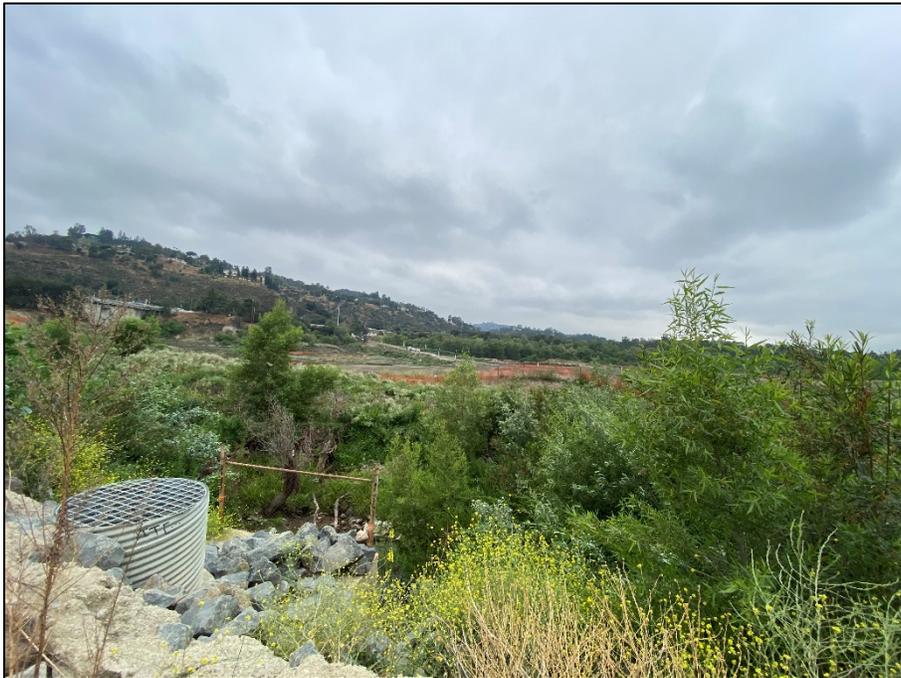
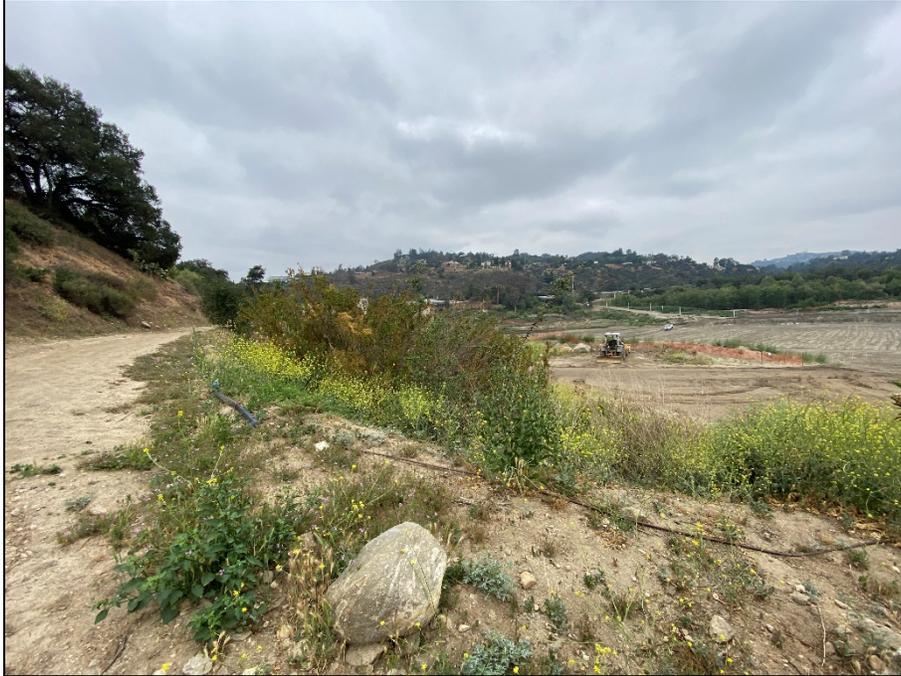
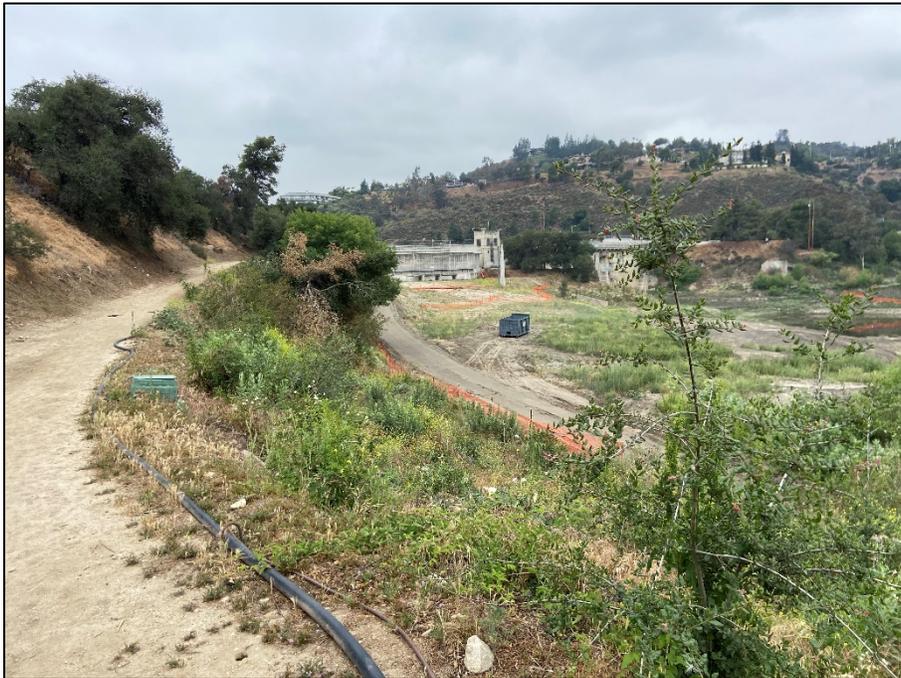
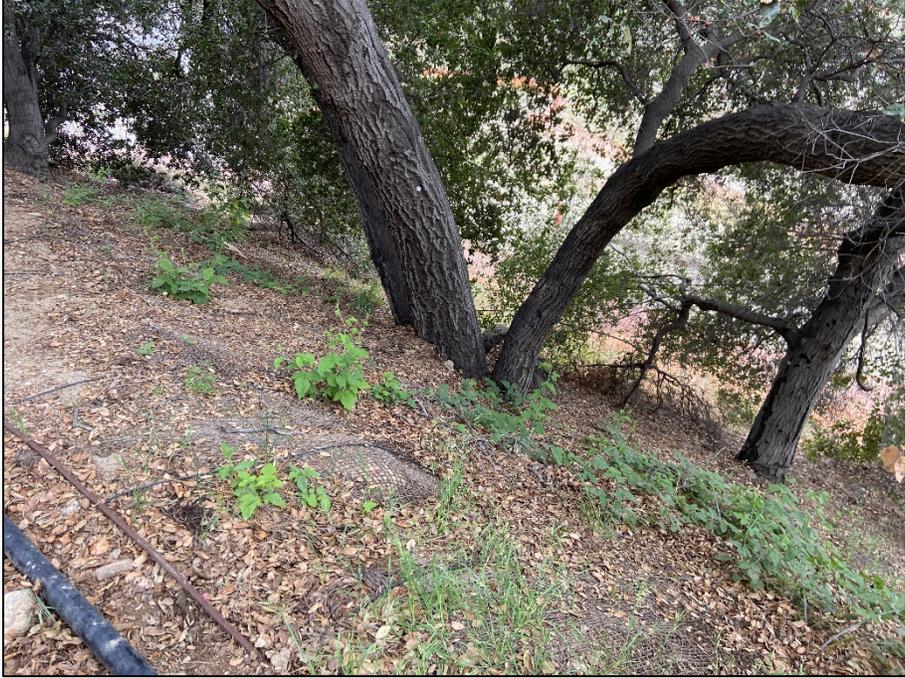
The overall health of the container plants in DG-3A was noted as being good. Approximately 10 percent of the container plants in the Coast Live Oak Woodland portions of DG-3A were noted as showing varied levels of stress, which is 5 percent less than the percentage of container plants that were showing stress during the previous qualitative monitoring event. In addition, several oaks were showing significant signs of decline and may not survive. The decline appears to be the result of erosion and misplaced emitters. Approximately 15 percent of the container plants in the Mulefat Thickets portions of DG-3A were noted as showing varied levels of stress, which is approximately 5 to 10 percent more than the percentage of container plants that were showing stress during the previous qualitative monitoring event. Formal mortality counts were taken for DG-3A during the 2020 quantitative monitoring and were included in the 2020 annual reporting. The types of stress the plants were exhibiting are the same as those described for the plants in DG-2A. However, erosion is also a problem in some areas of DG-3A. Some of the planting basins were observed to have varied levels of erosion and should be repaired. Similar to DG-2A, the container planted willow species and Fremont's cottonwoods were no longer exhibiting seasonal dieback and the willow and mulefat stakes were observed to be thriving. During the monitoring visit, the planted coast live oak (*Quercus agrifolia*) acorns were inspected for survivorship and health. Approximately 20 germinated coast live oak acorns appear to still be present in DG-3A. The majority of the germinated acorns appear to be in good health. During the monitoring, it was noted that an existing coast live oak tree (Tree Tag #39) was experiencing severe branch failure for multiple branches. The cause of the branch failure was unclear and further investigation should be conducted. The installation of the plants in the DG-3A mitigation area appears to have been completed successfully. The current issues noted during the monitoring are not expected to have a negative effect on the continued growth of the plants in the mitigation area. Photos 11 through 15 in Attachment B document the mitigation area during the monitoring visit.

Nonnative weed cover in DG-3A was estimated at approximately 35 to 45 percent, which is approximately 20 to 25 percent more than the level of nonnative cover that was observed during the previous qualitative monitoring event. Nonnative species observed in DG-3A included black mustard, poison hemlock, perennial pepperweed, annual yellow sweetclover (*Melilotus indicus*), tree tobacco, rabbitsfoot grass (*Polypogon monspeliensis*) and wild radish (*Raphanus sativus*). Many of the nonnative weeds observed in this mitigation area are starting to flower and will soon go to seed. Weed abatement should be conducted for this mitigation area as soon as possible.

Photo 11: Overview Mitigation Area DG-3A Altadena Drain

Photo 12: Overview Mitigation Area DG-3A Altadena Drain

Photo 13: Overview Mitigation Area DG-3A Oak Woodland

Photo 14: Overview Mitigation Area DG-3A Oak Woodland

Photo 15: Overview Mitigation Area DG-3A Oak Woodland

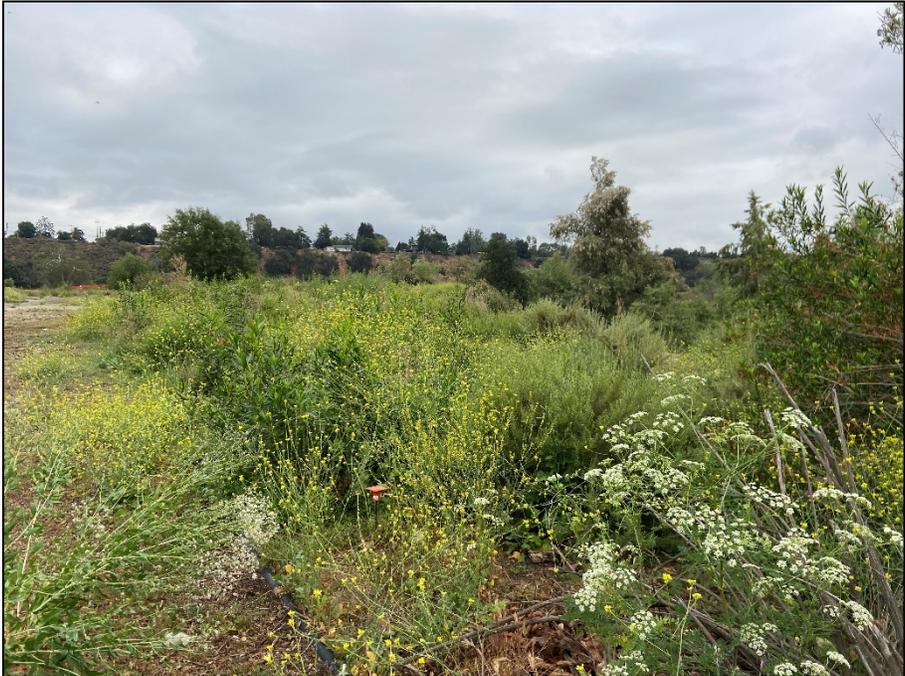
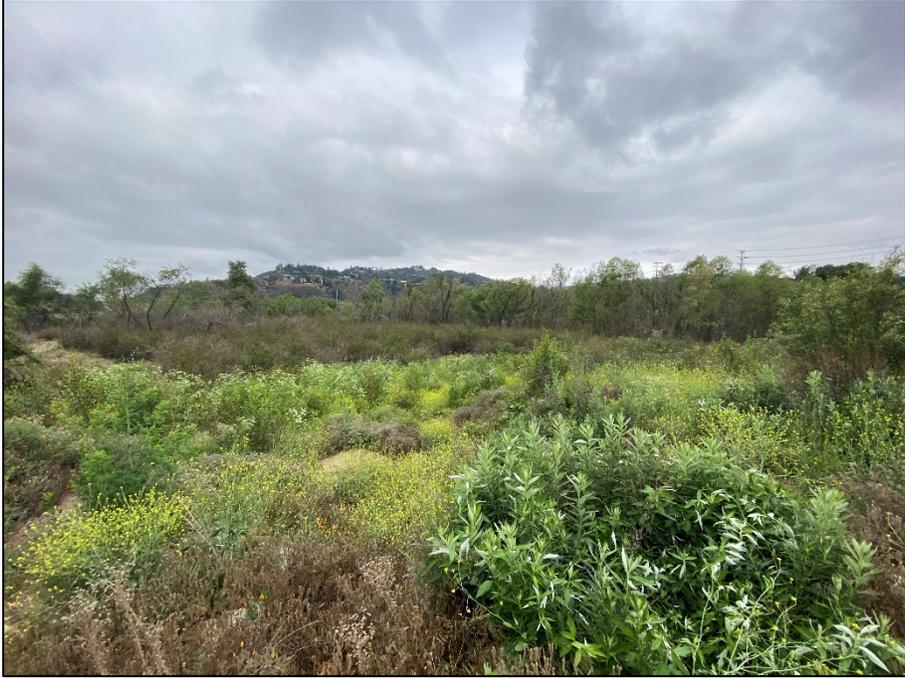
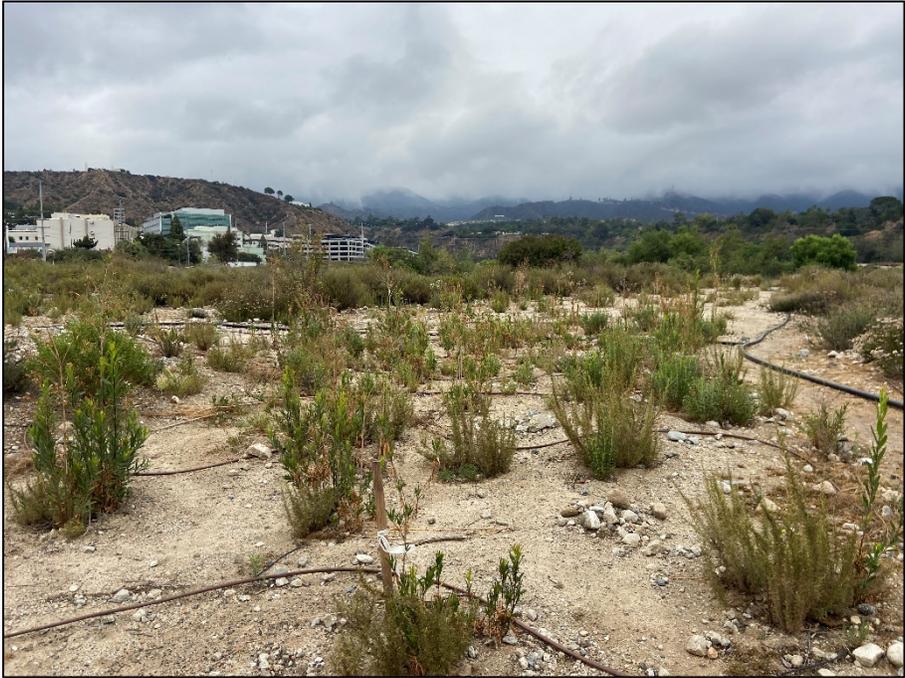
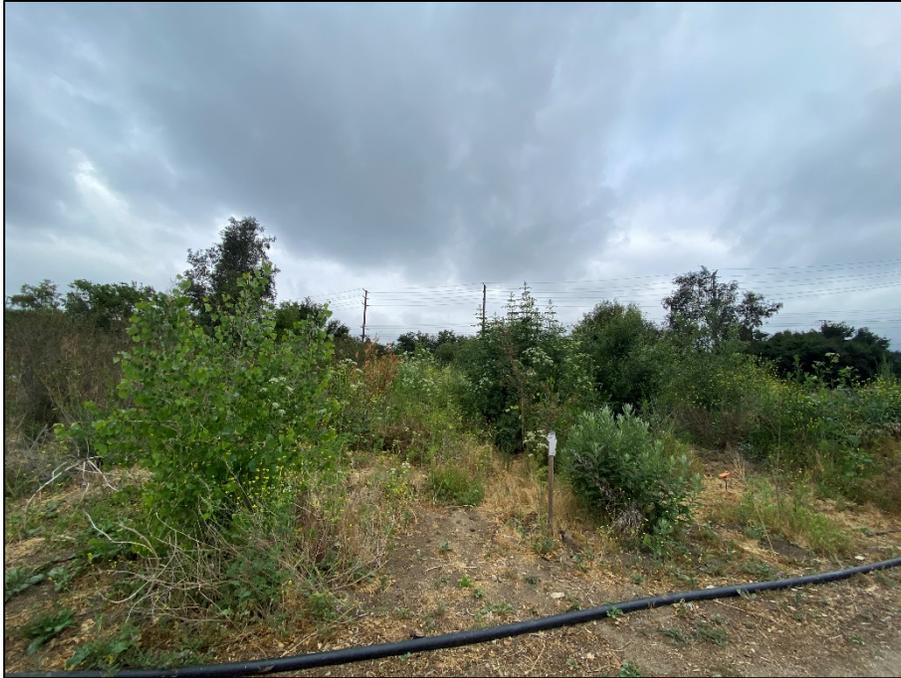
The overall health of the container plants in mitigation area DG-4 was noted as being good. Approximately 10 percent of container plants in the coastal sage scrub portions of DG-4 were showing varied levels of stress which is approximately the same as the percentage of plants showing stress during the previous qualitative monitoring event. Approximately 10 percent of container plants in the riparian portions of DG-4 were showing varied levels of stress, which is approximately the same as the percentage of plants showing stress during the previous qualitative monitoring event. The stress appears to be mostly due to the same reasons described in DG-2A. For most portions of DG-4, only a negligible number of container plants were noted as being missing or dead. Formal mortality counts were taken for DG-4 during the 2020 quantitative monitoring and were included in the 2020 annual reporting. The container planted willow species and Fremont's cottonwood were no longer showing signs of seasonal dieback and the willow and mulefat stakes were observed to be thriving. Some of the planting basins were observed to have minor erosion and should be repaired. The installation of plants in the DG-4 mitigation area appears to have been completed successfully and the issues noted during the monitoring are not expected to have an impact on the continued growth of the plants. Photos 16 through 19 in Attachment B document the mitigation area during the monitoring visit.

Nonnative weed cover in DG-4 was estimated at approximately 45 percent for most areas, which is approximately 20 to 25 percent more than what was observed during the previous qualitative monitoring event. It should be noted that portions of DG-4 that are adjacent to weed infested portions of Phase 2 (i.e., DG-4A) were observed to have new germination of perennial pepperweed. Nonnative species observed in DG-4 included black mustard, red brome, Italian thistle (*Carduus pycnocephalus*), tocalote, poison hemlock, red-stemmed filaree, perennial pepperweed, white horehound, chamomile (*Matricaria chamomilla*), annual yellow sweetclover, and curly dock. Nonnative weed cover, especially perennial pepperweed, is a significant problem in portions of the DG-4 mitigation area. Because perennial pepperweed can produce dense colonies through seed germination and underground rhizomes (rhizomatous roots), removal of this species without the use of systemic herbicide is very difficult. In

addition, many of the nonnative weeds observed in this mitigation area are starting to flower and will soon go to seed. Weed abatement should be conducted for this mitigation area as soon as possible.

Photo 16: Overview Mitigation Area DG-4

Photo 17: Overview Mitigation Area DG-4

Photo 18: Overview Mitigation Area DG-4

Photo 19: Overview Mitigation Area DG-4

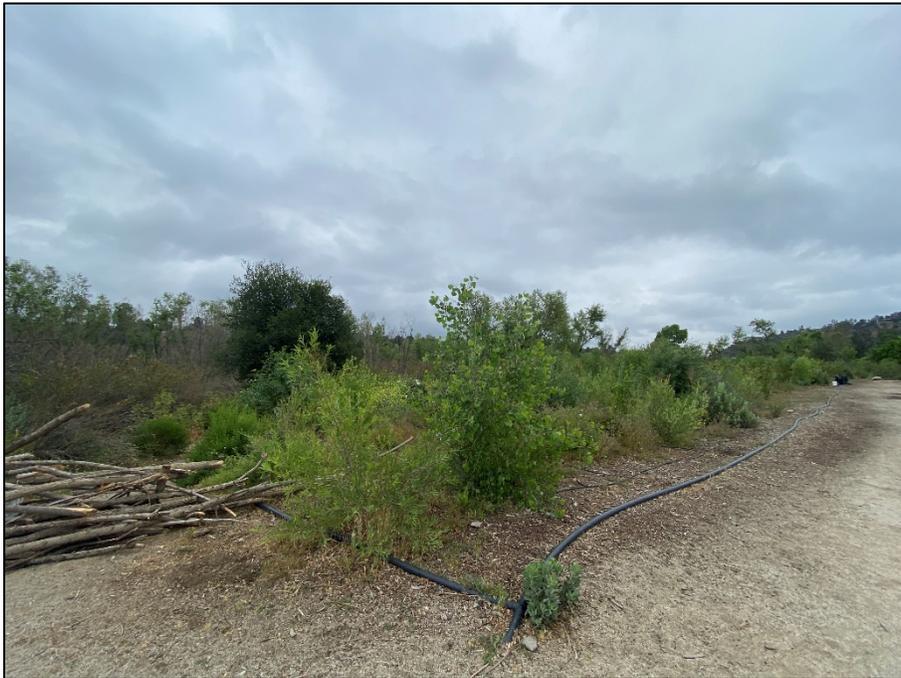
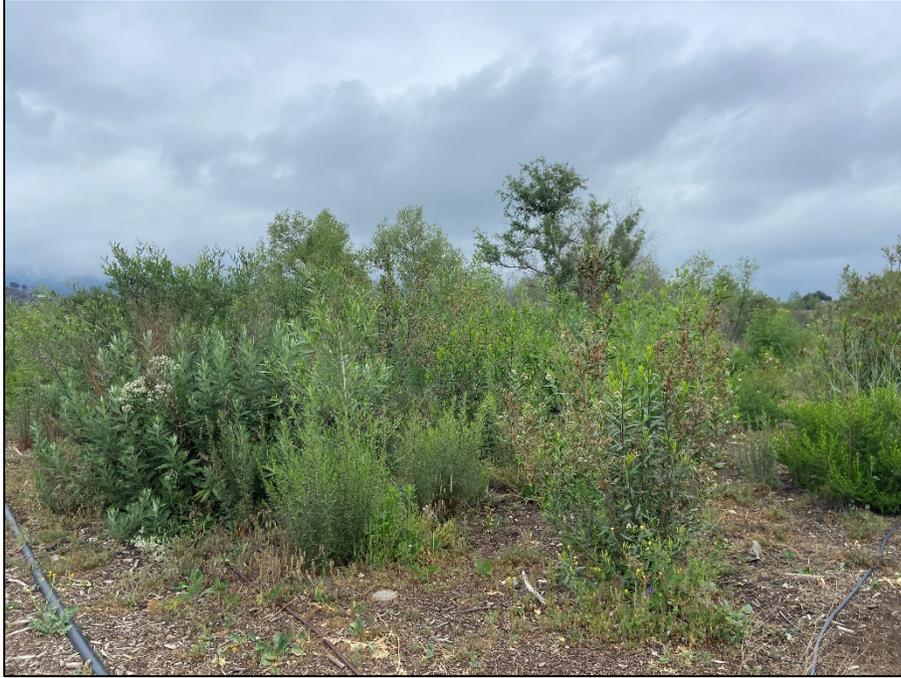
The overall health of the container plants in mitigation area DG-4B was noted as being good and this mitigation area is becoming well established. A negligible number of container plants appeared stressed, while approximately five percent were showing stress during the previous qualitative monitoring event. The types of stress the plants were exhibiting are the same as those described for the plants in DG-2A. A negligible number of container plants were noted as being missing or dead. Formal mortality counts were taken for DG-4B during the 2020 quantitative monitoring and were included in the 2020 annual reporting. Similar to DG-4, the container planted willow species and Fremont's cottonwoods were no longer showing signs of seasonal dieback. Some of the planting basins were observed to have minor erosion and should be repaired. The installation of plants in the DG-4B mitigation area appears to have been completed successfully and the issues noted during the monitoring are not expected to have an impact on the continued growth of the plants. Photos 20 and 21 in Attachment B document the mitigation area during the monitoring visit.

Nonnative weed cover in DG-4B was estimated to be approximately 20 percent, which is approximately 5 percent more than the percentage of nonnative cover that was observed during the previous qualitative monitoring event. Nonnative species observed in DG-4B included black mustard, poison hemlock, red-stemmed filaree, white horehound, and perennial pepperweed.

Photo 20: Overview Mitigation Area DG-4B

Photo 21: Overview Mitigation Area DG-4B

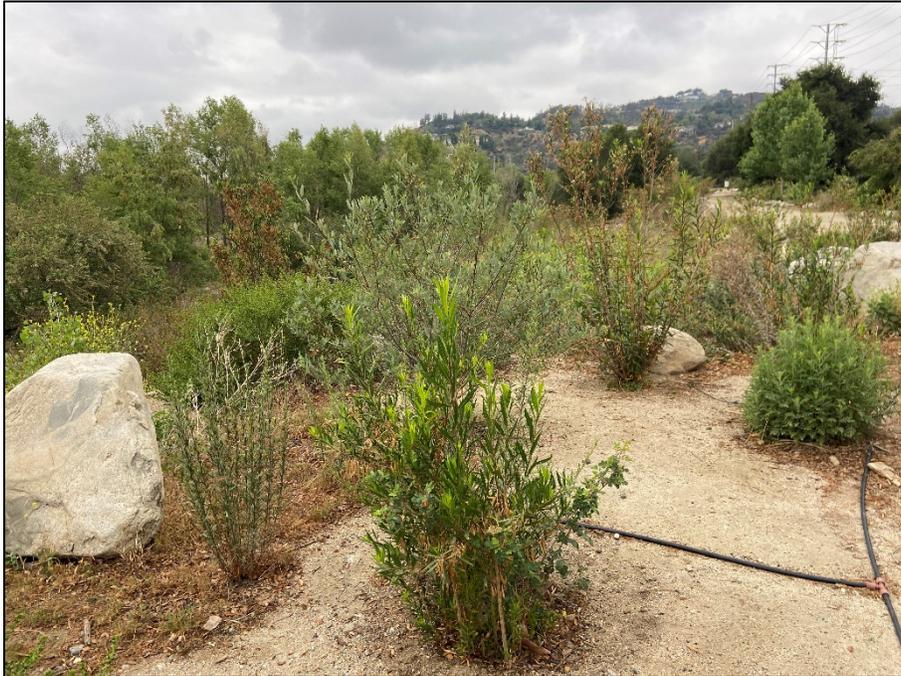
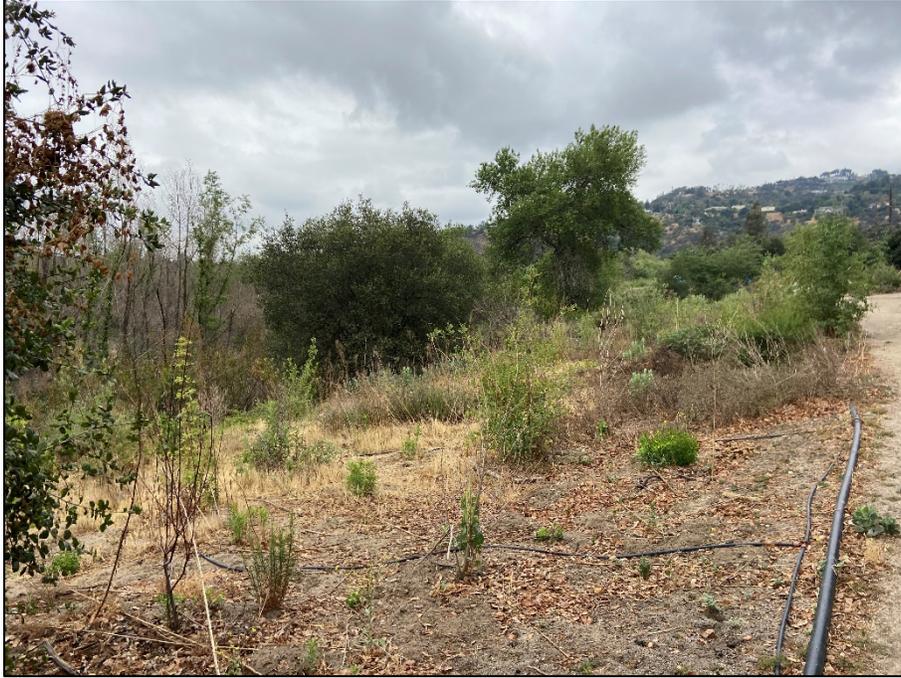
The overall health of the container plants in mitigation area DG-4C was noted as being good. Approximately 10 percent of all container plants were noted as showing minor levels of stress, which is approximately the same percentage of plants that were showing stress during the previous qualitative monitoring event. The types of stress the plants were exhibiting are the same as those described for the plants in DG-2A. A negligible number of container plants were noted as being missing or dead. Formal mortality counts were taken for DG-4C during the 2020 quantitative monitoring and were included in the 2020 annual reporting. Similar to DG-4, the container planted willow species and Fremont's cottonwood were no longer showing signs of seasonal dieback. Some of the planting basins were observed to have minor erosion and should be repaired. The installation of plants in the DG-4C mitigation area appears to have been completed successfully and the issues noted during the monitoring are not expected to have an impact on the continued growth of the plants. Photos 22 and 23 in Attachment B document the mitigation area during the monitoring visit.

Nonnative weed cover in DG-4C was estimated at approximately 25 percent, which is approximately 5 percent higher than the level of nonnative cover that was observed during the previous qualitative monitoring event. Nonnative species observed in DG-4C included black mustard, red brome, red-stemmed filaree, foxtail barley (*Hordeum murinum*), perennial pepperweed, white horehound, annual yellow sweetclover.

Photo 22: Overview Mitigation Area DG-4C

Photo 23: Overview Mitigation Area DG-4C

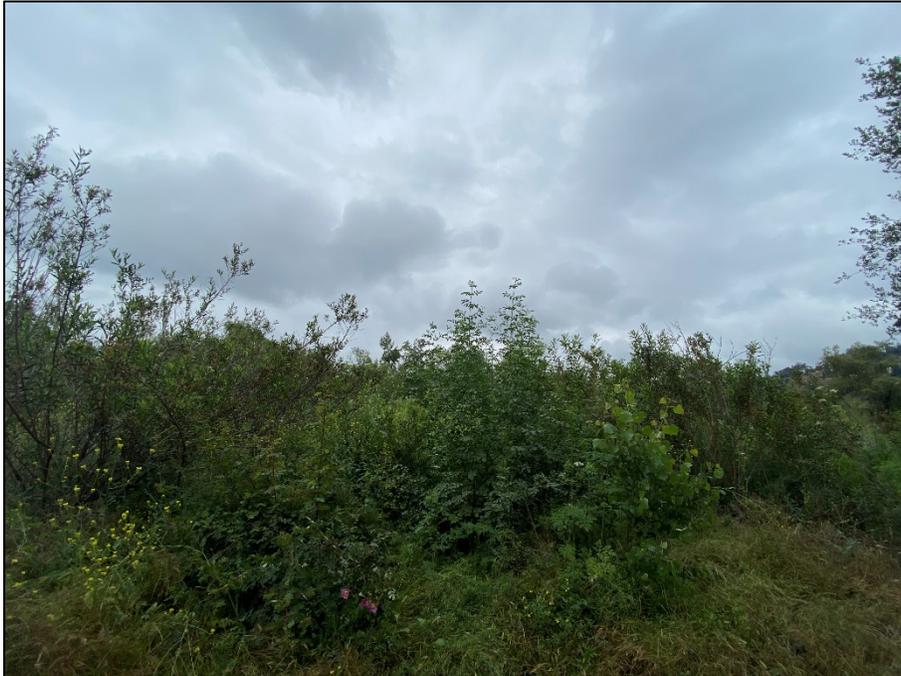
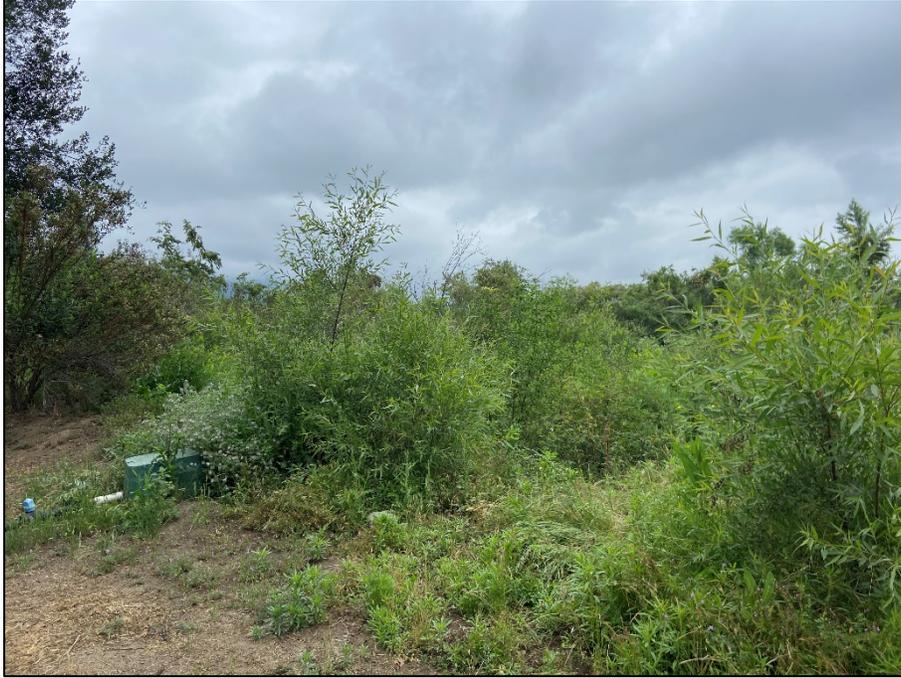
The overall health of the container plants in the DG-5 mitigation area was noted as being good. Approximately 10 percent of all container plants were noted as showing varied levels of stress, which is approximately the same percentage of plants that were showing stress during the previous qualitative monitoring event. Gopher herbivory, which has been a significant problem in DG-5 during past monitoring visits, was not observed; however, this may have been due to the high level of weed proliferation creating a visual buffer. Formal mortality counts were taken for DG-5 during the 2020 quantitative monitoring and were included in the 2020 annual reporting. Similar to DG-4, the container planted willow species and Fremont's cottonwoods were no longer showing signs of seasonal dieback. Some of the planting basins were observed to have minor erosion and should be repaired. The installation of plants in the DG-5 mitigation area appears to have been completed successfully and the issues noted during the monitoring are not expected to have a negative impact on the continued growth of the plants. Photos 24 and 25 in Attachment B document the mitigation area during the monitoring visit.

Nonnative weed cover in DG-5 was estimated at approximately 45 percent, which is approximately 10 percent lower than the percent of nonnative weed cover that was observed during the previous qualitative monitoring event; however, many of the nonnative weeds observed have gone to flower and will produce seed soon. Nonnative weeds are beginning to proliferate throughout this mitigation area. Nonnative species observed in DG-5 included black mustard, Italian thistle, poison hemlock, perennial pepperweed, annual yellow sweetclover, curly doc, and London rocket (*Sisymbrium irio*).

Photo 24: Overview Mitigation Area DG-5

Photo 25: Overview Mitigation Area DG-5
