Re: Devil's Gate Reservoir Restoration Project – Phase 1 Restoration Qualitative Monitoring Conducted on February 10, 2023

1.0 INTRODUCTION

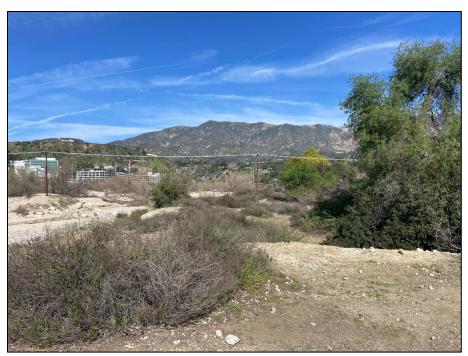
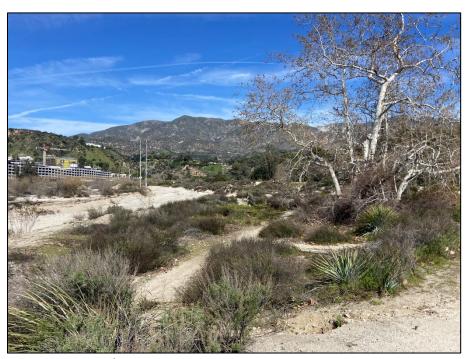
Photo 1: Overview Mitigation Area DG-1

Container plants were not installed in the DG-1 or DG-1 WOUS mitigation areas, but these areas were seeded with native plant species. Native plant growth was noted throughout the DG-1 and DG-1 WOUS mitigation areas, likely both from natural recruitment and from seeding; however, germination was observed to be very minimal in most of these mitigation areas and most of the native annuals were observed to be dead for the season. Portions of DG-1 WOUS were noted as being scoured during the 2020 and 2021 wet seasons and had minimal plant growth. Native plants such as California sagebrush (*Artemisia californica*), California buckwheat (*Eriogonum fasciculatum*), and common phacelia (*Phacelia distans*) were observed sprouting in the DG-1 and DG-1 WOUS mitigation areas. Native cover for the DG-1 and DG-1 WOUS mitigation areas was estimated to be approximately 65 percent with some areas having relatively dense cover and other areas being scoured and/or having minimal cover. Photos 1 and 2 in Attachment B document the status of the mitigation areas during the monitoring visit.

Nonnative weed cover in DG-1 and DG-1 WOUS was estimated to be approximately five percent, which is approximately four percent higher than the level of weed cover that was observed during the previous qualitative monitoring event. Nonnative species observed in DG-1 and DG-1 WOUS included black mustard (*Brassica nigra*), nonnative grasses (*Bromus* spp.), and red-stemmed filaree (*Erodium cicutarium*). All nonnative weeds were just starting to germinate and had not gone to flower or seed. In addition, many of the annual nonnative weeds were observed to be dead for the season.

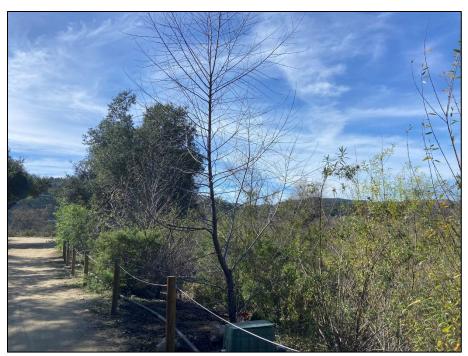
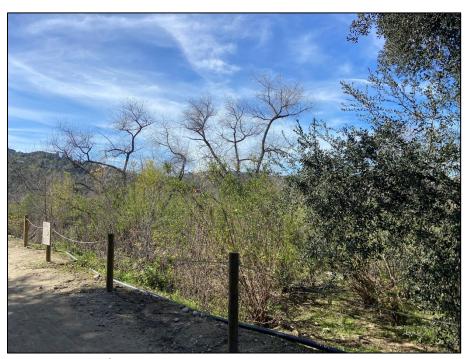
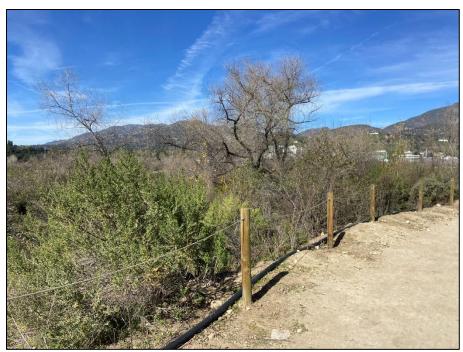
Photo 3: Overview Mitigation Area DG-2A

The overall health of the container plants in DG-2A was noted as being good. Approximately less than five percent of the container plants in DG-2A were noted as showing varied levels of stress, which is approximately the same as the percentage of container plants that were showing stress during the previous qualitative monitoring event. Stress may be occurring as a result of 1) competition from

nonnative and invasive weeds, 2) misplaced emitters, or 3) recreational traffic through the mitigation areas. There were no additional container plants noted as being missing or dead. Formal mortality counts were taken for DG-2A during the 2020, 2021, and 2022 quantitative monitoring events. Most of the willows (*Salix* sp.) and Fremont's cottonwoods (*Populus fremontii*) were continuing to show signs of seasonal dieback. Some of the willows in this mitigation area were noted as having rust fungus (*Melampsora* spp.) on some of their foliage and should be monitored for any decline in health and vigor. The installation of plants in the DG-2A mitigation area appears to have been completed successfully. The current issues identified during the monitoring visit are not expected to have an effect on the continued growth of the plants in the mitigation area. Photos 3 through 5 in Attachment B document the status of the mitigation area during the monitoring visit.

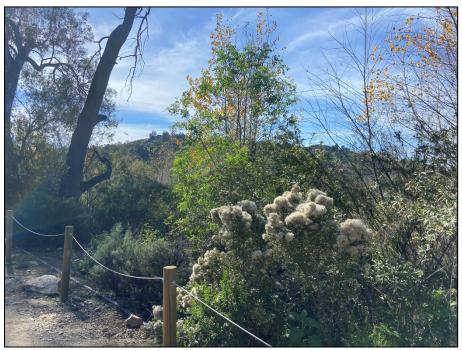
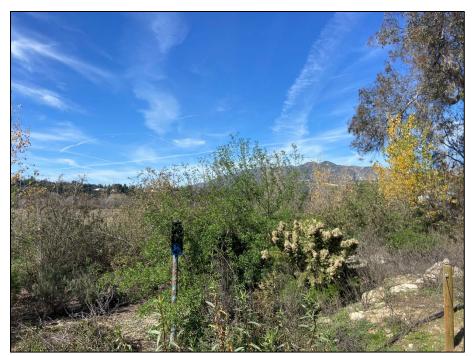
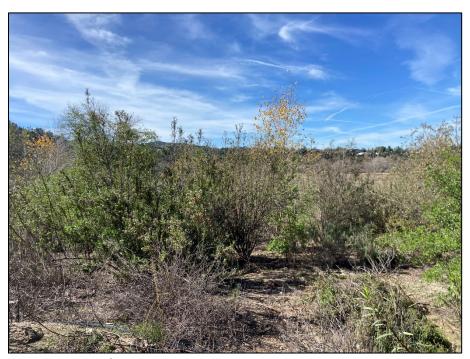
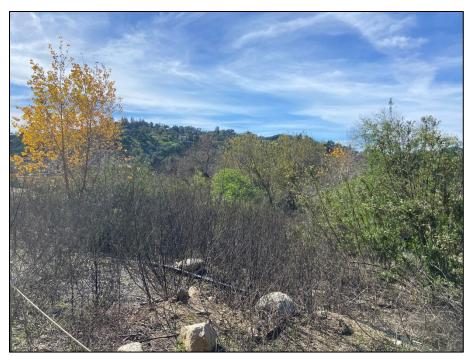
Photo 6: Overview Mitigation Area DG-2B

The overall health of the container plants in DG-2B was noted as being good. Approximately less than five percent of the container plants in DG-2B were noted as showing varied levels of stress, which is approximately the same percentage of container plants that were showing stress during the previous qualitative monitoring event. Stress was likely due to the same reasons as those described for DG-2A. In addition, insect galls were observed on several of the willow species. Formal mortality counts were taken for DG-2B during the 2020, 2021, and 2022 quantitative monitoring events. Similar to DG-2A, most of the willows and Fremont's cottonwoods were continuing to show signs of seasonal dieback. The installation of the plants in the DG-2B mitigation area appears to have been successfully completed. The current issues identified during the monitoring visit are not expected to have an effect on the continued growth of plants in the mitigation area. Photos 6 through 9 in Attachment B document the status of the mitigation area during the monitoring visit.

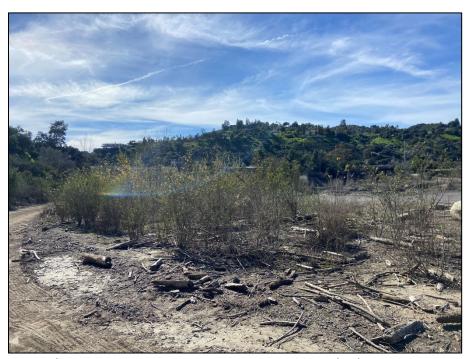
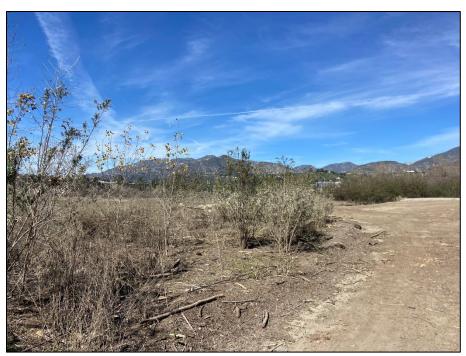
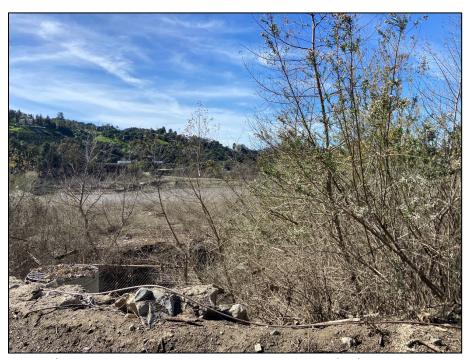
Photo 10: Overview Mitigation Area DG-3A Altadena Drain

Approximately 15 percent of the container plants in the Mulefat Thickets portions of DG-3A were noted as showing varied levels of stress, which is approximately 10 percent more than the percentage of container plants that were showing stress during the previous qualitative monitoring event. It should also be noted that many of the container plants and stakes installed near Altadena Drain were observed to be thriving. Formal mortality counts were taken for DG-3A during the 2020, 2021, and 2022 quantitative monitoring events. The types of stress the plants were exhibiting are the same as those described for the plants in DG-2A. However, erosion is also a problem in some areas of DG-3A. In addition, the Mulefat Thickets portions of DG-3A and the lower extent of the Coast Live Oak Woodland portions of DG-3A experienced approximately 16-days of inundation following heavy storm events in January 2023. Following the inundation, many portions of DG-3A had a high level of woody debris within the mitigation area. Most of the container plants and stakes appear to be recovering from the inundation. Some of the planting basins were observed to have varied levels of erosion and should be repaired. The willow and mulefat stakes were observed to be thriving in this mitigation area. The installation of the plants in the DG-3A mitigation area appears to have been completed successfully. The current issues noted during the monitoring are not expected to have an effect on the continued growth of the plants in the mitigation area. Photos 10 through 15 in Attachment B document the status of the mitigation area during the monitoring visit.

Minor erosion to planting basins was observed throughout the Phase 1 mitigation areas. The severe erosion noted in DG-3A near Altadena Drain during previous monitoring visits was noted as showing signs of worsening from the recent heavy rainfall in the area. Due to the steepness of the slope in the Coast Live Oak Woodland portion of the DG-3A mitigation area, erosion will likely continue to be somewhat of an issue in this area; however, jute nettings are currently in place on the slope and will help to lessen the severity of erosion issues. As native cover increases in this area, erosion issues should lessen. The severity of the erosion should continue to be monitored in all planted areas and if warranted, erosion Best Management Practices (BMPs) should be installed in appropriate areas. This may only require the installation of straw wattles at select sites to prevent existing rills from becoming larger. However, until more native perennial plants become established in these areas, there is the potential that intense rainfall may create additional erosion problems.

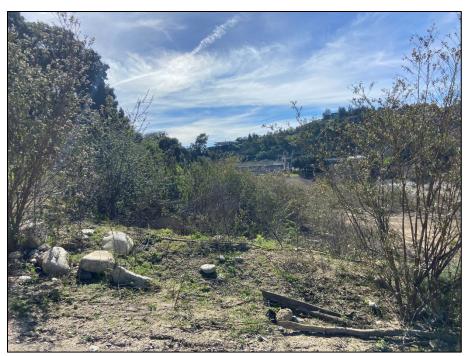
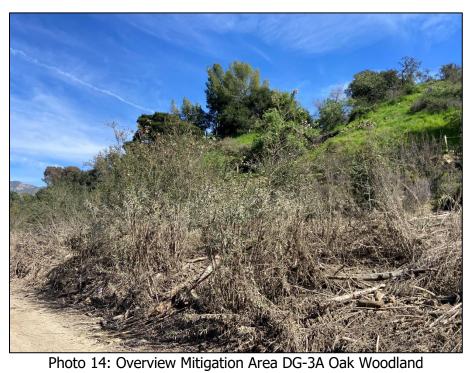
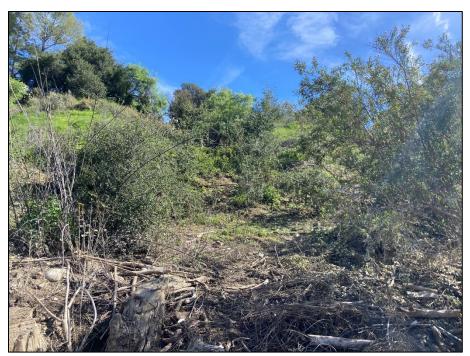
Photo 13: Overview Mitigation Area DG-3A Oak Woodland

The overall health of the container plants in DG-3A was noted as being good. Approximately 10 percent of the container plants in the Coast Live Oak Woodland portions of DG-3A were noted as showing varied levels of stress, which is approximately five percent more than the percentage of container plants that were showing stress during the previous qualitative monitoring event. During the monitoring visit, the planted coast live oak acorns were inspected for survivorship and health. Approximately 20 germinated coast live oak acorns appear to still be present in DG-3A. The majority of the germinated acorns appear to be in good health. During the monitoring, it was noted that an existing coast live oak tree (Tree Tag #39) is continuing to experience branch failure for multiple branches. The cause of the branch failure was unclear.

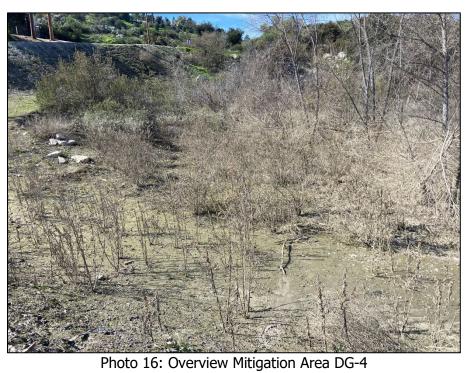
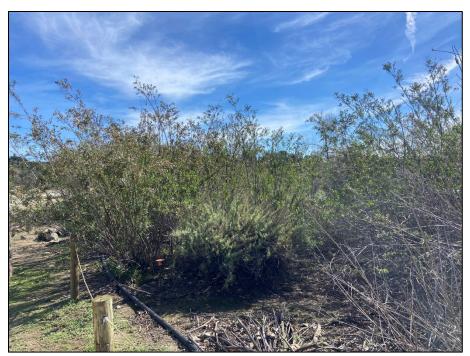
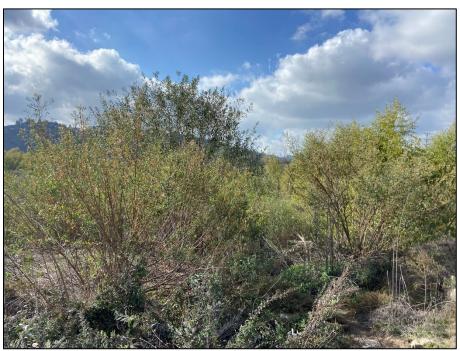
Photo 17: Overview Mitigation Area DG-4

The overall health of the container plants in mitigation area DG-4 was noted as being good. Approximately five percent of container plants in the coastal sage scrub portions of DG-4 were showing varied levels of stress which is approximately five percent less than the percentage of plants showing stress during the previous qualitative monitoring event. Approximately 10 to 15 percent of container plants in most of the riparian portions of DG-4 were showing varied levels of stress, depending on the section of DG-4, which is approximately 5 to 10 percent more than the percentage of plants showing stress during the previous qualitative monitoring event. The causes of stress appear to be mostly due to the same reasons described in DG-2A. In addition, the southern portions of DG-4 experienced approximately 16-days of inundation following heavy storm events in January 2023 and many of the container plants in this area appear dead or in a condition unlikely to recover. For most portions of DG-4 that did not experience inundation, only a negligible number of container plants were noted as being missing or dead. Formal mortality counts were taken for DG-4 during the 2020, 2021, and 2022 quantitative monitoring events. Similar to DG-2A, the willows and Fremont's cottonwoods were continuing to show signs of seasonal dieback. Some of the planting basins were observed to have minor erosion and should be repaired. The installation of plants in the DG-4 mitigation area appears to have been completed successfully and the issues noted during the monitoring are not expected to have an impact on the continued growth of the plants. Photos 16 through 18 in Attachment B document the status of the mitigation area during the monitoring visit.

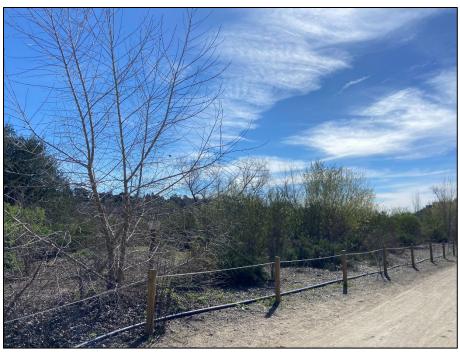
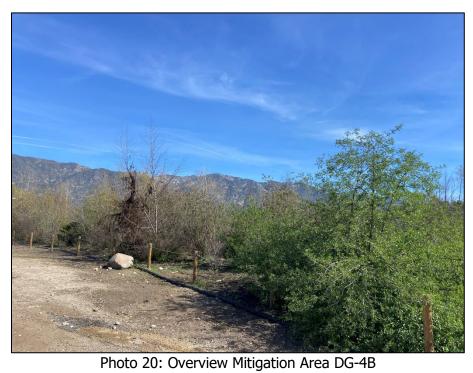
Photo 19: Overview Mitigation Area DG-4B

The overall health of the container plants in mitigation area DG-4B was noted as being good and this mitigation area is becoming well established. Approximately less than five percent of container pants were showing signs of drought stress which is approximately the same percentage of plants that were stressed during the previous qualitative monitoring event. The types of stress the plants were exhibiting are the same as those described for the plants in DG-2A. A negligible number of container plants were noted as being missing or dead. Formal mortality counts were taken for DG-4B during the 2020, 2021, and 2022 quantitative monitoring events. Some of the planting basins were observed to have minor erosion and should be repaired. The installation of plants in the DG-4B mitigation area appears to have been completed successfully and the issues noted during the monitoring are not expected to have an impact on the continued growth of the plants. Photos 19 and 20 in Attachment B document the current status of the mitigation area during the monitoring visit.

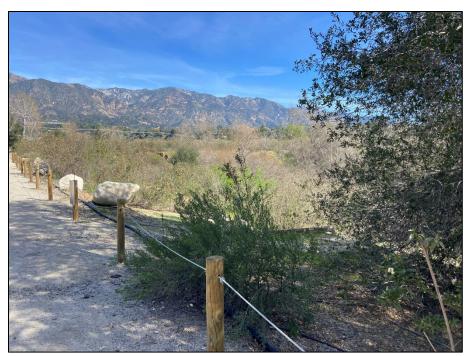
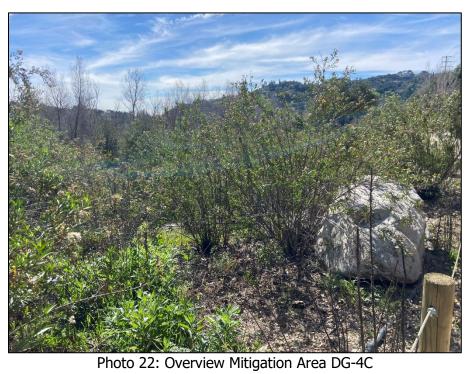
Photo 21: Overview Mitigation Area DG-4C

The overall health of the container plants in mitigation area DG-4C was noted as being good. Approximately 5 to 10 percent of all container plants were noted as showing minor levels of stress, which is approximately the same as the percentage of plants that were showing stress during the previous qualitative monitoring event. The types of stress the plants were exhibiting are the same as those described for the plants in DG-2A. A negligible number of container plants were noted as being missing or dead. Formal mortality counts were taken for DG-4C during the 2020, 2021, and 2022 quantitative monitoring events. Similar to DG-2A, most of the willows and Fremont's cottonwoods were continuing to show signs of seasonal dieback. Some of the planting basins were observed to have minor erosion and should be repaired. The installation of plants in the DG-4C mitigation area appears to have been completed successfully and the issues noted during the monitoring are not expected to have an impact on the continued growth of the plants. Photos 21 and 22 in Attachment B document the status of the mitigation area during the monitoring visit.

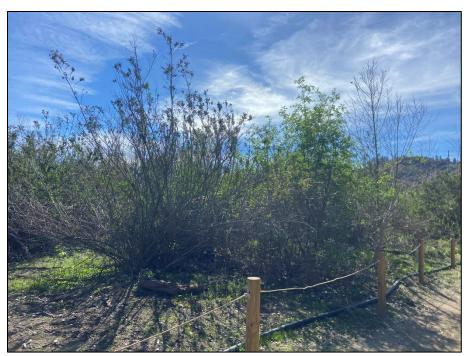
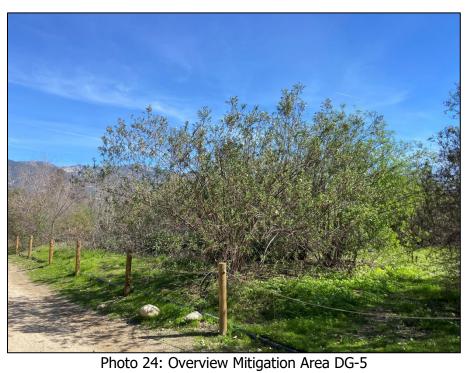
Photo 23: Overview Mitigation Area DG-5

The overall health of the container plants in the DG-5 mitigation area was noted as being good. Approximately less than five percent of all container plants were noted as showing varied levels of stress, which is approximately the same as the percentage of plants that were showing stress during the previous qualitative monitoring event. Formal mortality counts were taken for DG-5 during the 2020, 2021, and 2022 quantitative monitoring events. Similar to DG-2A, most of the willows and Fremont's cottonwoods were continuing to show signs of seasonal dieback. Some of the planting basins were observed to have minor erosion and should be repaired. The installation of plants in the DG-5 mitigation area appears to have been completed successfully and the issues noted during the monitoring are not expected to have a negative impact on the continued growth of the plants. Photos 25 and 26 in Attachment B document the status of the mitigation area during the monitoring visit.
