September 8, 2021
2018-047.031

Re: *Devil's Gate Reservoir Restoration Project – Phase 2 Restoration Plant Establishment Period Monitoring Conducted on August 26, 2021*

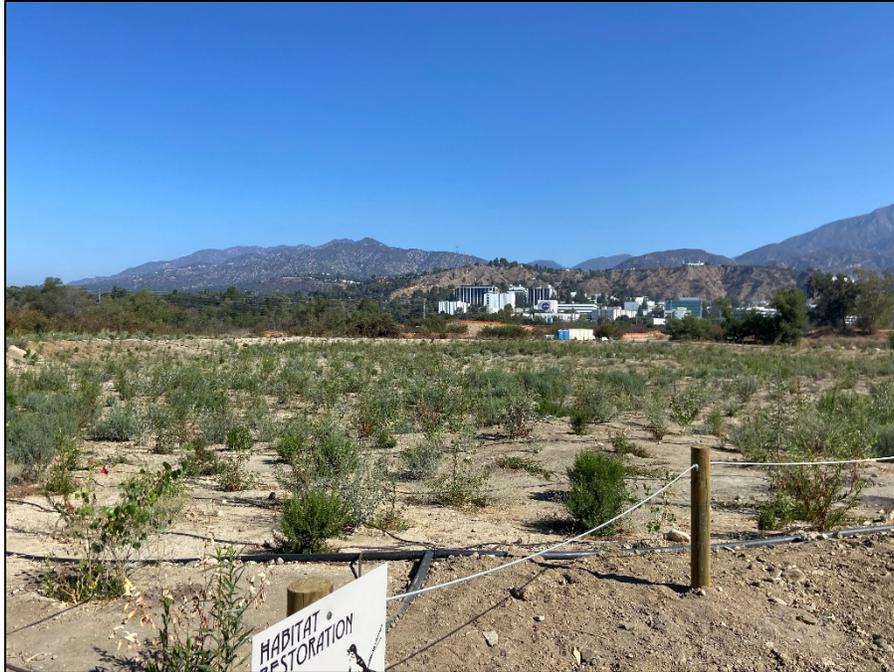
Photo 1: Overview Mitigation Area DG-W-1 (Johnson Field)

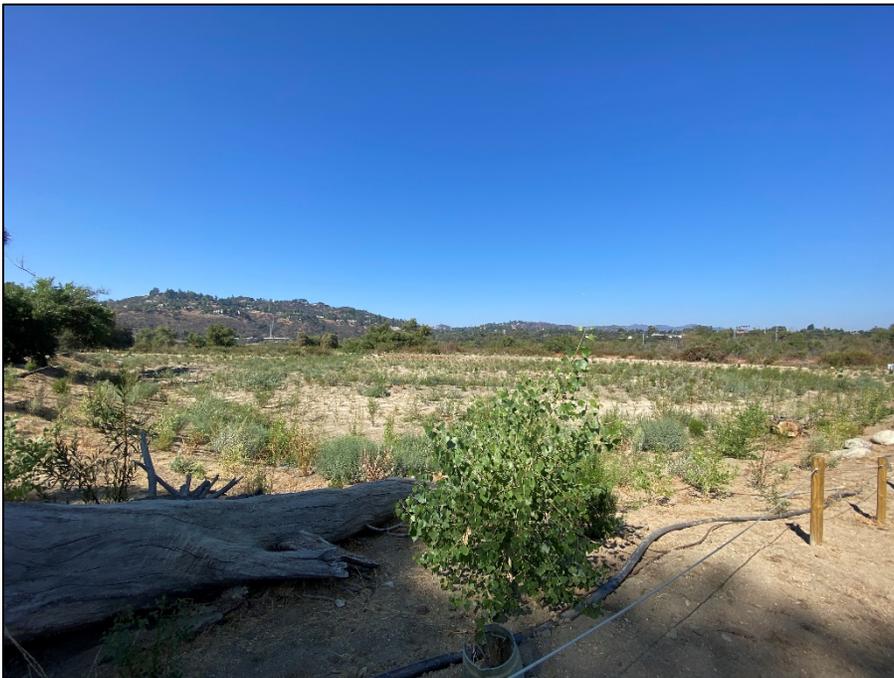
Photo 2: Overview Mitigation Area Overview Mitigation Area DG-W-1 (Johnson Field)

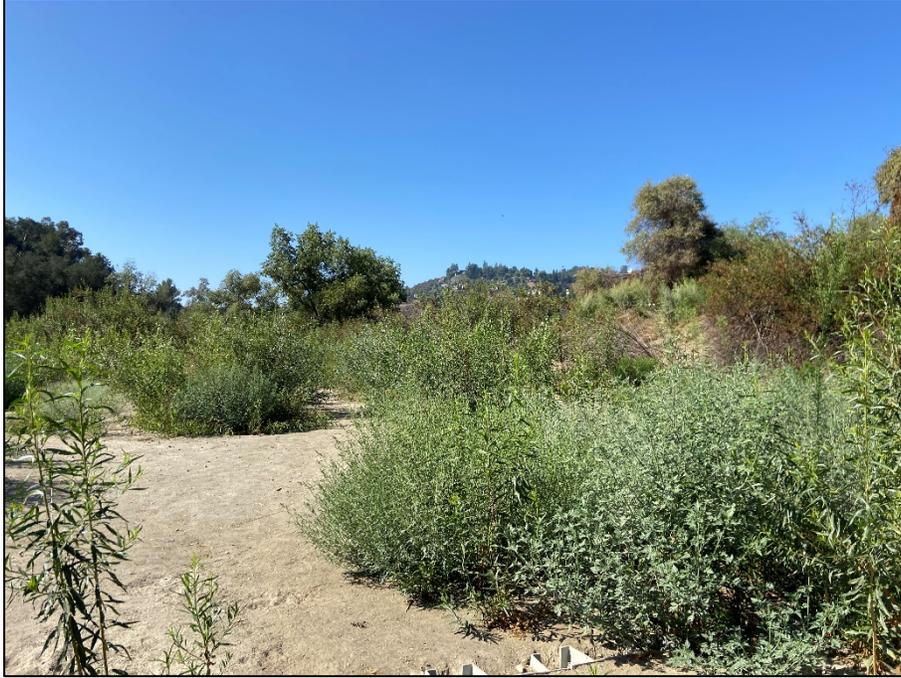
Photo 3: Overview Mitigation Area Overview Mitigation Area DG-2 & DG-2 New Channels

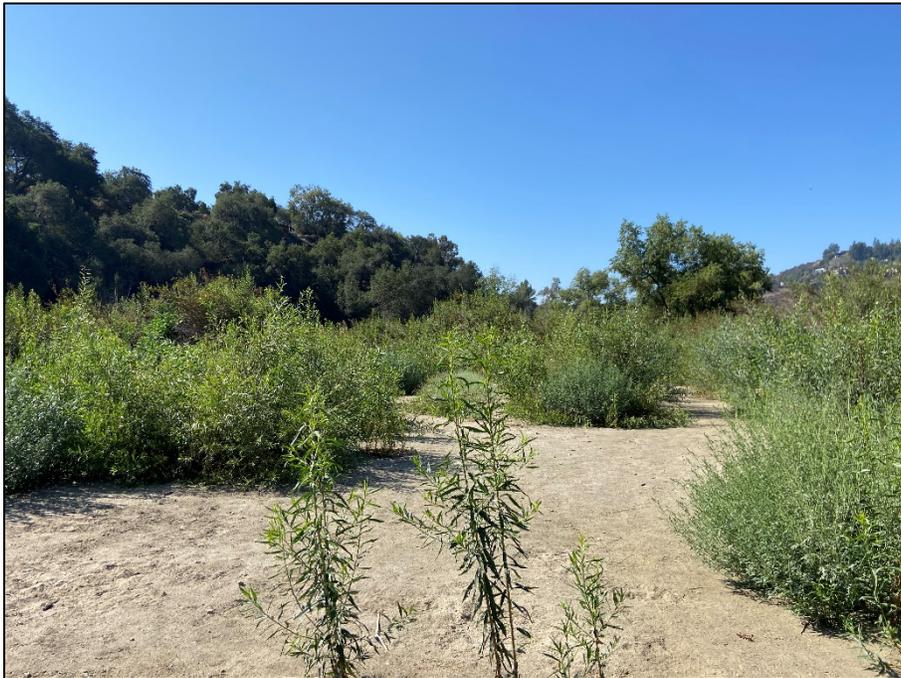
Photo 4: Overview Mitigation Area DG-2 & DG-2 New Channels

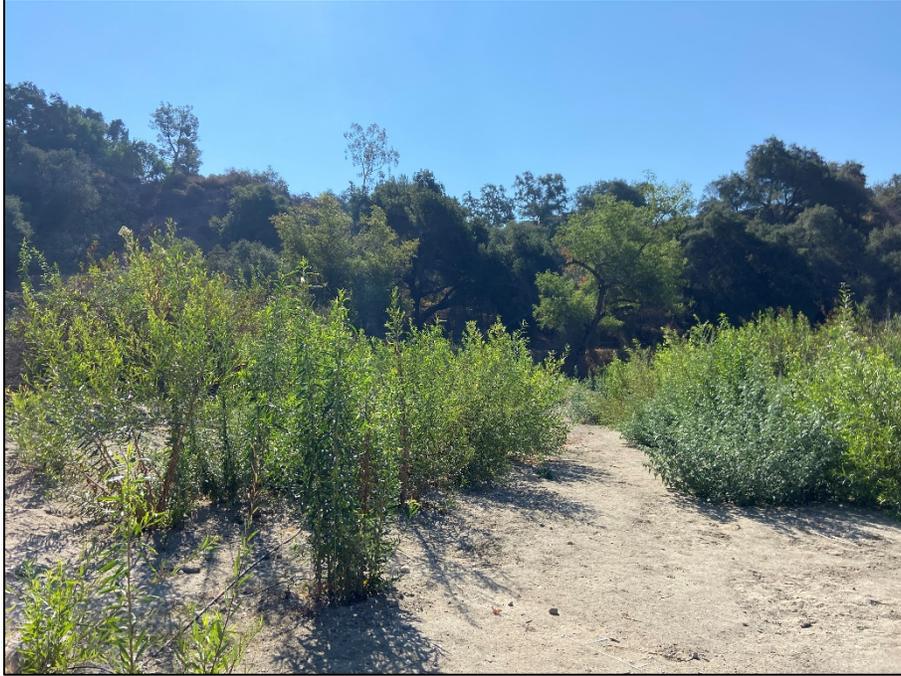
Photo 5: Overview Mitigation Area DG-2 & DG-2 WOUS

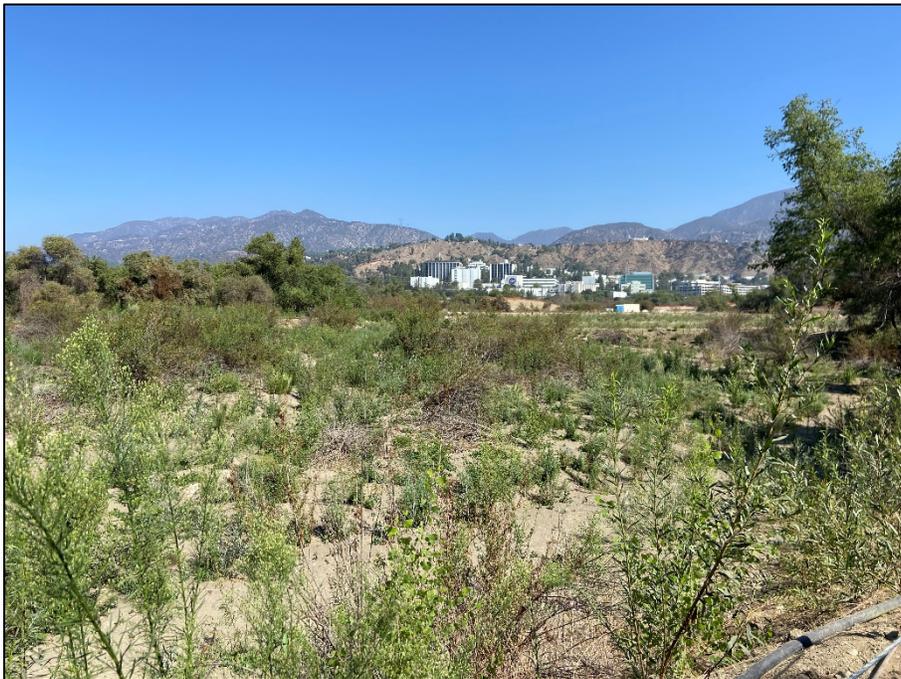
Photo 6: Overview Mitigation Area DG-2, DG-2 New Channels, DG-2 WOUS

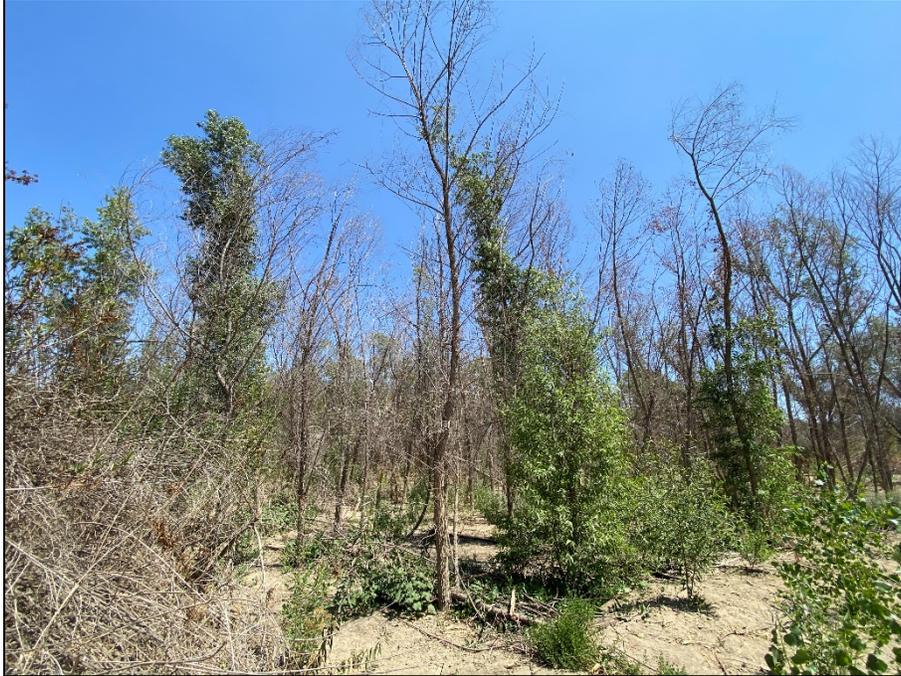
Photo 7: Overview Mitigation Area DG-W-2 (Mining Pit)

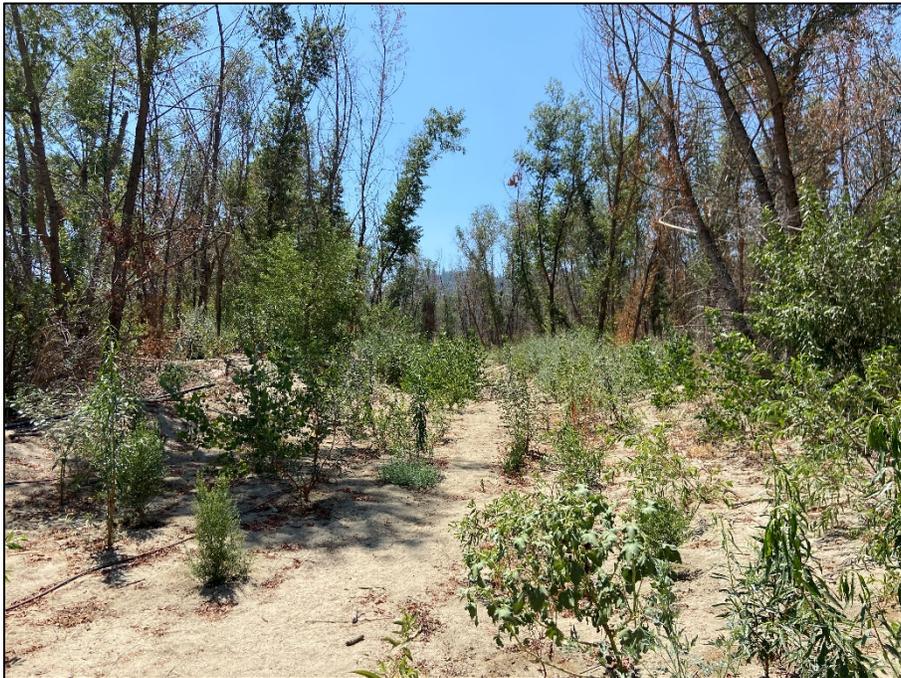
Photo 8: Overview Mitigation Area DG-W-2 (Mining Pit)

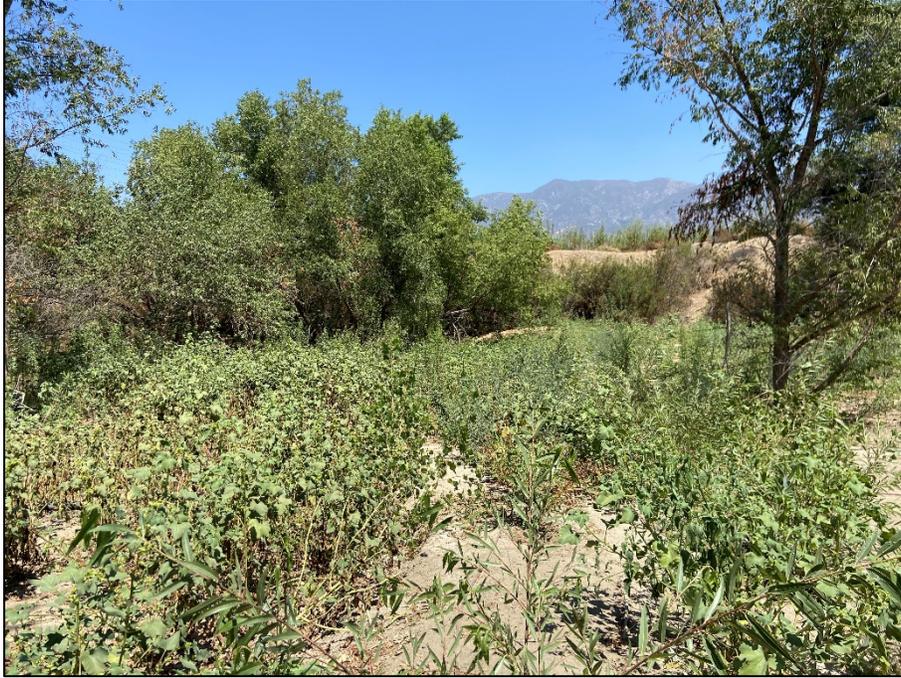
Photo 9: Overview Mitigation Area DG-W-2 (Mining Pit)

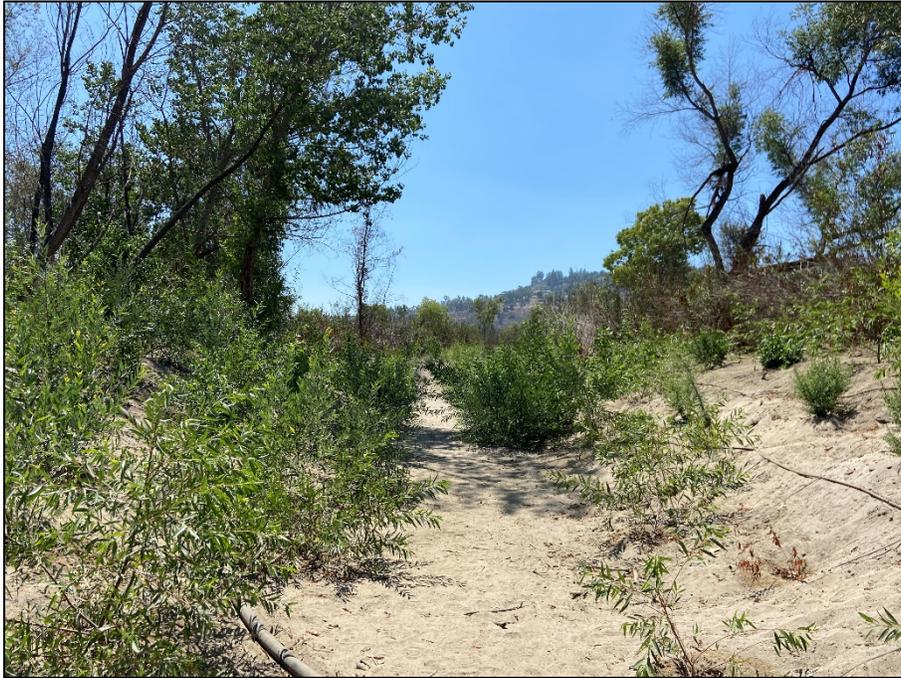
Photo 10: Overview Mitigation Area DG-W-2 (Mining Pit Outlet)

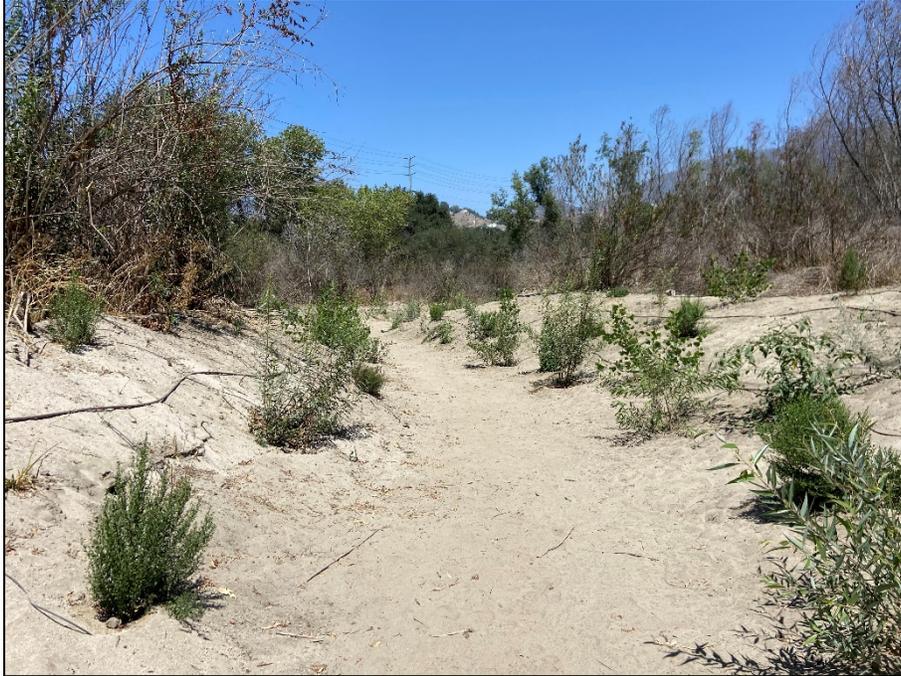
Photo 11: Overview Mitigation Area DG-W-2 (Mining Pit Outlet)

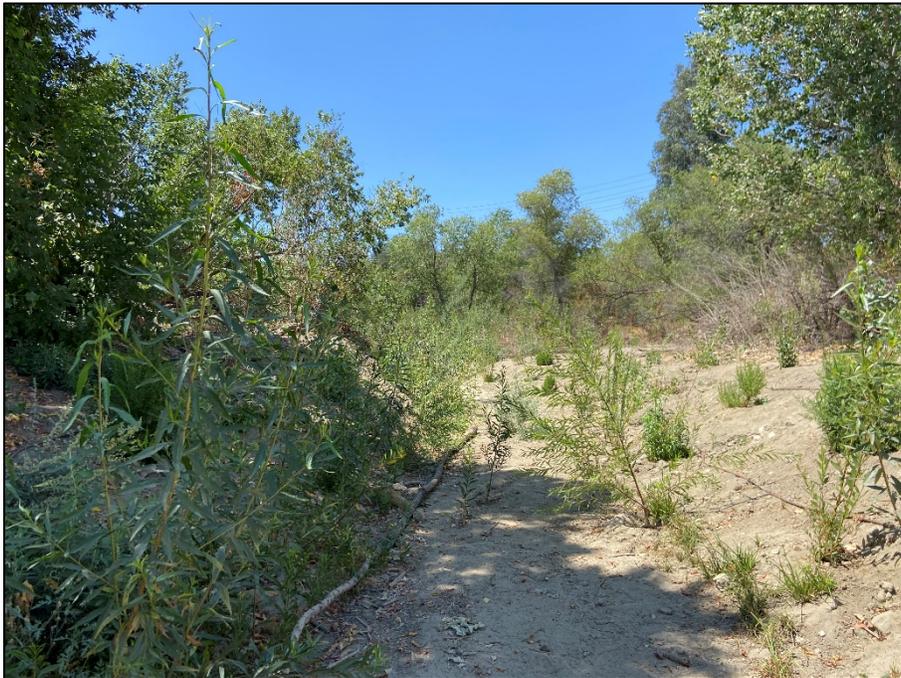
Photo 12: Overview Mitigation Area DG-W-2 (Mining Pit Outlet)

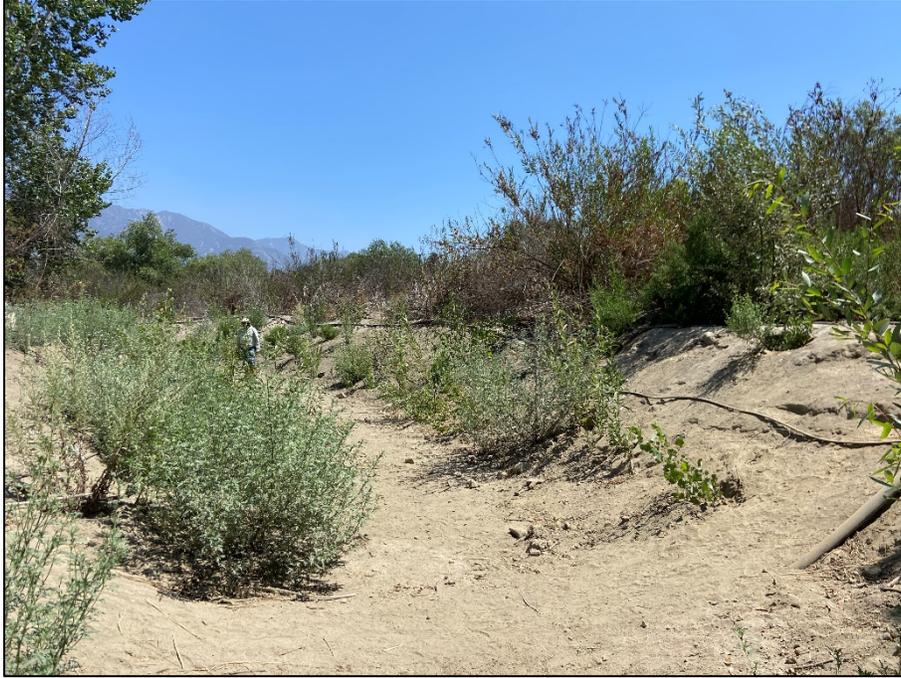
Photo 13: Overview Mitigation Area DG-W-2 (Mining Pit Outlet)

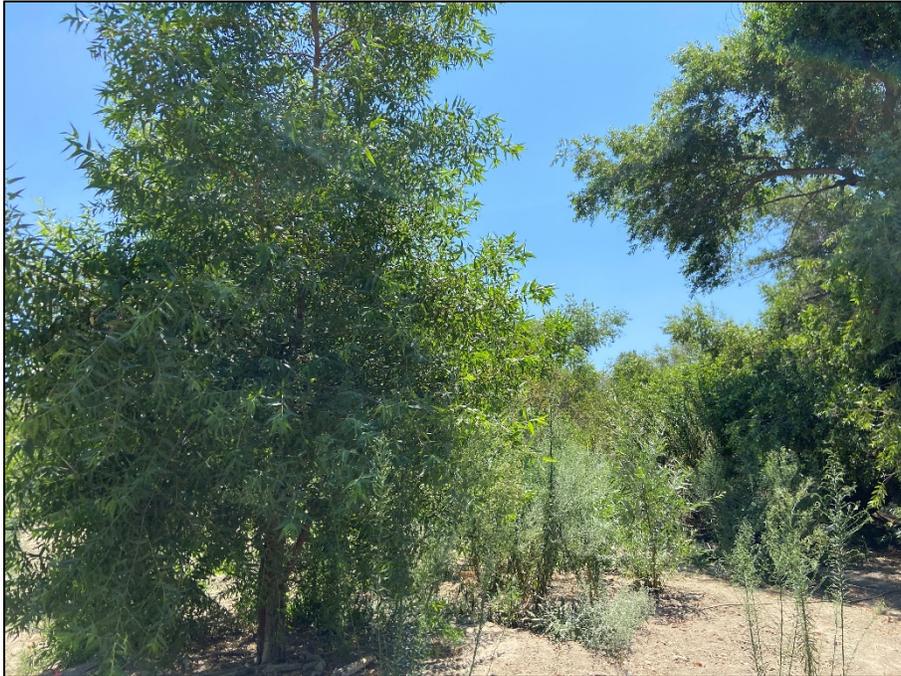
Photo 14: Overview Mitigation Area DG-4 Sheet Flow/DG-SF-1
