September 29, 2021
2018-047.031

Re: *Devil's Gate Reservoir Restoration Project – Phase 2 Restoration Qualitative Monitoring Conducted on September 17, 2021*

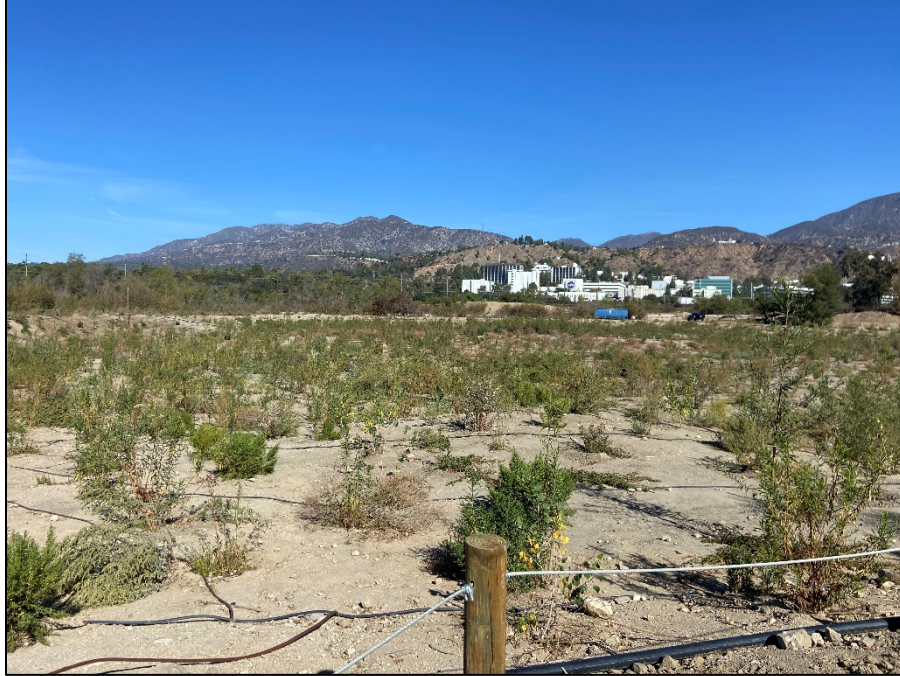
Photo 1: Overview Mitigation Area DG-W-1 (Johnson Field)

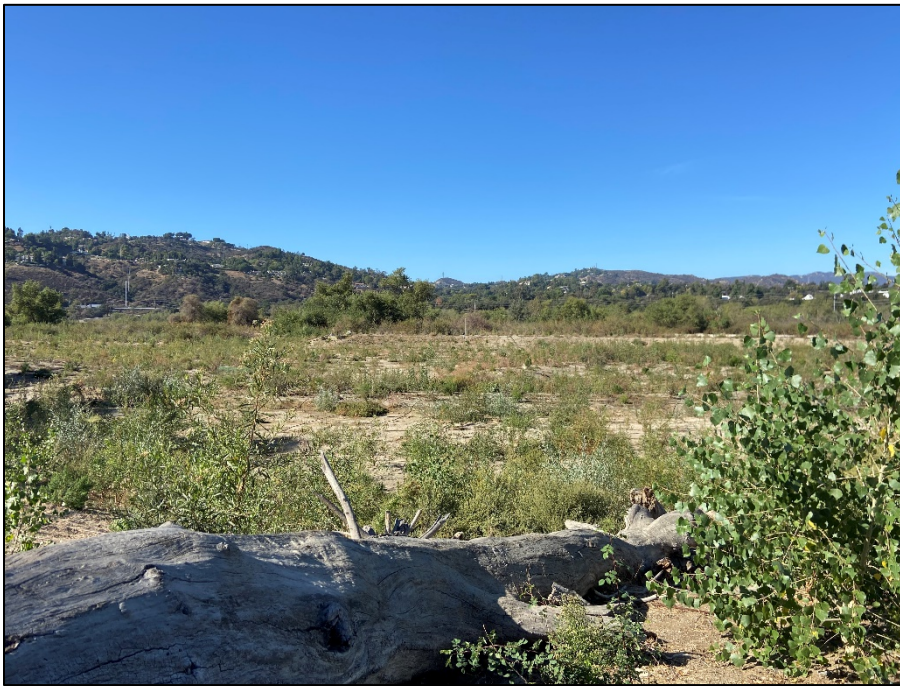
Photo 2: Overview Mitigation Area Overview Mitigation Area DG-W-1 (Johnson Field)

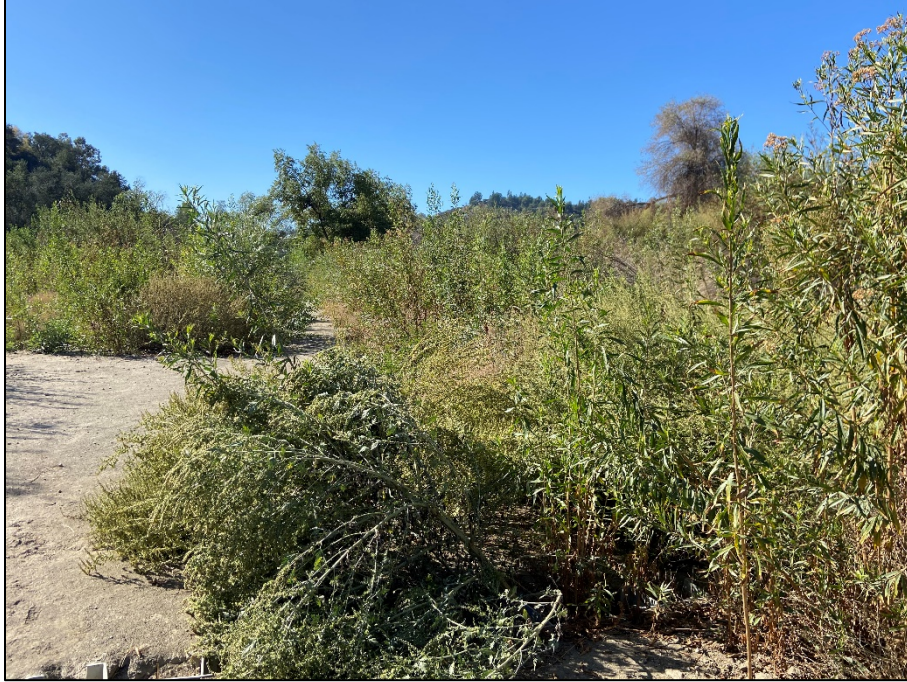
Photo 3: Overview Mitigation Area Overview Mitigation Area DG-2 & DG-2 New Channels

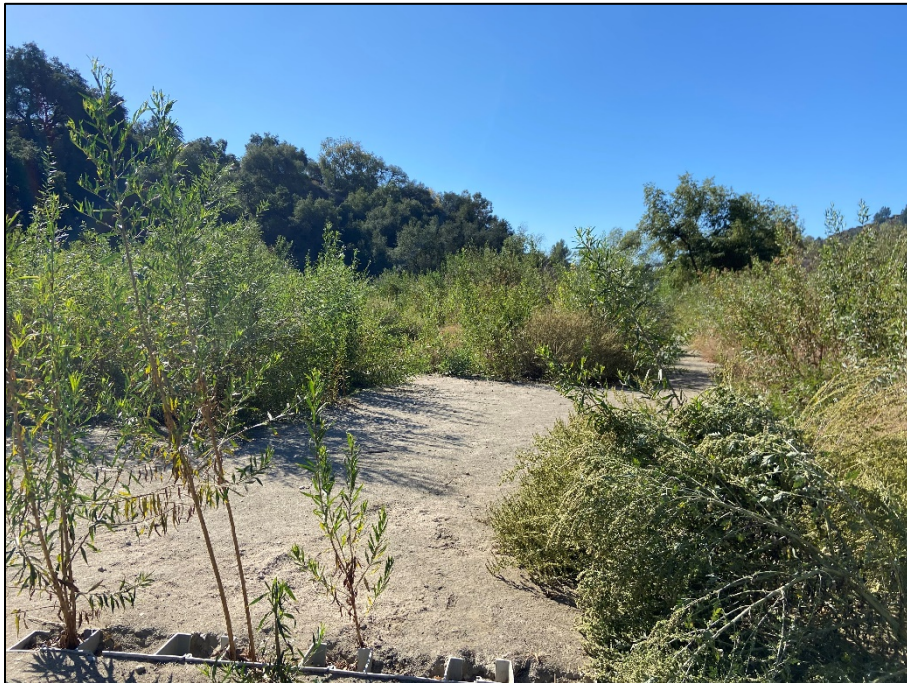
Photo 4: Overview Mitigation Area DG-2 & DG-2 New Channels

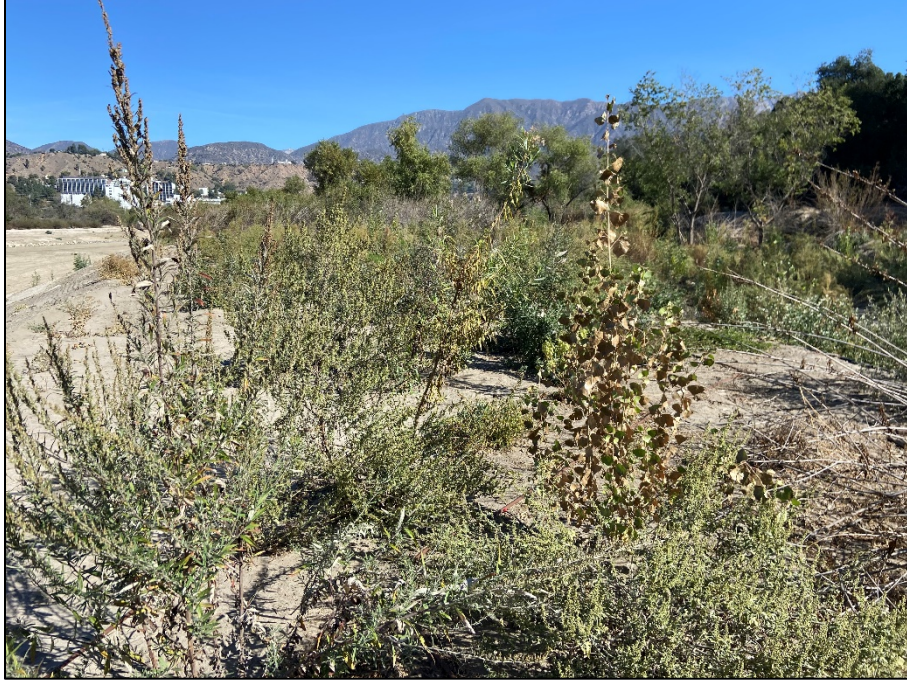
Photo 5: Overview Mitigation Area DG-2

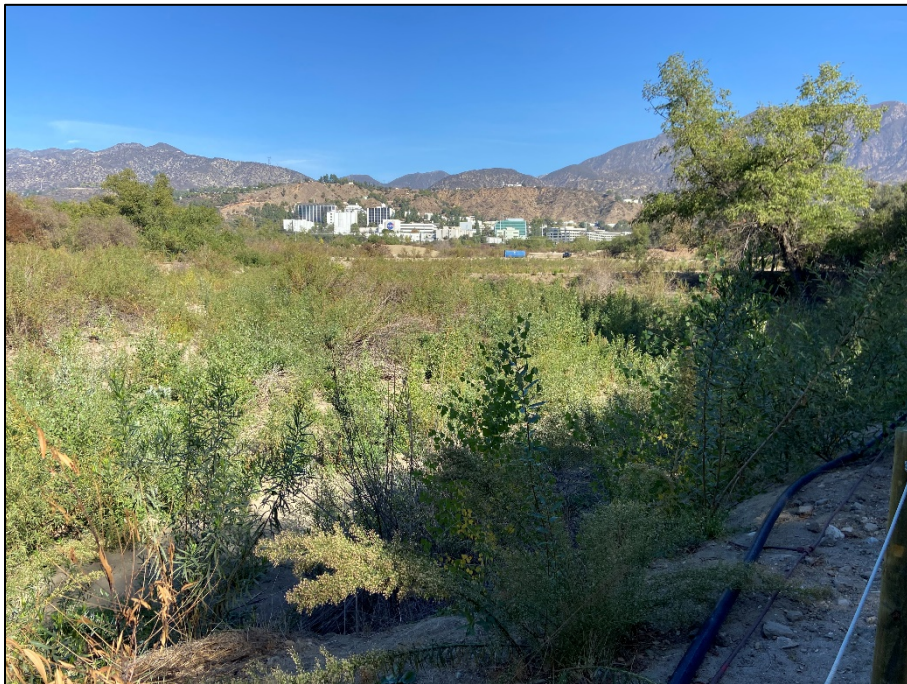
Photo 6: Overview Mitigation Area DG-2, DG-2 New Channels, DG-2 WOUS

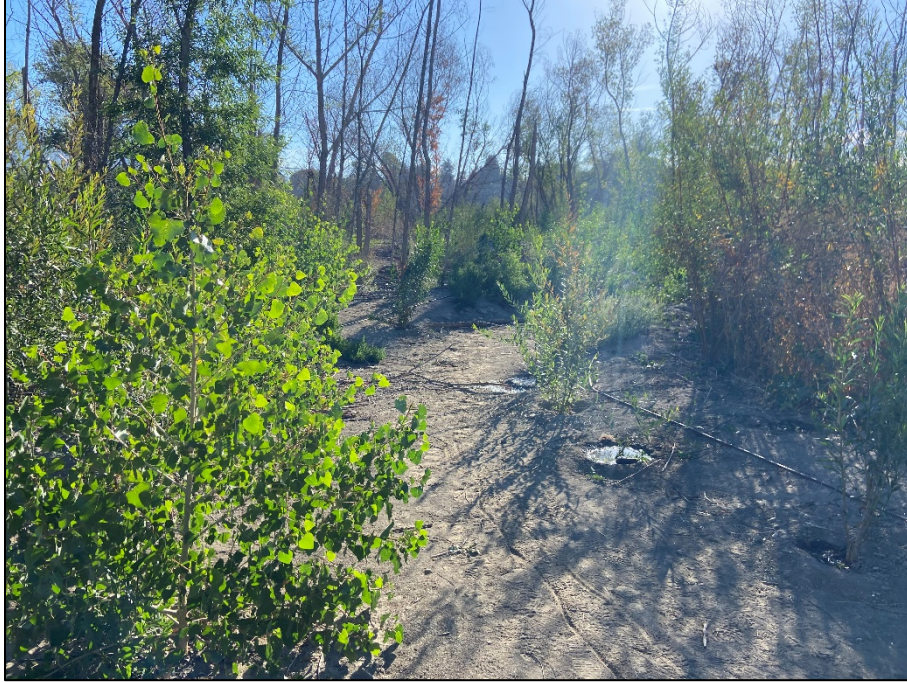
Photo 7: Overview Mitigation Area DG-W-2 (Mining Pit)

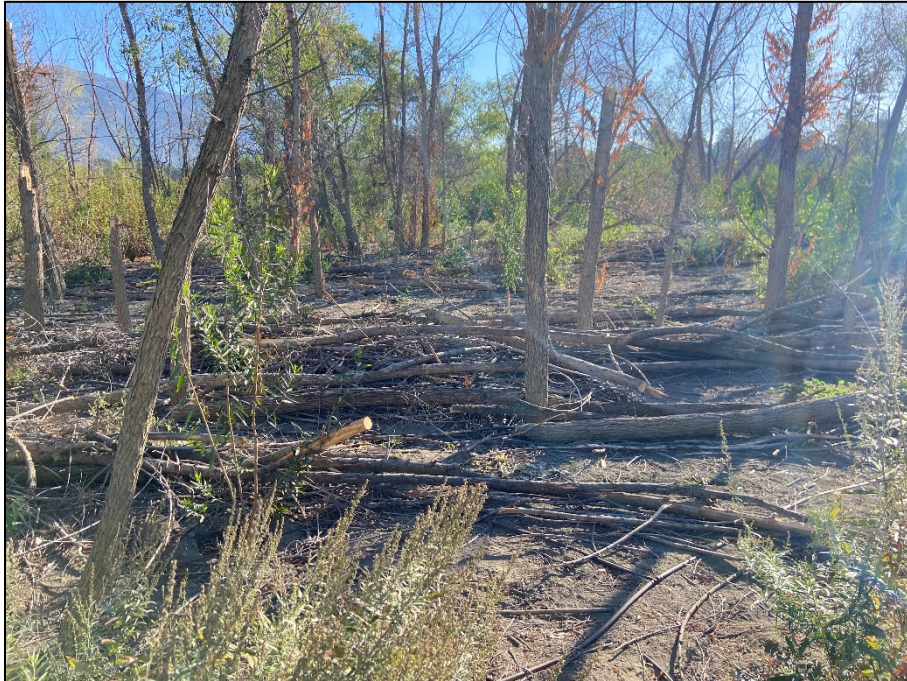
During the monitoring visit, it was noted that many of the existing mature black willow (*Salix gooddingii*) in this mitigation area were showing signs of beetle infestation. Signs of infestation included entry/exit holes, frass, galleries, fungal residue, and branch failure. Further investigation into this issue is being conducted with the help from the Los Angeles County Department of Agricultural Commissioner/Weights & Measures (ACWM). It should be noted that evidence of infestation was only noted on existing mature willows and not on any of the recently installed container plants.

Photo 8: Fallen Trees Mitigation Area DG-W-2 (Mining Pit)

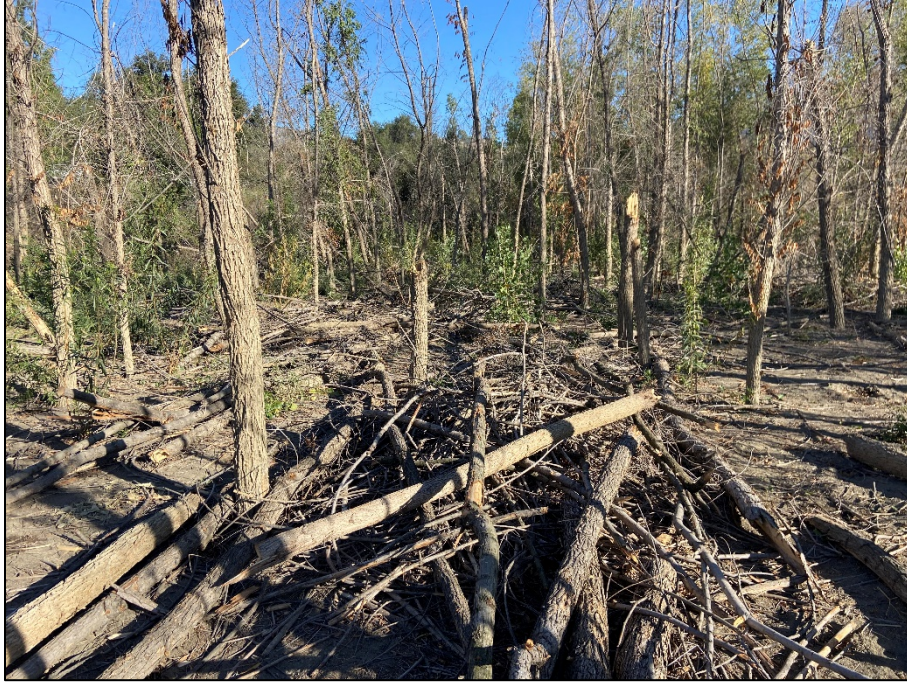
Photo 9: Fallen Trees Mitigation Area DG-W-2 (Mining Pit)

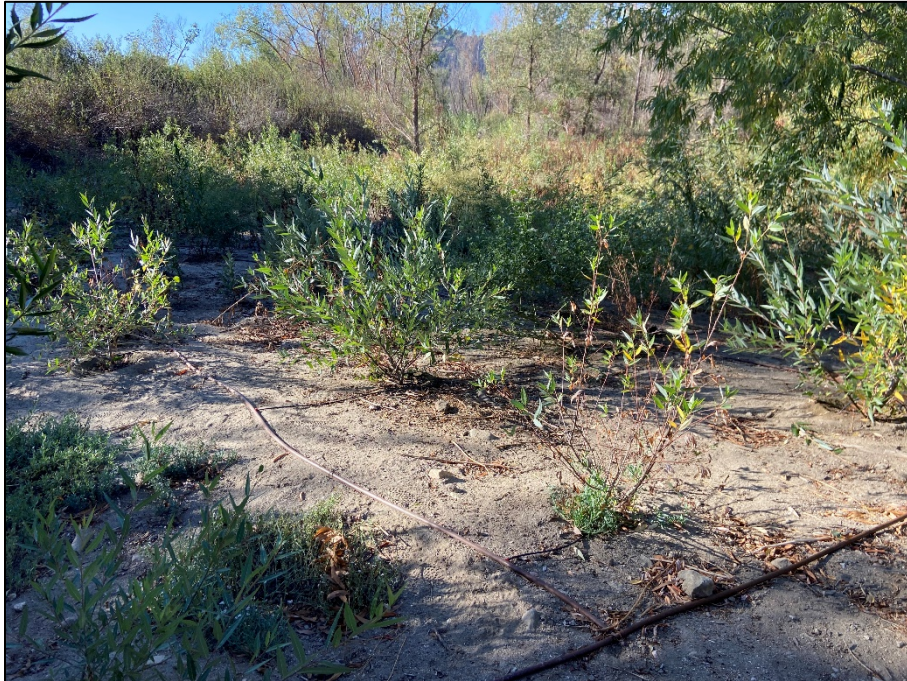
Photo 10: Overview Mitigation Area DG-W-2 (Mining Pit)

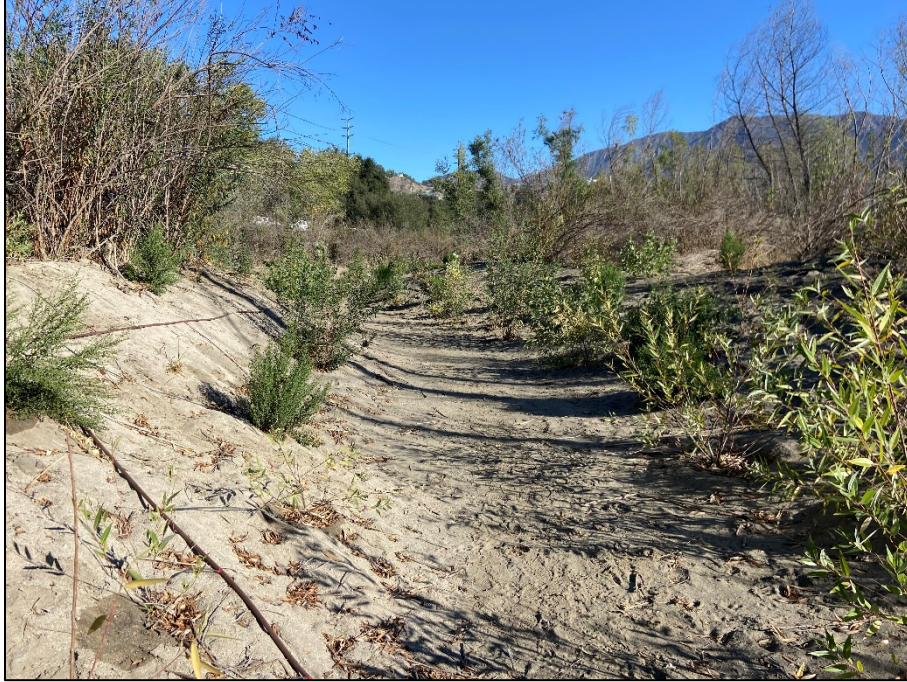
Photo 11: Overview Mitigation Area DG-W-2 (Mining Pit Outlet)

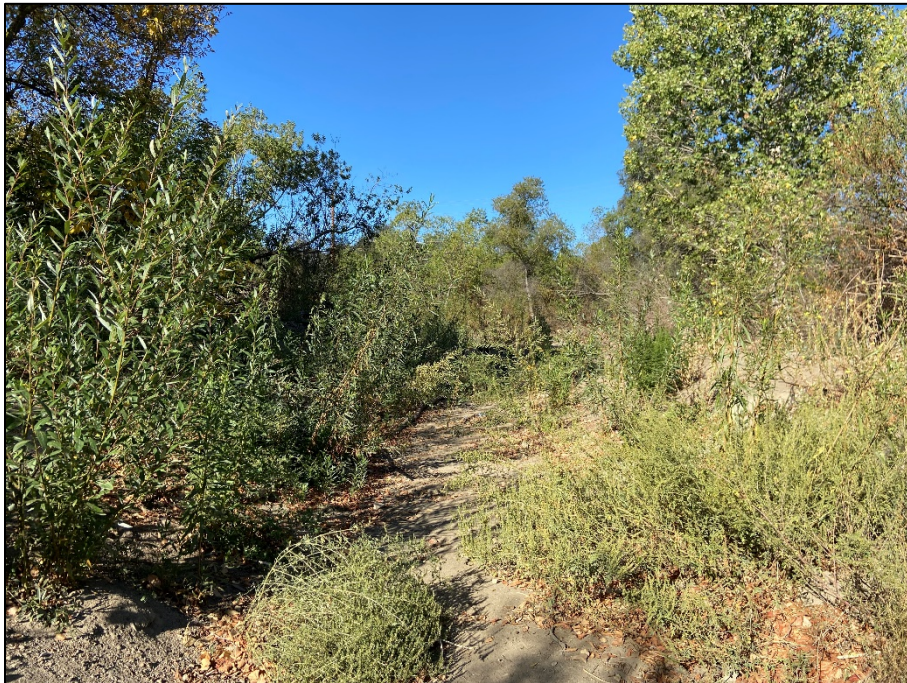
Photo 12: Overview Mitigation Area DG-W-2 (Mining Pit Outlet)

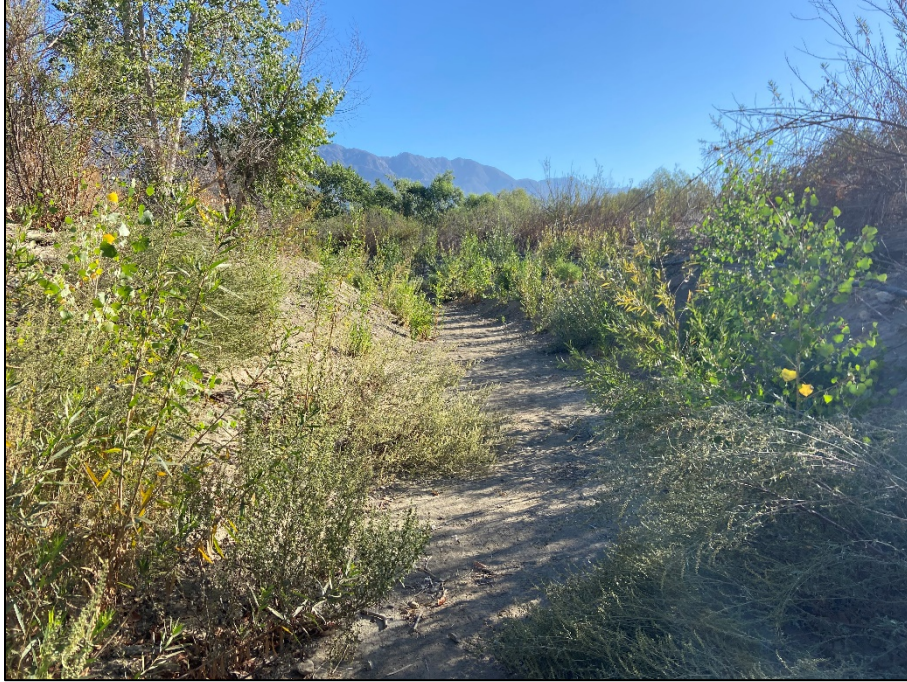
Photo 13: Overview Mitigation Area DG-W-2 (Mining Pit Outlet)

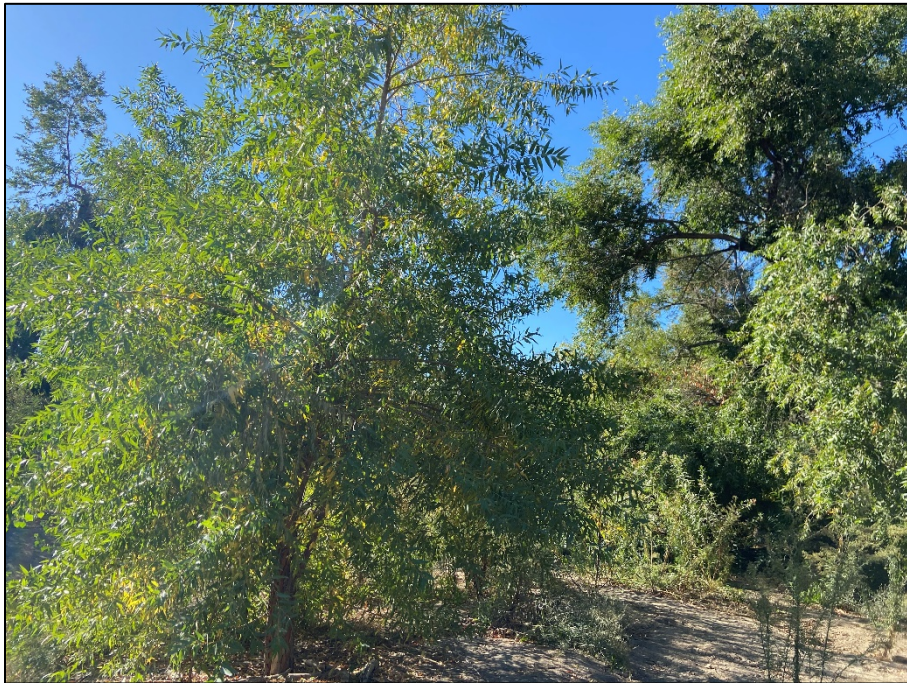
Photo 14: Overview Mitigation Area DG-4 Sheet Flow/DG-SF-1
