July 31, 2023
2017-116.006

Los Angeles County Public Works
900 South Fremont Avenue, 9th Floor
Alhambra, California 91803

Re: *Devil's Gate Reservoir Restoration Project – Phase 2 Restoration Qualitative Monitoring Conducted on May 22, 2023*

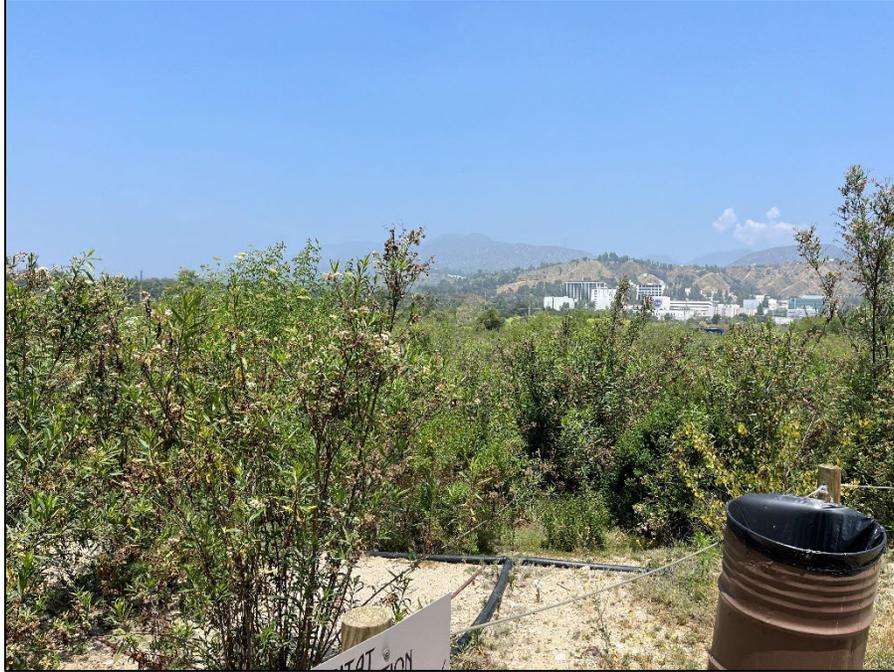
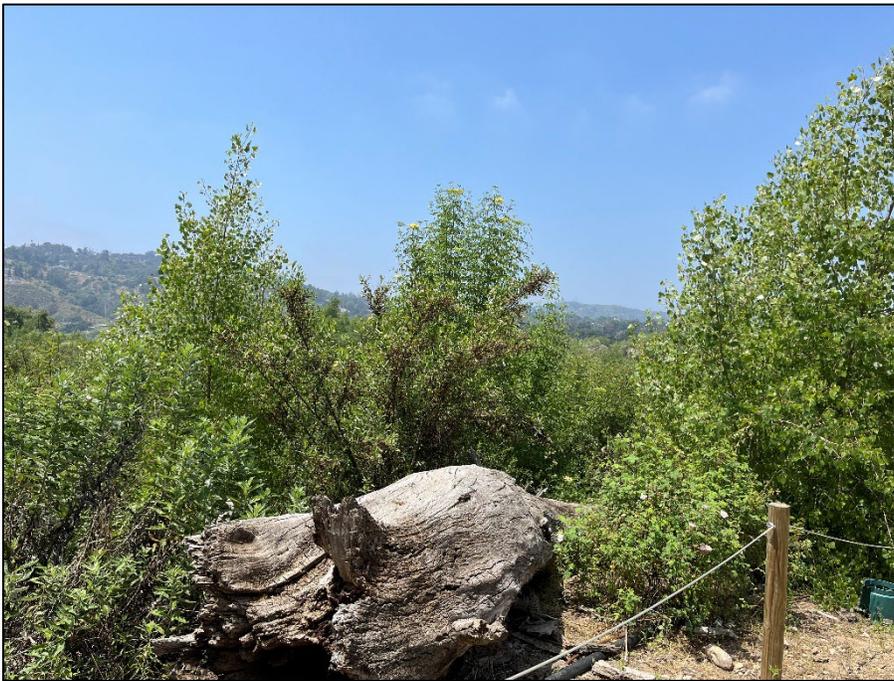
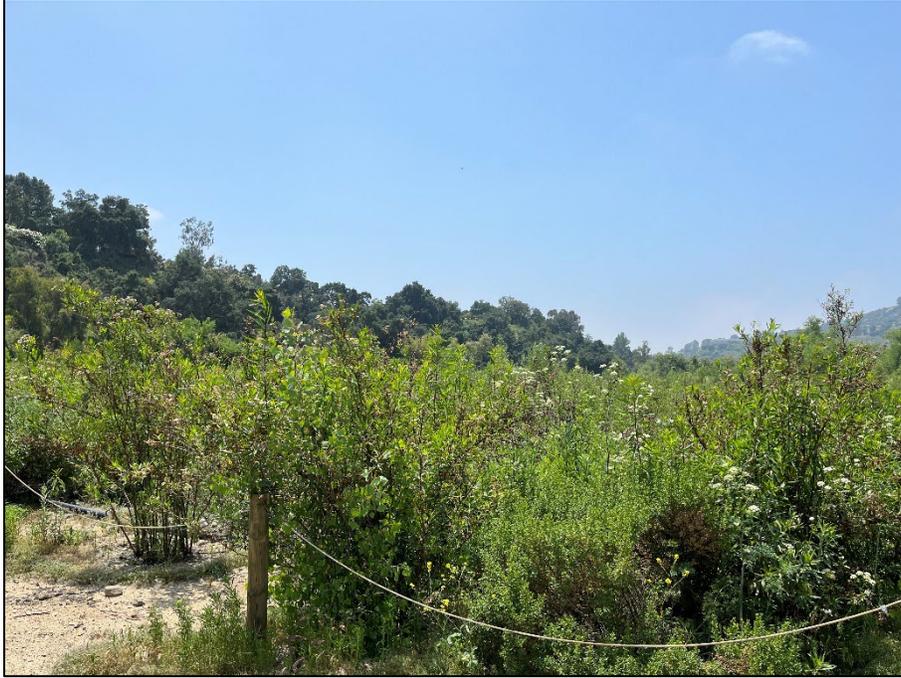
The overall health of the container plants in DG-W-1 was noted as being good. Approximately five percent of the container plants in DG-W-1 were noted as showing varied levels of stress and a negligible number were noted as being dead or missing. This is approximately five percent less than the percentage of plants that were showing stress during the last monitoring event. Stress may be occurring as a result of 1) competition from nonnative and invasive weeds, 2) misplaced emitters, or 3) recreational traffic through the mitigation areas. In addition, some of the willows were showing signs of dieback from rust fungus (*Melampsora* sp.). A handful of Fremont's cottonwoods (*Populus fremontii*) were also showing minor dieback which appeared to be the result of natural recruitment of mulefat within their basins. Evidence of dieback from *Phytophthora cactorum*, including wilting, stunted growth, leaf spotting, and/or browning along leaf margins and tips, was not observed on any of the container plants. The willows and Fremont's cottonwoods in this mitigation area were no longer showing signs of seasonal dieback during the monitoring visit. Formal mortality counts were taken for DG-W-1 during the 2021 and 2022 quantitative monitoring events. Some of the container plants were noted as lacking well defined basins and should have their basins properly constructed and/or repaired. The irrigation line appeared to be functioning properly for the mitigation area during the monitoring visit. The installation of plants in the DG-W-1 mitigation area appears to have been completed successfully. The current issues identified during the monitoring visit are not expected to have an effect on the continued growth of the plants in the mitigation area. Photos 1 through 3 in Attachment B document the mitigation area during the monitoring visit.

phacelia (*Phacelia distans*), and Parry's phacelia (*Phacelia parryi*). were observed sprouting in the DG-W-1 mitigation area. The California dodder growing on the container plants should be removed during weed abatement activities. Native cover was estimated to be approximately 85 percent in the DG-W-1 mitigation area.

Nonnative weed cover in DG-W-1 was estimated at approximately 10 percent, which is approximately the nine percent higher than the level of weed cover that was observed during the previous monitoring visit. It should be noted that weed cover in this mitigation area during the spring of 2022 was approximately less than two percent. The minor increase in nonnative cover during the spring of 2023 in this mitigation area is likely due to the increase in precipitation during the 2023 wet season and a higher level of weed cover is typical during the spring and summer months. Nonnative species observed in DG-W-1 included black mustard (*Brassica nigra*), poison hemlock (*Conium maculatum*), scarlet pimpernel (*Lysimachia arvensis*), and German chamomile (*Matricaria chamomilla*). Most of the nonnative weeds observed in this mitigation area were still vegetative and just beginning to germinate.

Photo 1: Overview Mitigation Area DG-W-1 (Johnson Field)

Photo 2: Overview Mitigation Area Overview Mitigation Area DG-W-1 (Johnson Field)

Photo 3: Overview Mitigation Area Overview Mitigation Area DG-W-1 (Johnson Field)

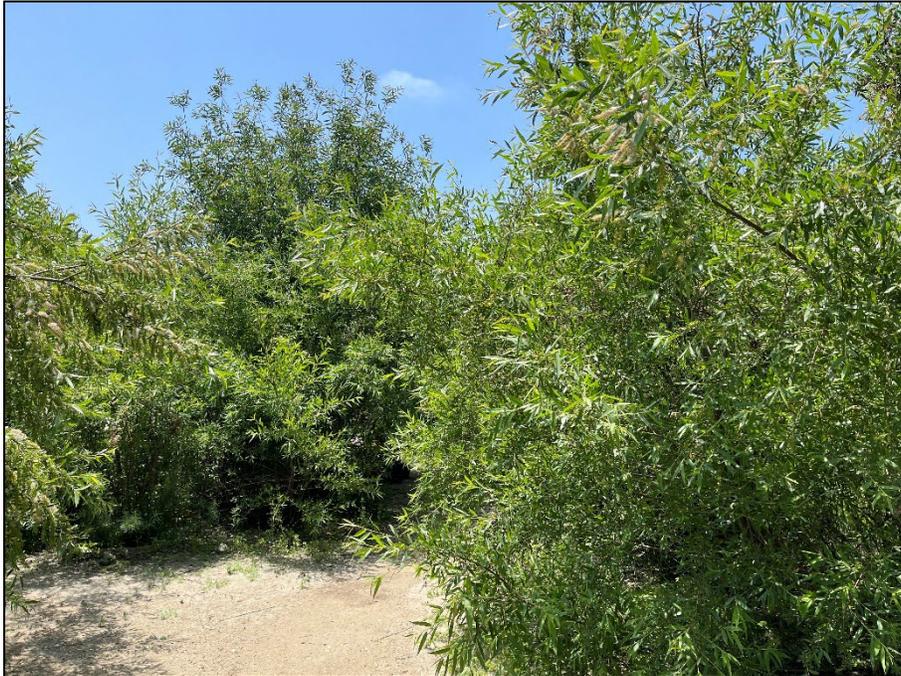
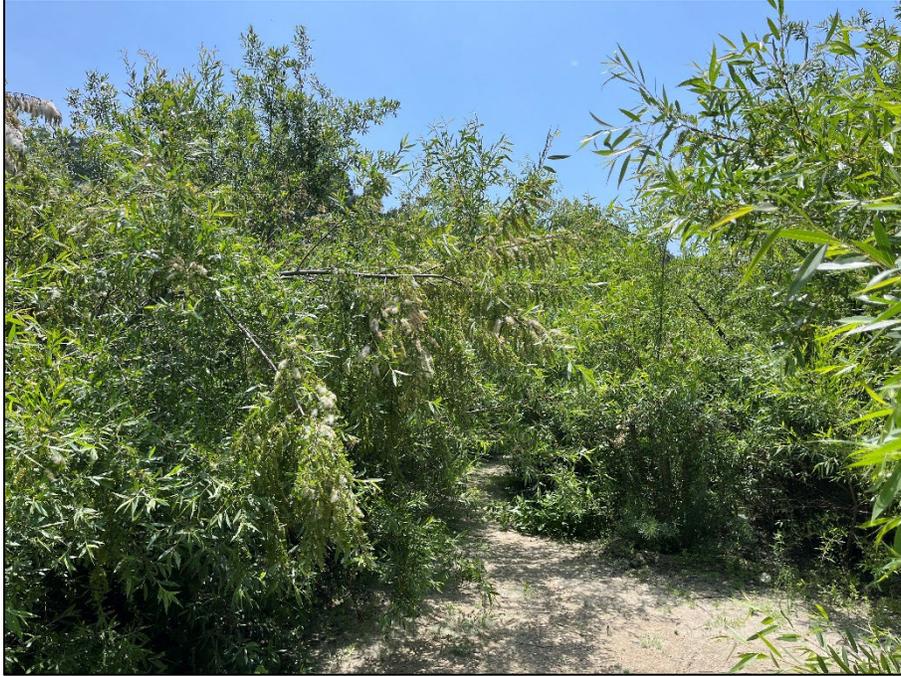
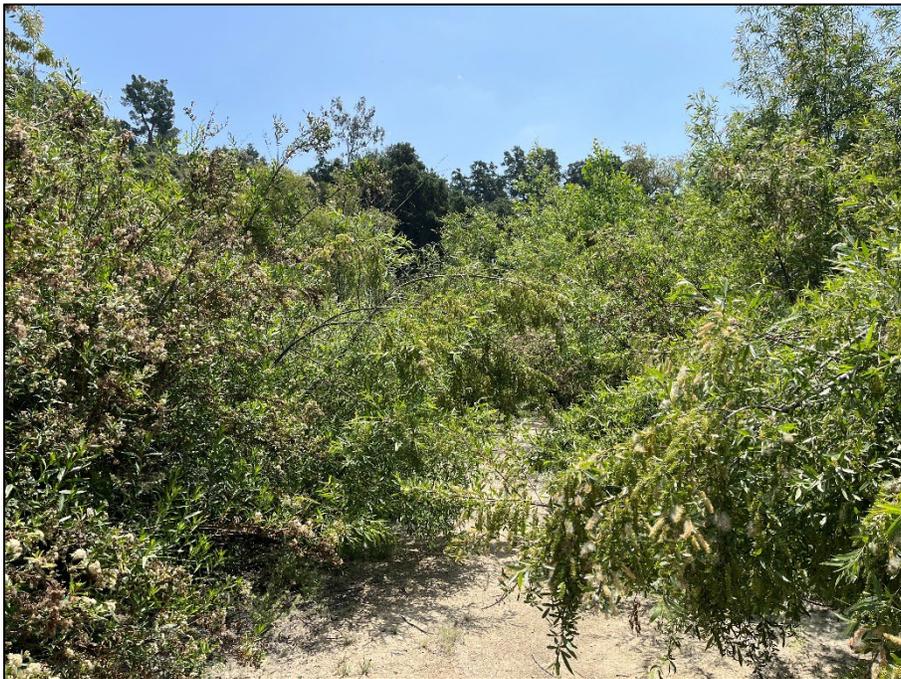
The overall health of the container plants in DG-2, DG-2 New Channels, and DG-2 WOUS was noted as being good. Approximately less than five percent of the container plants were noted as showing varied levels of stress and a negligible number were noted as being dead or missing. This is approximately the same percentage of plants that were showing stress during the last monitoring event. Stress may be occurring due to similar reasons described for DG-W-1. Evidence of dieback from *Phytophthora cactorum*, including wilting, stunted growth, leaf spotting, and/or browning along leaf margins and tips, was not observed on any of the container plants. Similar to DG-W-1, the willows and Fremont's cottonwoods in this mitigation area were no longer showing signs of seasonal dieback. Formal mortality counts were taken for DG-2, DG-2 New Channels, and DG-2 WOUS during the 2021 and 2022 quantitative monitoring events. Some of the container plants were noted as lacking well defined basins and should have their basins properly constructed and/or repaired. The irrigation line appeared to be functioning properly during the monitoring visit. During the monitoring visit, the grade control structure that was installed at the northern end of DG-2 New Channels where the channels connect to DG-W-1 was inspected for erosion. Minor erosion was observed, mostly towards the western end of the structure; however, no major erosion issues were observed, and the structure appears to be functioning properly. The installation of plants in the DG-2, DG-2 New Channels, and DG-2 WOUS mitigation areas appears to have been completed successfully. The current issues identified during the monitoring visit are not expected to have an effect on the continued growth of the plants in the mitigation area. Photos 4 through 6 in Attachment B document the mitigation areas during the monitoring visit.

Nonnative weed cover in the DG-2, DG-2 New Channels, and DG-2 WOUG mitigation areas was estimated at approximately five percent, which is approximately the same as the percentage that was observed during the last monitoring visit. It should be noted that weed cover in this mitigation area during the spring of 2022 was also approximately five percent. Nonnative species observed in this mitigation area included black mustard, poison hemlock, and perennial pepperweed (*Lepidium latifolium*). Most of the nonnative weeds observed in this mitigation area were vegetative and just starting to germinate.

Photo 4: Overview Mitigation Area DG-2 & DG-2 New Channels

Photo 5: Overview Mitigation Area DG-2 & DG-2 New Channels

Photo 6: Overview Mitigation Area DG-2 & DG-2 WOUS

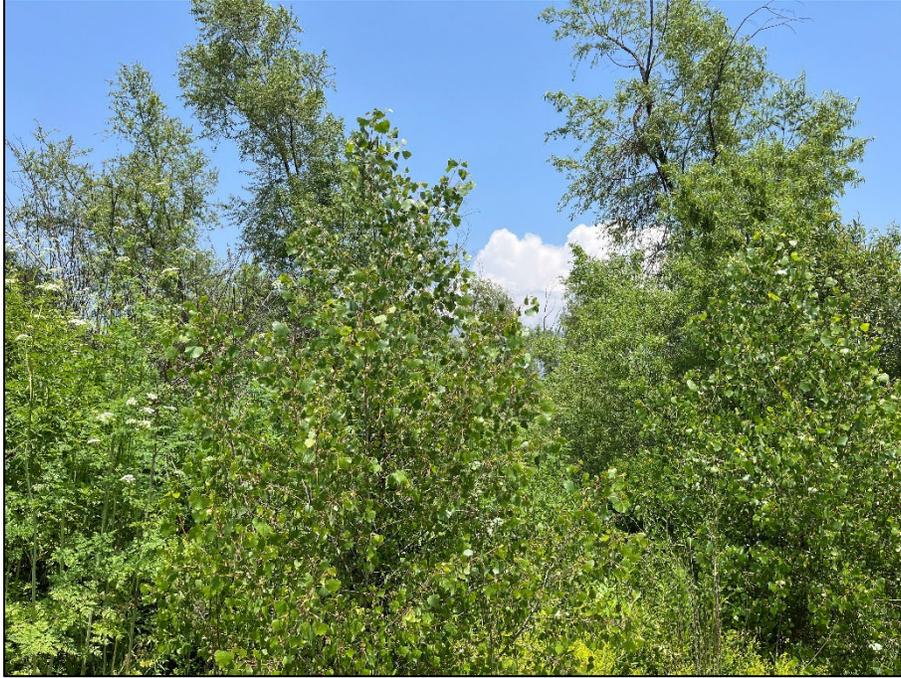
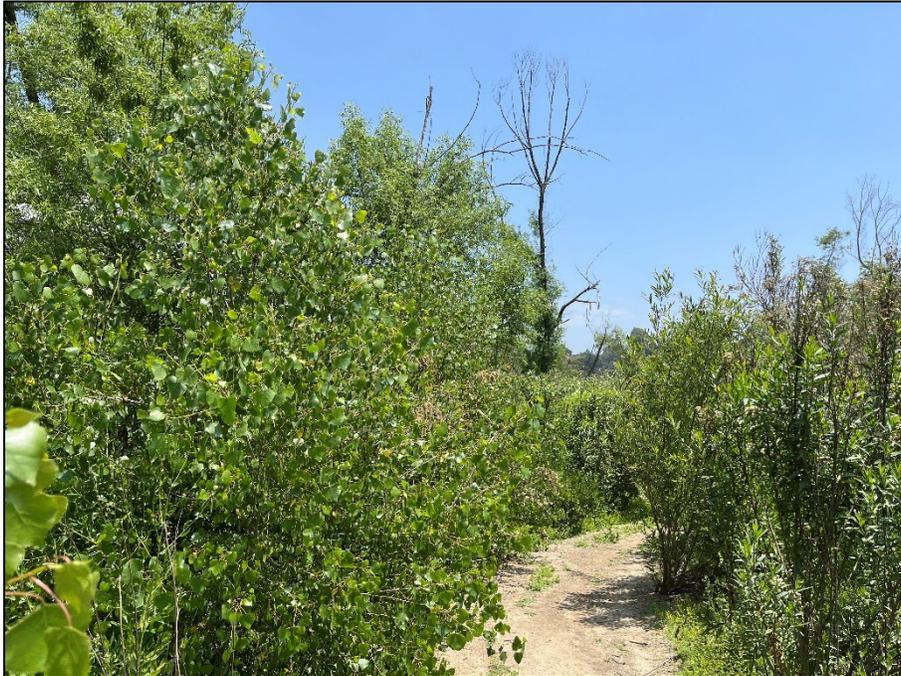
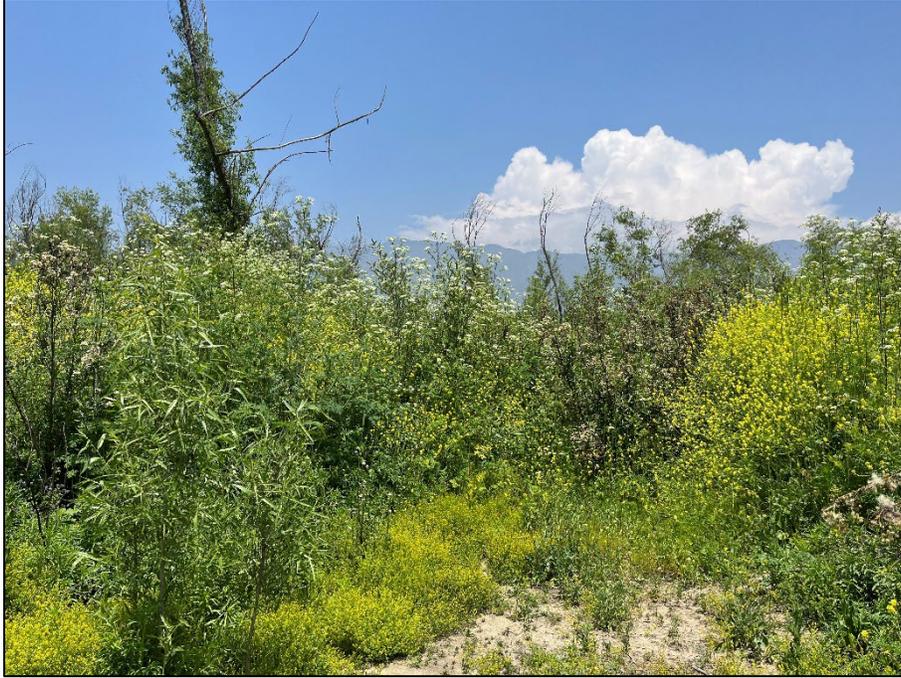
The overall health of the container plants in mitigation area DG-W-2 was noted as being good. Approximately 10 percent of the container plants were noted as showing varied levels of stress and a negligible number were noted as being dead or missing. This is approximately five percent less than the percentage of plants that were showing stress during the last monitoring event. Stress may be occurring due to similar reasons described for DG-W-1. Evidence of dieback from *Phytophthora cactorum*, including wilting, stunted growth, leaf spotting, and/or browning along leaf margins and tips, was not observed on any of the container plants. Similar to DG-W-1, the willows and Fremont's cottonwoods in this mitigation area were no longer showing signs of seasonal dieback. Formal mortality counts were taken for DG-W-2 during the 2021 and 2022 quantitative monitoring events. Some of the container plants were noted as lacking well defined basins and should have their basins properly constructed and/or repaired. The irrigation line appeared to be functioning properly for most areas of the mitigation area during the monitoring visit; however, some basins appeared to be dry and should be inspected for functionality. The installation of plants in the DG-W-2 mitigation area appears to have been completed successfully and the issues noted during the monitoring are not expected to have an impact on the continued growth of the plants. Photos 7 through 9 in Attachment B document the mitigation area during the monitoring visit.

During the monitoring visit, it was noted that many of the remaining mature black willows (*Salix gooddingii*) in this mitigation area were showing signs of recovery, such as sprouting vigorously from the base, from the polyphagous shot-hole borer (PSHB) infestation that was confirmed by the Los Angeles County Department of Agricultural Commissioner/Weights & Measures in December of 2021. The majority of the dead and hazardous black willows in this mitigation area were removed in October of 2022. Black willows that were determined to have the potential to recover were left in place and will continue to be monitored during the qualitative monitoring visits.

Nonnative weed cover in DG-W-2 was estimated at approximately 35 percent in the mitigation area, which is approximately 25 percent higher than the level of nonnative cover that was observed during the last monitoring event. It should be noted that weed cover in this mitigation area during the spring of 2022 was approximately 10 percent. The increase in nonnative cover during the spring of 2023 in this mitigation

area is likely due to the increase in precipitation during the 2023 wet season and a higher level of weed cover is typical during the spring and summer months. In addition, bird nests in DG-W-2 during the spring of 2023 have prevented crews from being able to conduct weed abatement activities in these areas. Nonnative species observed in DG-W-2 included black mustard, poison hemlock, perennial pepperweed, and wild radish (*Raphanus sativus*). Many of the nonnative weeds in this mitigation area were starting to produce flowers and or seed and should be removed as soon as the bird nests in this area fledge or are determined to be inactive.

Photo 7: Overview Mitigation Area DG-W-2 (Mining Pit)

Photo 8: Overview Mitigation Area DG-W-2 (Mining Pit)

Photo 9: Overview Mitigation Area DG-W-2 (Mining Pit)

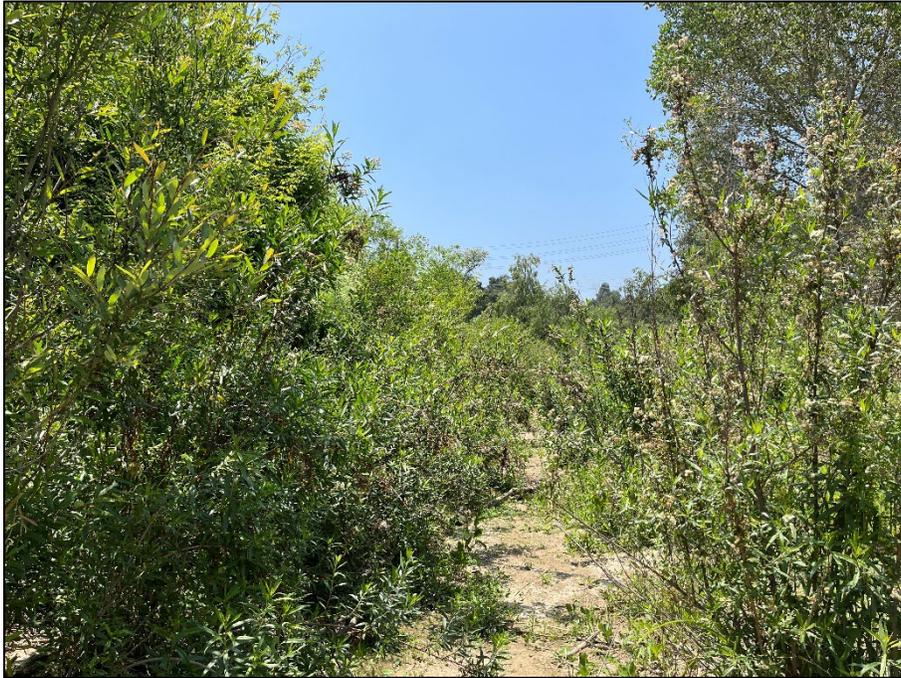
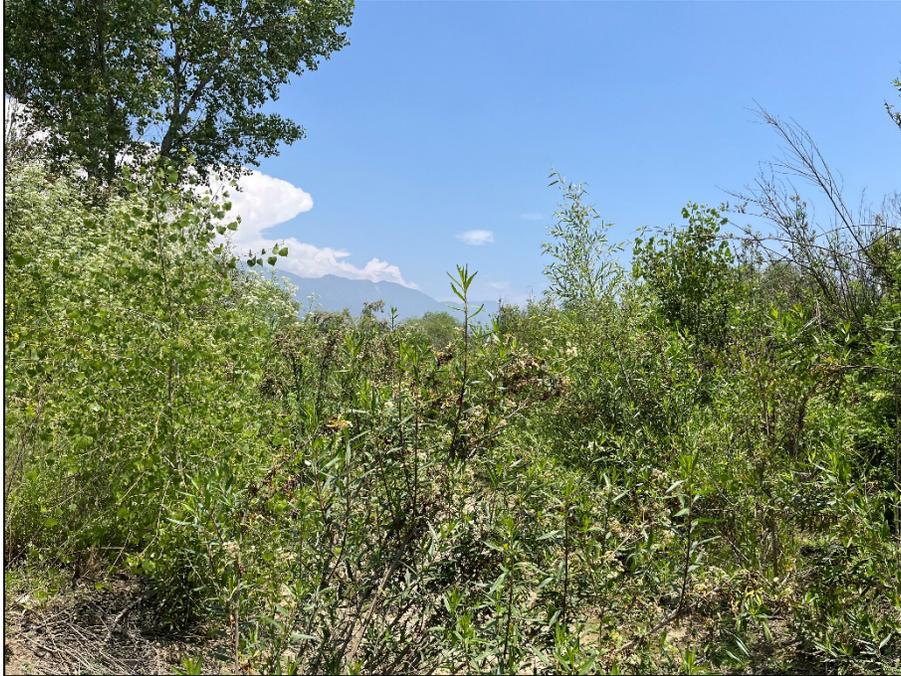
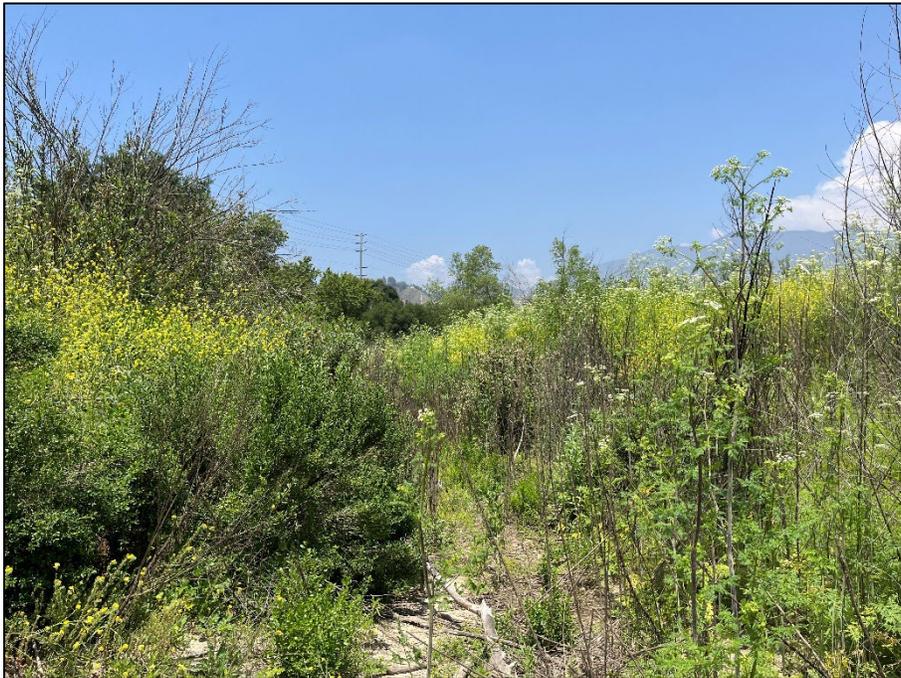
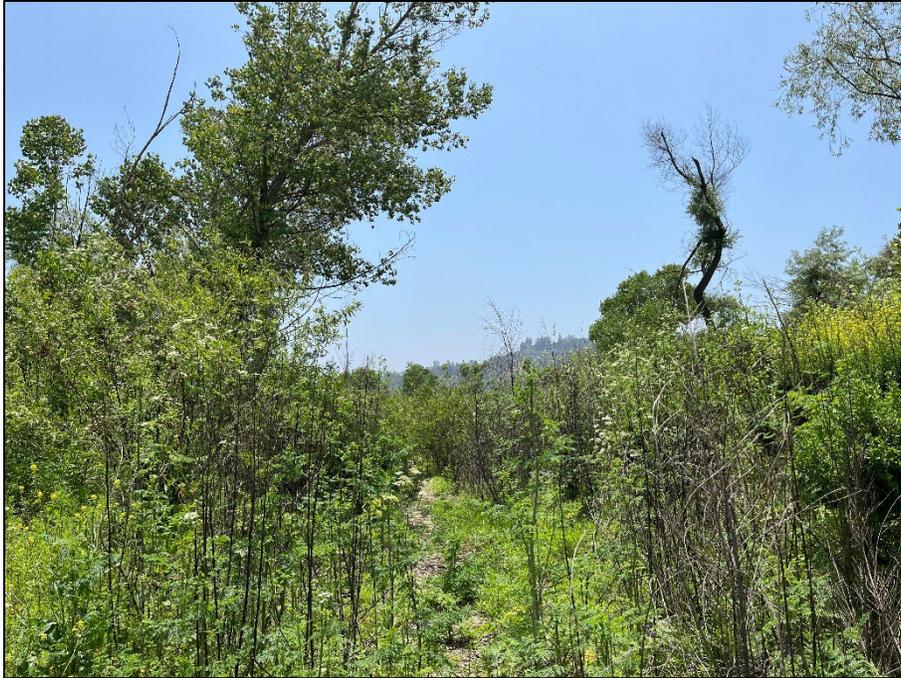
The overall health of the container plants in mitigation area DG-W-2 Outlet was noted as being good. Approximately 10 to 15 percent of the container plants were noted as showing varied levels of stress and a negligible number were noted as being dead or missing. This is approximately the same percentage of plants that were showing stress during the last monitoring event. Stress may be occurring due to similar reasons described for DG-W-1. Evidence of dieback from *Phytophthora cactorum*, including wilting, stunted growth, leaf spotting, and/or browning along leaf margins and tips, was not observed on any of the container plants. Similar to DG-W-1, the willows and Fremont's cottonwoods in this mitigation area were continuing to show signs of seasonal dieback. Formal mortality counts were taken for DG-W-2 Outlet during the 2021 and 2022 quantitative monitoring events. Some of the container plants were noted as lacking well defined basins and should have their basins properly constructed and/or repaired. The irrigation line appeared to be functioning properly for most areas of the mitigation area during the monitoring visit; however, some basins appeared to be dry and should be inspected for functionality. The installation of plants in the DG-W-2 Outlet mitigation area appears to have been completed successfully and the issues noted during the monitoring are not expected to have an impact on the continued growth of the plants. Photos 10 through 13 in Attachment B document the mitigation area during the monitoring visit.

Nonnative weed cover in DG-W-2 Outlet was estimated to be approximately 35 percent, which is approximately 30 percent more than the percentage of weed cover that was observed during the previous monitoring visit. The increased level of weed cover in this mitigation area was attributed to bird nests in the area preventing crews from conducting weed abatement. It should be noted that weed cover in this mitigation area during the spring of 2022 was approximately 10 percent. The increase in nonnative cover during the spring of 2023 in this mitigation area is likely due to the increase in precipitation during the 2023 wet season and a higher level of weed cover is typical during the spring and summer months. In addition, bird nests in DG-W-2 Outlet during the spring of 2023 have prevented crews from being able to conduct weed abatement activities in these areas. Nonnative species observed in DG-W-2 included black mustard, poison hemlock, perennial pepperweed, tree tobacco (*Nicotiana glauca*), and curly dock (*Rumex*

crispus). Many of the nonnative weeds in this mitigation area were starting to produce flowers and or seed and should be removed as soon as the bird nests in this area fledge or are determined to be inactive.

Photo 10: Overview Mitigation Area DG-W-2 (Mining Pit Outlet)

Photo 11: Overview Mitigation Area DG-W-2 (Mining Pit Outlet)

Photo 12: Overview Mitigation Area DG-W-2 (Mining Pit Outlet)

Photo 13: Overview Mitigation Area DG-W-2 (Mining Pit Outlet)

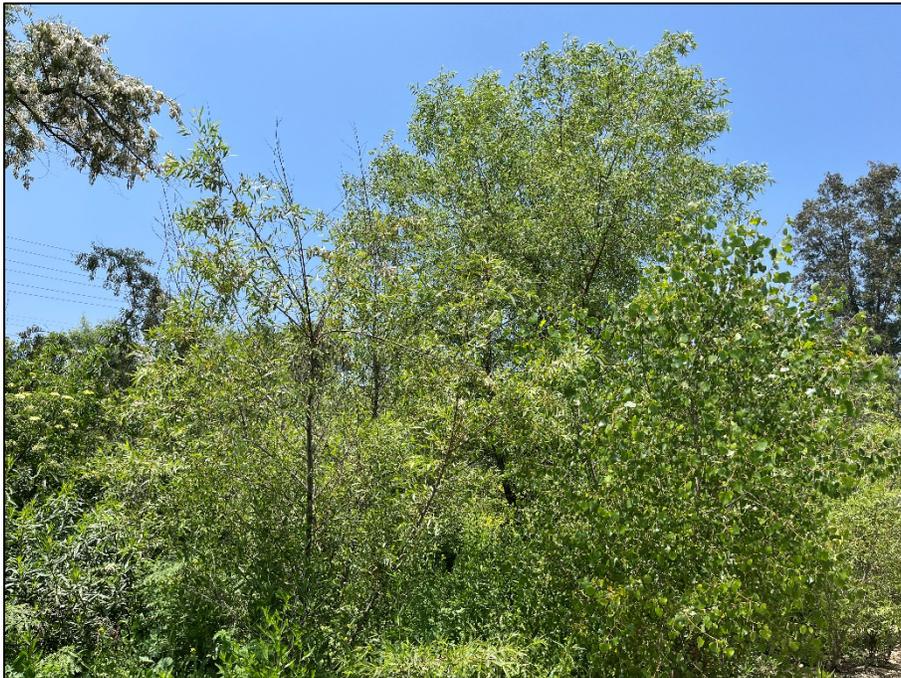
The overall health of the container plants in mitigation areas DG-4 Sheet Flow (northern) and DG-SF-1 was noted as being good. Approximately 10 percent of container plants were showing varied levels of stress which is approximately the same as the percentage of container plants that were showing stress during the previous monitoring event. Stress may be occurring due to similar reasons described for DG-W-1; however, the increased level of stress appears to be the result of prolonged inundation that occurred in January 2023. Evidence of dieback from *Phytophthora cactorum*, including wilting, stunted growth, leaf spotting, and/or browning along leaf margins and tips, was not observed on any of the container plants. Similar to DG-W-1, the willows and Fremont's cottonwoods in this mitigation area were starting to show minor seasonal dieback. Formal mortality counts were taken during the 2021 and 2022 quantitative monitoring events. Some of the container plants were noted as lacking well defined basins and should have their basins properly constructed and/or repaired. In addition, minor herbivory of young plants was observed within the DG-4 Sheet Flow and DG-SF-1 areas and should continue to be monitored. The irrigation line appeared to be functioning properly during the monitoring visit. The installation of plants in the DG-4 Sheet Flow and DG-SF-1 mitigation areas appears to have been completed successfully and the issues noted during the monitoring are not expected to have an impact on the continued growth of the plants. Photo 14 in Attachment B document the mitigation area during the monitoring visit.

Nonnative weed cover in DG-4 Sheet Flow and DG-SF-1 was estimated at approximately 35 percent, which is approximately 30 percent more than the level of weed cover that was observed during the previous monitoring visit. It should be noted that weed cover in this mitigation area during the spring of 2022 was approximately 70 percent and a higher level of weed cover is typical during the spring and summer months. In addition, bird nests in DG-4 Sheet Flow and DG-SF-1 during the spring of 2022 and 2023 have prevented crews from being able to conduct weed abatement activities in these areas. The increased level of weed cover in this mitigation area was attributed to bird nests in the area preventing crews from conducting weed abatement. Nonnative species observed in DG-4 Sheet Flow and DG-SF-1 included black mustard, poison hemlock, and perennial pepperweed. Many of the nonnative weeds in this mitigation area were starting to produce flowers and or seed and should be removed as soon as the bird nests in this area fledge or are determined to be inactive.

Photo 14: Overview Mitigation Area DG-4 Sheet Flow/Sheet Flow-1
