Re: Devil's Gate Reservoir Restoration Project – Phase 3 Restoration Qualitative Monitoring Conducted on November 17, 2023

1.0 INTRODUCTION

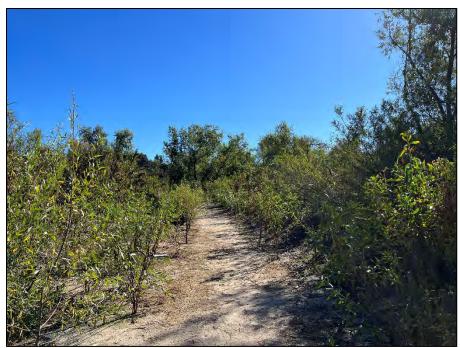
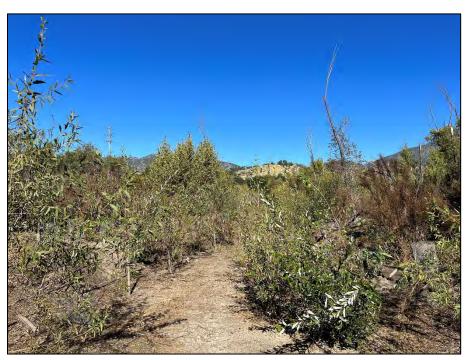
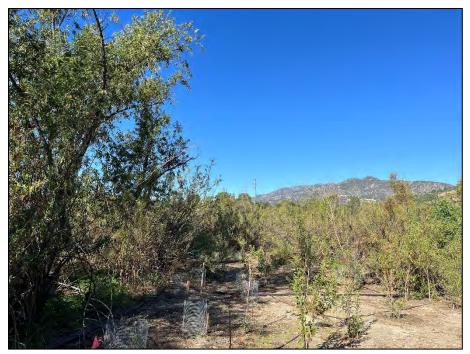
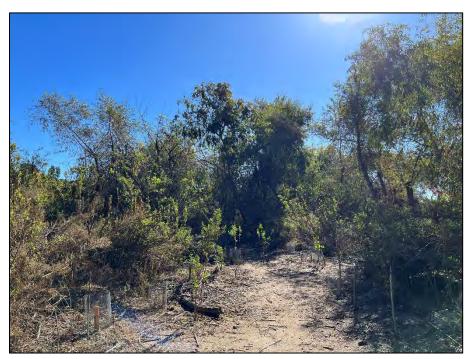
The overall health of the container plants in DG-4 WOUS and DG-4 WOUS Connections was noted as being good. Approximately 10 percent of the container plants and stakes in DG-4 WOUS and DG-4 WOUS Connections were noted as showing varied levels of stress and a negligible amount were noted as being dead or missing. This is approximately the same percentage of plants that were showing stress during the previous monitoring visit. Stress may be occurring as a result of 1) transplant shock, 2) herbivory by rabbits or other wildlife, 3) competition from nonnative and invasive weeds, 4) misplaced emitters, or 5) recreational traffic through the mitigation areas. Formal mortality counts will be taken for DG-4 WOUS and DG-4 WOUS Connections during the 2024 quantitative monitoring and will be included in the 2024 annual reporting. The majority of the recently planted mulefat and willow (*Salix* spp.) stakes were noted as showing signs of new growth; however, it appears that some did not germinate. Some of the container plants were noted as lacking well defined basins and should have their basins properly constructed and/or repaired. The installation of plants in the DG-4 WOUS and DG-4 WOUS Connections mitigation areas appears to have been completed successfully. The current issues identified during the monitoring visit are not expected to have an effect on the continued growth of the plants in the mitigation area. Photos 1 through 4 in Appendix B document the mitigation areas during the monitoring visit.

mexicana), and Douglas' nightshade (*Solanum douglasii*). In addition, California dodder (*Cuscuta californica*) was observed growing on some of the young container plants and should be removed. Native cover was estimated to be approximately 35 to 40 percent during the monitoring visit.

Nonnative weed cover in DG-4 WOUS and DG-4 WOUS Connections was estimated at approximately 2 percent, which is approximately 8 to 13 percent lower than what was observed during the previous monitoring visit and evidence of recent weed abatement was observed. Nonnative species observed included black mustard (*Brassica nigra*), poison hemlock (*Conium maculatum*), perennial pepperweed (*Lepidium latifolia*), and wand mullein (*Verbascum virgatum*). Most of the nonnative weeds observed in these mitigation areas were just starting to germinate and were not going to flower or seed. As weed abatement continues in the mitigation areas, it is anticipated that the seed bank of nonnative and invasive weeds will decrease; however, perennial pepperweed easily resprouts from rhizomatous roots that can be difficult to fully remove with hand tools.

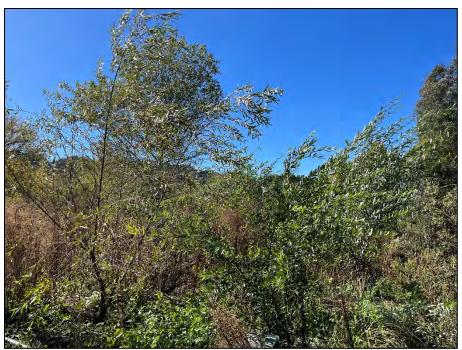
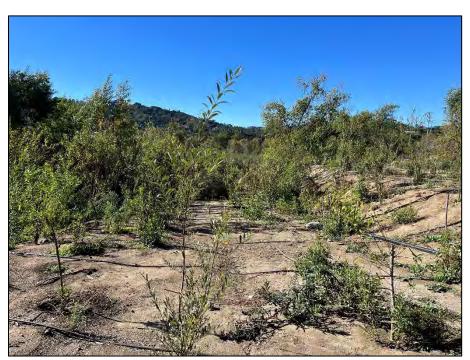
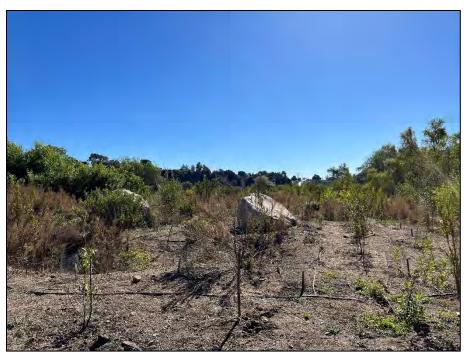
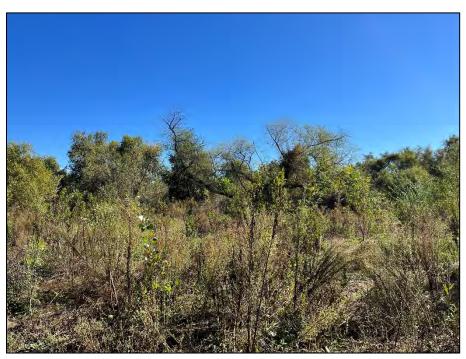
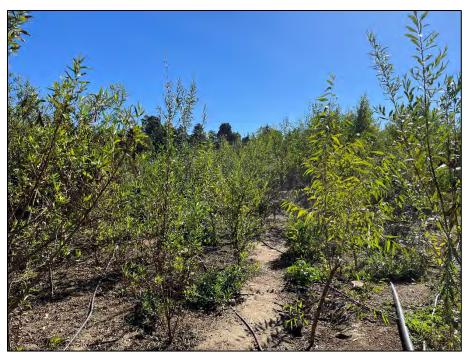
The overall health of the container plants in DG-4A was noted as being good to fair, depending on the location in the various areas labeled as DG-4A. Overall, approximately 10 percent of the container plants and stakes were noted as showing varied levels of stress. During the monitoring visit, replacement container plants were being installed to replace the container plants and stakes planted in the middle section of DG-4A that appeared to be dead or in a condition unlikely to recover during previous monitoring visits. Stress may be occurring due to similar reasons described for DG-4 WOUS and DG-4 WOUS Connections. It should also be noted that a portion of DG-4A was inundated for two short periods of time during January and February of 2023; however, the inundation does not appear to have contributed to higher levels of stress or mortality in these areas. Formal mortality counts will be taken for DG-4A during the 2024 quantitative monitoring and will be included in the 2024 annual reporting. The majority of the recently planted mulefat and willow stakes were noted as showing signs of new growth. Some of the container plants were noted as lacking well defined basins and should have their basins properly constructed and/or repaired. The installation of plants in the DG-4A mitigation area appears to have been completed successfully and the installation of the replacement container plants should increase native cover. The current issues identified during the monitoring visit are not expected to have an effect on the continued growth of the plants in the mitigation area. Photos 5 through 9 in Appendix B document the mitigation area during the monitoring visit.

Nonnative weed cover in the DG-4A mitigation area ranged from approximately 1 to 20 percent during the monitoring visit with the northern section of the mitigation area and the portions of the mitigation area where replacement plants were recently installed showing the lowest level of weed cover and signs of recent weed abatement and the middle section of the mitigation area showing the highest level of

weed cover. Nonnative species observed included tree of heaven (*Ailanthus altissima*), black mustard, poison hemlock, perennial pepperweed, and tree tobacco (*Nicotiana glauca*). Most of the nonnative weeds observed in this mitigation area were just starting to germinate; however, some of the black mustard was starting to flower and will soon go to seed. These areas should be weeded prior to seed production. As weed abatement continues in the mitigation areas, it is anticipated that the seed bank of nonnative and invasive weeds will decrease; however, perennial pepperweed easily resprouts from rhizomatous roots that can be difficult to fully remove with hand tools.

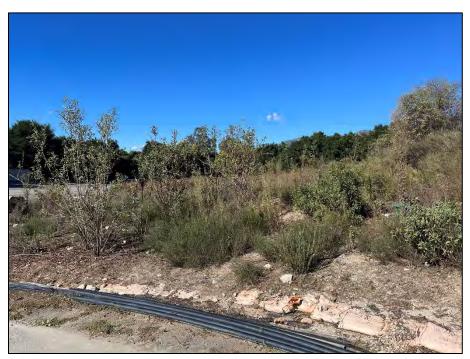
Photo 10: Overview Tire Wash

The overall health of the container plants in the Tire Wash mitigation area was noted as being good. Approximately 5 percent of the container plants were noted as showing varied levels of stress, which is approximately 5 to 10 percent less than the percentage of plants that were showing stress during the previous monitoring visit. During the monitoring visit, replacement container plants were noted as having been installed to replace the container plants that appeared to be dead or in a condition unlikely to recover during previous monitoring visits. Stress may be occurring due to similar reasons described for DG-4 WOUS and DG-4 WOUS Connections. Formal mortality counts will be taken for the Tire Wash during the 2024 quantitative monitoring and will be included in the 2024 annual reporting. Some of the container plants were noted as lacking well defined basins and should have their basins properly constructed and/or repaired. The installation of plants in the Tire Wash mitigation area appears to have been completed successfully. The current issues identified during the monitoring visit are not expected to have an effect on the continued growth of the plants in the mitigation area. Photo 10 in Appendix B documents the mitigation area during the monitoring visit.

Nonnative weed cover in the Tire Wash mitigation area was estimated at approximately 5 percent, which is approximately 3 percent more than the level of nonnative cover that was observed during the previous monitoring visit. Nonnative species observed included black mustard. Most of the nonnative weeds observed in this mitigation area were just starting to germinate; however, some were starting to flower and will soon go to seed. These areas should be weeded prior to seed production. As weed abatement continues in the mitigation areas, it is anticipated that the seed bank of nonnative and invasive weeds will decrease; however, perennial pepperweed easily resprouts from rhizomatous roots that can be difficult to fully remove with hand tools.

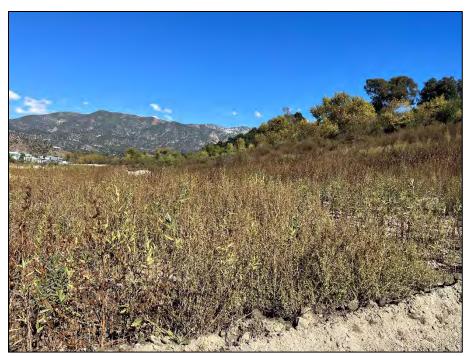
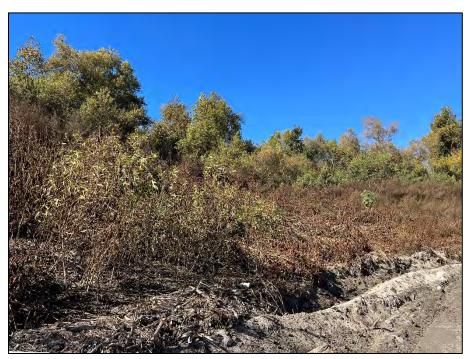
Container plants were not installed on the Side Slopes, but a portion of these areas were seeded with native plant species. Native plant growth was noted throughout the Side Slopes, likely both from natural recruitment and from seeding. Portions of the Side Slopes that were previously noted as having significant erosion that occurred as a result of heavy rainfall during the 2023 wet season and following the tropical

storm that occurred in late August 2023 were noted as having been repaired during the previous monitoring visit and will be seeded during the fall/winter of 2023/2024. Native plants such as annual bursage, mulefat, tall flatsedge, Canada horseweed, telegraph weed, black willow, and rough cocklebur (*Xanthium strumarium*) were observed sprouting on the Side Slopes. In addition, California dodder was observed growing on some of the shrubs on the Side Slopes, which could lead to future decline of these shrubs. Overall native cover was estimated to be approximately 40 percent during the monitoring visit; however, native cover in the areas without erosion was estimated to be 50 to 55 percent. Photos 11 and 12 in Appendix B document the Side Slopes during the monitoring visit.

Nonnative weed cover on the Side Slopes was estimated at approximately 5 to 10 percent, which is approximately 5 percent less than the level of weed cover that was observed during the previous monitoring visit and portions of the Side Slopes had evidence of recent weed abatement. Nonnative species observed on the Side Slopes included black mustard, perennial pepperweed, tree tobacco, and castor bean (*Ricinus communis*). Most of the nonnative weeds observed in this mitigation area were just starting to germinate; however, some were starting to flower and will soon go to seed. These areas should be weeded prior to seed production. As weed abatement continues in the mitigation areas, it is anticipated that the seed bank of nonnative and invasive weeds will decrease; however, perennial pepperweed easily resprouts from rhizomatous roots that can be difficult to fully remove with hand tools.

Portions of the Side Slopes that were previously noted as having significant erosion that occurred as a result of heavy rainfall during the 2023 wet season and following the tropical storm that occurred in late August 2023 were noted as having been repaired during the previous monitoring visit and will be seeded during the fall/winter of 2023/2024. As more perennial plants become established on the Side Slopes, erosion should become less of an issue; however, action will need to be taken to repair the damage caused by the erosion and measures should be taken to reduce damage from erosion in the future. Supplemental seeding of the Side Slopes should be implemented following the repair of the Side Slopes. During future monitoring events, erosion should continue to be monitored in all planted areas and if warranted, erosion Best Management Practices should be installed in appropriate areas. This may only require the installation of straw wattles at select sites to prevent existing rills from becoming larger.
