June 17, 2025
2023-005.07

**Re: *Devil's Gate Reservoir Restoration Project – Phase 2 Restoration Qualitative Monitoring
Conducted on February 10, 2025***

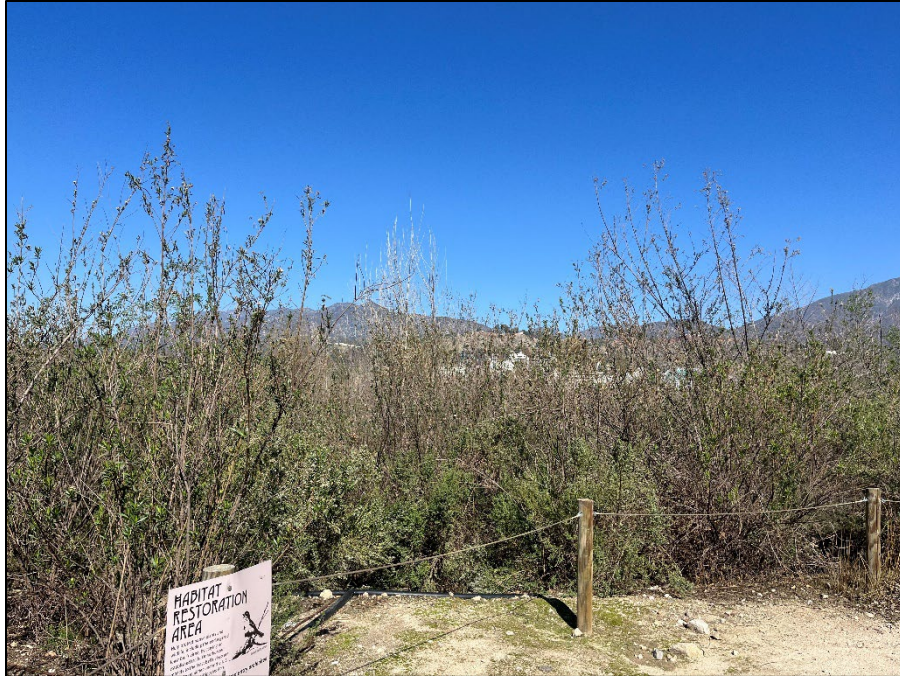
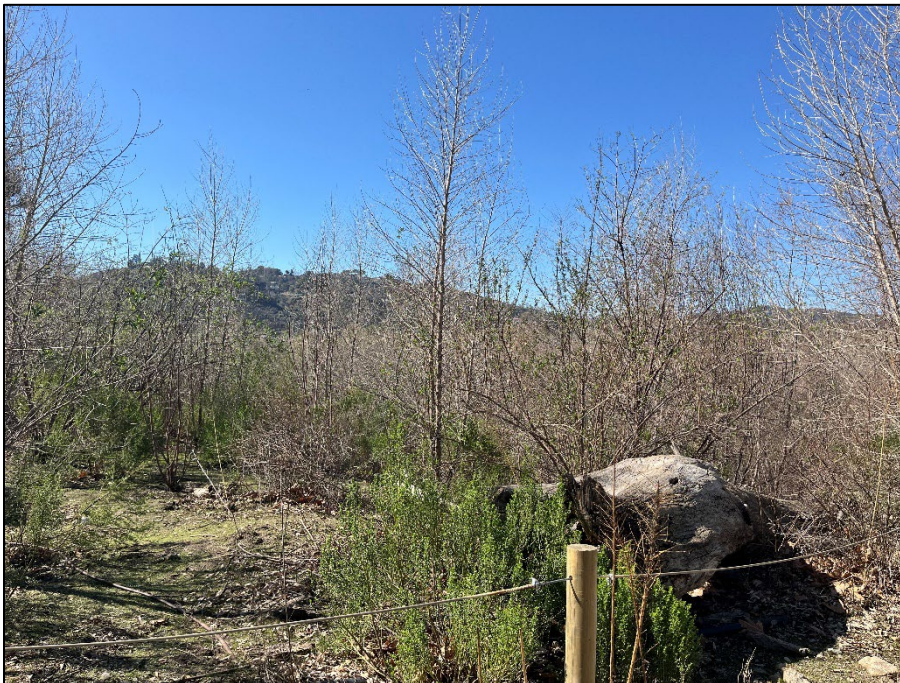
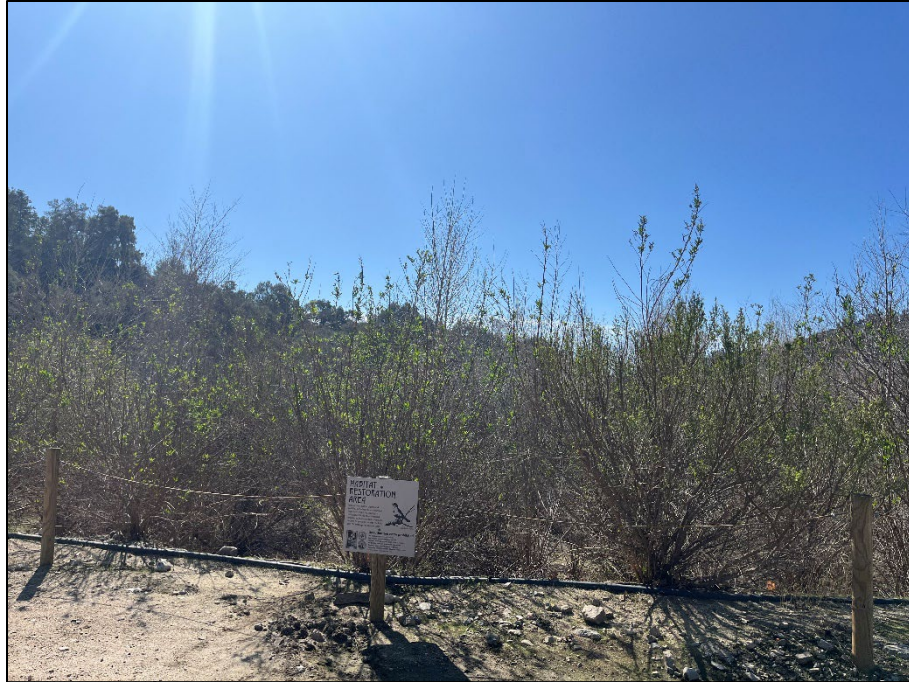
The overall health of the container plants in DG-W-1 was noted as being good. Approximately less than 5 percent of the container plants in DG-W-1 were noted as showing varied levels of stress and a negligible number were noted as dead or missing. This is approximately the same percentage of plants that were showing stress during the last monitoring event. Stress may be occurring because of competition from nonnative and invasive weeds or recreational traffic through the mitigation areas. Photos 1 through 3 in Attachment B document the mitigation area during the monitoring visit.

Photo 1: Overview Mitigation Area DG-W-1 (Johnson Field)

Photo 2: Overview Mitigation Area DG-W-1 (Johnson Field)

Photo 3: Overview Mitigation Area DG-W-1 (Johnson Field)

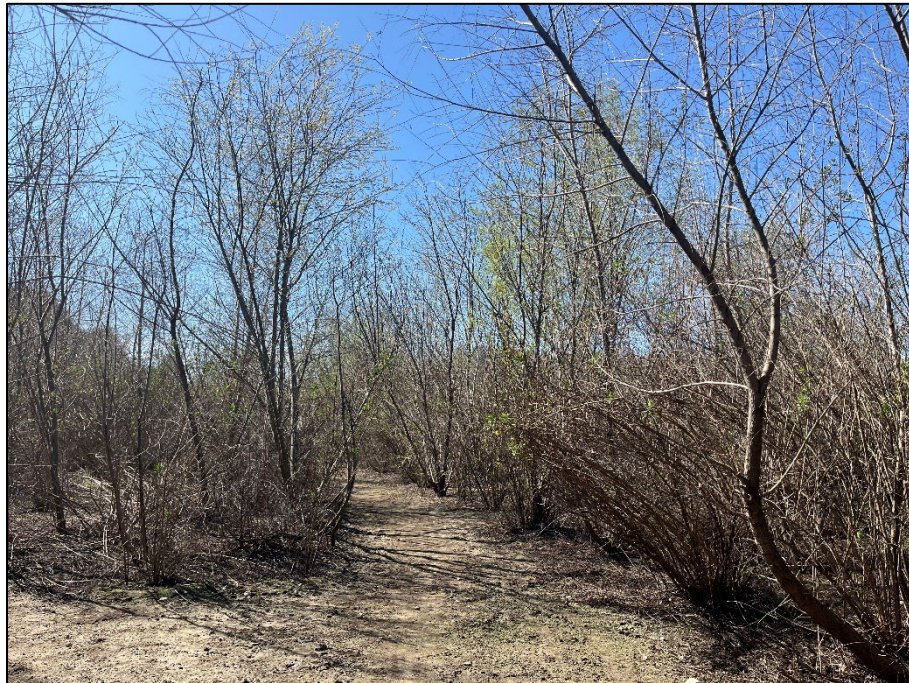
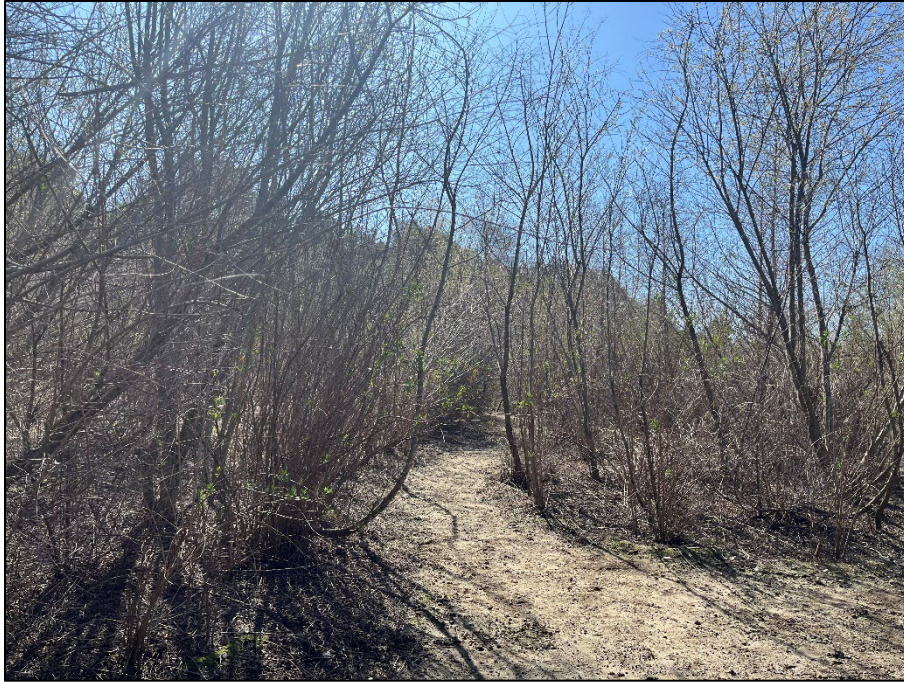
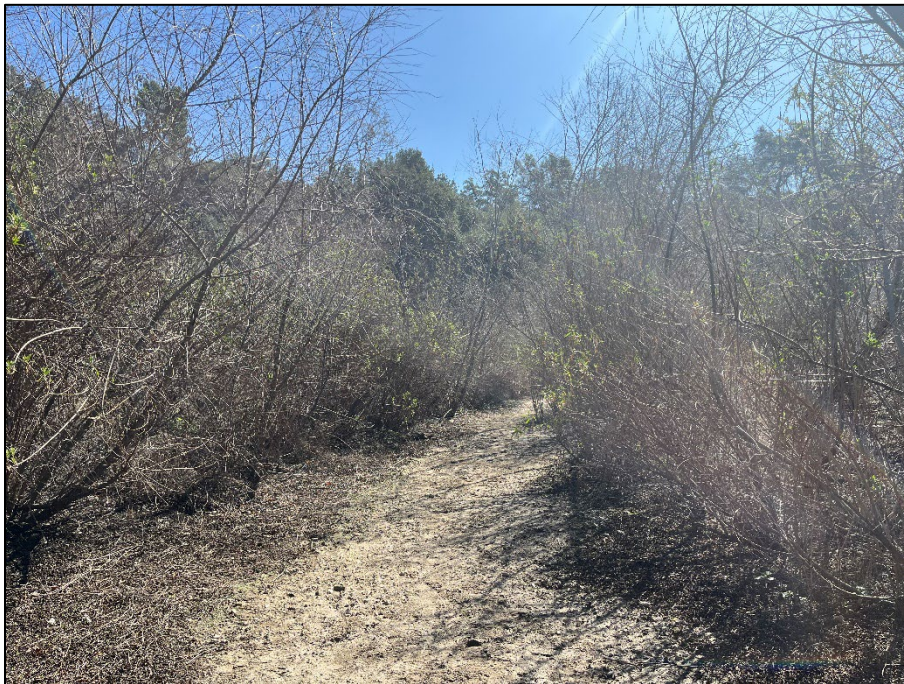
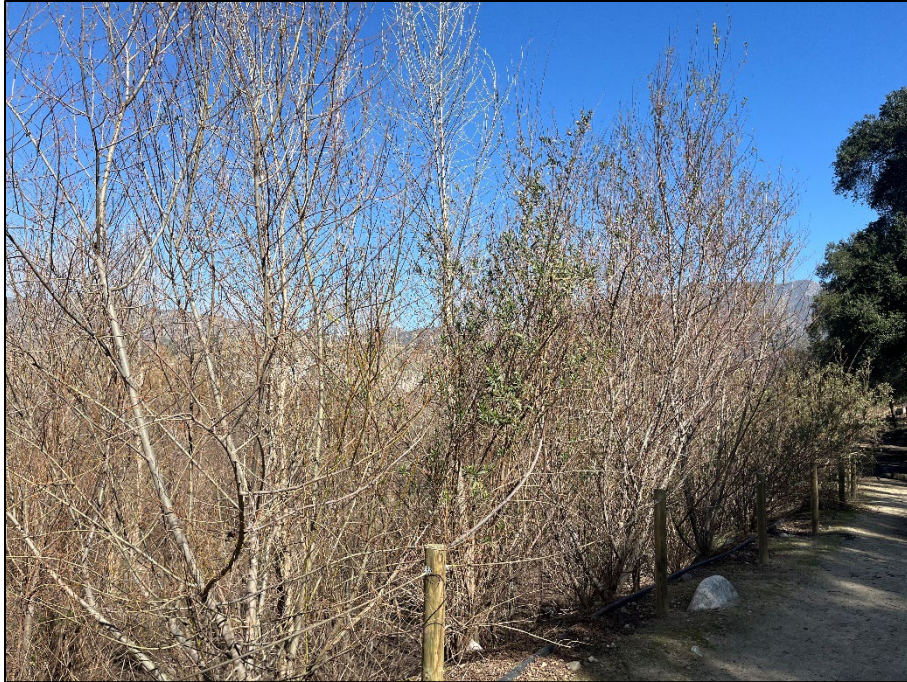
The overall health of the container plants in DG-2, DG-2 New Channels, and DG-2 WOUS was noted as being good. Approximately less than 5 percent of the container plants were noted as showing varied levels of stress and a negligible number were noted as dead or missing. This is approximately the same percentage of plants that were showing stress during the last monitoring event. Stress may be occurring due to similar reasons described for DG-W-1. During the monitoring visit, the grade control structure that was installed at the northern end of DG-2 New Channels where the channels connect to DG-W-1 was inspected for erosion. Minor erosion was observed, mostly towards the western end of the structure; however, no major erosion issues were observed, and the structure appears to be functioning properly. Photos 4 through 7 in Attachment B document the mitigation areas during the monitoring visit.

Photo 4: Overview Mitigation Area DG-2 & DG-2 New Channels

Photo 5: Overview Mitigation Area DG-2 & DG-2 New Channels

Photo 6: Overview Mitigation Area DG-2 & DG-2 WOVS

Photo 7: Overview Mitigation Area DG-2 & DG-2 WOUS

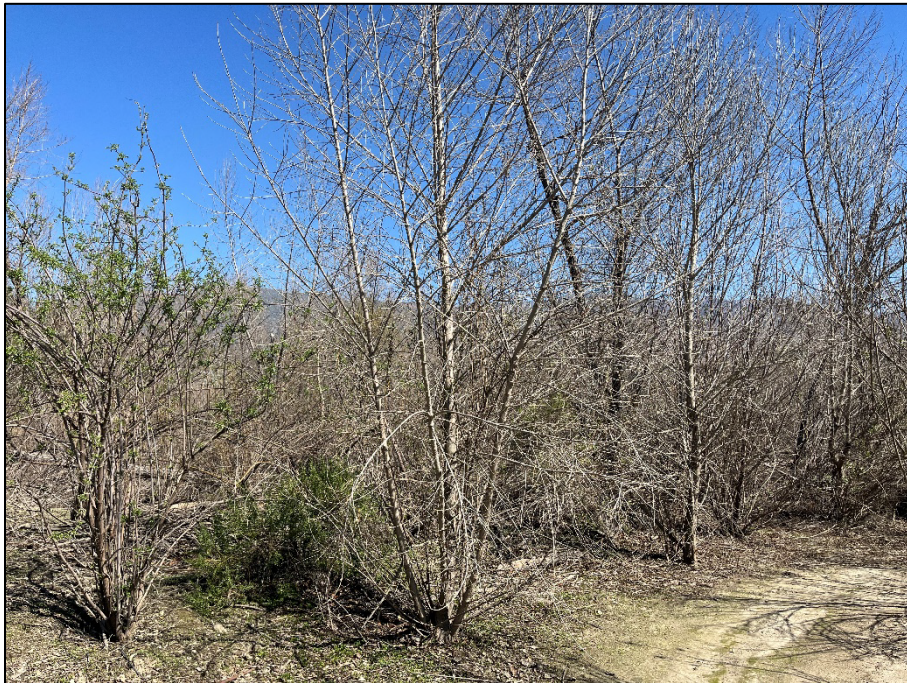
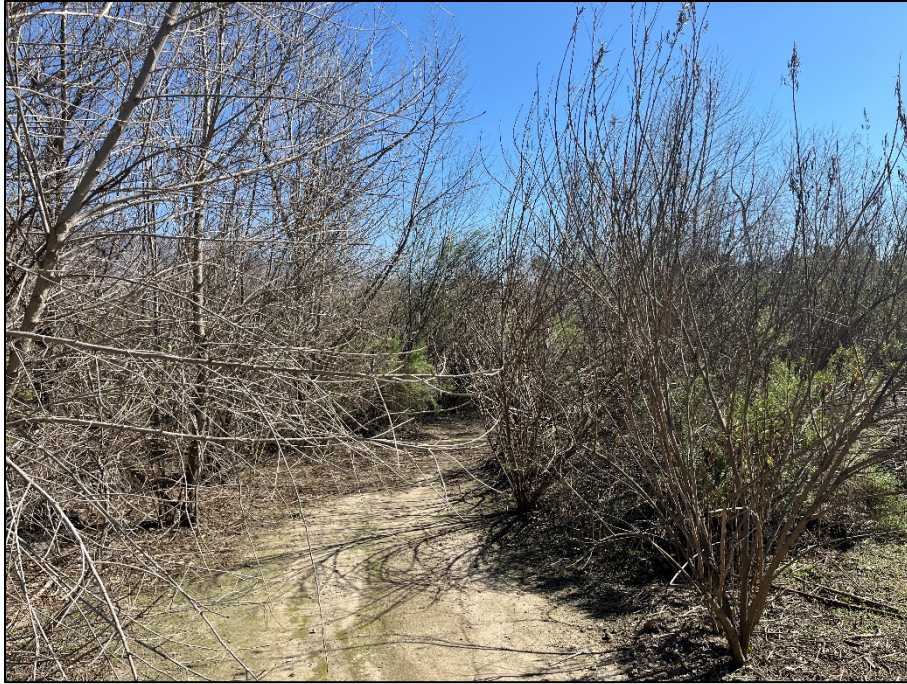
The overall health of the container plants in mitigation area DG-W-2 was noted as being good. Approximately less than 5 percent of the container plants were noted as showing varied levels of stress and a negligible number were noted as dead or missing. This is approximately the same percentage of plants that were showing stress during the last monitoring event. Stress may be occurring due to similar reasons described for DG-W-1. Photos 8 and 9 in Attachment B document the mitigation area during the monitoring visit.

During the monitoring visit, it was noted that many of the remaining mature black willows (*Salix gooddingii*) in this mitigation area were continuing to show signs of recovery from the invasive shot-hole borer (ISHB) infestation that was confirmed by the Los Angeles County Department of Agricultural Commissioner/Weights & Measures in December of 2021. The evidence of recovery on the willows that were left in place includes vigorous sprouting from the base of the trees. Most of the dead and hazardous black willows in this mitigation area were removed in October of 2022. Black willows that were determined to have the potential to recover were left in place and will continue to be monitored during the qualitative monitoring visits.

Photo 8: Overview Mitigation Area DG-W-2 (Mining Pit)

Photo 9: Overview Mitigation Area DG-W-2 (Mining Pit)

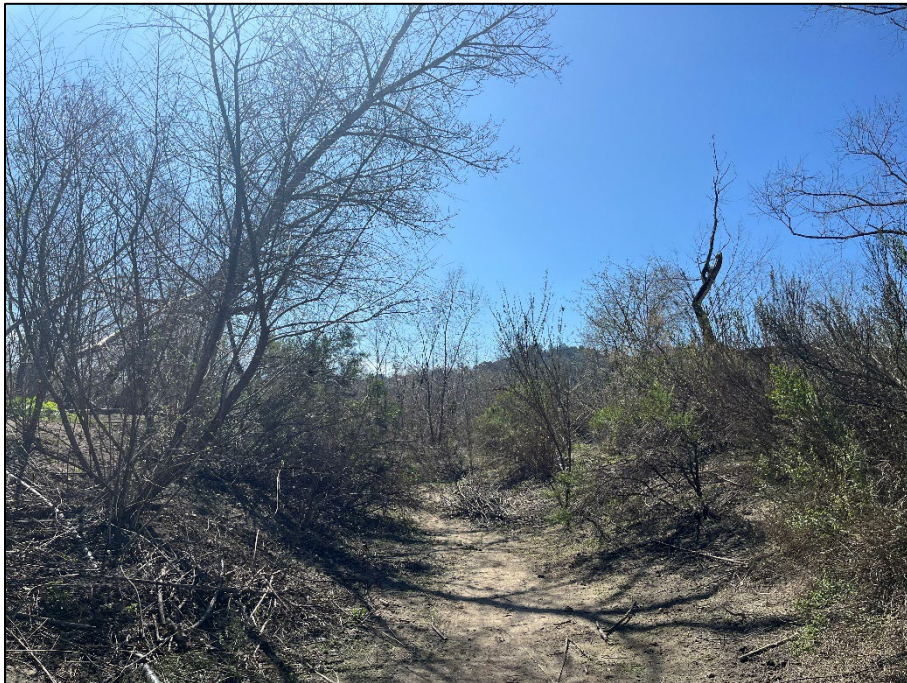
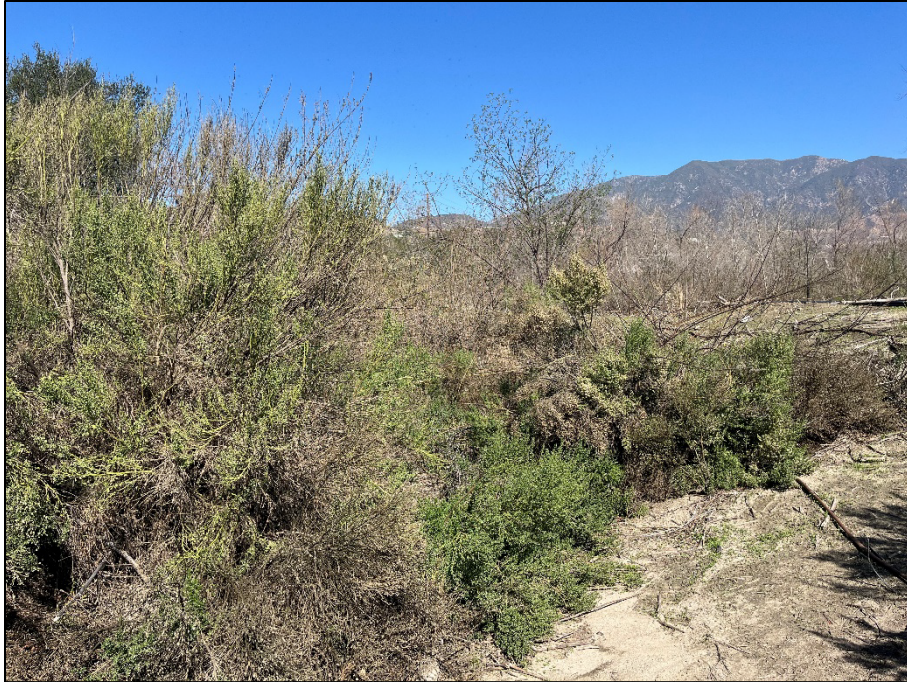
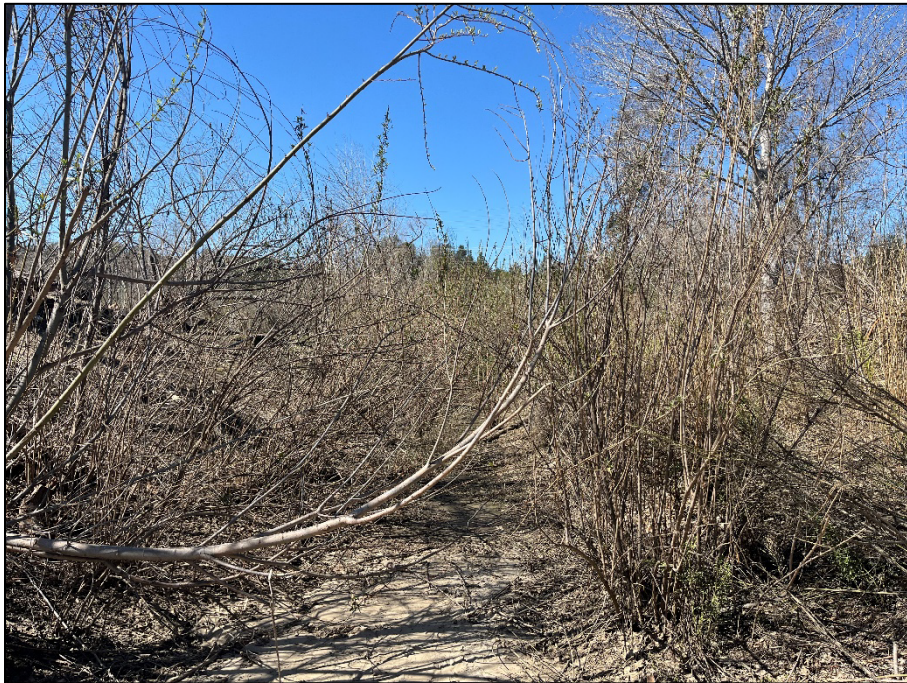
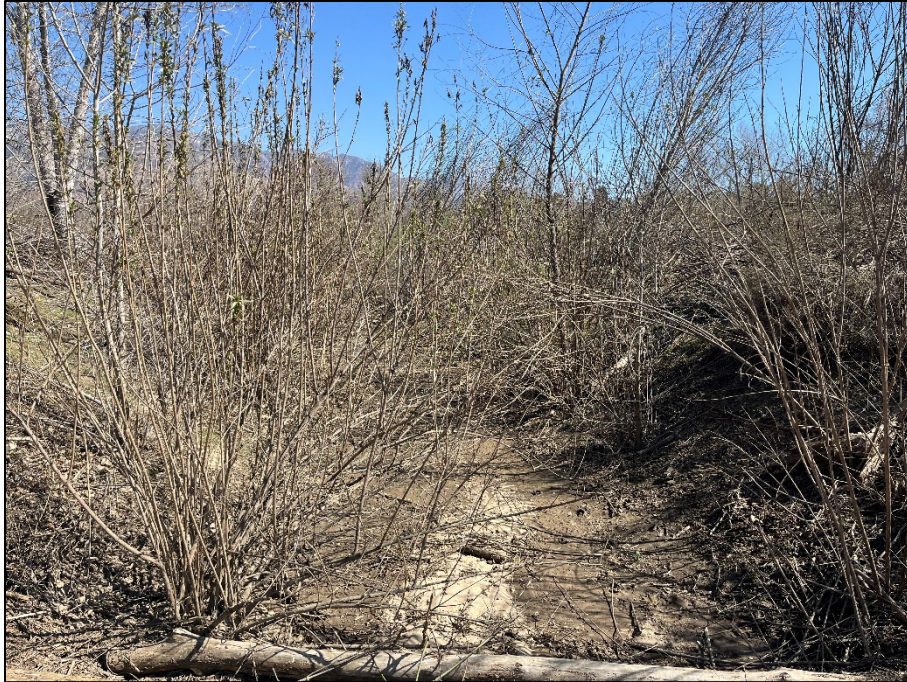
The overall health of the container plants in mitigation area DG-W-2 Outlet was noted as being good. Approximately 5 percent of the container plants were noted as showing varied levels of stress and a negligible number were noted as being dead or missing. This is approximately the same as the percentage of plants that were showing stress during the last monitoring event. Stress may be occurring due to similar reasons described for DG-W-1. Photos 10 through 13 in Attachment B document the mitigation area during the monitoring visit.

Photo 10: Overview Mitigation Area DG-W-2 Outlet

Photo 11: Overview Mitigation Area DG-W-2 Outlet

Photo 12: Overview Mitigation Area DG-W-2 Outlet

Photo 13: Overview Mitigation Area DG-W-2 Outlet

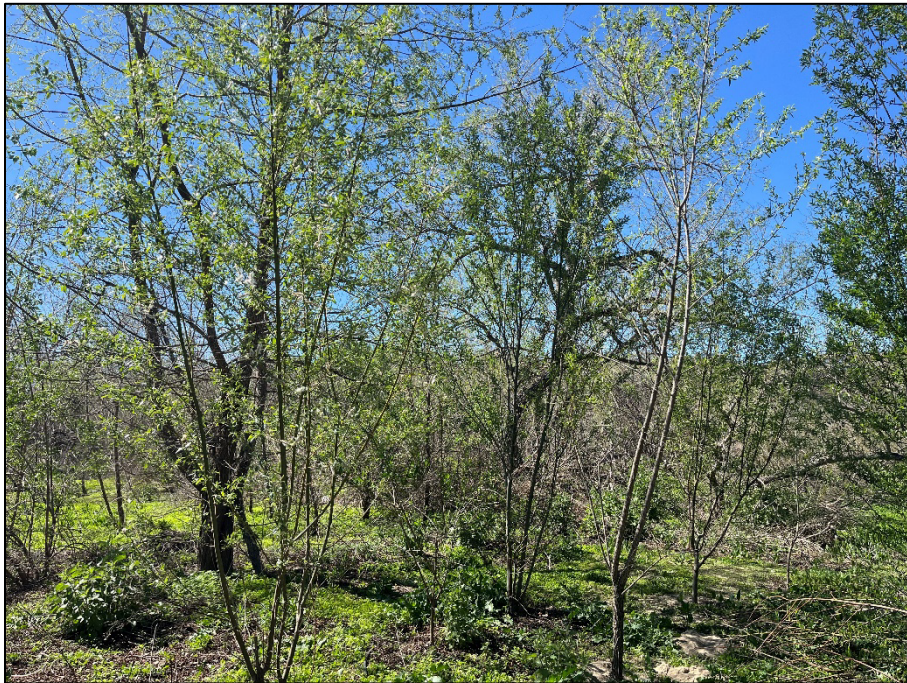
The overall health of the container plants in mitigation areas DG-4 Sheet Flow (northern) and DG-SF-1 were noted as being good. Approximately less than 5 percent of container plants were showing varied levels of stress, which is approximately the same percentage of container plants that were showing stress during the previous monitoring event. Stress may be occurring due to similar reasons described for DG-W-1. Photo 14 in Attachment B documents the mitigation area during the monitoring visit.

Photo 14: Overview Mitigation Area DG-SF-1
