October 3, 2023  
2017-116.006

**Re: *Devil's Gate Reservoir Restoration Project – Phase 2 Restoration Qualitative Monitoring Conducted on August 23, 2023***

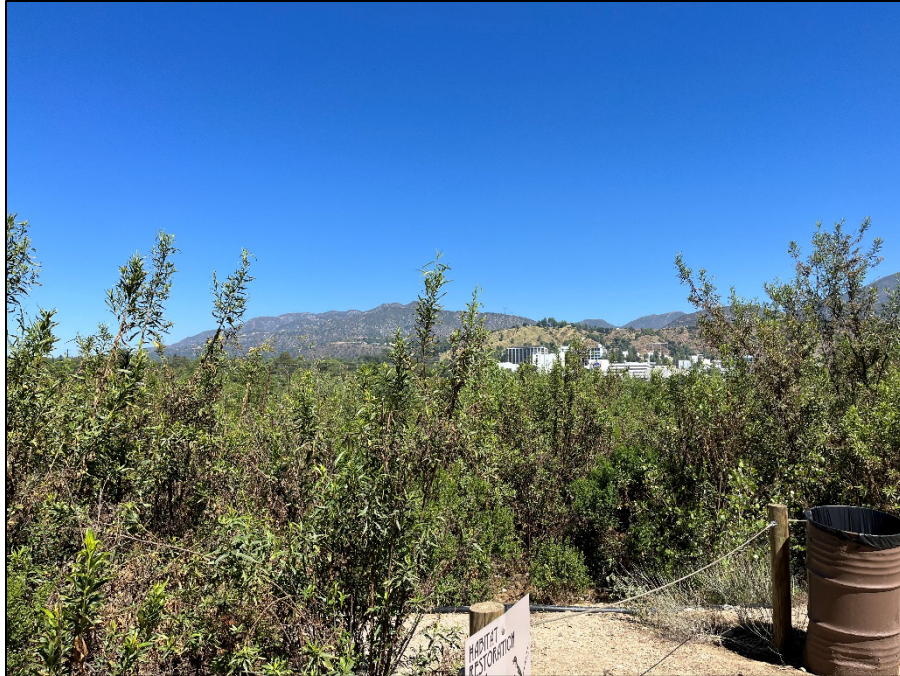
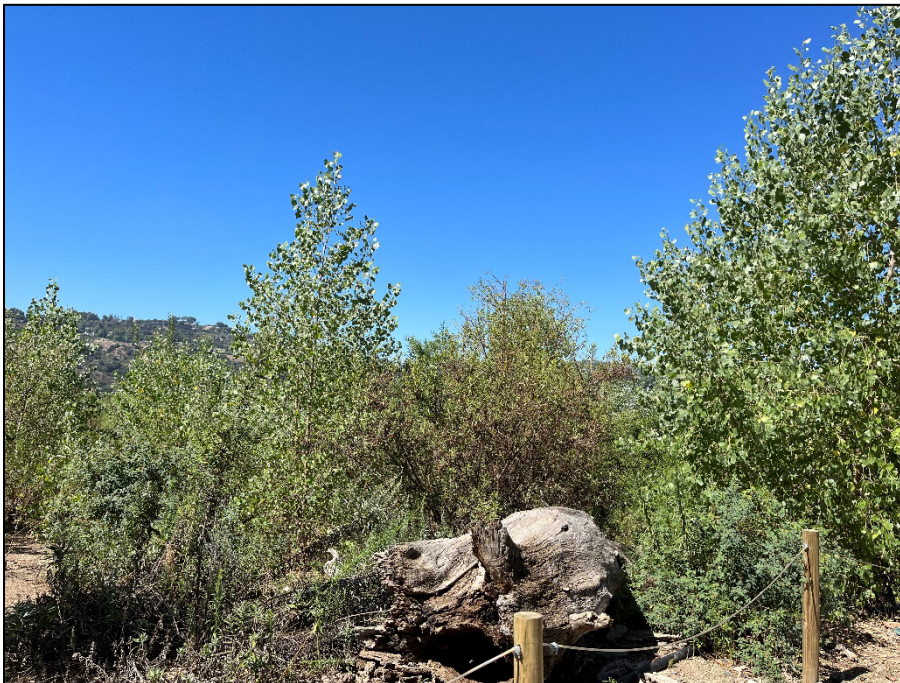
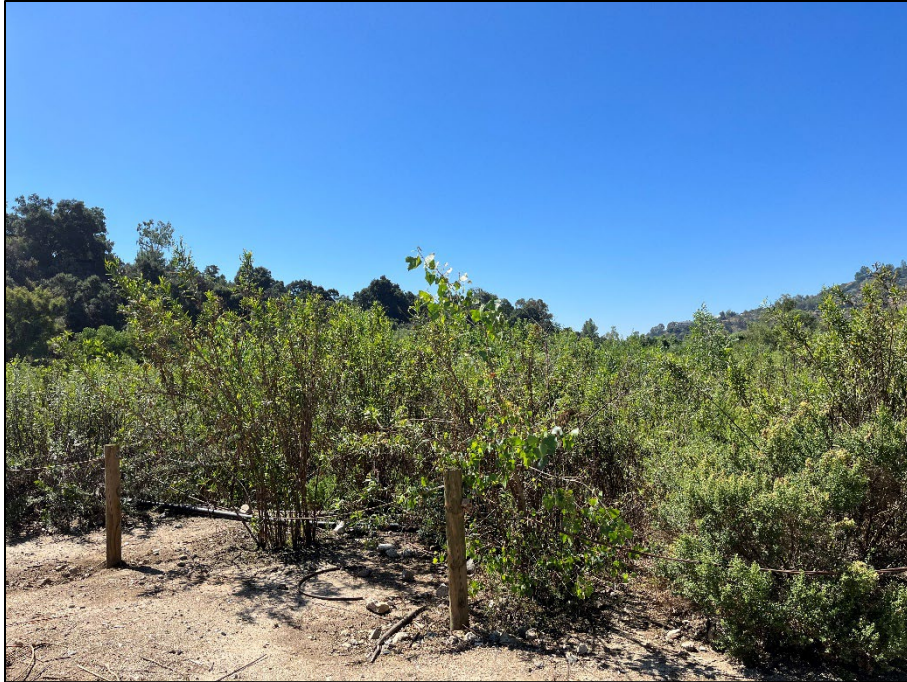
Photo 1: Overview Mitigation Area DG-W-1 (Johnson Field)

The overall health of the container plants in DG-W-1 was noted as being good. Approximately five percent of the container plants in DG-W-1 were noted as showing varied levels of stress and a negligible number were noted as being dead or missing. This is approximately the same percentage of plants that were showing stress during the last monitoring event. Stress may be occurring as a result of 1) competition from nonnative and invasive weeds, 2) misplaced emitters, or 3) recreational traffic through the mitigation areas. In addition, some of the willows were showing signs of dieback from rust fungus (*Melampsora* sp.). A handful of Fremont's cottonwoods (*Populus fremontii*) were also showing minor dieback which appeared to be the result of natural recruitment of mulefat within their basins. Evidence of dieback from *Phytophthora cactorum*, including wilting, stunted growth, leaf spotting, and/or browning along leaf margins and tips, was not observed on any of the container plants. The willows and Fremont's cottonwoods in this mitigation area were no longer showing signs of seasonal dieback during the monitoring visit. Formal mortality counts were taken for DG-W-1 during the 2021, 2022, and 2023 quantitative monitoring events. Some of the container plants were noted as lacking well defined basins and should have their basins properly constructed and/or repaired. The irrigation line appeared to be functioning properly for the mitigation area during the monitoring visit. The installation of plants in the DG-W-1 mitigation area appears to have been completed successfully. The current issues identified during the monitoring visit are not expected to have an effect on the continued growth of the plants in the mitigation area. Photos 1 through 3 in Attachment B document the mitigation area during the monitoring visit.

*grandiflora*) were observed sprouting in the DG-W-1 mitigation area. The California dodder growing on the container plants should be removed during weed abatement activities. Native cover was estimated to be approximately 80 percent in the DG-W-1 mitigation area.

Nonnative weed cover in DG-W-1 was estimated at approximately one percent, which is approximately nine percent lower than the level of weed cover that was observed during the previous monitoring visit. It should be noted that weed cover in this mitigation area during the summer of 2022 was approximately less than one percent showing that this mitigation area has consistently low nonnative weed cover. Nonnative species observed in DG-W-1 included black mustard (*Brassica nigra*), poison hemlock (*Conium maculatum*), and perennial pepperweed (*Lepidium latifolium*). Most of the nonnative weeds observed in this mitigation area were still vegetative and just beginning to germinate.

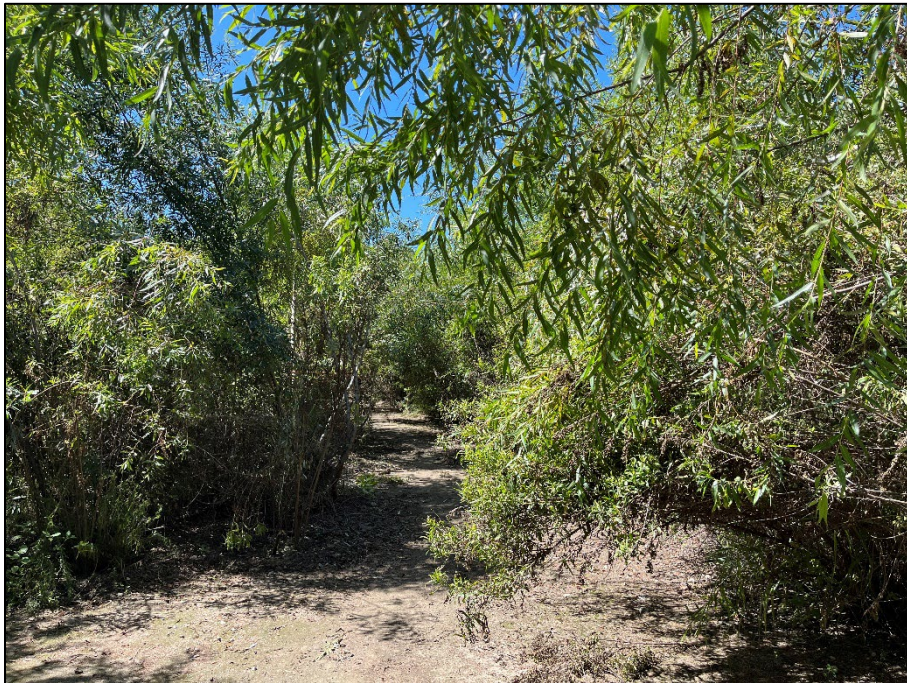
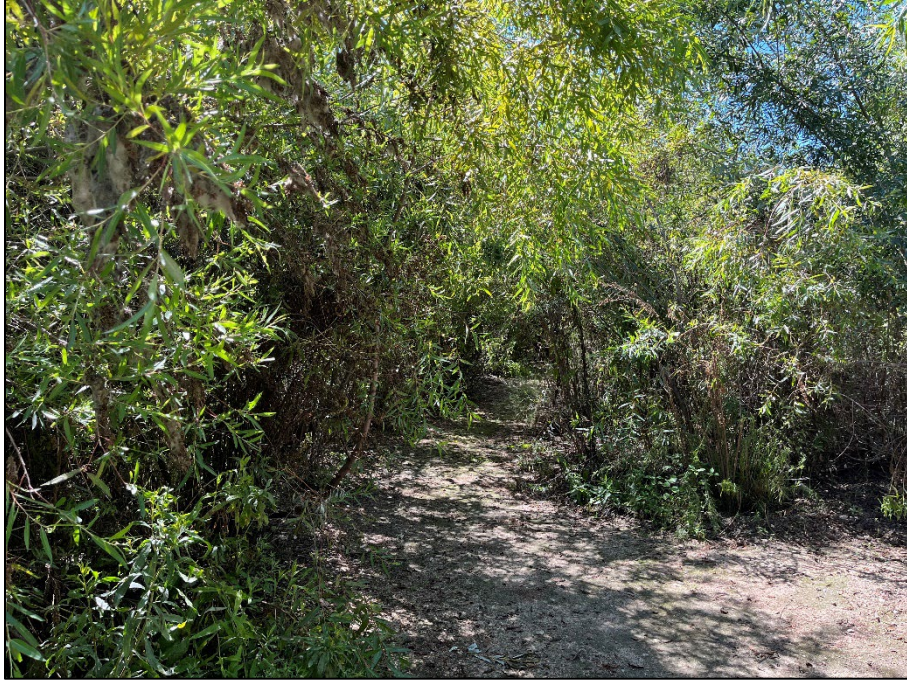
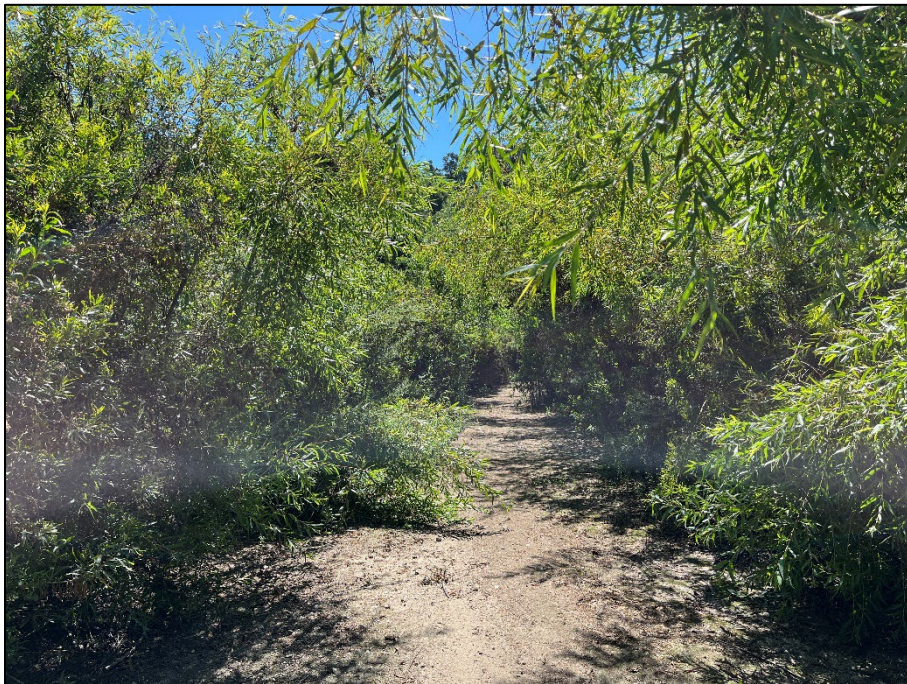
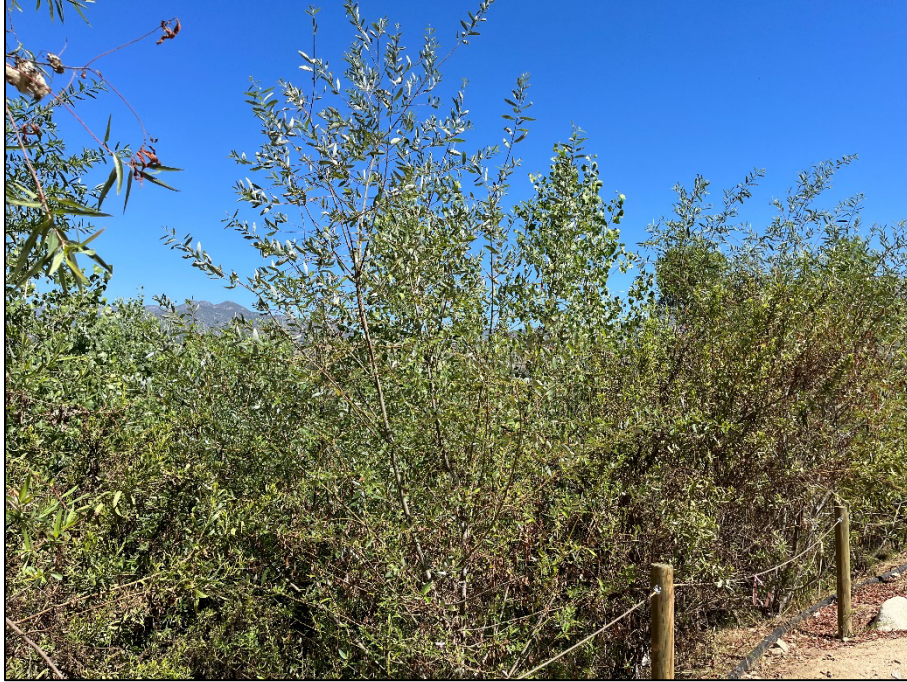
Photo 4: Overview Mitigation Area DG-2 & DG-2 New Channels

The overall health of the container plants in DG-2, DG-2 New Channels, and DG-2 WOUS was noted as being good. Approximately less than five percent of the container plants were noted as showing varied levels of stress and a negligible number were noted as being dead or missing. This is approximately the same percentage of plants that were showing stress during the last monitoring event. Stress may be occurring due to similar reasons described for DG-W-1. Evidence of dieback from *Phytophthora cactorum*, including wilting, stunted growth, leaf spotting, and/or browning along leaf margins and tips, was not observed on any of the container plants. Similar to DG-W-1, the willows and Fremont's cottonwoods in this mitigation area were no longer showing signs of seasonal dieback. Formal mortality counts were taken for DG-2, DG-2 New Channels, and DG-2 WOUS during the 2021, 2022, and 2023 quantitative monitoring events. Some of the container plants were noted as lacking well defined basins and should have their basins properly constructed and/or repaired. The irrigation line appeared to be functioning properly during the monitoring visit. During the monitoring visit, the grade control structure that was installed at the northern end of DG-2 New Channels where the channels connect to DG-W-1 was inspected for erosion. Minor erosion was observed, mostly towards the western end of the structure; however, no major erosion issues were observed, and the structure appears to be functioning properly. The installation of plants in the DG-2, DG-2 New Channels, and DG-2 WOUS mitigation areas appears to have been completed successfully. The current issues identified during the monitoring visit are not expected to have an effect on the continued growth of the plants in the mitigation area. Photos 4 through 7 in Attachment B document the mitigation areas during the monitoring visit.

Native plant growth was noted throughout the DG-2, DG-2 New Channels, and DG-2 WOUS mitigation areas, likely from both natural recruitment and from seeding. Native plants such as mugwort, mulefat, Canada horseweed, Douglas' nightshade (*Solanum douglasii*), and stinging nettle (*Urtica dioica*) were observed sprouting in the mitigation areas. The California dodder that was observed growing on some of the container plants during the previous monitoring visit appeared to have been removed. Native cover was estimated to be approximately 80 percent in the DG-2, DG-2 New Channels, and DG-2 WOUS mitigation areas.

Nonnative weed cover in the DG-2, DG-2 New Channels, and DG-2 WOUS mitigation areas was estimated at approximately one percent, which is approximately four percent lower than the percentage that was

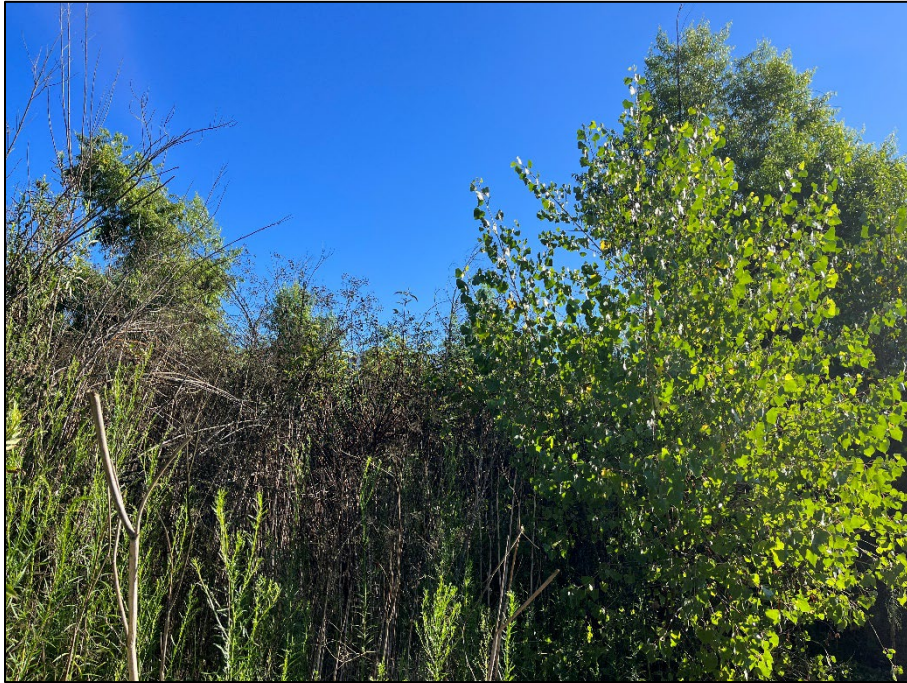
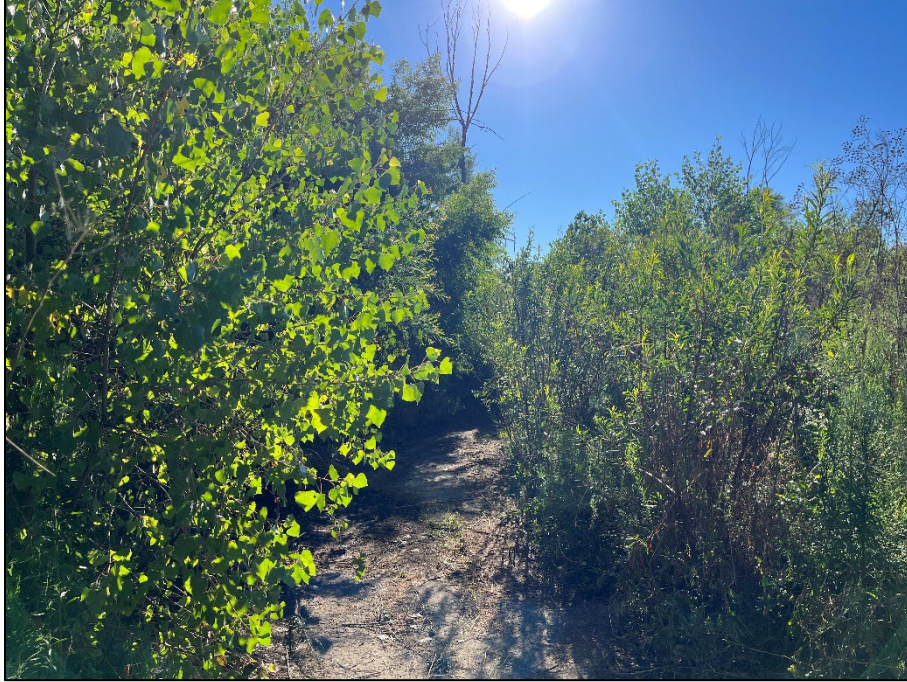
Photo 8: Overview Mitigation Area DG-W-2 (Mining Pit)

The overall health of the container plants in mitigation area DG-W-2 was noted as being good. Approximately five percent of the container plants were noted as showing varied levels of stress and a negligible number were noted as being dead or missing. This is approximately five percent less than the percentage of plants that were showing stress during the last monitoring event. Stress may be occurring due to similar reasons described for DG-W-1. Evidence of dieback from *Phytophthora cactorum*, including wilting, stunted growth, leaf spotting, and/or browning along leaf margins and tips, was not observed on any of the container plants. Similar to DG-W-1, the willows and Fremont's cottonwoods in this mitigation area were no longer showing signs of seasonal dieback. Formal mortality counts were taken for DG-W-2 during the 2021, 2022, and 2023 quantitative monitoring events. Some of the container plants were noted as lacking well defined basins and should have their basins properly constructed and/or repaired. The irrigation line appeared to be functioning properly for most areas of the mitigation area during the monitoring visit; however, some basins appeared to be dry and should be inspected for functionality. The installation of plants in the DG-W-2 mitigation area appears to have been completed successfully and the issues noted during the monitoring are not expected to have an impact on the continued growth of the plants. Photos 8 and 9 in Attachment B document the mitigation area during the monitoring visit.

During the monitoring visit, it was noted that many of the remaining mature black willows (*Salix gooddingii*) in this mitigation area were showing signs of recovery, such as sprouting vigorously from the base, from the polyphagous shot-hole borer (PSHB) infestation that was confirmed by the Los Angeles County Department of Agricultural Commissioner/Weights & Measures in December of 2021. However, some additional black willows were observed to have fallen over during the recent storm event. The majority of the dead and hazardous black willows in this mitigation area were removed in October of 2022. Black willows that were determined to have the potential to recover were left in place and will continue to be monitored during the qualitative monitoring visits.

Nonnative weed cover in DG-W-2 was estimated at approximately 10 percent in the mitigation area, which is approximately 25 percent less than the level of nonnative cover that was observed during the last monitoring event. It should be noted that weed cover in this mitigation area during the summer of 2022

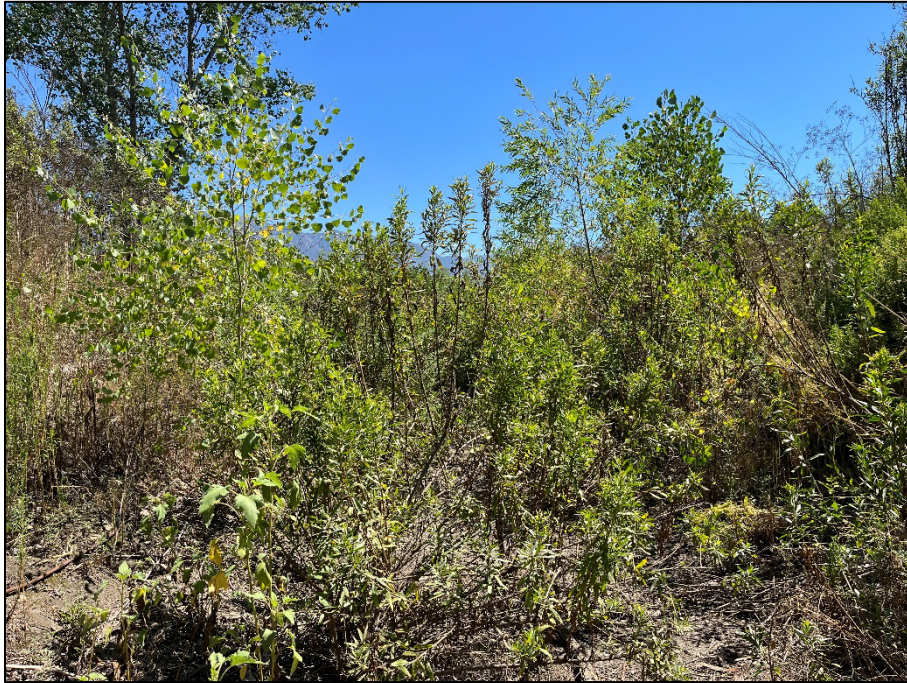
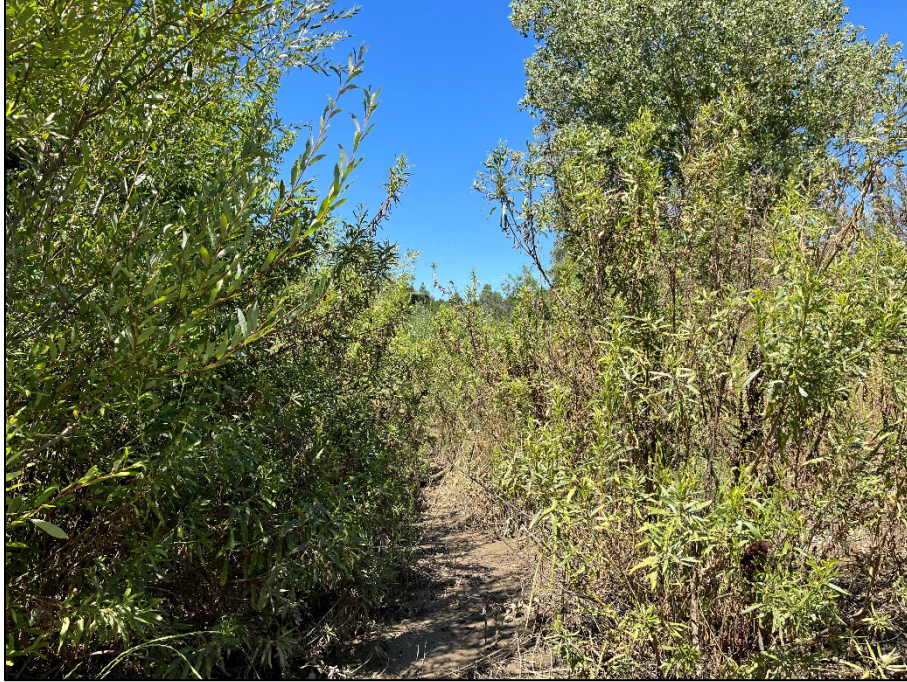
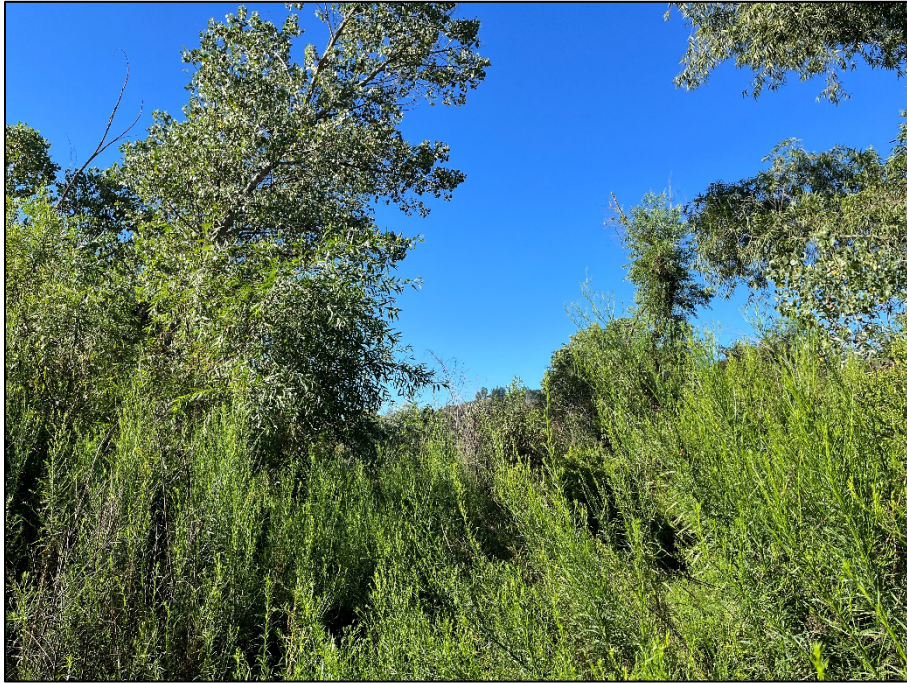
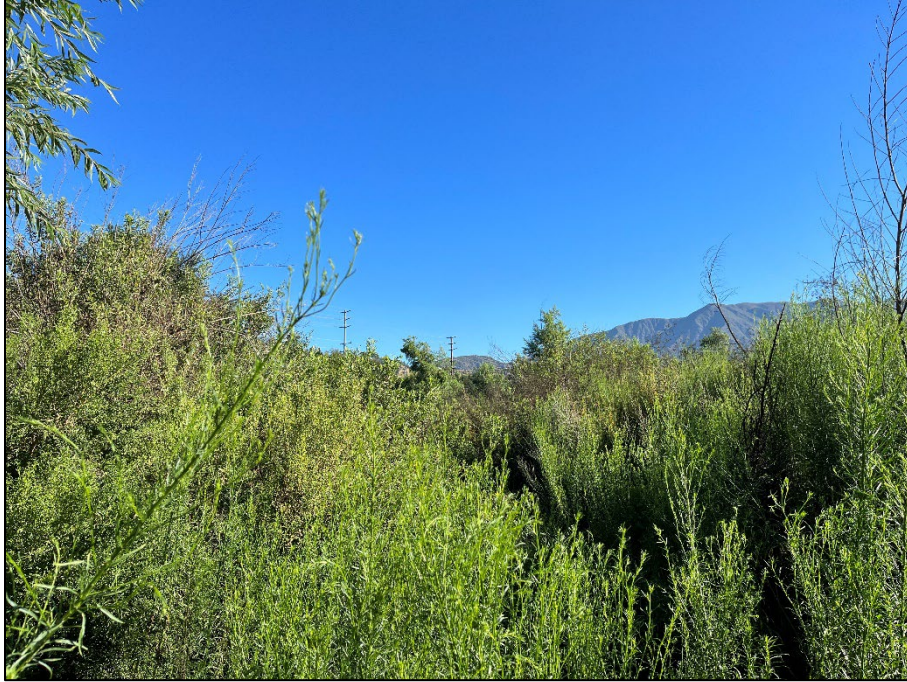
Photo 10: Overview Mitigation Area DG-W-2 (Mining Pit Outlet)

The overall health of the container plants in mitigation area DG-W-2 Outlet was noted as being good. Approximately 10 percent of the container plants were noted as showing varied levels of stress and a negligible number were noted as being dead or missing. This is approximately five percent less than the percentage of plants that were showing stress during the last monitoring event. Stress may be occurring due to similar reasons described for DG-W-1. Evidence of dieback from *Phytophthora cactorum*, including wilting, stunted growth, leaf spotting, and/or browning along leaf margins and tips, was not observed on any of the container plants. Similar to DG-W-1, the willows and Fremont's cottonwoods in this mitigation area were continuing to show signs of seasonal dieback. Formal mortality counts were taken for DG-W-2 Outlet during the 2021, 2022, and 2023 quantitative monitoring events. Some of the container plants were noted as lacking well defined basins and should have their basins properly constructed and/or repaired. The irrigation line appeared to be functioning properly for most areas of the mitigation area during the monitoring visit; however, some basins appeared to be dry and should be inspected for functionality. The installation of plants in the DG-W-2 Outlet mitigation area appears to have been completed successfully and the issues noted during the monitoring are not expected to have an impact on the continued growth of the plants. Photos 10 through 13 in Attachment B document the mitigation area during the monitoring visit.

Native plant growth was noted throughout the DG-W-2 Outlet mitigation area, and what was present is likely from both natural recruitment and from seeding. Native plants such as annual bursage, tall flatsedge (*Cyperus eragrostis*), Canada horseweed, Jimson weed (*Datura wrightii*), many flowered monkeyflower (*Erythranthe floribunda*), and rough cocklebur were observed sprouting in the DG-W-2 Outlet mitigation area. California dodder that was previously noted on container plants appears to have been removed during recent maintenance activities. Native cover was estimated to be approximately 70 percent in the DG-W-2 Outlet mitigation area.

Nonnative weed cover in DG-W-2 Outlet was estimated to be approximately less than five percent, which is approximately 30 percent less than the percentage of weed cover that was observed during the previous monitoring visit. It should be noted that weed cover in this mitigation area during the summer of 2022 was approximately less than one percent showing that this mitigation area has consistently low nonnative weed cover. Nonnative species observed in DG-W-2 included black mustard, Jerusalem oak goosefoot (*Dysphania botrys*), and perennial pepperweed. Most of the nonnative weeds observed in this mitigation area were vegetative and just starting to germinate.

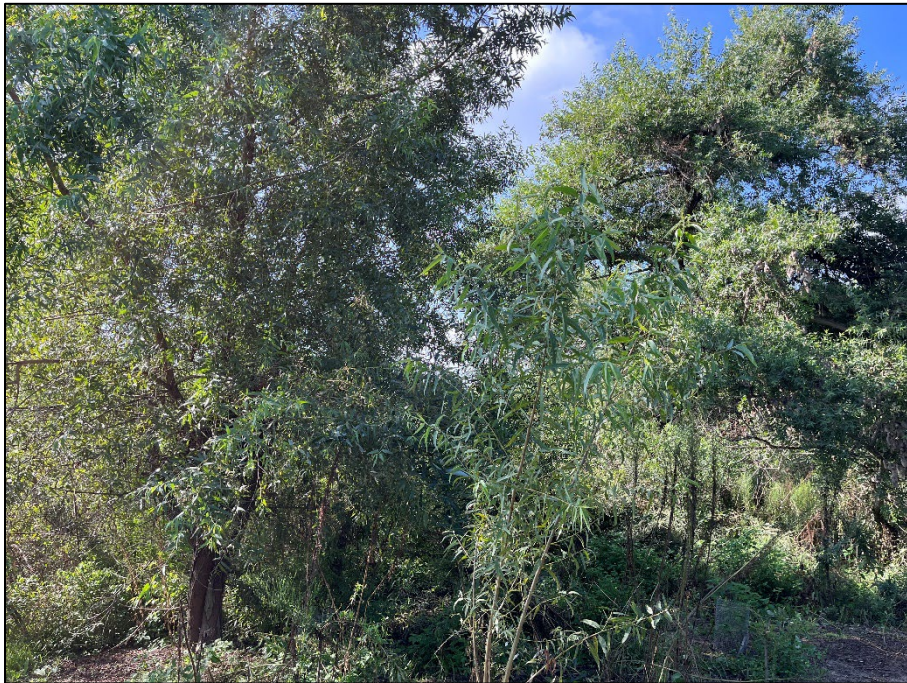
Photo 14: Overview Mitigation Area DG-4 Sheet Flow/Sheet Flow-1

The overall health of the container plants in mitigation areas DG-4 Sheet Flow (northern) and DG-SF-1 was noted as being good. Approximately 10 percent of container plants were showing varied levels of stress which is approximately the same as the percentage of container plants that were showing stress during the previous monitoring event. Stress may be occurring due to similar reasons described for DG-W-1. Evidence of dieback from *Phytophthora cactorum*, including wilting, stunted growth, leaf spotting, and/or browning along leaf margins and tips, was not observed on any of the container plants. Similar to DG-W-1, the willows and Fremont's cottonwoods in this mitigation area were no longer showing seasonal dieback. Formal mortality counts were taken during the 2021, 2022, and 2023 quantitative monitoring events. Some of the container plants were noted as lacking well defined basins and should have their basins properly constructed and/or repaired. The irrigation line appeared to be functioning properly during the monitoring visit. The installation of plants in the DG-4 Sheet Flow and DG-SF-1 mitigation areas appears to have been completed successfully and the issues noted during the monitoring are not expected to have an impact on the continued growth of the plants. Photo 14 in Attachment B document the mitigation area during the monitoring visit.

Minimal native plant germination was noted throughout the DG-4 Sheet Flow and DG-SF-1 mitigation area, and what was present is likely from both natural recruitment and from seeding. Native plants such as mugwort, tall flatsedge, and Canada horseweed were observed sprouting in the DG-4 Sheet Flow and DG-SF-1 mitigation areas. Native cover was estimated to be approximately 55 percent in the DG-4 Sheet Flow/DG-SF-1 mitigation area.

Nonnative weed cover in DG-4 Sheet Flow and DG-SF-1 was estimated at approximately 15 percent, which is approximately 20 percent less than the level of weed cover that was observed during the previous monitoring visit. It should be noted that weed cover in this mitigation area during the summer of 2022 was approximately less than five percent. The minor increase in nonnative cover during the summer of 2023 in this mitigation area is likely due to the increase in precipitation during the 2023 wet season. In addition, bird nests in DG-4 Sheet Flow and DG-SF-1 during the spring and summer of 2023 have prevented crews from being able to conduct weed abatement activities in these areas. Nonnative species observed in DG-4 Sheet Flow and DG-SF-1 included black mustard, poison hemlock, and perennial pepperweed. Most of the nonnative weeds observed in this mitigation area were vegetative and just starting to germinate.
